Lake Magdalene

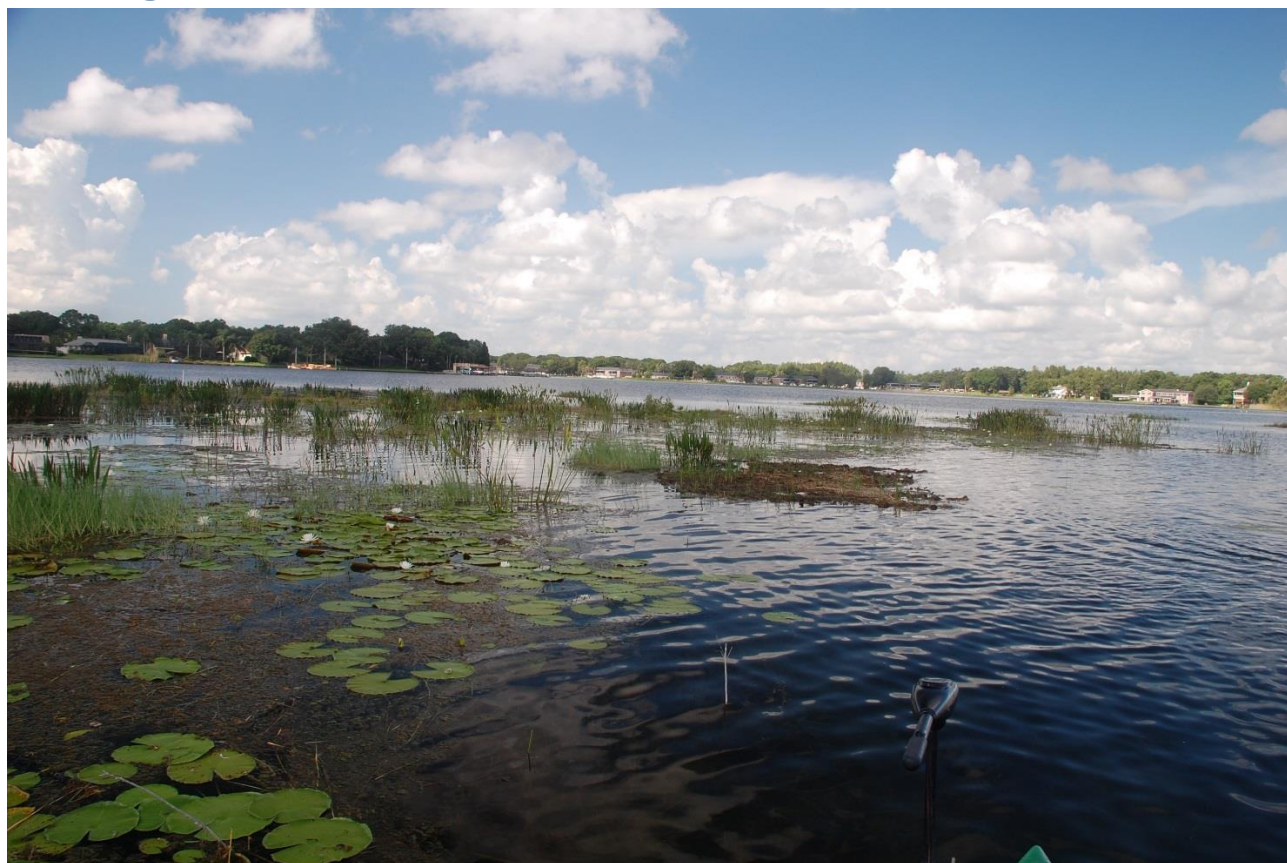
Figure 3 Overview photograph of Lake Magdalene

The lake assessment for Lake Magdalene was conducted on July 26, 2016. Lake Magdalene received a lake habitat assessment (FEDP form FD 9000-6) score of 74 due to suboptimal scores for Secchi, Vegetation Quality, Bottom Substrate Quality and Adverse Watershed Land Use. Marginal scores were achieved for Stormwater Inputs, Lakeside Adverse Human Alterations and Upland Buffer Zone.

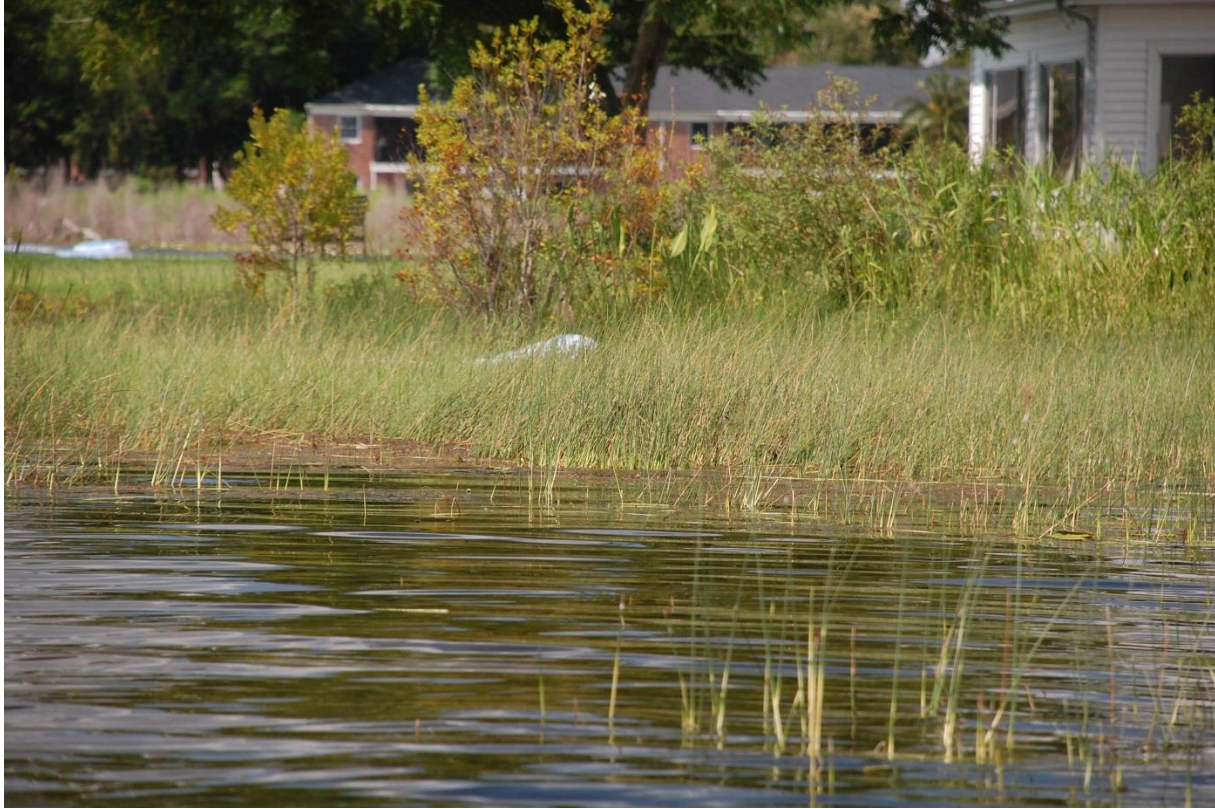
Figure 4 Lake Magdalene had a buffering zone of emergent vegetation surrounding the lake containing a mixture of native and invasive species.

The Lake Vegetation Index identified 57 species of wetland vegetation growing in the four selected sections along Lake Magdalene. The majority of these species (43) are native species. The remaining 14 species (Shown in Bold in Table 2) are non-native and invasive to this region. The vegetation community along Lake Magdalene is dominated by a variety of emergent species including *Typha*, *Panicum repens* and *Melaleuca quinquenervia* (Figure 5). The water's surface in Lake Magdalene was dominated by *Nymphaea odorata* (Figure 6) and *Nuphar*. The calculated LVI score for Lake Magdalene was 50, above the impairment threshold of 37. Figure 7 shows the map of Lake Magdalene detailing the LVI regions used for the assessment. Table 2 details the species list results of the Lake Vegetation Index. Table 3 details the scoring result for the Lake Vegetation Index. Submerged vegetation was abundant during the assessment and was dominated by *Vallisneria Americana*, *Utricularia radiata* and *Utricularia foliosa*. By analyzing the collected sonar chart, submerged aquatic vegetation covered approximately 52% of the surface area of Lake Magdalene. This submerged vegetation inhabits an estimated 14.3% of the water volume in Mango Lake.

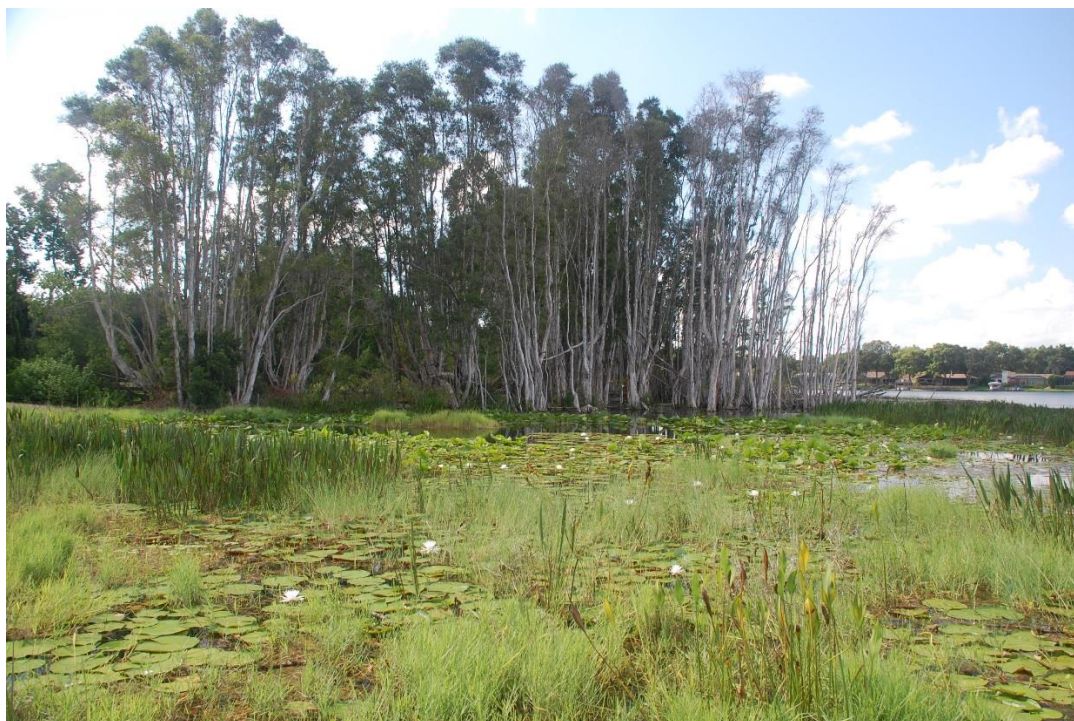
Figure 5 *Melaleuca quinquenervia* on Lake Magdalene

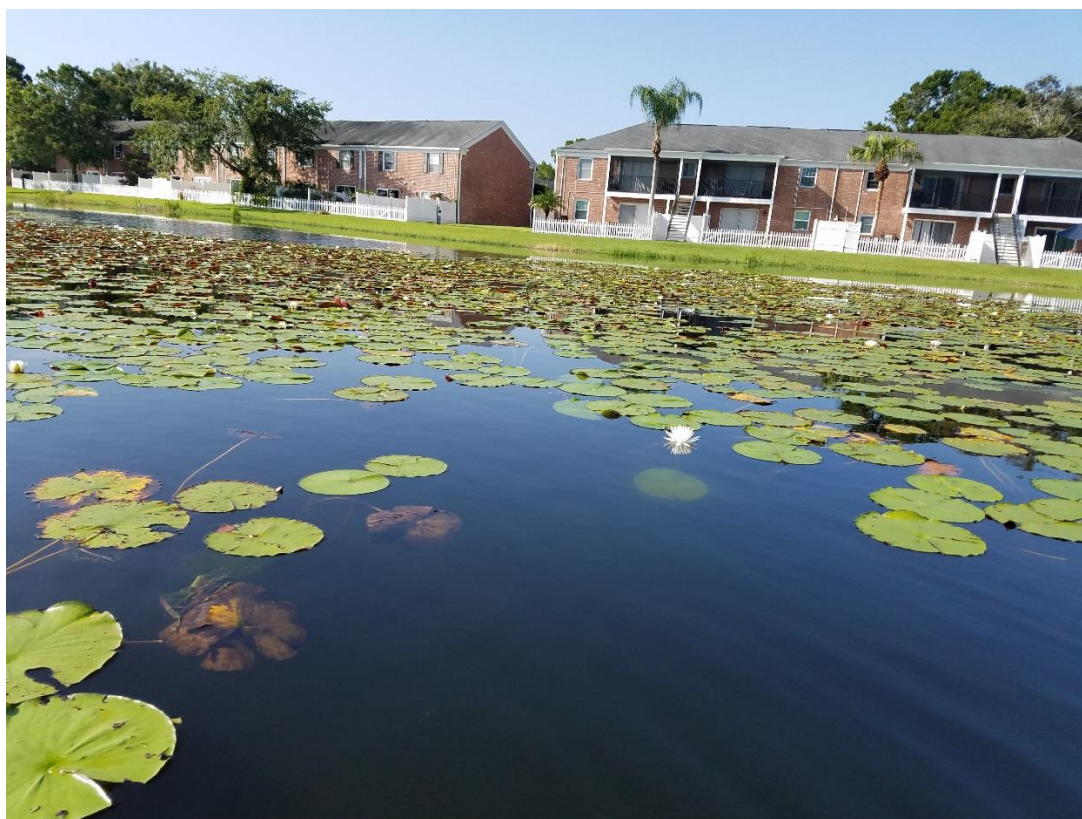
Figure 6 *Nymphaea odorata* on Lake Magdalene
