# Lake Maurine

LAKE HABITAT ASSESSMENT, LAKE VEGETATION INDEX, SUBMERGED  
VEGETATION SURVEY AND WATER QUALITY

David Eilers, Karina Gonthier | USF Water Institute | July 10, 2023

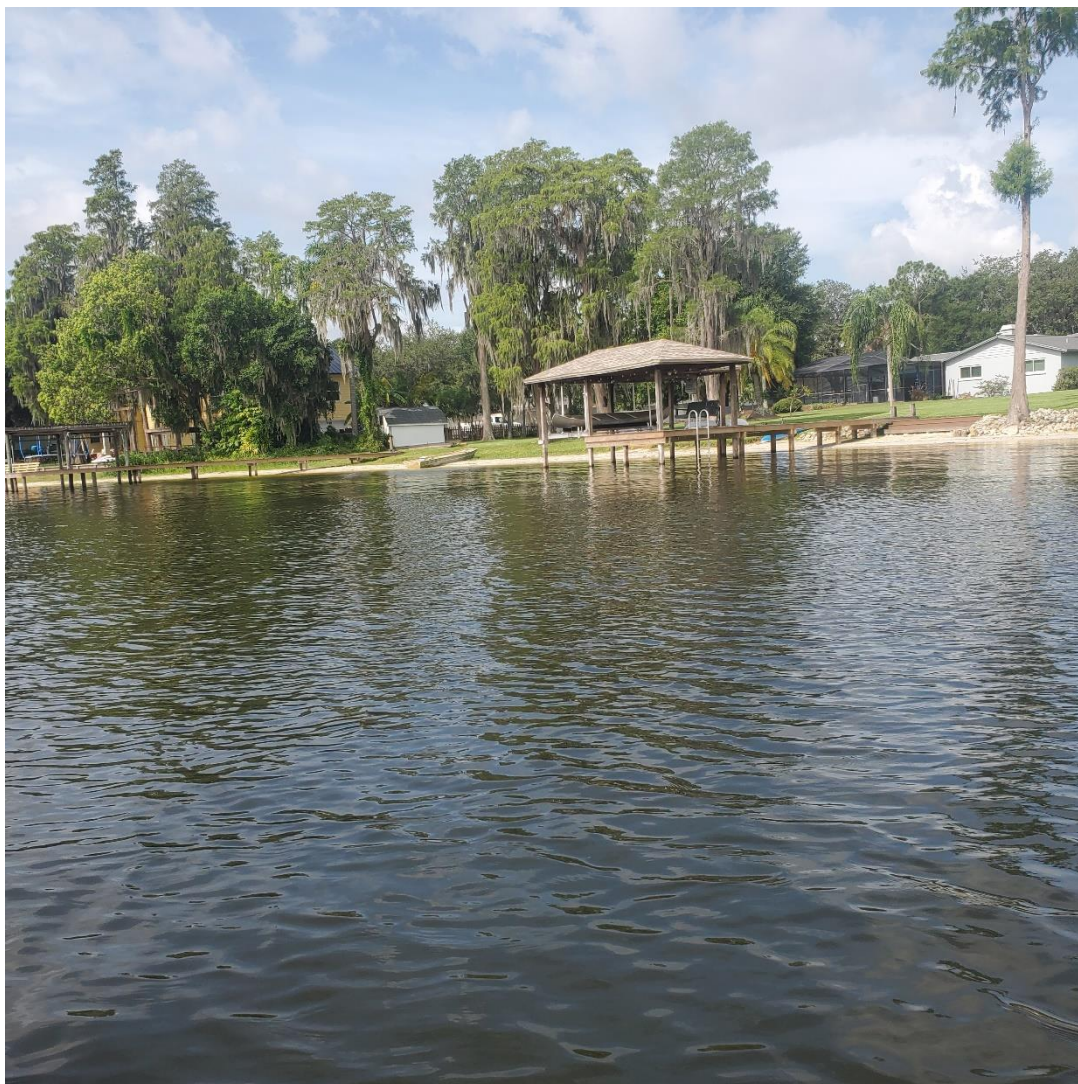
Figure 3 Overview photograph of Lake Maurine showing the residential portion of shoreline along region 2 of the Lake Vegetation Index.

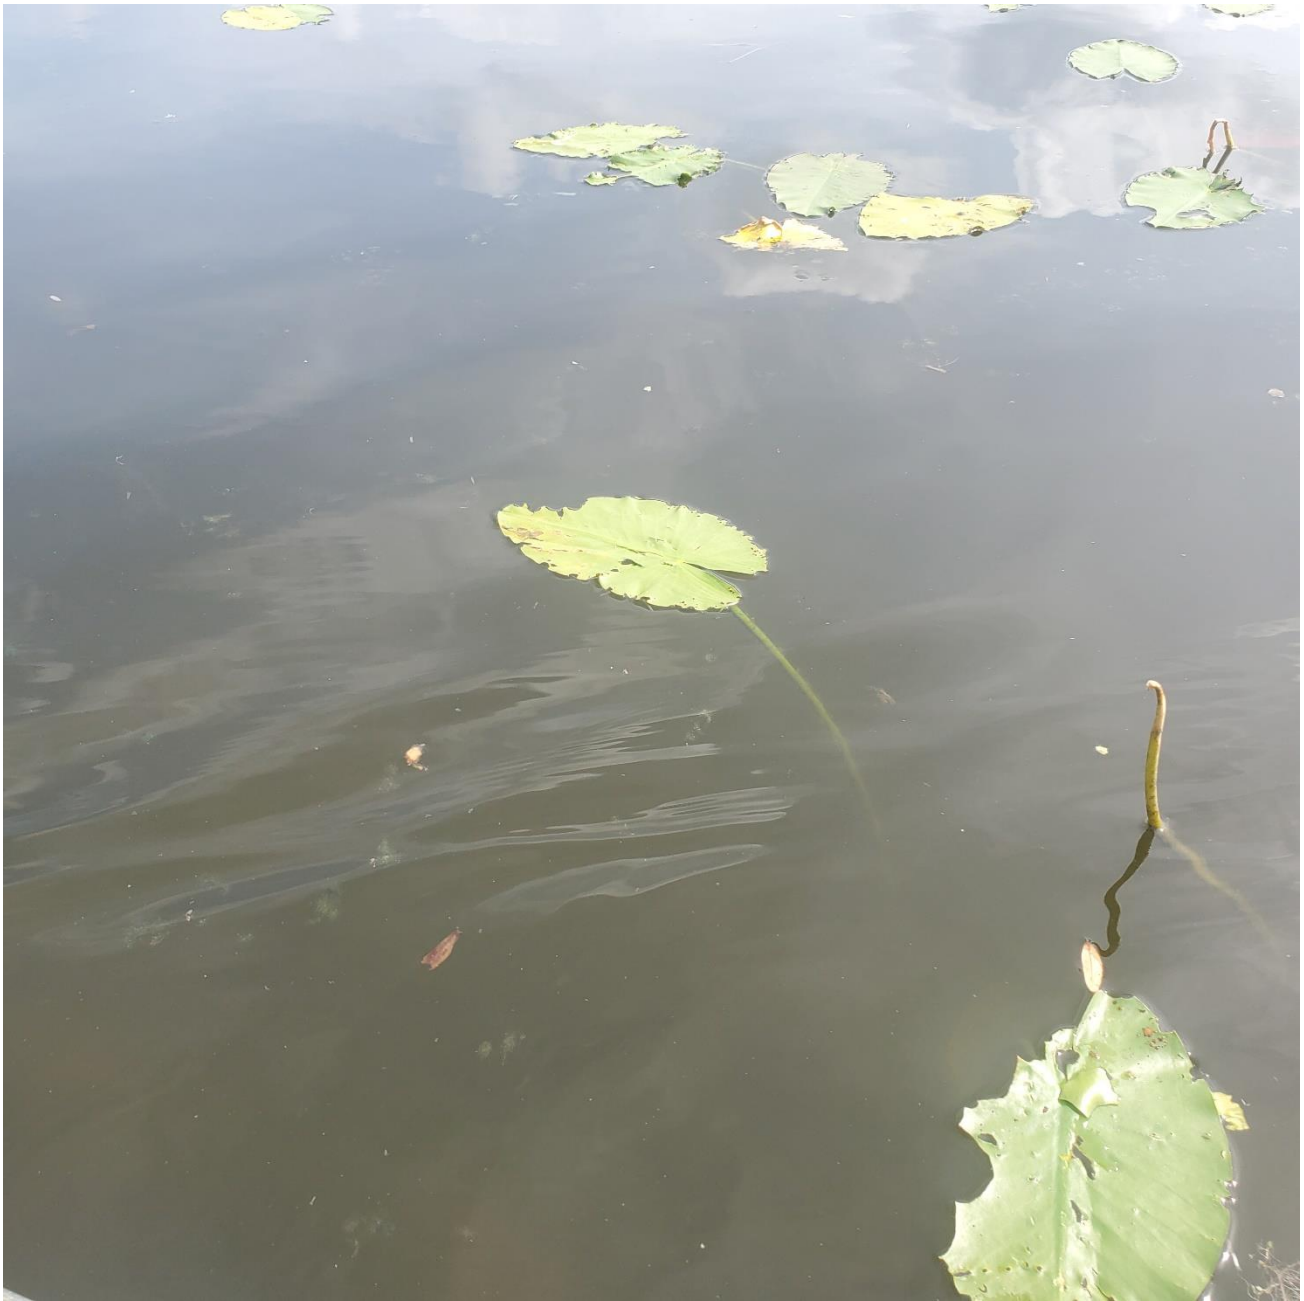
*Figure 4 Nuphar, was the most abundant and dominant species observed during the Lake Vegetation Index on Lake Maurine*

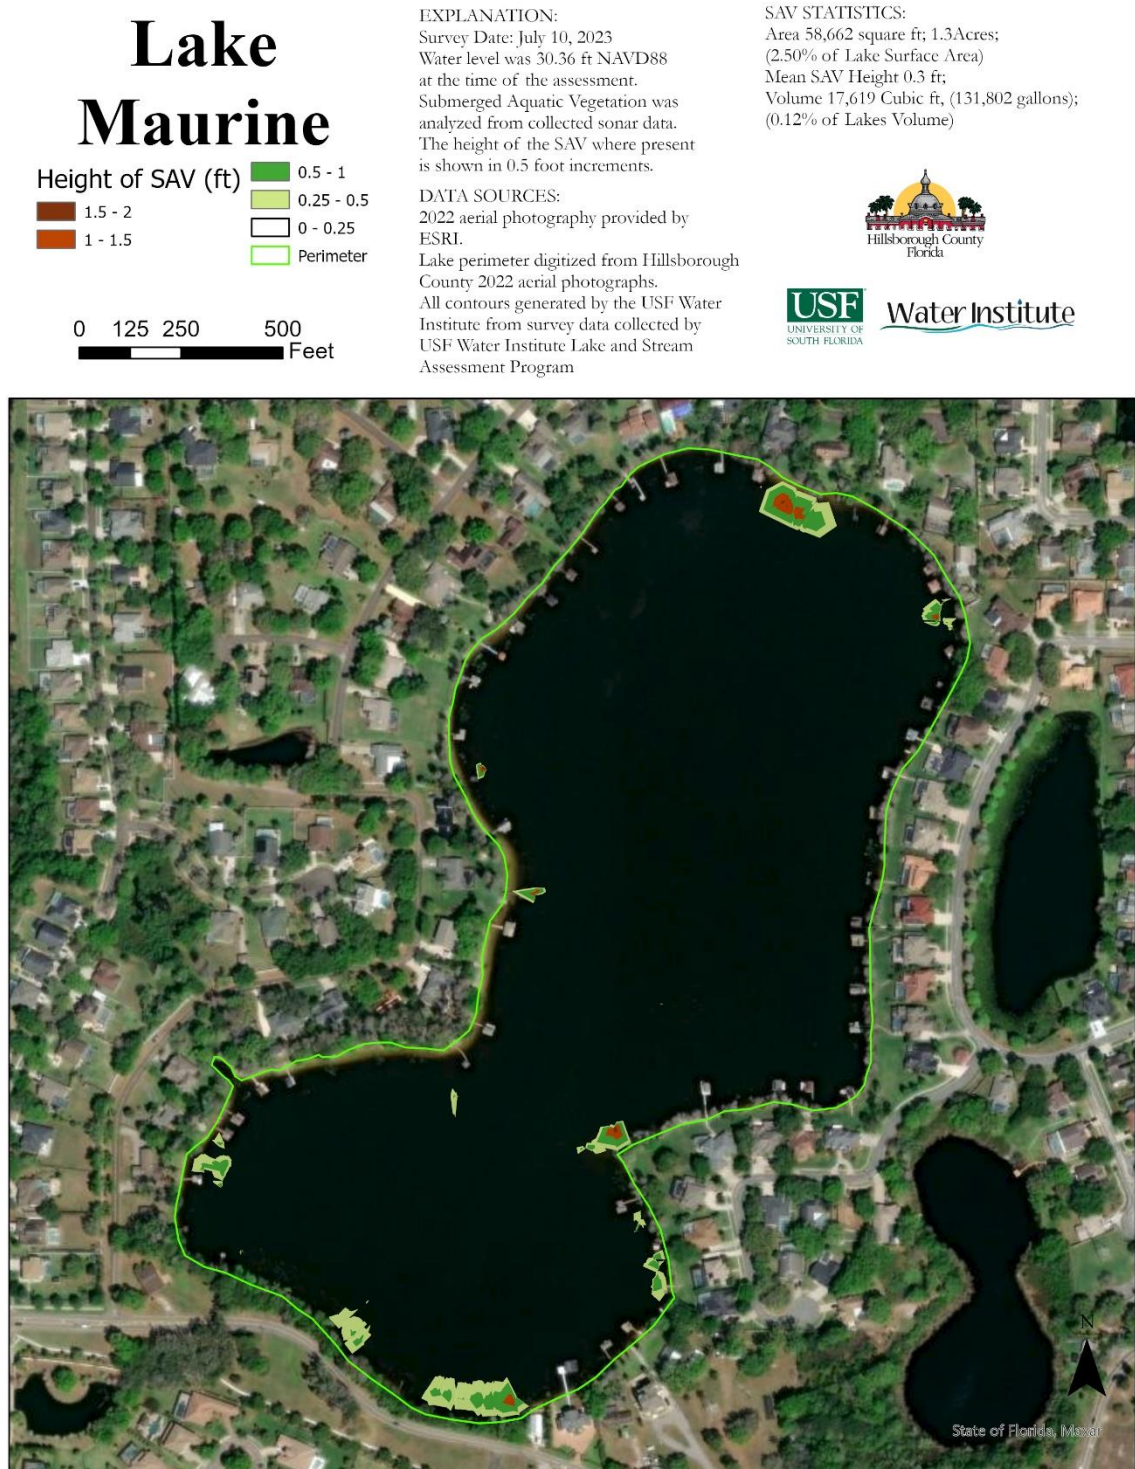
*Figure 5 Lake Maurine Submerged Aquatic Vegetation Assessment Results*

By analyzing the collected sonar chart, submerged aquatic vegetation potentially covered approximately 2.5% of the surface area of Lake Maurine. This submerged vegetation inhabits an estimated 0.12% of the water volume in Lake Maurine. Figure 5 shows the results of the SAV analysis indicating the location and height of SAV estimated from collected sonar readings.
