# Lake Rogers

## Study Area

Lake Rogers is located in Lake Rogers Park, west of the Veterans Express Way between Crawley Road and highway 582 in Odessa, Florida. The Landscape Development Intensity Index of the 100 meter buffer around Lake Rogers is dominated by Upland Mixed – Coniferous/Hardwood (58.17%) and Mixed Upland Nonforested (31.86%) land uses. The resulting LDI value for the 100 meter buffer around Lake Rogers is 1.35. The LDI value calculated for the FDEP WBID containing Lake Rogers was 4.35 with approximately 29.6% Residential, 8.6% Upland Mixed – Coniferous/Hardwood, 8% Stream and Lake Swamps (bottomland), 7.5% Cypress, and 6% Reservoirs land uses.

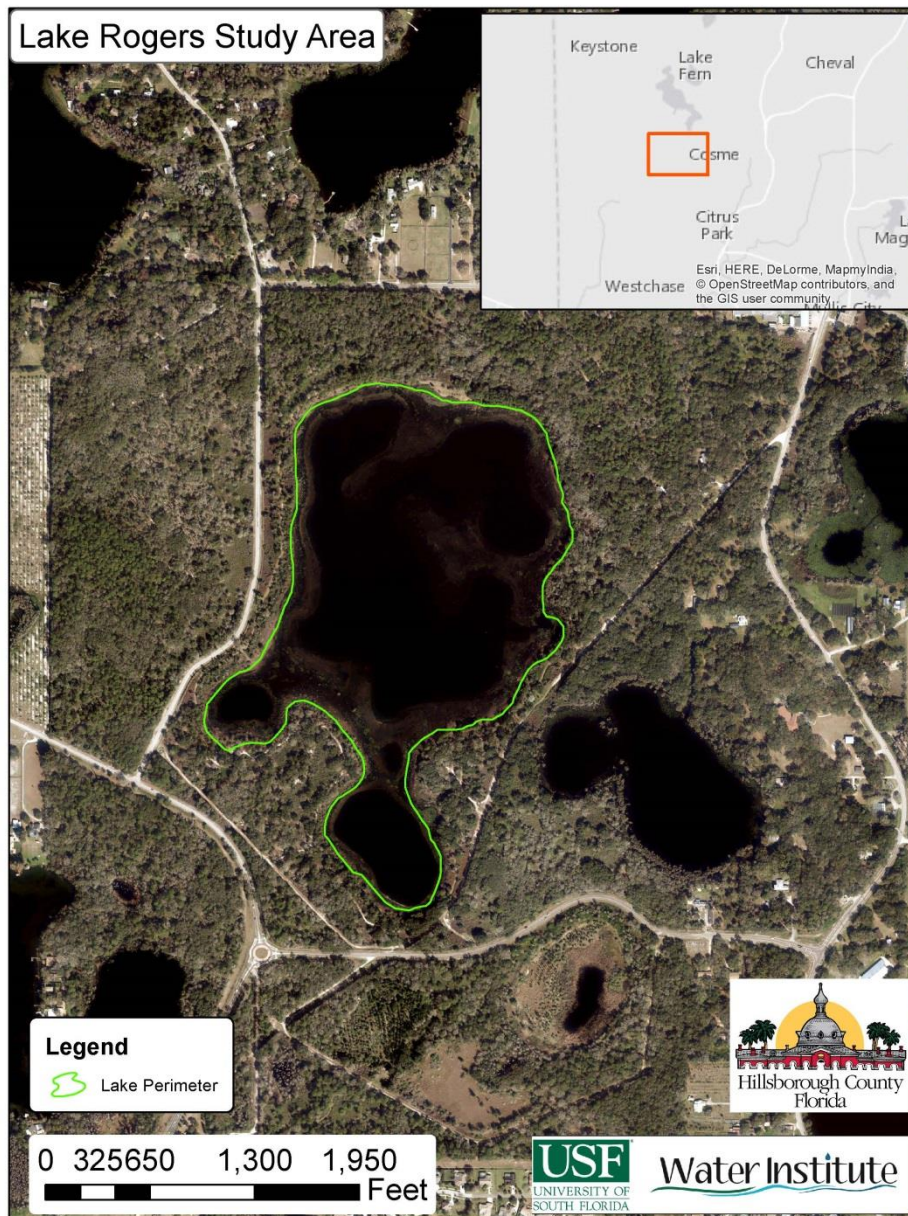
Figure 1 2016 Lake Rogers Assessment Study Area Map

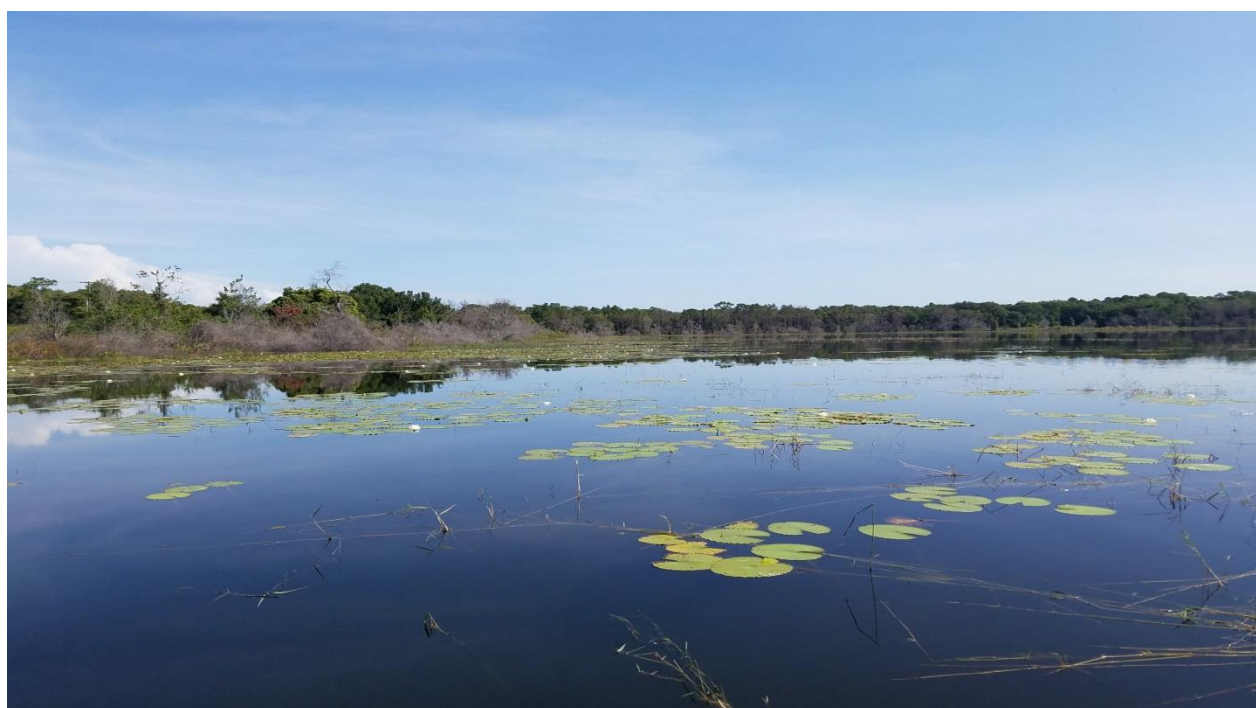
**Figure 3 Overview photograph of Lake Rogers.**

The lake assessment for Lake Rogers was conducted on August 2, 2016. Lake Rogers received a lake habitat assessment (FEDP form FD 9000-6) score of 120 due to optimal scores for Vegetation Quality, Stormwater Inputs, Lakeside Adverse Human Alteration, Upland Buffer Zone and Adverse Watershed Land Use as well as suboptimal scores for Secchi and Bottom Substrate Quality.

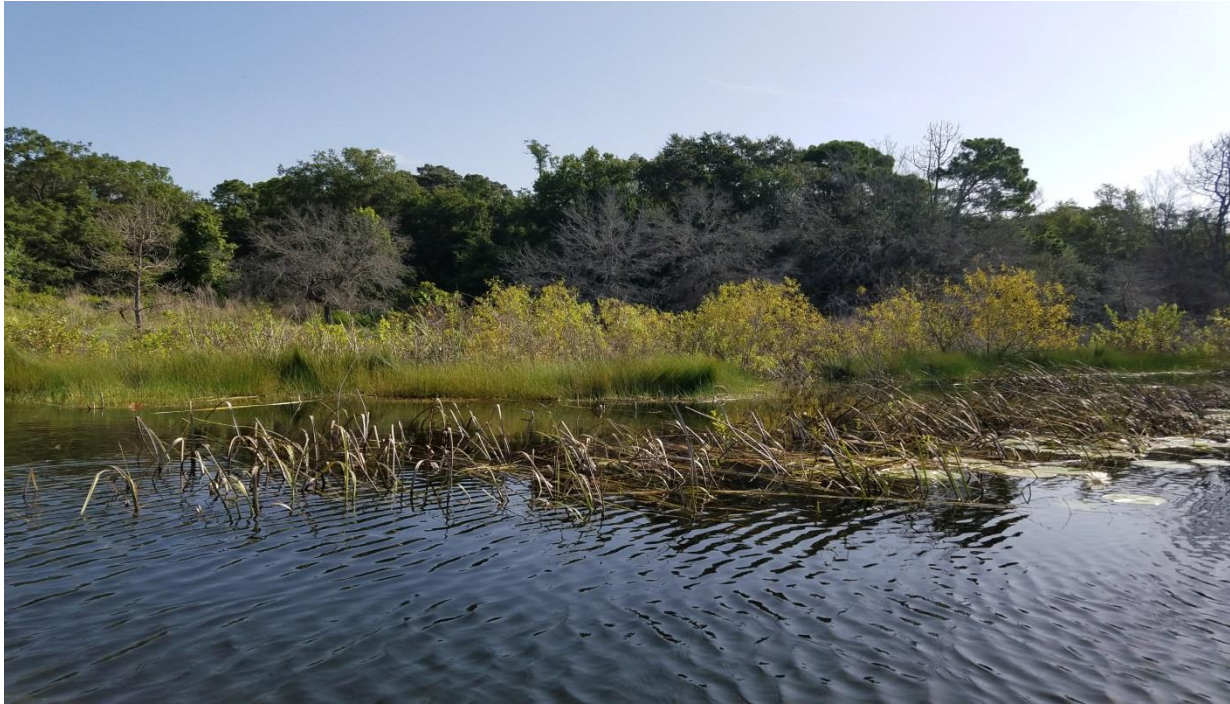
**Figure 4 Lake Rogers had a buffering zone of emergent vegetation surrounding the lake containing a mixture of native and invasive species. High water levels are evident**

It is important to note that the prolonged high water has shown changes in the vegetation community. Many stressed and dead trees were observed along the shoreline. Compared to the LVI scores from our previous sampling in 2011, during a period of low water, both the overall LVI score (73 in 2011) and total number of species observed has decreased.

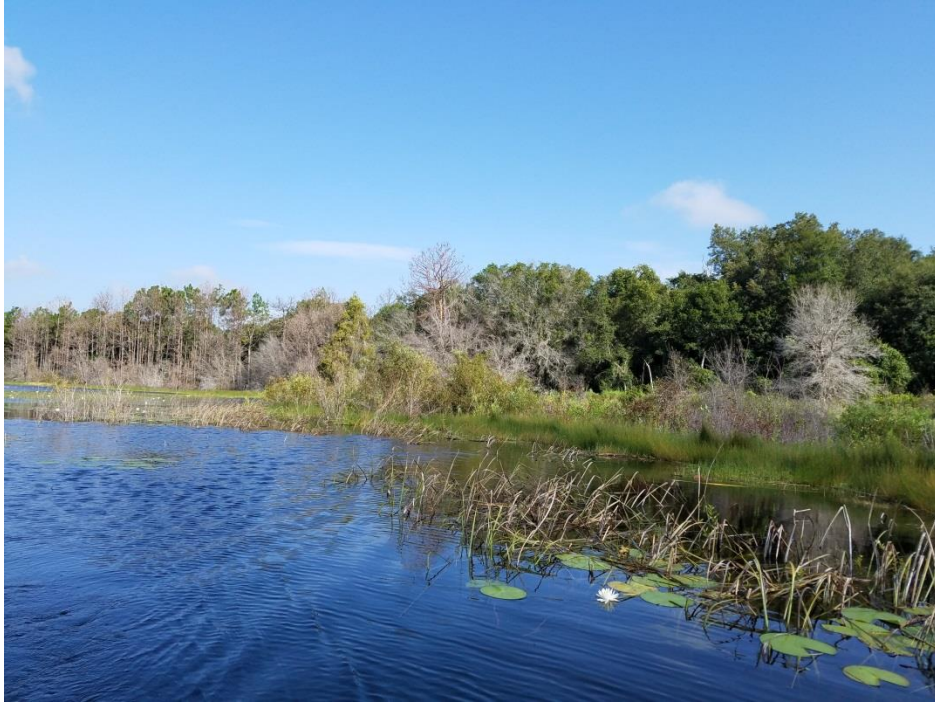
Figure 5 Emergent vegetation community on Lake Rogers.

The Lake Vegetation Index identified 41 species of wetland vegetation growing in the four selected sections along Lake Rogers. The majority of these species (38) are native species. The remaining 3 species (*Panicum repens*, *Melaleuca quinquenervia* and *Ludwigia peruviana*) are non-native and invasive to this region. The vegetation community along Lake Rogers is dominated by a variety of emergent species including *Quercus laurifolia*, *Fuirena scirpoidea* and *Panicum hemitomon* (Figure 5). The water's surface in Lake Rogers was dominated by *Nymphaea odorata* (Figure 6). The calculated LVI score for Lake Rogers was 63, above the impairment threshold of 37. Figure 7 shows the map of Lake Rogers detailing the LVI regions used for the assessment. Table 2 details the species list results of the Lake Vegetation Index. Table 3 details the scoring result for the Lake Vegetation Index. Submerged vegetation was observed during the assessment. By analyzing the collected sonar chart, submerged aquatic vegetation covered approximately 6% of the surface area of Lake Rogers. This submerged vegetation inhabits an estimated 0.95% of the water volume in Lake Rogers.

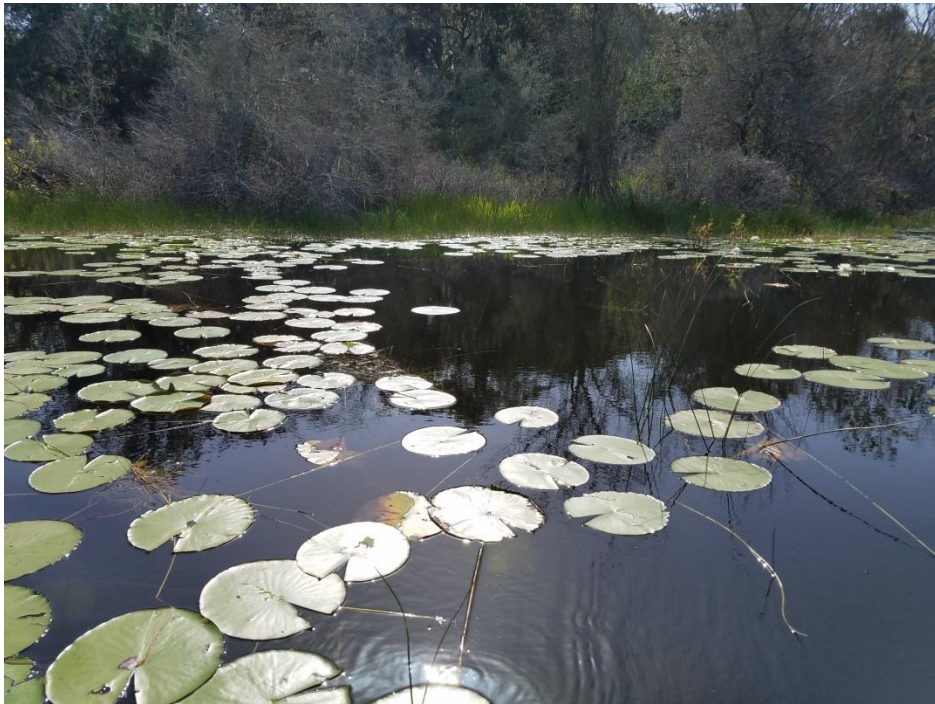
Figure 6 *Nymphaea odorata* on Lake Rogers.

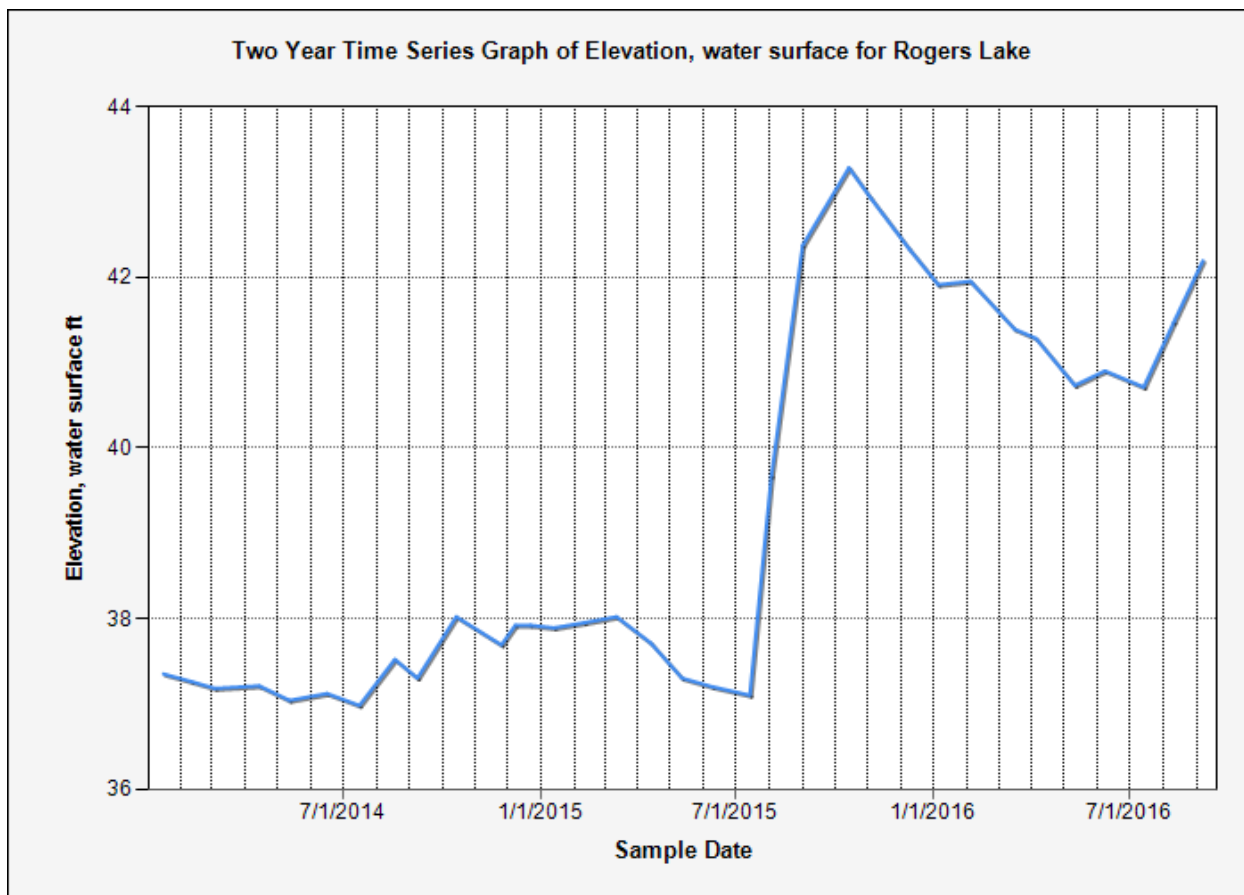
The results of the assessment should be considered as an extreme circumstance due to the increased lake stage present on Lake Rogers at the time See Figure 8 below. Lake Rogers resides in an active well field, and has recently been connected to other nearby lakes, some of which are characterized by colored, acidic water. The resulting increase in stage level and decrease in light penetration has eliminated the vast majority of the submerged vegetation community and disrupted the emergent vegetation community. The results of the assessment of Lake Rogers shows impairment based on Total Nitrogen, Total Phosphorous and Chlorophyll-a concentrations according to the FDEP numeric nutrient criteria using the single sample taken during this assessment. Long term sampling would be necessary to determine actual NNC values. The system does not show impairment in the vegetation

Figure 8 Two Year Graph of Lake Stage for Lake Rogers.
