Lake Wimauma

Figure 1 2016 Lake Wimauma Assessment Study Area Map

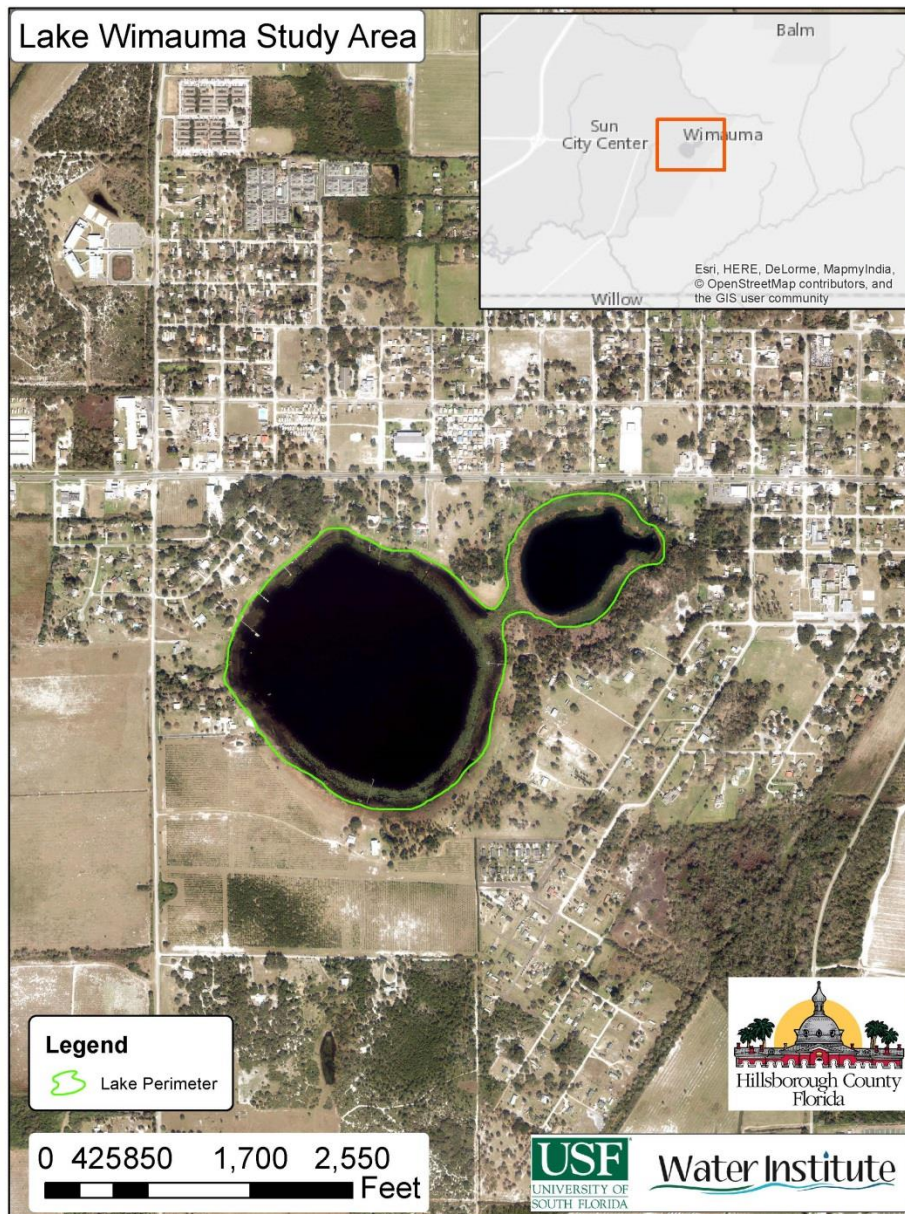
Lake Wimauma is located south of highway 674, east of W Lake Dr. in Wimauma, Florida. The Landscape Development Intensity Index of the 100 meter buffer around Lake Dan is dominated by Low Density, <2 dwelling units/acre (54%), Cropland and Pastureland (17.47%), and Stream and Lake Swamps (bottomland) (14.9%) land uses. The resulting LDI value for the 100 meter buffer around Lake Wimauma is 4.80. The LDI value calculated for the FDEP WBID containing Lake Wimauma was 2.83 with approximately 29.4% Other Open Lands (Rural), 13% Stream and Lake Swamps (bottomland), 12.1% Shrub and Brushland, and 11% Low Density, <2 dwelling units/acre natural landscapes.

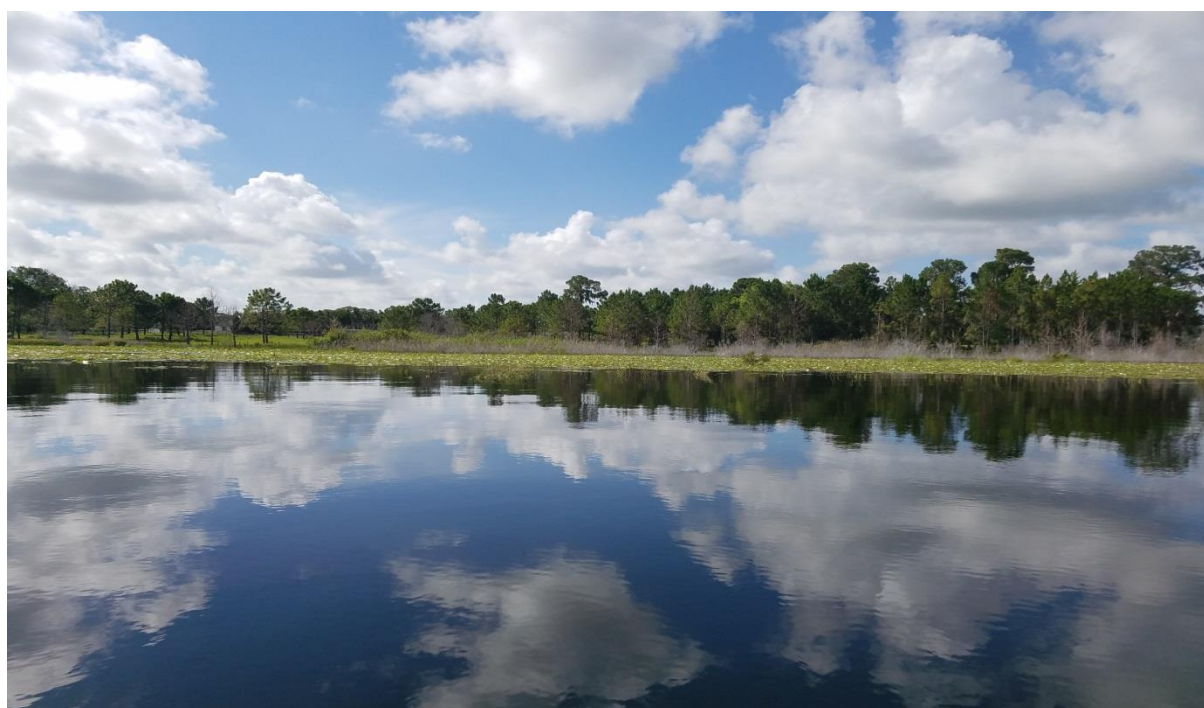
Figure 3 Overview photograph of Lake Wimauma.

The lake assessment for Lake Wimauma was conducted on July 12, 2016. Lake Wimauma received a lake habitat assessment (FEDP form FD 9000-6) score of 86 due to suboptimal scores for Secchi, Vegetation Quality, Stormwater Inputs, Bottom Substrate Quality, Lakeside Adverse Human Alterations and Adverse Watershed Land Use. Marginal scores were achieved for Upland Buffer Zone.

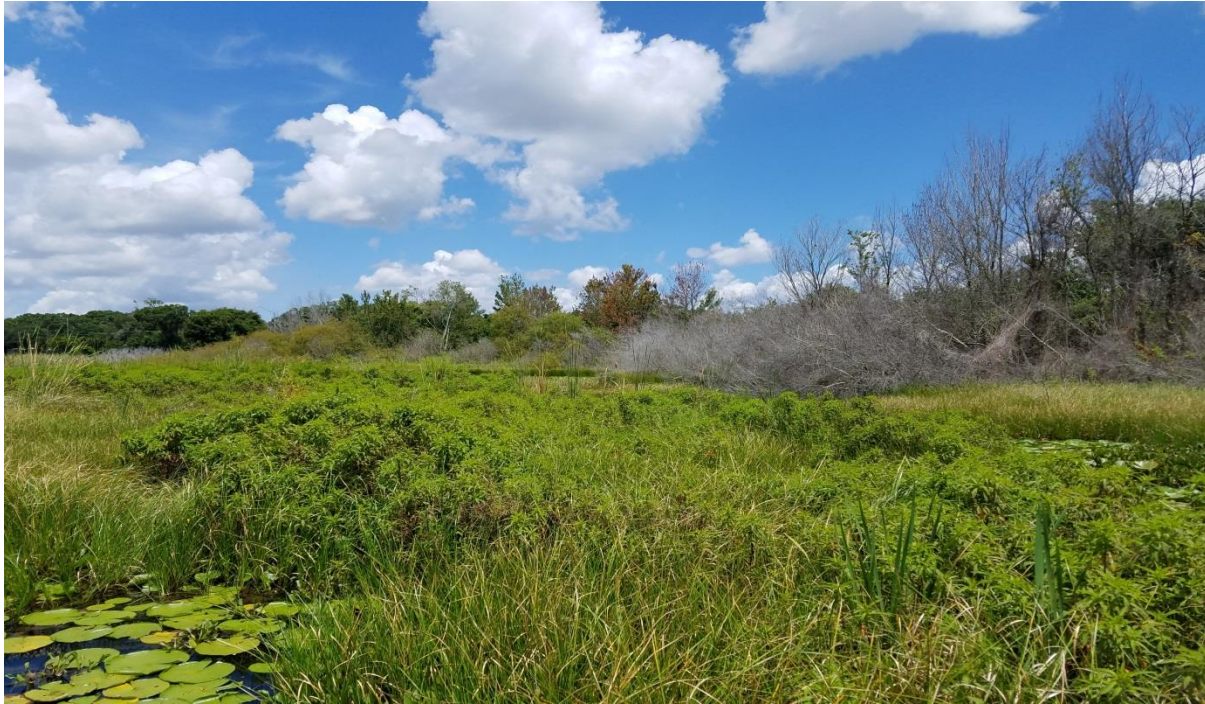
Figure 4 Lake Wimauma had a buffering zone of emergent vegetation surrounding the lake containing a mixture of native and invasive species.

The Lake Vegetation Index identified 44 species of wetland vegetation growing in the four selected sections along Lake Wimauma. The majority of these species (33) are native species. The remaining 11 species (Shown in Bold on Table 2) are non-native and invasive to this region. Dominant and Co-dominant species are denoted with a “C” or a “D” in Table 2. The vegetation community along Lake Wimauma is dominated by a variety of emergent species including *Typha*, *Panicum repens* and *Ludwigia peruviana* (Figure 4). The water’s surface in Lake Wimauma was dominated by *Nymphaea odorata* (Figure 6). The calculated LVI score for Lake Wimauma was 32, below the impairment threshold of 37. Figure 7 shows the map of Lake Wimauma detailing the LVI regions used for the assessment. Table 2 details the species list results of the Lake Vegetation Index. Table 3 details the scoring result for the Lake Vegetation Index. Submerged vegetation was sparsely observed during the assessment. By analyzing the collected sonar chart, submerged aquatic vegetation covered approximately 5% of the surface area of Lake Wimauma. This submerged vegetation inhabits an estimated 0.63% of the water volume in Lake Wimauma.
