Lake Dosson

LAKE HABITAT ASSESSMENT, LAKE VEGETATION INDEX, SUBMERGED
VEGETATION SURVEY AND WATER QUALITY

David Eilers | USF Water Institute | July 29, 2024

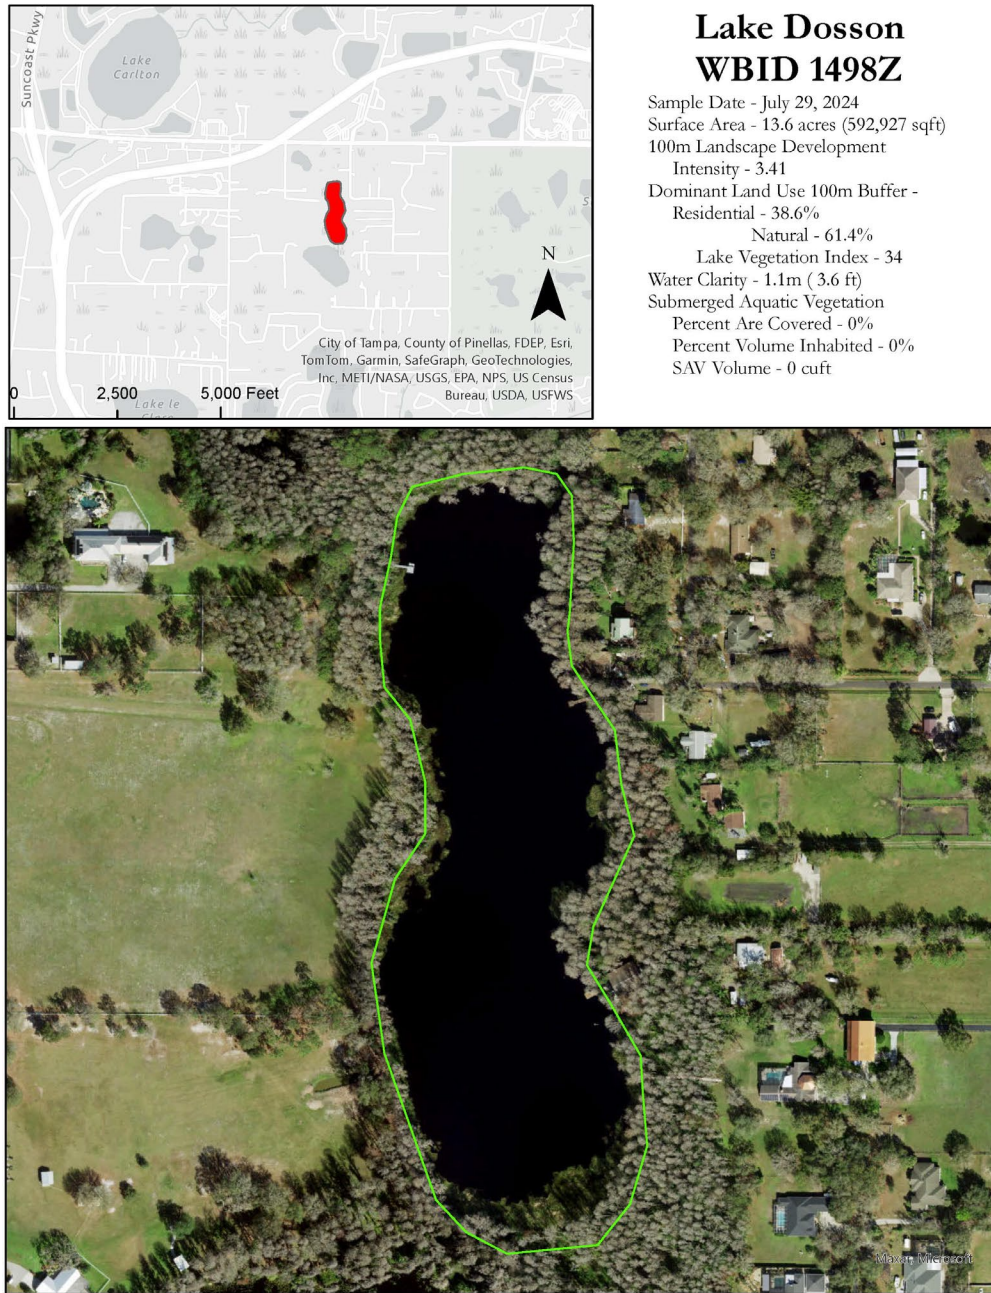
FIGURE 1: 2024 Lake Dosson ASSESSMENT STUDY AREA MAP

Lake Dosson is located in the Coastal Old Tampa Bay Watershed in north-western Hillsborough County, Florida. The Landscape Development Intensity Index of the 100 meter buffer around Lake Dosson is dominated by natural (61.4%) and residential (38.6%) land uses. The resulting LDI value for the 100 meter buffer around Lake Dosson is 3.41.

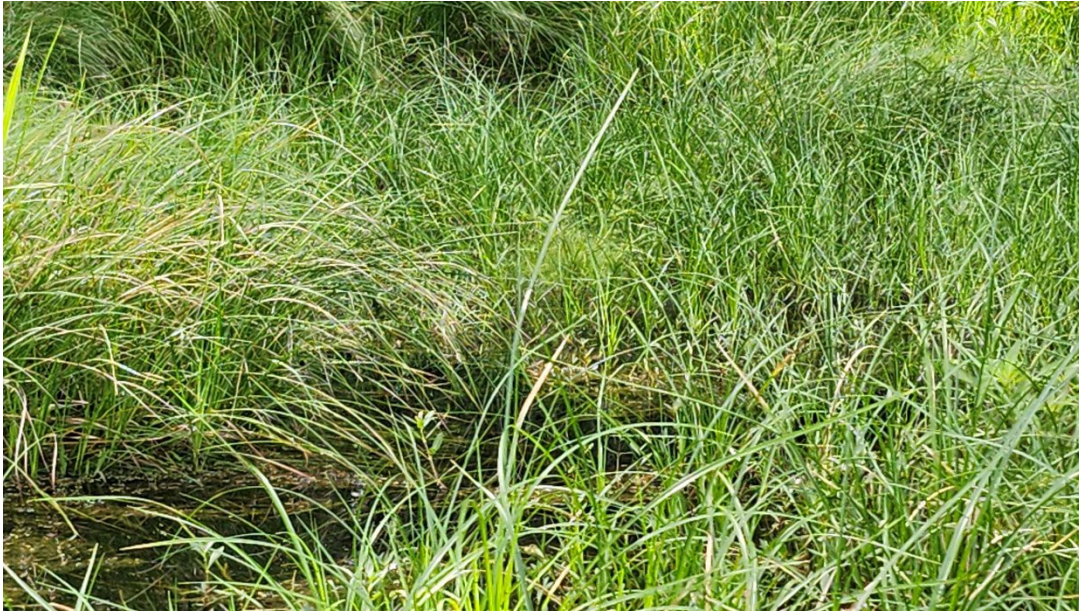
Figure 3 Overview photograph of Lake Dosson showing *Panicum repens* which was present in all regions but dominate in region 2

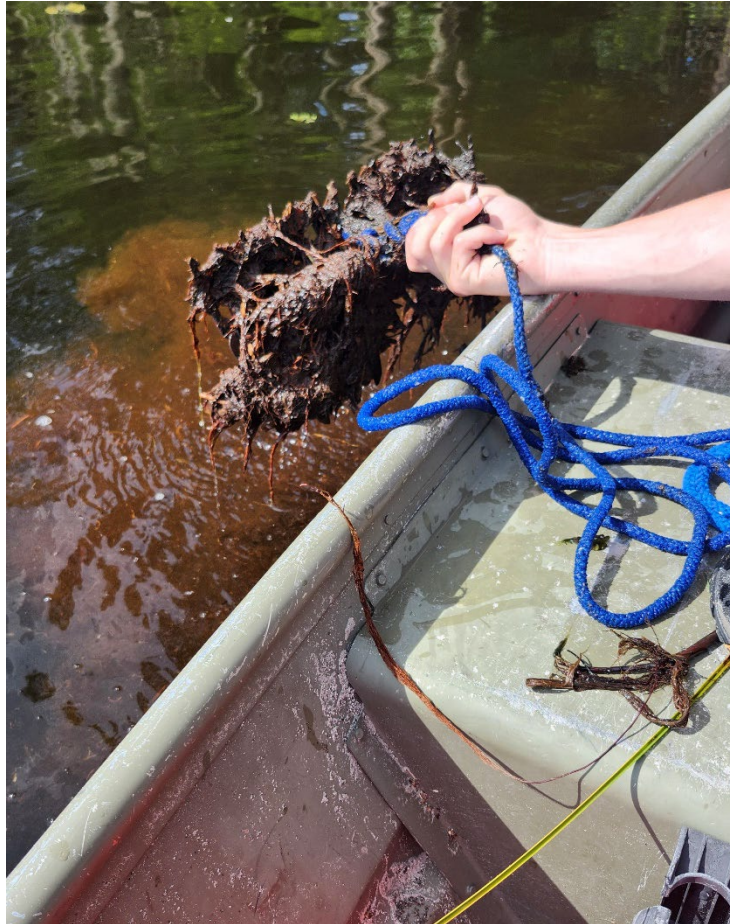
The lake assessment for Lake Dosson was conducted on July 29, 2024. The water in Lake Dosson was characterized as tannic with slightly turbid water. The secchi disk depth was 1.1 meters limiting the growth of submerse aquatic vegetation. The vegetation quality of the plants in and buffering Lake Dosson are predominantly native species with extensive growths of the non-native invasive species *Panicum repens* as it was present in all regions but dominate in region 2. The percentage of non-native FLEPPC 1 species ranged from 6.67% (region 11) to 28.57% (region 2). Stormwater reaches the lake predominately via ditches, pipes, and cultivated vegetation and has a few BMPs. The development along the shoreline has maintained the nearshore *Taxodium* however the shrub and native ground cover communities have been maintained for residential turf grasses. The bottom substrate quality was dominated by sandy/silt with coarse particulate organic matter near shore and submersed vegetation.

Figure 4 of muck collected on Frotus rake

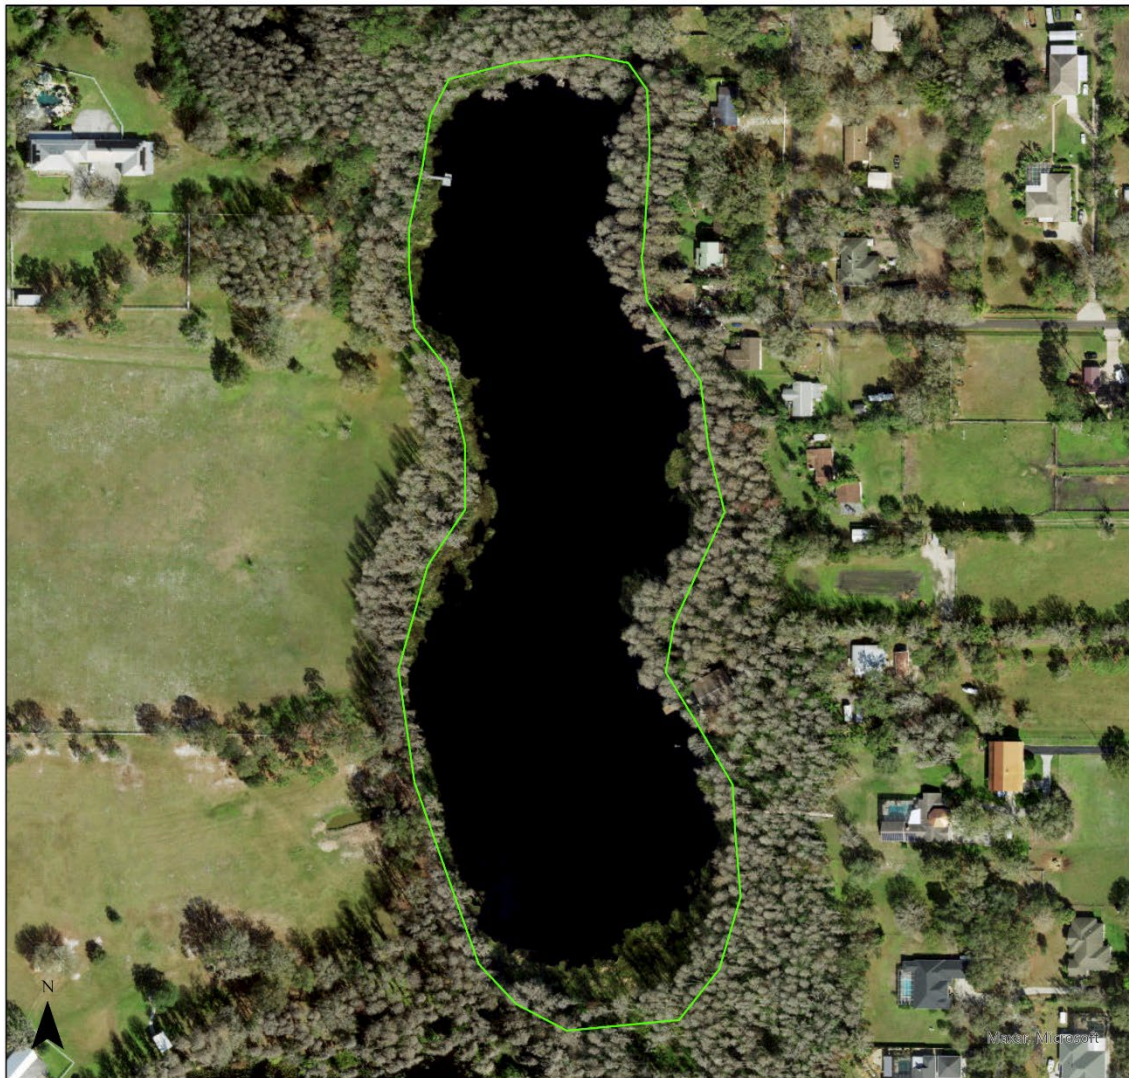
Figure 5 Lake Dosson Submersed Aquatic Vegetation Assessment Results

Figure 5 shows the results of the SAV analysis and how there were no submersed aquatic vegetation found during the assessment.

No submersed aquatic vegetation was observed at the time of the assessment.

Survey Date: July 29, 2024
Water level was 51.1 ft NAVD88 at the time of the assessment.
Submersed Aquatic Vegetation was analyzed from collected sonar data.
The height of the SAV where present is shown in 1 foot increments.

Area 0 square ft; 0 Acres;
(0%) of Lake Surface Area)
Mean SAV Height 0 ft;
Volume 0 Cubic ft, (0 gallons);
(0% of Lakes Volume)
