Lake Ellen

LAKE HABITAT ASSESSMENT, LAKE VEGETATION INDEX, SUBMERGED
VEGETATION SURVEY AND WATER QUALITY

David Eilers | USF Water Institute | September 11, 2024

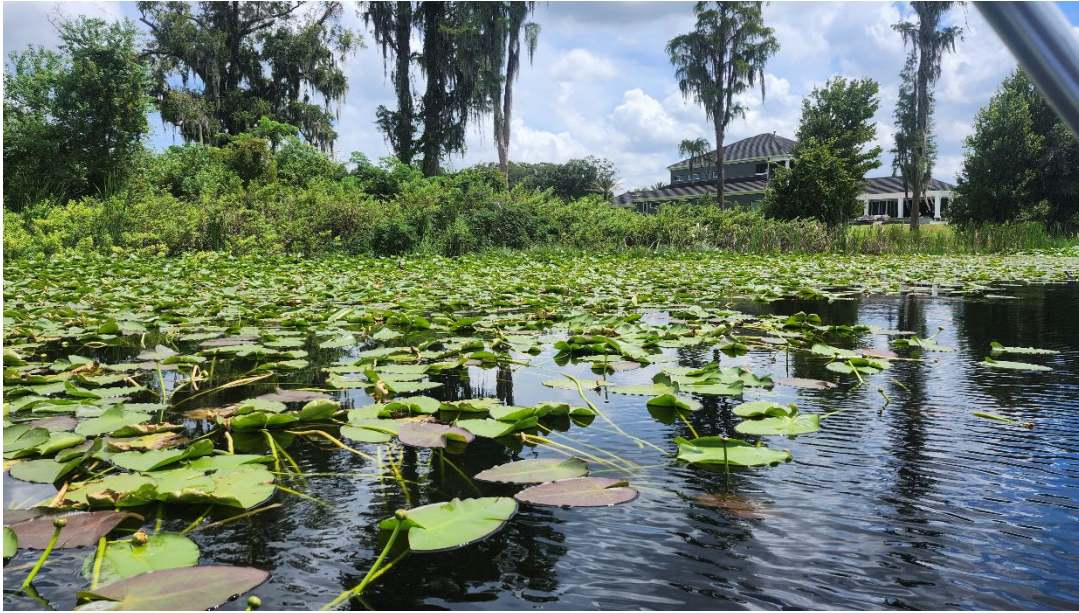
Figure 3 Overview photograph of Lake Ellen showing *Nuphar* which was present at segments 5 and 8

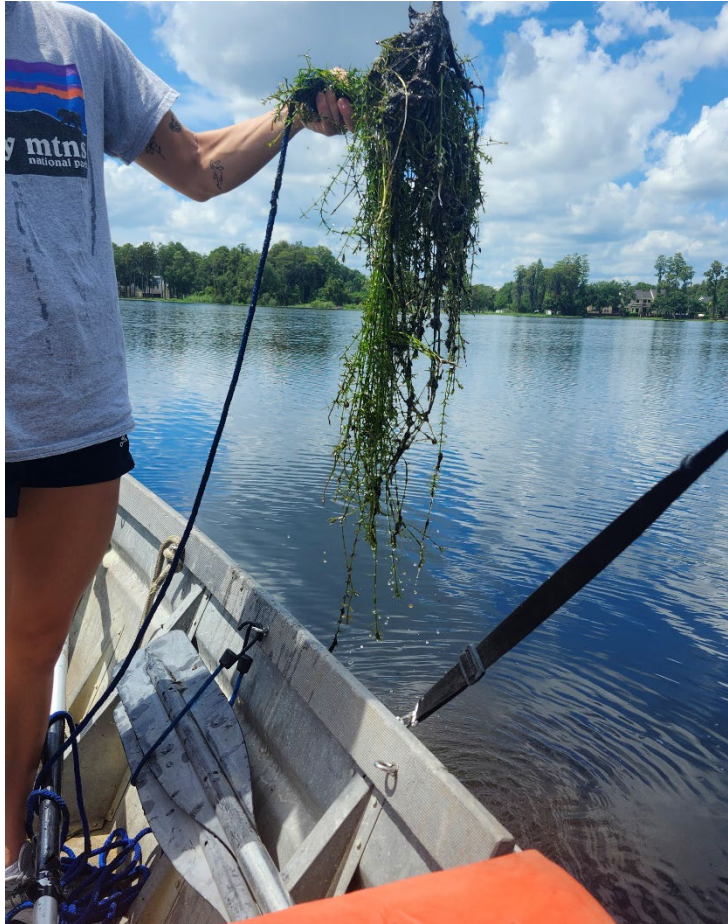
Figure 4 Hydrilla verticillata collected with the Frotus rake, considered dominate in all segments

The Lake Vegetation Index identified 38 species of wetland vegetation growing in the four selected sections along Lake Ellen. The majority of these species (29) are native species. The remaining 9 species (*shown in **bold** in Table 2*) are non- native or invasive to this region. The vegetation community along the shorelines of Lake Ellen has been altered by lawn maintenance activities leaving a *Taxodium* canopy with a sparse shrub and ground cover community. The edges of the lake are dominated by species able to rapidly colonize following the frequent disturbance of mowing, such as *Panicum repens*. At the time of the assessment the water transparency was 1.07 m (3.5 ft). Low annual average secchi disk depths lead to a littoral zone being dominated by submersed vegetation. Among the submersed vegetation found, *Hydrilla verticillata*. The floating leaved vegetation *Hydrocotyle* and *Nuphar* were found in two of the four regions.

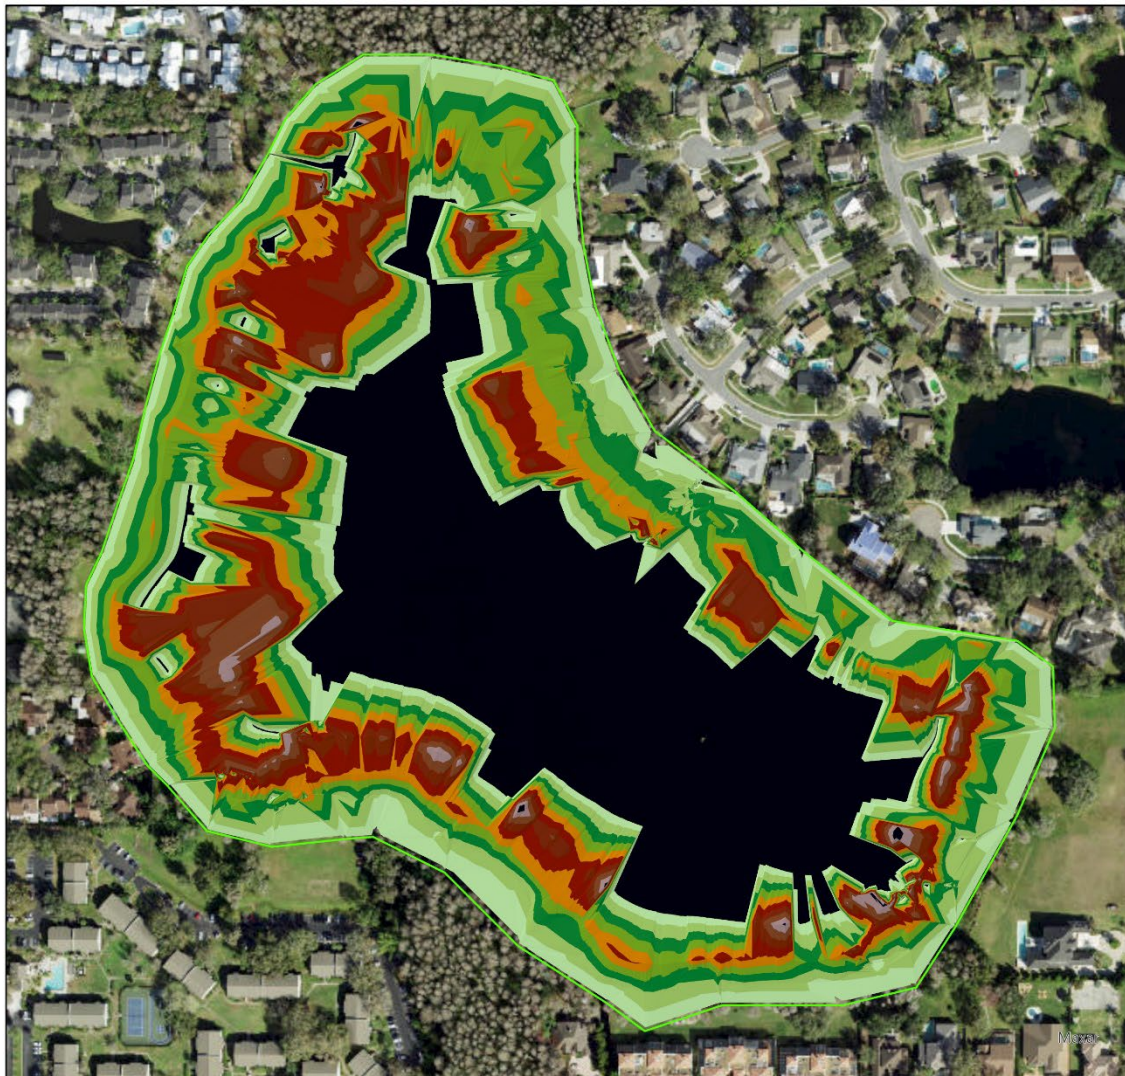
Figure 5 Lake Ellen Submerged Aquatic Vegetation Assessment Results

By analyzing the collected sonar chart, submerged aquatic vegetation potentially covered approximately 70.69% of the surface area of Lake Ellen. This submerged vegetation inhabits an estimated 19.74% of the water volume in Lake Ellen. Figure 5 shows the results of the SAV analysis indicating the location and height of SAV estimated from collected sonar readings.

Survey Date: September 11, 2024
 Water level was unknown at the time of the assessment.
 Submerged Aquatic Vegetation was analyzed from collected sonar data.
 The height of the SAV where present is shown in 1 foot increments.

Area 1,683,919 square ft; 38.7 Acres;
 (70.69% of Lake Surface Area)
 Mean SAV Height 2.9 ft;
 Volume 4,926,731 Cubic ft, (36,854,760 gallons);
 (19.74 % of Lakes Volume)
