Lake Hooker

LAKE HABITAT ASSESSMENT, LAKE VEGETATION INDEX, SUBMERGED
VEGETATION SURVEY AND WATER QUALITY

David Eilers | USF Water Institute | August 28, 2024

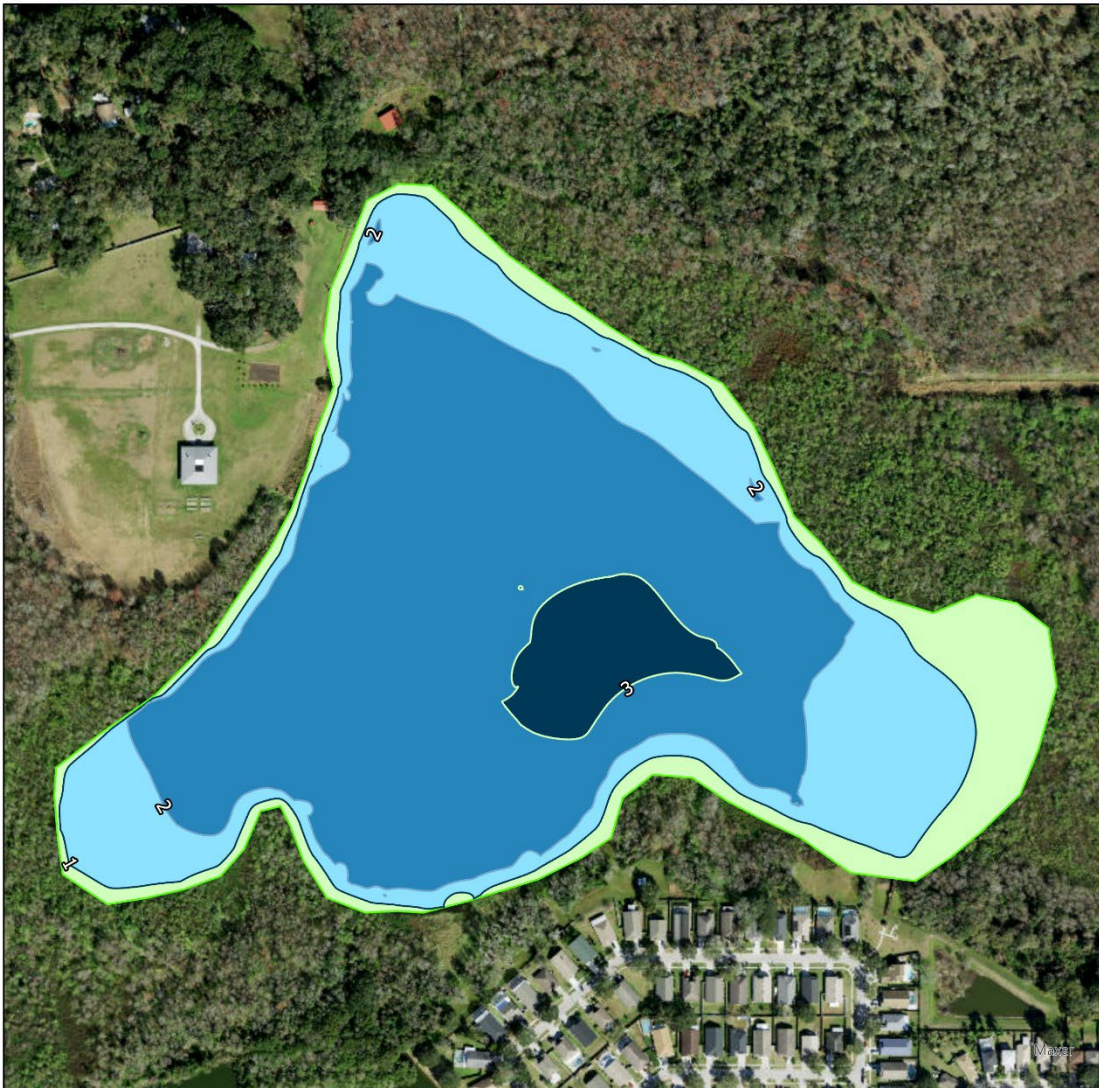
Figure 2: 2024 2-Foot Bathymetric Contour Map for Lake Hooker

At the time of the assessment, Lake Hooker was experiencing normal water levels (42.37 feet NAVD88 on staff gauge) resulting in a 55.9 acre water body. Lake Hooker at the time of the assessment had a mean water depth of 2 feet and a maximum observed depth of 3.9 feet. The volume at this time was approximately 36,740,863 gallons. Figure 2 shows the resulting bathymetric contour map for Lake Hooker from data collected on August 28, 2024. The collected data has been overlain the 2022 ESRI Basemap aerials.

EXPLANATION:
Survey Date: August 28, 2024
Water level was 42.37 ft NAVD88 at the time of the assessment.
Contours are expressed in absolute depth below this level.

LAKE MORPHOLOGY:
Perimeter 7564.2 ft;
Area 55.9 Acres;
(2,433,714 Sqft)
Mean Depth 2 ft;
Volume 112.8 Acre-ft,
(36,740,863 gallons);
Deepest point 3.9 ft

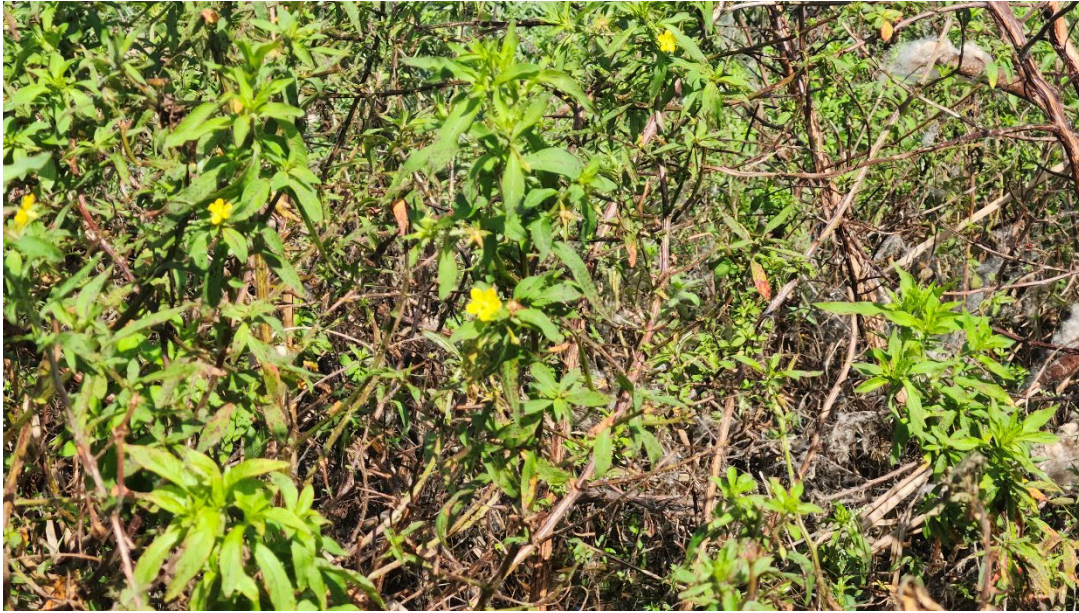
Figure 3 Overview photograph of Lake Hooker showing *Ludwigia leptocarpa* which was present in all regions but dominant in region 2

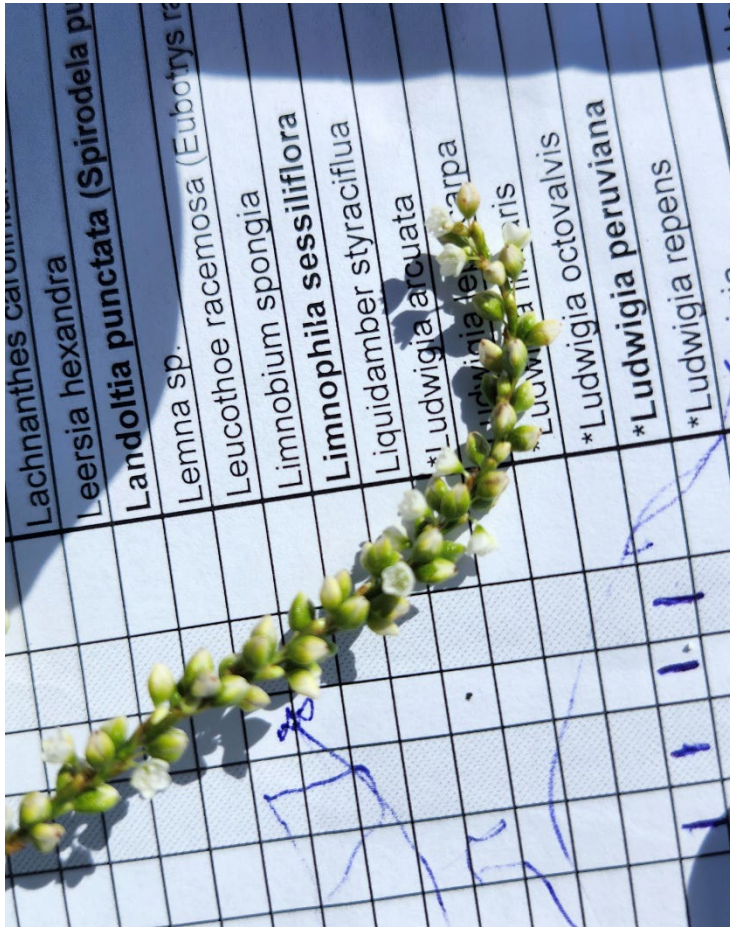
Figure 4 *Persicaria punctata* which was found at Lake Hooker in regions 5, 8, and 11 but dominant in region 11

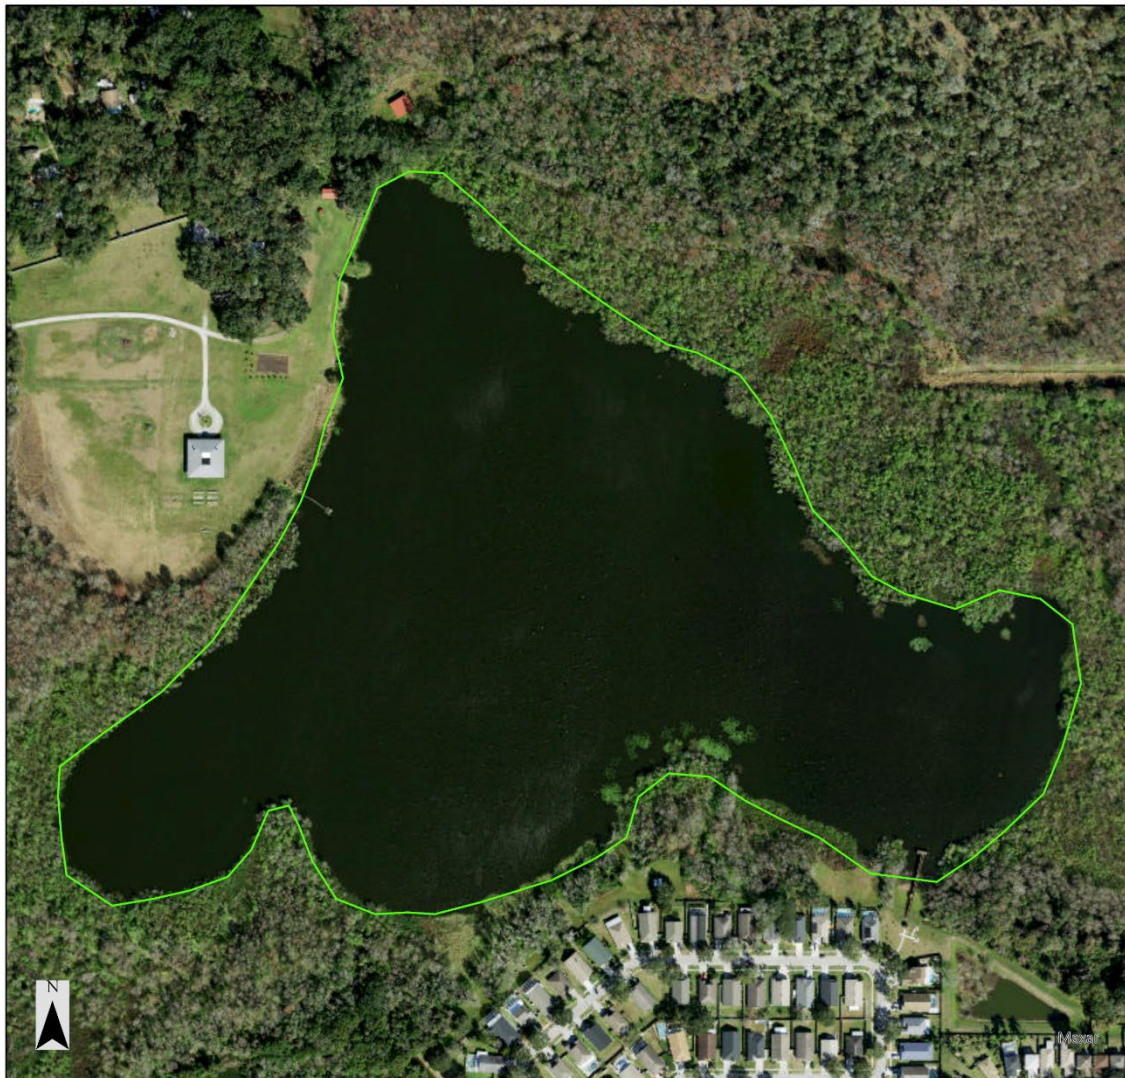
Figure 5 Lake Hooker Submersed Aquatic Vegetation Assessment Results

Figure 5 shows the results of the SAV analysis and how there were no submersed aquatic vegetation found during the assessment.

No submersed aquatic vegetation was observed at the time of the assessment.

Survey Date: August 28, 2024
Water level was 42.37 ft NAVD88 at the time of the assessment. Submersed Aquatic Vegetation was analyzed from collected sonar data. The height of the SAV where present is shown in 1 foot increments.

Area 0 square ft; 0 Acres;
(0% of Lake Surface Area)
Mean SAV Height 0 ft;
Volume 0 Cubic ft, (0 gallons);
(0% of Lakes Volume)
