Lake Julia

Study Area

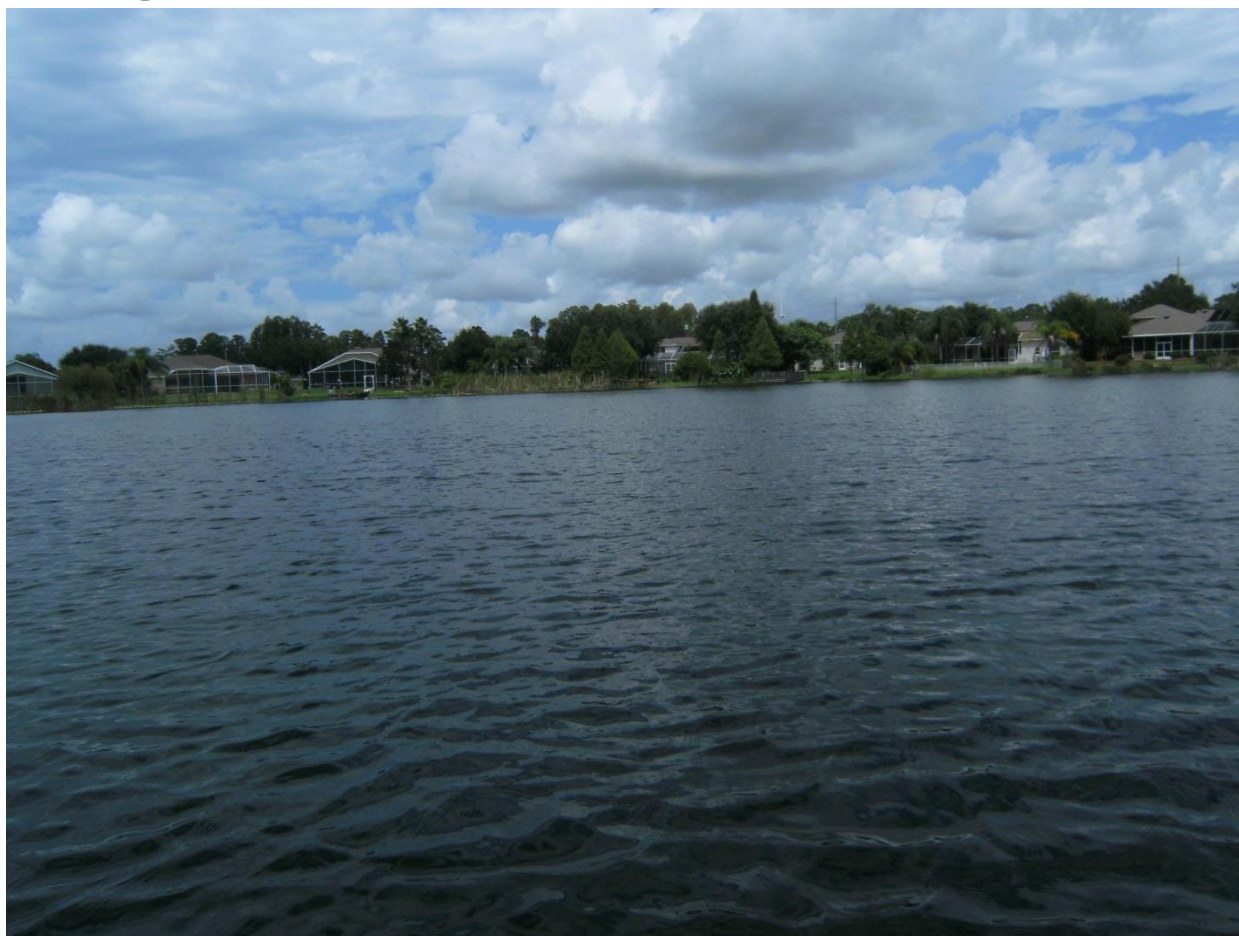
Figure 3 Overview photograph of Lake Julia

The lake assessment for Lake Julia was conducted on August 13, 2015. Lake Julia received a lake habitat assessment (FEDP form FD 9000-6) score of 70 due to suboptimal scores for Secchi, Vegetation Quality and Stormwater Inputs. Marginal scores were achieved for Bottom Substrate Quality, Adverse Watershed Land Use and Lakeside Adverse Human Alterations. Upland Buffer Zone received poor scores.

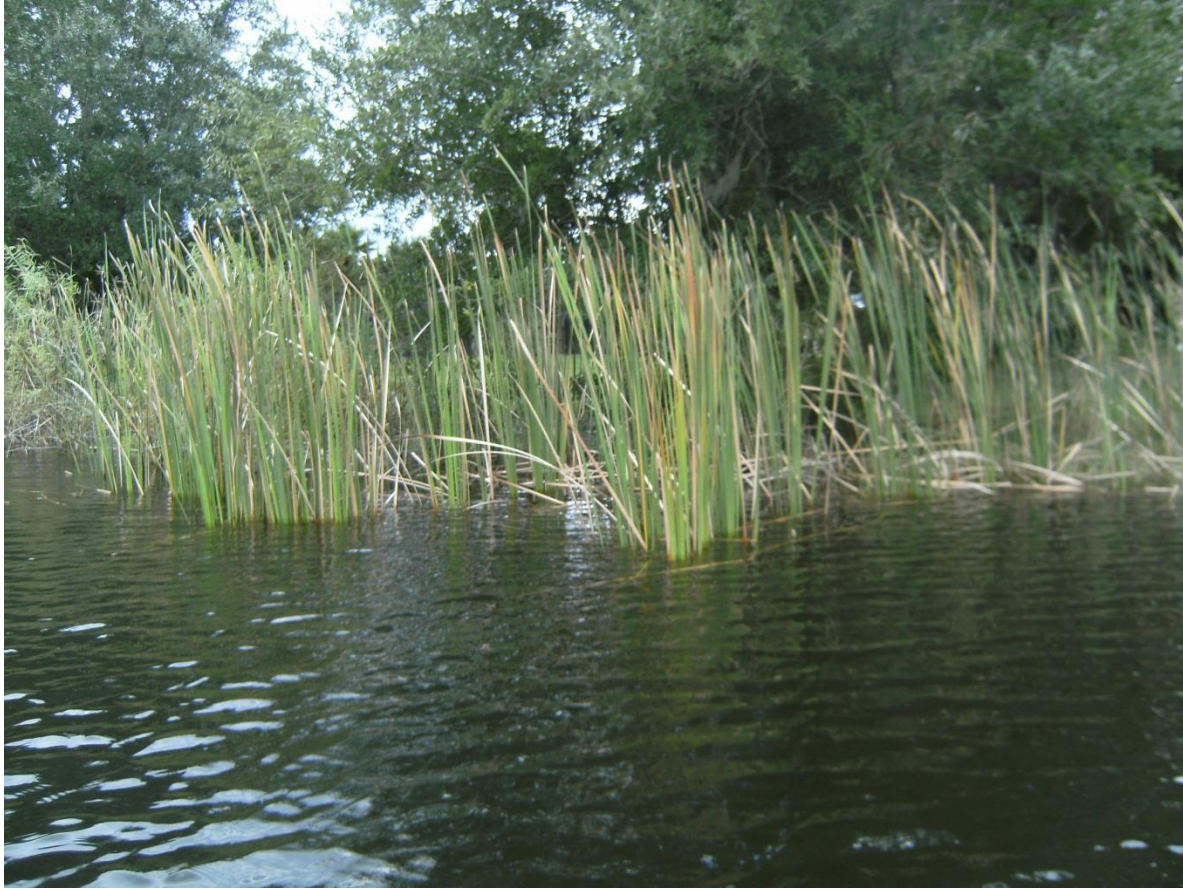
Figure 4 The majority of the emergent vegetation community on Lake Julia was dominated by *Typha*.

The Lake Vegetation Index identified 22 species of wetland vegetation growing in the four selected sections along Lake Julia. The majority of these species (16) are native species. The remaining 6 species (*Panicum repens*, *Alternanthera philoxeroides*, *Arundo donax*, *Mimosa pigra*, *Salvinia minima* and *Ludwigia peruviana*) are non-native and invasive to this region. The vegetation community along Lake Julia is dominated by a variety of emergent species including *Typha* (Figure 4). The water's surface in Lake Julia was dominated by *Salvinia minima*. The submerged vegetation community was dominated by the macroalgae *Nitella* shown in Figure 5). The calculated LVI score for Lake Julia was 48, above the impairment threshold of 37. Figure 7 shows the map of Lake Julia detailing the LVI regions used for the assessment. Table 2 details the species list results of the Lake Vegetation Index. Table 3 details the scoring result for the Lake Vegetation Index. Submerged vegetation was abundant during the assessment. By analyzing the collected sonar chart, submerged aquatic vegetation covered approximately 75% of the surface area of Lake Julia. This submerged vegetation inhabits an estimated 18.06% of the water volume in Lake Julia.
