# Little Halfmoon Lake

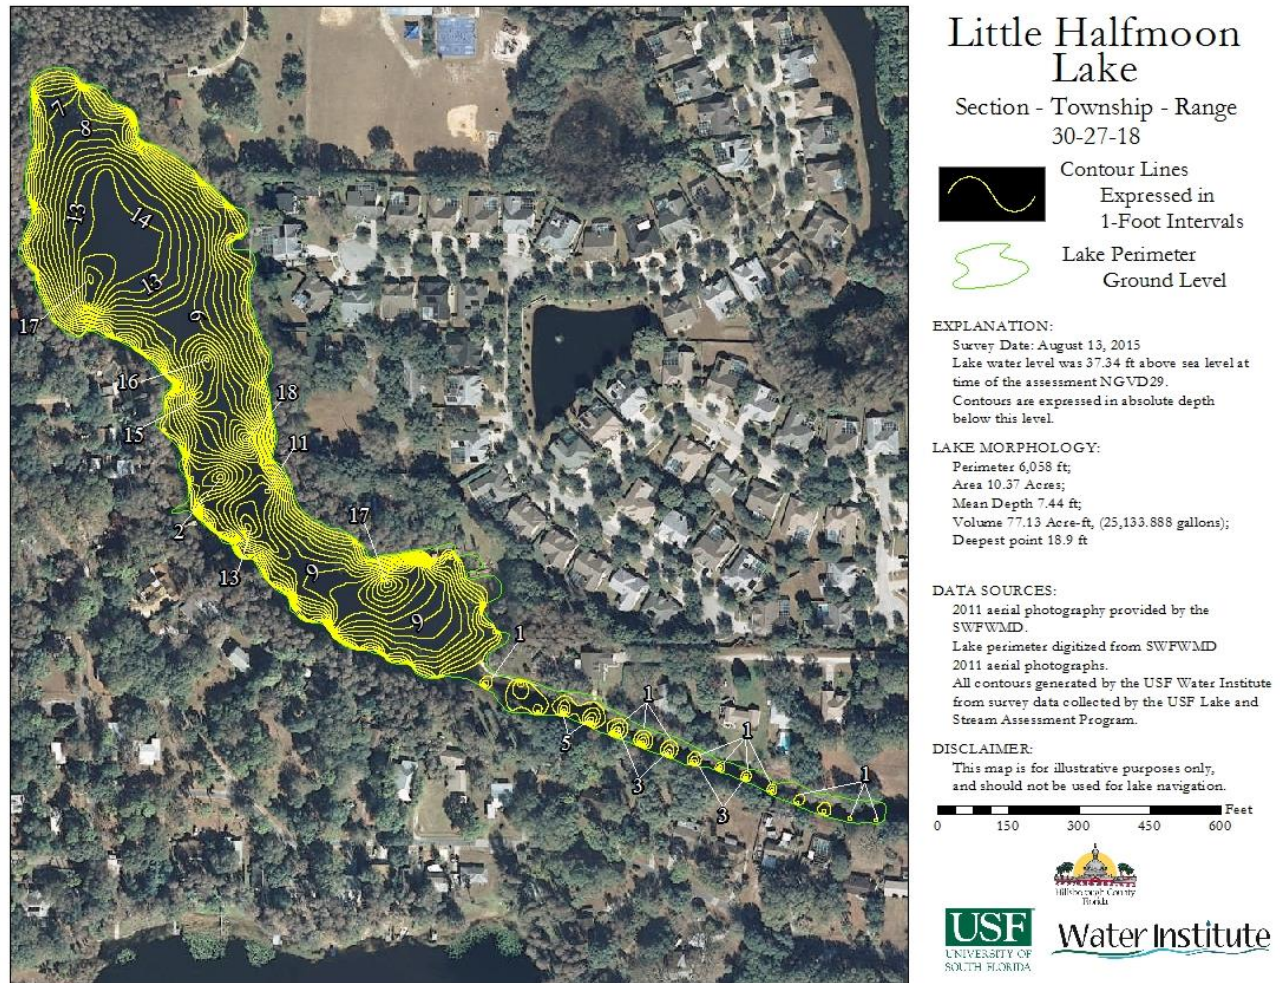
Figure 2 2015 1-Foot Bathymetric Contour Map for Little Halfmoon Lake

Little Halfmoon Lake is an elongated, deep system. At the time of the assessment, Little Halfmoon Lake was experiencing moderately high water levels resulting in a 10.36 acre water body. Little Halfmoon Lake at the time of the assessment had a mean water depth of 7.44 feet and a maximum observed depth of 18.99 feet. The volume at this time was approximately 25,133,888 gallons. Figure 2 shows the resulting bathymetric contour map for Little Halfmoon Lake from data collected on August 13, 2015. The collected data has been overlain the 2011 Hillsborough County aerials.

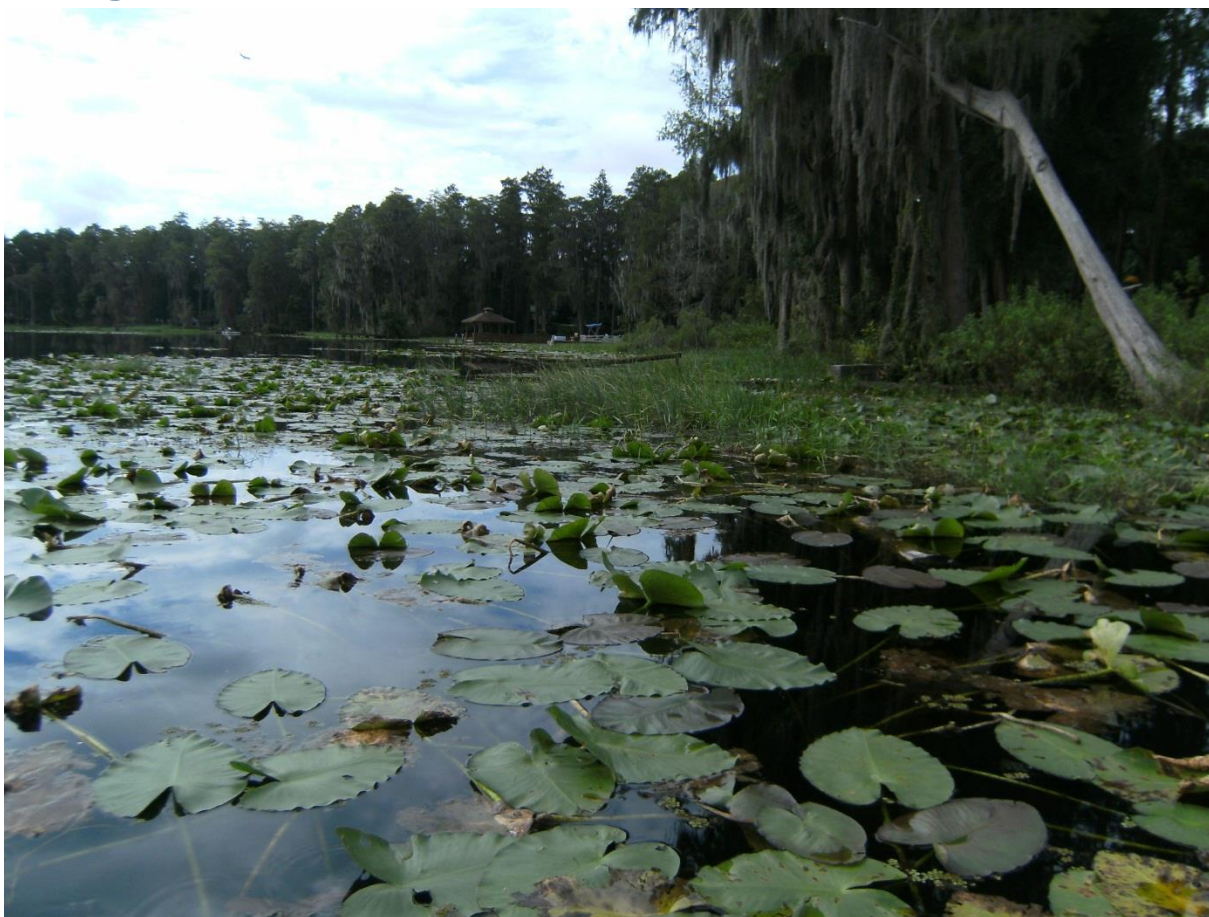
**Figure 3 Overview photograph of Little Halfmoon Lake**

The lake assessment for Little Halfmoon Lake was conducted on August 13, 2015. Little Halfmoon Lake received a lake habitat assessment (FEDP form FD 9000-6) score of 81 due to Optimal scores for Stormwater Inputs and suboptimal scores for Secchi, Vegetation Quality and Upland Buffer Zone. Marginal scores were achieved for Bottom Substrate Quality, Lakeside Adverse Human Alterations, and Adverse Watershed Land Use.

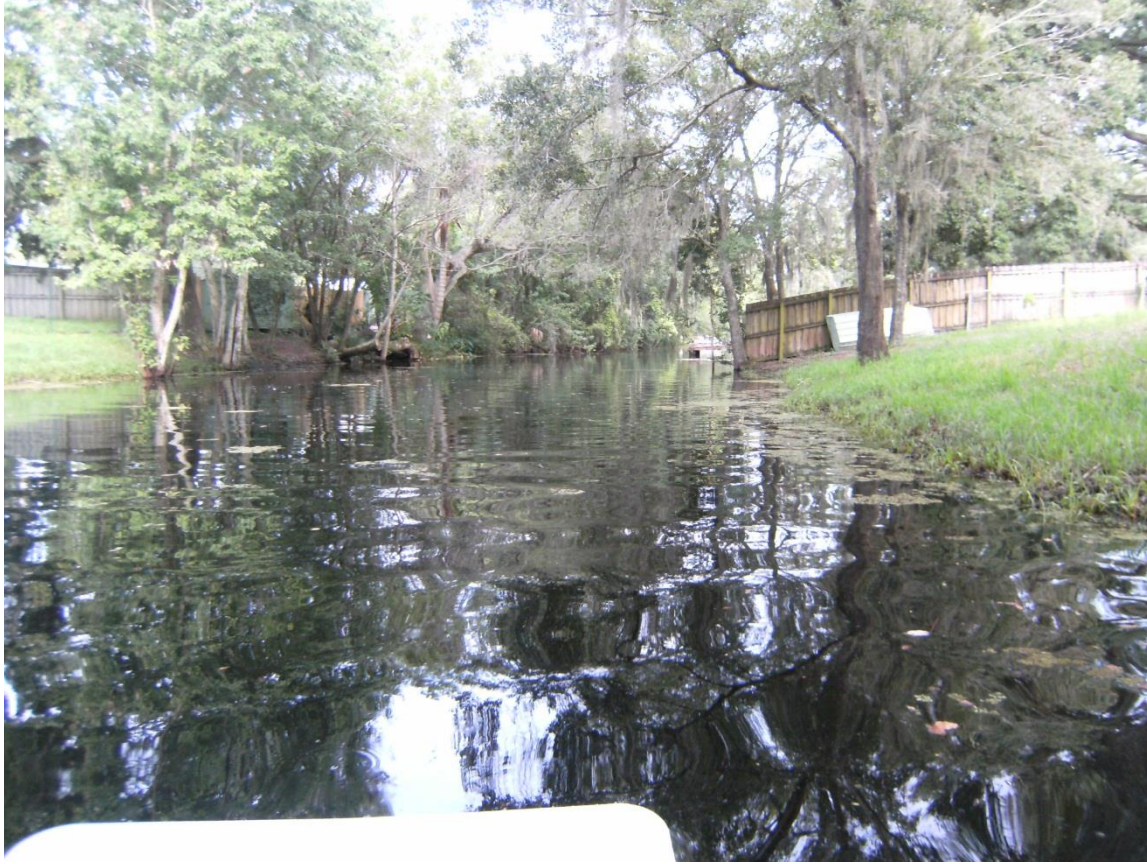
Figure 4 Little Halfmoon Lake had a buffering zone of emergent vegetation surrounding the lake containing a mixture of native and invasive species.

The Lake Vegetation Index identified 37 species of wetland vegetation growing in the four selected sections along Little Halfmoon Lake. The majority of these species (25) are native species. The remaining 12 species (*Panicum repens*, *Alternanthera philoxeroides*, *Sapium sebiferum*, *Sphagneticola trilobata*, *Ruellia simplex*, *Melaleuca quinquemervia*, *Schinus terebinthifolius*, *Colocassia esculenta*, *Oxycaryum cubense*, *Salvinia minima*, *Urochloa mutica* and *Ludwigia peruviana*) are non-native and invasive to this region. The vegetation community along Little Halfmoon Lake is dominated by a variety of emergent species including *Ludwigia peruviana*, *Taxodium* and *Blechnum serrulatum* (Figure 5). The water's surface in Little Halfmoon Lake was dominated by *Nuphar* (Figure 6). The calculated LVI score for Little Halfmoon Lake was 28, below the impairment threshold of 37. Figure 7 shows the map of Little Halfmoon Lake detailing the LVI regions used for the assessment. Table 2 details the species list results of the Lake Vegetation Index. Table 3 details the scoring result for the Lake Vegetation Index. Submerged vegetation observed during the assessment included *Potamogeton diversifolius*. By analyzing the collected sonar chart, submerged aquatic vegetation covered approximately 26% of the surface area of Little Halfmoon Lake. This submerged vegetation inhabits an estimated 4.38% of the water volume in Little Halfmoon Lake.

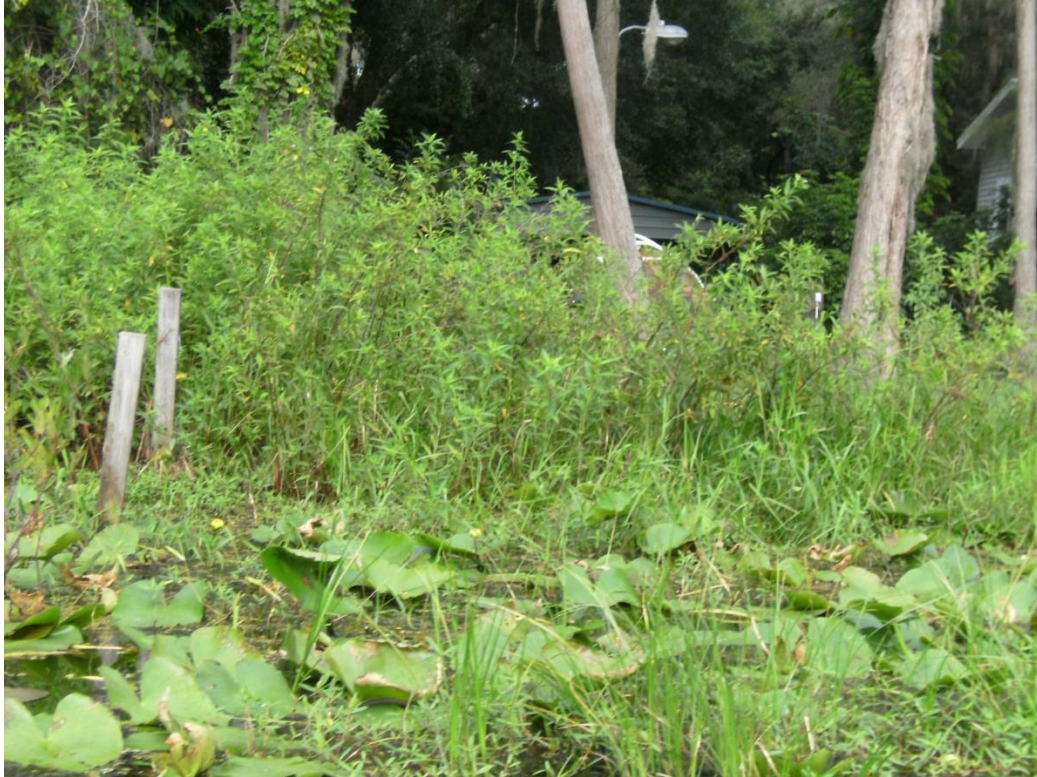
Figure 5 *Ludwigia peruviana* on Little Halfmoon Lake

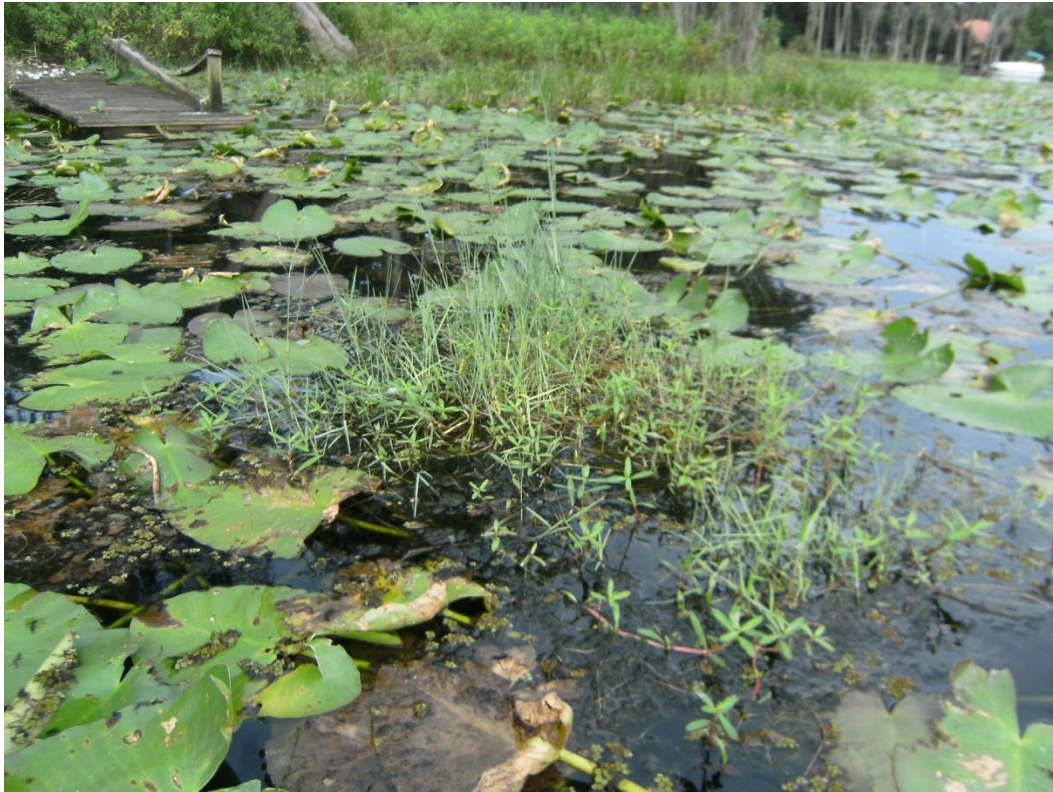
Figure 6 *Nuphar* on Little Halfmoon Lake
