EcoSummary

Long Branch upstream of 69th ST. culvert

March 21, 2002

BioRecon: A rapid, cost-effective screening mechanism for identification of biological impairment

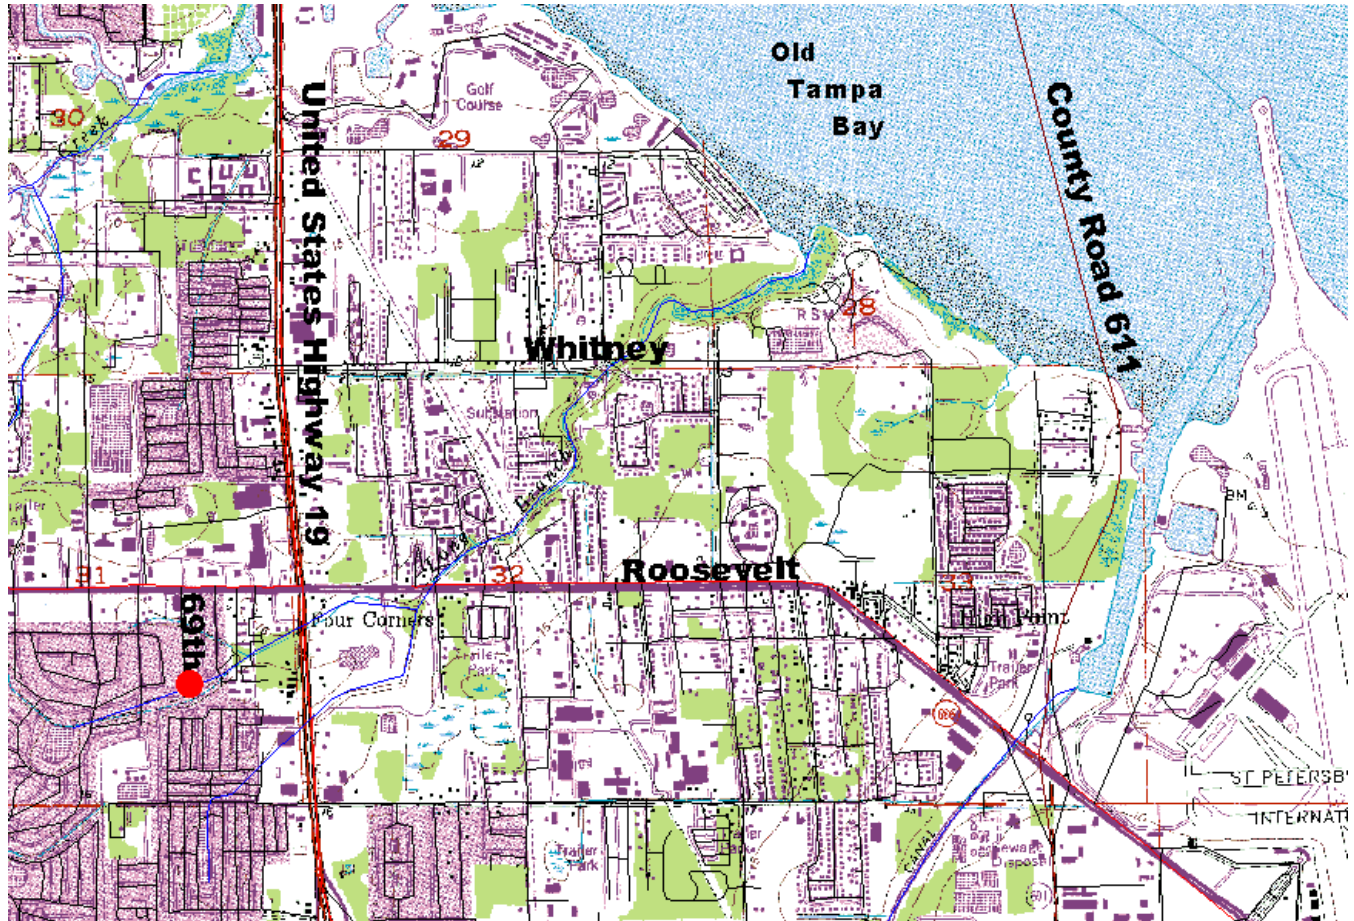
Long Branch upstream of 69th ST. culvert

The sampling site was located upstream of 69th Street. The creek had been ditched and culverted under the road. The creek flowed between a mobile home park and residential neighborhood. The entire watershed is heavily developed.

Water velocity was 0.2 m/s. Instream habitat was plentiful and included vegetation, woody snags and shell rubble.

The habitat assessment score was 65 out of 160, which places it in the marginal category for habitat characterization. The marginal score was due largely to the fact that there was severe habitat smothering, channelization, moderately unstable banks and reduced riparian zone width and quality. Dissolved oxygen was 5.6 mg/l, conductivity was 689 umho/cm, pH was 7.52 SU and temperature was 25.7 deg. C. The results of the biorecon indicated that Long Branch is impaired. None of the parameters exceeded its threshold value. There was one EPT taxa (threshold is 4) and the Florida Index taxa was 0 (threshold is 10).

Long Branch functions as a stormwater drainage system for residential and urban development, as do many streams in Pinellas County. Stormwater runoff is directly piped or ditched to the creek in order to prevent flooding by carrying excess rainwater away from streets, homes, and businesses. Because much of the system contains no filters or other types of pre-treatment, it also serves the
