# Long Branch Creek

## Bacterial Pollution Control Plan

Draft Report  
January 2017

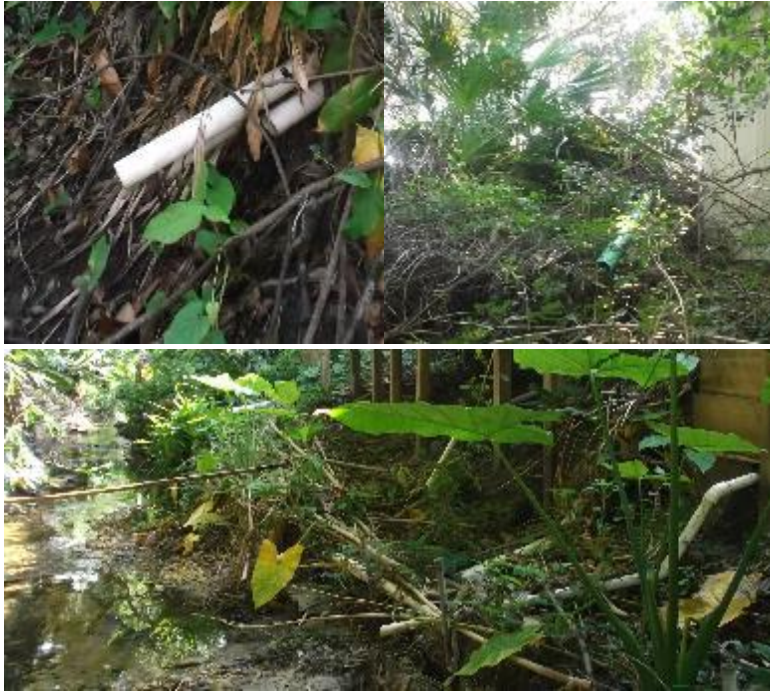
Figure 20. Illicit connections to Poinciana ditch

Several illicit connections of an unknown origin were found in Poinciana ditch. The connections were from residential backyards on either side of the ditch (Figure 20). It is suspected that they were mainly from washing machines, pools, and yard or roof drains. These were forwarded to County NPDES inspectors for enforcement (Appendix A).

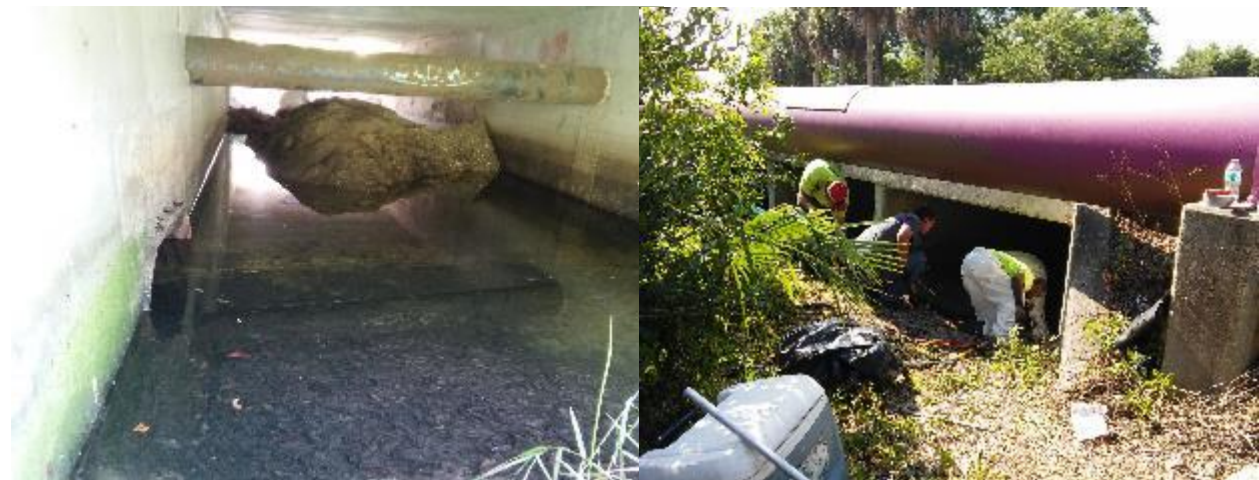
**Figure 27: Workers removing sediment from Long Branch Creek under Whitney Rd.**

In the Whitney Rd. area, sediment accrual under Whitney Rd. in the creek was observed. Approximately 200 feet of open drainage conveyance was cleared of exotic vegetation equating to 30 tons removed in March 2015. Sediment under the box culvert was excavated and disposed of in the spring 2016. A total of 300 tons of sediment was removed. See figures below.
