Long Pond

LAKE HABITAT ASSESSMENT, LAKE VEGETATION INDEX, SUBMERGED
VEGETATION SURVEY AND WATER QUALITY

David Eilers | USF Water Institute | July 22, 2024

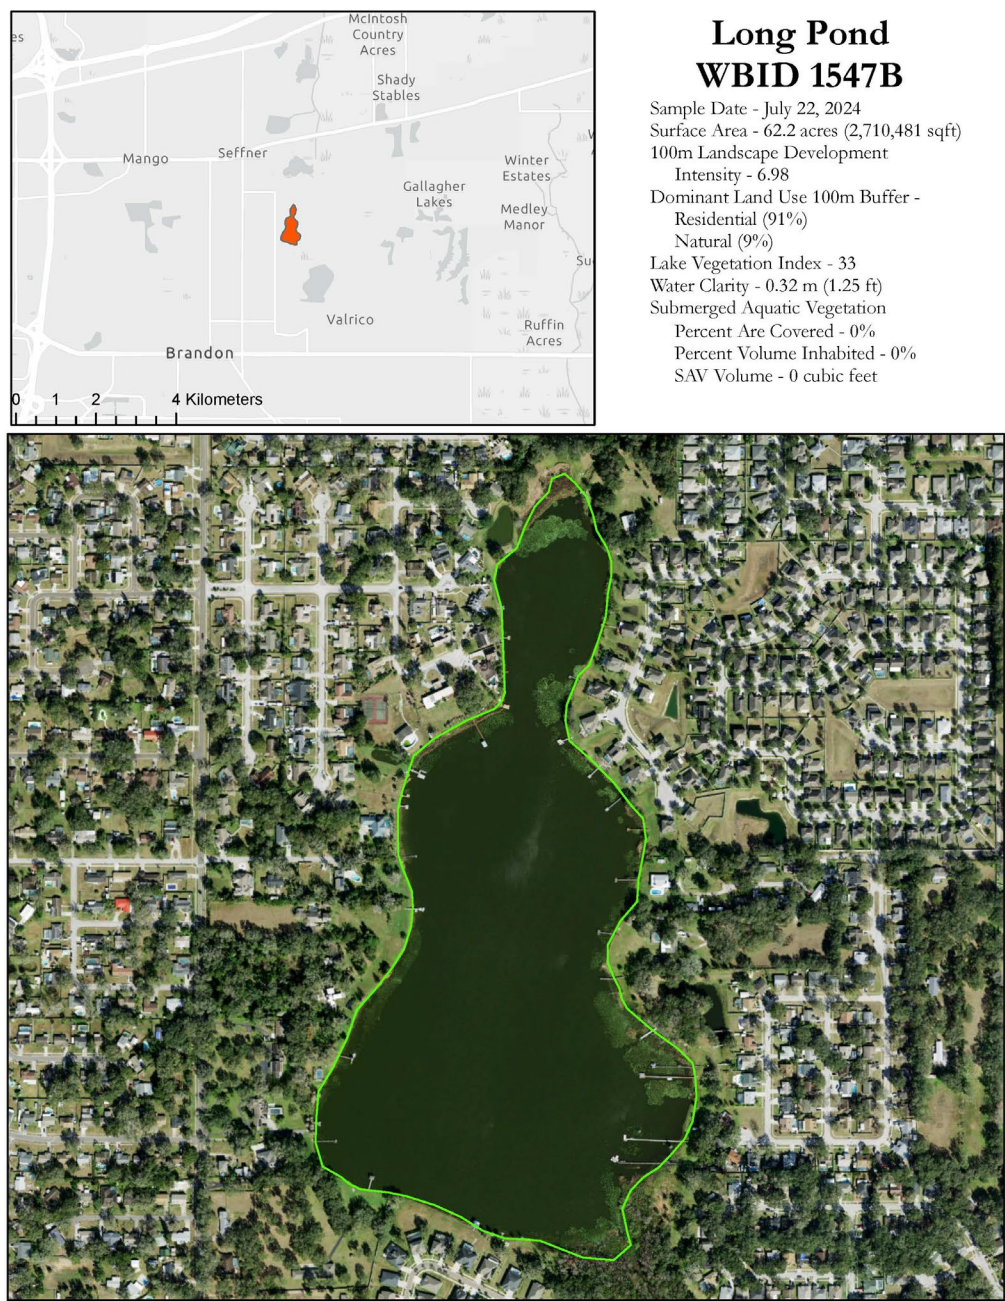
FIGURE 1: 2024 LONG POND ASSESSMENT STUDY AREA MAP

Long Pond is located in Eastern Hillsborough County, Florida. The Landscape Development Intensity Index of the 100 meter buffer around Long Pond is dominated by residential (91%) and natural (9%) land uses. The resulting LDI value for the 100 meter buffer around Long Pond is 6.98.

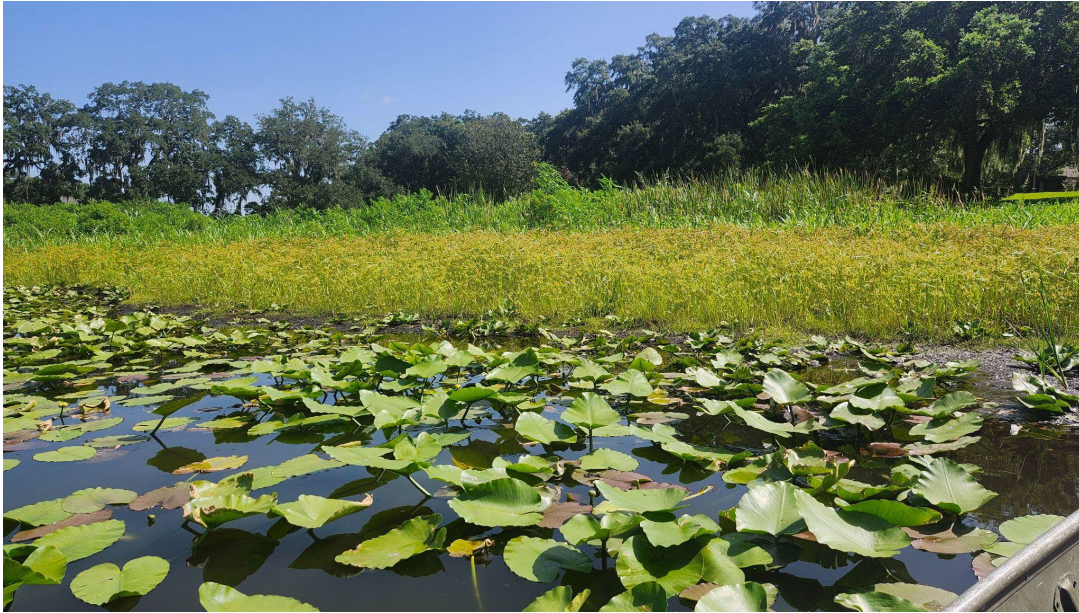
Figure 3 Overview photograph of Long Pond showing the presence of emergent vegetation

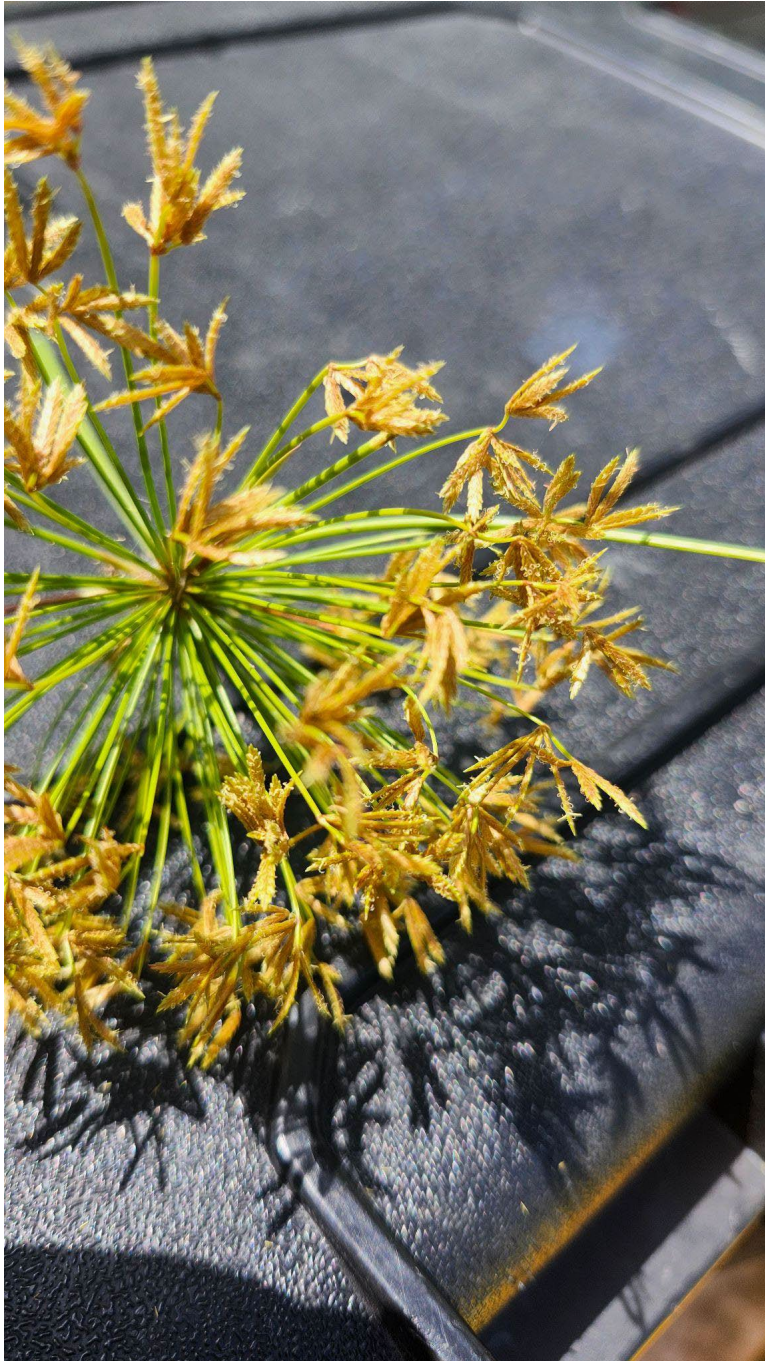
Figure 4 *Cyperus prolifer* collected in region 7.

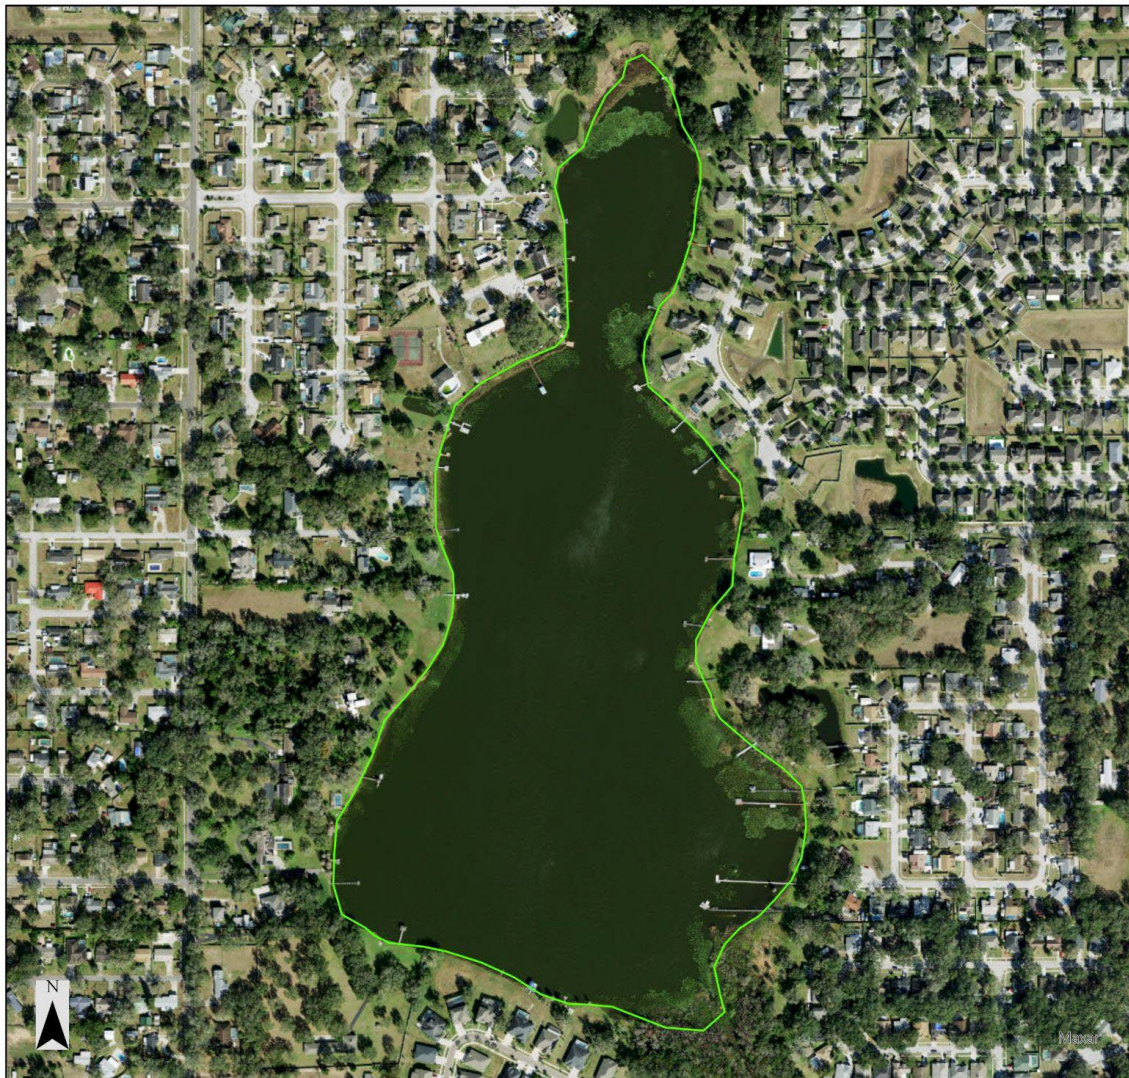
Figure 5 Long Pond Submersed Aquatic Vegetation Assessment Results

By analyzing the collected sonar chart, submerged aquatic vegetation potentially covered approximately 0% of the surface area of Long Pond. This submerged vegetation inhabits an estimated 0% of the water volume in Long Pond. This confirms the results found during the LVI assessment. Figure 5 shows the results of the SAV analysis indicating the location and height of SAV estimated from collected sonar readings.

No submersed aquatic vegetation was observed at the time of the assessment.

Area 0 square ft; 0 Acres;
(0%) of Lake Surface Area)
Mean SAV Height 0 ft;
Volume 0 Cubic ft, (0gallons);
(0% of Lakes Volume)
