Mango Lake

Figure 1 2016 Mango Lake Assessment Study Area Map

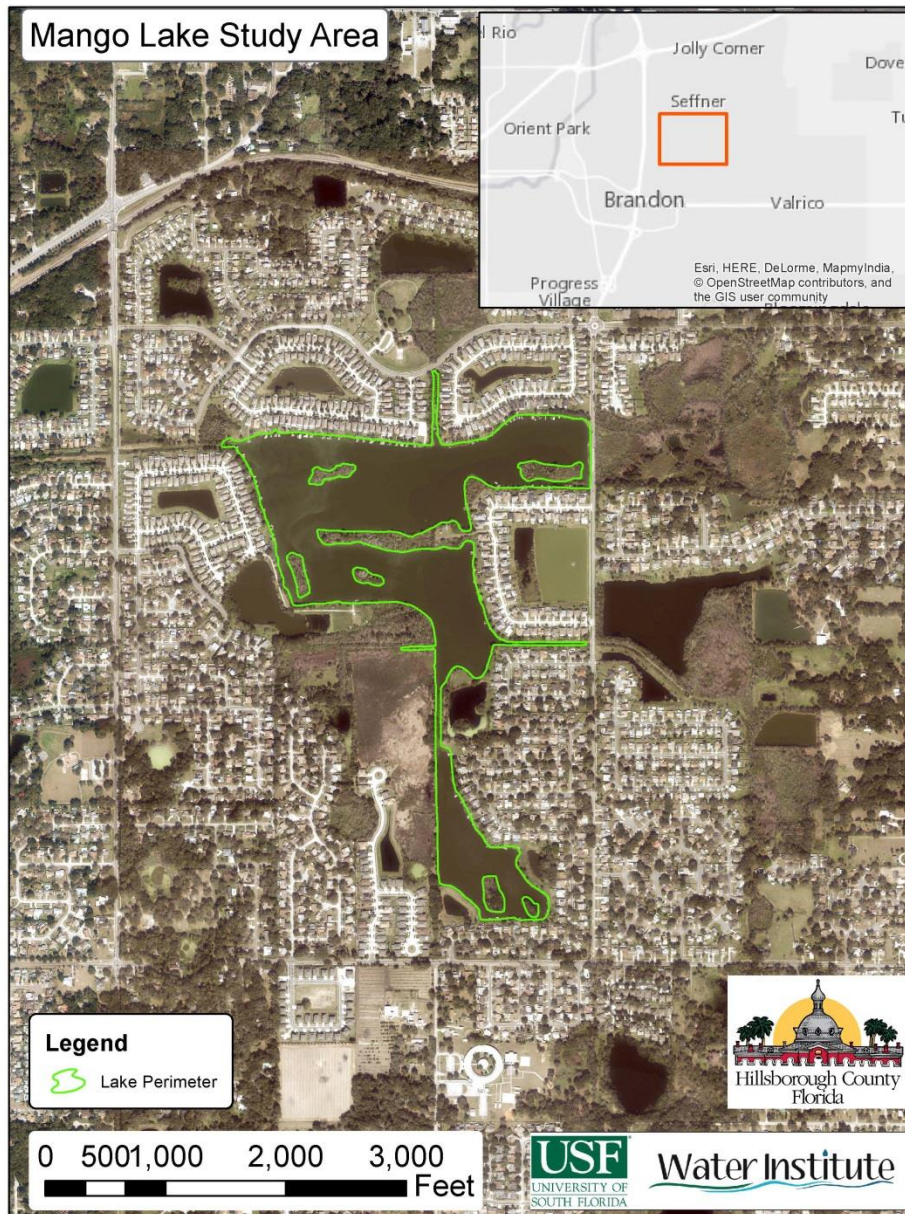
Mango Lake is located south of Broadway Ave between Lakewood Drive and Highview Road near Brandon, Florida. The Landscape Development Intensity Index of the 100 meter buffer around Mango Lake is dominated by Residential (64.04%), Reservoirs (10.16%) and Natural (23.72%) land uses. The resulting LDI value for the 100 meter buffer around Mango Lake is 5.95. The LDI value calculated for the FDEP WBID containing Mango Lake was 6.51 with approximately 49.4% of the land use being Residential, 15.7% Commercial and Services, 6.8% Industrial/ Institutional and 9.3% Agricultural.

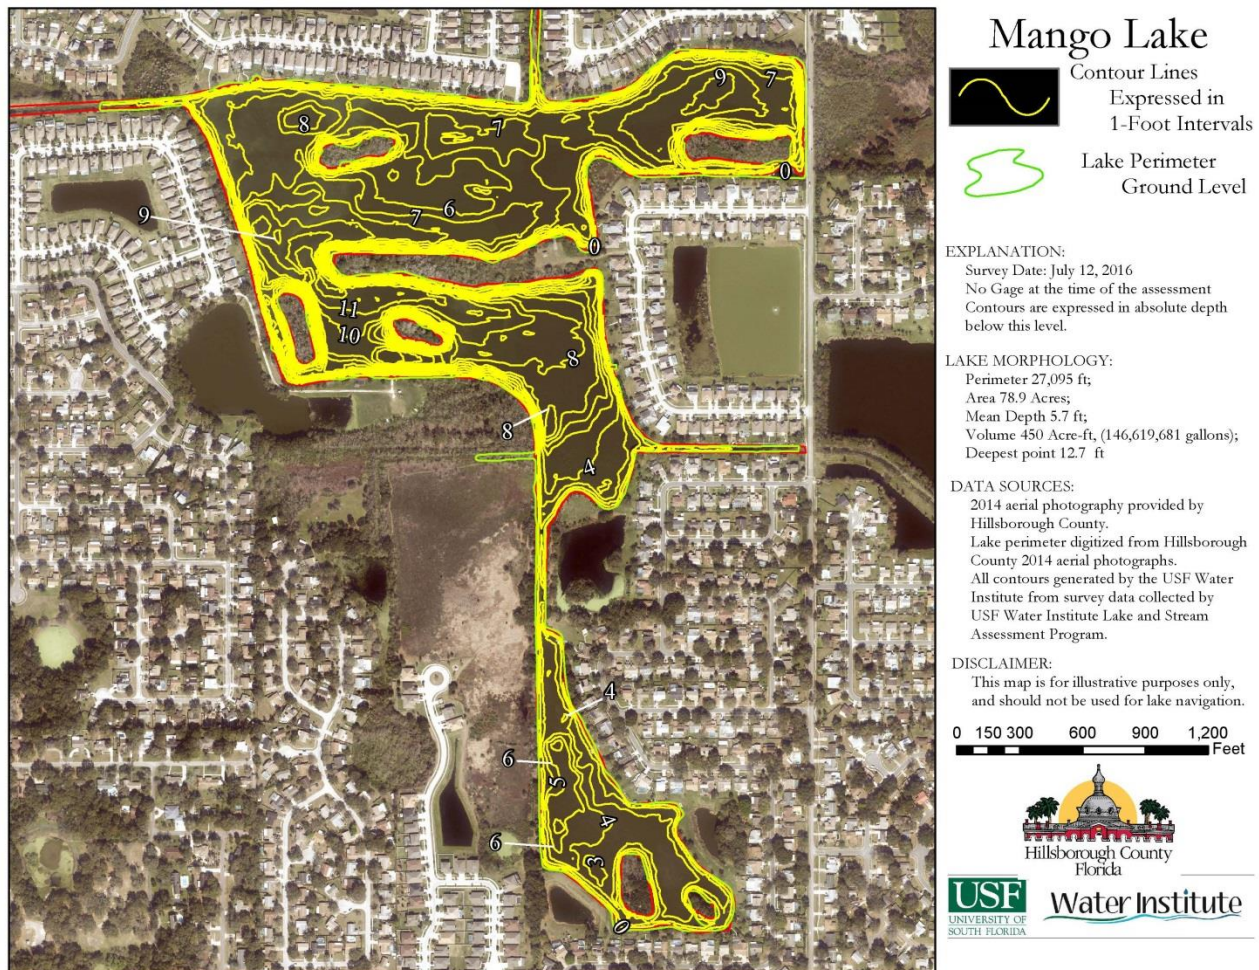
Figure 2 2016 1-Foot Bathymetric Contour Map for Mango Lake

Mango Lake is a heavily altered, created lake in an urban setting. At the time of the assessment, Mango Lake was experiencing moderately high water levels resulting in a 78.9 acre water body. Mango Lake at the time of the assessment had a mean water depth of 5.7 feet and a maximum observed depth of 12.7 feet. The volume at this time was approximately 146,619,681 gallons. Figure 2 shows the resulting bathymetric contour map for Mango Lake from data collected on July 20, 2016. The collected data has been overlain the 2014 Hillsborough County aerals.

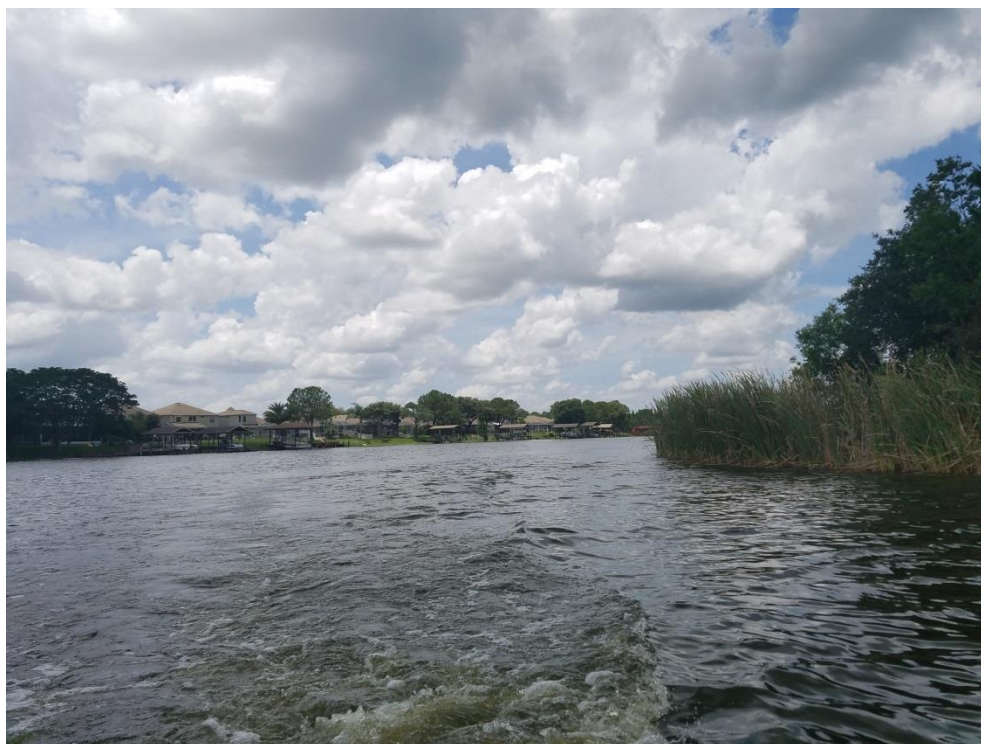
Figure 3 Overview photograph of Mango Lake

The lake assessment for Mango Lake was conducted on July 20, 2016. Mango Lake received a lake habitat assessment (FEDP form FD 9000-6) score of 64 due to suboptimal scores for Bottom Substrate Quality and Adverse Watershed Land Use. Marginal scores were achieved for Vegetation Quality, Stormwater Inputs, Lakeside Adverse Human Alterations and Upland Buffer Zone. Secchi received poor scores.

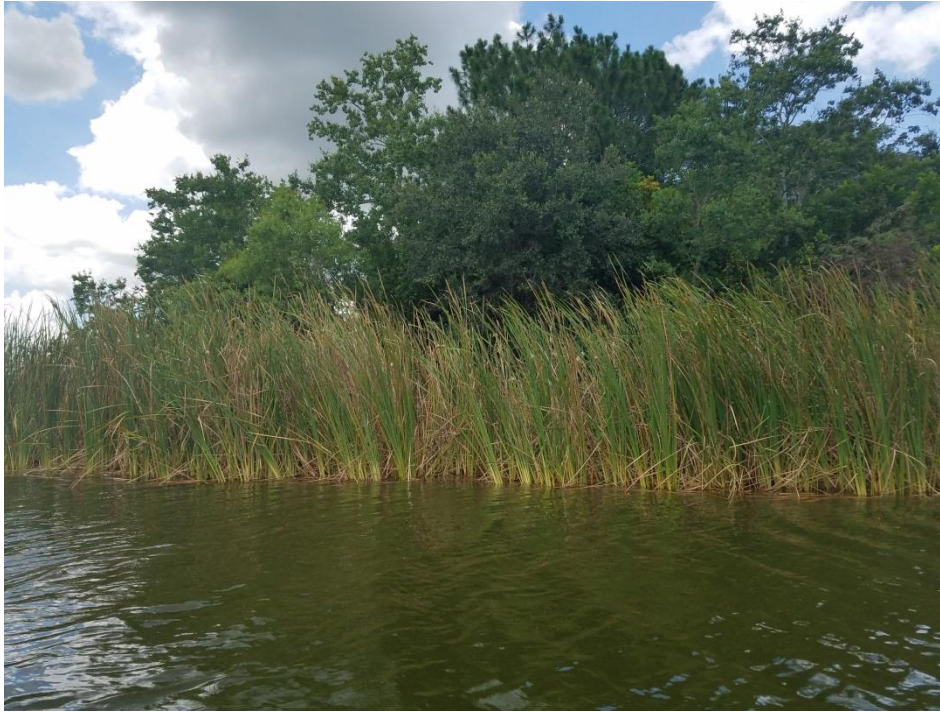
Figure 4 Mango Lake had a buffering zone of emergent vegetation surrounding the lake containing a mixture of native and invasive species.

The Lake Vegetation Index identified 51 species of wetland vegetation growing in the four selected sections along Mango Lake. The majority of these species (35) are native species. The remaining 16 species (Shown in Bold in Table 2) are non-native and invasive to this region. The vegetation community along Mango Lake is dominated by a variety of emergent species including *Typha*, *Panicum repens* and *Colocasia esculenta* (Figure 5). The water's surface in Mango Lake was dominated by *Pistia stratiotes* and *Eichhornia crassipes* (Figure 6). The calculated LVI score for Mango Lake was 14, below the impairment threshold of 37. Figure 7 shows the map of Mango Lake detailing the LVI regions used for the assessment. Table 2 details the species list results of the Lake Vegetation Index. Table 3 details the scoring result for the Lake Vegetation Index. Submerged vegetation was observed during the assessment and was dominated by *Hydrilla verticillata*. By analyzing the collected sonar chart, submerged aquatic vegetation covered approximately 6% of the surface area of Mango Lake. This submerged vegetation inhabits an estimated 1.3% of the water volume in Mango Lake.

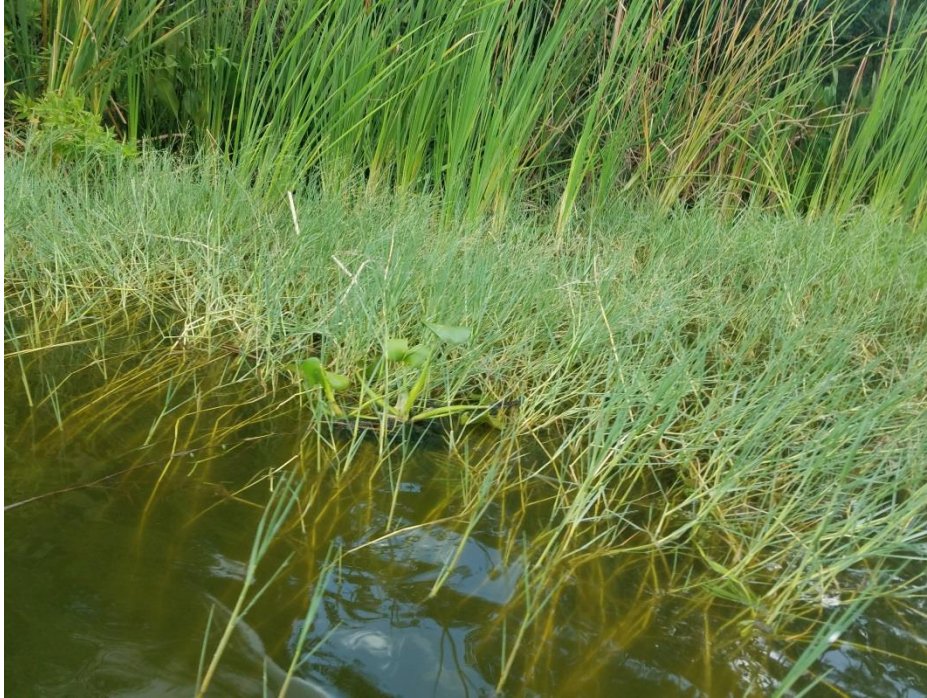
Figure 5 *Panicum repens* and *Typha* on Mango Lake

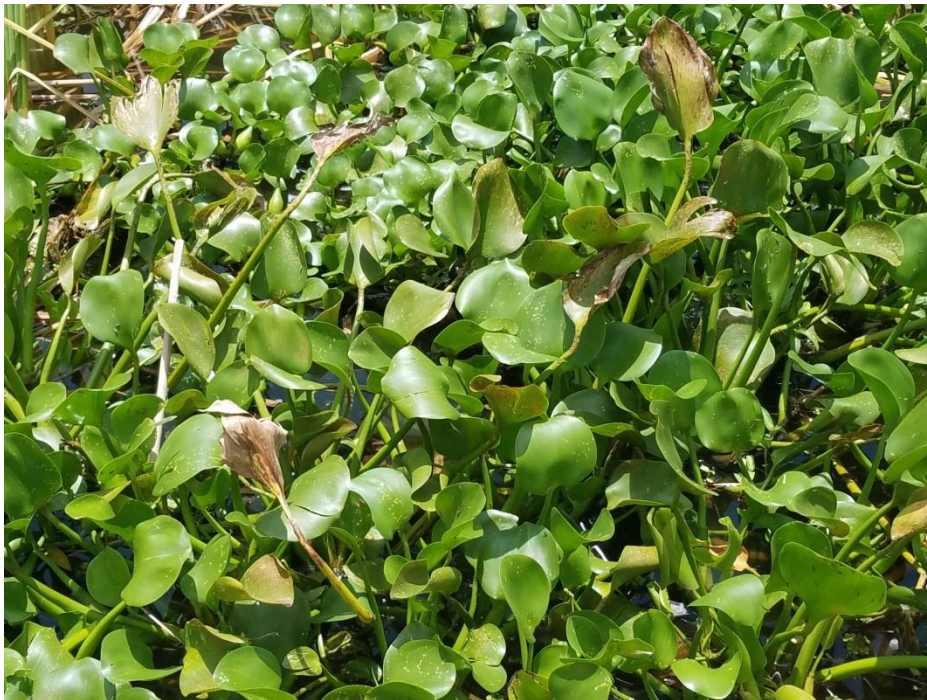
Figure 6 *Eicchornia crassipes* on Mango Lake
