RESERVOIR ASSESSMENT REPORT FOR MEDARD RESERVOIR IN HILLSBOROUGH COUNTY, FLORIDA

Date Assessed: August 19 & 20, 2009

INTRODUCTION

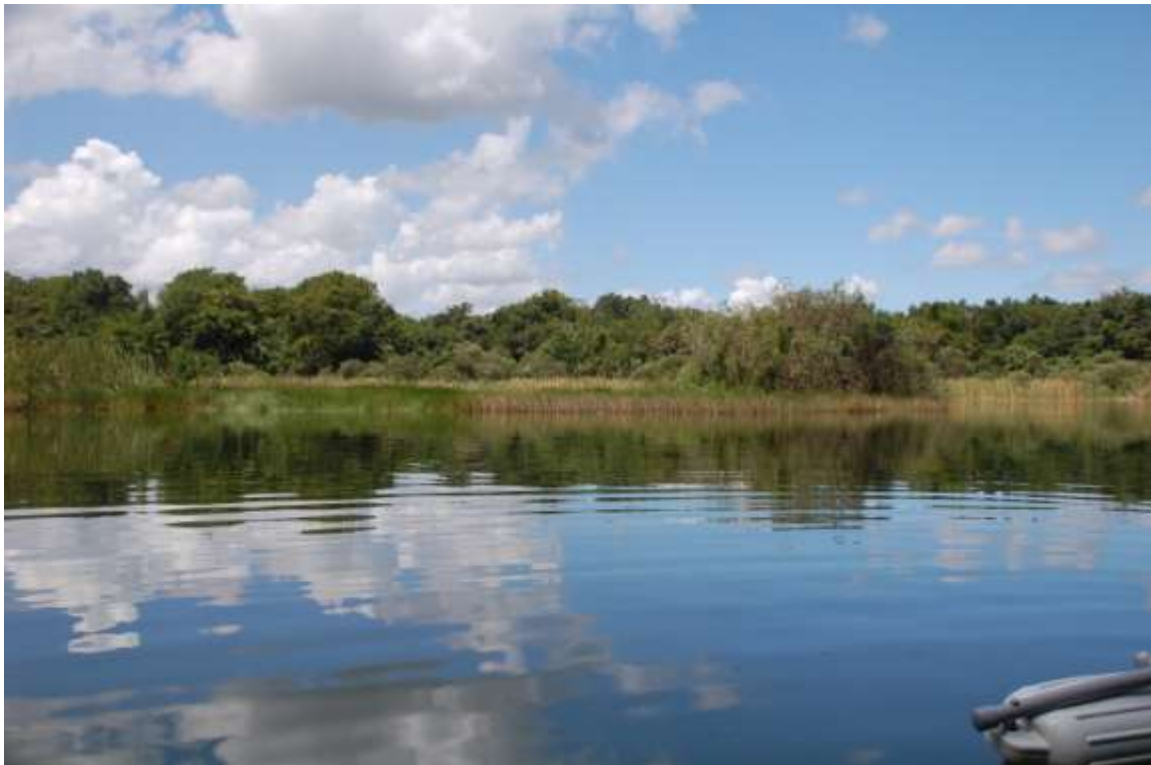
Figure 1. Photo of Medard Reservoir, taken August 19, 2009.

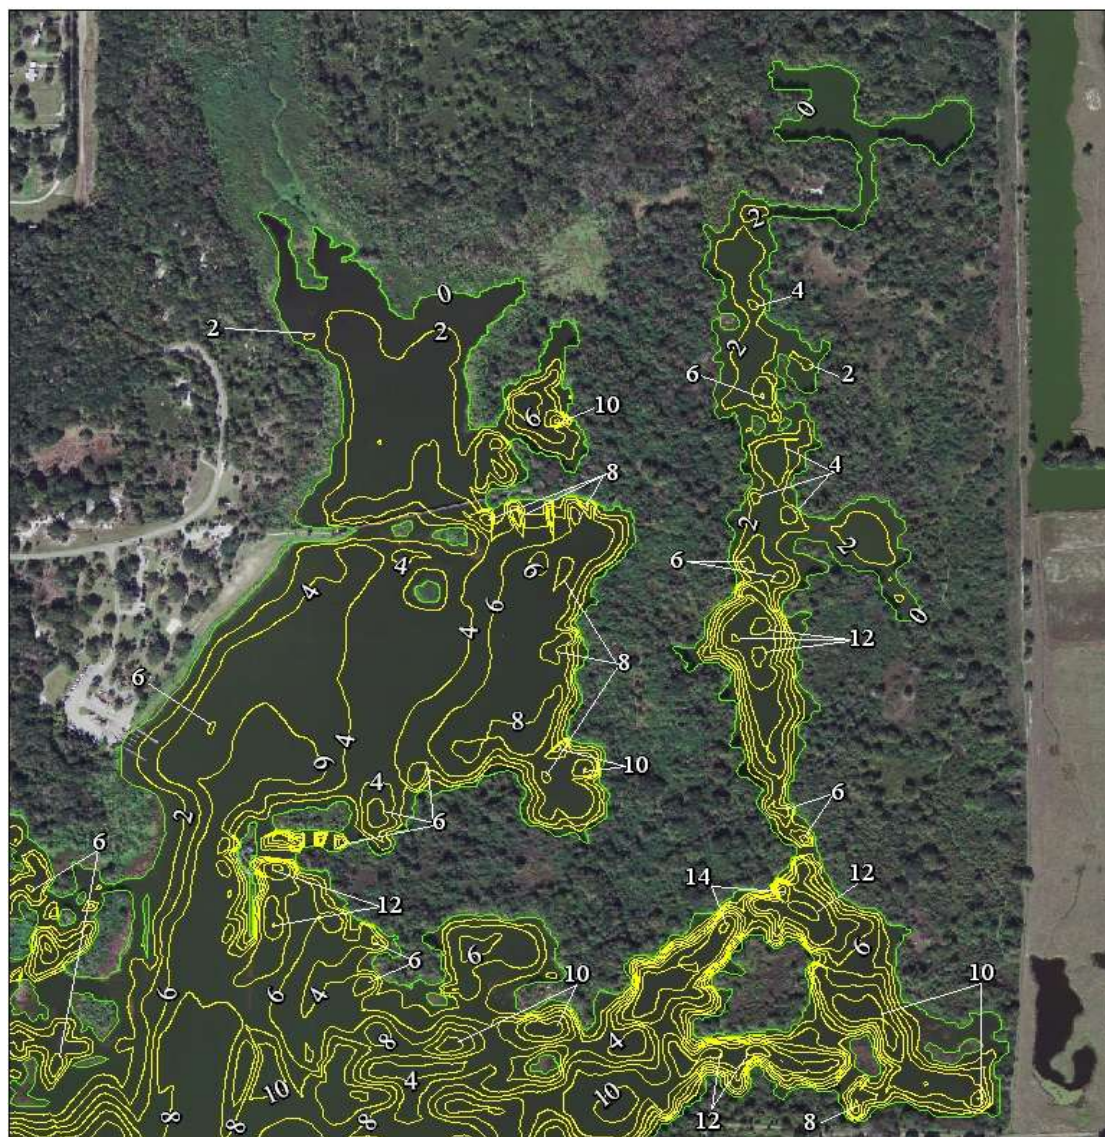
Figure 3. Contour map for Medard Reservoir (northeast). The mapping technique used in 2009 employs a standard DGPS for horizontal position and a fathometer for depth.

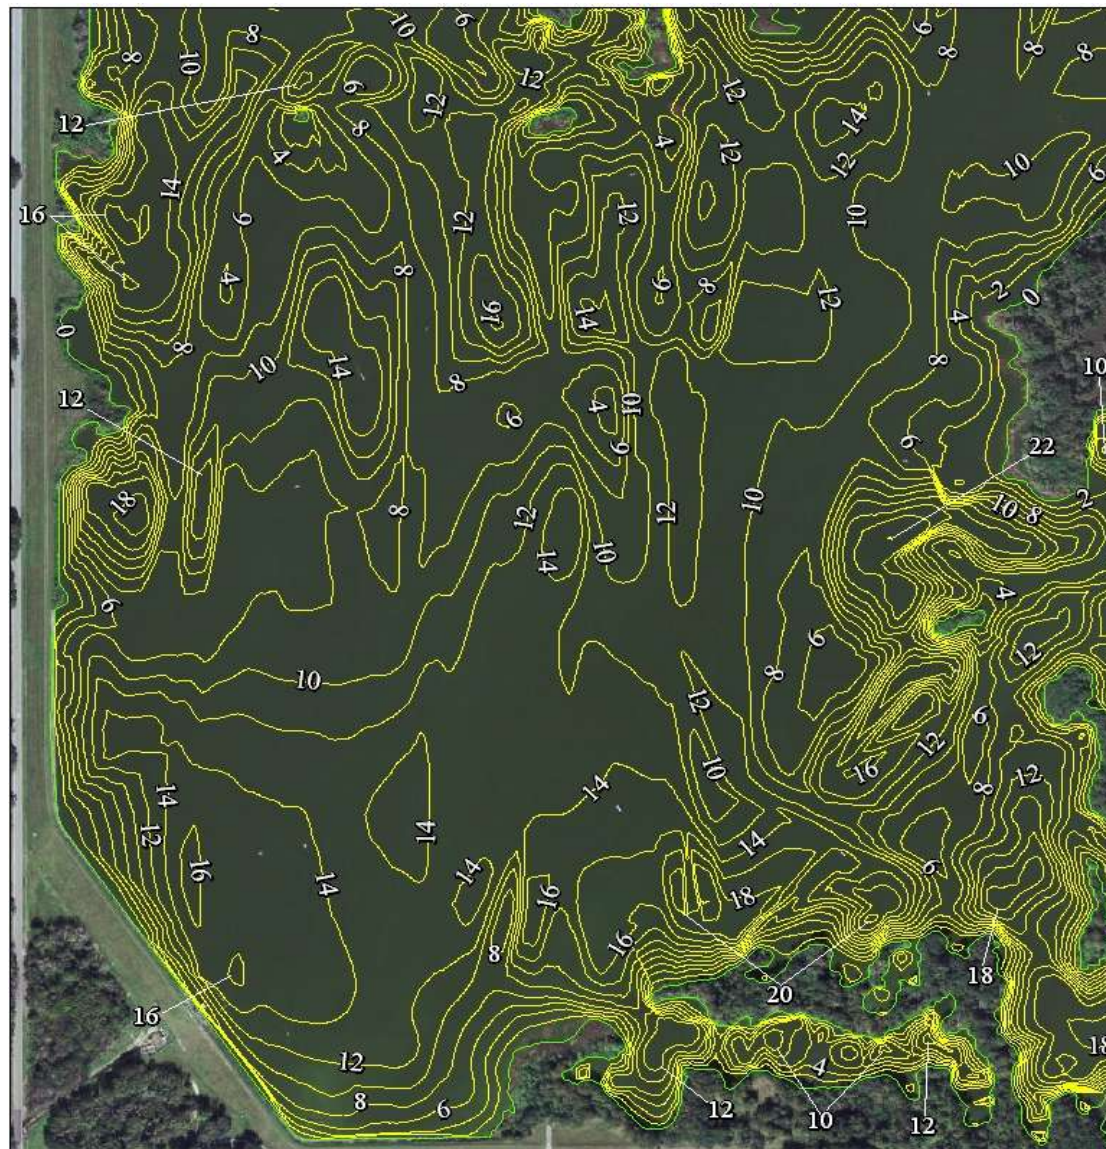
Figure 5. Contour map for Medard Reservoir (southwest). The mapping technique used in 2009 employs a standard DGPS for horizontal position and a fathometer for depth.

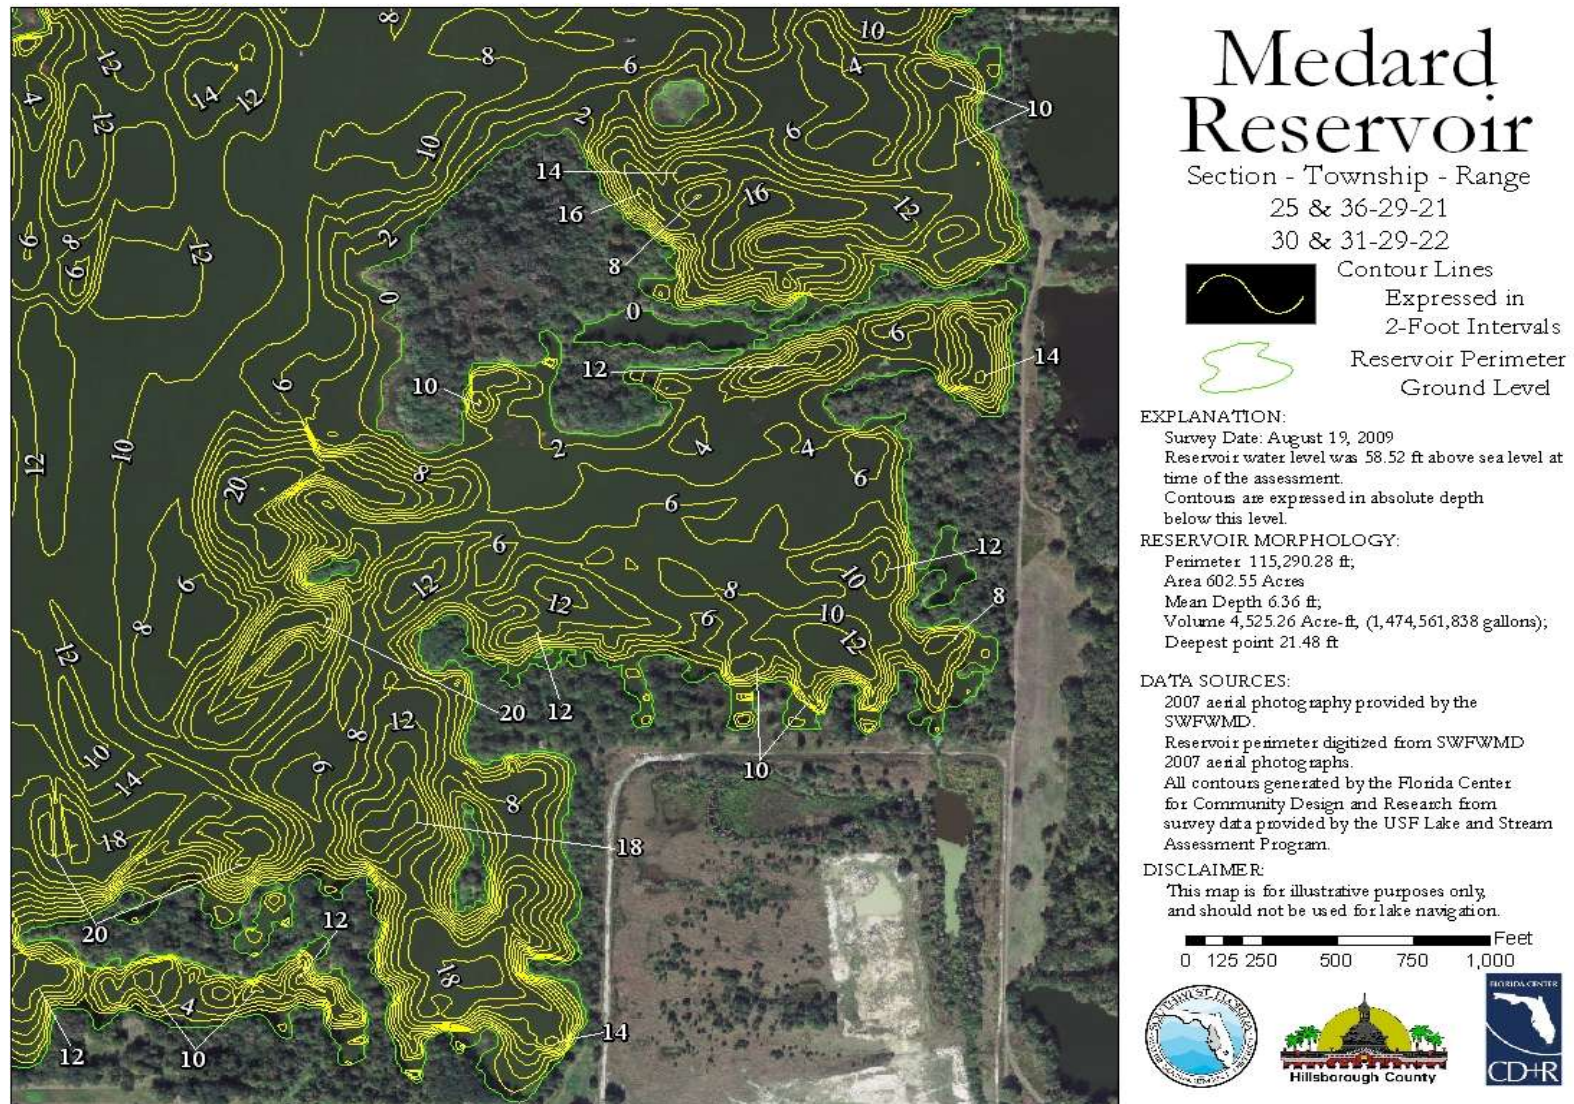
Figure 6. Contour map for Medard Reservoir (southeast). The mapping technique used in 2009 employs a standard DGPS for horizontal position and a fathometer for depth.

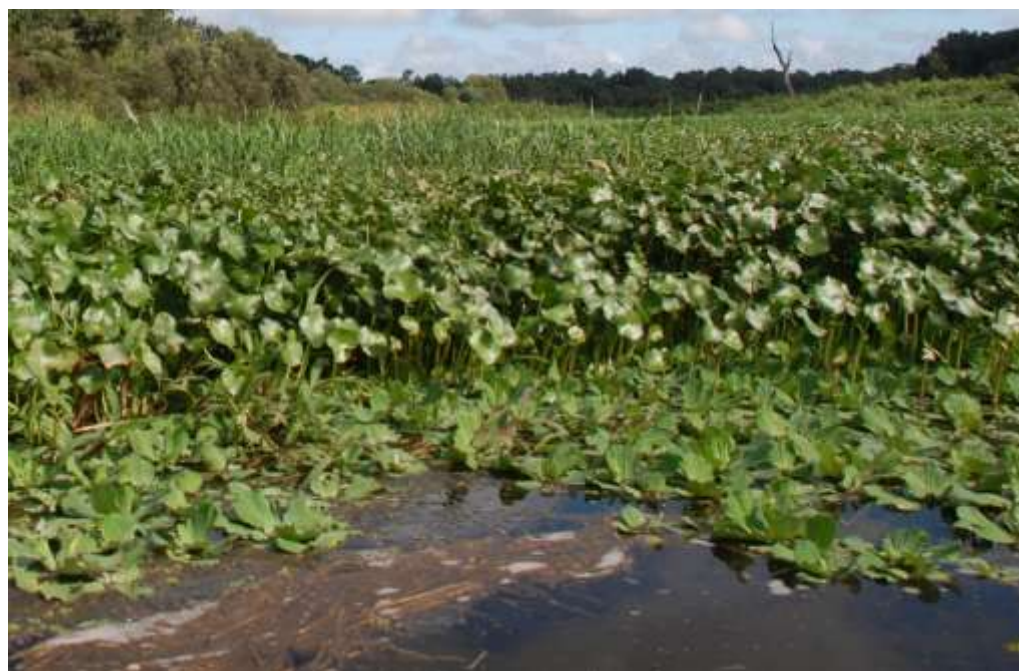
Figure 8. *Pistia stratioides*, (Water Lettuce), in the foreground, is a non-native invasive species found on Medard Reservoir. *Hydrocotyl umbellata*, (Water Pennywort), in the middle is a common native species found on Medard Reservoir.

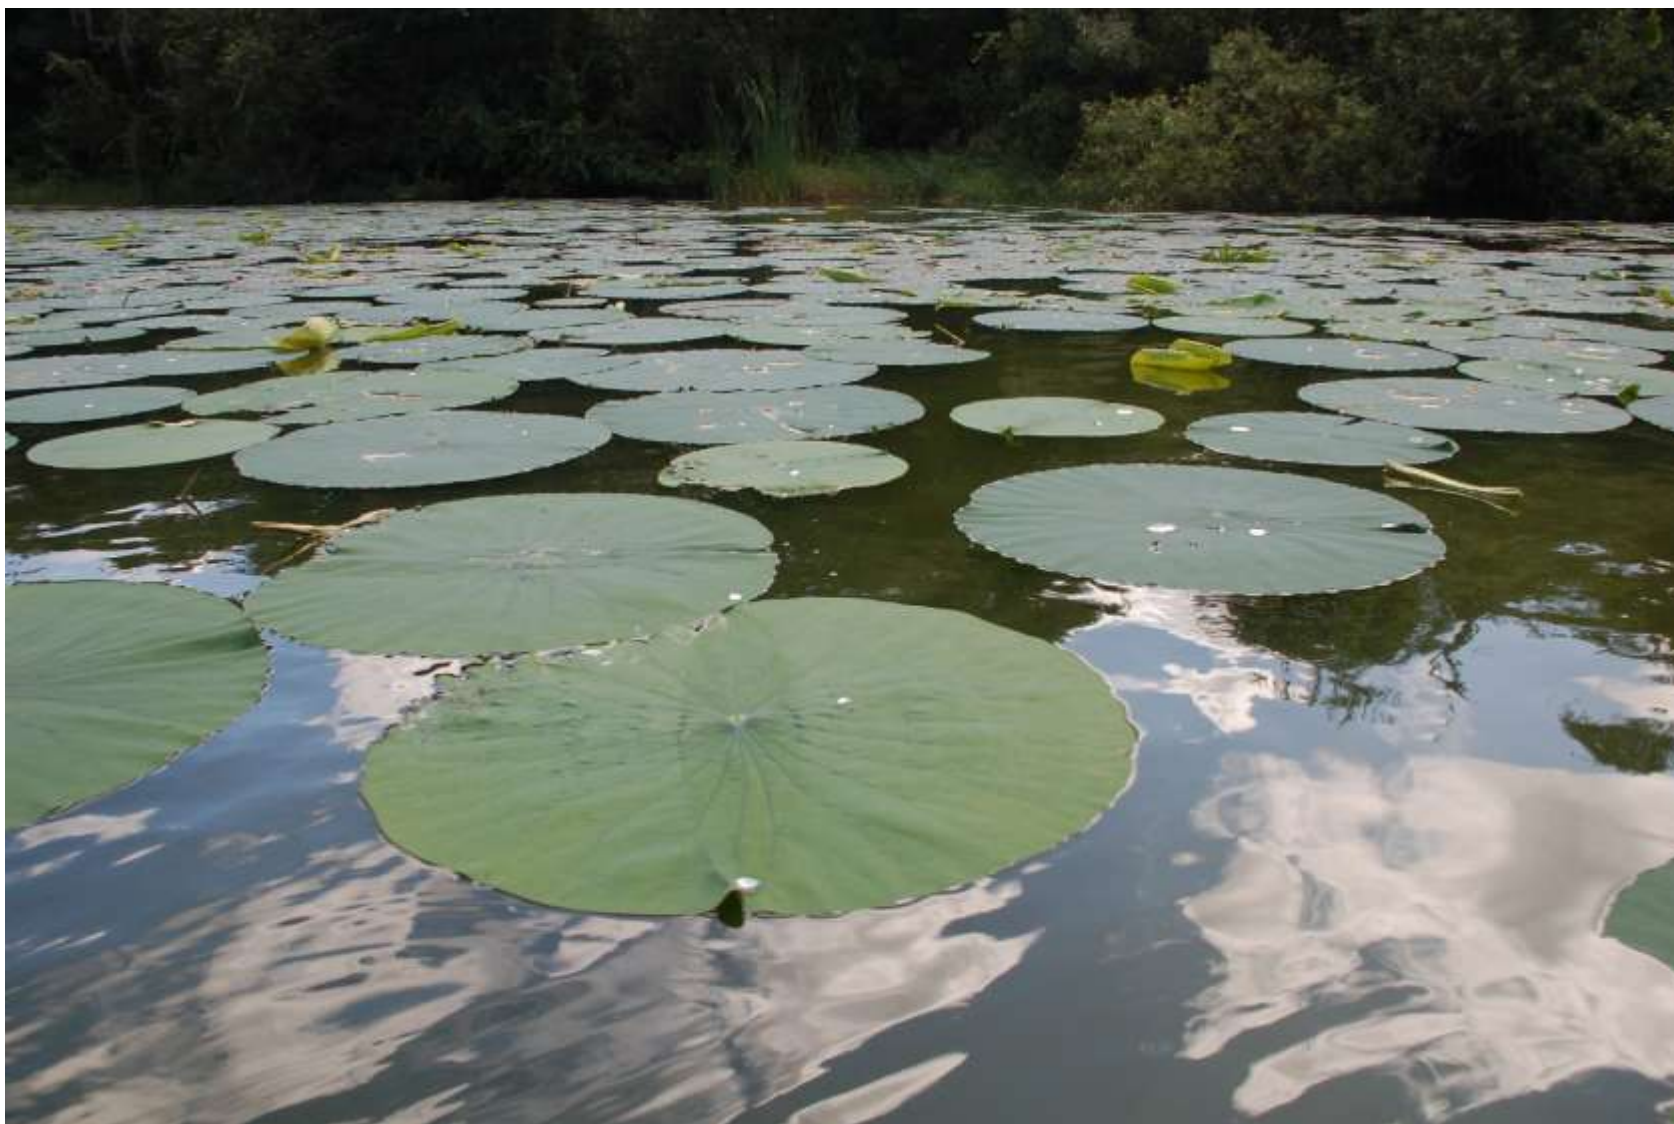
Figure 9. Photograph of *Nelumbo lutea*, (American Lotus) on Medard Reservoir. This native floating vegetation was found on Medard Reservoir although it was not found at a vegetation assessment site.

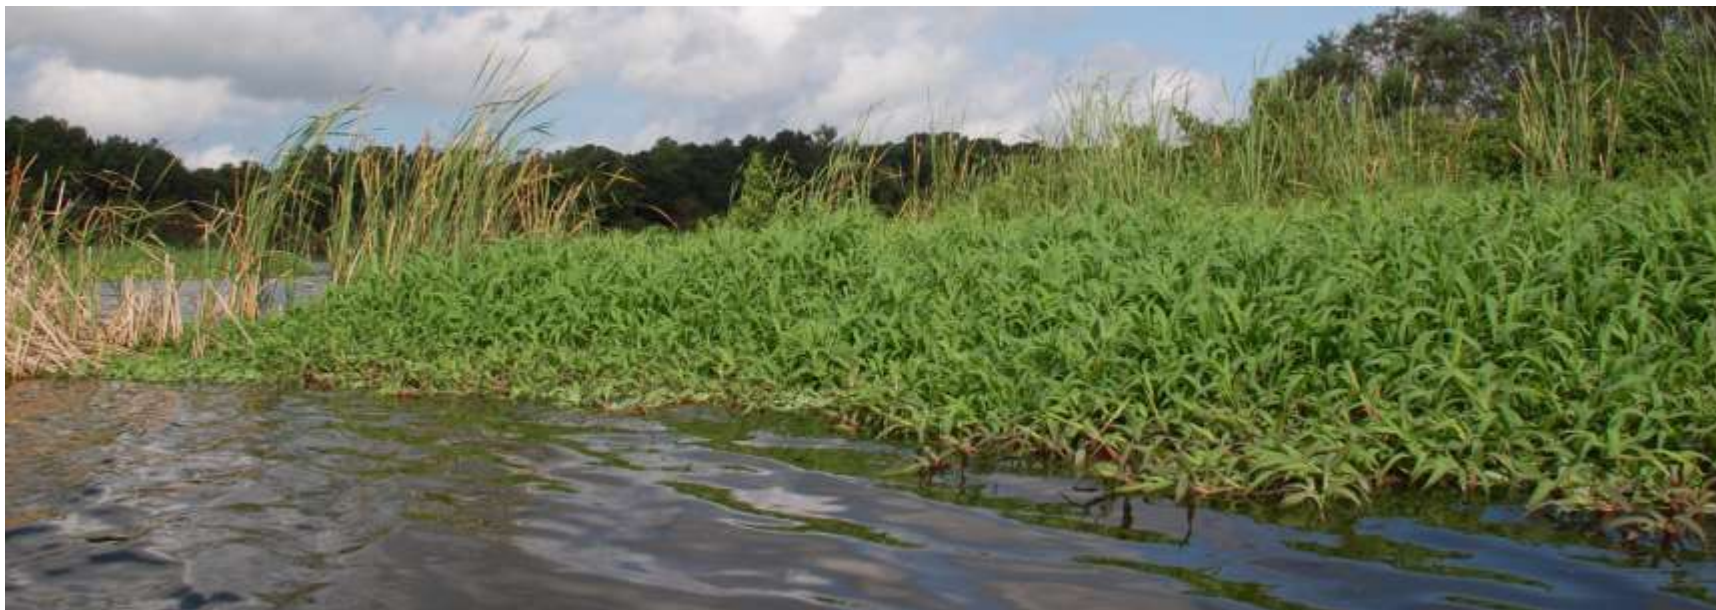
Figure 10. *Paspalum repens*, (Water Paspalum) is a native emergent grass found on Medard Reservoir shown here in the foreground. *Typha* spp., (Cattails) are also a native emergent vegetation commonly found on Medard Reservoir shown here just behind the *Paspalum repens*.

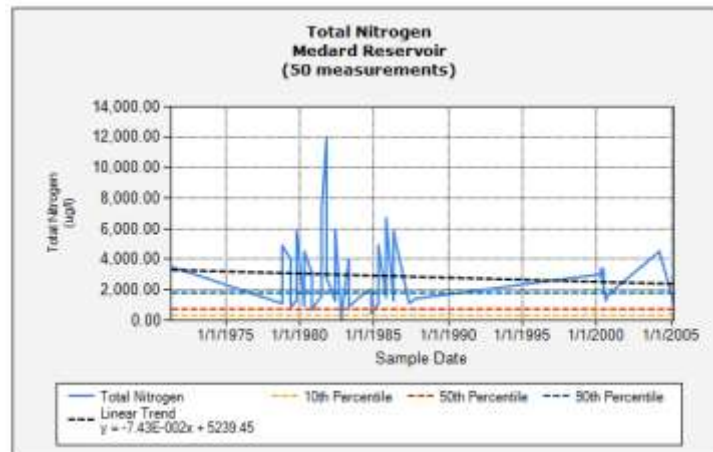
Figure 13. Total Nitrogen in µg/L from multiple sources.
