# Mill Creek

## Methods

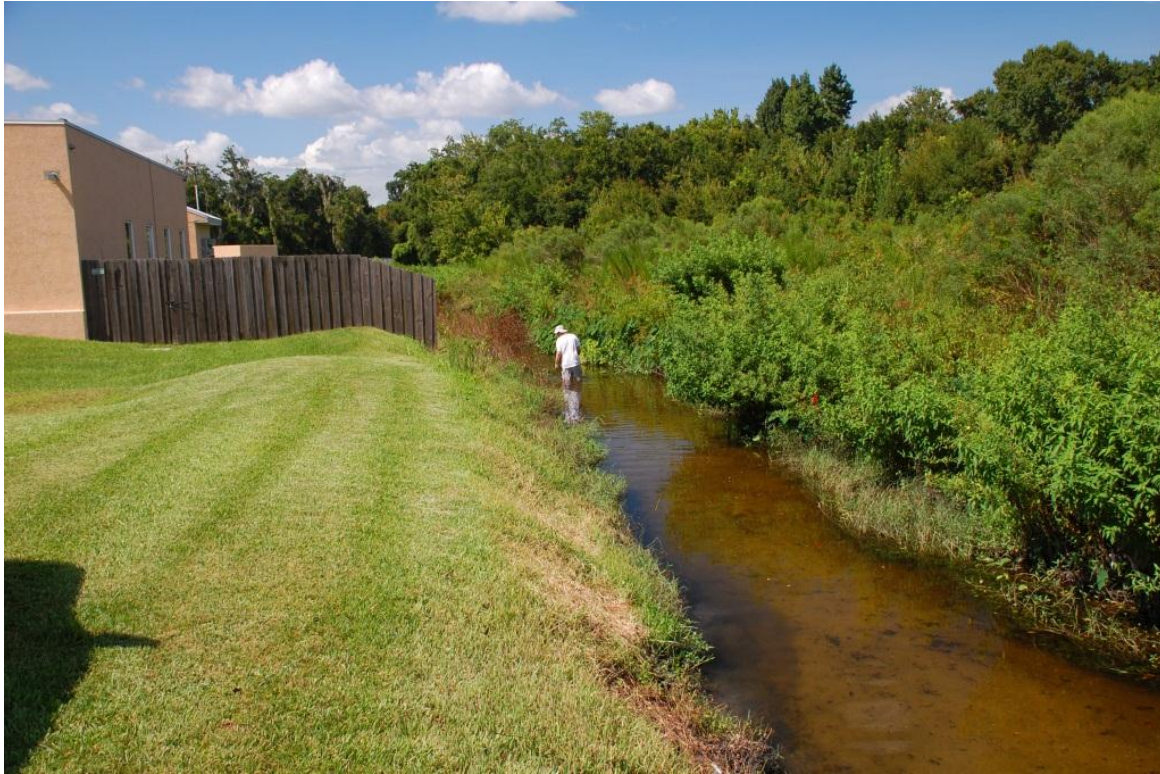
Figure 2 Overview photograph of Mill Creek at Victoria Ave Sample site

Mill Creek near Victoria Avenue received a habitat assessment score of 57 due to low substrate diversity/availability, habitat smothering by sand, and related habitat problems that stem from artificial straightening of stream channels. The channel observed was very straight lacking any sinuosity that would be expected in a Coastal Plain flow regime. The right bank showed far more signs of instability from channelization than the left and most vegetation was invasive. The left bank, however, had a slope angle  $<60^\circ$  with bankfull  $>60\%$ . Water in the creek flowed clear at time of assessment and fish were commonly observed in the habitat, however, Mill Creek has been prior observed at a separate locality than was sampled, to flash and become tannic after times of heavy rainfall (see Figure 3). Two stable pools were observed but based on the average width of the creek of 4.9 m, three pools would have been ideal. A minor erosional slump surface was also noted on the right bank at the 80 m mark. Average flow velocity measured over three locations was suboptimal at 0.17 m/sec at the time of assessment at the 20 meter mark. The riparian buffer zone was completely absent on the right bank (see Figure 2) due to a maintenance easement and vegetation removal was obvious. The riparian buffer zone was  $>18$  m on the left bank.

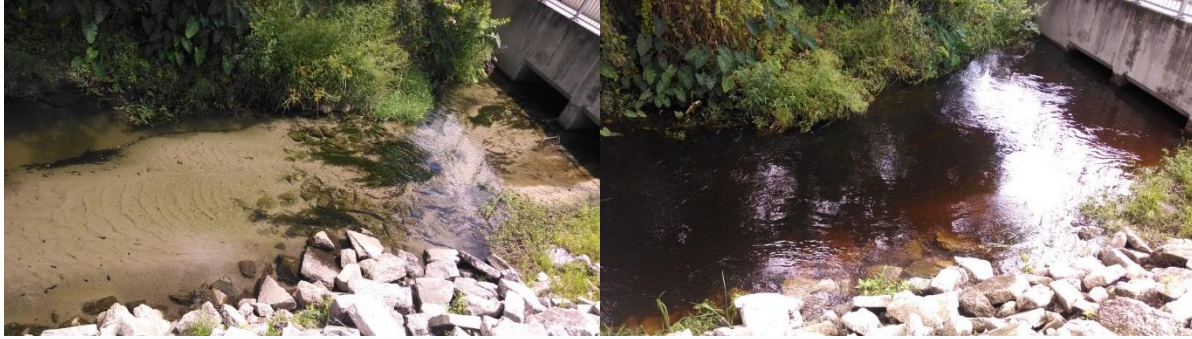
**Figure 3 Left, Mill Creek flowing clearly on a normal day (7/2/2014), Right, Mill Creek flashing tannic after heavy rainfall (7/16/2014).**

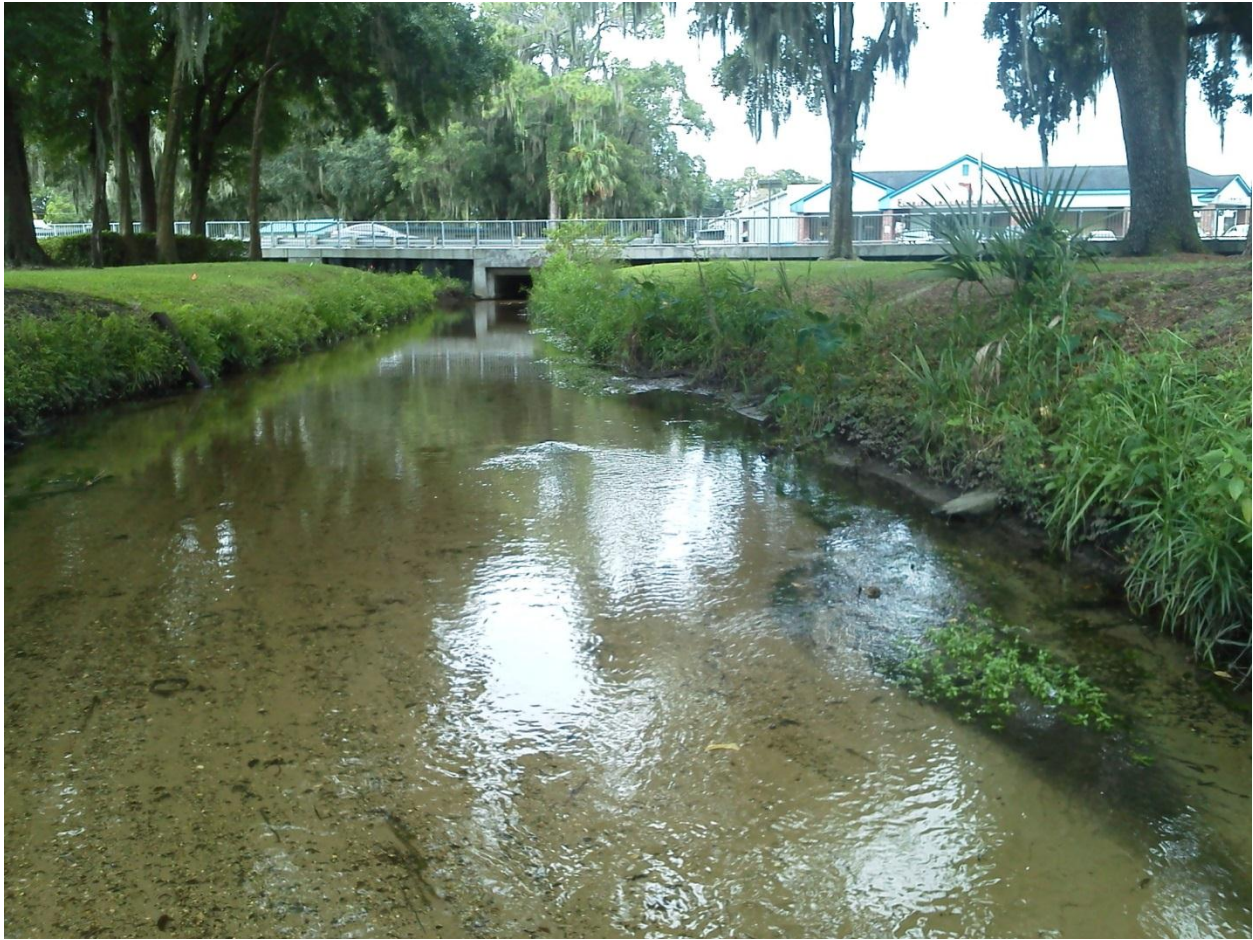
Figure 4 Overview photograph of Mill Creek at West Risk St Sample Site

Mill Creek at West Risk Street received a Habitat Assessment score of 99. While the channel was most definitely artificially straightened lacking any sinuosity that would be expected in a Coastal Plain flow regime, there were a number of positives observed. Along most of the left bank and some of the right, each 10 m section typically contained 2 m<sup>2</sup> of fine root habitat. We also observed a total of 6 productive pools in the creek within our 100 m section which is greater than what would be expected in optimal conditions. There were also plenty of snags observed along both banks as well as exposed rocky habitat. Overall, we observed a decent amount of habitat available for macroinvertebrates along this section (see Figure 5). The primary factors holding this section of creek from a good habitat score were the over steepened banks at >60%, a lack of good armoring along most of the creek on both sides, a very narrow, almost absent riparian buffer zone along both banks due to intense human activity and due to evidence of bank undercutting.

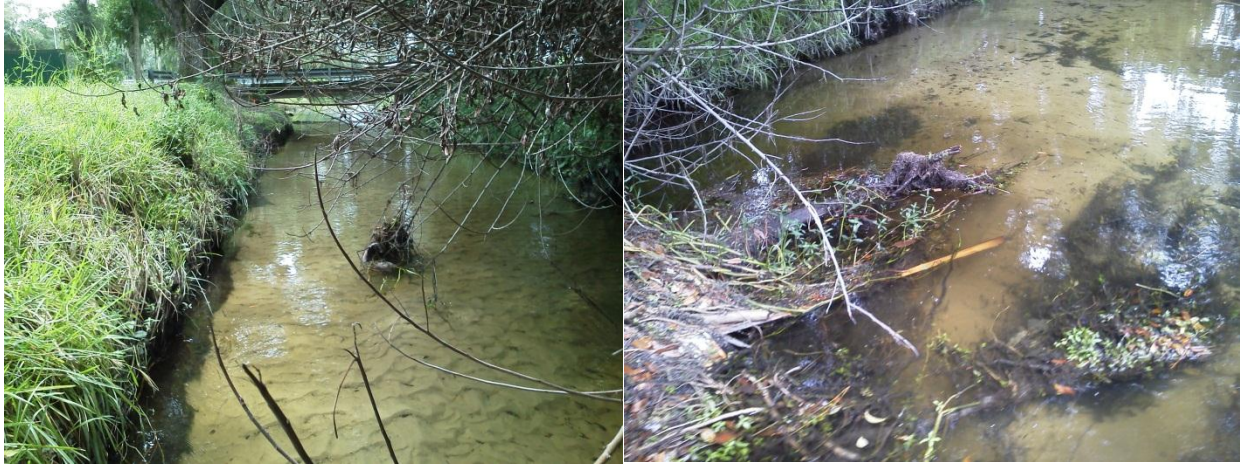
Figure 5: Left, photo of Mill Creek along Aexandria/Victoria sampling locality, note presence of fine roots along left bank, Right, snag crossing over half of creek with presence of pool and leaf packs.

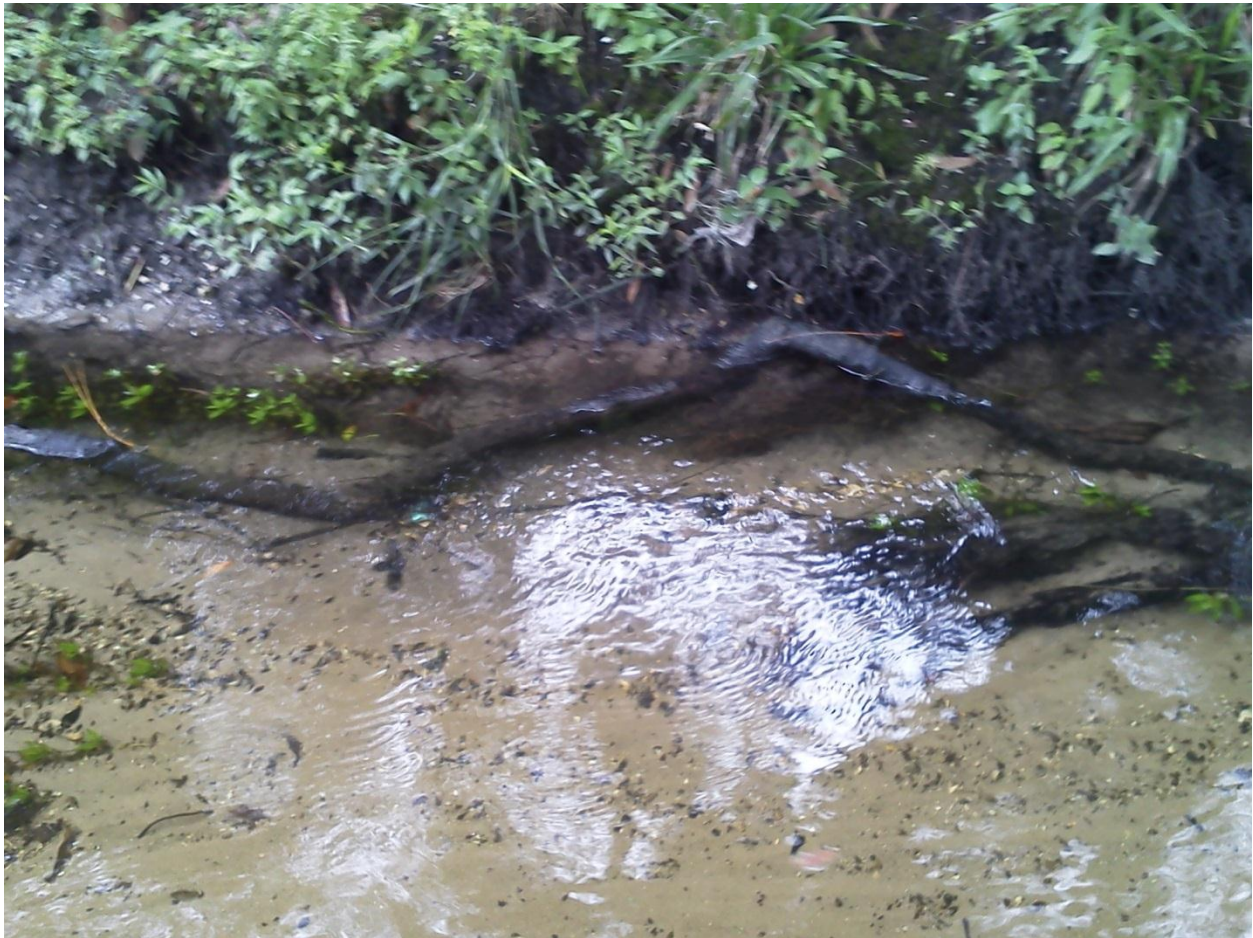
Figure 6 Photo showing exposed roots of vegetation indicating bank undercutting.
