**MITIGATION OPTIONS FOR FISH AND WILDLIFE
RESOURCES AFFECTED BY PORT AND OTHER
WATER-DEPENDENT DEVELOPMENTS IN
TAMPA BAY,
FLORIDA**

Biological Report 86(6)
June 1986

R. Steve Dial and Donald R. Deis
Continental Shelf Associates, Inc.
759 Parkway Street
Jupiter, FL 33477

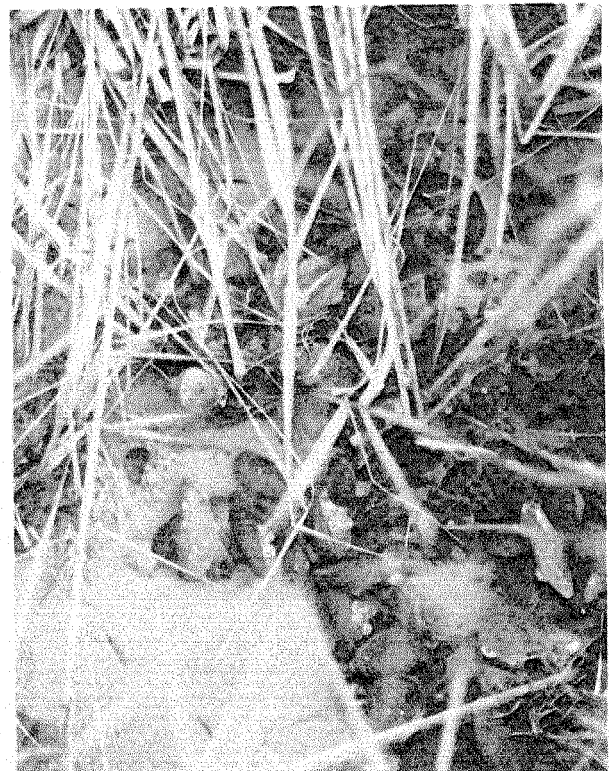
Fishes and wildlife observed during the assessment included Eucinostomus argenteus (spot-fin mojarras) in the Palm River, Geukensia demissa (ribbed mussel) attached to the base of the S. alterniflora (Figure 7), and Littorina anquilifera (marsh periwinkle) on the stems. Many Uca spp. (fiddler crab) holes were observed in the S. alterniflora band.

Figure 7. Ribbed mussels (Geukensia demissa) attached to base of Spartina alterniflora.

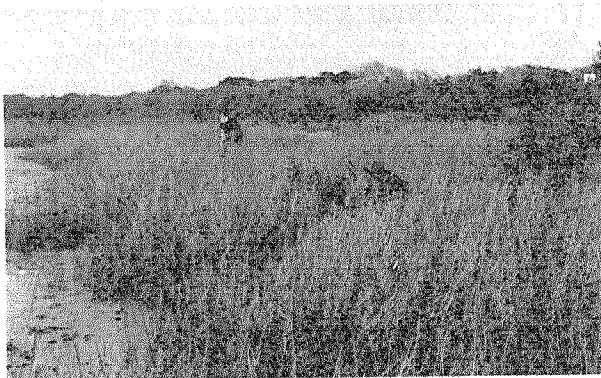
at 1130 hours (approximately low tide), 6 years after planting. Overall, Sunken Island was the most diversified restoration project visited during this survey due to the combination of many different kinds of habitats found there (i.e., S. alterniflora marsh, mangroves, upland, open sand beach, shallow intertidal, and subtidal) (Figures 22, 23, and 24). The S. alterniflora plugs had coalesced into a marsh and R. mangle, A. germinans, and L. racemosa seedlings had recruited and reached 0.5 to 1.5 m in height (Figure 22).

Figure 22. Sunken Island restoration area, 28 November 1984, with band of Spartina alterniflora and higher marsh of Avicennia germinans, Laguncularia racemosa, and Paspalum vaginatum.

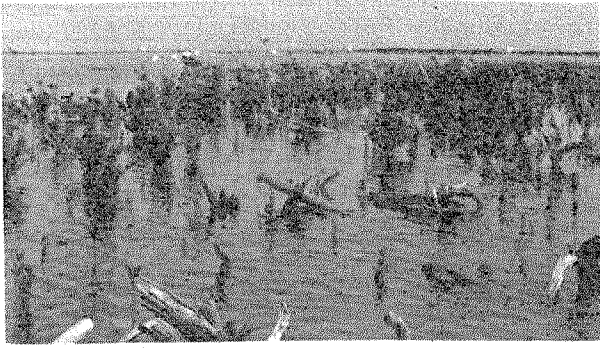
Figure 27. Frandorson property 9 months following restoration. Majority of seedlings are white (Laguncularia racemosa) or black (Avicennia germinans) mangroves from natural recruitment or new growth from remaining root stock.

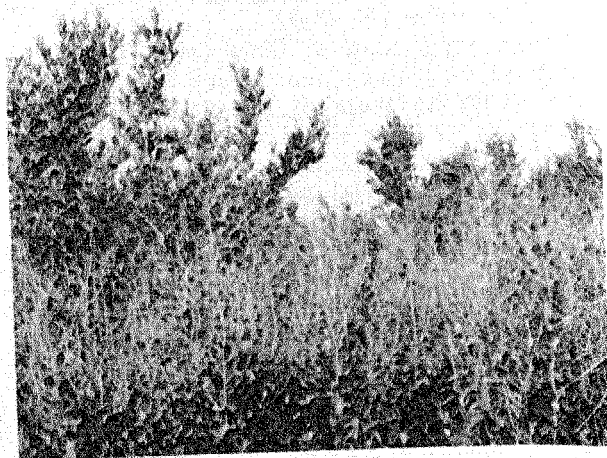
Figure 30. Mangrove community at west end of transect, 28 November 1984, dominated by red (*Rhizophora mangle*) mangroves in foreground and dense black (*Avicennia germinans*) and white (*Laguncularia racemosa*) mangroves in background.

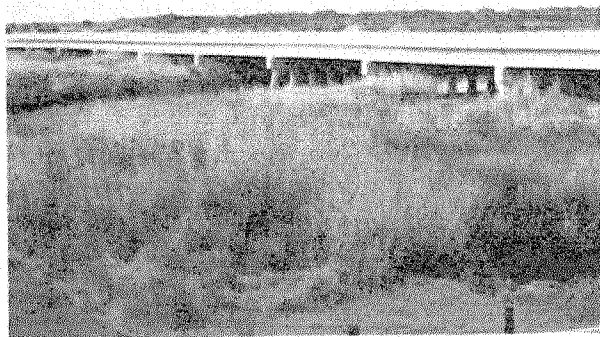
Figure 32. South end of Branches Hammock mitigation site, 26 November 1984, 4.5 years following revegetation with Juncus roemerianus.

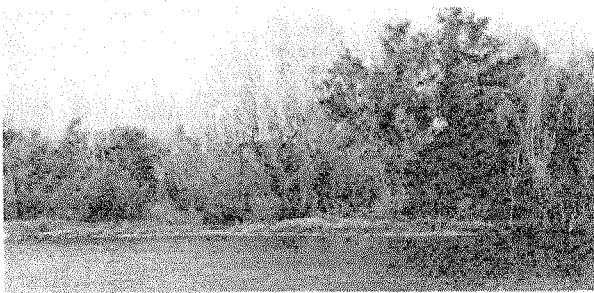
Figure 38. Area (Transect 1) planted with Spartina alterniflora 12 May 1984, as observed on 29 November 1984. Mangrove habitat in background shows existing habitat prior to unauthorized clearing.

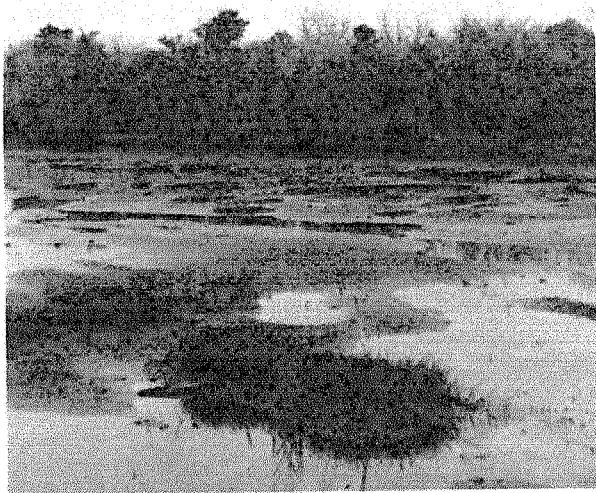
Figure 39. Area (Transect 2) planted with Spartina alterniflora 12 May 1984, as observed on 29 November 1984. A few sprigs are noticeable in the background, with Paspalum vaginatum in higher area.

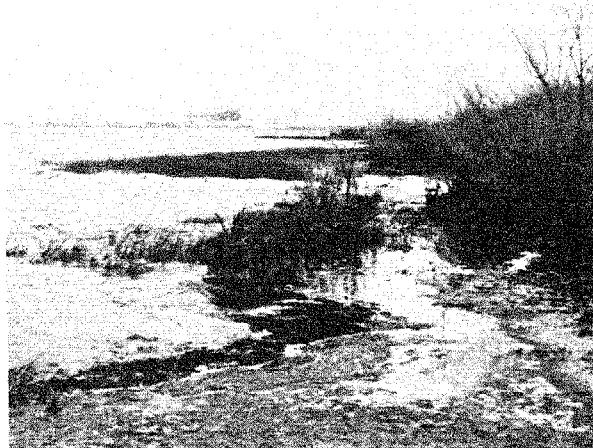
Figure 72. Shoreline near Gardinier, Inc. gypsum pile with fringing *Spartina alterniflora* marsh, drift algae (*Ulva* sp.), and freeze-damaged mangroves.

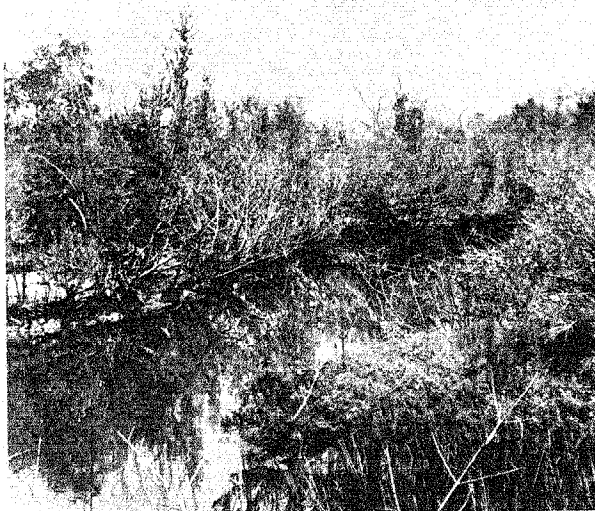
Figure 95. Interior tidal creeks at Booth Point showing freeze damaged mangroves, *Juncus roemerianus*, *Salicornia virginica*, and upland vegetation on spoil mounds.
