Moore Lake Drain

Habitat Assessment

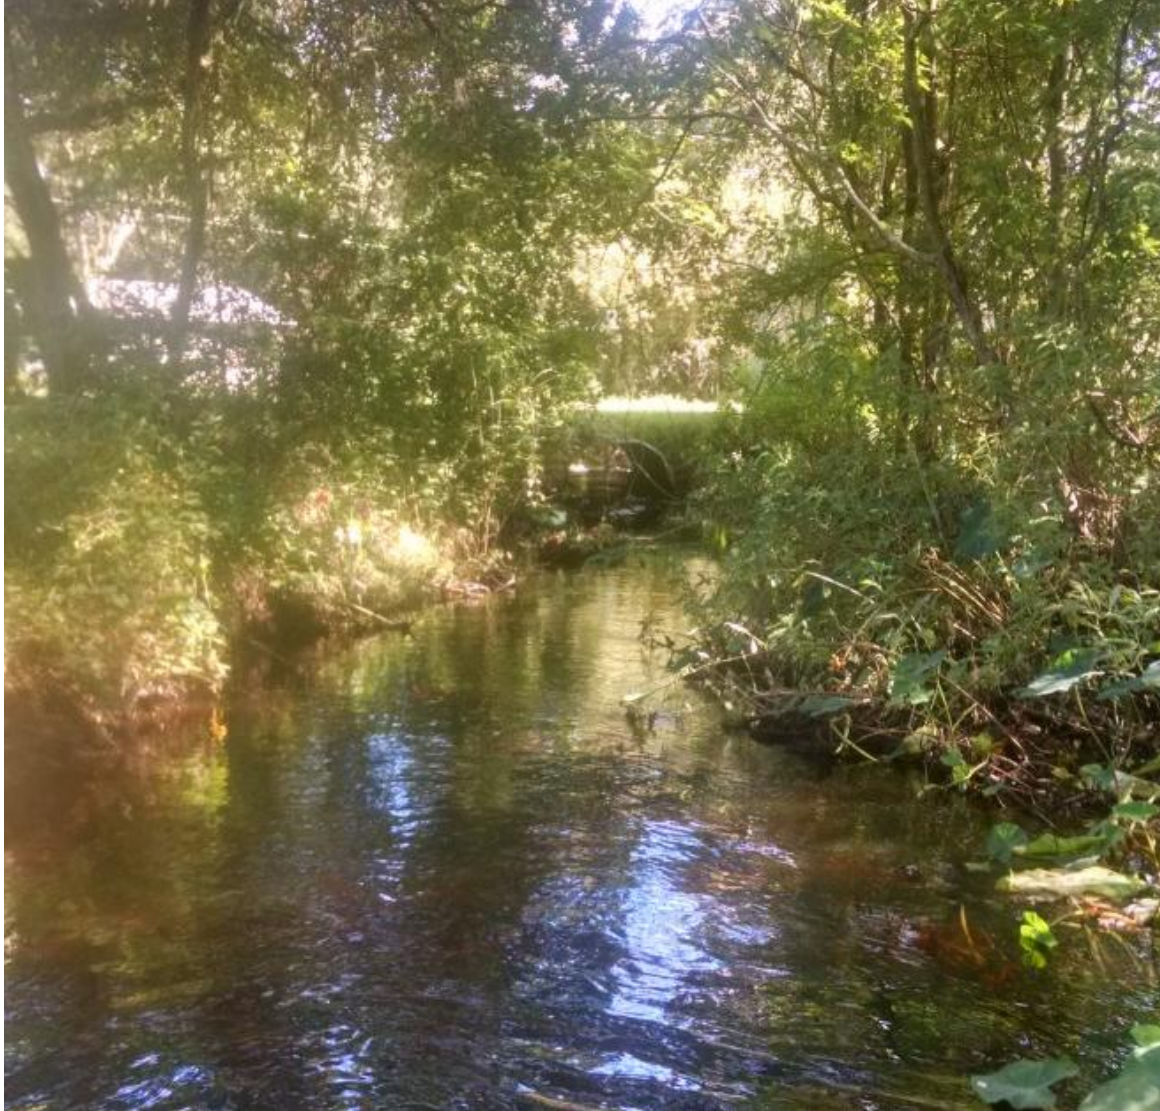
Figure 2 Overview photograph of Moore Lake Drain at Glen Harwell Rd, note the artificially straight channel and the presence of heavy shade.

Moor Lake Drain on Glen Harwell Rd received a habitat assessment score of 75 due to low substrate availability, habitat smothering by sand/silt (resulting in an absence of pools), a very low riparian buffer zone, and high degree of invasive vegetation. The observed section at Glen Harwell consisted of an artificially straightened channel that lacked sinuosity that would be expected in a typical coastal plain flow regime. Slope angle on both banks was greater than 60 degrees over the entire section but presence of good armoring vegetation and roots were noted as well as bankfull being >60% of bank height. Due to the smothering noted from excessive sand and silt, no stable pools were noted

over the 100 m transect. Flow velocity was measured at both the 40 m and 100 m marks and average velocity was recorded at 0.17 m/s at the time of assessment. The thickness of the riparian zone was measured at 11-15 m and 40 m for the left and right banks respectively.

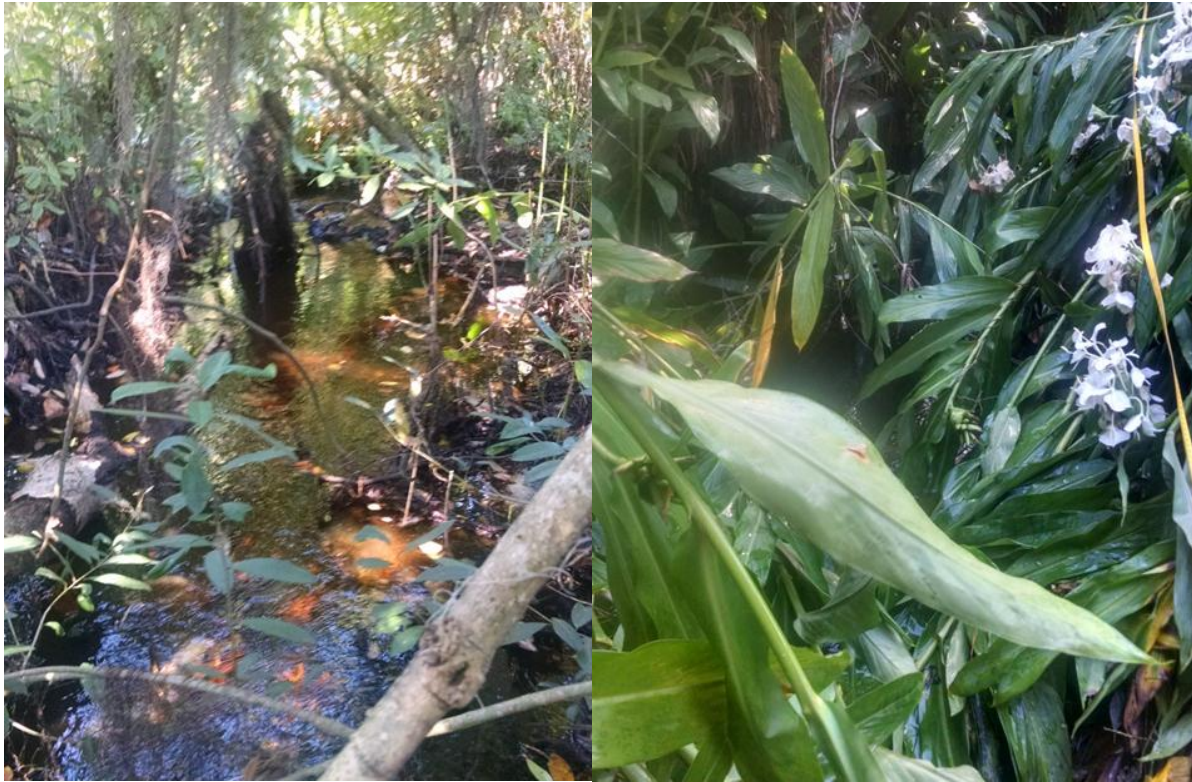
Figure 3 Overview photo of Moore Drain at East of Bethlehem Rd, Right - Photo taken West of Bethlehem Rd showing very heavy smothering by escaped domesticated Ginger (*Hedychium coronatum*)

Moore Lake Drain at Bethlehem Road received an overall habitat assessment score of 99 primarily due to suboptimal substrate diversity and availability and due to much of the creek being smothered by a single plant species (see Figure 3 Right). Available habitats were notably sand smothered and while the creek was overall very shallow, stable pools were noted though not as many as would be optimal. Artificial channelization was not noted within the section to the East of Bethlehem road. However, there was a more than notably heavy presence of Ginger (*Hedychium coronarium*) growing within the transect area especially to the West of Bethlehem Rd. We noted the presence of productive leaf packs as well as a number of snags within heavily wooded areas. Given the shallow depth of the creek and lack of artificial channelization, banks were observed stable on both sides. All three parameters for stable banks (slope <60 degrees, armored banks, and bankful <60% bank height) were met with few exceptions. Water velocity was slightly suboptimal 0.25 m/s at the time of assessment at the 55 meter mark. The width of the riparian buffer zone to the East of Bethlehem was >18 meters on average whereas to the West of Bethlehem was 10 m.
