LAKE ASSESSMENT REPORT FOR LAKE NOREAST IN HILLSBOROUGH COUNTY FLORIDA

Date Assessed: May 22, 2007

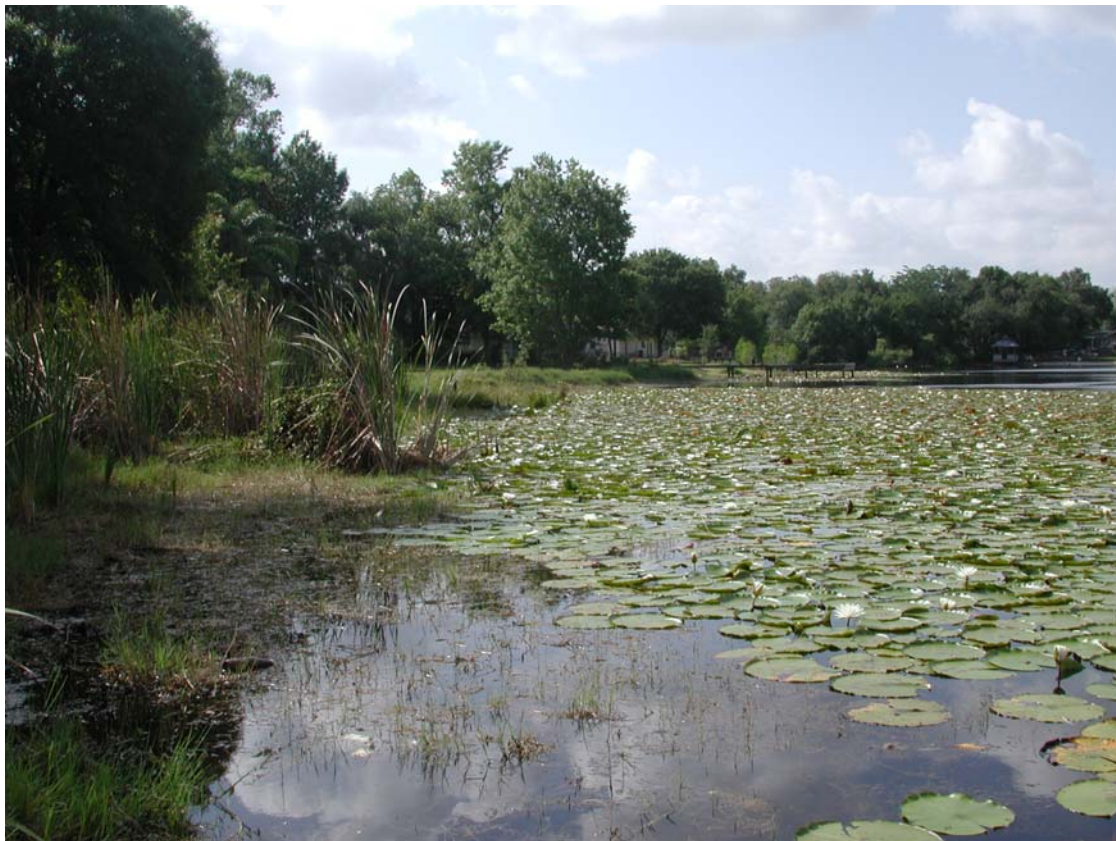
Figure 1. General Photograph of Lake Noreast taken on May 22, 2007.

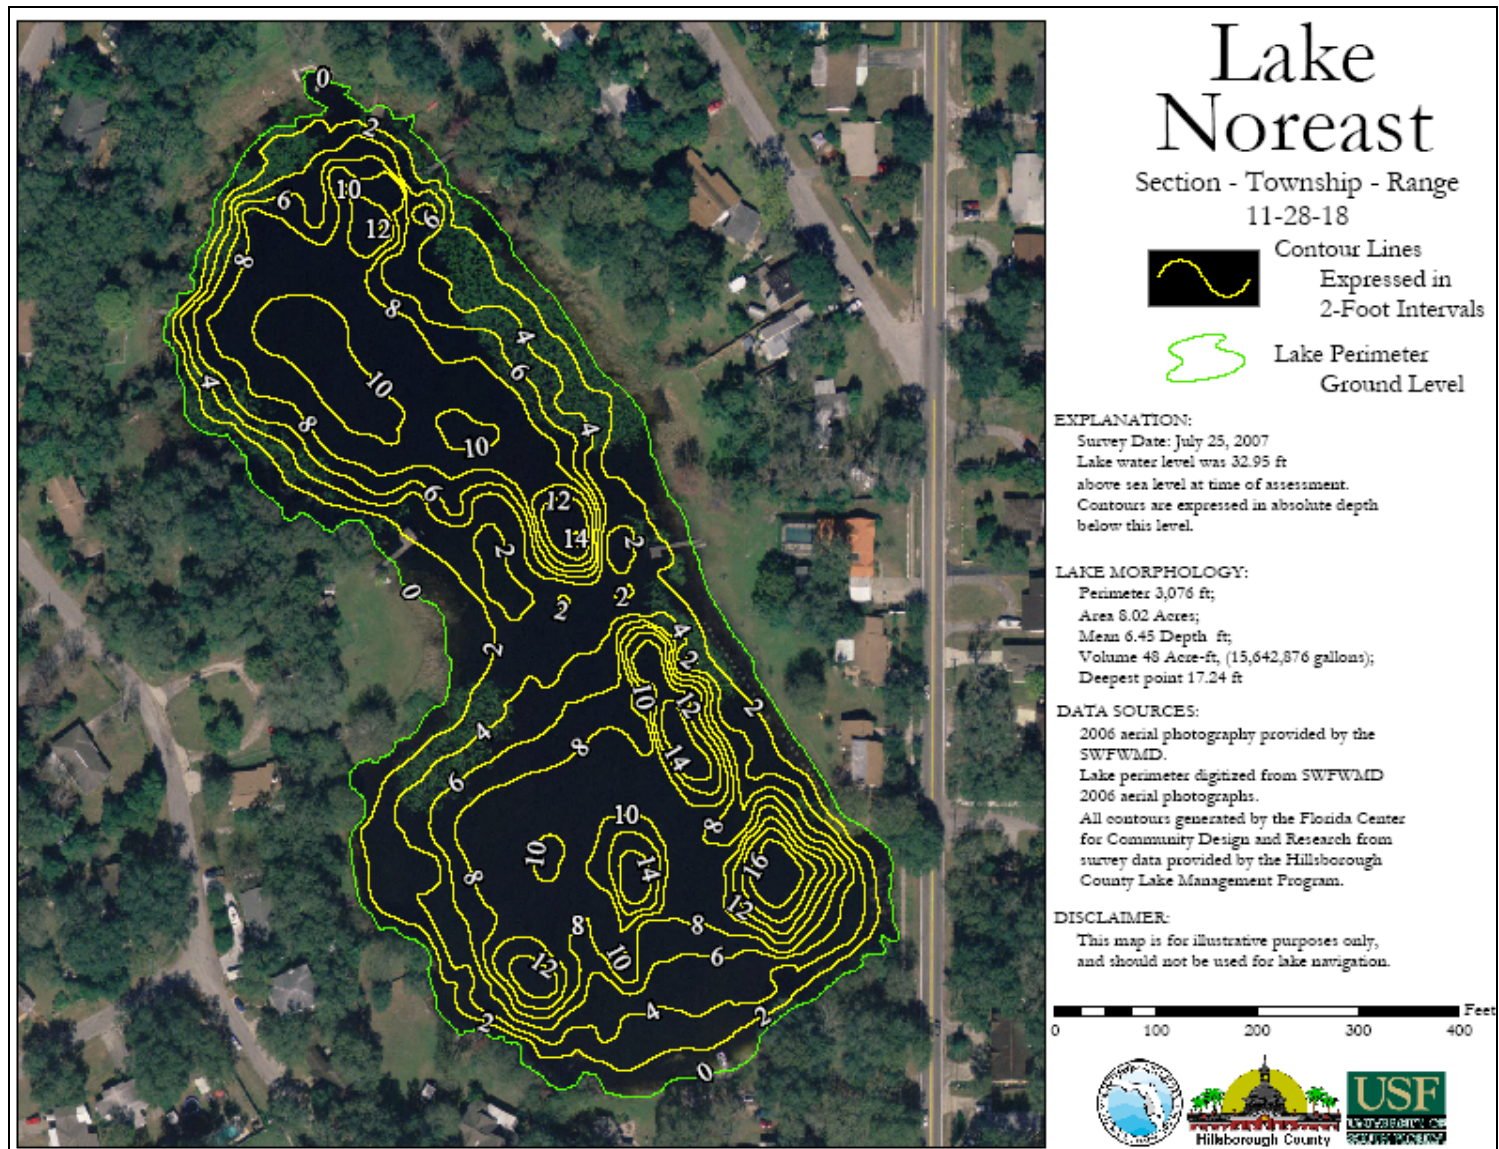
Figure 1. Contour map for Lake Noreast. The mapping technique used in 2007 employs a standard DGPS for horizontal position and a fathometer for depth.

Bathymetric Mapⁱⁱ. The bottom of the lake was mapped using a Lowrance LCX 26C HD Wide Area Augmentation System (WAAS)ⁱⁱⁱ enabled Global Positioning System (GPS) with fathometer (bottom sounder) to determine the boat's position, and bottom depth in a single measurement. The result is an estimate of the lake's area, mean and maximum depths, and volume and the creation of a bottom contour map (Figure 2). Besides pointing out the deeper fishing holes in the lake, the morphologic data derived from this part of the assessment can be valuable to overall management of the lake vegetation as well as providing flood storage data for flood models. Table 1 provides the lake's morphologic parameters in various units.

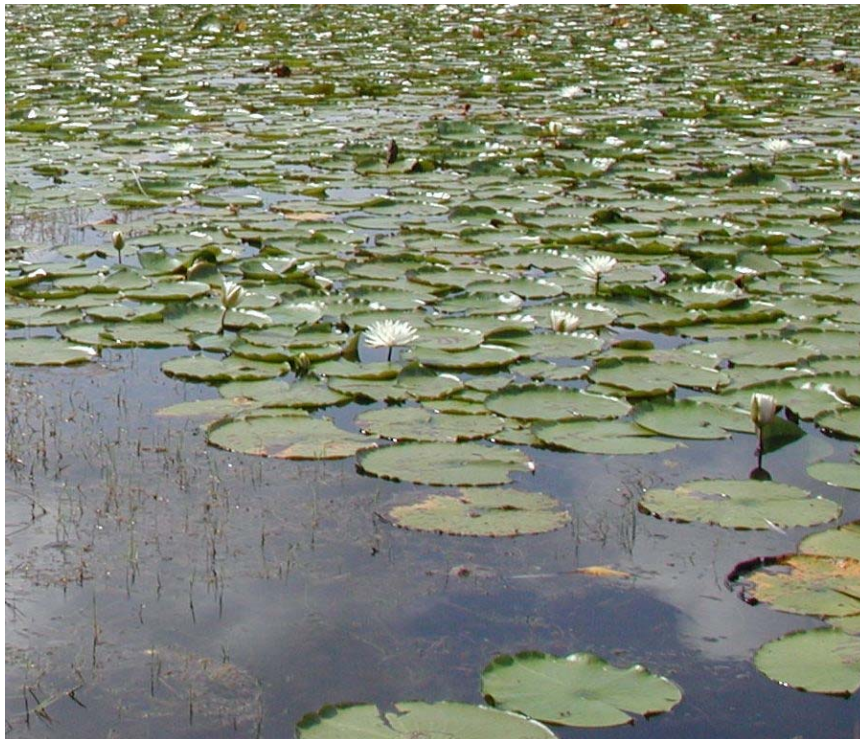
Figure 4. *Nymphaea odorata*, American White Water lily, Fragrant Water Lily, is native floating vegetation common in Florida providing shelter for several species of fish and invertebrates. Although this species is a native, when population densities become large they can shade out other native floating and submerged vegetation as well as causing difficulty in navigation to boat users.

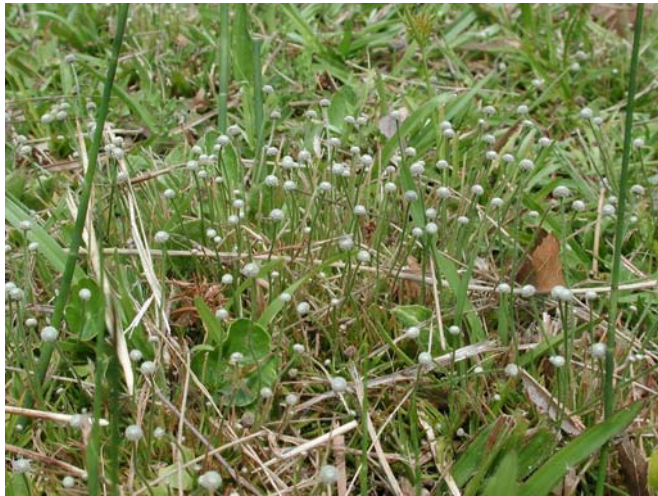
Figure 5. *Lachnocaulon spp.*, *Bog Buttons*, is a small native wetland vegetation common along moist roadsides, ditches and lake shores.

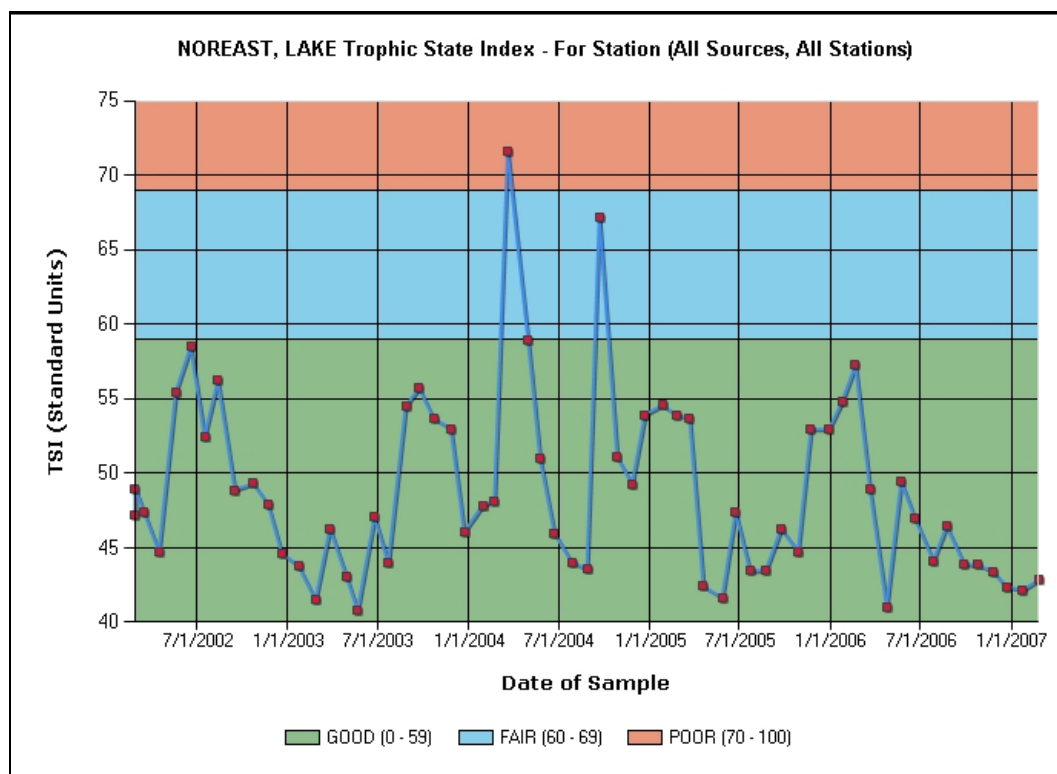
Figure 6. Recent Trophic State Index (TSI) graph from Hillsborough Watershed Atlas. For the latest date go to:

Note: The graph above includes benchmarks for using verbal descriptors of "good", "fair" and "poor". The verbal descriptors for these benchmarks are based on an early determination by stakeholders of the generally acceptable and understood terms for describing the state of lakes. The same benchmarks are used for nutrient graphs (Nitrogen and Phosphorus), chlorophyll graphs and trophic state index (TSI) graphs. The TSI is a calculated index of lake condition based on nutrient and chlorophyll (a) concentrations (please see "Learn more about Trophic State Index"). The benchmarks are established based on the TSI range that relates to a specific descriptor. The source for the TSI concentration relationships is the Florida Water Quality Assessment, 1996, 305(b) (Table 2-8).

A critical element in any lake assessment is the long-term water chemistry data set. The primary source of water quality trend data for Florida Lakes is the Florida LAKEWATCH volunteer and the Florida LAKEWATCH water chemistry data. Hillsborough County is fortunate to have a large cadre of volunteers who have collected lake water samples for significant time period. Noreast has volunteer generated sample data from 2002 through 2007. These data are displayed and analyzed on the Water Atlas as shown in Figure 6. Additional data, when available, is also included on the Water Atlas; however, the LAKEWATCH data remains the primary source for this lake. By the trend data shown in the figure, the lake may be considered good to fair health terms of the trophic state index. This lake is a (clear) water lake and as such it must maintain a TSI of below 40 to not be considered impaired by the State of Florida guidelines^y. The lake's long term water quality data does indicate enough violations of these criteria to be classified by Florida DEP as impaired. The more recent trends indicate a possibly improving trend; however, there are still a large number of violations of the nutrient standard for clear lakes.
