North Crystal Lake

LAKE HABITAT ASSESSMENT, LAKE VEGETATION INDEX, SUBMERGED
VEGETATION SURVEY AND WATER QUALITY

David Eilers, A. Richardson, T. Khan | USF Water Institute | July 24, 2024

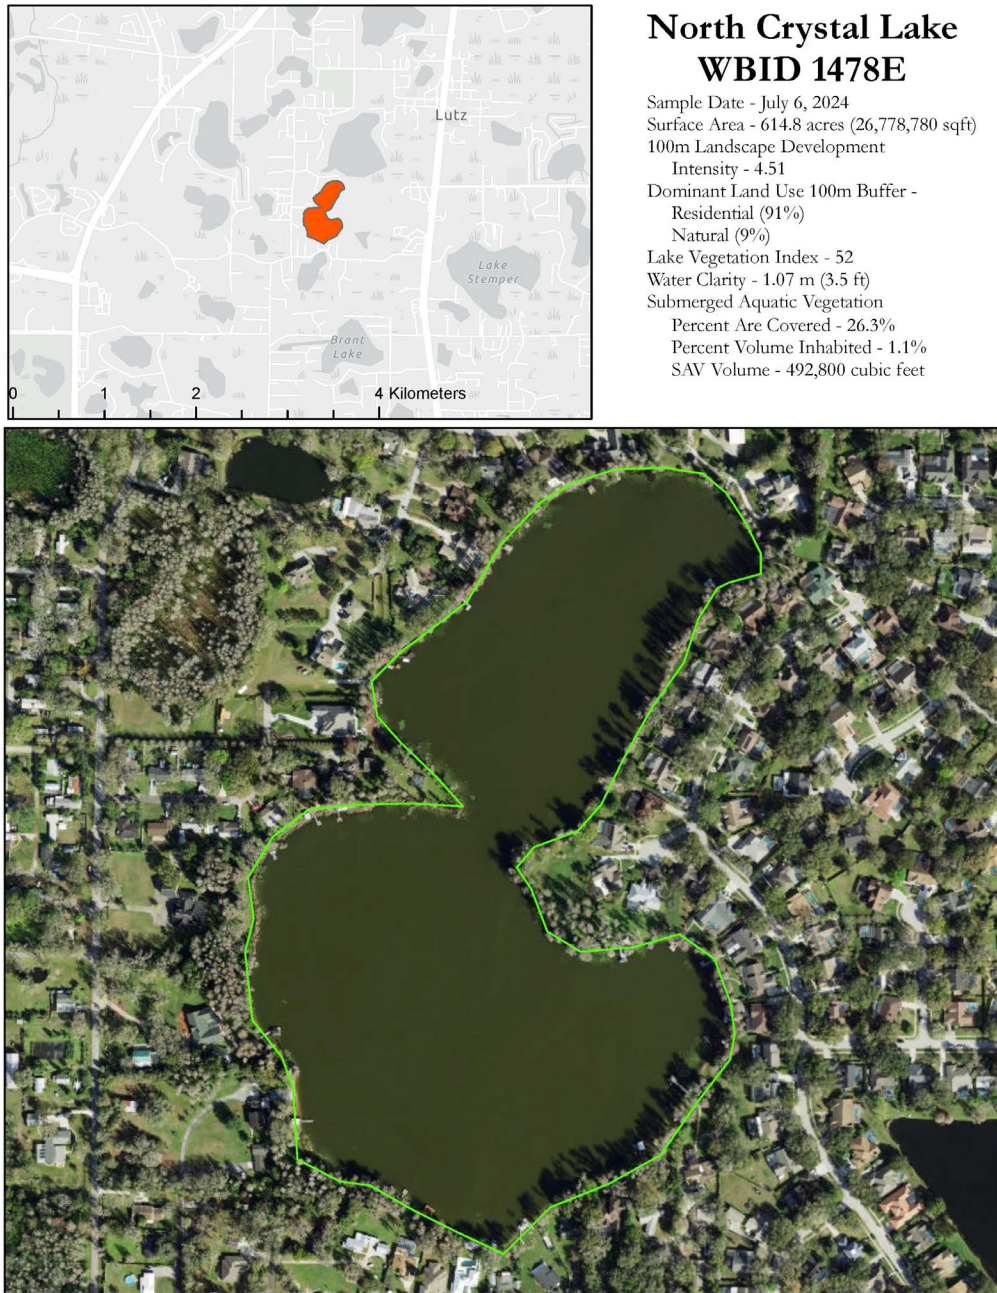
FIGURE 1: 2024 NORTH CRYSTAL LAKE ASSESSMENT STUDY AREA MAP

North Crystal Lake is located in the Coastal Old Tampa Bay Watershed in north-western Hillsborough County, Florida. The Landscape Development Intensity Index of the 100 meter buffer around North Crystal Lake is dominated by residential (91%) and natural (9%) land uses. The resulting LDI value for the 100 meter buffer around North Crystal Lake is 4.51.

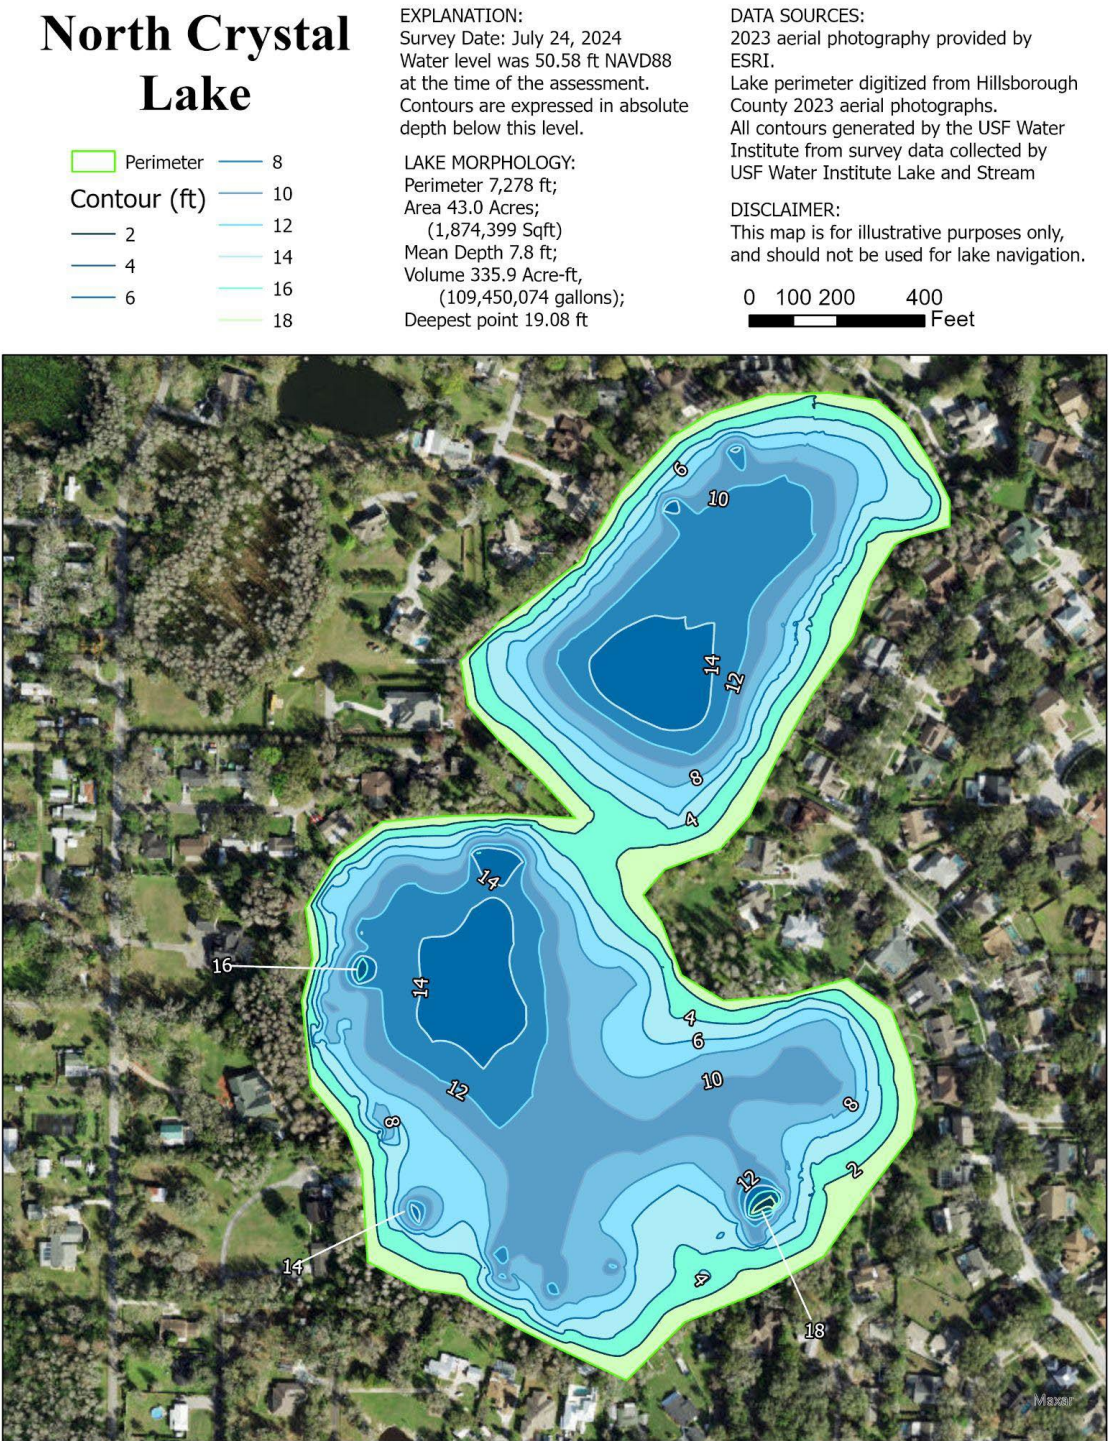
Figure 2: 2024 2-Foot Bathymetric Contour Map for North Crystal Lake

At the time of the assessment, North Crystal Lake was experiencing normal water levels (50.58 feet NAVD88 on staff gauge) resulting in a 43 acre water body. North Crystal Lake at the time of the assessment had a mean water depth of 7.8 feet and a maximum observed depth of 19.08 feet. The volume at this time was approximately 109,450,074 gallons. Figure 2 shows the resulting bathymetric contour map for North Crystal Lake from data collected on July 24, 2024. The collected data has been overlain the 2023 ESRI Basemap aerials.

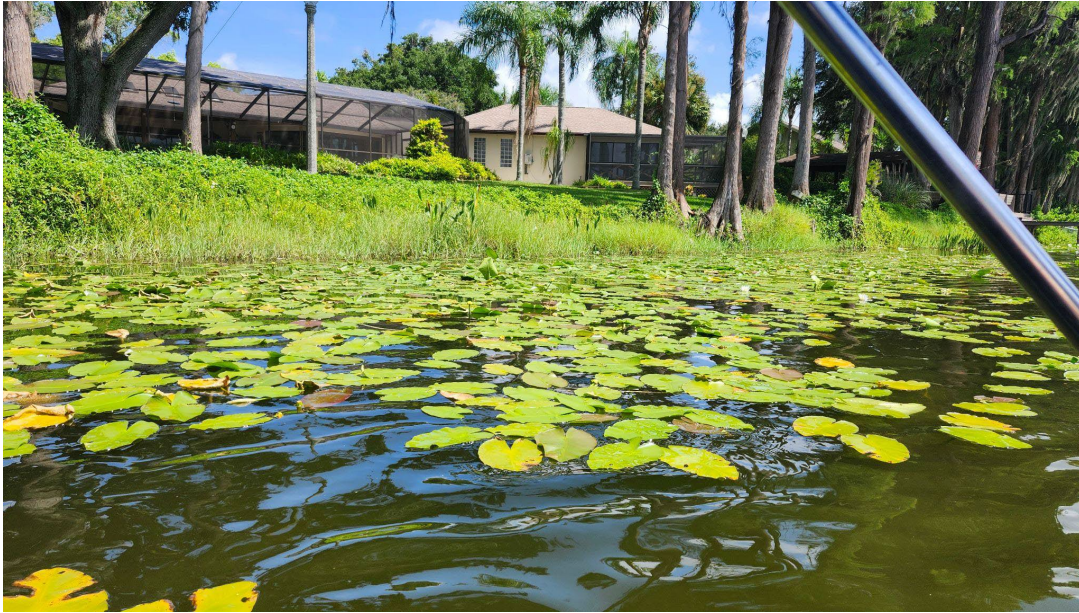
Figure 3 Overview photograph of North Crystal Lake showing Nuphar which was co-dominant in all regions

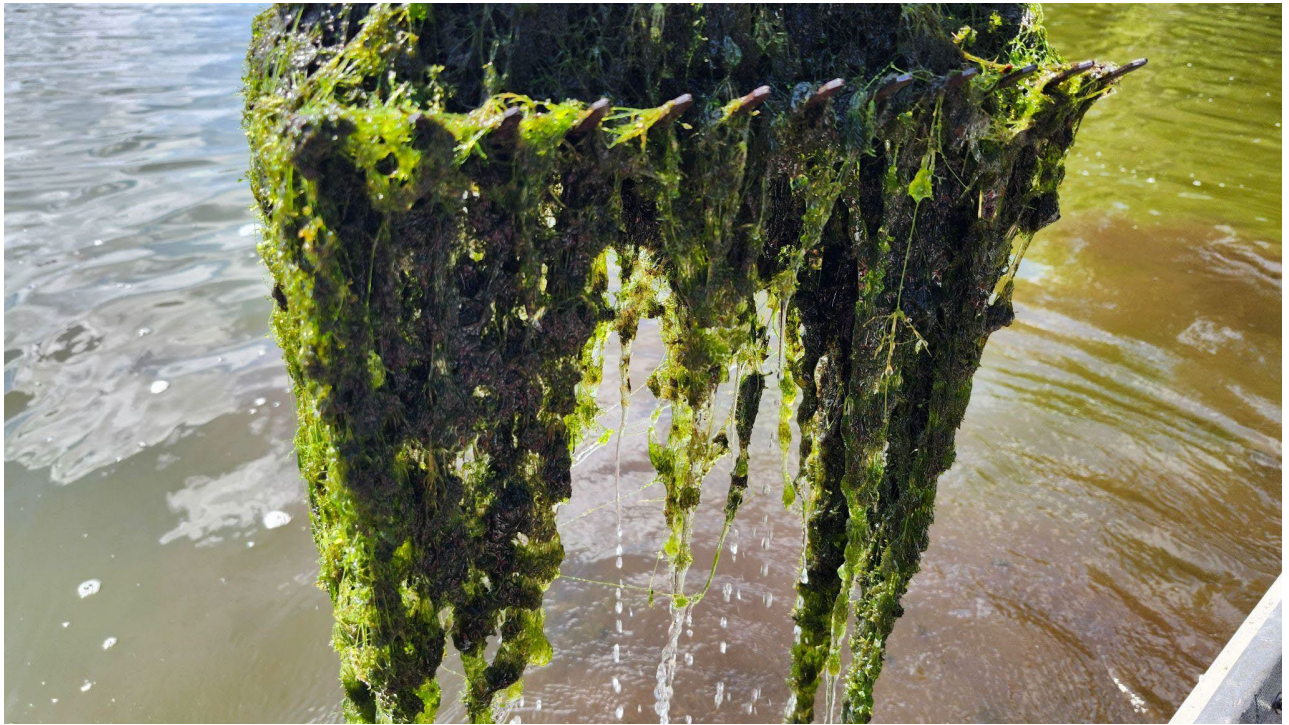
Figure 4 Nitella collected on Frotus rake, found in segments 5, 8, and 11 of North Crystal Lake but was co-dominant in segments 8 and 11

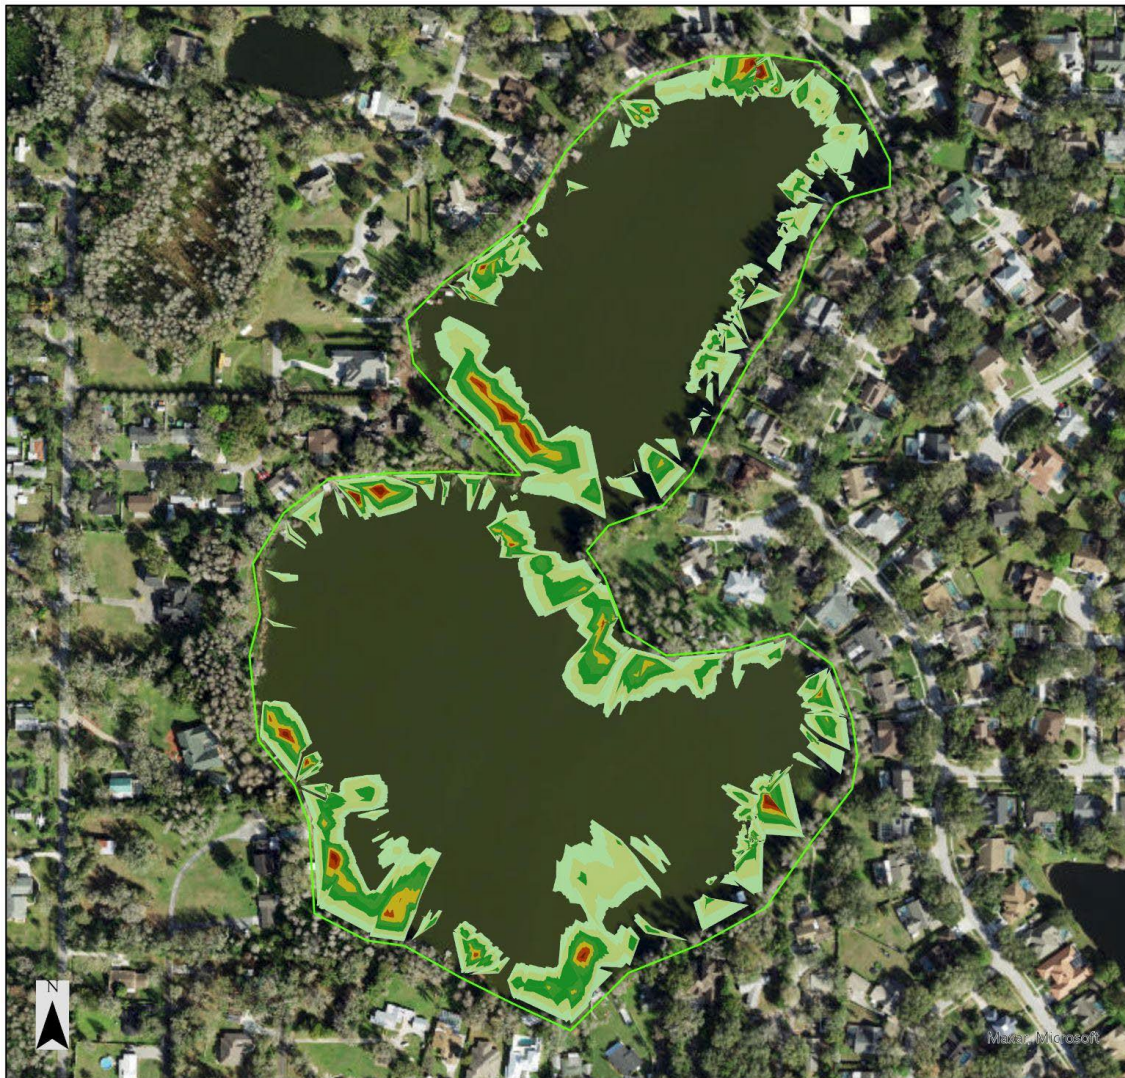
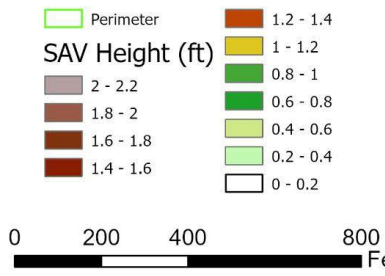
Figure 5 North Crystal Lake Submerged Aquatic Vegetation Assessment Results

By analyzing the collected sonar chart, submerged aquatic vegetation potentially covered approximately 26.29% of the surface area of North Crystal Lake. This submerged vegetation inhabits an estimated 1.10% of the water volume in North Crystal Lake. Figure 5 shows the results of the SAV analysis indicating the location and height of SAV estimated from collected sonar readings.

Survey Date: July 24, 2024
 Water level was 50.58 ft NAVD88 at the time of the assessment.
 Submerged Aquatic Vegetation was analyzed from collected sonar data.
 The height of the SAV where present is shown in 1 foot increments.

Area 492,800 square ft; 11.3 Acres;
 (26.29% of Lake Surface Area)
 Mean SAV Height 0.3 ft;
 Volume 161,051 Cubic ft, (1,204,751 gallons);
 (1.10% of Lakes Volume)

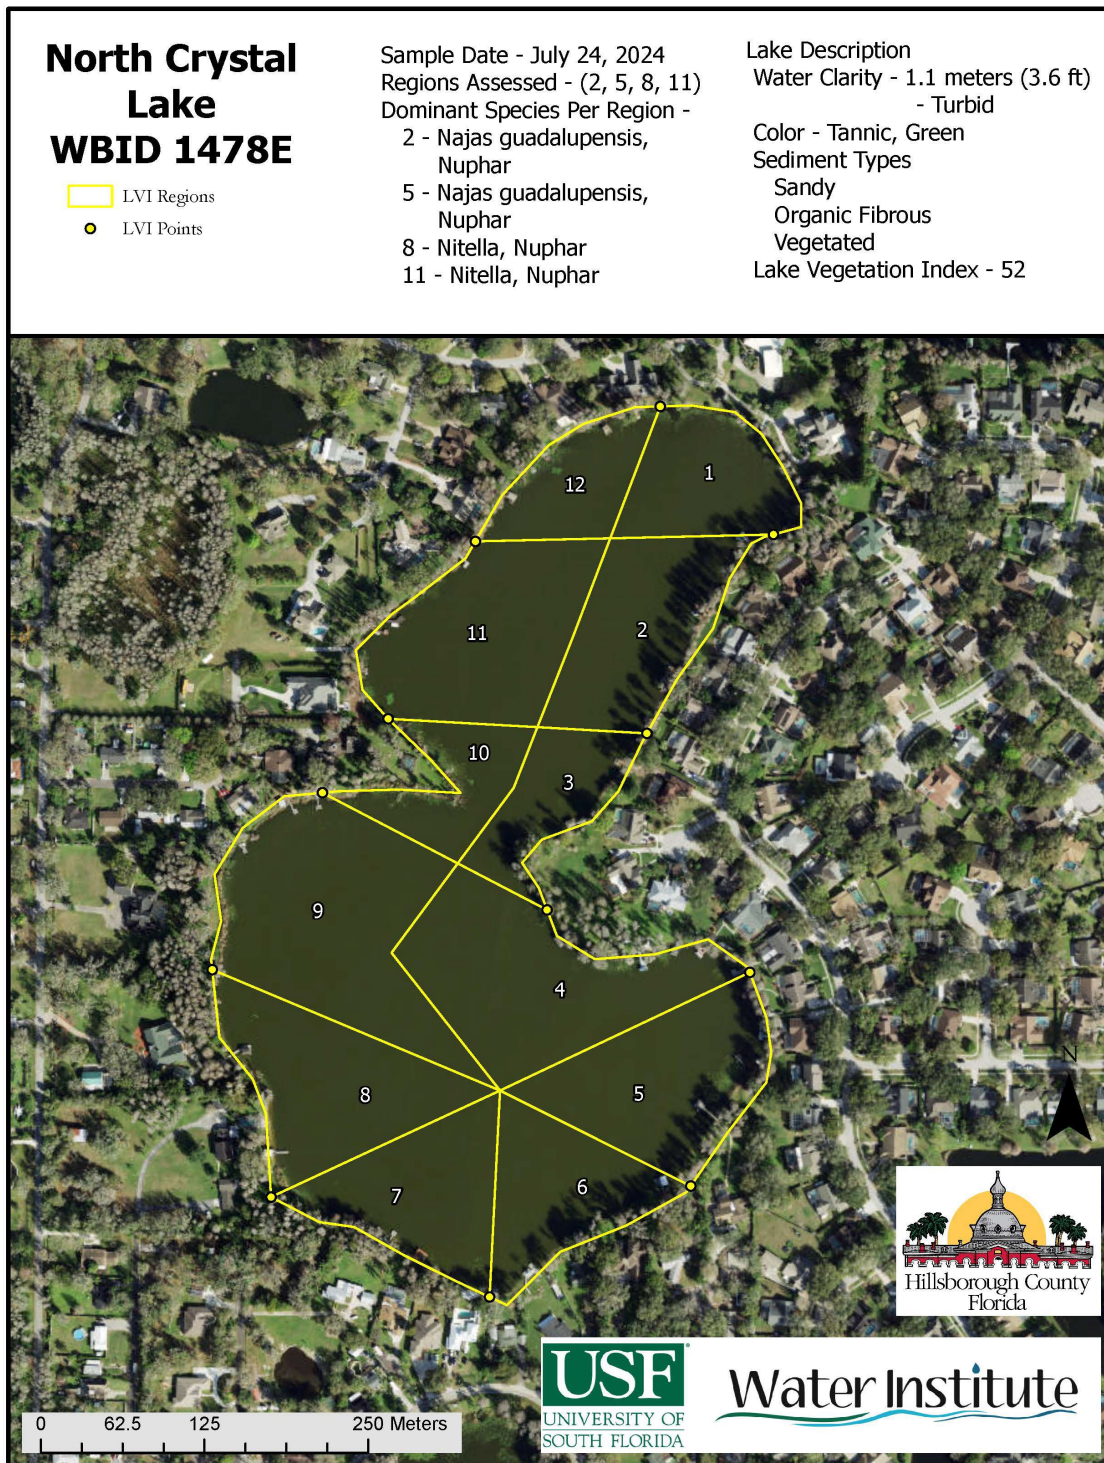
Figure 6: Lake Vegetation Index region map for North Crystal Lake

The calculated LVI score for North Crystal lake was 52, above the impairment threshold of 43 indicating the vegetation community is not showing evidence of being “Impaired”. Figure 6 shows the map of North Crystal Lake detailing the LVI regions used for the assessment (Regions 2, 5, 8, 11). Table 2 details the species list results of the Lake Vegetation Index. Table 3 details the scoring result for the Lake Vegetation Index.
