LAKE ASSESSMENT REPORT FOR LAKE OSCEOLA IN HILLSBOROUGH COUNTY, FLORIDA

Date Assessed: July 6, 2007

Assessed by: Sarah Koenig and David Eilers

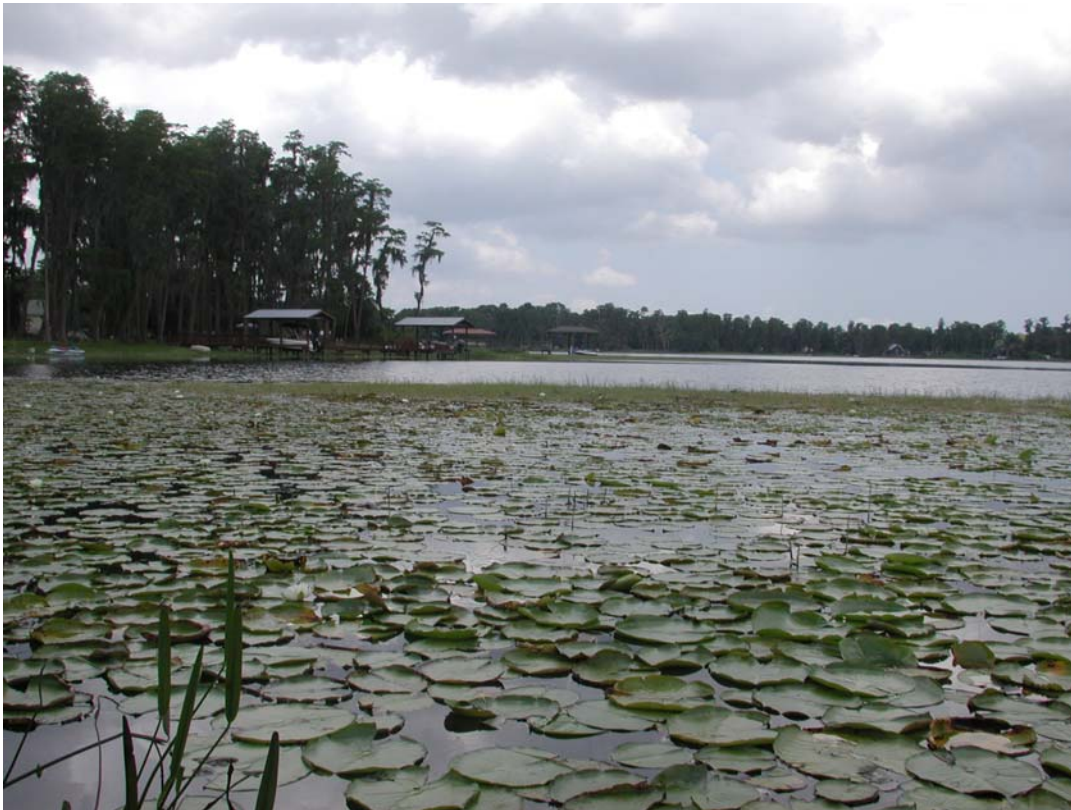
Figure 1. Photograph of Lake Osceola taken on July 6, 2007.

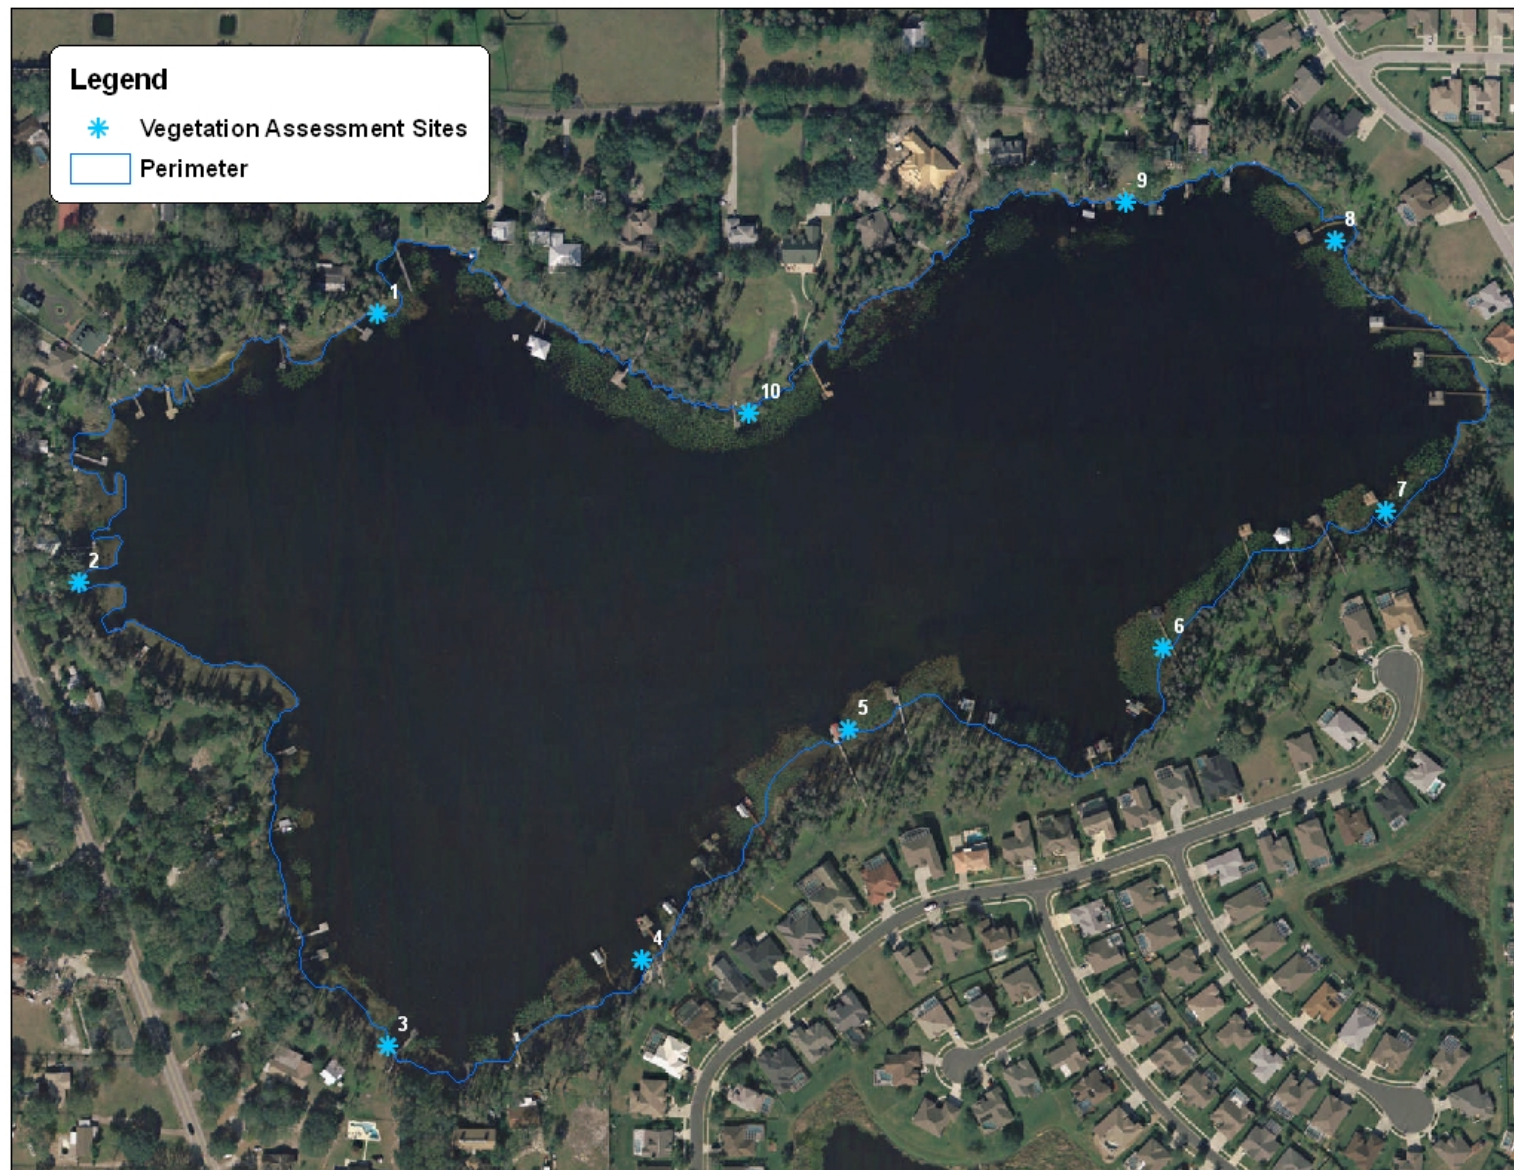
Figure 3. 2006 six-inch resolution aerial photograph showing location of the vegetation assessment sites on Lake Osceola. Major emergent and floating vegetation zones as well as structures such as docks are also observable in this aerial.

The lake's apparent vegetative cover and shoreline detail are evaluated using the latest lake aerial photograph as shown in Figure 3 and by use of WAAS enabled GPS. Submerged vegetation is determined from the analysis of bottom returns from the Lowrance 26c HD combined GPS/fathometer described earlier. As depicted in Figure 3, ten vegetation assessment sites were chosen for intensive sampling based on the *Lake Assessment Protocol* (copy available on request) for a lake of this size. The site positions are set using GPS and then loaded into a GIS mapping program (ArcGIS) for display. Each site is sampled in the three primary vegetative zones (emergent, submerged and floating)^{iv}. The latest aerials high resolution aerial photos are used to provide shore details (docks, structures, vegetation zones) and to calculate the extent of surface vegetation coverage. The primary indices of submerged vegetation cover and biomass for the lake, percent area coverage (PAC) and percent volume infestation (PVI), are determined by transiting the lake by boat and employing a fathometer to collect "hard and soft return" data. These data are later analyzed for presence and absence of vegetation and to determine the height of vegetation if present. The PAC is determined from the presence and absence analysis of 100 sites in the lake and the PVI is determined by measuring the difference between hard returns (lake bottom) and soft returns (top of vegetation) for sites (within the 100 analyzed sites) where plants are determined present.

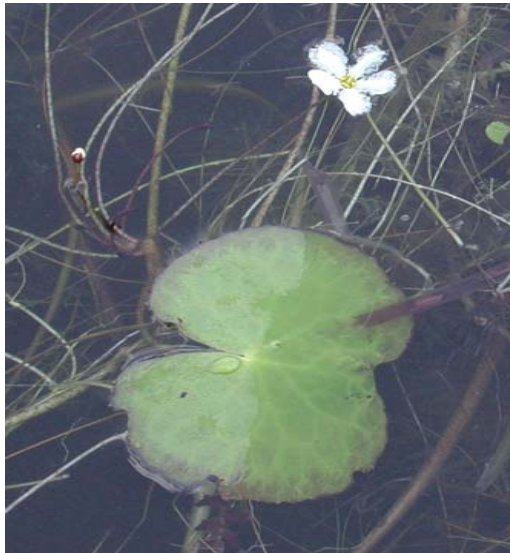
Figure 4. *Nymphoides aquatica*, Banana Lily, Big Floatingheart, is a native species, however there are several very similar species which have been introduced to Florida wetlands by the plant trade for ornamental ponds.

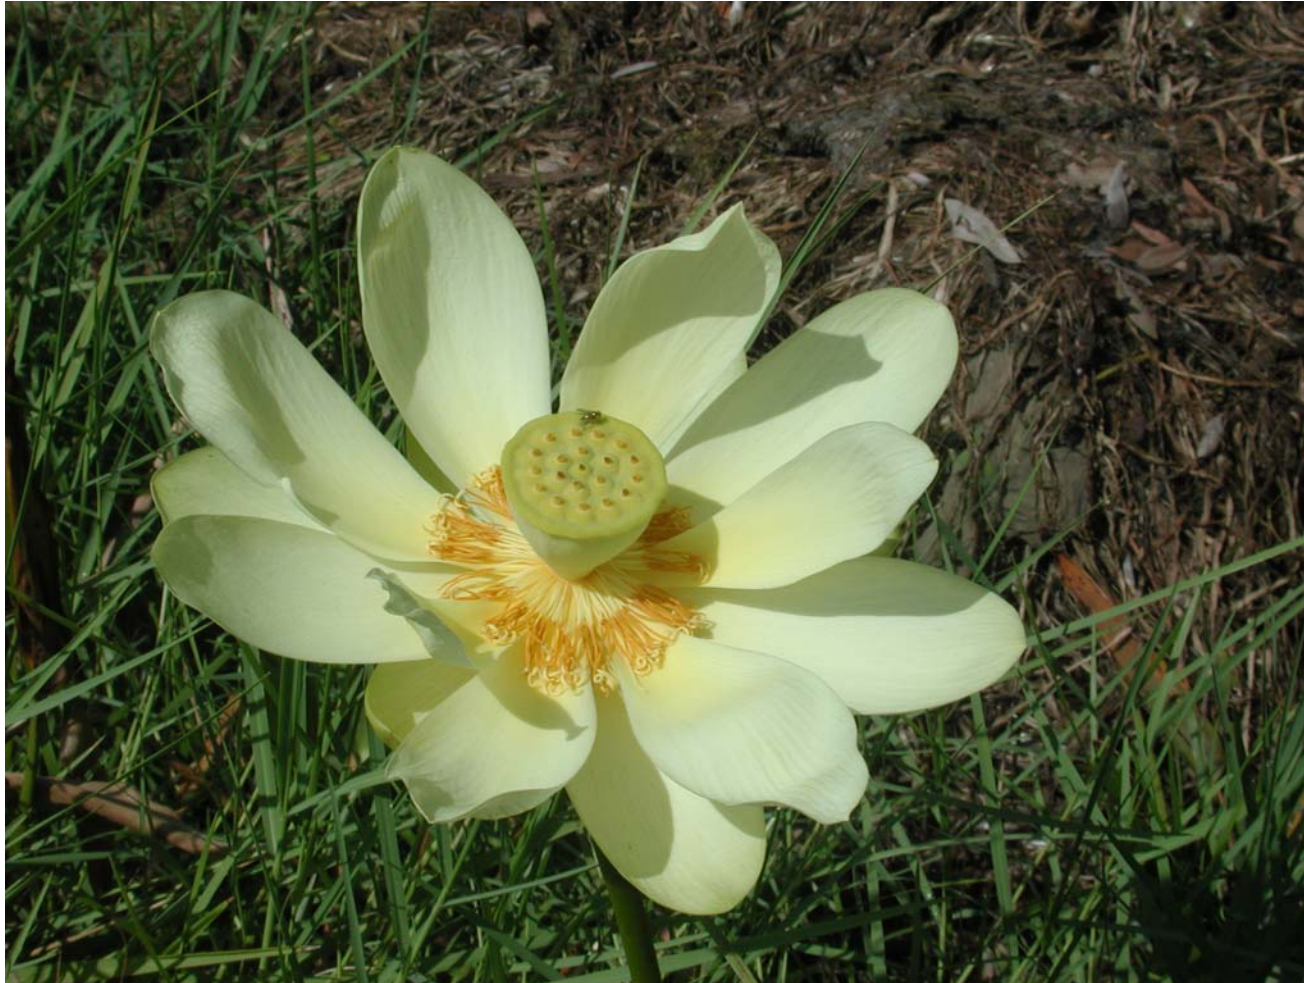
Figure 5. *Nelumbo lutea*, Lotus Lilly, American Lotus, is a native floating leaved vegetation in Florida usually found in the shallows of lakes and ponds. This species provides shelter for fish and its seeds are a favorite of water fowl.

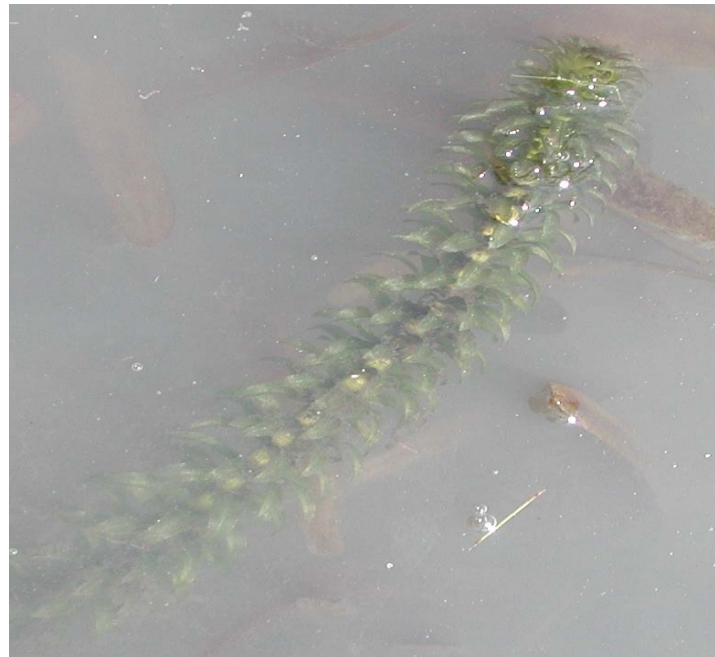
Figure 6. *Hydrilla verticillata*, Hydrilla, water thyme, is a non-native invasive submerged plant from Asia. Hydrilla possesses many physiological adaptations that increases its competitive advantage. This species displaces native submerged vegetation by growing up to 1 inch per day and subsequently shading out competitors. In addition, Hydrilla can spread by fragmentation, which allows this plant to be spread across several waterbodies by traveling on boats and trailers.
