# LAKE ASSESSMENT REPORT FOR PINE POND IN HILLSBOROUGH COUNTY FLORIDA

Date Assessed: May 28, 2007

Assessed by: Sarah Koenig and David Eilers

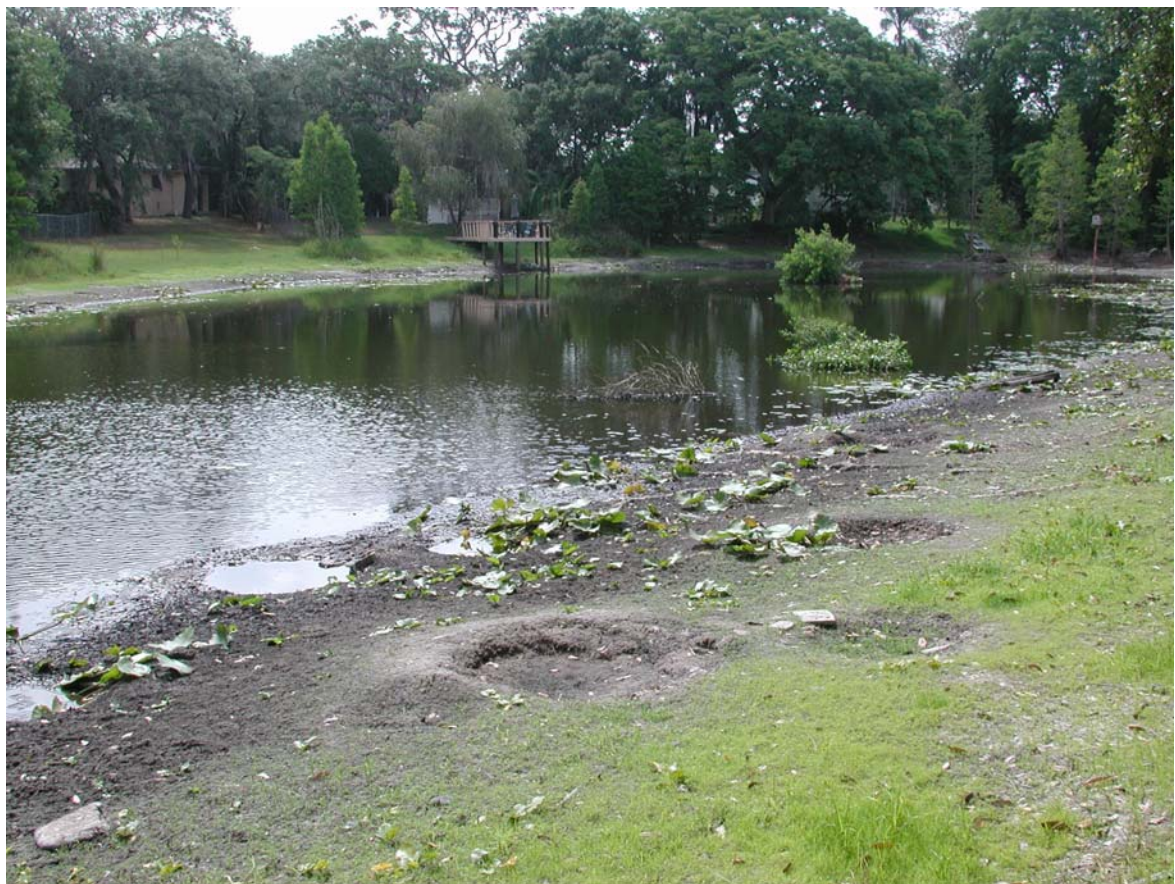
**Figure 1. General Photograph of Pine Pond taken on May 28, 2007.**

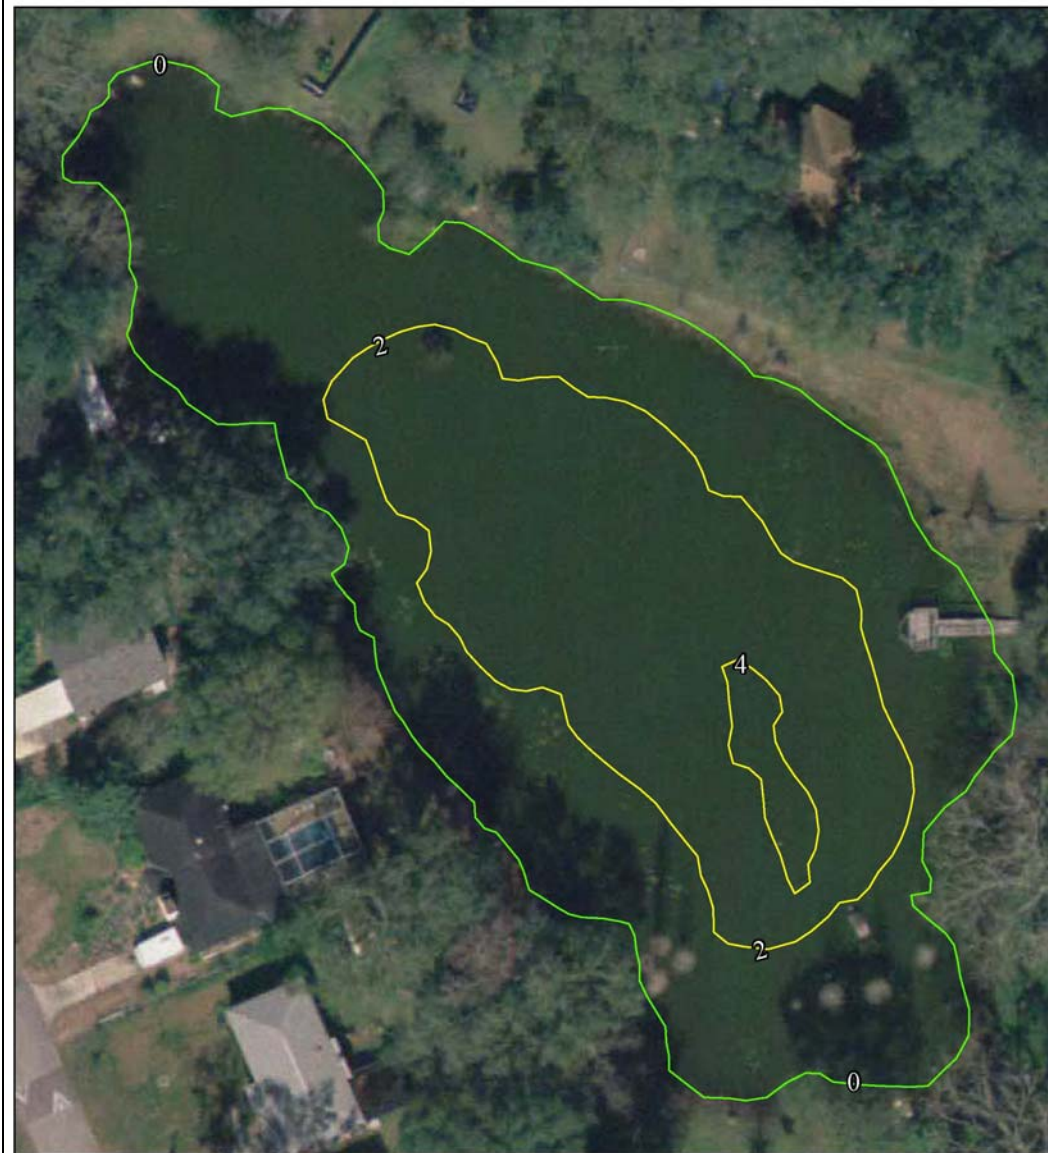
# Pine Pond

Survey Date: May 28, 2007  
Water level was 32.583 ft from the  
reference point of 28.06077266,  
-82.46976031 at time of assessment.  
Contours are expressed in absolute depth  
below this level.

Perimeter 1,070 ft;  
Area 1.07 Acres;  
Mean Depth 2.63 ft;  
Volume-1.69 Acre-ft, (551,265 gallons);  
Deepest point 4.16 ft

**Figure 1. Contour map for Pine Pond. The mapping technique used in 2007 employs a standard DGPS for horizontal position and a fathometer for depth.**

**Bathymetric Map<sup>ii</sup>**. The bottom of the lake was mapped using a Lowrance LCX 26C HD Wide Area Augmentation System (WAAS)<sup>iii</sup> enabled Global Positioning System (GPS) with fathometer (bottom sounder) to determine the boat's position, and bottom depth in a single measurement. The result is an estimate of the lake's area, mean and maximum depths, and volume and the creation of a bottom contour map (Figure 2). Besides pointing out the deeper fishing holes in the lake, the morphologic data derived from this part of the assessment can be valuable to overall management of the lake vegetation as well as providing flood storage data for flood models. Table 1 provides the lake's morphologic parameters in various units.

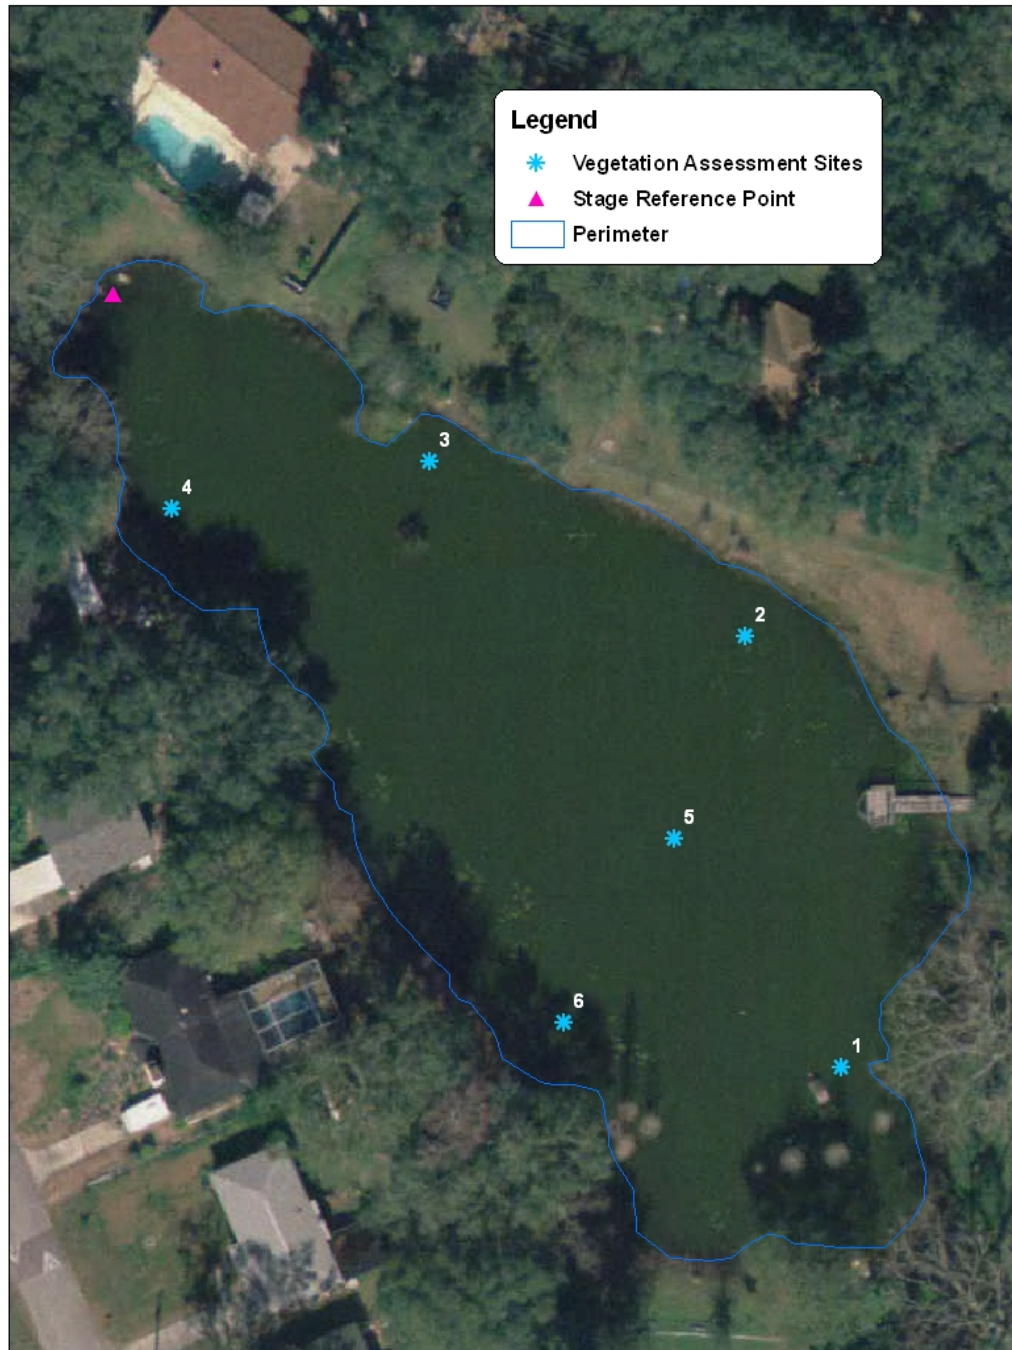
**Figure 3. 2006 six-inch resolution aerial photograph showing location of the vegetation assessment sites on Pine Pond. Major emergent and floating vegetation zones as well as structures such as docks are also observable in this aerial.**

The lake's apparent vegetative cover and shoreline detail are evaluated using the latest lake aerial photograph as shown in Figure 3 and by use of WAAS enabled GPS. Submerged vegetation is determined from the analysis of bottom returns from the Lowrance 26c HD combined GPS/fathometer described earlier. As depicted in Figure 3, six vegetation assessment sites were chosen for intensive sampling based on the *Lake Assessment Protocol* (copy available on request) for a lake of this size. The site positions are set using GPS and then loaded into a GIS mapping program (ArcGIS) for display. Each site is sampled in the three primary vegetative zones (emergent, submerged and floating)<sup>iv</sup>. The latest aerials high resolution aerial photos are used to provide shore details (docks, structures, vegetation zones) and to calculate the extent of surface vegetation coverage. The primary indices of submerged vegetation cover and biomass for the lake, percent area coverage (PAC) and percent volume infestation (PVI), are determined by transiting the lake by boat and employing a fathometer to collect "hard and soft return" data. These data are later analyzed for presence and absence of vegetation and to determine the height of vegetation if present. The PAC is determined from the presence and absence analysis of 100 sites in the lake and the PVI is determined by measuring the difference between hard returns (lake bottom) and soft returns (top of vegetation) for sites (within the 100 analyzed sites) where plants are determined present.

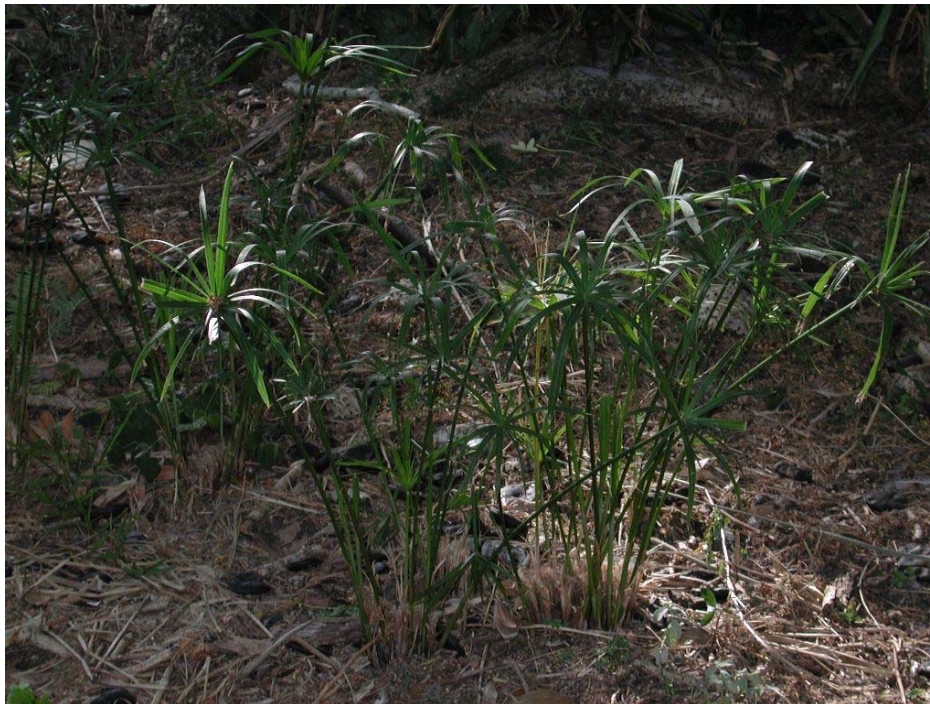
**Figure 5.** *Cyperus alternifolius*, Umbrella Sedge, is a non-native, invasive sedge that has become naturalized in wet areas. This species is commonly sold as an ornamental landscape plant.
