# CITY OF PINELLAS PARK PINELLAS PARK DITCH No. 5 (WBID 1668B) BACTERIAL POLLUTION CONTROL PLAN

**JUNE, 2017**

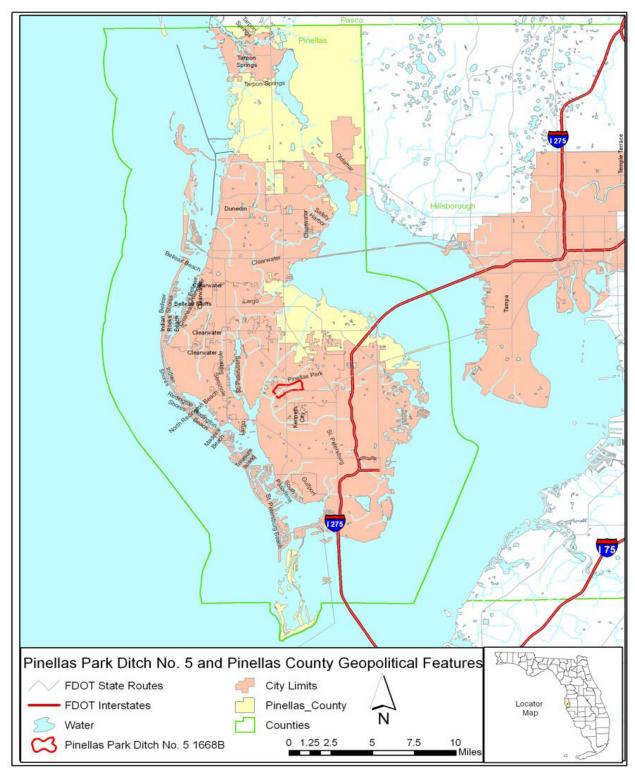
Figure 1 – Pinellas Park Ditch No. 5, WBID 1668B

The Pinellas Park Ditch No. 5 (WBID 1668B) waterbody segment is located within the Long Bayou Watershed, in the west central portion of Pinellas County, Florida, (Figure 1). Pinellas Park Ditch No. 5, discharges to Saint Joes Creek which flows into the Cross Bayou, Long Bayou, and the Boca Ciega Bay estuaries. The Pinellas Park Ditch No. 5 has a surface area of 0.6 square miles and is entirely within Pinellas County.

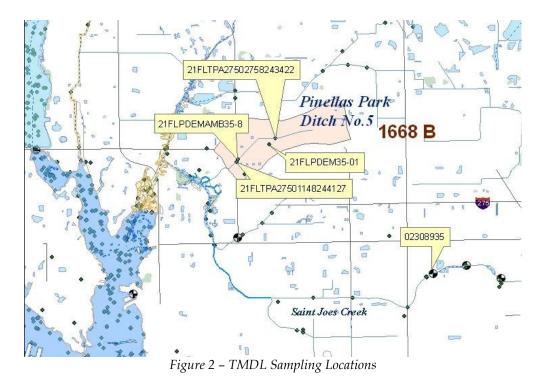
Please reference Figure 2 to view the locations where sampling associated with the TMDL occurred.

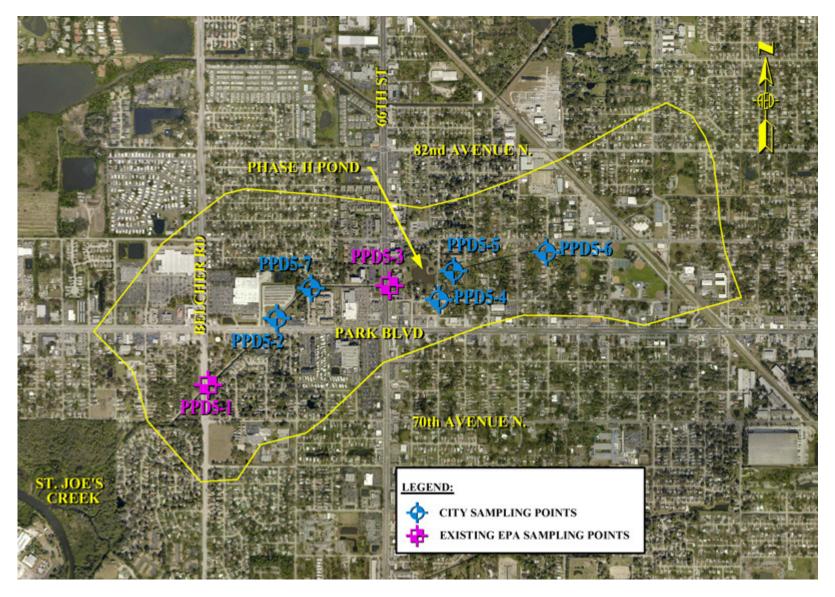
Figure 3 – BPCP Sampling Locations

In total, the BPCP entails testing at seven (7) locations. Please reference Figure 3 on the following page to view the locations of these sampling points in relation to the overall watershed. Additional discussion on the justification for selecting these sites is provided below.

This sampling location is located at the downstream reaches of the impaired waterbody's limits. It is believed that sampling the downstream-most end of the ditch would provide clarity on the bacteria loading that eventually migrates to Saint Joe's Creek; a downstream waterbody also identified as having a fecal impairment. Further, this is the approximate location of sample ID 21FLTPA27501148244127 which was one (1) of the two (2) sampling points utilized in the EPA's TMDL.

This sampling location is located upstream of a large culverted crossing of Park Blvd. This site was site was selected in an effort to isolate the basin area confined by Belcher Road and 66<sup>th</sup> Street. Runoff from residential and commercial areas is discharged upstream of this location.

Located upstream of a culverted crossing of 66<sup>th</sup> Street, this sample location is located at the control structure associated with the "Phase II Pond". This sampling point essentially identifies fecal concentrations for the eastern half of the basin. Further, this is the approximate location of sample ID 21FLTPA2750758243422 which was one (1) of the two (2) sampling points utilized in the EPA's TMDL.

Park Blvd., a highly traveled FDOT-owned highway has runoff routed to the aforementioned "Phase II Pond". This sampling point is intended to identify the fecal concentrations within the commercial corridor that abuts this roadway. Many restaurants are located along this corridor and dumpsters for these facilities are near stormwater collection structures. The actual testing location is at a piped outfall to the "Phase II Pond".

This sampling location is located at a piped outfall to the "Phase II Pond". However, this outfall serves the residential and multi-family communities upstream of the pond and north of Park Blvd.

Located at the upstream end of the ditch, this sample location is taken immediately downstream of a headwall. This sampling location is intended to identify the fecal concentrations of all upstream locations. High readings at this site allow this City to pinpoint possible fecal sources within the upstream reaches of the watershed.

This sampling location was added after the Walk the Waterbody field exercise. At the sampling location, a shallow open ditch conveyance system outfalls to the main ditch. Field investigation found that this location was directly downstream of an observed homeless camp, an extensive stray cat population and residential neighborhood. The open ditch was found to convey flows to main ditch at minimal velocities and covered by heavy canopy (resulting in minimal exposure to sunlight).

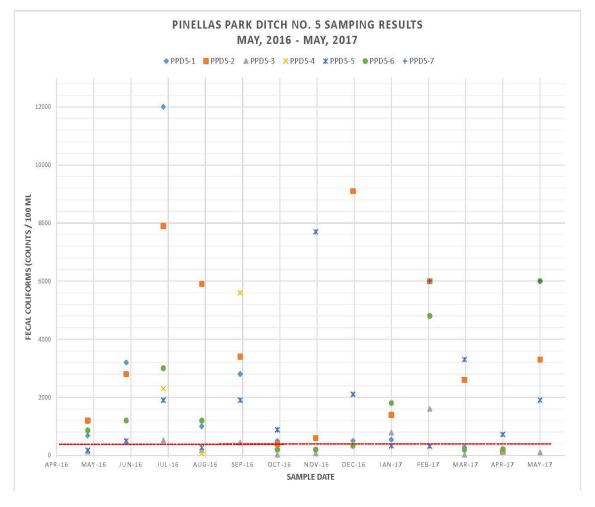
Figure 4A – Pinellas Park Ditch No. 5 Sampling Results \* \* 30,000 Count Obtained During 09/2016 Testing @ PPD5-6 Not Plotted to Improve Chart Legibility

To date, the City has obtained twelve (12) consecutive months of sampling results. This duration mimics the duration utilized by the EPA in preparation of the TMDL. While the City is of the opinion that absolute determinations on SWMP effectiveness cannot be made based upon such a short testing period (when considering all of the variables at play), it is believed that the data identifies positive trends. Please reference Figure 4A below to view a scatter plot of the sampling results.

As evidenced by the above-presented figures, multiple sample recordings identify fecal counts above the allowable 400 counts / 100 mL. However, it shall be noted that the average counts obtained at PPD5-1 and PPD5-3 are lower when compared to the results presented in the EPA TMDL. Please see the summary below:
