ROOSEVELT CREEK NUTRIENT SOURCE EVALUATION AND ASSESSMENT

**Final Report
September 2010**

Environmental Research and Design, Inc.
Harvey H. Harper, III, Ph.D., P.E.
3419 Trentwood Blvd., Suite 102
Orlando, FL 32812
Phone: 407-855-9465

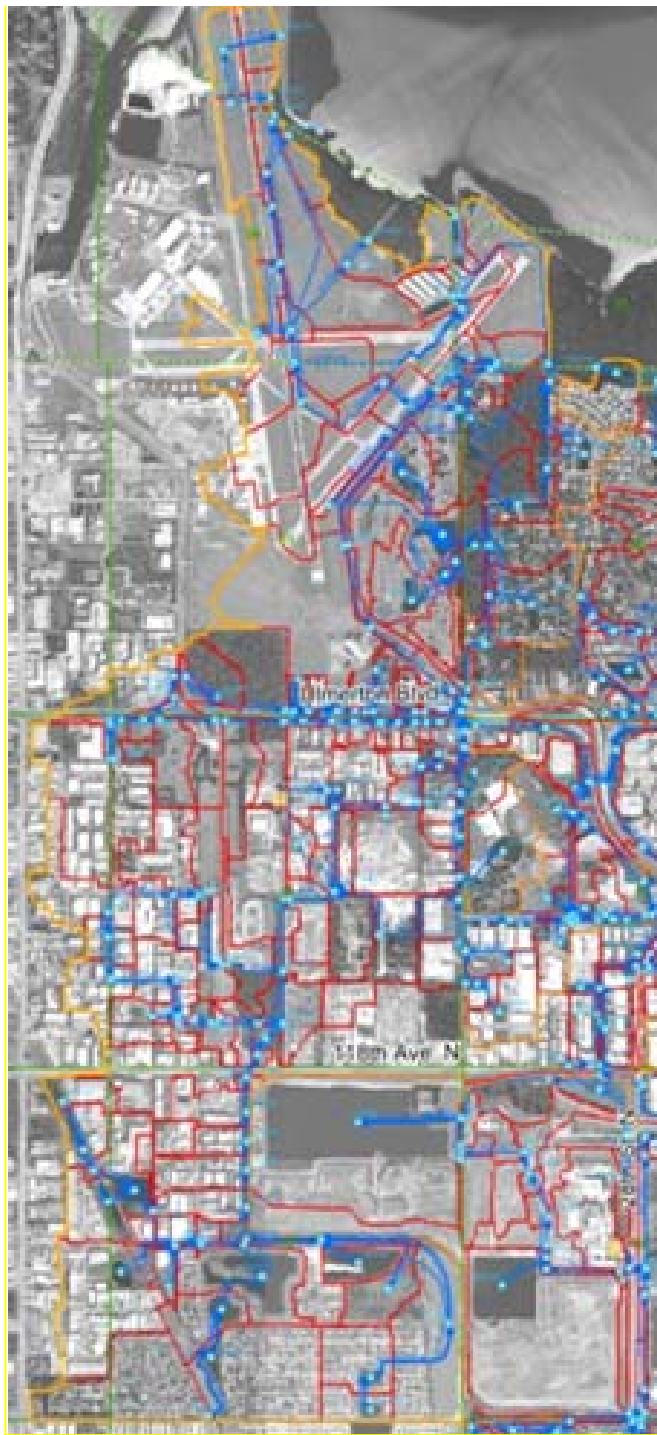
Figure 2-6. Inventory of Primary (Blue Lines) and Secondary (Red Lines) Drainage Conveyance Systems for Sub-basin H.

An inventory of primary and secondary drainage conveyance systems for Sub-basin H is given on Figure 2-6 (Parsons, 2007). This figure provides a schematic of the primary conveyance system for Channel 5, as well as secondary conveyance systems intersecting with the main channel. With the exception of the pumped inflow from the Bridgeway Acres Landfill, water movement within Sub-basin H occurs entirely by gravity.

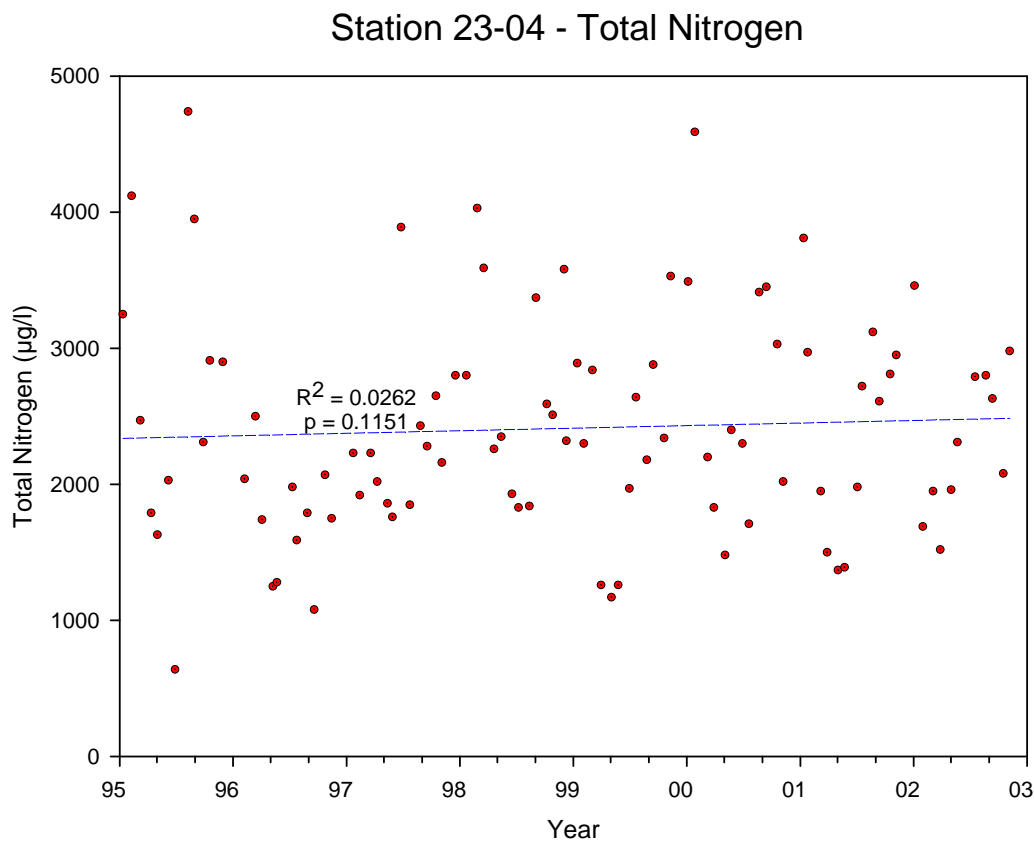
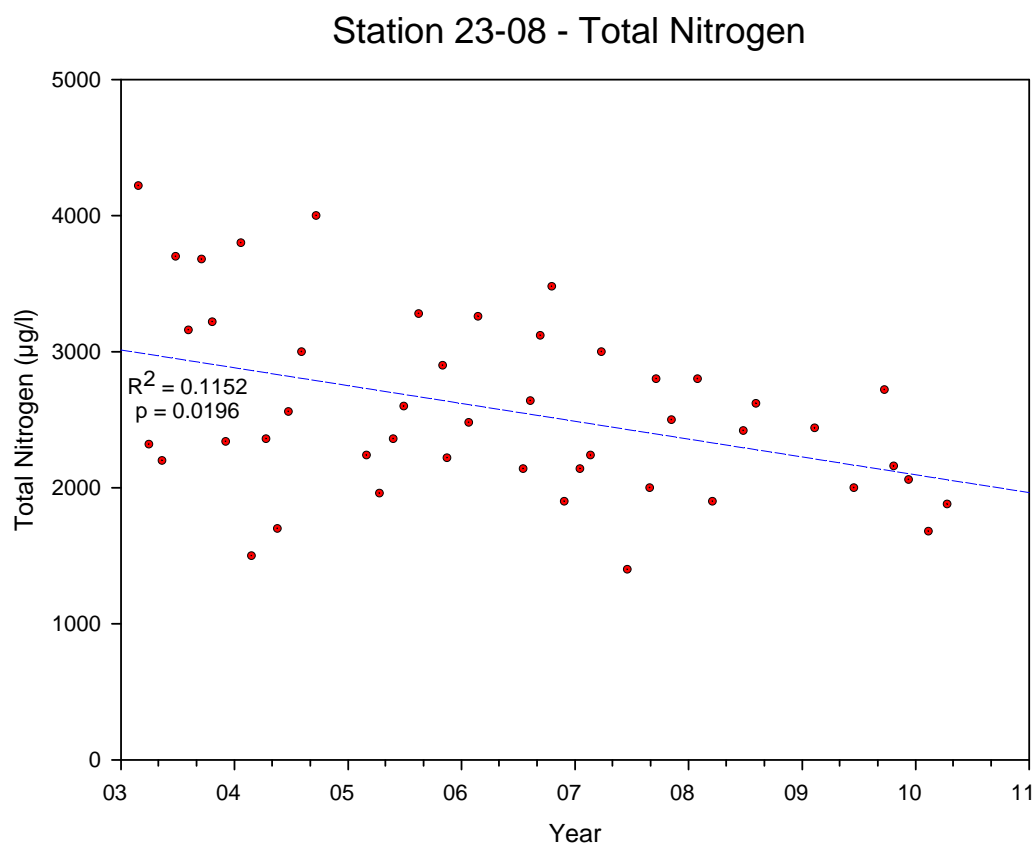
A comparison of trends in historical total nitrogen concentrations in Pinellas County monitoring Sites 23-04 and 23-08 is given on Figure 2-14. A “best fit” regression line is provided for each of the two plots to assist in identifying significant water quality trends. The calculated probability value (p-value) is also provided for each regression line which indicates the level of significance associated with each regression model. A model which is significant at a 95% confidence level would be associated with a p-value of 0.05. However, waterbodies exhibit normal seasonal and cyclic variations in water quality which can reduce the statistical significance of a regression model due to normal sources of variability which are unrelated to potential temporal trends. This normal variability may lead to elevated p-values which suggest that trends may not be significant when significant trends actually exist. Therefore, for evaluating water quality trends in surface waters, a p-value of 0.1 or less is generally considered to indicate a significant statistical trend, with p-values from 0.1-0.2 indicating a likely significant trend, and p-values greater than 0.2 indicating an insignificant trend. R-square (R^2) values are also provided for each regression line which provide another indicator of the strength of the relationship between concentrations and time.

Figure 2-14. Trends in Historical Total Nitrogen Concentrations at Pinellas County Monitoring Sites 23-04 (1/95-11/02) and 23-08 (2/03-4/10).

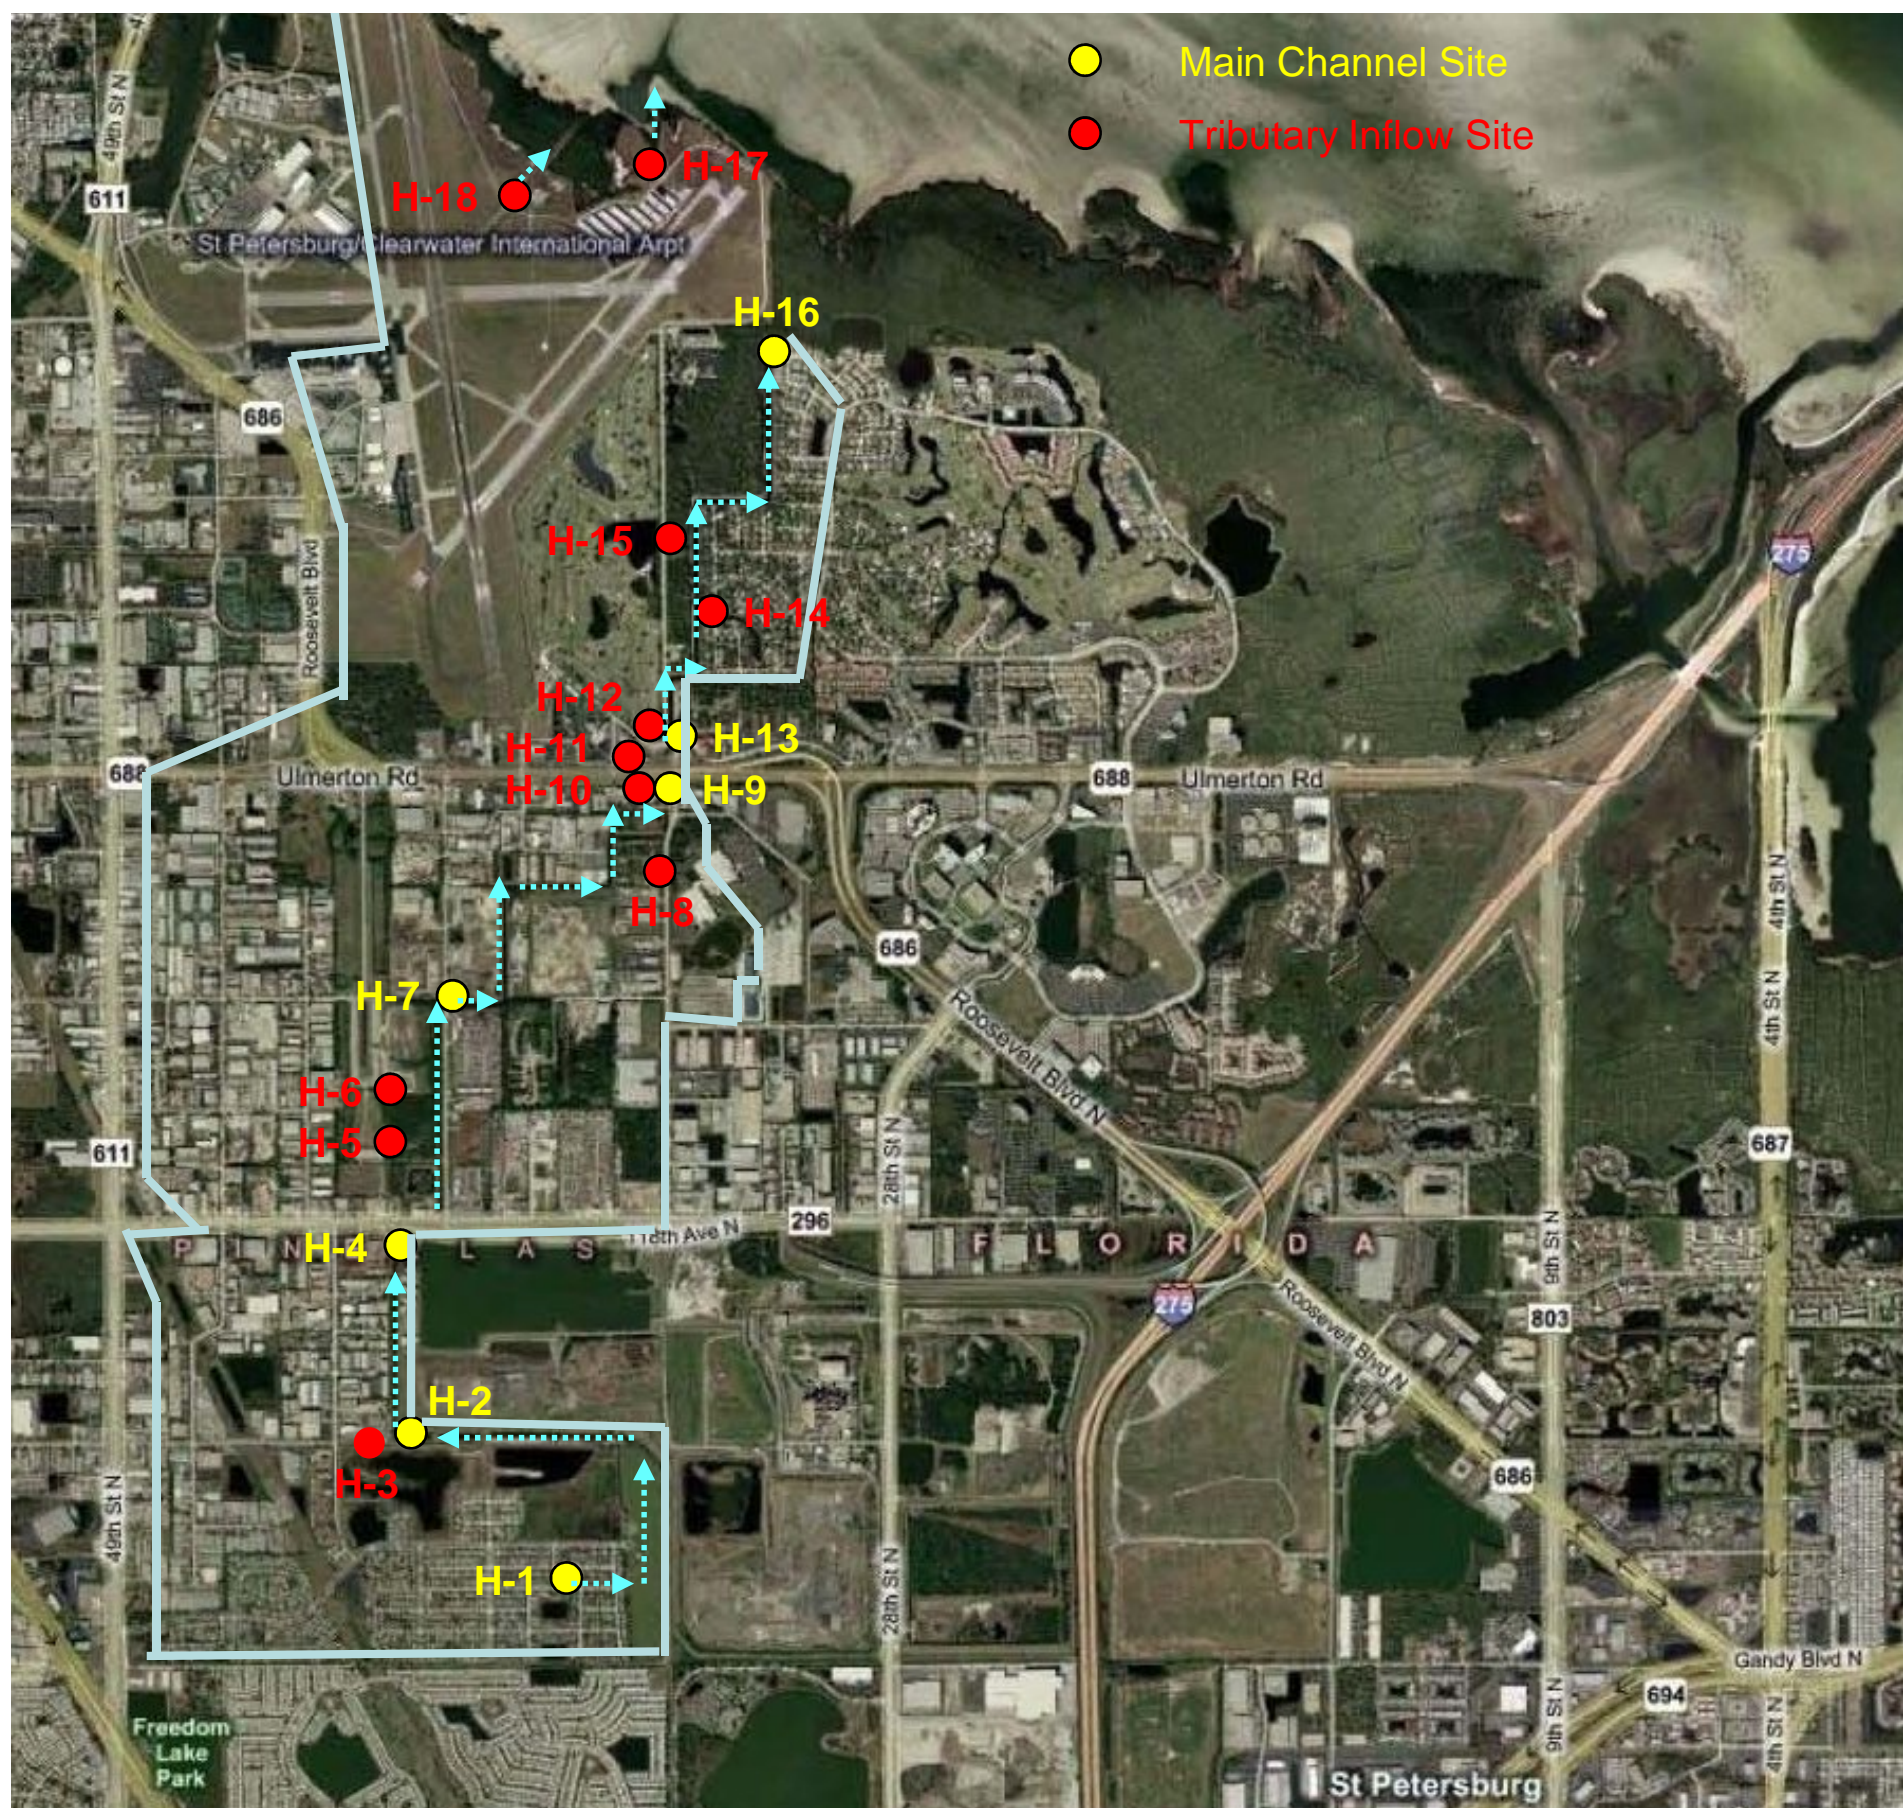
An overview of surface water monitoring sites selected within the Roosevelt Creek Sub-basin H study area is given on Figure 3-1. Eighteen separate monitoring sites were selected to quantify nutrient loadings discharging through the system. Five of the proposed monitoring sites are located along the main stream of Channel 5 to quantify changes in flow rates and nutrient loadings along the main path of the channel. Eleven sites reflect inputs into Channel 5 to assist in identifying potential sources of elevated nutrient inputs into the channel. Two additional sites which represent inflows directly to Old Tampa Bay from the St. Petersburg/Clearwater International Airport were also monitored. A tabular summary of monitoring sites in Roosevelt Creek Sub-basin H is given on Table 3-1. The selected monitoring sites were intended to provide an analysis of water quality characteristics, including changes in nutrient loadings, during migration through the study area.

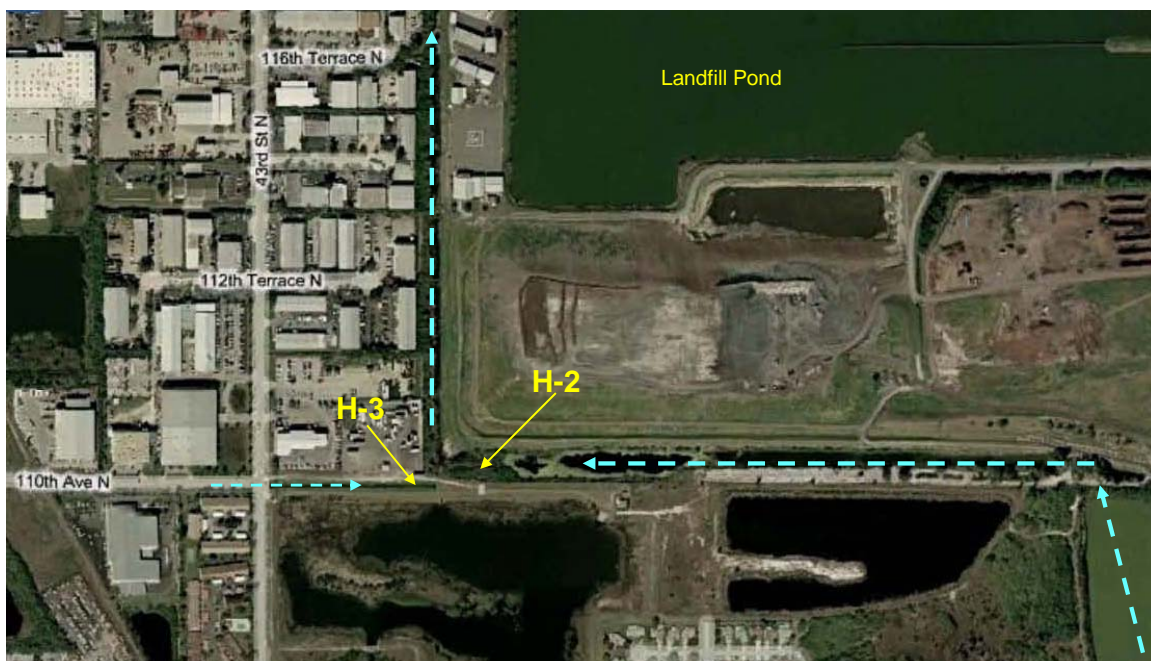
The location of surface water monitoring Site H-2 is given on Figure 3-3. This site is located southwest of the Bridgeway Acres Landfill area and is the first site located along the main channel portion of Channel 5. This site provides background conditions for evaluation of changes in water quantity and water quality during migration through the Channel 5 system. A photograph of monitoring Site H-2 is given on Figure 3-4. Samples were collected on the downstream side of the 8-ft wide rectangular weir structure.

Figure 3-3. Location of Monitoring Sites H-2 and H-3.

The monitoring location for Site H-3 is also indicated on Figure 3-3. This site represents a small tributary inflow to the main channel which includes drainage inputs originating along 110th Avenue North. Photographs of monitoring Site H-3 are given on Figure 3-5. Monitoring was conducted on the upstream side of the 72-inch RCP culvert prior to discharge into the main channel.

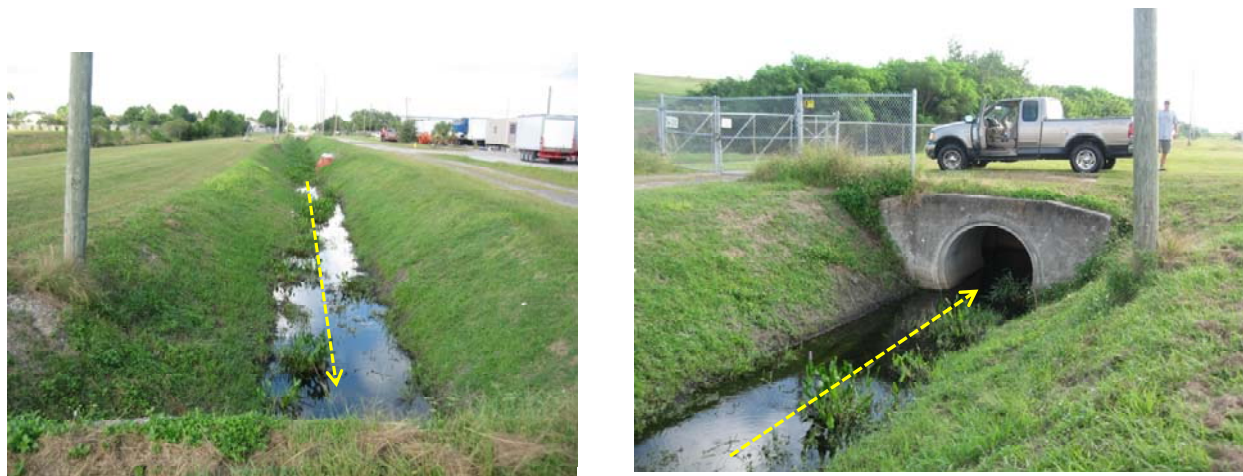
Figure 3-5. Photographs of Monitoring Site H-3.

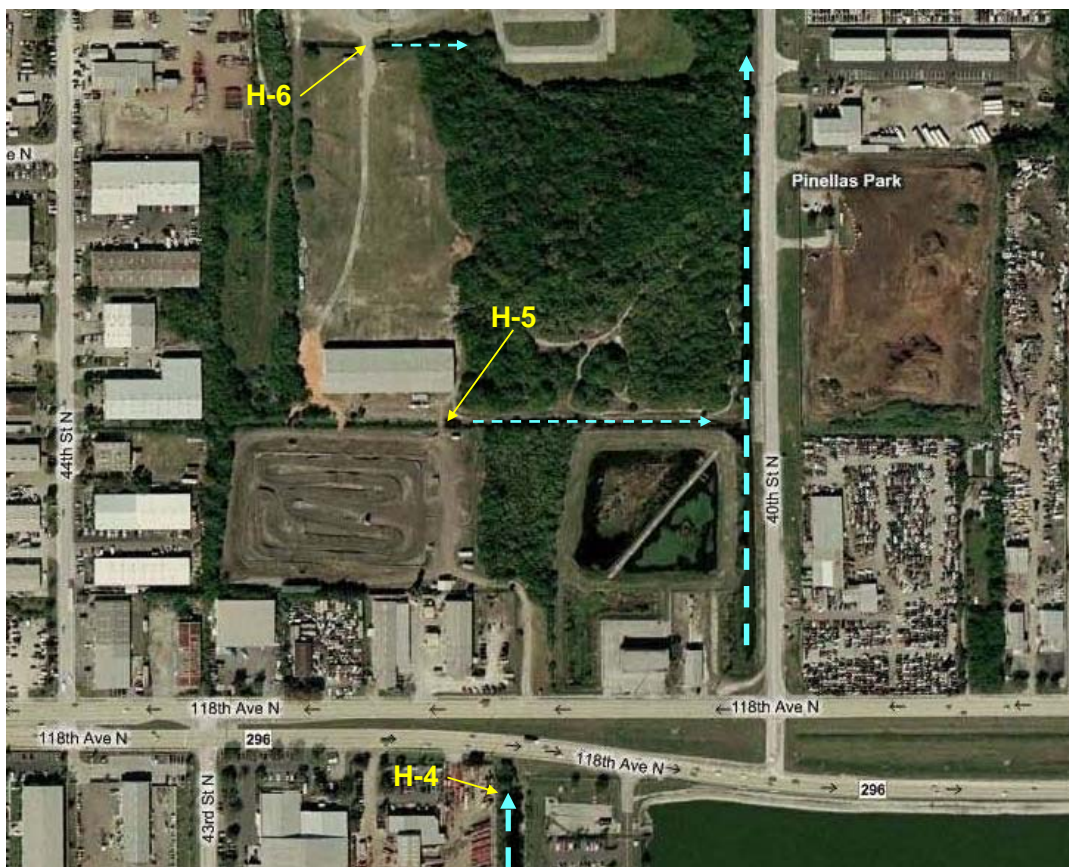
Locations for surface water monitoring Sites H-4, H-5, and H-6 are indicated on Figure 3-6. Site H-4 is located within the main channel of Channel 5, immediately south of 118th Avenue North. This site reflects changes in water quantity or quality during migration through the main channel between monitoring Sites H-2 and H-4. This site is located at the weir structure on the northwest side of Bridgeway Acres Landfill which is illustrated on Figure 2-9. This structure contains a total of 24 ft of horizontal rectangular weir. The pumped inflow from the Bridgeway Acres Landfill is introduced into Channel 5 approximately 50 ft upstream from the weir structure and enters the channel through a submerged pipe which could not be monitored directly.

Figure 3-6. Location of Monitoring Sites H-4, H-5, and H-6.

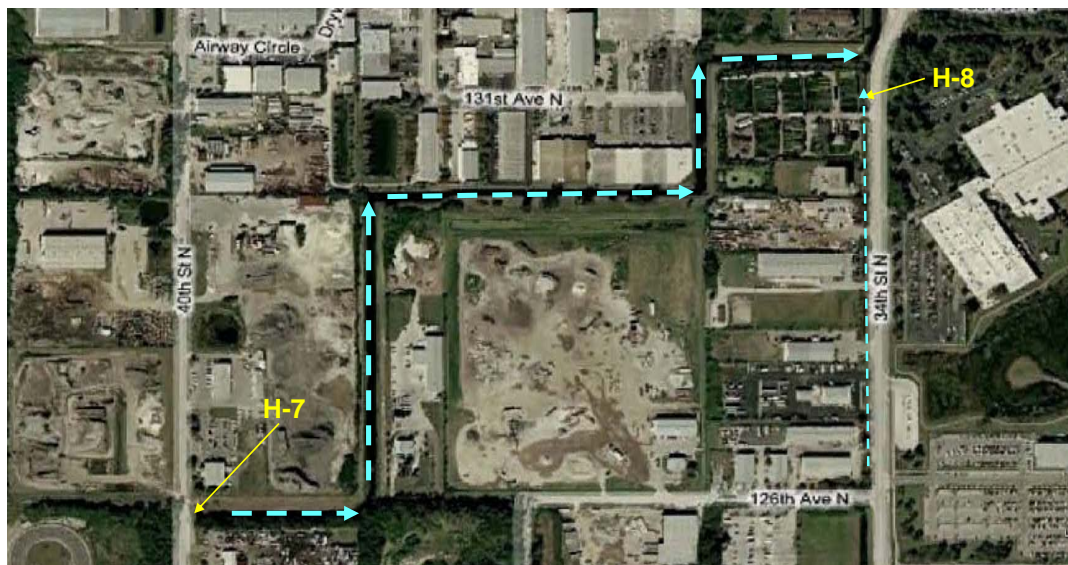
Locations for monitoring Sites H-7 and H-8 are indicated on Figure 3-9. Site H-7 is located within the main channel of Channel 5 and is designed to evaluate changes in water quality and quantity which occur between 118th Avenue North and 40th Street North. Photographs of monitoring Site H-7 are given on Figure 3-10. This monitoring site is located on the upstream side of the four 60-inch RCPs and one 36-inch RCP which convey Channel 5 beneath 40th Street North. The channel in this area is approximately 50 ft in width with a relatively shallow flow. The bottom of the channel consists primarily of sand and muck with little vegetation.

Figure 3-9. Location of Monitoring Sites H-7 and H-8.

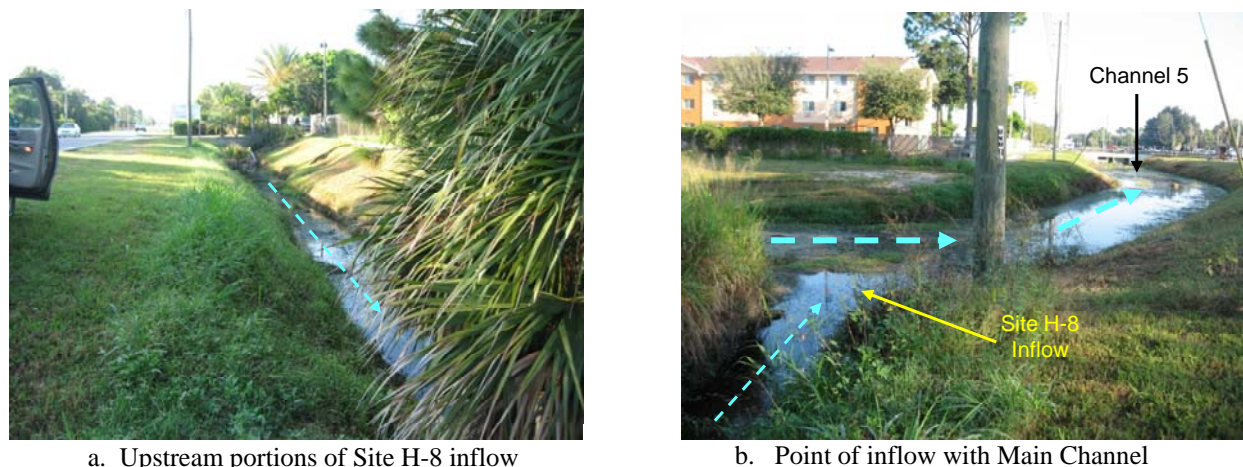
Monitoring Site H-8 reflects a minor tributary inflow into the main channel which provides drainage for areas along 34th Street North. Photographs of monitoring Site H-8 are given on Figure 3-11. This site consists of a roadway drainage system which runs parallel to 34th Street North. Discharges through this channel occur primarily as a result of rain events, although a low level baseflow was observed during most monitoring events.

Figure 3-11. Photographs of Monitoring Site H-8.
