# LAKE ASSESSMENT REPORT FOR ROUND LAKE IN HILLSBOROUGH COUNTY FLORIDA

Date Assessed: June 26, 2007  
Assessed by: Sarah Koenig and David Eilers  
Reviewed by: Jim Griffin, Ph.D.

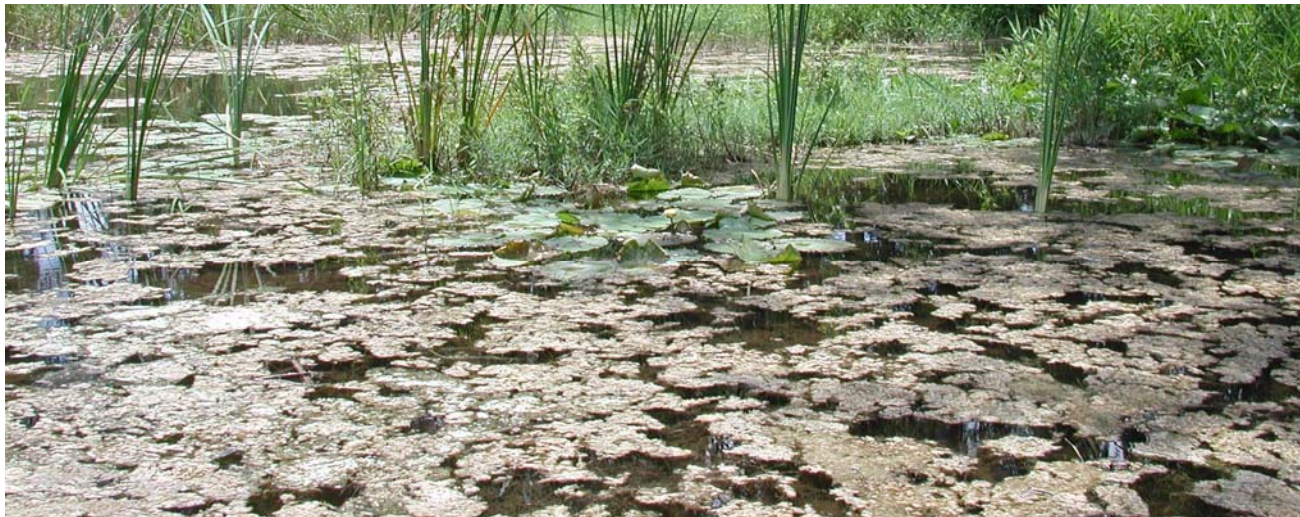
**Figure 6.** *Algal Spp.*, Algal Mats, are a native species and is common in Florida waterbodies. However, when exposed to excessive nutrients such as runoff fertilizer from lawns these species can experience rapid population growth covering much of the surface and subsurface of the lake, causing dissolved oxygen levels to lower and smothering other submerged vegetation.

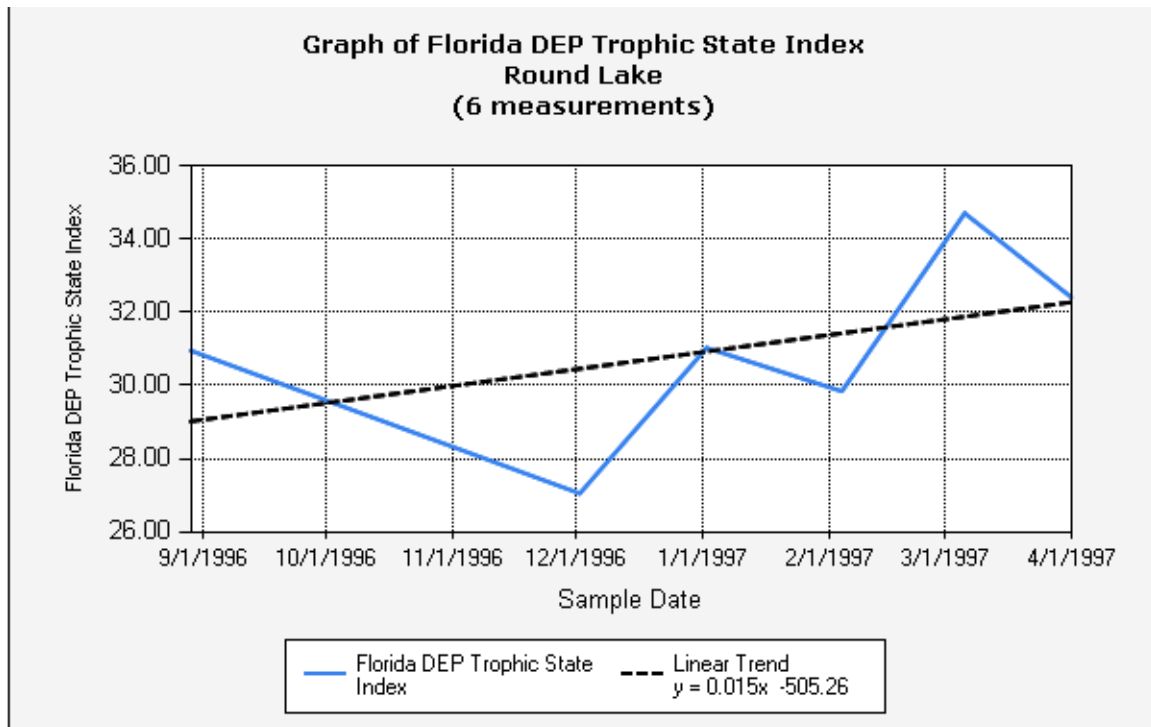
Figure 7. TSI trend data from Southwest Florida Water Management District data for Round Lake (new Water Atlas Data Download display <http://www.hillsborough.wateratlas.usf.edu/DataDownload/?rid=2879>).

A critical element in any lake assessment is the long-term water chemistry data set. The primary source of water quality trend data for Florida Lakes is the Florida LAKEWATCH volunteer and the Florida LAKEWATCH water chemistry data. Unfortunately, Round Lake has not had a volunteer since 1998 and no trend data was available through LAKEWATCH. The Southwest Florida Water Management District conducted a study of the lake between 1996 and 1997 (<http://www.hillsborough.wateratlas.usf.edu/upload/documents/Round%20mfl%20memo%20feb2003.pdf>) and these data are available on the Water Atlas Data Download component. Figure 7 below shows a graph of the TSI over this period. Round Lake is a clear water lake (color < 40 pcu) and as such it must maintain a TSI of below 40 to not be considered impaired by the State of Florida guidelines<sup>v</sup>. The lake is not considered impaired by FDEP. No recent trend data exist and it is important that the LAKEWATCH sampling be resumed to track the condition of this lake.
