Lake Raleigh

LAKE HABITAT ASSESSMENT, LAKE VEGETATION INDEX, SUBMERGED
VEGETATION SURVEY AND WATER QUALITY

David Eilers, Abigail Richardson, Towfiqul Islam Khan | USF Water Institute | July 16,
2024

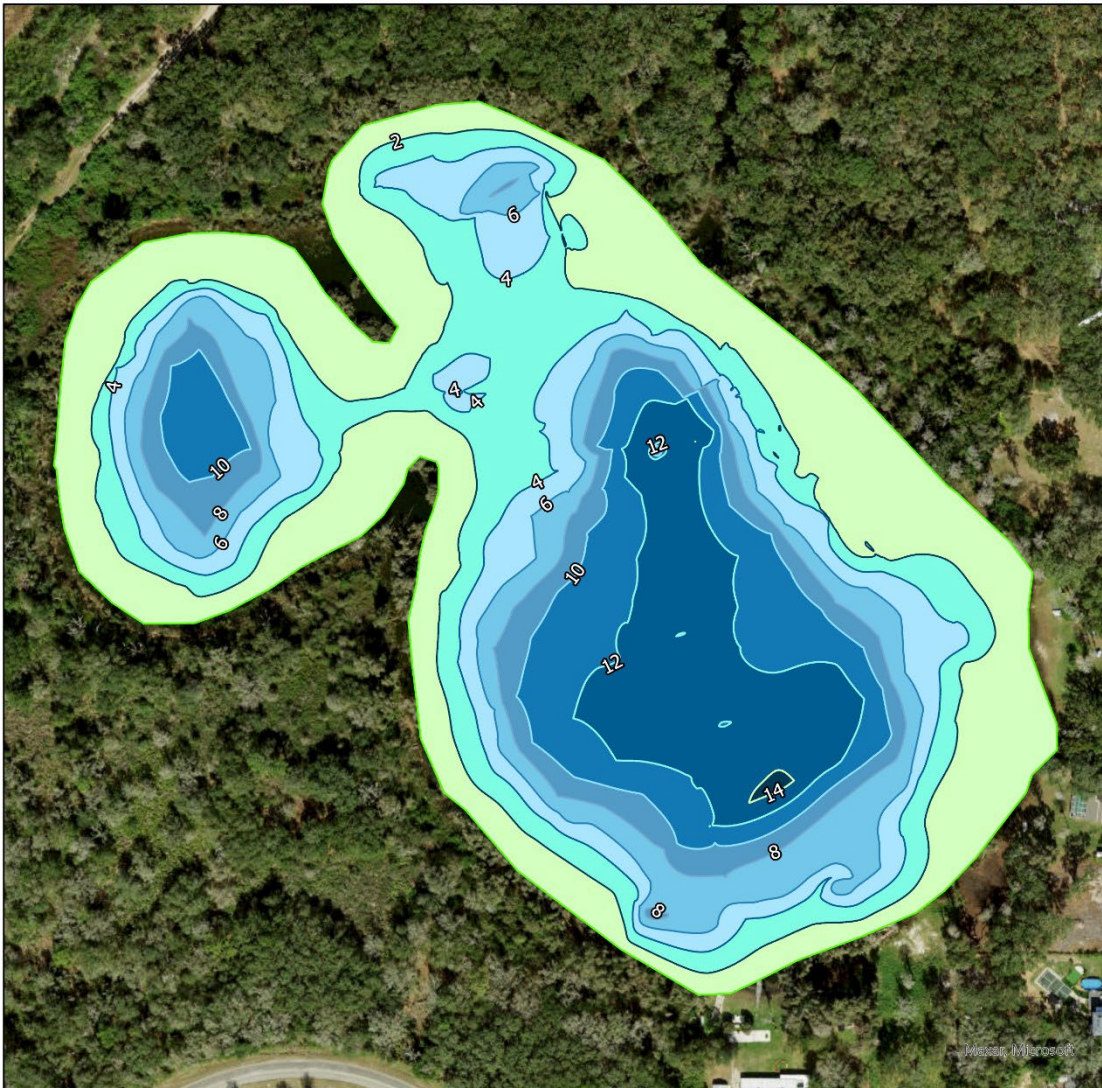
Figure 2: 2024 2-Foot Bathymetric Contour Map for Lake Raleigh

At the time of the assessment, Lake Raleigh was experiencing low water levels (33.45 feet NAVD88 on staff gauge) resulting in a 22.6 acre water body. Lake Raleigh at the time of the assessment had a mean water depth of 5.3 feet and a maximum observed depth of 14.3 feet. The volume at this time was approximately 38,906,772 gallons. Figure 2 shows the resulting bathymetric contour map for Lake Raleigh from data collected on July 16, 2024. The collected data has been overlain the 2023 ESRI Basemap aerials.

EXPLANATION:
 Survey Date: July 16, 2024
 Water level was 33.45 ft NAVD88
 at the time of the assessment.
 Contours are expressed in absolute
 depth below this level.

LAKE MORPHOLOGY:
 Perimeter 4,904 ft;
 Area 22.6 Acres;
 (983,371 Sqft)
 Mean Depth 5.3 ft;
 Volume 119.4 Acre-ft,
 (38,906,772 gallons);
 Deepest point 14.34 ft

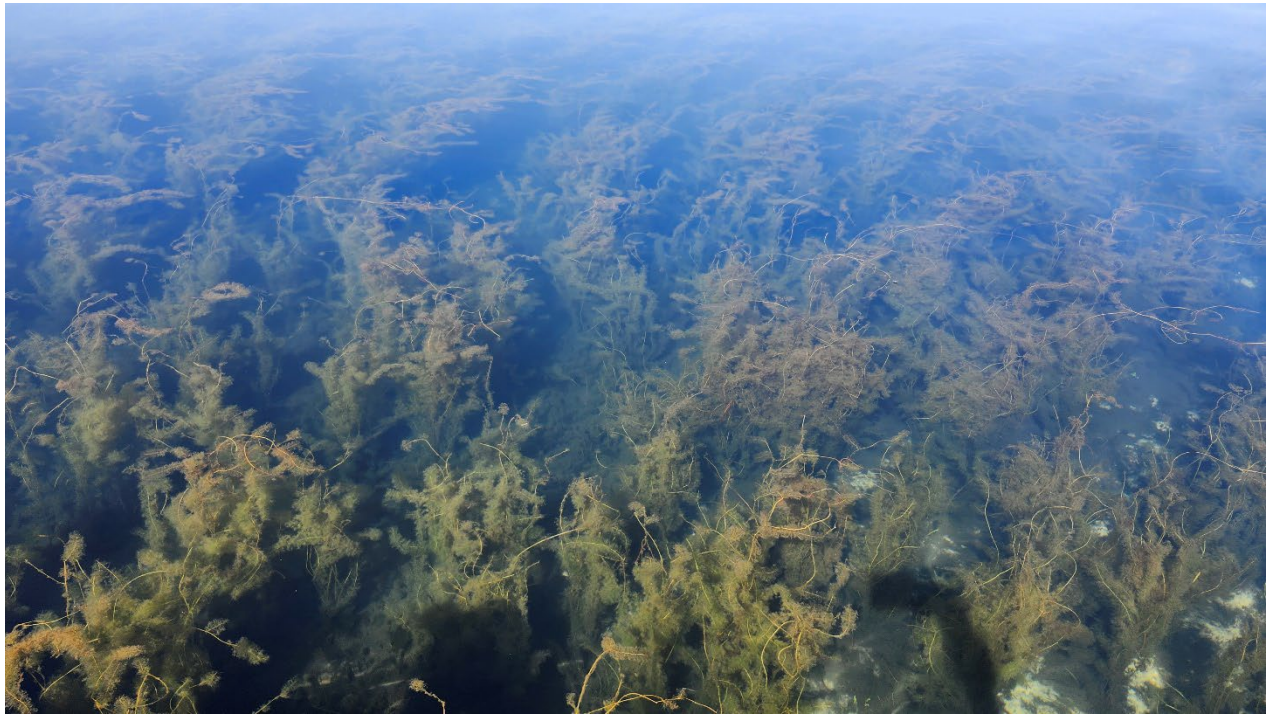
Figure 3 Lake Raleigh had robust growth by the native submersed species *myriophyllum laxum*.

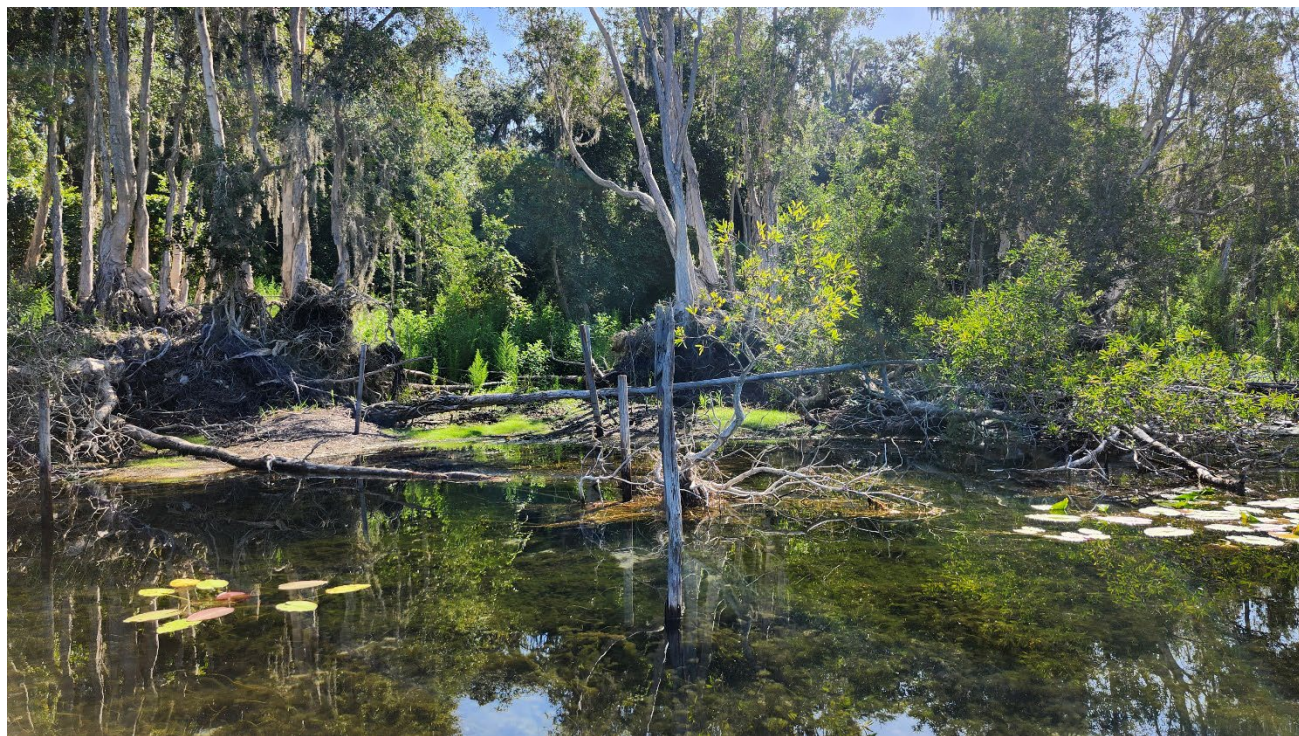
Figure 4 Melaleuca quinquenervia was common along the undeveloped shorelines of Lake Raleigh

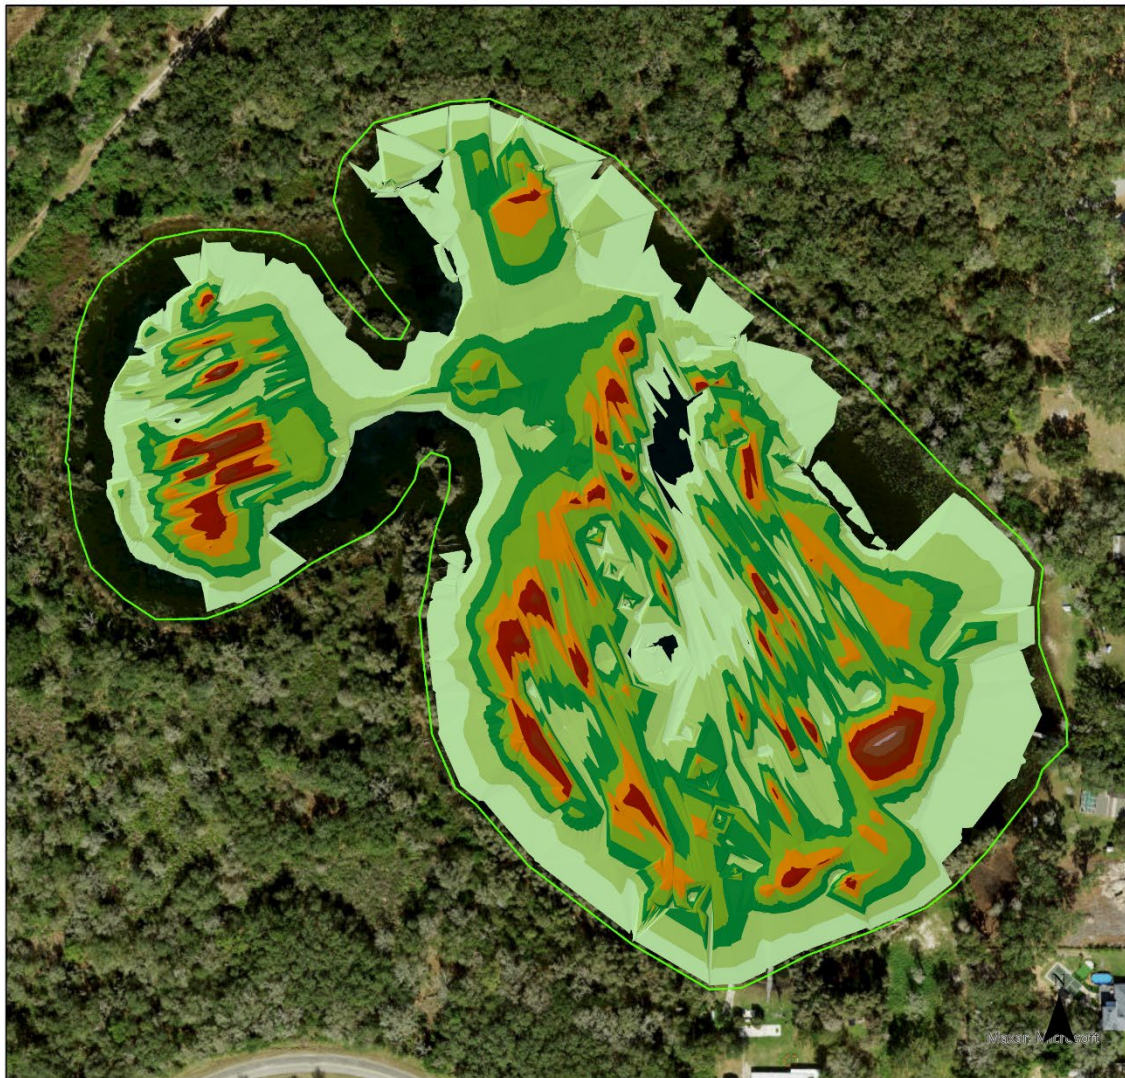
Figure 5 Lake Raleigh Submerged Aquatic Vegetation Assessment Results

By analyzing the collected sonar chart, submerged aquatic vegetation potentially covered 81.79% of the surface area of Lake Raleigh. This submerged vegetation inhabits an estimated 31.01% of the water volume in Lake Raleigh. Figure 5 shows the results of the SAV analysis indicating the location and height of SAV estimated from collected sonar readings.

Survey Date: July 16, 2024
 Water level was 33.45 NAVD88
 at the time of the assessment.
 Submerged Aquatic Vegetation was
 analyzed from collected sonar data.
 The height of the SAV where present
 is shown in 1 foot increments.

Area 804,336 square ft; 18.5 Acres;
 (81.79% of Lake Surface Area)
 Mean SAV Height 2.0 ft;
 Volume 1,612,996 Cubic ft, (12,066,128
 gallons);
 (31.01% of Lakes Volume)
