ROCKY / BRUSHY CREEK WATERSHED MANAGEMENT PLAN

(Chapters 1-15)

Ayres Associates Inc
8875 Hidden River Parkway, Suite 200
Tampa, Florida 33637

December 2007

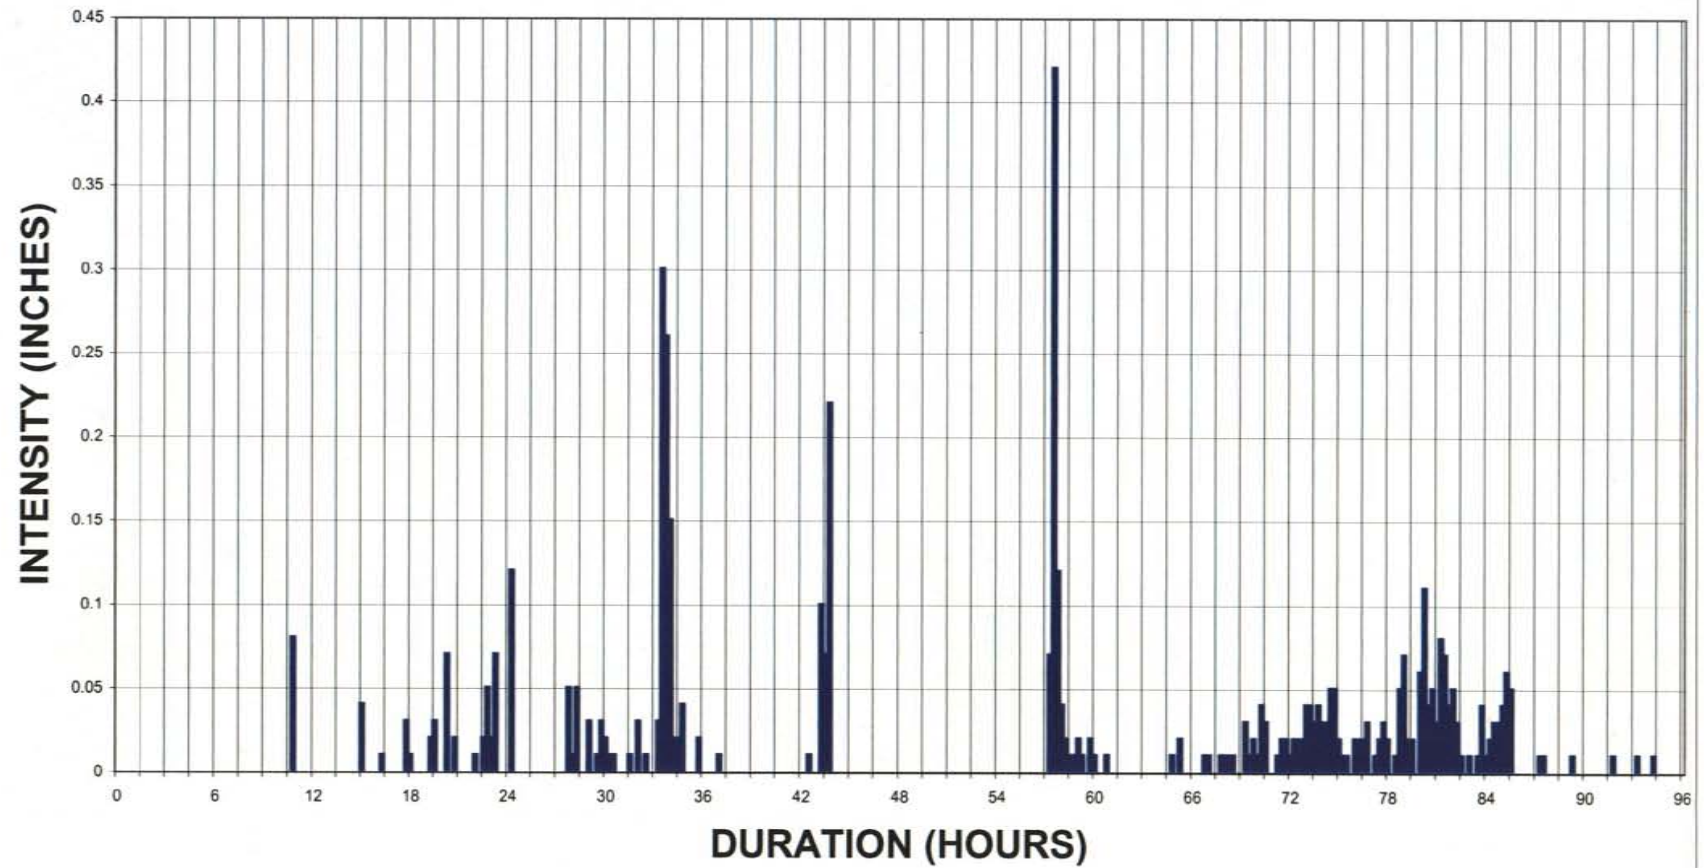
Figure 5-2

LAKE ALLEN DECEMBER 10TH THRU 13TH 96 HOUR RAINFALL DISTRIBUTION

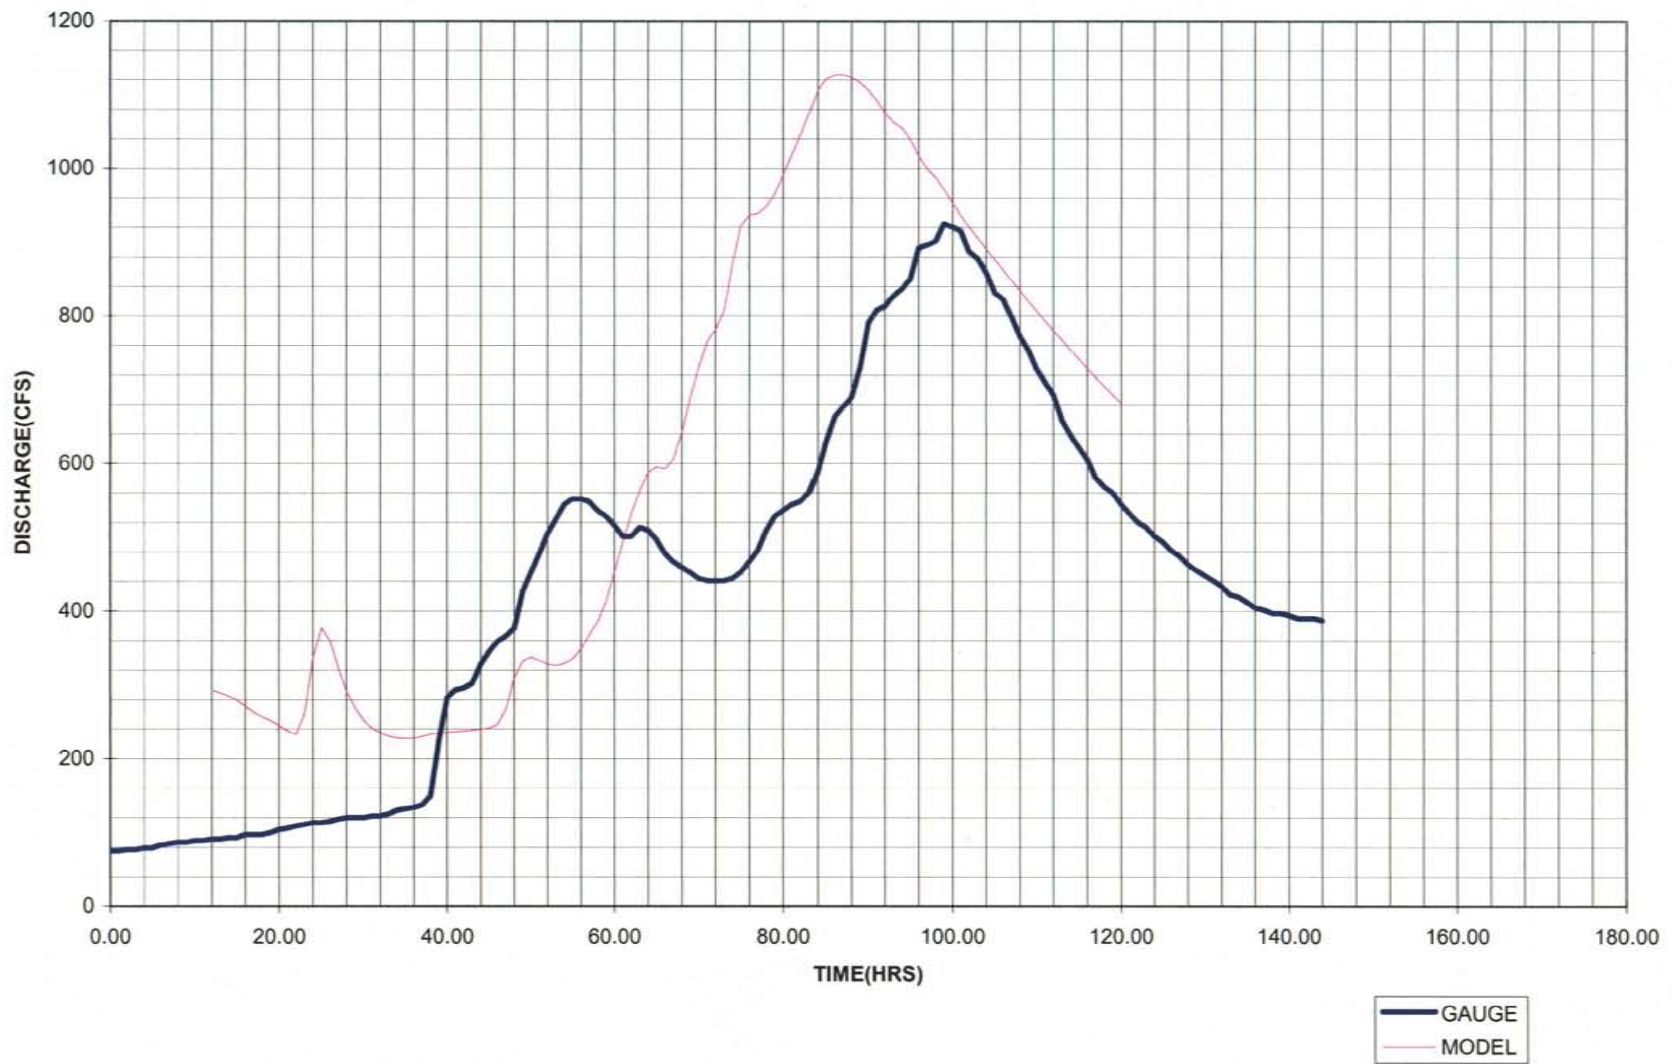
Figure 5.23

DLA 1072 DISCHARGE @ LINBAUGH R2
