# Saddleback Lake

LAKE HABITAT ASSESSMENT, LAKE VEGETATION INDEX, SUBMERGED  
VEGETATION SURVEY AND WATER QUALITY

David Eilers, Karina Gonthier | USF Water Institute | September 7, 2023

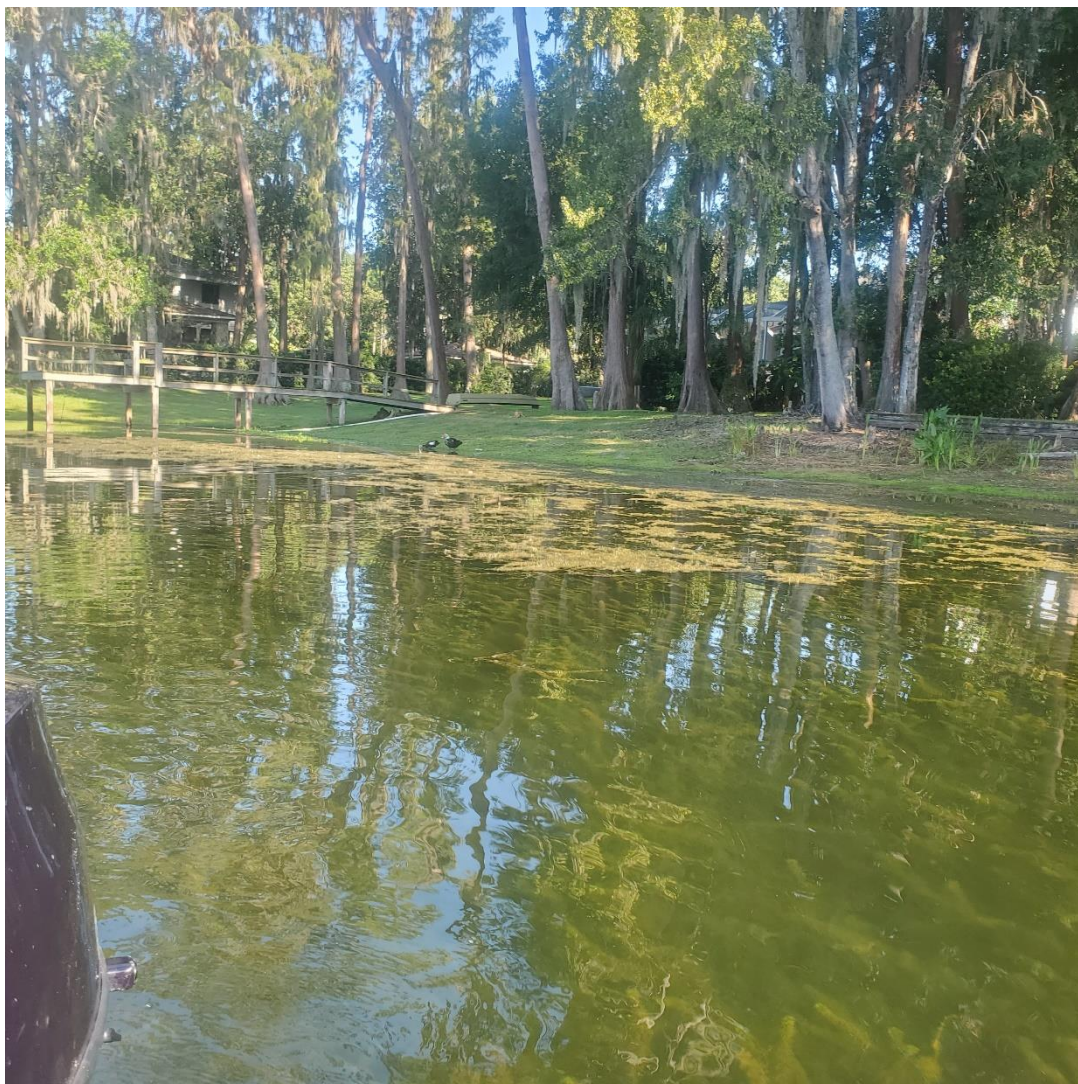
Figure 3 Overview photograph of Saddleback Lake showing the residentially developed portion of shoreline featuring a canopy of *Taxodium*.

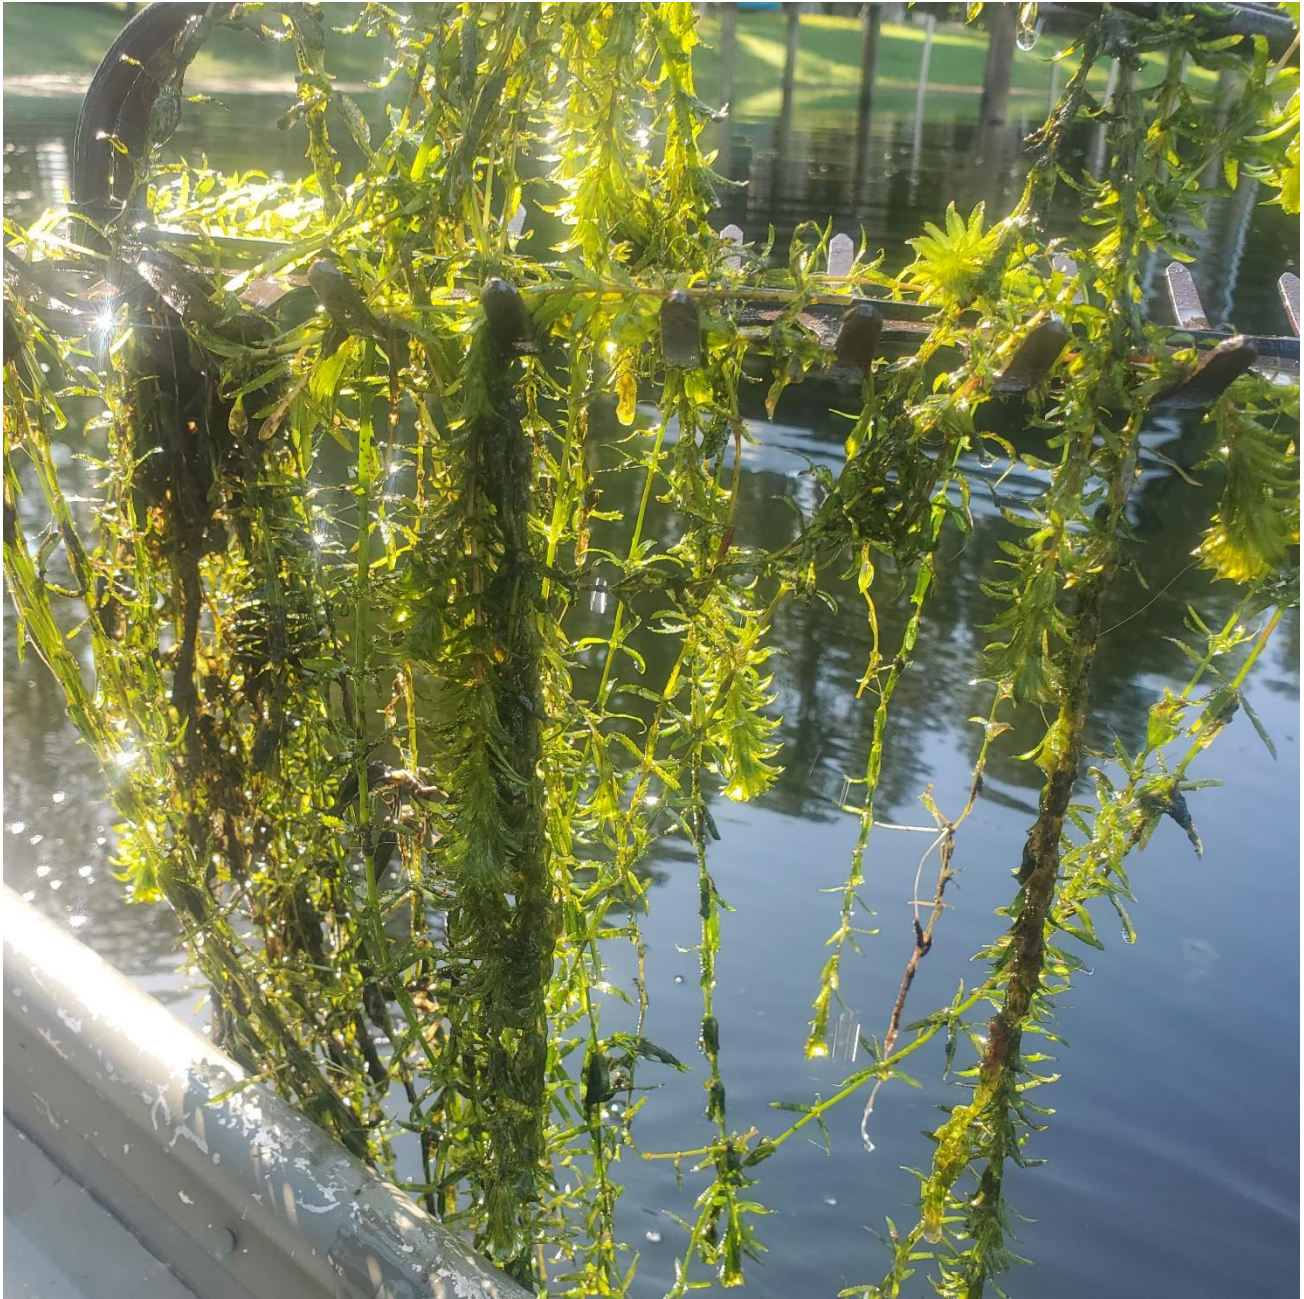
*Figure 4 Hydrilla verticillata was dominant in all regions of the Lake Vegetation Index on Saddleback Lake*

The system does show impairment in the vegetation communities according to the Lake Vegetation Index with abundant invasive species (8) and an overall LVI score of 31. The primary issues in the Lake Vegetation Index is the dominance by *Hydrilla verticillata*. The assessment also revealed a submerged aquatic vegetation community comprising 6 species occupying 52.35% of the surface area and 6.74% of the volume of Saddleback Lake.
