# Sand Pond

### Study Area Analysis

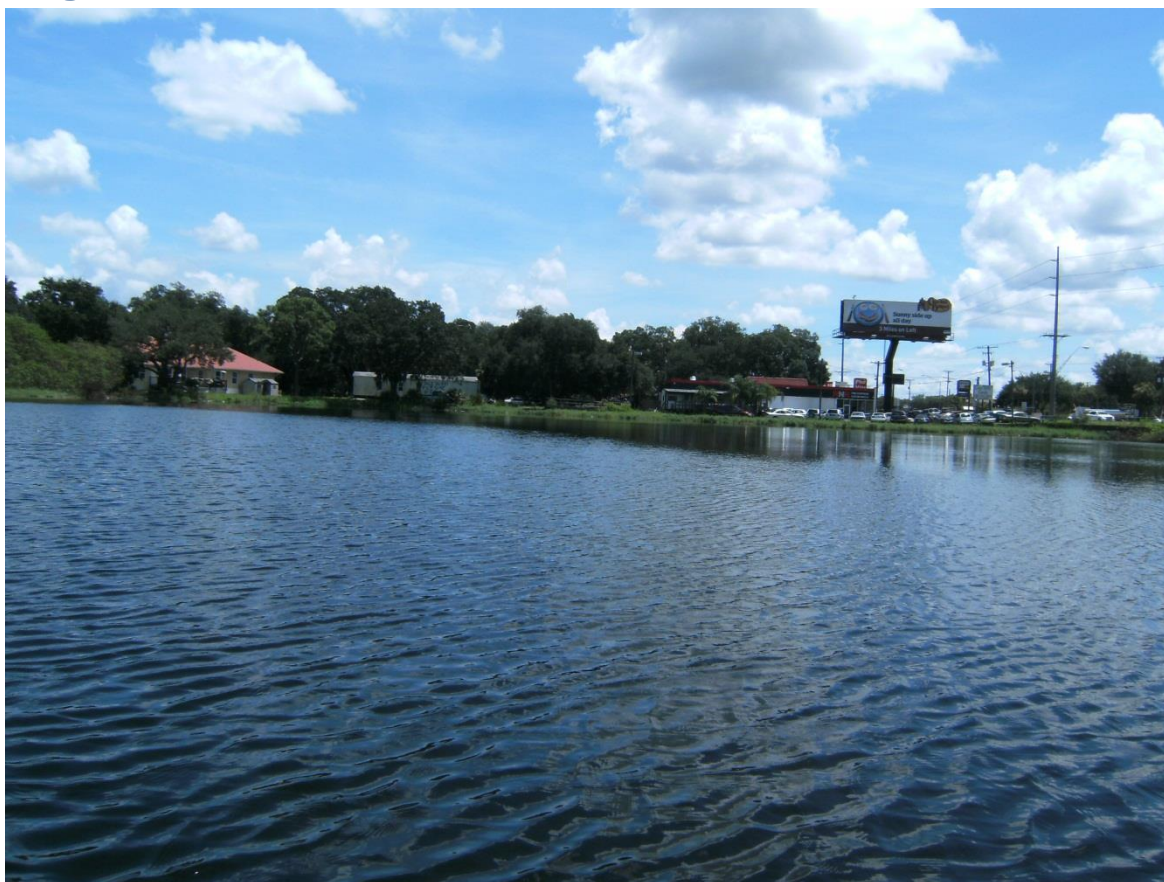
**Figure 3 Overview photograph of Sand Pond**

The lake assessment for Sand Pond was conducted on August 17, 2015. Sand Pond received a lake habitat assessment (FEDP form FD 9000-6) score of 30 due to marginal scores for Secchi and poor scores for Vegetation Quality, Stormwater Inputs, Adverse Watershed Land Use, Bottom Substrate Quality, Lakeside Adverse Human Alterations and Upland Buffer Zone.

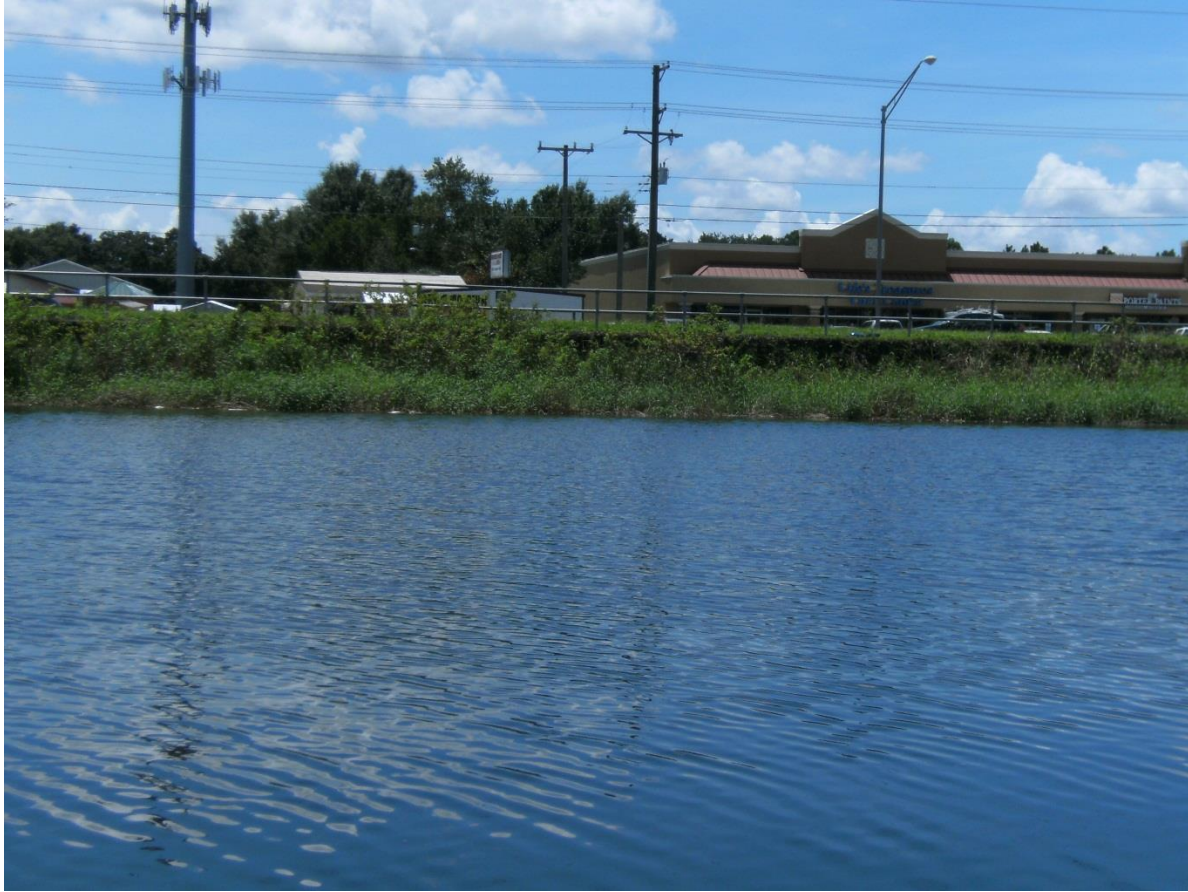
**Figure 4 Sand Pond had a buffering zone of emergent vegetation surrounding the lake dominated by invasive species.**

The Lake Vegetation Index identified 8 species of wetland vegetation growing in the four selected sections along Sand Pond. The minority of these species (3) are native species. The remaining 5 species (*Alternanthera philoxeroides*, *Schinus terebinthifolius*, *Pistia stratiotes*, *Urochloa mutica* and *Ludwigia peruviana*) are non-native and invasive to this region. The vegetation community along Sand Pond is dominated by a few emergent species including *Urochloa mutica* (Figure 5), *Ludwigia peruviana* and *Salix caroliniana*. The water's surface in Sand Pond was dominated by *Pistia stratiotes* (Figure 6). The calculated LVI score for Sand Pond was 0, below the impairment threshold of 37. Figure 7 shows the map of Sand Pond detailing the LVI regions used for the assessment. Table 2 details the species list results of the Lake Vegetation Index. Table 3 details the scoring result for the Lake Vegetation Index. Submerged vegetation was not observed during the assessment. By analyzing the collected sonar chart, submerged aquatic vegetation covered approximately 8% of the surface area of Sand Pond. This submerged vegetation inhabits an estimated 3.27% of the water volume in Sand Pond.
