Spartman Branch

Methods

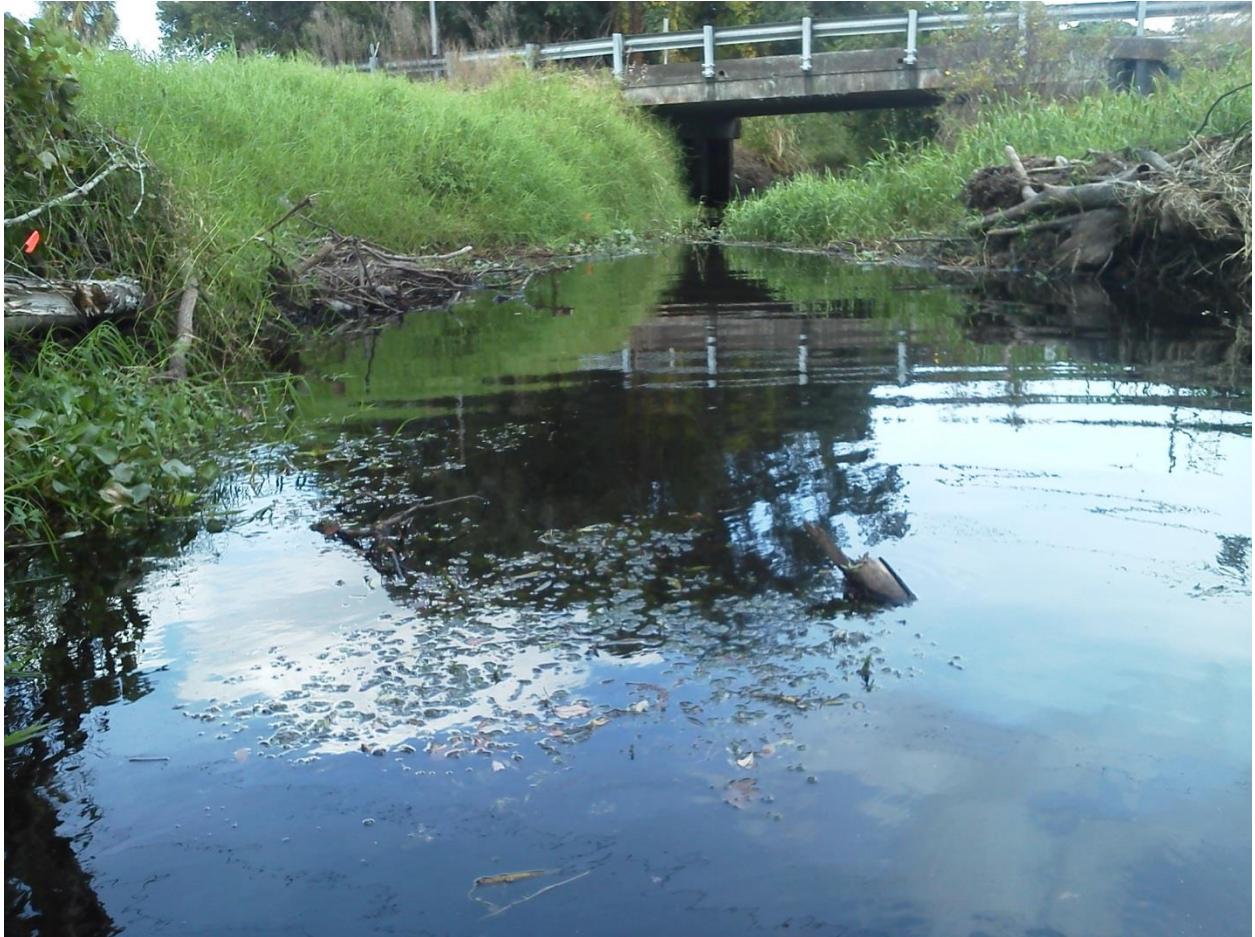
Figure 2 Overview photograph of Spartman Branch at Beauchamp

Spartman Branch at Beauchamp Road received a Habitat Assessment score of 83. The conditions contributing to this score are due to suboptimal substrate diversity, suboptimal availability and some artificial channelization. This stream was also dominated by non-native invasive species. Bankfull was optimal throughout the stream at >60% of bank height. Water velocity was marginal and measured at 40 m at an observed rate of 0.1 m/s. Habitat smothering was marginal due to an inadequate number of stable pools. Bank stability was suboptimal since the slope was somewhat steep in the left bank where the slope was >60 degrees and the right bank slope was >60 degrees at certain points. The riparian buffer zone was rated poor due to intensive human activities and a riparian buffer width of <6m. Riparian zone vegetation quality is marginal on both sides and <50% of this zone was undisturbed.

During the Rapid Periphyton Survey, periphyton was not observed. The average canopy cover in the 100 meter region was 33.63%. The Secchi Disk Depth was measured as 2.2' at the 50 meter mark. The average water depth at the time of the assessment was 3'.

The Linear Vegetation Survey identified 13 species rooted in the water at the time of the assessment. There were a total of 71 species observations in the 100 meter study area. Plant communities at the Beauchamp site was mostly invasive consisting of Alligator Weed (*Alternanthera philoxeroides*), Water Hyacinth (*Eichornia crassipes*), East Indian Hygrophila (*Hygrophila polysperma*) Peruvian Primrosewillow, (*Ludwigia peruviana*), and Parrot Feather (*Limnophila sessiliflora*). Of the plants present within each study site, no one plant was clearly dominant over other species present. The mean Coefficient of Conservatism (CoC) metric for the study area was 1.06 and the % FLEPPC metric for the study area was 63.38%.

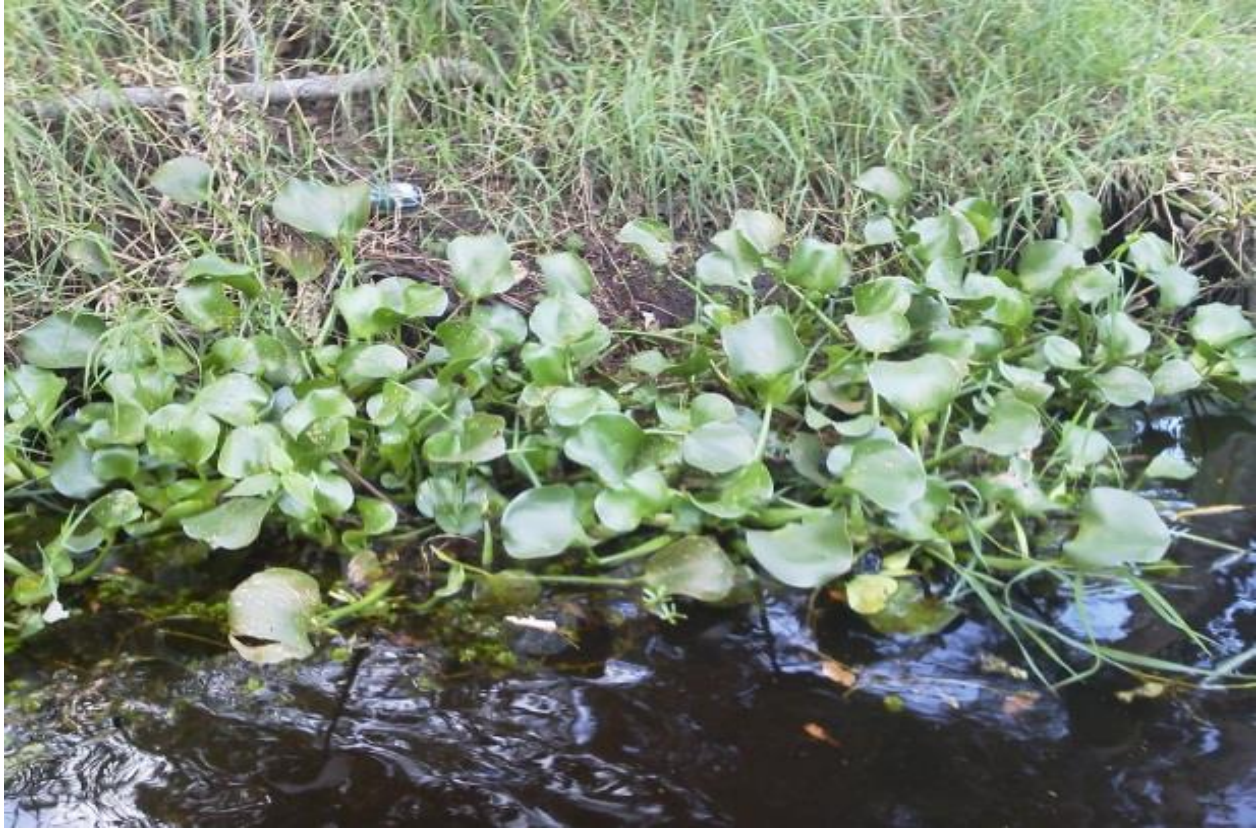
Figure 3 Presence of Water Hyacinth (*Eichornia crassipes*) at Spartman Branch at Beauchamp

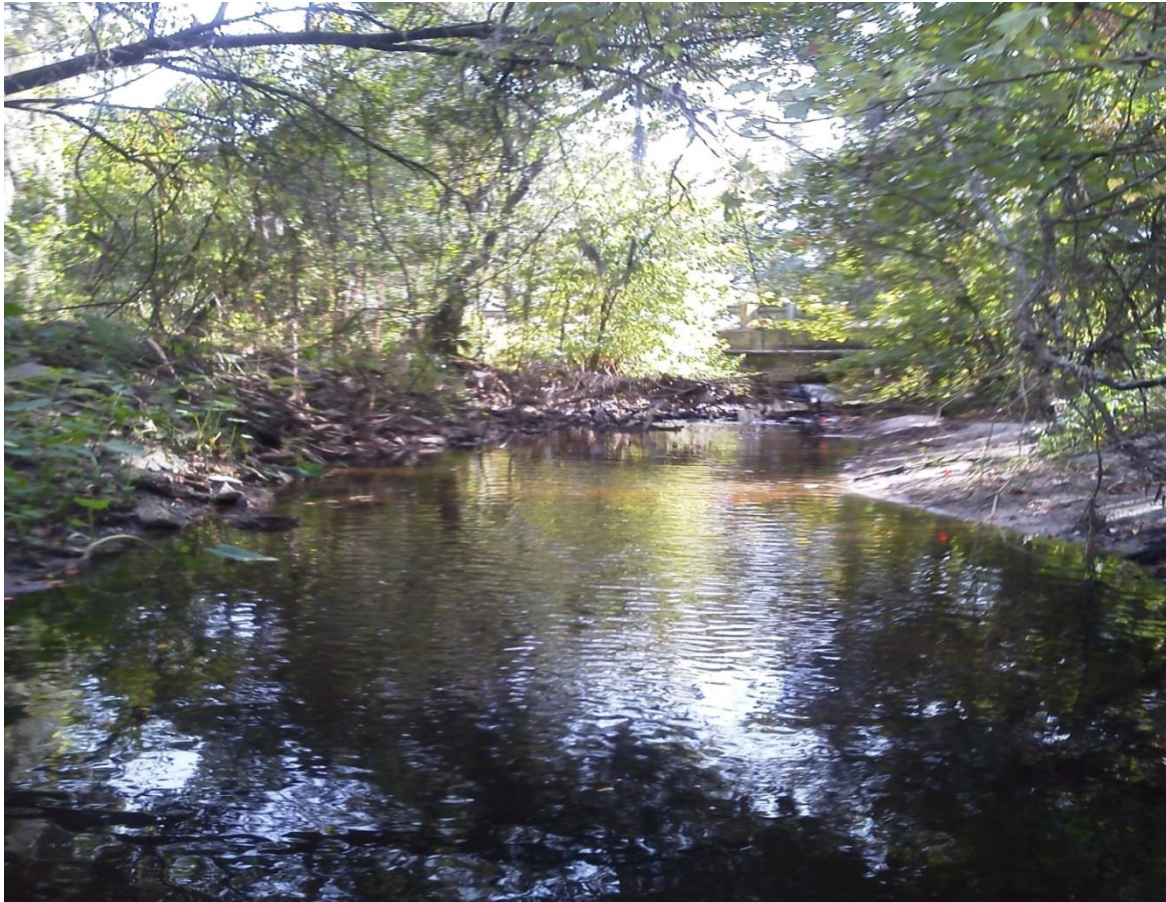
Figure 4 Overview photograph of Spartman Branch at 574

Spartman Branch at SR 574 received a Habitat Assessment score of 83. The conditions contributing to this score are due to a high level of habitat smothering. This stream contained no stable pools and was affected by sand accumulation. Artificial straightening was evident but the stream has recovered some sinuosity. Undercutting was observed and >50% of the banks observed contained root exposure (Figure 5). Substrate diversity was suboptimal as a result of the presence of three major productive habitats (snags, aquatic vegetation, and leaf packs). Substrate availability was optimal since >30% major productive habitat was present. Water velocity was measured at 65m and rated suboptimal at 0.13m/sec. This stream recovered some sinuosity but was rated suboptimal due to straightening. Bank stability on the left was suboptimal and bank undercutting was observed. The right bank was also suboptimal due to some erosion (Figure 5). The left bank had a riparian zone thickness of 15 m and the right had a zone thickness of 10 m. The riparian zone vegetation quality was suboptimal with 50% to 80% undisturbed.

During the Rapid Periphyton Survey, no periphyton was observed. The average canopy cover in the 100 meter region was 81.66%. The Secchi Disk Depth was measured at 1.75' at the 100 meter mark. The average water depth at the time of the assessment was 2'.

The Linear Vegetation Survey identified 8 species rooted in the water at the time of the assessment. Half of these species (4) are non-native, invasive species. The remaining 4 species are native to this region. Of the plants present within each study site, no one plant was clearly dominant over other species present. There were a total of 41 species observations in the 100 meter study area. The mean Coefficient of Conservatism (CoC) metric for the study area was 1.59 and the % FLEPPC metric for the study area was 60.98%.

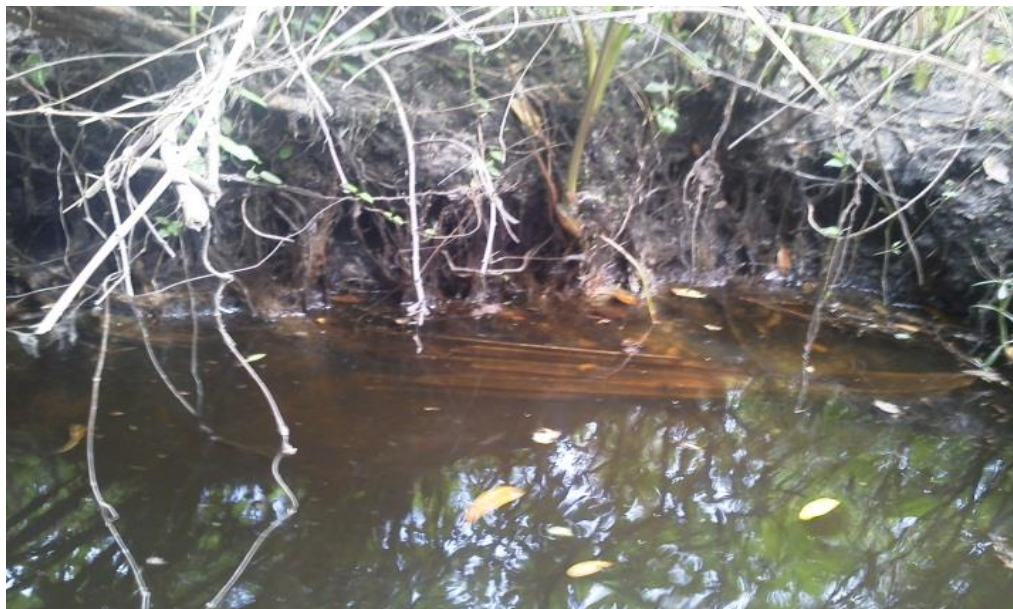
Figure 5 Example of root exposure/bank undercutting at the Hwy 574 site
