Starvation Lake

LAKE HABITAT ASSESSMENT, LAKE VEGETATION INDEX, SUBMERGED
VEGETATION SURVEY AND WATER QUALITY

David Eilers, Karina Gonthier | USF Water Institute | August 9, 2023

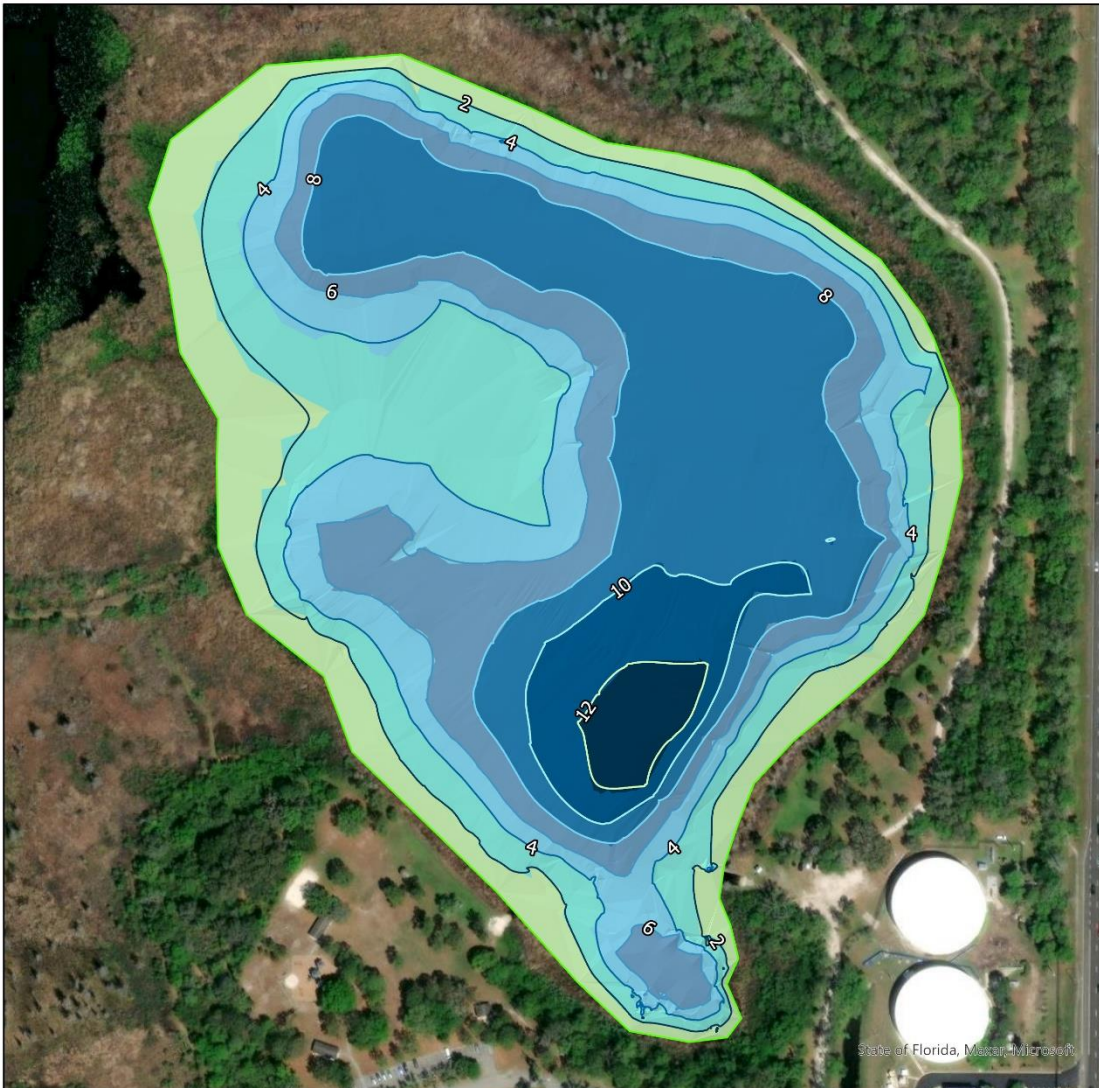
Figure 2: 2023 2-Foot Bathymetric Contour Map for Starvation Lake

At the time of the assessment, Starvation Lake was experiencing normal water levels (49.38 feet NAVD88 on staff gauge) resulting in a 35.4 acre water body. Starvation Lake at the time of the assessment had a mean water depth of 5.8 feet and a maximum observed depth of 12.95 feet. The volume at this time was approximately 66,511,964 gallons. Figure 2 shows the resulting bathymetric contour map for Starvation Lake from data collected on August 9, 2023. The collected data has been overlain the 2022 ESRI Basemap aeriols.

EXPLANATION:
 Survey Date: August 9, 2023
 Water level was 49.38 ft NAVD88 at the time of the assessment.
 Contours are expressed in absolute depth below this level.

LAKE MORPHOLOGY:
 Perimeter 4,989 ft;
 Area 35.4 Acres;
 (1,540,282 Sqft)
 Mean Depth 5.8 ft;
 Volume 204.1 Acre-ft,
 (66,511,964 gallons);
 Deepest point 12.95 ft

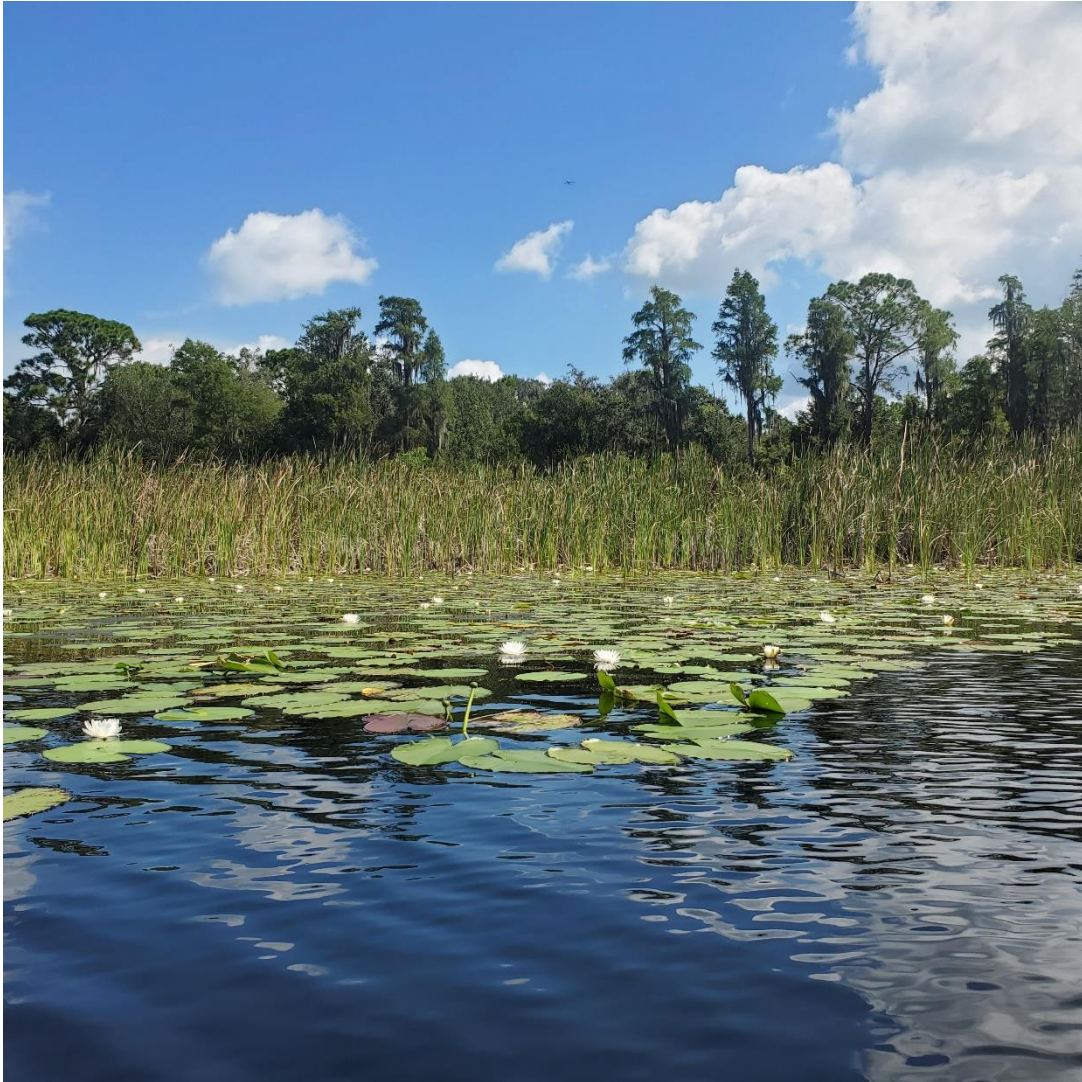
Figure 3 Overview photograph of Starvation Lake showing the undeveloped portion of shoreline along region 11 of the Lake Vegetation Index.

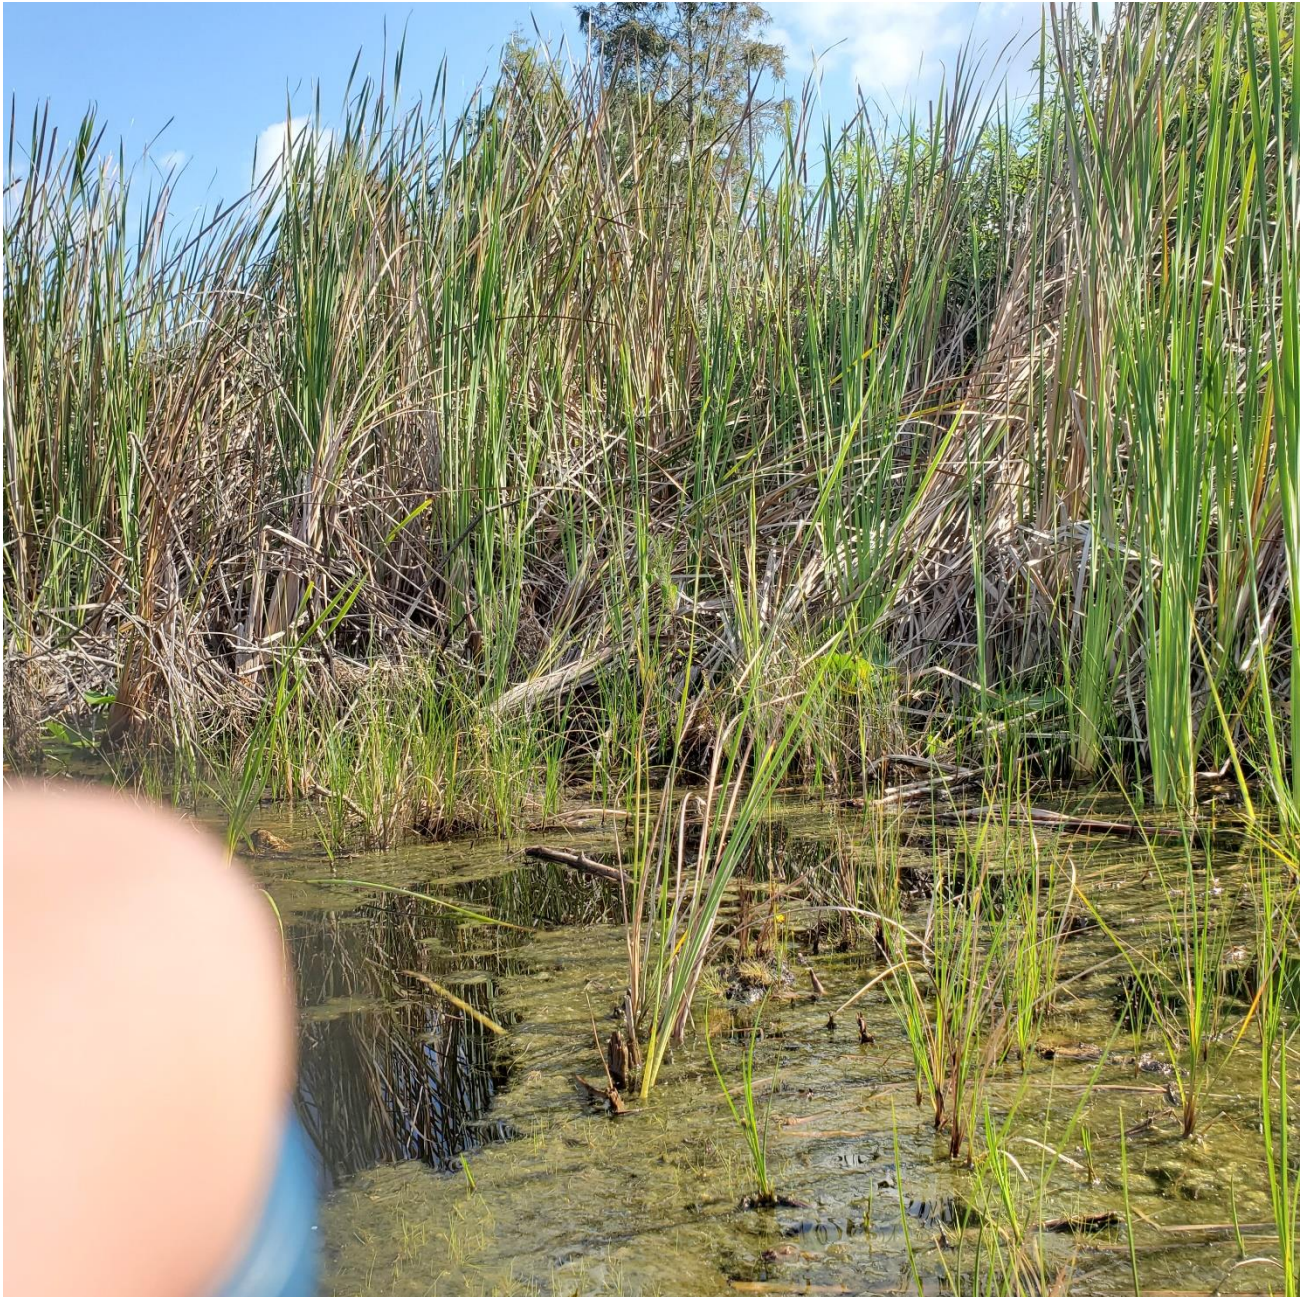
Figure 4 Typha was abundant along the shorelines of Starvation Lake

The Lake Vegetation Index identified 29 species of wetland vegetation growing in the four selected sections along Starvation Lake. All of these species (29) are native species. The vegetation community along the shorelines of Starvation Lake has been protected from the common removal of the shrub and groundcover strata that is common in more residential land use lakes in the region. At the time of the assessment the water transparency was 2.13 m (7.0 ft). High annual average secchi disk depths allow for an extensive littoral zone with establishment of floating leaved and submerged aquatic vegetation. Four species of submerged aquatic vegetation were observed during the lake vegetation index. *Eleocharis baldwinii* and *Najas guadalupensis* were both co-dominant species in LVI regions. The floating leaved vegetation community had 3 species observed with both *Nuphar* and *Nymphaea odorata* being co-dominant in LVI regions.

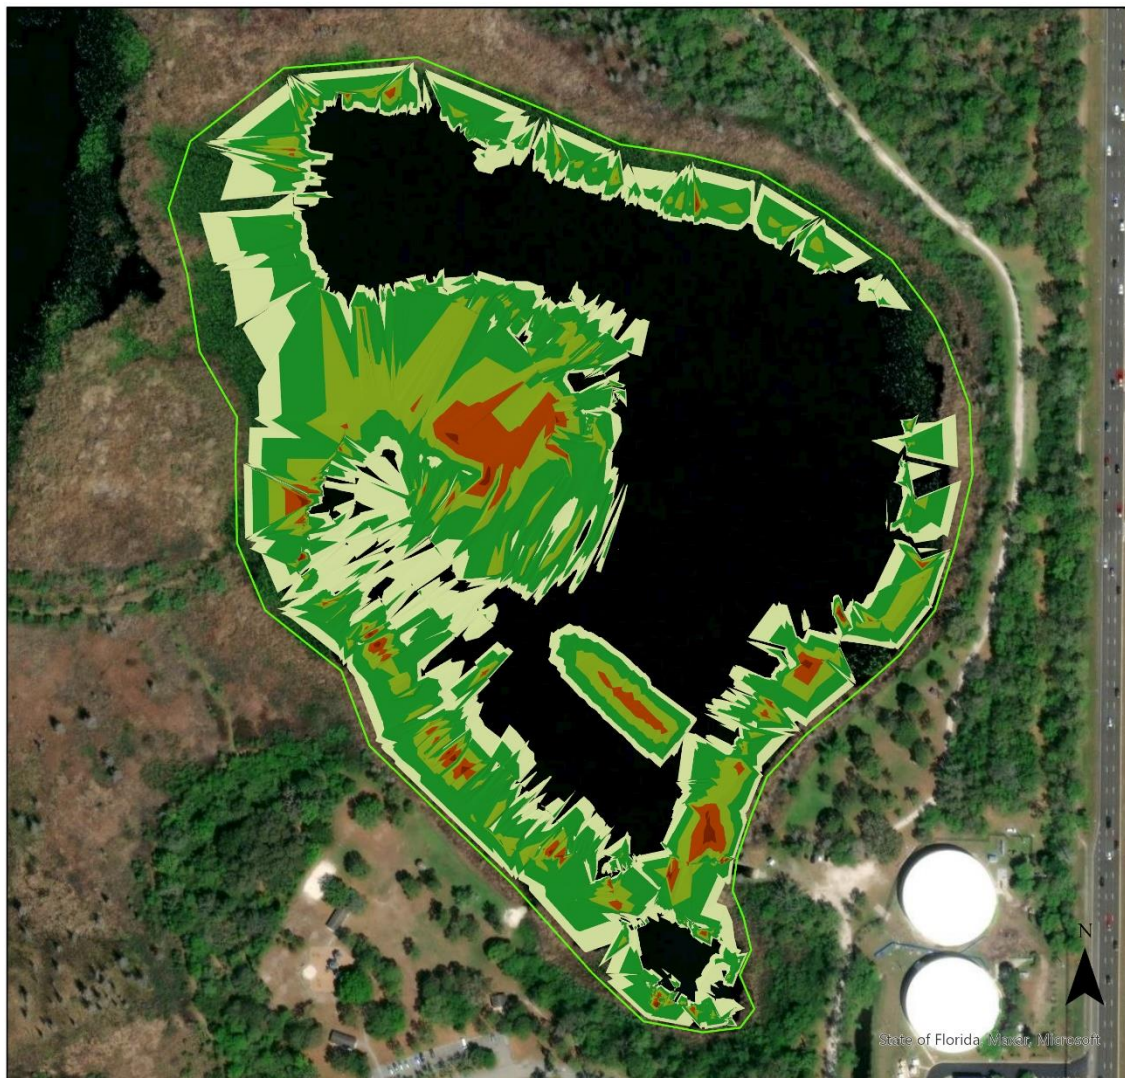
Figure 5 Starvation Lake Submerged Aquatic Vegetation Assessment Results

By analyzing the collected sonar chart, submerged aquatic vegetation potentially covered approximately 51.82% of the surface area of Starvation Lake. This submerged vegetation inhabits an estimated 4.38% of the water volume in Starvation Lake. Figure 5 shows the results of the SAV analysis indicating the location and height of SAV estimated from collected sonar readings.

EXPLANATION:
 Survey Date: August 9, 2023
 Water level was 49.38 ft at the time of the assessment. Submerged Aquatic Vegetation was analyzed from collected sonar data. The height of the SAV where present is shown in 0.5 foot increments.

SAV STATISTICS:
 Area 798,204 square ft; 18.3 Acres; (51.82% of Lake Surface Area)
 Mean SAV Height 0.5 ft;
 Volume 389,794 Cubic ft, (2,915,884 gallons);
 (4.38% of Lakes Volume)

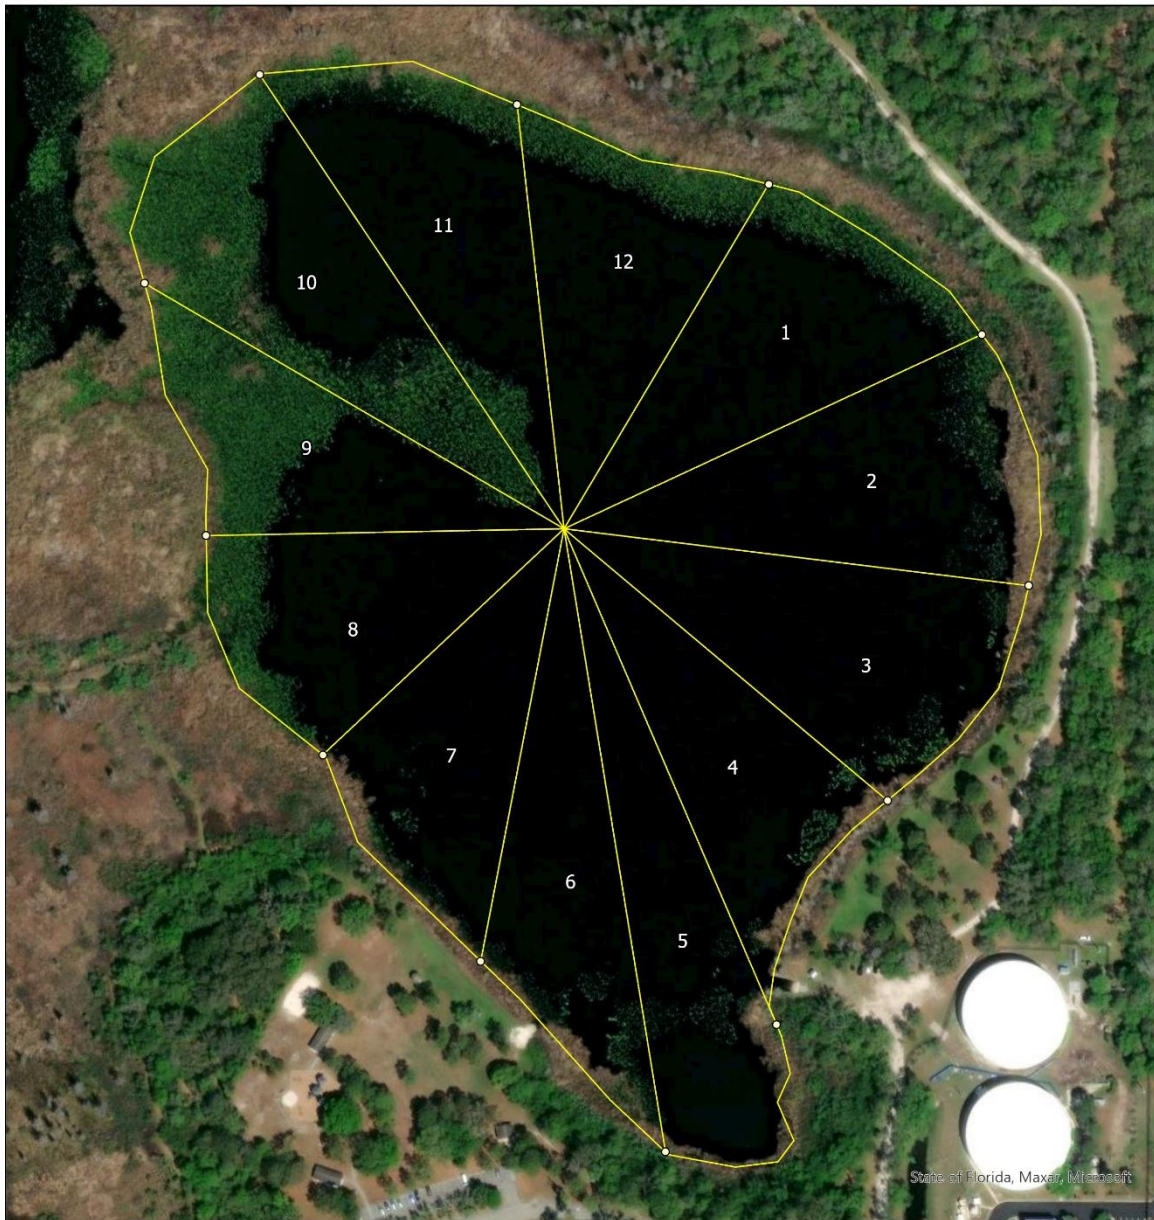
Figure 6: Lake Vegetation Index region map for Starvation Lake

Sample Date - August 9, 2023
 Regions Assessed - 2, 5, 8, 11
 Dominant Species per Region -
 2 - Eleocharis baldwinii,
 Nymphaea odorata
 5 - Najas guadalupensis, Typha
 8 - Najas guadalupensis,
 Nymphaea odorata
 11 - Eleocharis baldwinii,
 Nymphaea odorata

Lake Description
 Water Clarity - 2.1m (7.0ft)
 Color - Slightly Turbid, Clear
 Sediment Types - Sandy/Silt,
 Vegetated, CPOM
 Lake Vegetation Index - 76

The calculated LVI score for Starvation Lake was 76, well above the impairment threshold of 43 indicating the vegetation community is showing evidence of being “Healthy”. Though Starvation Lake scored high overall in the LVI, the total taxa found in each section was low with only 12 taxa identified in region 8. The region with the highest number of taxa was region 5 with 23 species. Figure 6 shows the map of Starvation Lake detailing the LVI regions used for the assessment (Regions 2, 5, 8, 11). Table 2 details the species list results of the Lake Vegetation Index. Table 3 details the scoring result for the Lake Vegetation Index.
