# Sugarhouse Creek Stream Assessment

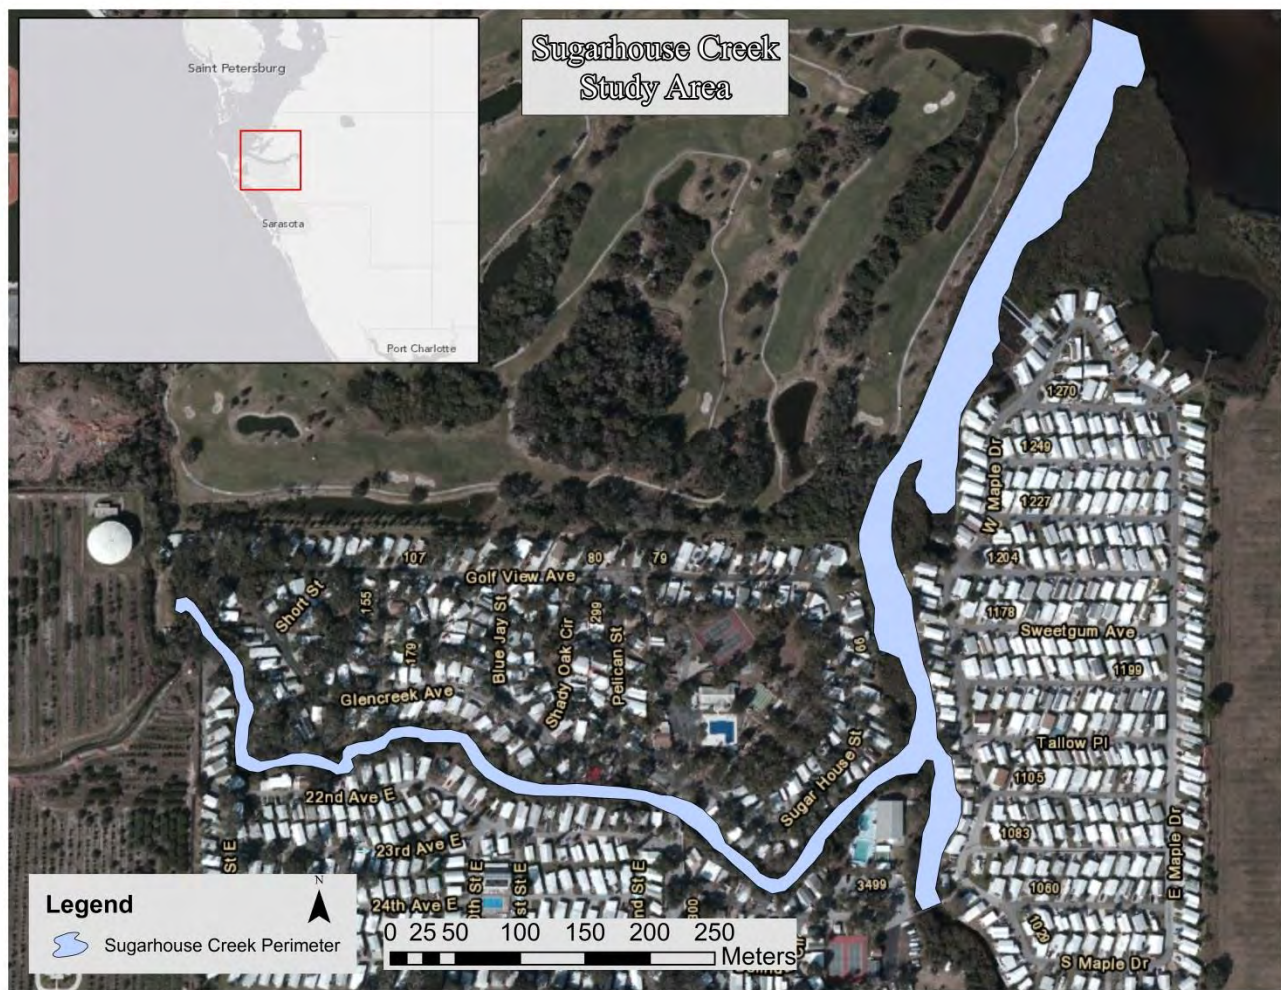
Figure 36. Overview of the Sugarhouse Creek Study Area

Sugarhouse Creek is located in Manatee County converges from two creek branches with different landscapes before converging and flowing into the estuary. The western branch of Sugarhouse Creek has steep banks and is highly ditched and runs through agricultural lands and a high density residential area. The southern branch of Sugarhouse Creek has a natural upland forest buffer which has banks that naturally sloped and receives water from a upstream medium density residential area. The downstream portion of Sugarhouse Creek is impacted on either side by a high density mobile home park and a golf course to the north where it flows into the Braden River. The Braden River is a natural area with marsh and mangrove habitats and a medium to low saline water. The Braden River eventually flows into Lower Tampa Bay through the Manatee River. This creek is impacted by both agriculture and a high density urban environment with a receiving water body that has natural habitat and a low salinity. The watershed and buffer area immediately surrounding Sugarhouse Creek are very similar and results in both having a LDI value of 6.0.

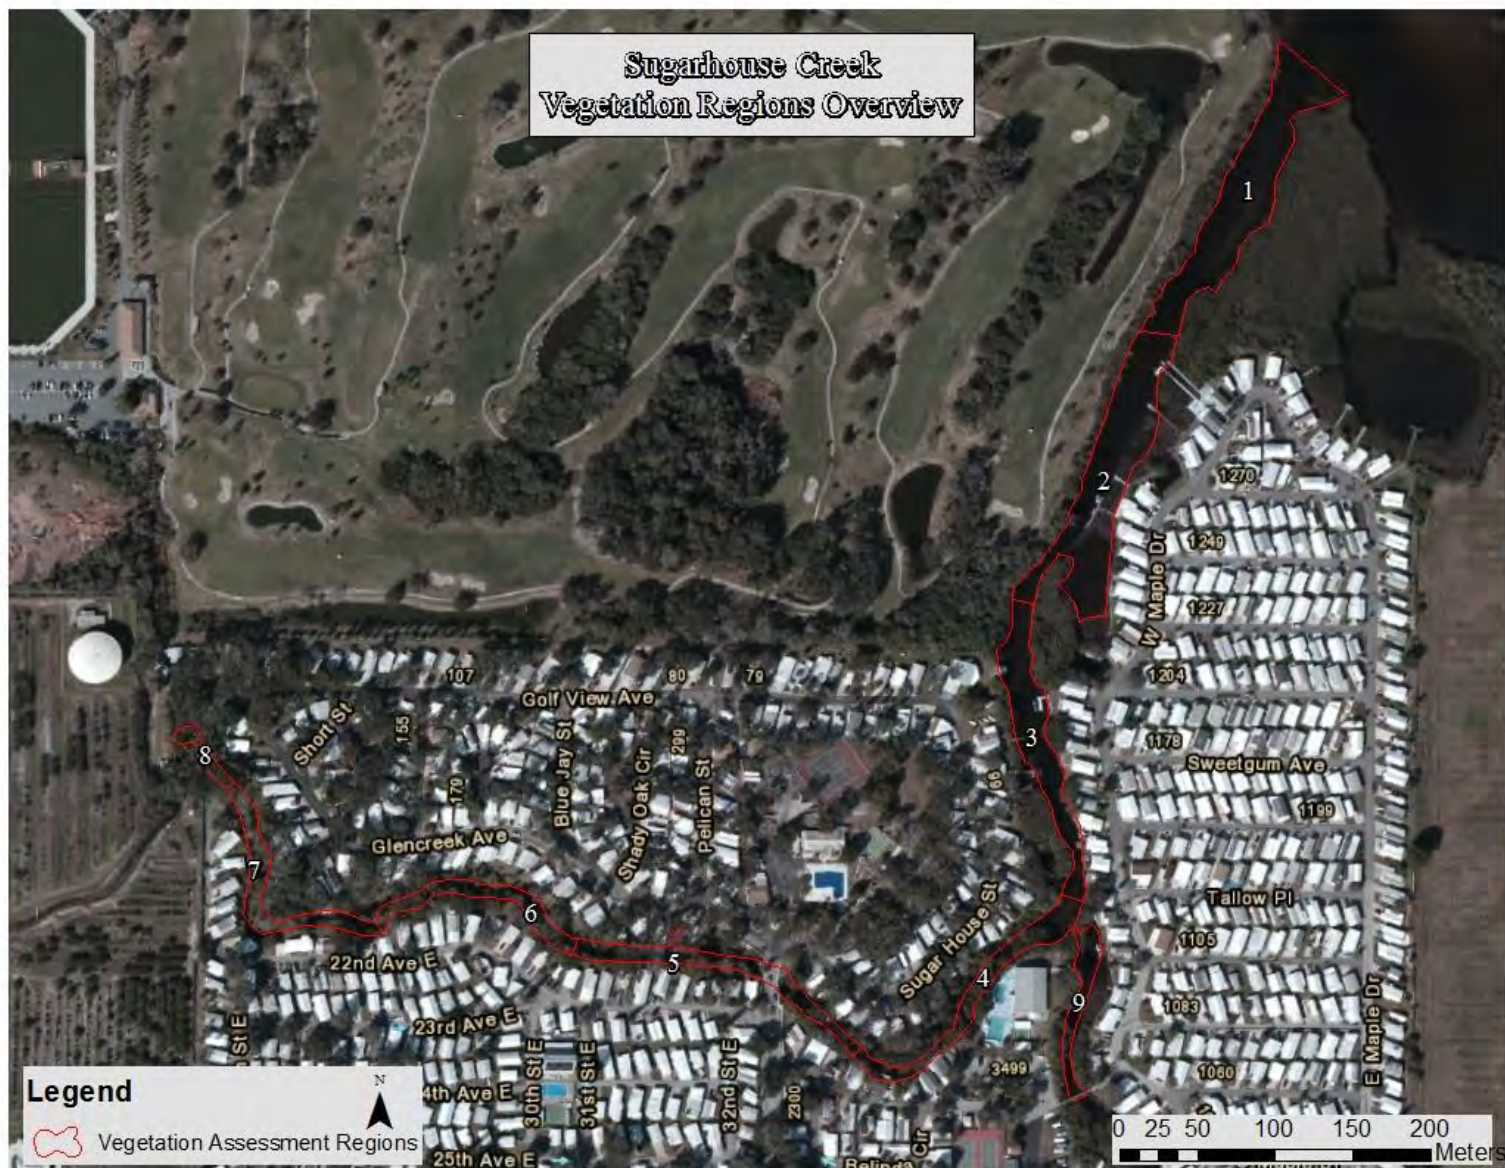
Figure 37. Overview of Sugarhouse Creek Vegetation Assessment Regions

The Sugarhouse Creek vegetation assessment encompassed 9 vegetation regions from the mouth in the Braden River to the footbridge on the south branch and the agricultural field on the west branch as shown in Figure 37. In these regions, 46 species of vegetation were identified. Regions 1 through 5 and Region 9 were dominated by mangroves (*Rhizophora mangle*, *Laguncularia racemosa* and *Avicennia germinans*) with few other salt tolerant species present. The most upstream mangrove was *Laguncularia racemosa* in Region 6. The first occurrence of Leather Fern (*Acrostichum danaeifolium*) was in Region 3, becoming dominant in regions 5 through 7. Needle Rush (*Juncus roemerianus*) was first observed in Region 2 with the last occurrence in regions 3 and 9. Above Region 6 the vegetation communities are populated by many species indicative of dominating freshwater influence.

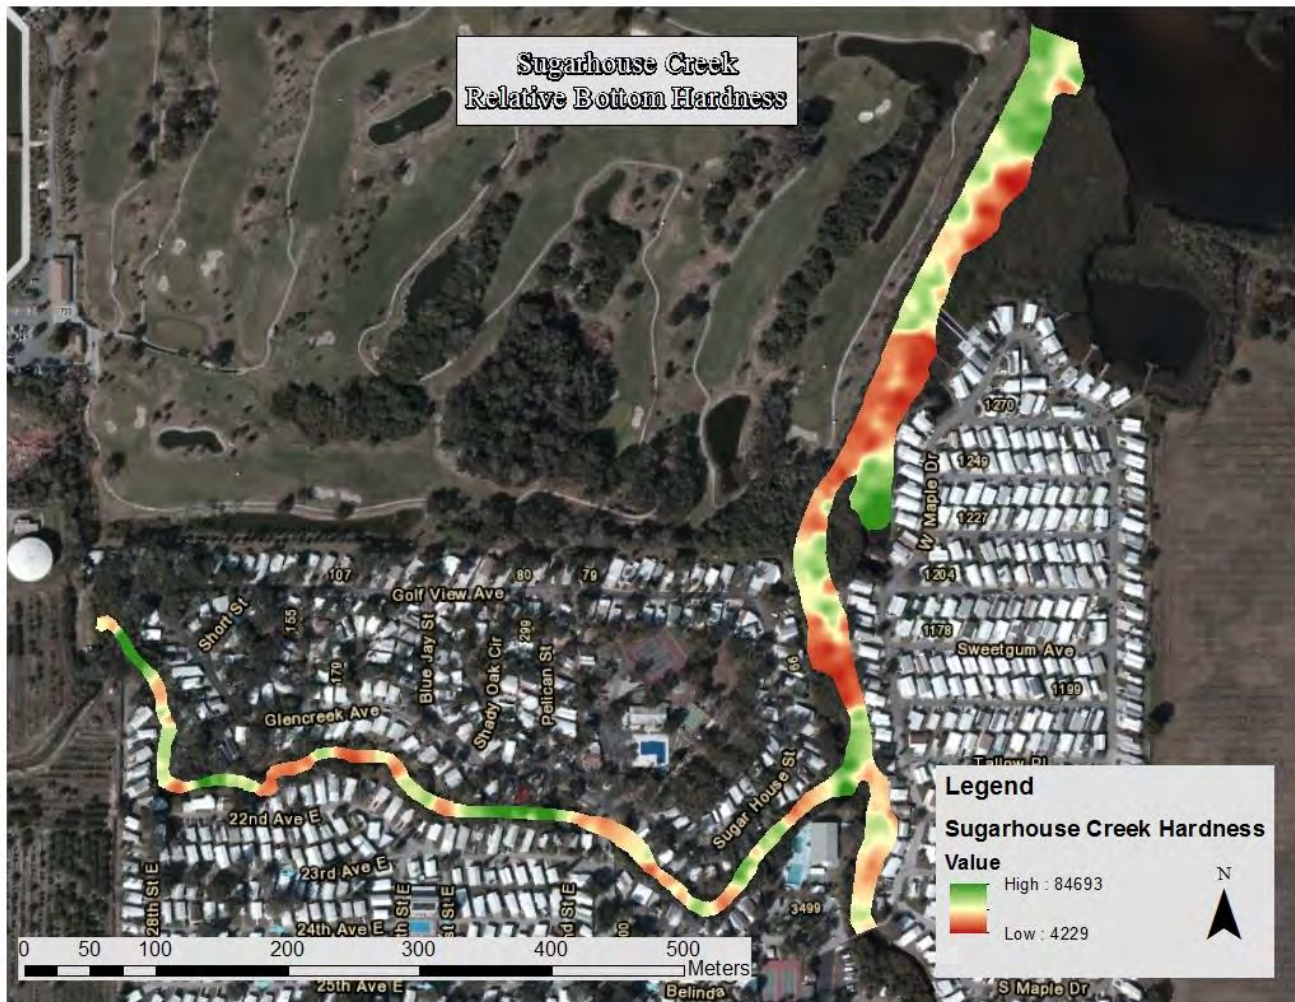
Figure 39. Sugarhouse Creek Relative Bottom Hardness Map

Collected sonar data was processed through Dr. Depth software to analyze the strength of the return signal from the bottom to get an estimate of the relative bottom hardness for Sugarhouse Creek. Figure 39 shows the bottom hardness raster for Sugarhouse Creek. This map is meant to help identify locations of harder and softer bottoms for benthic invertebrate sampling, fish sampling and benthic chlorophyll sampling.

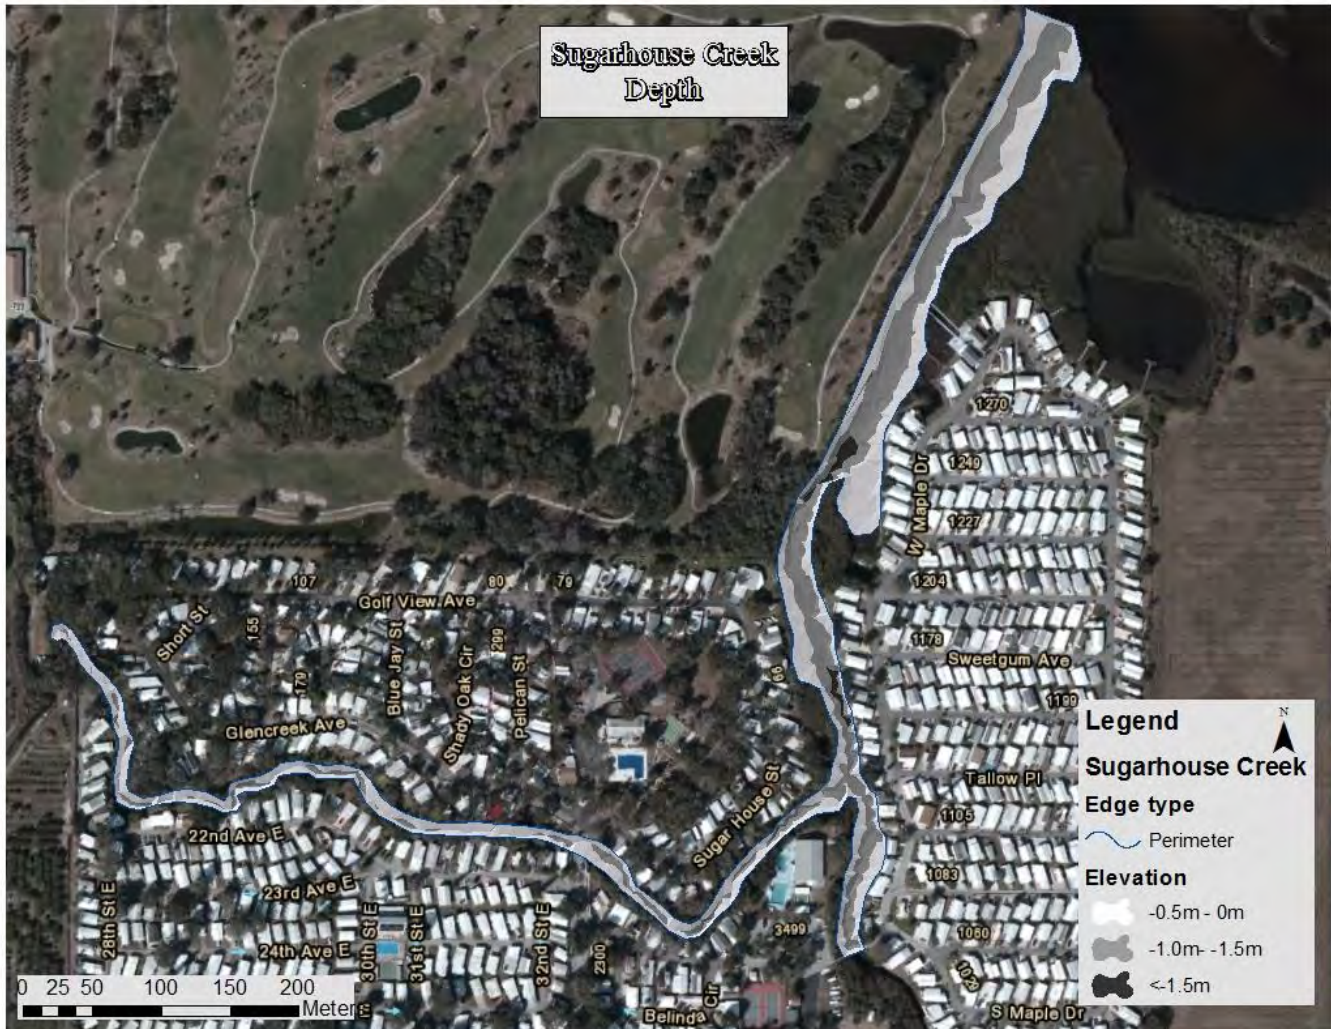
Figure 40. Sugarhouse Creek Bathymetric Stratum Map

In the study area, Sugarhouse Creek had a mean depth of 2.06 feet and a maximum depth of 4.71 feet. A total of 7.26 acres of creek was mapped during the assessment. At the time of assessment, Sugarhouse Creek contained an estimated 3,302,061 gallons of water in the study area. Figure 40 details the bathymetric mapping for Sugarhouse Creek showing the three depth stratum.
