# Sunshine Lake

LAKE HABITAT ASSESSMENT, LAKE VEGETATION INDEX, SUBMERGED  
VEGETATION SURVEY AND WATER QUALITY

David Eilers, Karina Gonthier | USF Water Institute | July 26, 2023

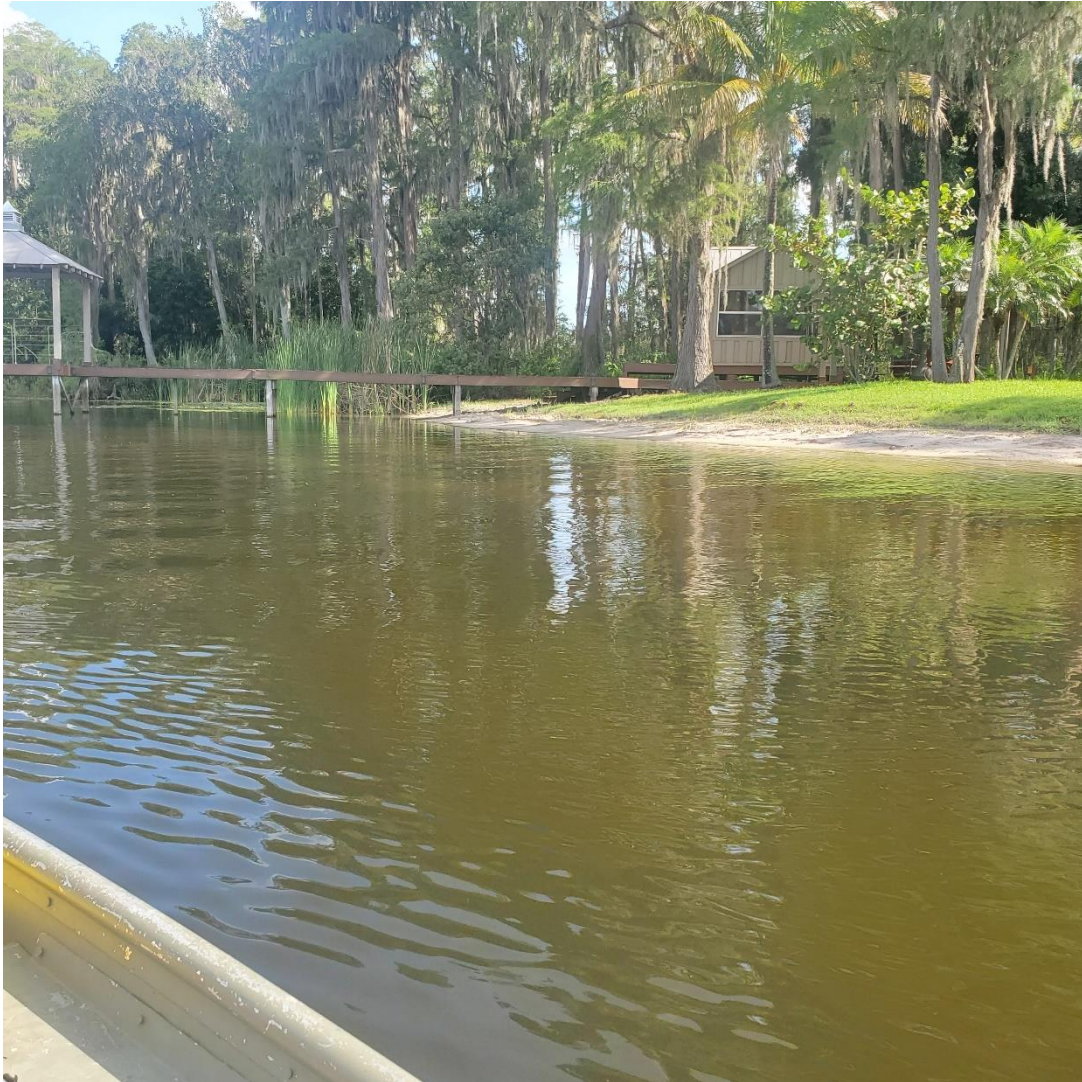
Figure 3 Overview photograph of Sunshine Lake showing the residential portion of shoreline along region 1 of the Lake Vegetation Index.

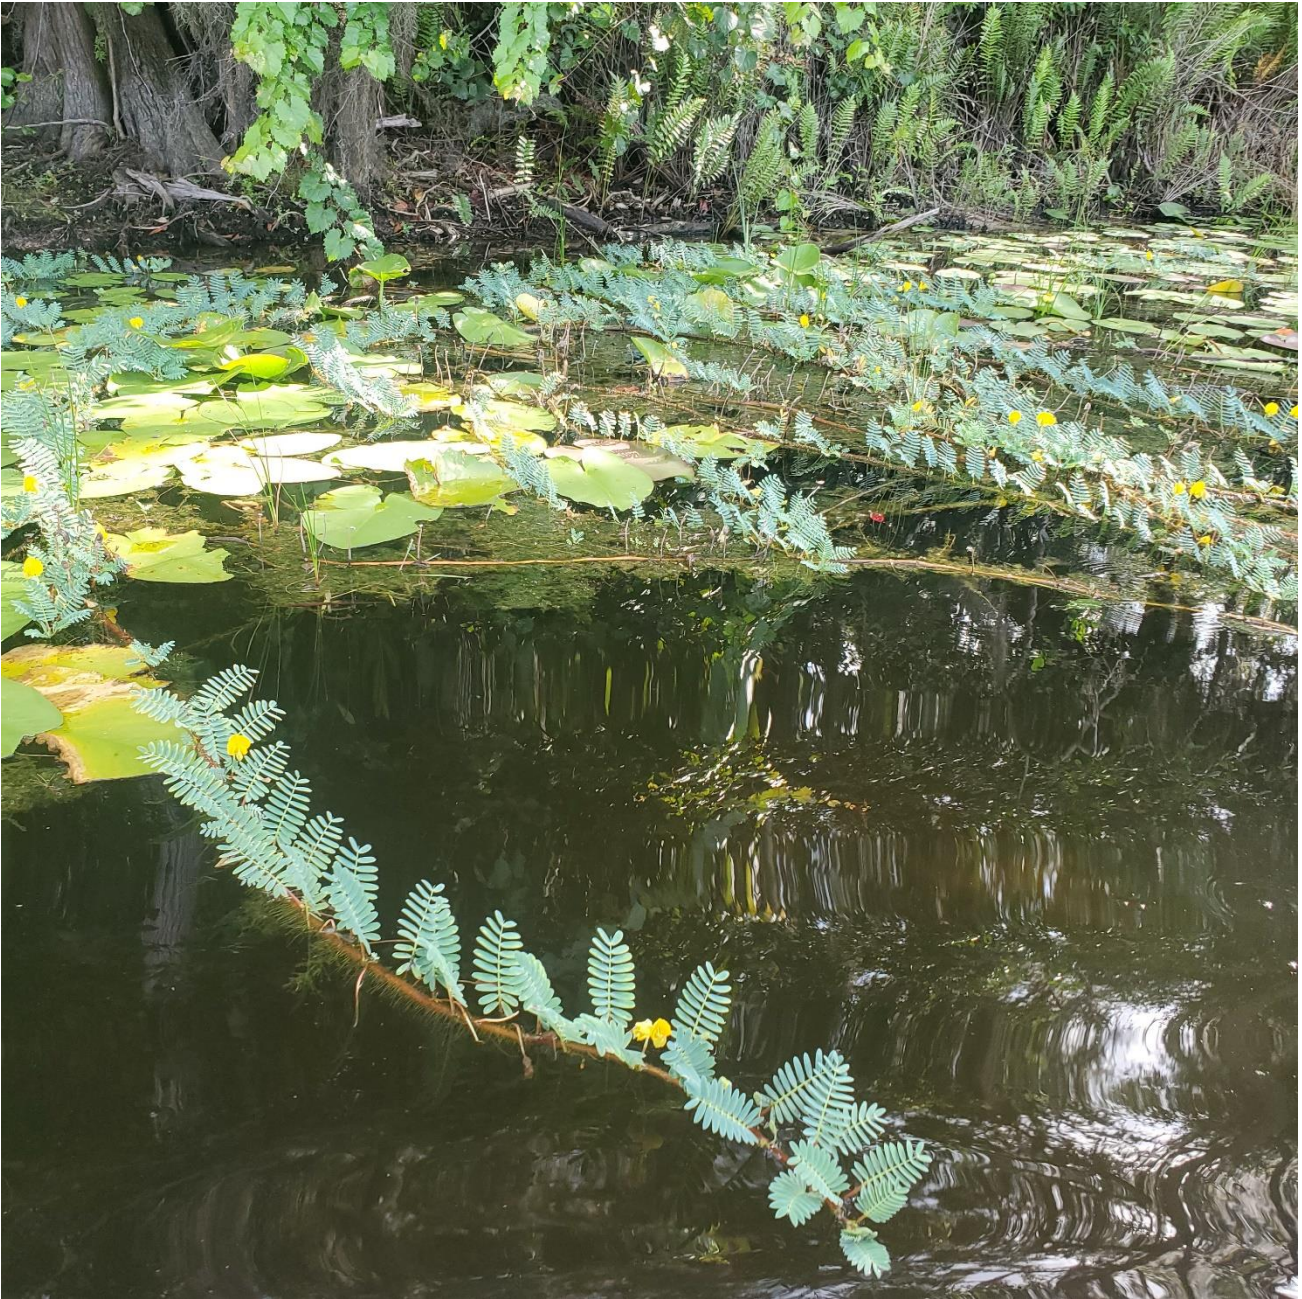
Figure 4 Sunshine Lake is one of two lakes in the state with verified presence of *Aeschynomene fluitans*, a non-native species.
