# **Alafia River Oyster Bar Restoration Demonstration Project**

## **Final Monitoring Report**

**September 1995 through December 1998**

**February 15, 1999**

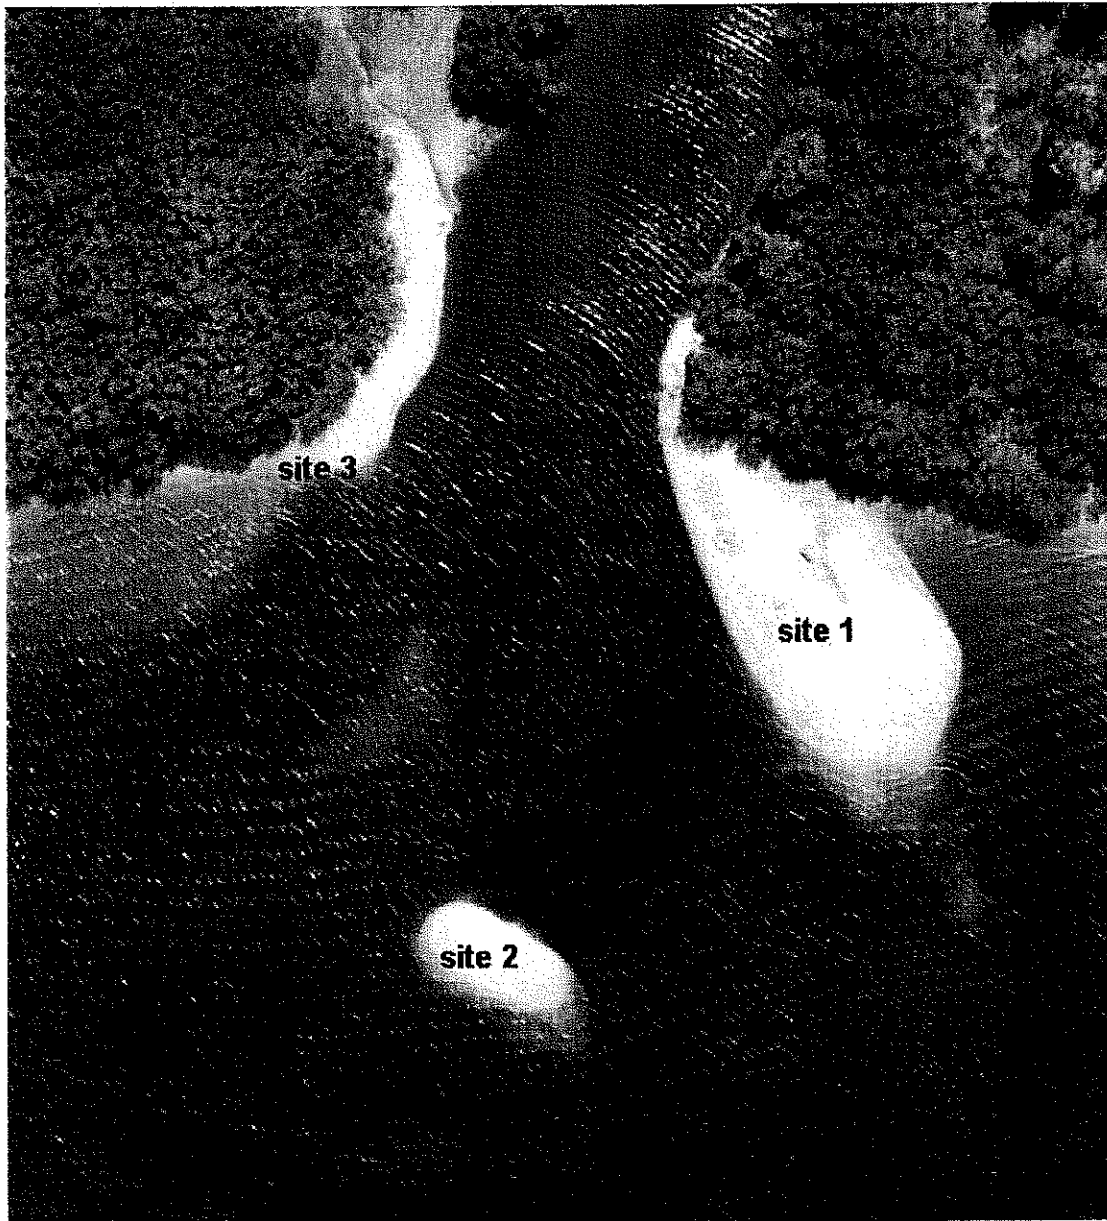
The following aerial photo was taken shortly after the oyster bars were constructed in 1995. The top of the photo is the south side of the river. The three lighter (white) colored areas are the bars. They were placed at the mouth of a newly created ditch, reconnecting the river to the large mangrove area to the south.

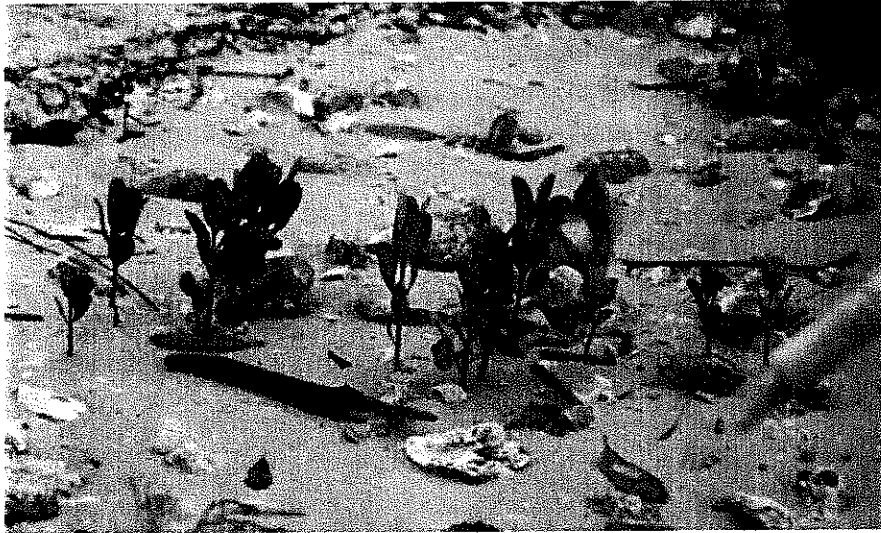
Jan. 27, 1999 new mangroves on the oyster bar

**Year Two** (Sept. 1996 - Sept. 1997): In year two, the most dramatic biological changes were attributed to the continued growth of the mangroves. A stable stand of Black and White mangroves began to dominate the south-central portion of the largest oyster bar. These trees, which obviously did not exist prior to the bars creation, were now ranging from two to four feet in height. Also continuing to grow were the occasional Marsh Elder and Sea Blite. This healthy vegetation seems to have played an important role, not only by providing additional habitat for birds and mammals using the bar, but also by stabilizing the substrate. A diverse community of wildlife continues to be recorded utilizing the oyster bars. The following is a list of those species observed during the reporting period:

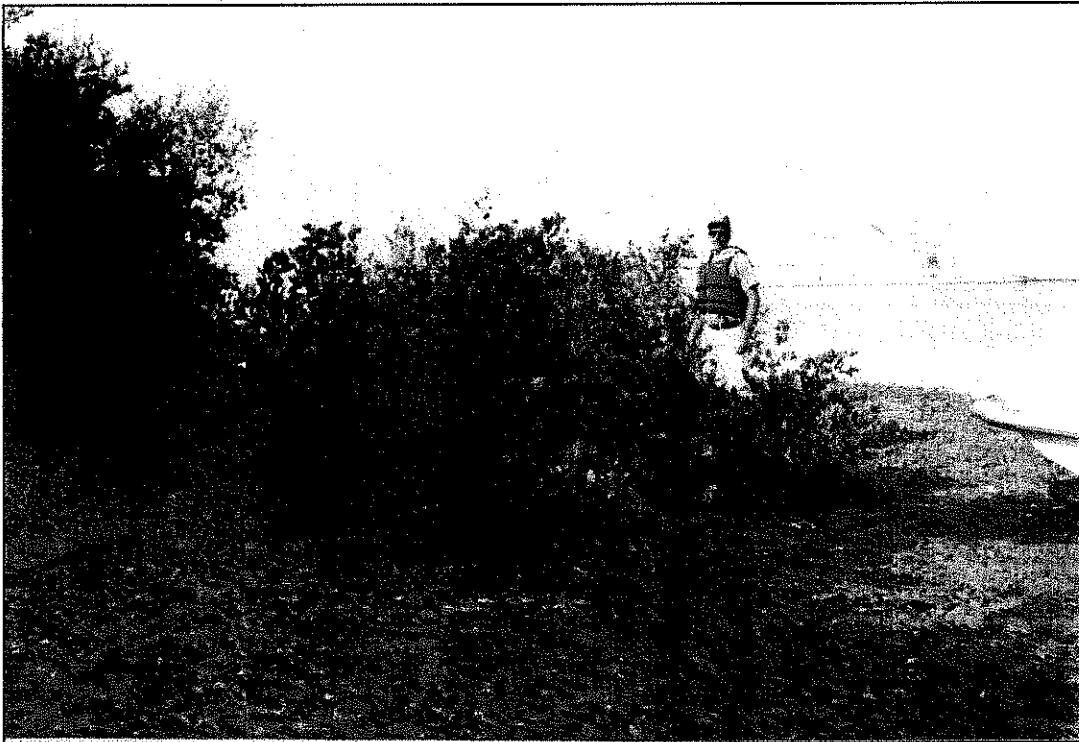
Jan. 27, 1999 view of oyster bar looking NW

**Year Three** (Sept. 1997 - Dec. 1998): After three years the bars have changed. Live oyster clusters are growing around the bars but at a relatively low density. Most of what you see is a sand bar laden with dead oyster shell above the tidal line, scattered but sparse live oyster clusters below the tide line and a healthy growth of mangroves invading the bar (some 3 to 6 feet high). It is expected that the clusters of shell will continue to grow and eventually completely cover the sandy areas. Bird and animal tracks are common. The project sign erected in 1995 has fallen down and is resting in the mangroves. It will be removed shortly. The following is a list of those species observed during the reporting period:

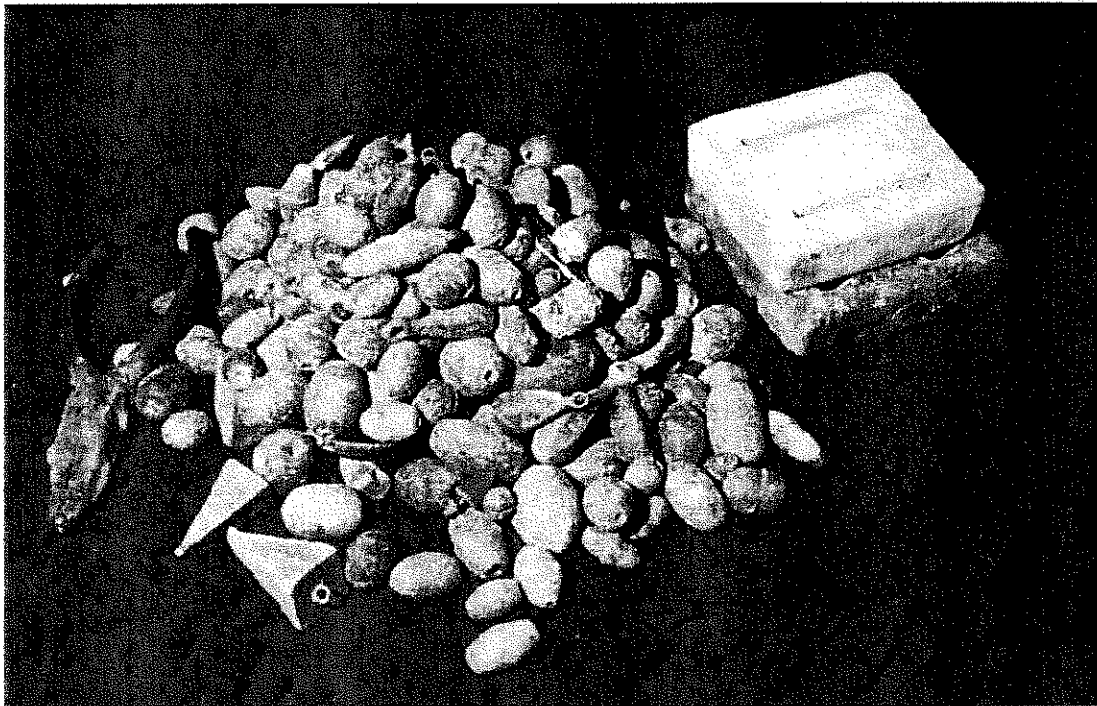
One unexpected finding, noticed on our initial field trip to the site, was the relatively large number of lead fishing weights scattered about the shell. The sinkers were picked up, cleaned, dried, and weighed. Two hundred and eleven (211) sinkers weighing 16.6 pounds were recovered, plus 2 scuba divers weights (4 pounds each) for a grand total of 24.6 pounds of lead! Fishing pliers, pocket knives, fishing lures, soft drink glass bottles and a few coins were also found. The sinkers will be recycled by EPC fisherman.

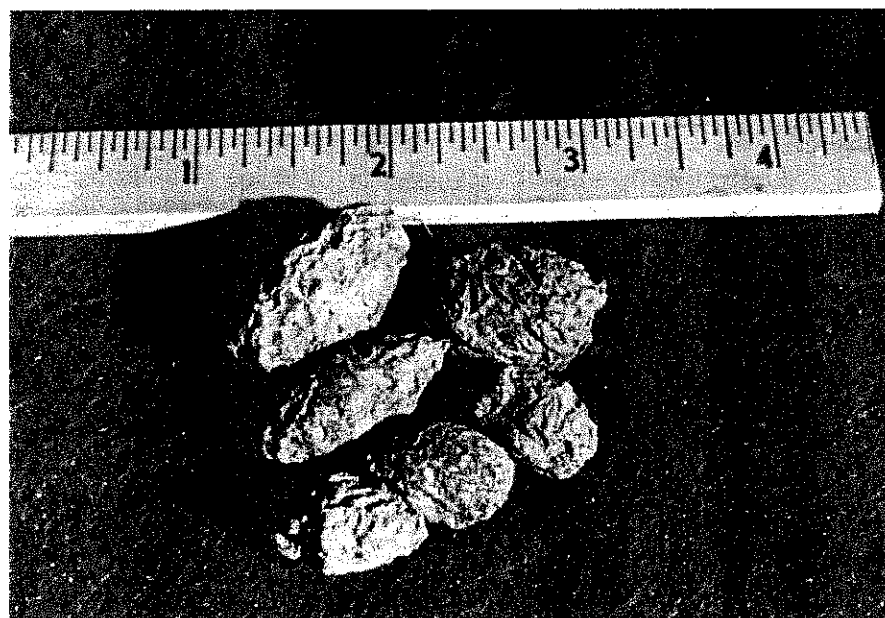
An unusual feature observed on most of the sinkers, were the claw marks apparently made by stone crabs. For some unknown reason the crabs apparently like to claw the sinkers. The oyster shell material came from a maintenance dredging project performed by Florida Dock and Dredge, Inc., just off of the dock at Weedon Island in the Riviera Bay area of Pinellas County. The fishing weights apparently came from this popular

Claw marks on lead fishing sinkers

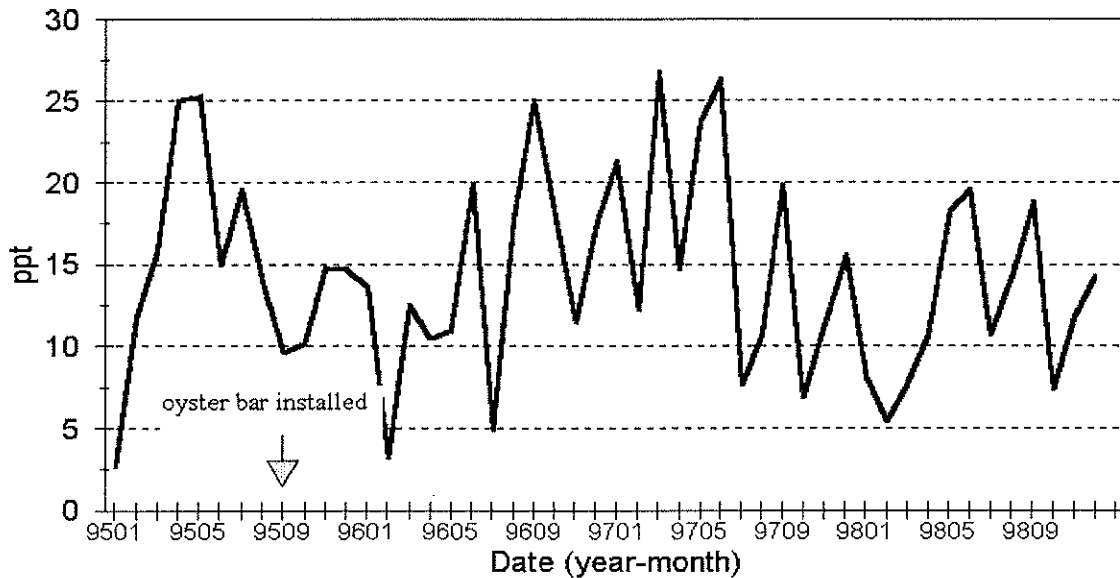
Average of sites 8 & 74

## Salinity at surface (Alafia River)

Salinity in the oyster bar area appears to have varied widely from a low of 1 ppt to a high of 29 ppt, based on a review of average surface salinities at sites 8 and 74 for the period January 1, 1995 through December 31, 1998. Salinity over the past three (3) years has probably been averaging about 16 ppt. This salinity regime appears to sustain this oyster bar. Farther upriver larger oyster bars appear to be thriving under similar salinity ranges. Water flow, food supply, disease and predation all play a role in oyster bar productivity.

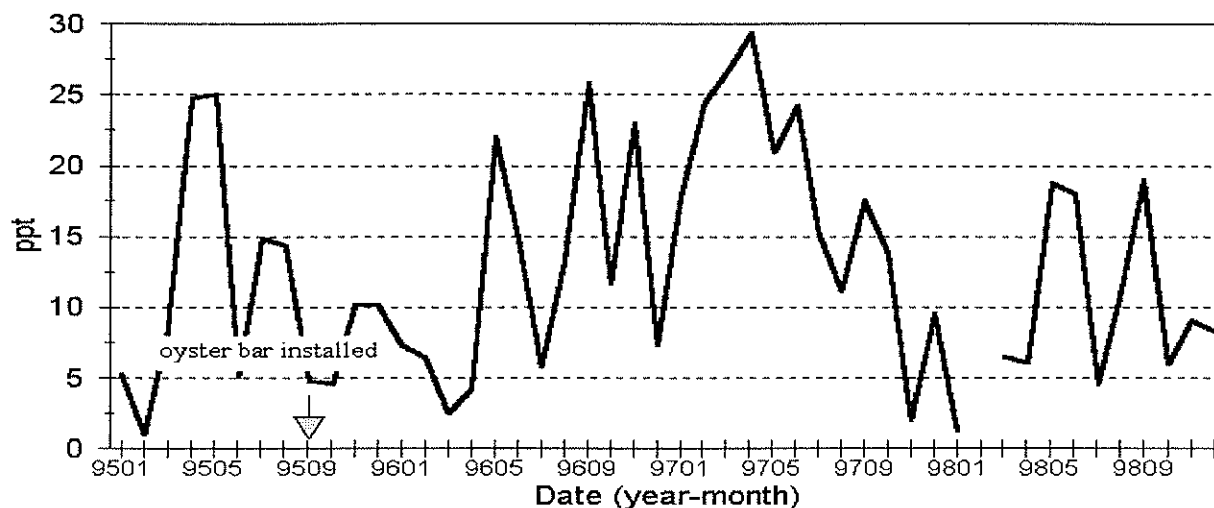
Site 74 (0.5 mile E. of Oyster Bar)

## Salinity at surface (Alafia River)

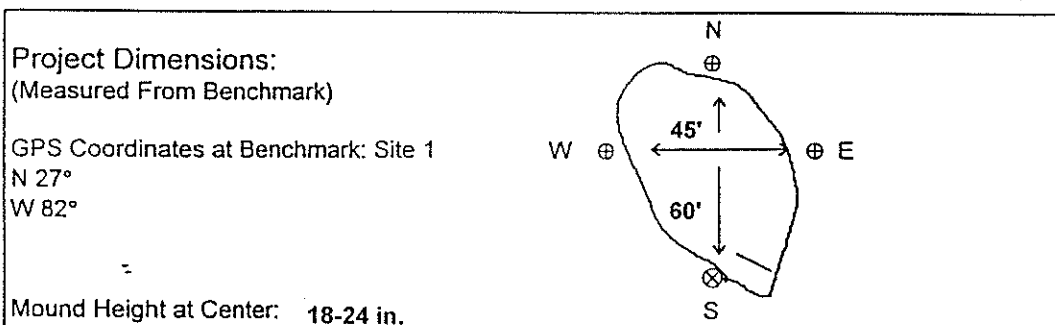
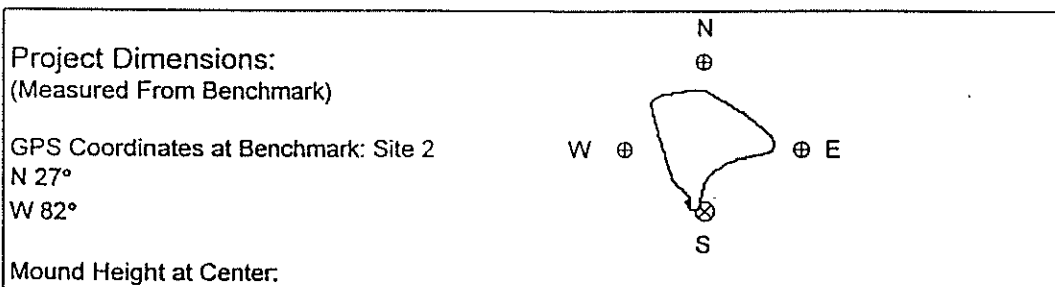
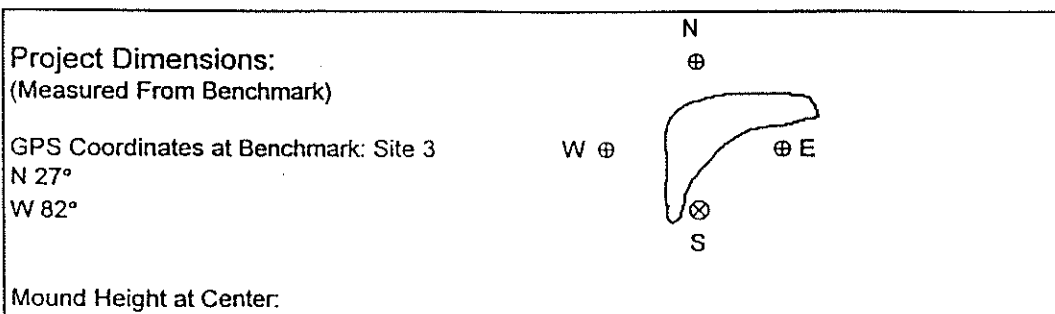
Date: 5/14/97	Time: 0936	Reef Project: Alafia Oyster Bars		
Bird Species Observed:	Weather: Sunny	Field Crew: Ash / Lockwood	Y	N
Scaup Duck	Air Temp: 26 C	Live Oysters Observed ?	X	
Brown Pelican	Water Temp: 24 C	Oyster Samples Collected?		X
	Wind: SW 5	Fish Observed ?	X	
	Tide Height: 1.5ft.	Juv. Mullet, Atlantic Needlefish		
	Ebb Flood X			
		Plant Growth Observed ?	X	
	Total Time Spent:	Mangroves, Beachcarpet, Iva.		
	2 Hrs.	Sea blite

General Observations/Notes: Melongena, Stone crabs, Horseshoe crabs, Hermit crabs  
Mangroves: Blacks 2-4ft. tall , Whites 2-3ft. tall,  
Found additional 1.1 lbs. of fishing leads

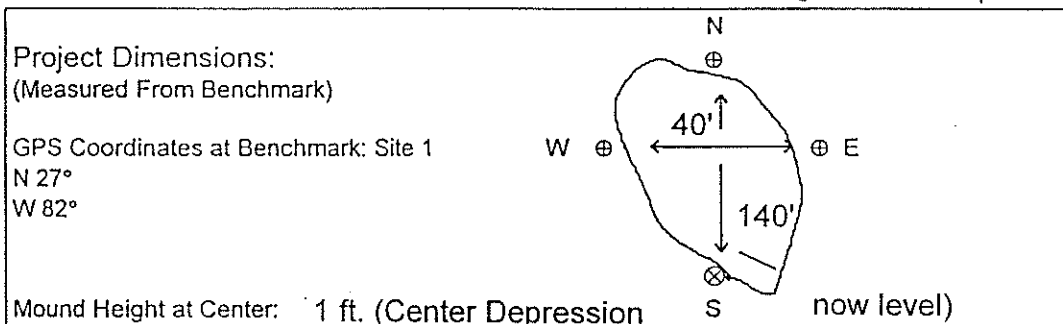
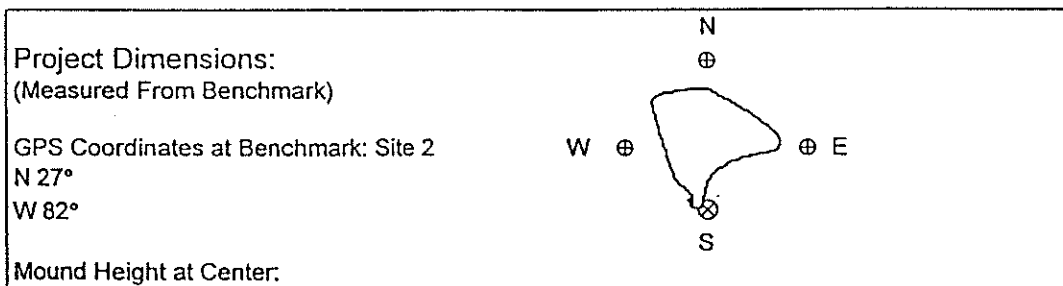
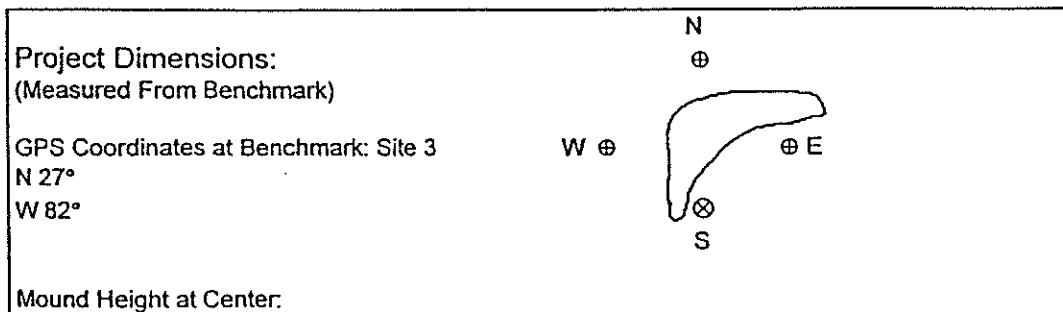
# EPC Oyster Projects Field Data Sheet

Date: 12/4/97	Time: 1355	Reef Project: Allafia Oyster Bars		
Bird Species Observed:	Weather: Clouds/Drizzle	Field Crew: Cardinale/Ash/Lockwood	Y	N
Green Heron	Air Temp: 24 C	Live Oysters Observed ?	X	
	Water Temp: 19 C	Oyster Samples Collected?		X
	Wind: WSW 5	Fish Observed ?	X	
	Tide Height: 1 ft.	Mullet		
	Ebb Flood X			
		Plant Growth Observed ?		
	Total Time Spent:	Black/Red/White Mangroves		
	3.5 Hrs.	Iva spp.

General Observations/Notes: Found 90 fishing leads (Total 5.35lbs.)  
 White Mangroves 1-2ft Tall (50%) 3-4ft Tall (50%) Oysters 1.5-2inches  
 Black Mangroves 1.5ft Tall Iva spp. 3ft Tall Melongena corona present
