# Trout Creek

STREAM HABITAT ASSESSMENT, STREAM CONDITIONS INDEX, LINEAR  
VEGETATION SURVEY, RAPID PERIPHYTON SURVEY AND WATER QUALITY

David Eilers, Karina Gonthier | USF Water Institute | March 23, 2023

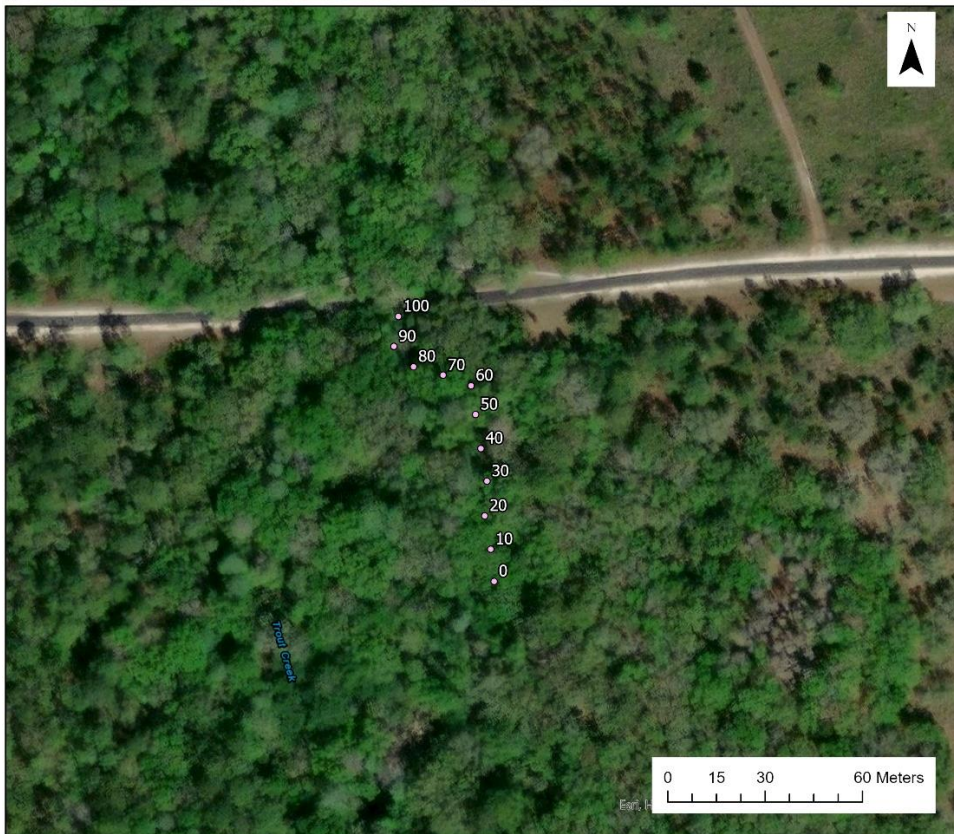
Figure 1 2023 Trout Creek Study Area Map

Trout Creek is located in north-central Hillsborough County in the Hillsborough River Watershed. Its headwaters are located north of Bruce B. Downs Blvd and Hunters Green Dr. in Tampa. The outfall of Trout Creek is in the Hillsborough River. The assessment of Trout Creek was conducted on March 23<sup>rd</sup>, 2023, and, at the time, the water levels were on the lower end for the dry season but not indicative of drought conditions. The Trout Creek WBID covers 12.32 miles and is dominated by forest/natural (99.6%) land cover. The resulting calculated landscape development intensity index (LDI) score was 1.03.

Mouth - Hillsborough River  
Area - 7,885 Acres (12.32 Sq Miles)  
Landscape Development  
Intensity - 1.03  
Stream Habitat Assessment - 104  
Rapid Peiphyton Survey -  
% ranked 4-6 - 7%  
Linear Vegetation Survey  
< 2 square meters of rooted  
vegetation  
Stream Condition Index - 66

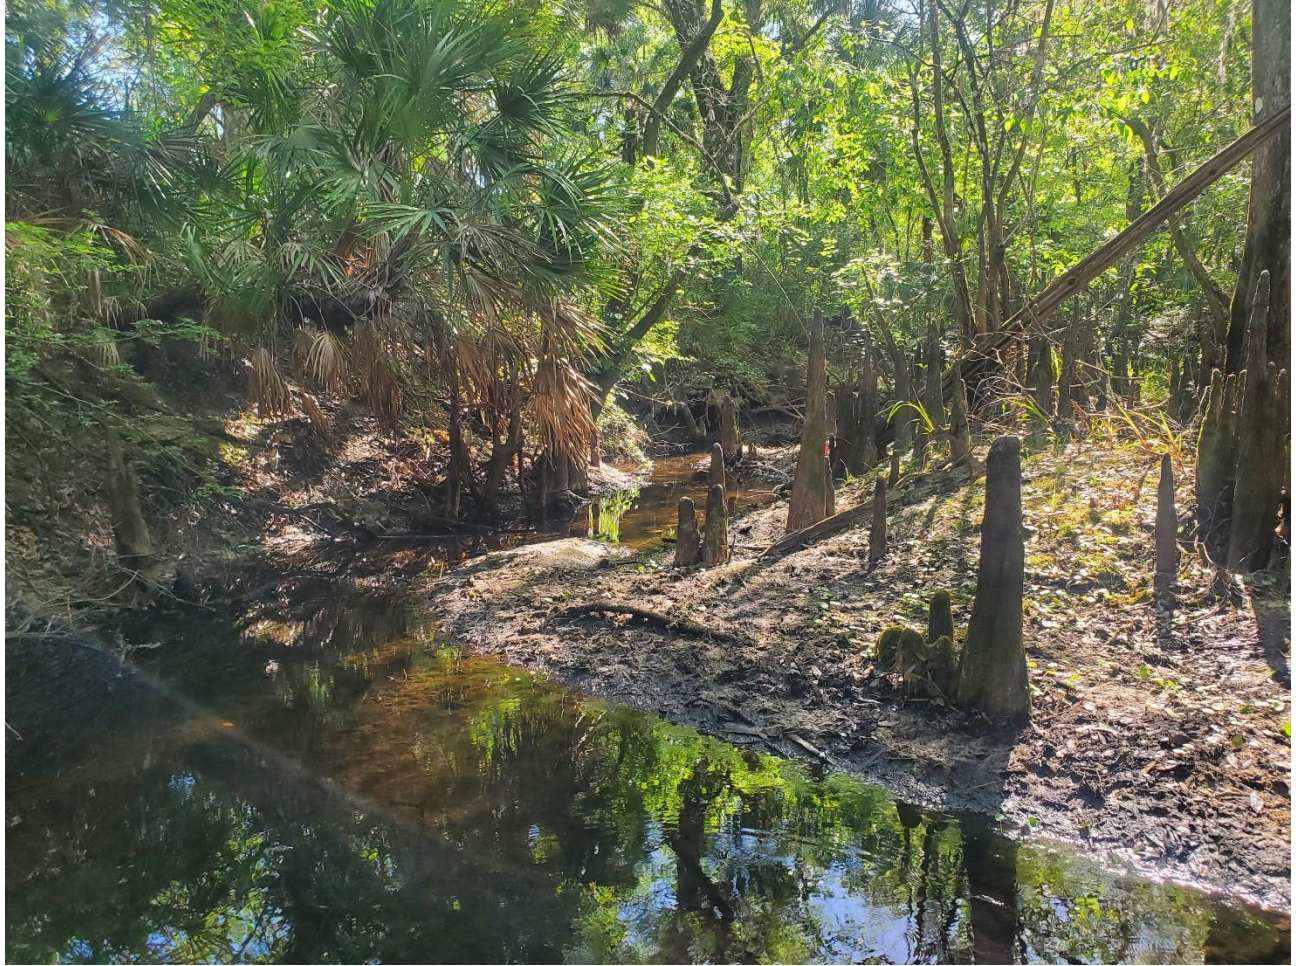
*Figure 2 Overview photograph of the Trout Creek Sample Site showing the natural sinuosity of the stream as well as the low water conditions and prevalent silt smothering.*

The primary habitat components of the FDEP Habitat Assessment focus on in-water habitat. The primary habitat components score in the suboptimal category for Habitat Smothering (adequate number of stable pools but much greater than 25% of the habitats were affected by sand/silt smothering). Substrate Diversity (presence of two major productive habitats (snags, leaf packs/mats)) and Water Velocity (0.06 m/s) were scored as marginal. Substrate Availability was scored as poor for having major productive habitats in only 3.3% of the stream. Minor habitats included roots, and sand and silt deposits. The total score for the primary habitat components was a 29 out of 80.

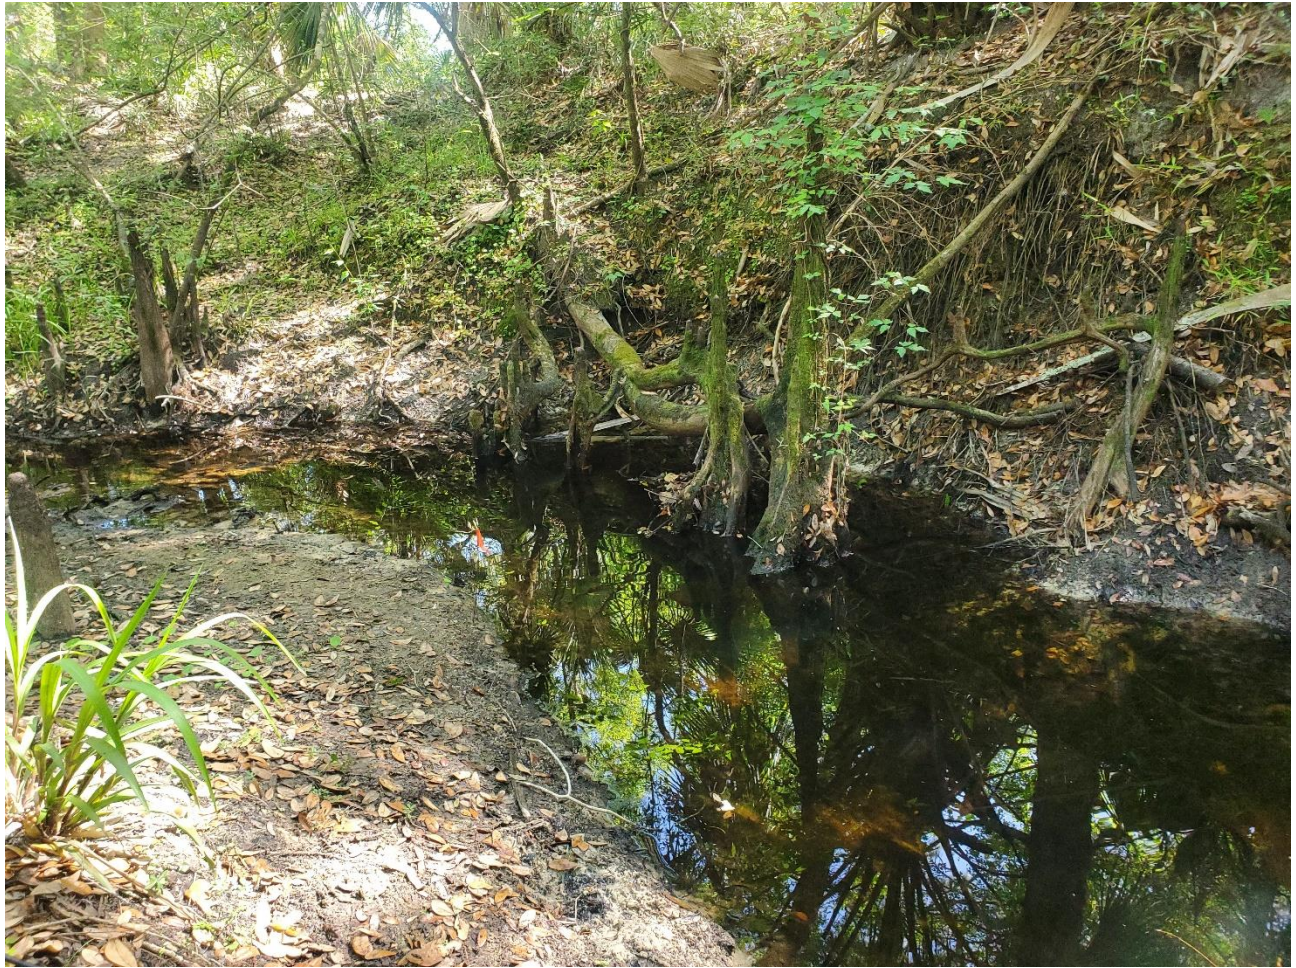
*Figure 3 Snag and leaf packs/mats were the most abundant major productive habitats in Trout Creek.*
