LAKE ASSESSMENT DOCUMENT

Crescent Lake 10/2/98 Watershed: Brooker Creek

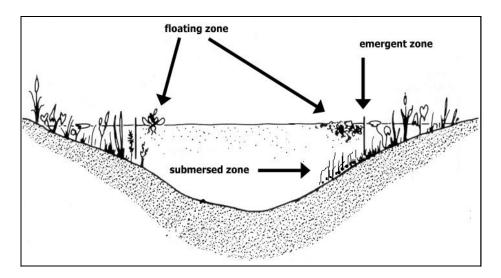
In addition to an overall survey of the types of plants on a lake, an estimate of the standing crop (biomass) of the lake has been obtained for many lakes. This was done by calculating the average weight of the vegetation within a quarter-meter square quadrat tossed haphazardly into three zones (see Figure) at each sampling site around the lake: (1) the emergent zone, (2) the floating zone and (3) the submersed zone. The average weight of the plants (Table 4) from all sampling sites and the dominant type of vegetation (Table 5) are provided. If data tables are not shown, no standing crop estimates were obtained for this lake.
