# Lake Assessment Report for Pretty Lake in Hillsborough County, Florida

Date Assessed: May 24, 2011

Assessed by: David Eilers, Ryan Locicero, Alden Earle and Kris Caldwell

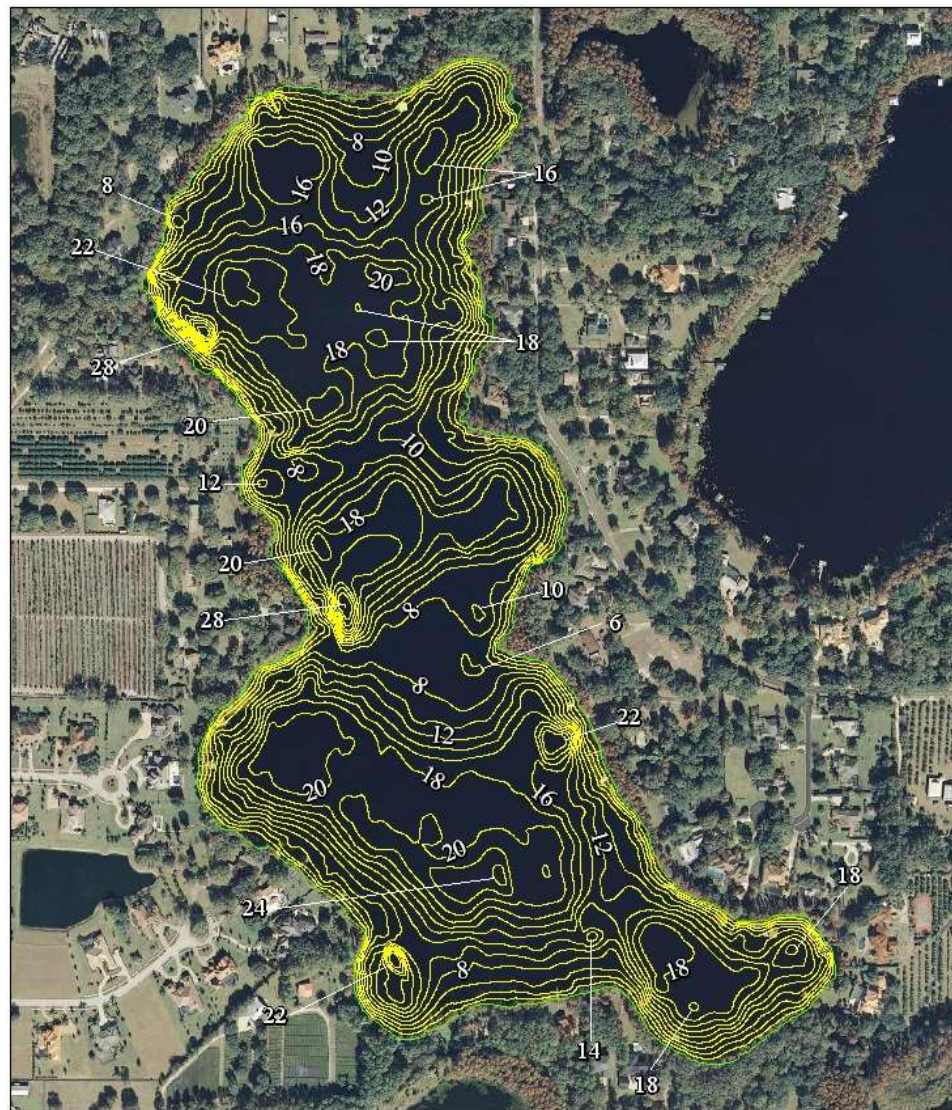
Figure 2. 2011 2-Foot Bathymetric Contour Map for Pretty Lake

Contour Lines  
Expressed in  
2-Foot Intervals

Survey Date: May 24, 2011  
Lake water level was 44.15 ft above sea level at  
time of the assessment NGVD29.  
Contours are expressed in absolute depth  
below this level.

Perimeter: 11,523.8 ft;  
Area: 84.51 Acres  
Mean Depth: 11.56 ft;  
Volume: 1,075.59 Acre-ft. (350,482,024.3 gallons);  
Deepest point: 29.64 ft

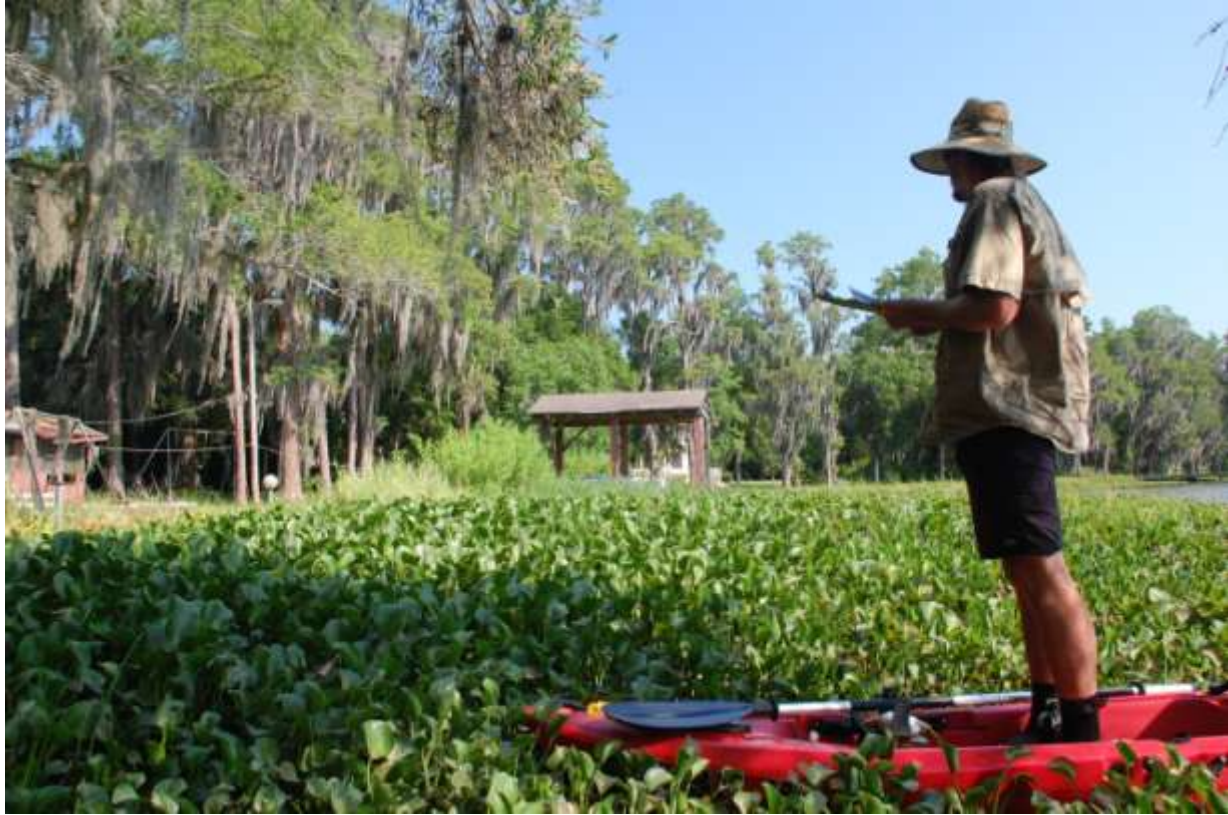
**Figure 4. FCCDR staff assessing the floating vegetation zone on Pretty Lake. The vegetation was dominated by non-native, invasive species such as *Eichhornia crassipes* pictured here.**

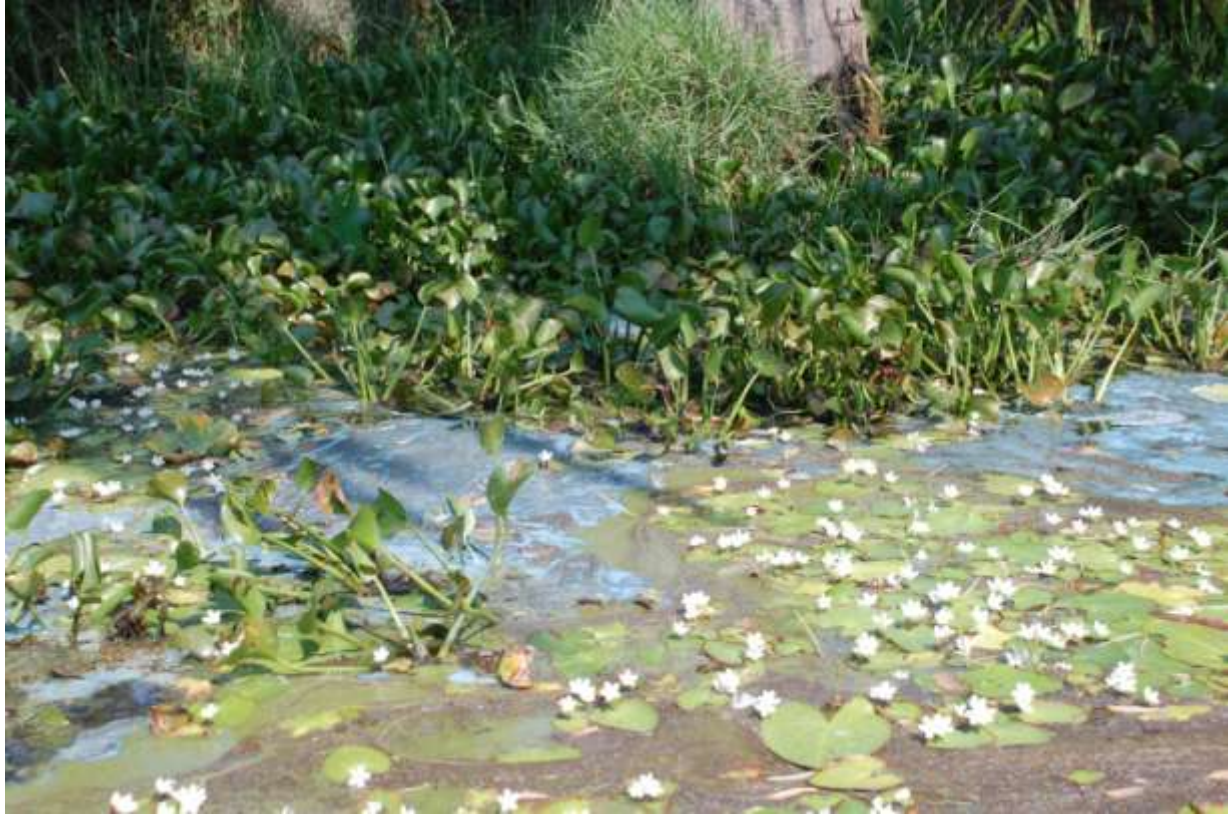
**Figure 5. Image of several non-native invasive species on Pretty Lake.**

The number diversity of species on Pretty Lake is high with 63 species observed during the assessment, however a large number of these, 33%, are non-native invasive species. The large number of invasives and their dominance in the vegetation community is the main reason the LVI score for Pretty Lake is in the impaired category at 33. This LVI value could be improved through active vegetation management practices such as manual invasive species removal. Treating these invasives with chemical means will likely cause a similar algal bloom as seen during the assessment due to the release of nutrients from the decaying biomass.

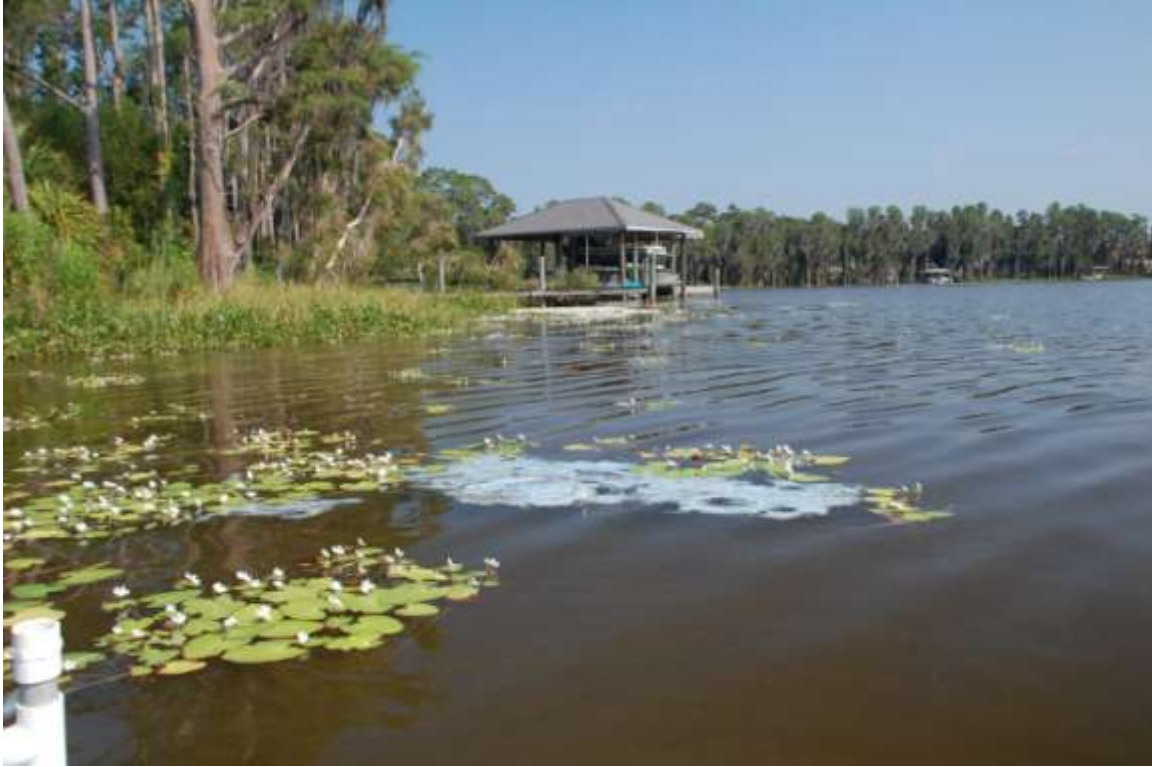
**Figure 6. Blue-Green alagae mats were present on Pretty Lake during the assessment.**

At the time of the assessment, Pretty Lake was experiencing a large algal bloom due to a recent aquatic herbicide application on a neighboring lake. This treatment caused the decay of existing biomass and a resulting release of nutrients into the water column. As a result Pretty Lake had extremely elevated nutrients in the water column and a decreased secchi disk depth. Noticeable mats of blue-green algae were noted during the assessment. The levels of nutrients present would categorize Pretty Lake as hypereutrophic and impaired based on these nutrients.

At the time of the assessment, Pretty Lake was experiencing a large algal bloom due to a recent aquatic herbicide application on a neighboring lake. This treatment caused the decay of existing biomass and a resulting release of nutrients into the water column. As a result Pretty Lake had extremely elevated nutrients in the water column and a decreased secchi disk depth. Noticeable mats of blue-green algae were noted during the assessment.

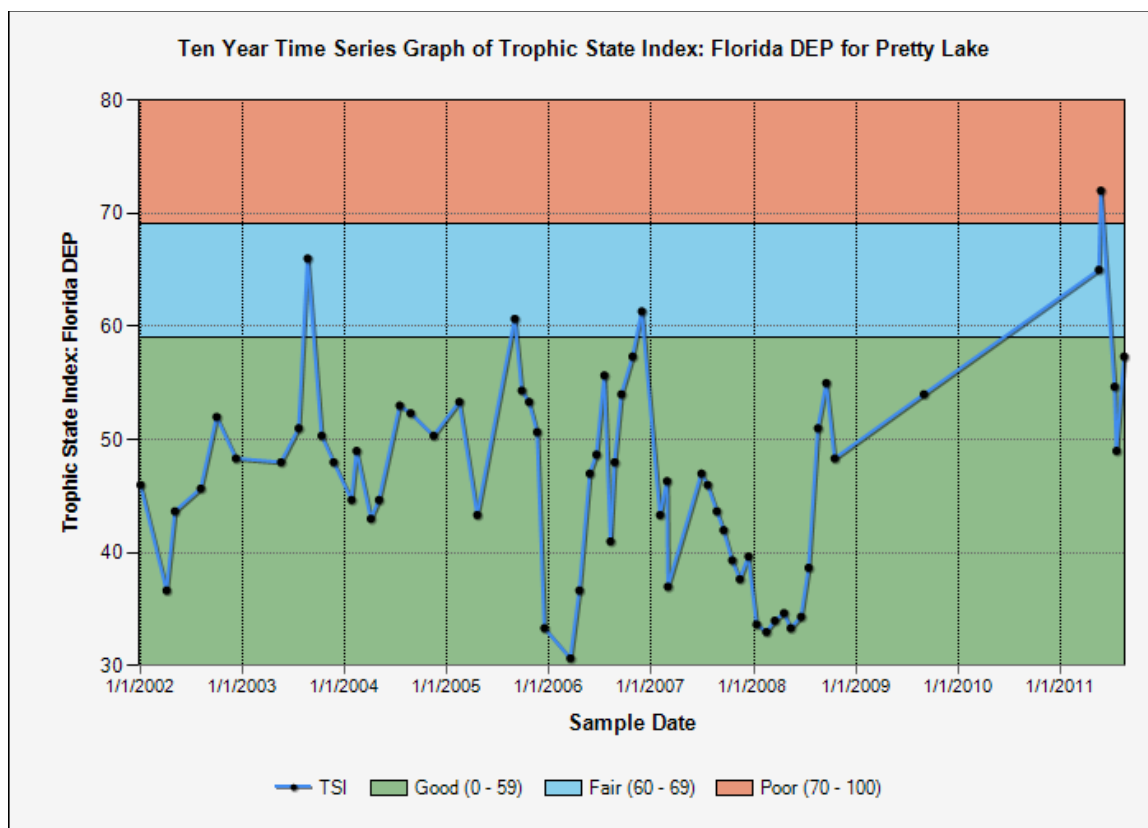
Figure 7. Recent Trophic State Index (TSI) graph for Pretty Lake<sup>vi</sup>

These data are displayed and analyzed on the Water Atlas as shown in Figure 7, Figure 8, and Figure 9 for Pretty Lake. The figures are graphs of: (1) the overall trophic state index (TSI)<sup>1</sup>, which is a method commonly used to characterize the productivity of a lake, and may be thought of as a lake's ability to support plant growth and a healthy food source for aquatic life; (2) the chlorophyll a concentration, which indicates the lake's algal concentration, and (3) the lake's Secchi Disk depth which is a measure of water visibility and depth of light penetration. These data are used to evaluate a lake's ecological health and to provide a method of ranking lakes and are indicators used by the US Environmental Protection Agency (USEPA) and the Florida Department of Environmental Protection (FDEP) to determine a lake's level of impairment. The chlorophyll a and Secchi Disk depth graphs include benchmarks which indicate the median values for the various parameters for a large number of Lakes in Florida expressed as percentiles.

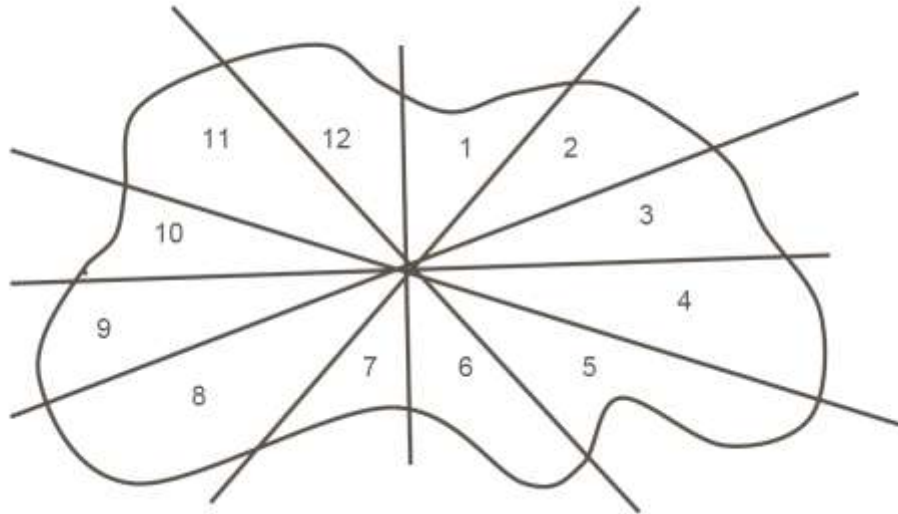
Diagram showing the method used to divide a typical lake into 12 sections for replicate sampling:
