Lower St. Johns River Basin

Thermal Imaging Summary Report

August 31, 2009

Fecal Coliform Source Identification Thermal Imaging Summary Report

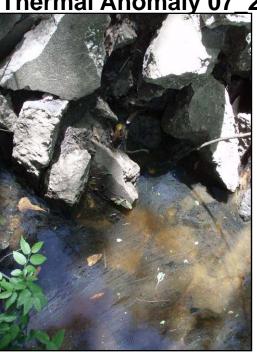
Thermal Anomaly 07_27-158_A

07_27-158_A	Flow from under rip rap at JEA lift station N116	BF2	1967	279	Merrimac Ave.; JEA lift station N116	COJ EQD sample collection (FC = 500 CFU/100mL; 03/31/09)	COJ EQD
07_27-158_B	Low-lying area; no pipes or odors observed	BF2	1967	279	Merrimac Ave.		
07_27-158_C	Multiple ground water inputs in low-lying area; no odors	BF2	1967	279	Merrimac Ave.		
07_27-158_D	NA: on private property; unable to access site	BF2	1967	279	Merrimac Ave.		
07_27-158_E	NA: on private property; unable to access site	BF2	1967	279	Merrimac Ave.		
07_27-158_F	NA: on private property; unable to access site	BF2	1967	279	Merrimac Ave.		
07_27-158_G	NA: on private property; unable to access site	BF2	1967	279	Merrimac Ave.		
06_30-71_A-C	NA: on private property; unable to access site	BF2	1967	279	Euclid St.		
05_27-146_A-B	NA: on private property; unable to access site	BF2	1967	279	East of Euclid St.		
04_30-45_A	Potential artesian well in main channel	BF2	1967	279	West of Herschel St. behind Harpoon Louie's	Requested follow-up 04/08/09	COJ EQD
