# **Peace River and Withlacoochee River Threats Assessments and Fish Assemblage Monitoring**

**Final Report July 1, 2015 – June 30, 2019**

Submitted to Florida State Wildlife Grants Program  
August 1, 2019  
PID: 98462501284

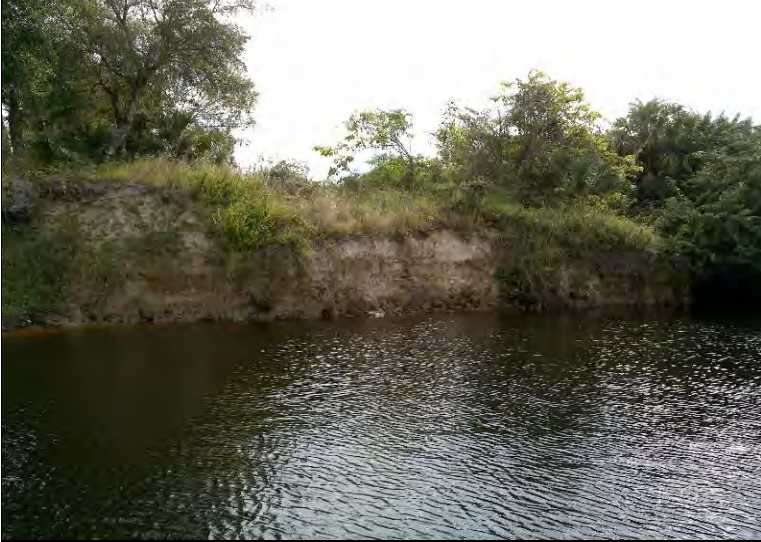
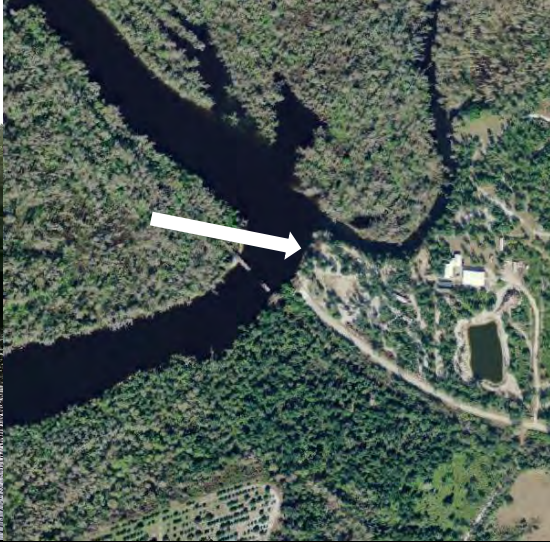
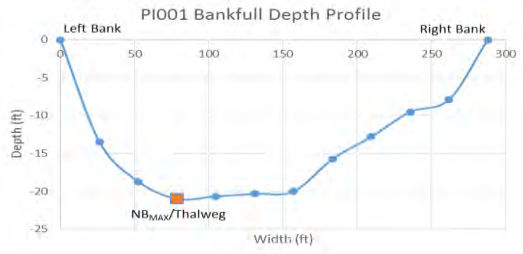
Peace River			Severity Scale: 5.5-Moderate
Watershed: Peace River Subwatershed: Lettuce Lake Latitude: 27.08903 Longitude: -81.98089			County: Desoto Site Number: PI001 Reach Length: 492 ft. Landowner: David Gutierrez

Pfankuch-Channel Stability:	Good	0	
Channel Alteration:	None	0	
Bank Erosion:	Mass-wasting	1.5	
BEHI:	Moderate (20.48)	0.5	
Local NPSP:	Moderate Potential	1	
Shoring Structures:	None	0	
Pipe Discharge:	*Present	1.5	
Water Odor:	Normal	0	
Fish Passage Barrier:	None	0	
RB: Riparian Buffer:	100 ft.	0	
LB: Riparian Buffer:	20 ft.	0.75	
RB: Floodplain Access:	Full	0	
LB: Floodplain Access:	Partial	0.25	
<b>Severity Scale:</b>		<b>5.5</b>	<b>Additional Site Features</b>
			Stream Channel Woody Material: Moderate
			Impoundments: None
			Substrate Composition: Medium Sand
			Bank Material: Sandy Clay
			Near Bank Stress: High
			RB Landuse: Natural Forest
			LB Landuse: Natural Forest, Residential

Notes: *Drainage ditch from agricultural area; Loose material at toe of bank from recent erosion; 303d: Impaired - Aquatic Life Harvesting (Mercury in Fish Tissue), Chlorophyll-A			
Restoration Option 1

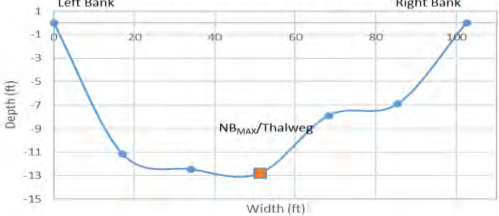
Risk Factor	Ranking	Score	<div> PI002 Bankfull Depth Profile

</div>
Pfankuch-Channel Stability:	Good	0	
Channel Alteration:	None	0	
Bank Erosion:	Active	1	
BEHI:	Low (13.66)	0	
Local NPSP:	No Evidence	0	
Shoring Structures:	None	0	
Pipe Discharge:	None	0	
Water Odor:	Normal	0	
Fish Passage Barrier:	None	0	
RB: Riparian Buffer:	100 ft.	0	
LB: Riparian Buffer:	10 ft.	0.75	
RB: Floodplain Access:	Full	0	
LB: Floodplain Access:	Partial	0.25	
<b>Severity Scale:</b>		<b>2.0</b>	
			Additional Site Features
			Stream Channel Woody Material: Moderate
			Impoundments: None
			Substrate Composition: Medium Sand
			Bank Material: Sandy Clay
			Near Bank Stress: Moderate
			RB Landuse: Natural Forest

LB Landuse: Natural Forest, Residential
303d: Impaired - Aquatic Life Harvesting (Mercury in Fish Tissue), Chlorophyll-A			
Restoration Option 1

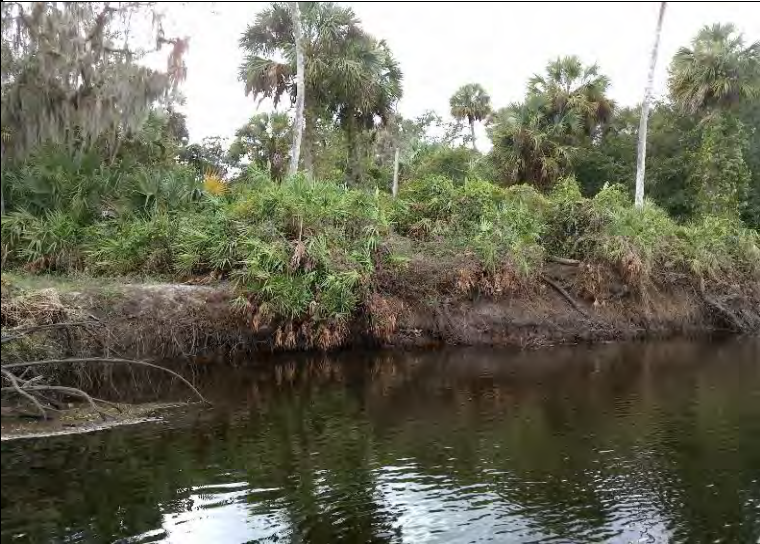
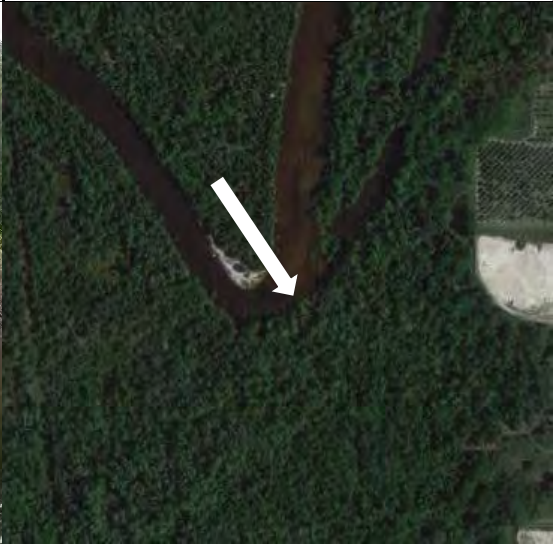
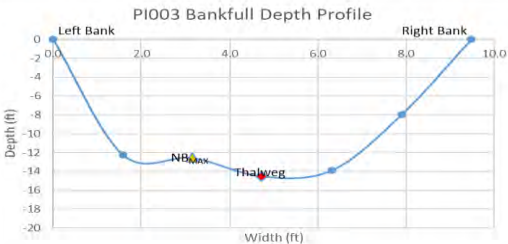
Peace River			Severity Scale: 1.0-Low
Watershed: Peace River Subwatershed: Lower Horse Creek Latitude: 27.11975 Longitude: -81.95080			County: Desoto Site Number: PI003 Reach Length: 345 ft. Landowner: CSX Transportation Inc.

Pfankuch-Channel Stability:	Good	0	
Channel Alteration:	None	0	
Bank Erosion:	Active	1	
BEHI:	Low (11.44)	0	
Local NPSP:	No Evidence	0	
Shoring Structures:	None	0	
Pipe Discharge:	None	0	
Water Odor:	Normal	0	
Fish Passage Barrier:	None	0	
RB: Riparian Buffer:	100 ft.	0	
LB: Riparian Buffer:	100 ft.	0	
RB: Floodplain Access:	Full	0	
LB: Floodplain Access:	Full	0	
<b>Severity Scale:</b>		<b>1.0</b>	<b>Additional Site Features</b>
			Stream Channel Woody Material: Numerous
			Impoundments: None
			Substrate Composition: Medium Sand
			Bank Material: Sand
			Near Bank Stress: Low
			RB Landuse: Natural Forest
			LB Landuse: Natural Forest
303d: Impaired - Aquatic Life Harvesting (Mercury in Fish Tissue)

Restoration Option 2

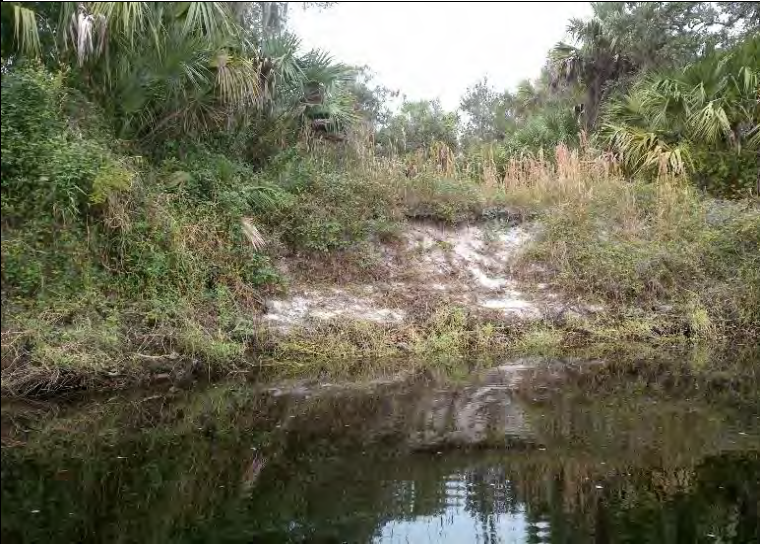
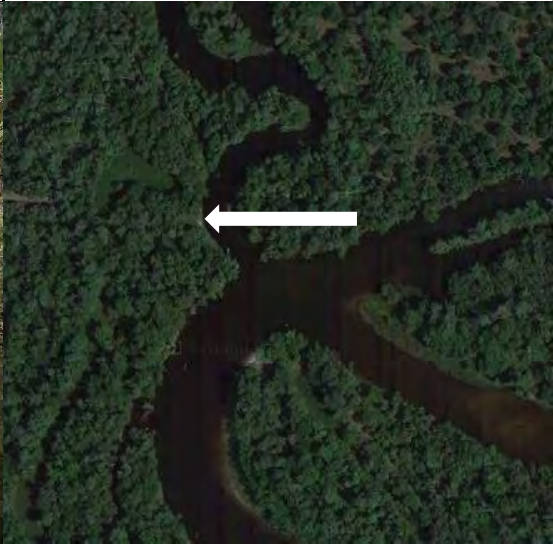
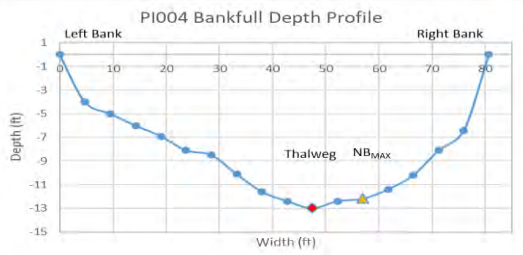
Horse Creek			Severity Scale: 1.5-Low	
Watershed: Peace River Subwatershed: Lower Horse Creek Latitude: 27.10447 Longitude: -81.98413			County: Desoto Site Number: PI004 Reach Length: 154 ft. Landowner: State of Florida (TIITF)

Risk Factor	Ranking	Score		
Pfankuch-Channel Stability:	Good	0		
Channel Alteration:	None	0		
Bank Erosion:	Active	1		
BEHI:	Moderate (25.33)	0.5		
Local NPSP:	No Evidence	0		
Shoring Structures:	None	0		
Pipe Discharge:	None	0		
Water Odor:	Normal	0		
Fish Passage Barrier:	None	0		
RB: Riparian Buffer:	100 ft.	0		
LB: Riparian Buffer:	100 ft.	0		
RB: Floodplain Access:	Full	0		
LB: Floodplain Access:	Full	0		
Severity Scale:		1.5		
Notes: 303d: NA				
Restoration Option 1

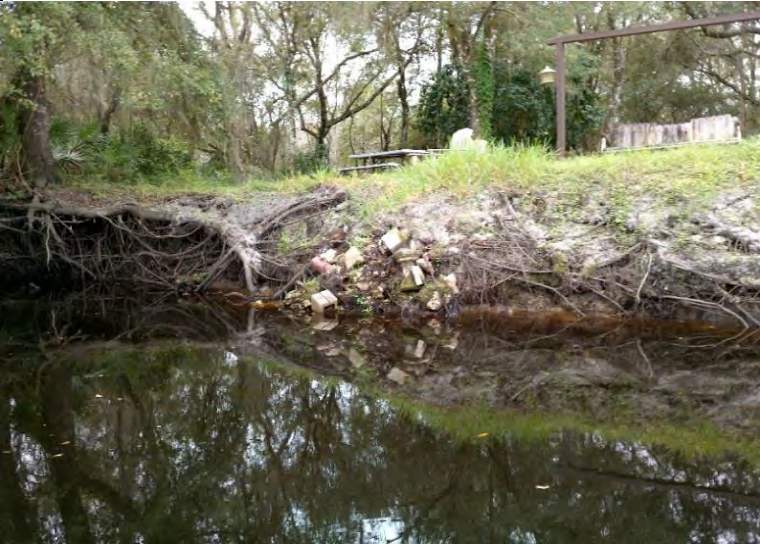
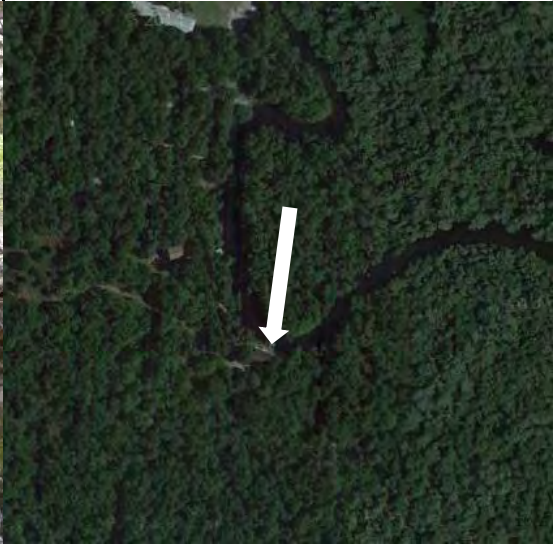
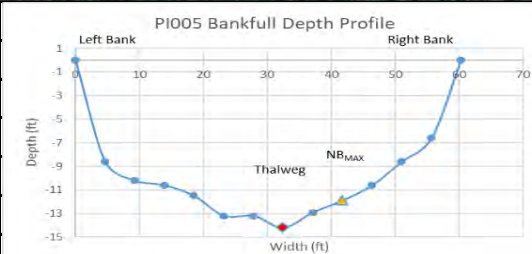
Horse Creek			Severity Scale: 3.75-Low
Watershed: Peace River Subwatershed: Lower Horse Creek Latitude: 27.10904 Longitude: -81.98753			County: Desoto Site Number: PI005 Reach Length: 147 ft. Landowner: Patricia Eaton

Risk Factor	Ranking	Score	
Pfankuch-Channel Stability:	Good	0	
Channel Alteration:	None	0	
Bank Erosion:	Active	1	
BEHI:	Moderate (25.76)	0.5	
Local NPSP:	No Evidence	0	
Shoring Structures:	Present	1.5	
Pipe Discharge:	None	0	<b>Additional Site Features</b> Stream Channel Woody Material: Moderate Impoundments: None Substrate Composition: Medium Sand Bank Material: Sand Near Bank Stress: Moderate RB Landuse: Residential LB Landuse: Natural Forest
Water Odor:	Normal	0	
Fish Passage Barrier:	None	0	
RB: Riparian Buffer:	0 ft.	0.75	
LB: Riparian Buffer:	100 ft.	0	
RB: Floodplain Access:	Full	0	
LB: Floodplain Access:	Full	0	
<b>Severity Scale:</b>		<b>3.75</b>	
Notes: 303d: Impaired - Public Water Supply (BOD, DO)

Restoration Option 2

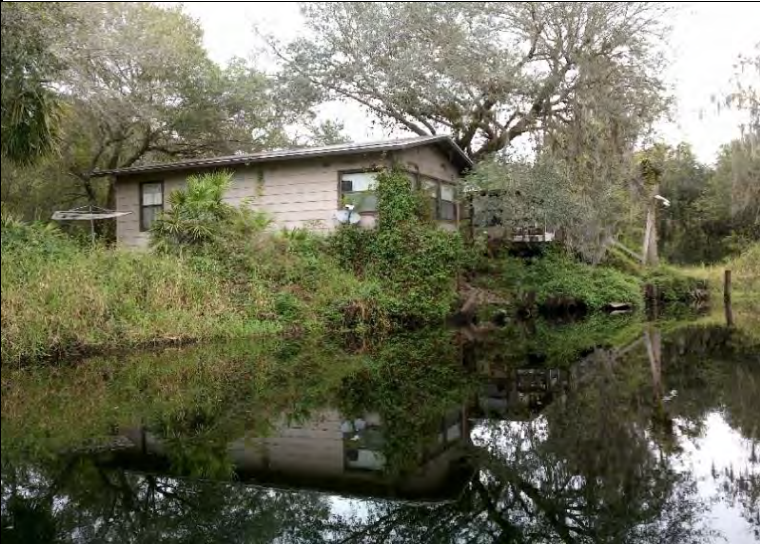
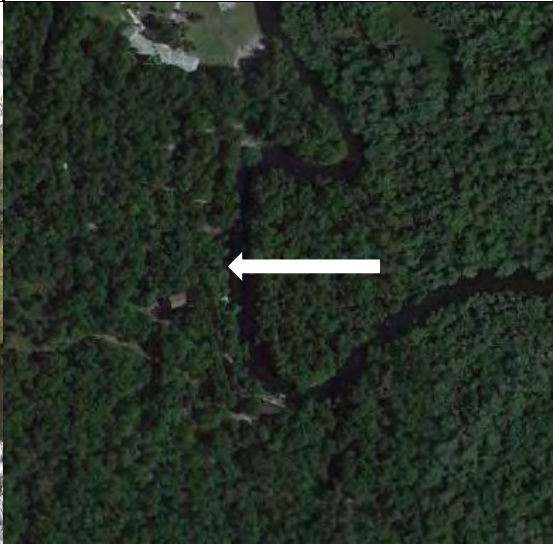
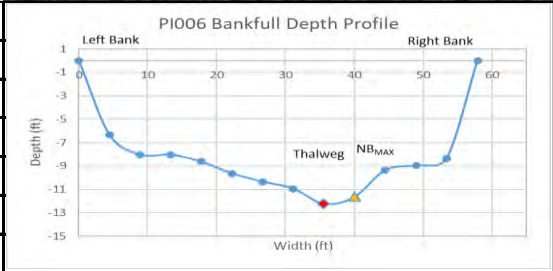
Horse Creek			Severity Scale: 2.75-Low
Watershed: Peace River Subwatershed: Lower Horse Creek Latitude: 27.10988 Longitude: -81.98820			County: Desoto Site Number: PI006 Reach Length: 315 ft. Landowner: Jean Stephens

Risk Factor	Ranking	Score	
Pfankuch-Channel Stability:	Good	0	
Channel Alteration:	None	0	
Bank Erosion:	Non-eroding	0	
BEHI:	Moderate (22.01)	0.5	
Local NPSP:	No Evidence	0	
Shoring Structures:	Present	1.5	
Pipe Discharge:	None	0	
Water Odor:	Normal	0	
Fish Passage Barrier:	None	0	
RB: Riparian Buffer:	0 ft.	0.75	
LB: Riparian Buffer:	100 ft.	0	
RB: Floodplain Access:	Full	0	
LB: Floodplain Access:	Full	0	
Severity Scale:		2.75	
Notes: 303d: Impaired - Public Water Supply (BOD, DO)			
Restoration Option 2

Additional Site Features
Stream Channel Woody Material: Moderate
Impoundments: None
Substrate Composition: Medium Sand
Bank Material: Sand
Near Bank Stress: Moderate
RB Landuse: Residential
LB Landuse: Natural Forest

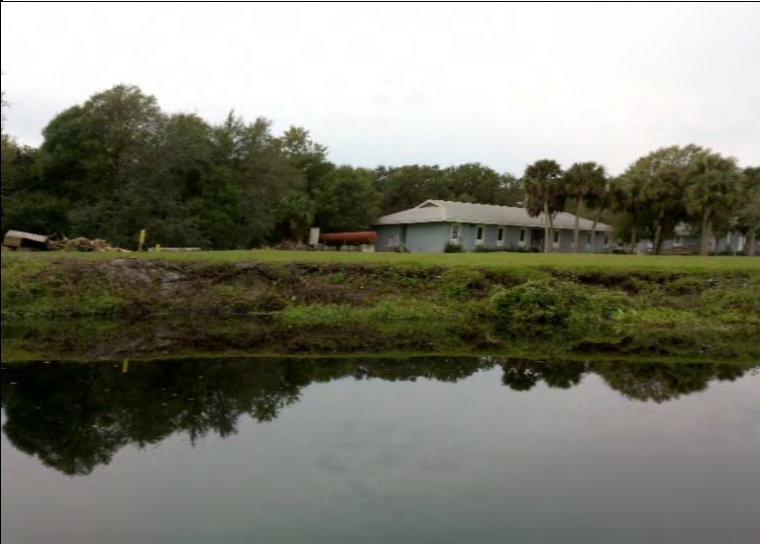
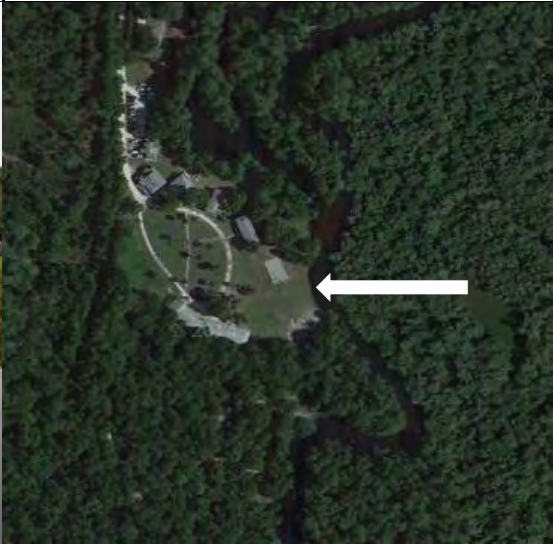
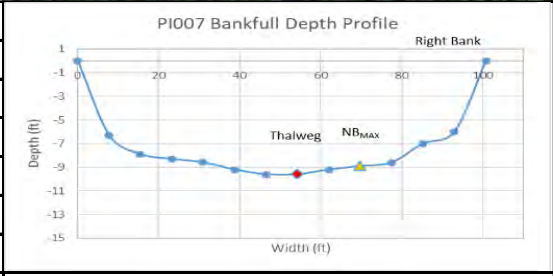
Horse Creek			Severity Scale: 2.25-Low
Watershed: Peace River Subwatershed: Lower Horse Creek Latitude: 27.11130 Longitude: -81.98770			County: Desoto Site Number: PI007 Reach Length: 740 ft. Landowner: TIITF/Children & Families

Pfankuch-Channel Stability:	Good	0	
Channel Alteration:	None	0	
Bank Erosion:	Active	1	
BEHI:	Moderate (20.44)	0.5	
Local NPSP:	No Evidence	0	
Shoring Structures:	None	0	
Pipe Discharge:	None	0	
Water Odor:	Normal	0	
Fish Passage Barrier:	None	0	
RB: Riparian Buffer:	0 ft.	0.75	
LB: Riparian Buffer:	100 ft.	0	
RB: Floodplain Access:	Full	0	
LB: Floodplain Access:	Full	0	
<b>Severity Scale:</b>		<b>2.25</b>	<b>Additional Site Features</b> Stream Channel Woody Material: Moderate Impoundments: None Substrate Composition: Medium Sand Bank Material: Sand Near Bank Stress: Moderate RB Landuse: Residential LB Landuse: Natural Forest
Notes: 303d: Impaired - Public Water Supply (BOD, DO)

Restoration Option 1

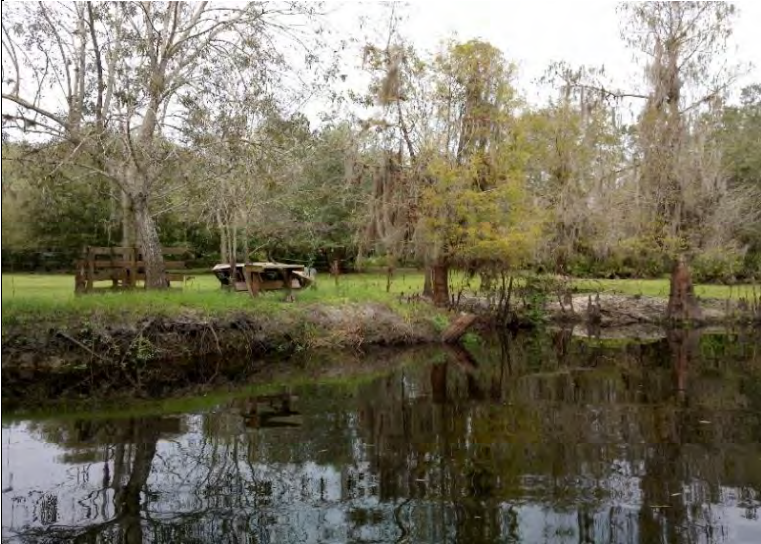
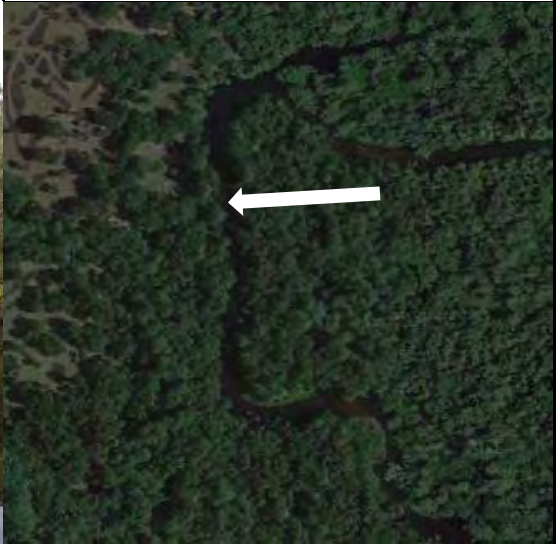
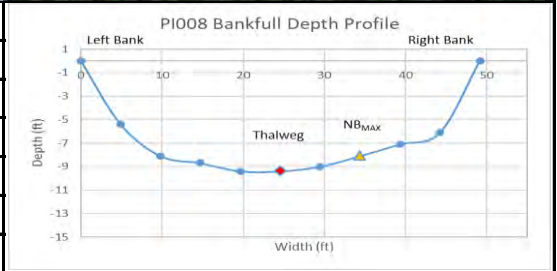
Horse Creek			Severity Scale: 2.25-Low
Watershed: Peace River Subwatershed: Lower Horse Creek Latitude: 27.11645 Longitude: -81.98770			County: Desoto Site Number: PI008 Reach Length: 275 ft. Landowner: TIITF/State of Florida

Risk Factor	Ranking	Score	
Pfankuch-Channel Stability:	Good	0	
Channel Alteration:	None	0	
Bank Erosion:	Active	1	
BEHI:	Moderate (25.66)	0.5	
Local NPSP:	No Evidence	0	
Shoring Structures:	None	0	
Pipe Discharge:	None	0	
Water Odor:	Normal	0	
Fish Passage Barrier:	None	0	
RB: Riparian Buffer:	0 ft.	0.75	
LB: Riparian Buffer:	100 ft.	0	
RB: Floodplain Access:	Full	0	
LB: Floodplain Access:	Full	0	
Severity Scale:		2.25	
Notes: Cattle access; Property of Frank V. Desguin ends near river bank; 303d: Impaired - Public Water Supply (BOD, DO)			
Restoration Option 2 or 3

Additional Site Features	
Stream Channel Woody Material:	Numerous
Impoundments:	None
Substrate Composition:	Medium Sand
Bank Material:	Sand
Near Bank Stress:	Low
RB Landuse:	Agriculture, Natural Forest
LB Landuse:	Natural Forest

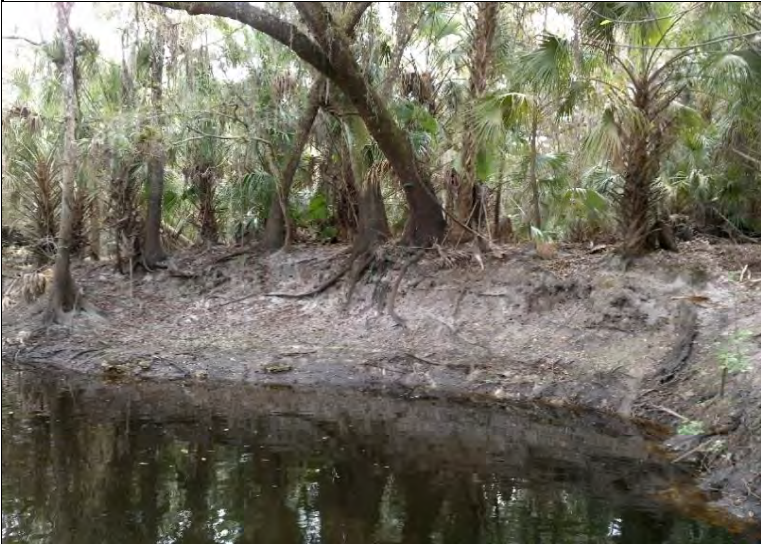
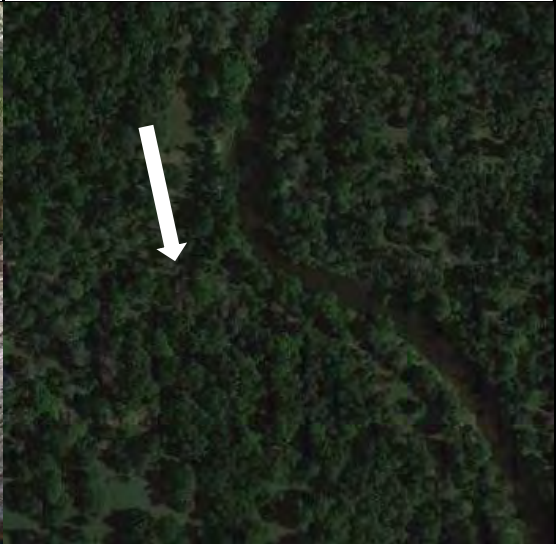
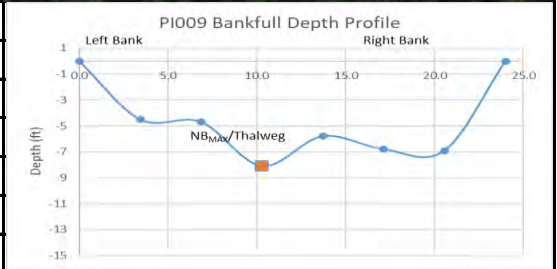
Limestone Creek			Severity Scale: 2.5-Low
Watershed: Peace River Subwatershed: Limestone Creek Latitude: 27.37881 Longitude: -81.84332			County: Hardee Site Number: PI009 Reach Length: 45 ft. Landowner: Ben Hill Griffin Inc.

Risk Factor	Ranking	Score	
Pfankuch-Channel Stability:	Good	0	
Channel Alteration:	None	0	
Bank Erosion:	Active	1	
BEHI:	High (31.43)	1	
Local NPSP:	Slight Potential	0.5	
Shoring Structures:	None	0	
Pipe Discharge:	None	0	
Water Odor:	Normal	0	
Fish Passage Barrier:	None	0	
RB: Riparian Buffer:	100 ft.	0	
LB: Riparian Buffer:	100 ft.	0	
RB: Floodplain Access:	Full	0	
LB: Floodplain Access:	Full	0	
Severity Scale:		2.5	
Notes: Cattle access; 303d: Impaired - Aquatic Life Harvesting (DO)			
Restoration Option 1

Additional Site Features
Stream Channel Woody Material: Infrequent
Impoundments: None
Substrate Composition: Medium Sand
Bank Material: Sand/Silt/Limestone
Near Bank Stress: Low
RB Landuse: Natural Forest
LB Landuse: Natural Forest

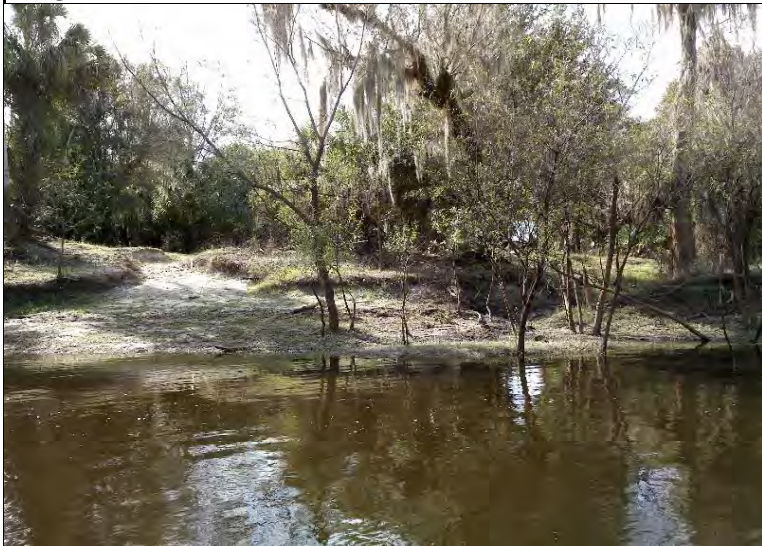
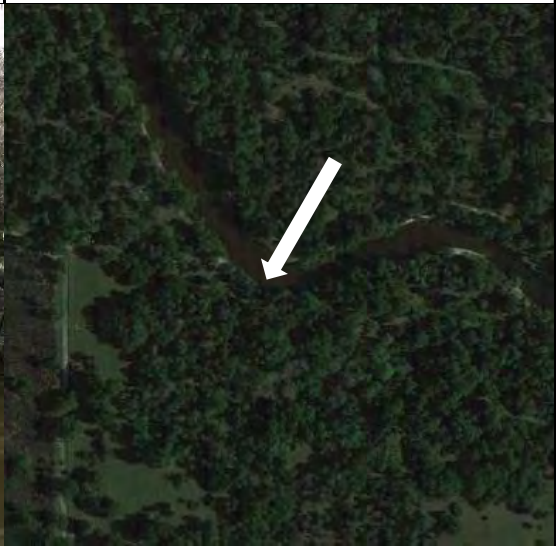
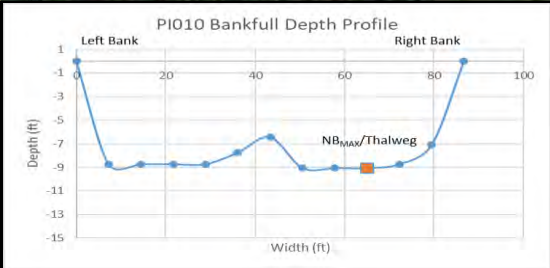
Peace River			Severity Scale: 2.25-Low	
Watershed: Peace River Subwatershed: Peace River Branch Latitude: 27.37642 Longitude: -81.84036			County: Hardee Site Number: PI010 Reach Length: 392 ft. Landowner: Ben Hill Griffin Inc.

Pfankuch-Channel Stability:	Good	0		
Channel Alteration:	None	0		
Bank Erosion:	Active	1		
BEHI:	Moderate (20.66)	0.5		
Local NPSP:	No evidence	0		
Shoring Structures:	None	0		
Pipe Discharge:	None	0		
Water Odor:	Normal	0		
Fish Passage Barrier:	None	0		
RB: Riparian Buffer:	40 ft.	0.5		
LB: Riparian Buffer:	100 ft.	0		
RB: Floodplain Access:	Full	0		
LB: Floodplain Access:	Partial	0.25		
Severity Scale:		2.25		
Additional Site Features				
Stream Channel Woody Material: Infrequent				
Impoundments: None				
Substrate Composition: Medium Sand				
Bank Material: Sand				
Near Bank Stress: High				
RB Landuse: Natural Forest, Pasture				
LB Landuse: Natural Forest

Notes: Light cattle access (historic) which has recently been fenced out; 303d: Impaired - Aquatic				
Life Harvesting (mercury in fish tissue)				
Restoration Option 2 or 3

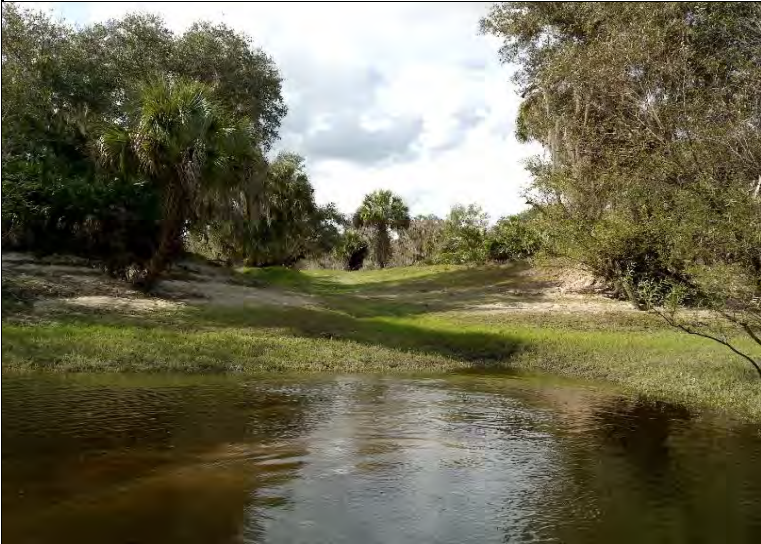
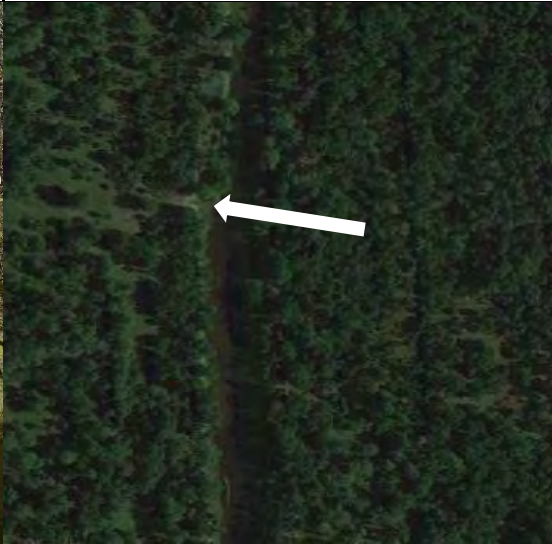
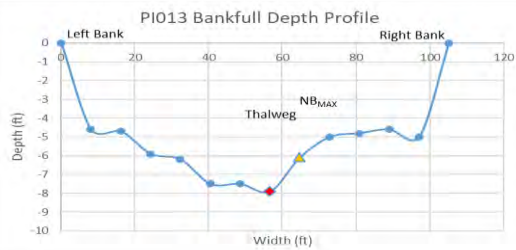
Peace River			Severity Scale: 2.0-Low
Watershed: Peace River Subwatershed: Peace River Branch Latitude: 27.36948 Longitude: -81.83217			County: Hardee Site Number: PI013 Reach Length: 44 ft. Landowner: Ben Hill Griffin Inc.

Risk Factor	Ranking	Score	
Pfankuch-Channel Stability:	Good	0	
Channel Alteration:	None	0	
Bank Erosion:	Historic	0.5	
BEHI:	Moderate (29.38)	0.5	
Local NPSP:	Slight Potential	0.5	
Shoring Structures:	None	0	
Pipe Discharge:	None	0	<b>Additional Site Features</b>
Water Odor:	Normal	0	Stream Channel Woody Material: Infrequent
Fish Passage Barrier:	None	0	Impoundments: None
RB: Riparian Buffer:	40 ft.	0.5	Substrate Composition: Medium Sand
LB: Riparian Buffer:	100 ft.	0	Bank Material: Sand
RB: Floodplain Access:	Full	0	Near Bank Stress: Moderate
LB: Floodplain Access:	Full	0	RB Landuse: Pasture
<b>Severity Scale:</b>		<b>2.0</b>	LB Landuse: Natural Forest
Notes: Campsite w/fire pit, possible cattle access; 303d: Impaired - Aquatic Life Harvesting (mercury in fish tissue)

Restoration Option 2 or 3

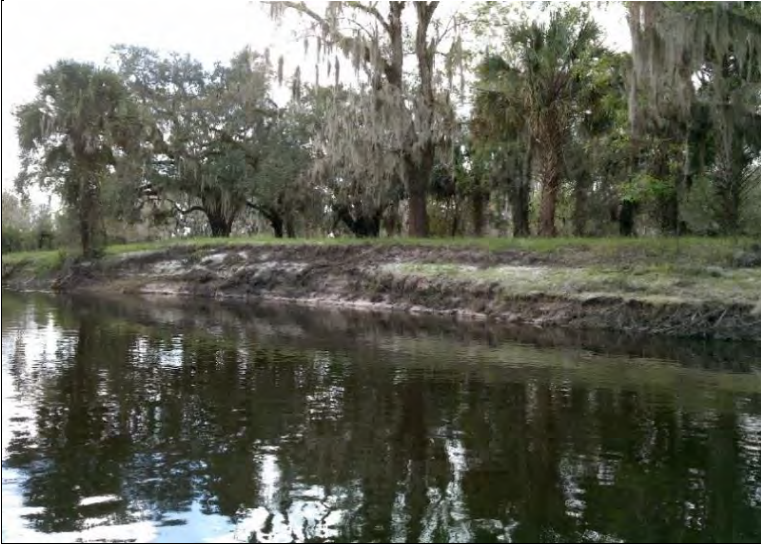
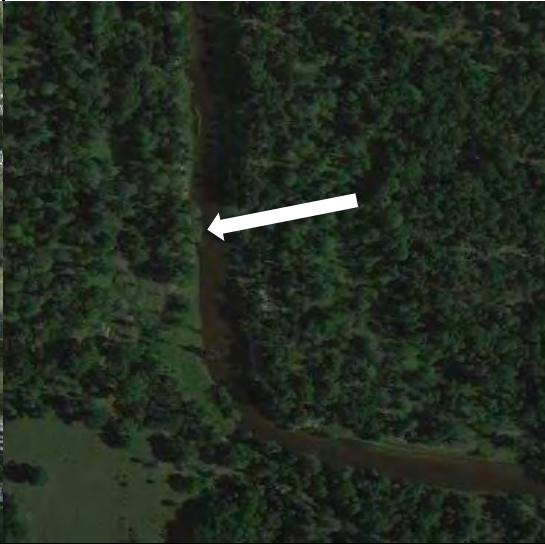
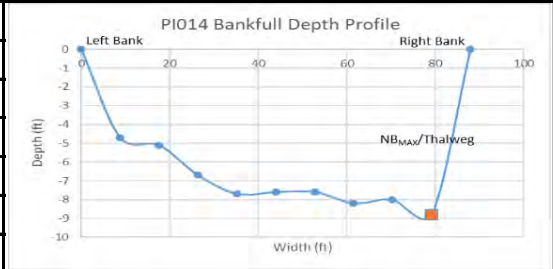
Peace River			Severity Scale: 2.0-Low
Watershed: Peace River Subwatershed: Peace River Branch Latitude: 27.36709 Longitude: -81.83198			County: Hardee Site Number: PI014 Reach Length: 110 ft. Landowner: Ben Hill Griffin Inc.

Risk Factor	Ranking	Score	
Pfankuch-Channel Stability:	Good	0	
Channel Alteration:	None	0	
Bank Erosion:	Active	1	
BEHI:	Moderate (25.04)	0.5	
Local NPSP:	No evidence	0	
Shoring Structures:	None	0	
Pipe Discharge:	None	0	
Water Odor:	Normal	0	
Fish Passage Barrier:	None	0	
RB: Riparian Buffer:	40 ft.	0.5	
LB: Riparian Buffer:	100 ft.	0	
RB: Floodplain Access:	Full	0	
LB: Floodplain Access:	Full	0	
<b>Severity Scale:</b>		<b>2.0</b>	
Notes: Farm road approx. 200 ft. behind river bank; Cattle access; Mostly grass with sparse trees; 303d: Impaired - Aquatic Life Harvesting (mercury in fish tissue)			
Restoration Option 1

Additional Site Features	
Stream Channel Woody Material:	Infrequent
Impoundments:	None
Substrate Composition:	Medium Sand
Bank Material:	Sand
Near Bank Stress:	Very High
RB Landuse:	Pasture, Natural Forest
LB Landuse:	Natural Forest

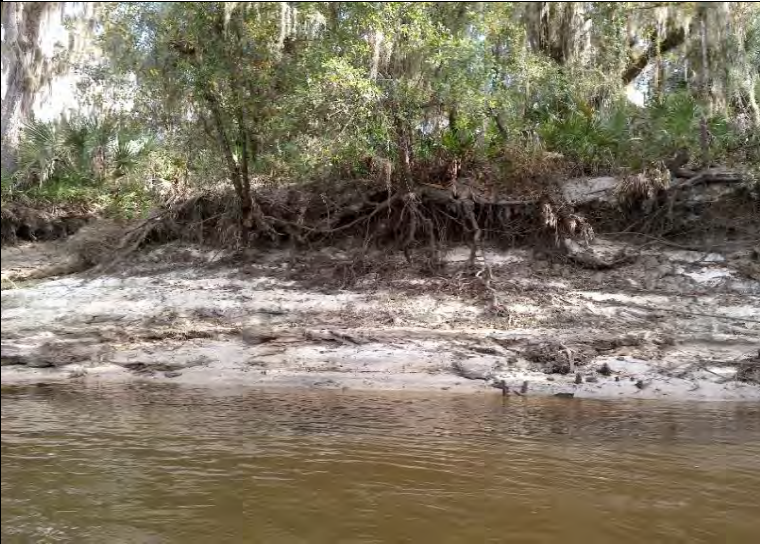
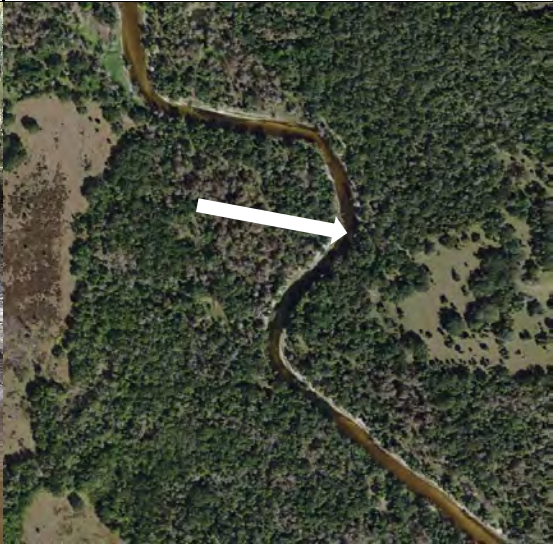
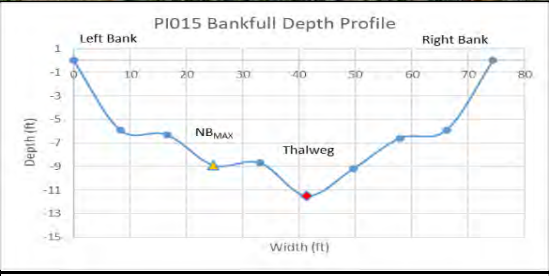
Peace River			Severity Scale: 3.5-Low
Watershed: Peace River Subwatershed: Peace River Branch Latitude: 27.36376 Longitude: -81.82900			County: Hardee Site Number: PI015 Reach Length: 58 ft. Landowner: Ben Hill Griffin Inc.

Pfankuch-Channel Stability:	Good	0	
Channel Alteration:	None	0	
Bank Erosion:	Active	1	
BEHI:	High (39.33)	1	
Local NPSP:	Moderate Potential	1	
Shoring Structures:	None	0	
Pipe Discharge:	None	0	
Water Odor:	Normal	0	
Fish Passage Barrier:	None	0	
RB: Riparian Buffer:	100 ft.	0	
LB: Riparian Buffer:	40 ft.	0.5	
RB: Floodplain Access:	Full	0	
LB: Floodplain Access:	Full	0	
Severity Scale:		3.5	<b>Additional Site Features</b> Stream Channel Woody Material: Numerous Impoundments: None Substrate Composition: Medium Sand Bank Material: Sand, Gravel Near Bank Stress: Low RB Landuse: Natural Forest LB Landuse: Pasture, Natural Forest
Notes: Cattle access; 303d: Impaired - Aquatic Life Harvesting (mercury in fish tissue)

Restoration Option 1

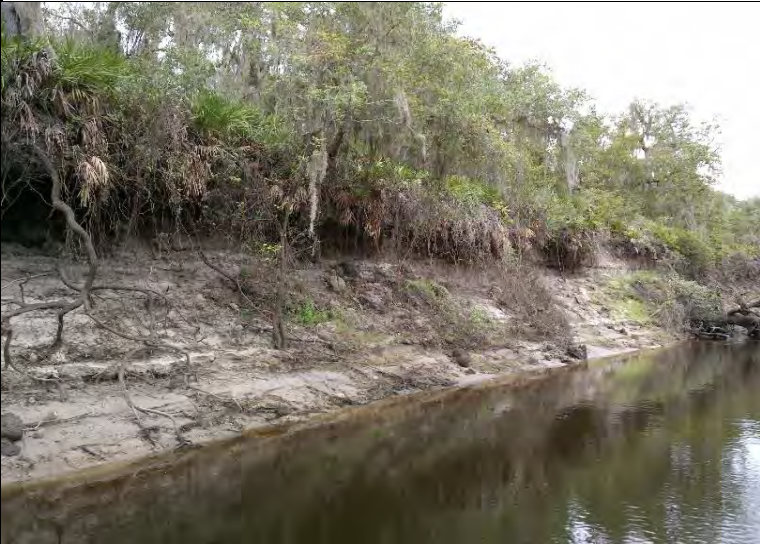
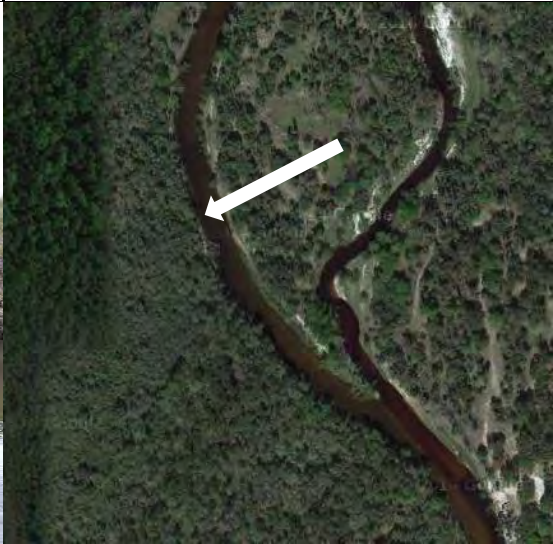
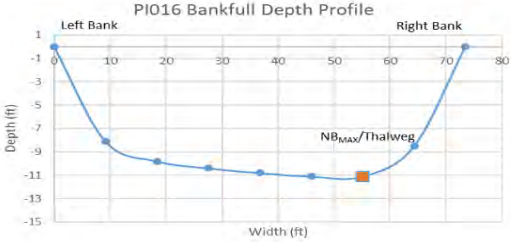
Peace River			Severity Scale: 3.25-Low
Watershed: Peace River Subwatershed: Peace River Branch Latitude: 27.35073 Longitude: -81.82693			County: Hardee Site Number: PI016 Reach Length: 403 ft. Landowner: Limestone Ranch LLC

Pfankuch-Channel Stability:	Good	0	
Channel Alteration:	None	0	
Bank Erosion:	Mass-wasting	1.5	
BEHI:	Very High (42.96)	1.5	
Local NPSP:	No Evidence	0	
Shoring Structures:	None	0	
Pipe Discharge:	None	0	
Water Odor:	Normal	0	
Fish Passage Barrier:	None	0	
RB: Riparian Buffer:	100 ft.	0	
LB: Riparian Buffer:	100 ft.	0	
RB: Floodplain Access:	Partial	0.25	
LB: Floodplain Access:	Full	0	
<b>Severity Scale:</b>		<b>3.25</b>	<b>Additional Site Features</b>
			Stream Channel Woody Material: Moderate
			Impoundments: None
			Substrate Composition: Medium Sand
			Bank Material: Sand, Small Gravel
			Near Bank Stress: High
			RB Landuse: Natural Forest
			LB Landuse: Natural Forest

Notes: 303d: Impaired - Aquatic Life Harvesting (mercury in fish tissue)			
Restoration Option 1

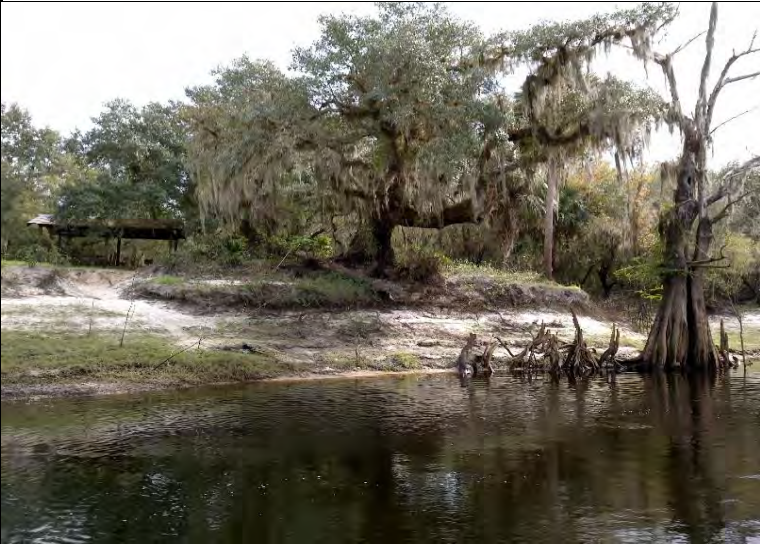
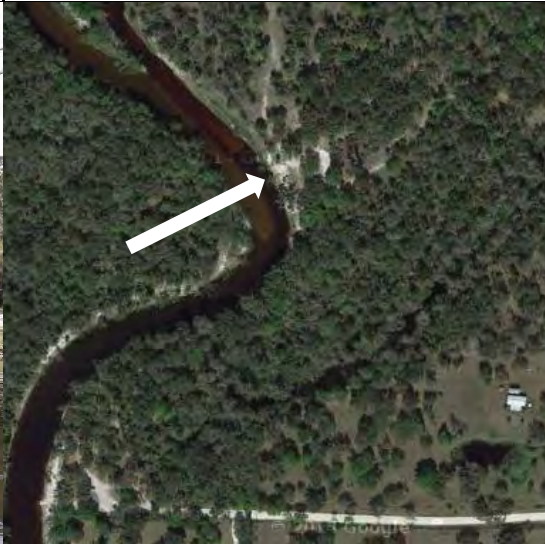
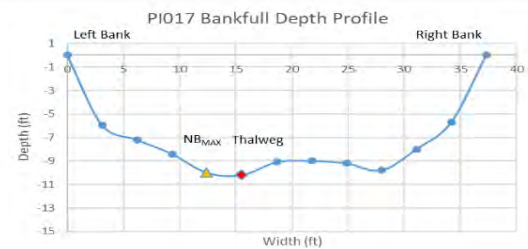
Peace River			Severity Scale: 2.5-Low
Watershed: Peace River Subwatershed: Peace River Branch Latitude: 27.34867 Longitude: -81.82478			County: Hardee Site Number: PI017 Reach Length: 160 ft. Landowner: Glen O. Douglas

Risk Factor	Ranking	Score	
Pfankuch-Channel Stability:	Good	0	
Channel Alteration:	None	0	
Bank Erosion:	Active	1	
BEHI:	Moderate (23.52)	0.5	
Local NPSP:	Slight Potential	0.5	
Shoring Structures:	None	0	
Pipe Discharge:	None	0	
Water Odor:	Normal	0	
Fish Passage Barrier:	None	0	
RB: Riparian Buffer:	100 ft.	0	
LB: Riparian Buffer:	40 ft.	0.5	
RB: Floodplain Access:	Full	0	
LB: Floodplain Access:	Full	0	
<b>Severity Scale:</b>		<b>2.5</b>

Additional Site Features
			Stream Channel Woody Material: Moderate
			Impoundments: None
			Substrate Composition: Fine Sand/Silt
			Bank Material: Sand
			Near Bank Stress: Moderate
			RB Landuse: Natural Forest
			LB Landuse: Natural Forest, Pasture

Notes: Recreational use area w/picnic pavilion; Cattle access; Water input at downstream end of site; 303d: Impaired - Aquatic Life Harvesting (fecal coliform, mercury in fish tissue)			
Restoration Option 1

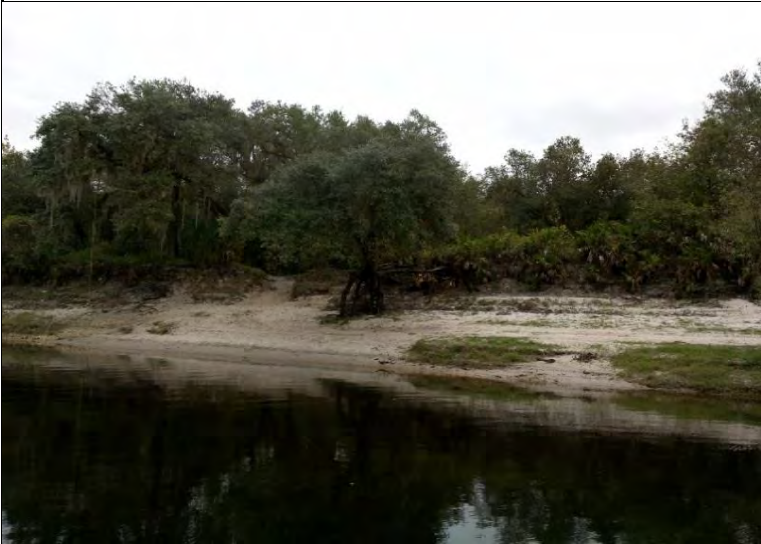
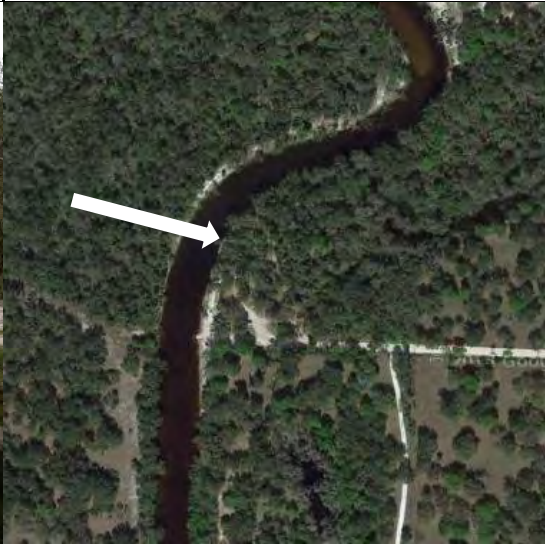
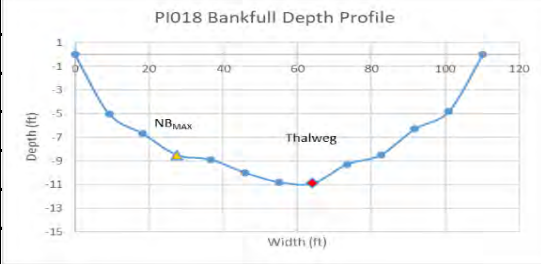
Peace River			Severity Scale: 4.5-Moderate
Watershed: Peace River Subwatershed: Peace River Branch Latitude: 27.34691 Longitude: -81.82620			County: Hardee Site Number: PI018 Reach Length: 59 ft. Landowner: IMC - Agrico Company

Pfankuch-Channel Stability:	Good	0	
Channel Alteration:	None	0	
Bank Erosion:	Active	1	
BEHI:	Very High (42.46)	1.5	
Local NPSP:	Obvious Sources	1.5	
Shoring Structures:	None	0	
Pipe Discharge:	None	0	
Water Odor:	Normal	0	
Fish Passage Barrier:	None	0	
RB: Riparian Buffer:	100 ft.	0	
LB: Riparian Buffer:	40 ft.	0.5	
RB: Floodplain Access:	Full	0	
LB: Floodplain Access:	Full	0	
<b>Severity Scale:</b>		<b>4.5</b>	<b>Additional Site Features</b>
			Stream Channel Woody Material: Infrequent
			Impoundments: None
			Substrate Composition: Medium Sand
			Bank Material: Sand
			Near Bank Stress: Low
			RB Landuse: Natural Forest
			LB Landuse: Recreation, Natural Forest

Notes: Upstream of Gardner public boat ramp; 303d: Impaired - Aquatic Life Harvesting (fecal coliform, mercury in fish tissue)			
Restoration Option 2 or 3

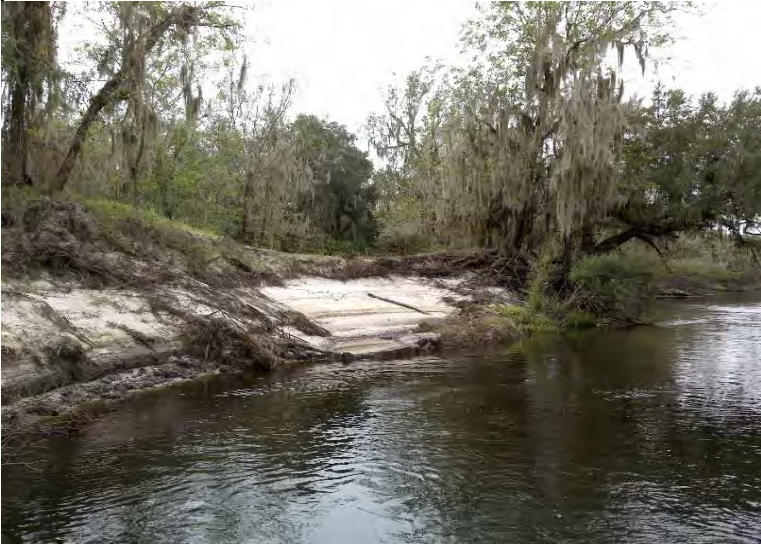
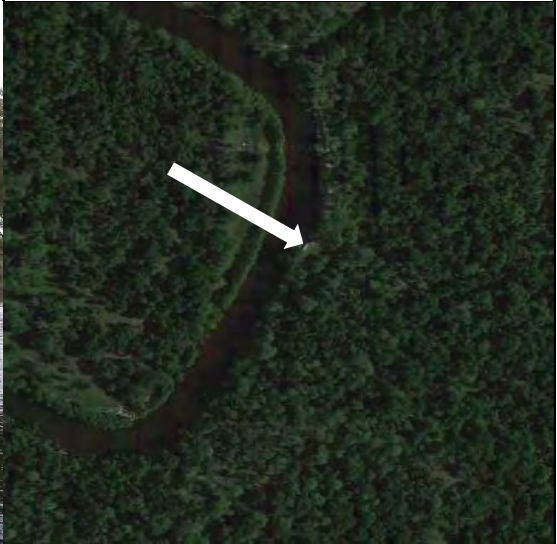
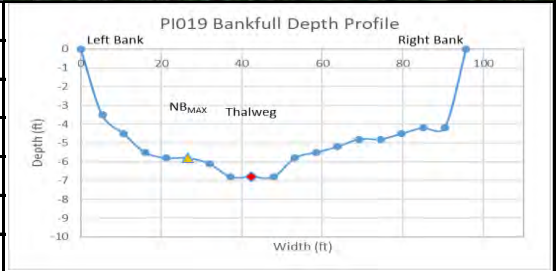
Peace River			Severity Scale: 4.0-Low
Watershed: Peace River Subwatershed: Peace River Branch Latitude: 27.30452 Longitude: -81.84046			County: Desoto Site Number: PI019 Reach Length: 461 ft. Landowner: Mildred Rosenthal

Risk Factor	Ranking	Score	
Pfankuch-Channel Stability:	Good	0	
Channel Alteration:	None	0	
Bank Erosion:	Active	1	
BEHI:	High (36.66)	1	
Local NPSP:	Obvious Sources	1.5	
Shoring Structures:	None	0	
Pipe Discharge:	None	0	
Water Odor:	Normal	0	
Fish Passage Barrier:	None	0	
RB: Riparian Buffer:	100 ft.	0	
LB: Riparian Buffer:	40 ft.	0.5	
RB: Floodplain Access:	Full	0	
LB: Floodplain Access:	Full	0	
<b>Severity Scale:</b>		<b>4.0</b>	
Notes: Cattle fence along bank with cattle access; 303d: Impaired - Aquatic Life Harvesting (fecal coliform, mercury in fish tissue)			
Restoration Option 1

Additional Site Features
Stream Channel Woody Material: Moderate
Impoundments: None
Substrate Composition: Medium Sand/Silt
Bank Material: Sand
Near Bank Stress: Moderate
RB Landuse: Natural Forest
LB Landuse: Pasture, Natural Forest

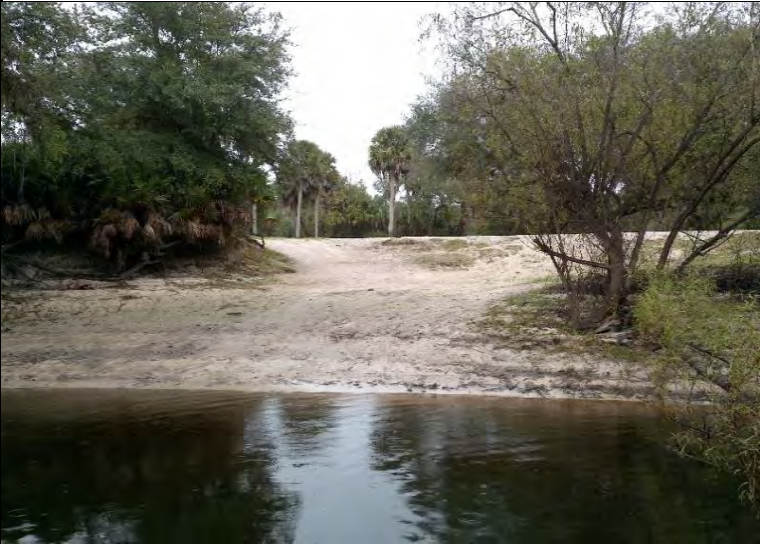
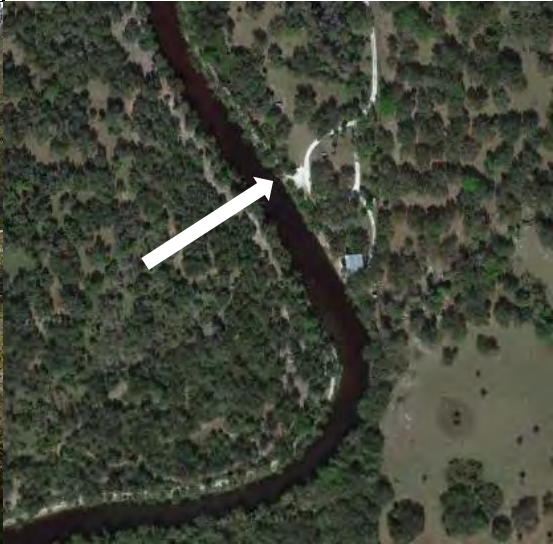
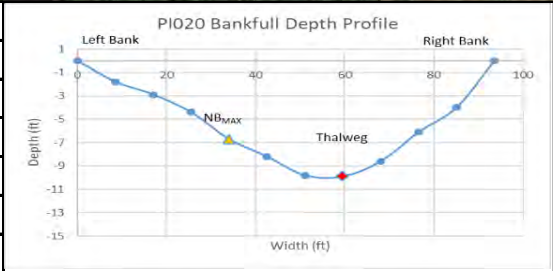
Peace River			Severity Scale: 4.0-Low
Watershed: Peace River Subwatershed: Peace River Branch Latitude: 27.34329 Longitude: -81.82555			County: Hardee Site Number: PI020 Reach Length: 28 ft. Landowner: Peace River Outpost Inc.

Risk Factor	Ranking	Score	
Pfankuch-Channel Stability:	Good	0	
Channel Alteration:	None	0	
Bank Erosion:	Active	1	
BEHI:	Extreme (48.05)	1.5	
Local NPSP:	Moderate Potential	1	
Shoring Structures:	None	0	
Pipe Discharge:	None	0	
Water Odor:	Normal	0	
Fish Passage Barrier:	None	0	
RB: Riparian Buffer:	100 ft.	0	
LB: Riparian Buffer:	40 ft.	0.5	
RB: Floodplain Access:	Full	0	
LB: Floodplain Access:	Full	0	
<b>Severity Scale:</b>		<b>4.0</b>	
Notes: Gardner Peace River Outpost takeout point; 303d: Impaired - Aquatic Life Harvesting (fecal coliform, mercury in fish tissue)			
Restoration Option 2

Additional Site Features
Stream Channel Woody Material: Moderate
Impoundments: None
Substrate Composition: Medium Sand/Silt
Bank Material: Sand
Near Bank Stress: Low
RB Landuse: Natural Forest
LB Landuse: Recreation

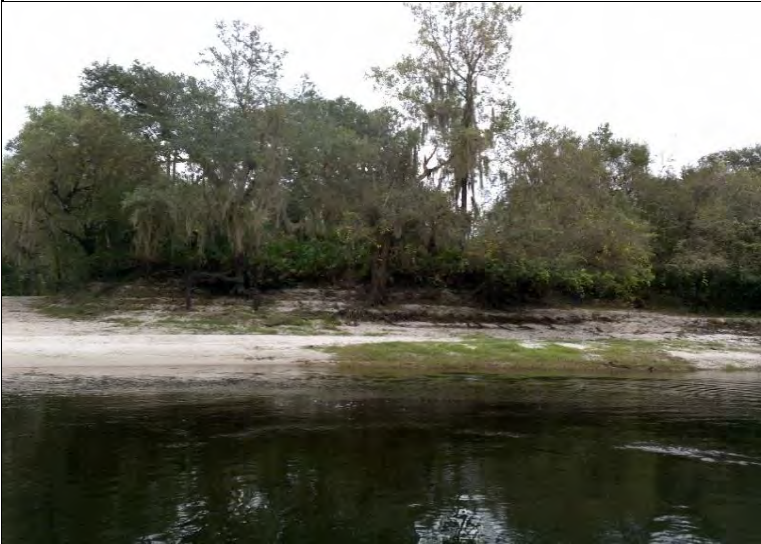
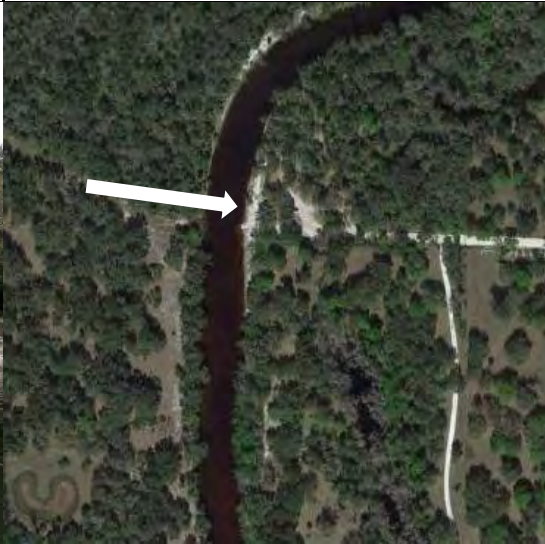
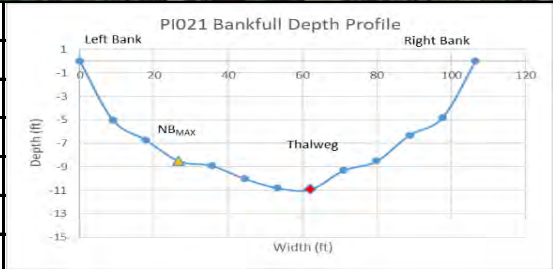
Peace River			Severity Scale: 4.5-Moderate
Watershed: Peace River Subwatershed: Peace River Branch Latitude: 27.34623 Longitude: -81.82635			County: Hardee Site Number: PI021 Reach Length: 93 ft. Landowner: Peace River Outpost Inc.

Risk Factor	Ranking	Score	
Pfankuch-Channel Stability:	Good	0	
Channel Alteration:	None	0	
Bank Erosion:	Active	1	
BEHI:	Very High (42.32)	1.5	
Local NPSP:	Obvious Sources	1.5	
Shoring Structures:	None	0	
Pipe Discharge:	None	0	
Water Odor:	Normal	0	
Fish Passage Barrier:	None	0	
RB: Riparian Buffer:	100 ft.	0	
LB: Riparian Buffer:	40 ft.	0.5	
RB: Floodplain Access:	Full	0	
LB: Floodplain Access:	Full	0	
<b>Severity Scale:</b>		<b>4.5</b>	
Notes: Gardner public boat ramp; unpaved road leading to boat launch is contributing a high sediment input, we estimated 96.3 C. Y. per rain event, 303d: Impaired - Aquatic Life Harvesting (fecal coliform, mercury in fish tissue)

Restoration Option 2

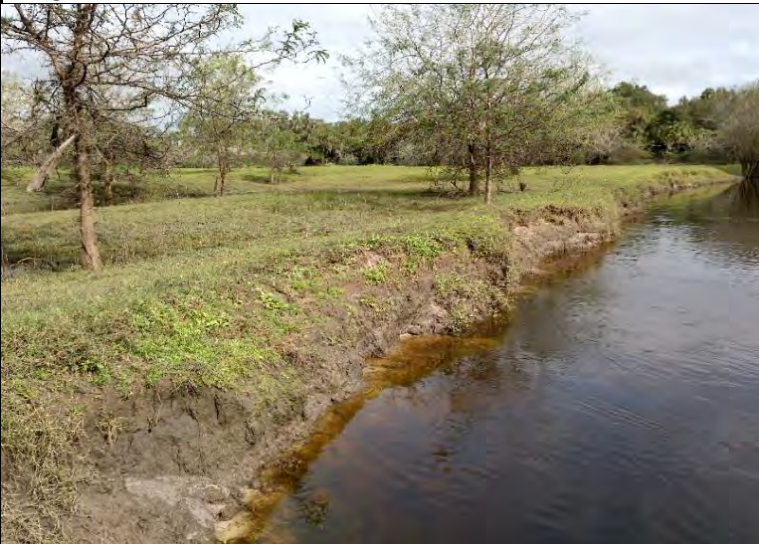
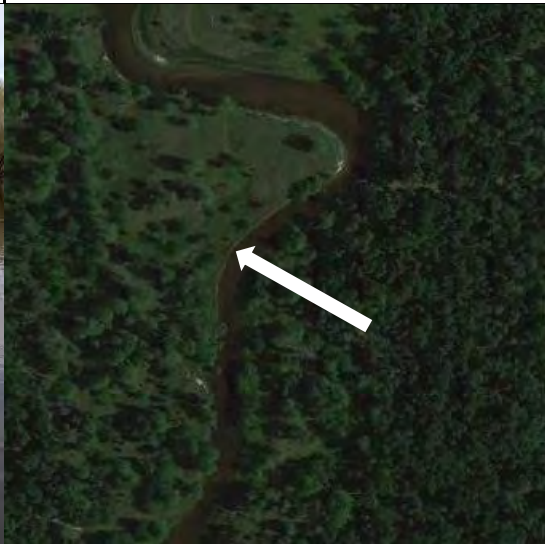
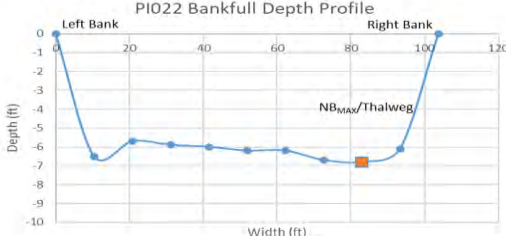
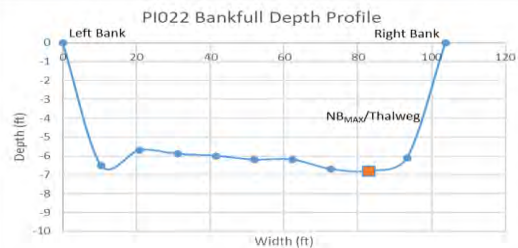
Peace River			Severity Scale: 5.75-Moderate	
Watershed: Peace River Subwatershed: Peace River Branch Latitude: 27.38539 Longitude: -81.84366			County: Hardee Site Number: PI022 Reach Length: 195 ft. Landowner: Ben Hill Griffin Inc.

Pfankuch-Channel Stability:	Poor	1.5		
Channel Alteration:	None	0		
Bank Erosion:	Active	1		
BEHI:	Moderate (20.54)	0.5		
Local NPSP:	Obvious Sources	1.5		
Shoring Structures:	None	0		
Pipe Discharge:	None	0		
Water Odor:	Normal	0		
Fish Passage Barrier:	None	0		
RB: Riparian Buffer:	0 ft.	0.75	Additional Site Features	
LB: Riparian Buffer:	40 ft.	0.5	Stream Channel Woody Material: Moderate	
RB: Floodplain Access:	Full	0	Impoundments: None	
LB: Floodplain Access:	Full	0	Substrate Composition: Medium Sand	
Severity Scale: 5.75			Bank Material: Sand/Silt/Clay	
			Near Bank Stress: High	
			RB Landuse: Pasture	
			LB Landuse: Pasture, Natural Forest

Notes: Low lying pasture in floodplain with cattle access; Bank material very cohesive;				
303d: Impaired - Aquatic Life Harvesting (mercury in fish tissue)				
Restoration Option 1
