# **Peace River and Withlacoochee River Threats Assessments and Fish Assemblage Monitoring**

**Final Report July 1, 2015 – June 30, 2019**

Submitted to Florida State Wildlife Grants Program  
August 1, 2019  
PID: 98462501284

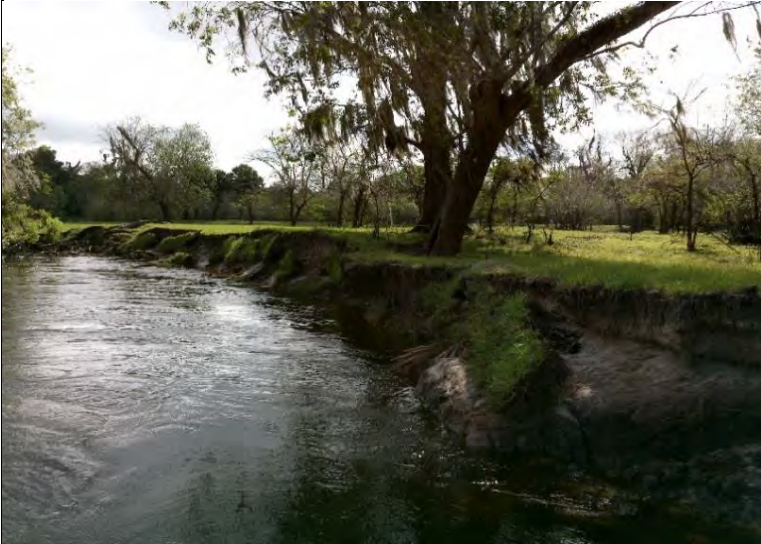
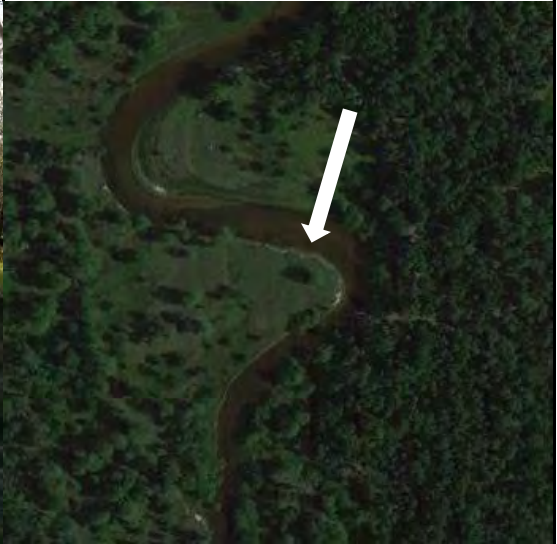
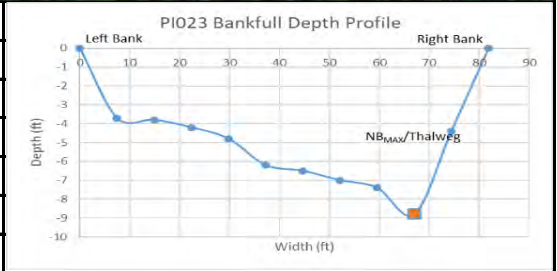
Peace River			Severity Scale: 7.5-High
Watershed: Peace River Subwatershed: Peace River Branch Latitude: 27.38657 Longitude: -81.84378			County: Hardee Site Number: PI023 Reach Length: 550 ft. Landowner: Ben Hill Griffin Inc.

Risk Factor	Ranking	Score	
Pfankuch-Channel Stability:	Poor	1.5	
Channel Alteration:	None	0	
Bank Erosion:	Mass-wasting	1.5	
BEHI:	Very High (41.32)	1.5	
Local NPSP:	Obvious Sources	1.5	
Shoring Structures:	None	0	
Pipe Discharge:	None	0	
Water Odor:	Normal	0	
Fish Passage Barrier:	None	0	
RB: Riparian Buffer:	0 ft.	0.75	
LB: Riparian Buffer:	0 ft.	0.75	
RB: Floodplain Access:	Full	0	
LB: Floodplain Access:	Full	0	
Severity Scale:		7.5	
Notes: Cattle access; 303d: Impaired - Aquatic Life Harvesting (mercury in fish tissue)			
Restoration Option 1

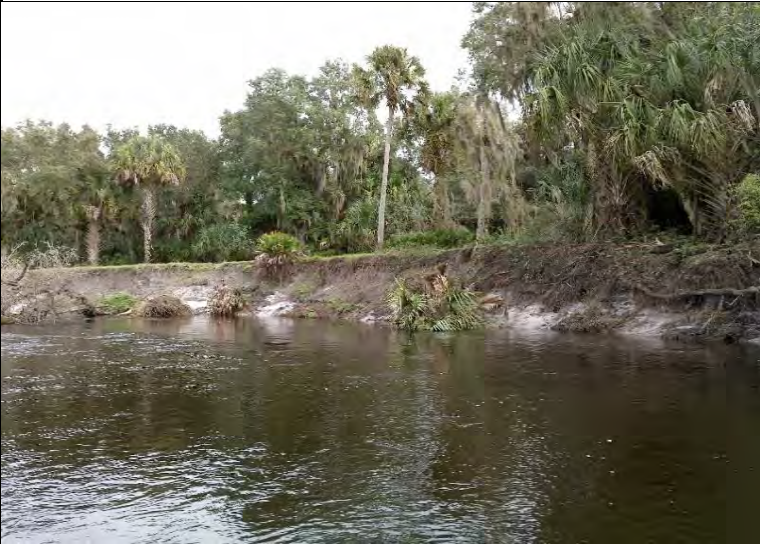
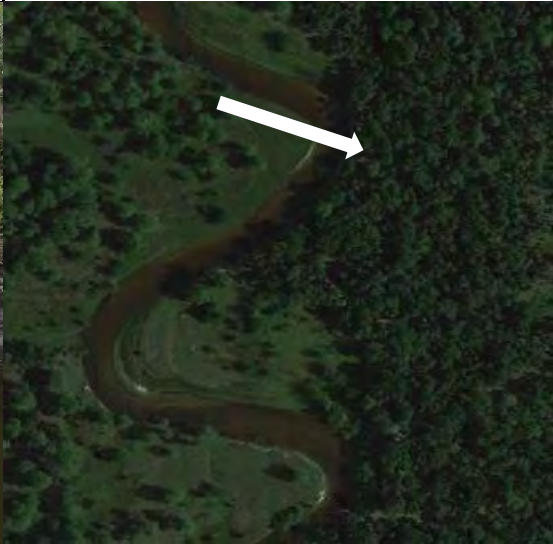
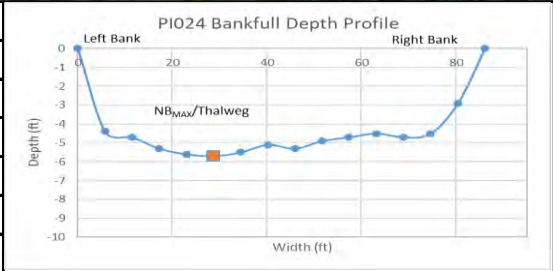
Peace River			Severity Scale: 6.5-Moderate
Watershed: Peace River Subwatershed: Peace River Branch Latitude: 27.38770 Longitude: -81.84354			County: Hardee Site Number: PI024 Reach Length: 380 ft. Landowner: Ben Hill Griffin Inc.

Risk Factor	Ranking	Score	
Pfankuch-Channel Stability:	Poor	1.5	
Channel Alteration:	None	0	
Bank Erosion:	Mass-wasting	1.5	
BEHI:	Very High (42.44)	1.5	
Local NPSP:	Slight Potential	0.5	
Shoring Structures:	None	0	
Pipe Discharge:	None	0	
Water Odor:	Normal	0	
Fish Passage Barrier:	None	0	
RB: Riparian Buffer:	0 ft.	0.75	
LB: Riparian Buffer:	40 ft.	0.5	
RB: Floodplain Access:	Full	0	
LB: Floodplain Access:	Partial	0.25	
Severity Scale:		6.5	
Notes: 303d: Impaired - Aquatic Life Harvesting (mercury in fish tissue)			
Restoration Option 1

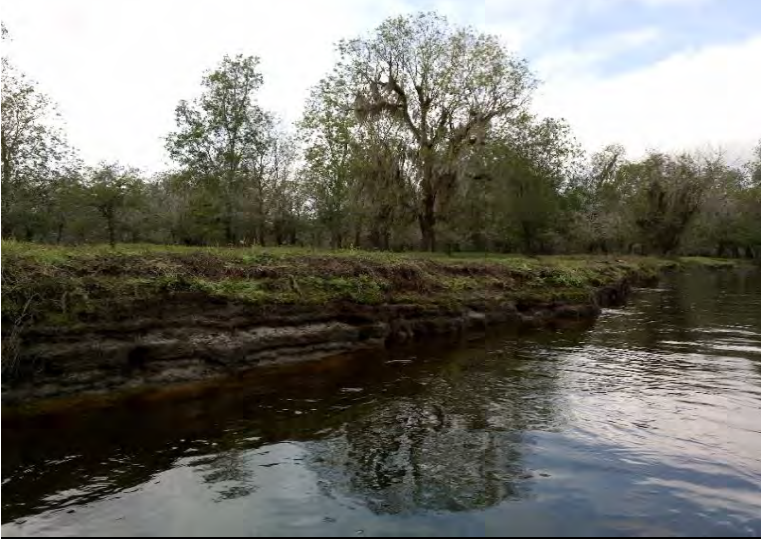
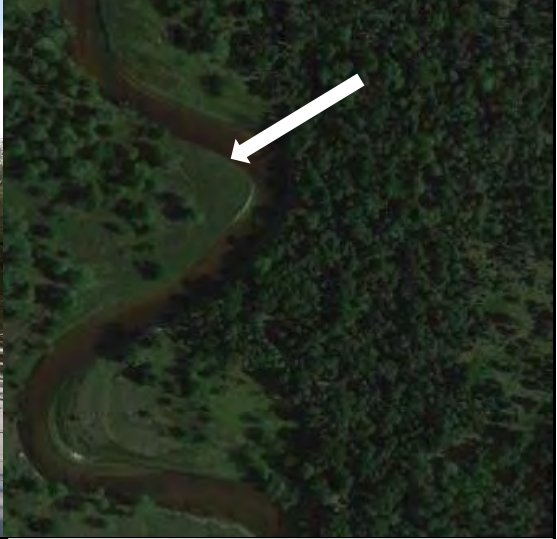
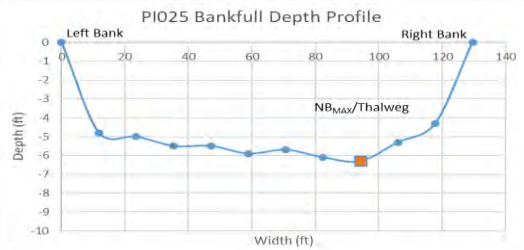
Peace River			Severity Scale: 5.75-Moderate
Watershed: Peace River Subwatershed: Peace River Branch Latitude: 27.38840 Longitude: -81.84299			County: Hardee Site Number: PI025 Reach Length: 456 ft. Landowner: Ben Hill Griffin Inc.

Risk Factor	Ranking	Score	
Pfankuch-Channel Stability:	Poor	1.5	
Channel Alteration:	None	0	
Bank Erosion:	Mass-wasting	1.5	
BEHI:	Moderate (26.32)	0.5	
Local NPSP:	Obvious Sources	1.5	
Shoring Structures:	None	0	
Pipe Discharge:	None	0	<b>Additional Site Features</b> Stream Channel Woody Material: Infrequent Impoundments: None Substrate Composition: Medium Sand Bank Material: Clay Near Bank Stress: High RB Landuse: Pasture LB Landuse: Natural Forest
Water Odor:	Normal	0	
Fish Passage Barrier:	None	0	
RB: Riparian Buffer:	0 ft.	0.75	
LB: Riparian Buffer:	100 ft.	0	
RB: Floodplain Access:	Full	0	
LB: Floodplain Access:	Full	0	
<b>Severity Scale:</b>		<b>5.75</b>	
Notes: Cattle access; 303d: Impaired - Aquatic Life Harvesting (mercury in fish tissue)

Restoration Option 1

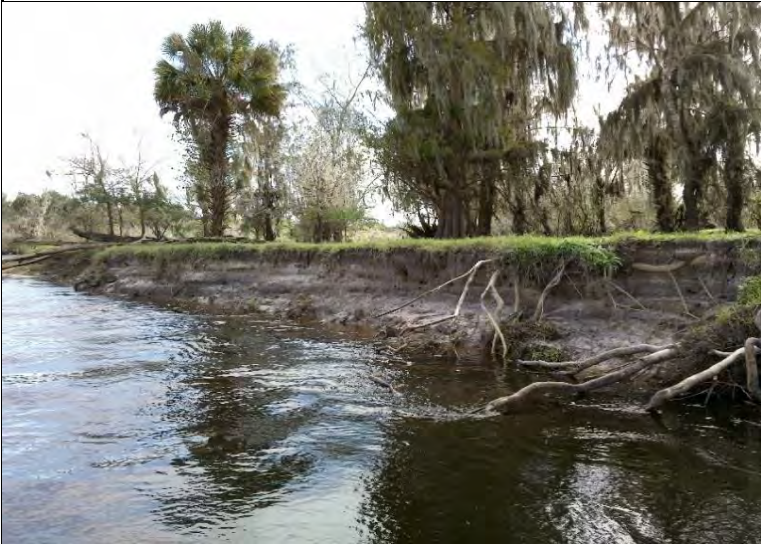
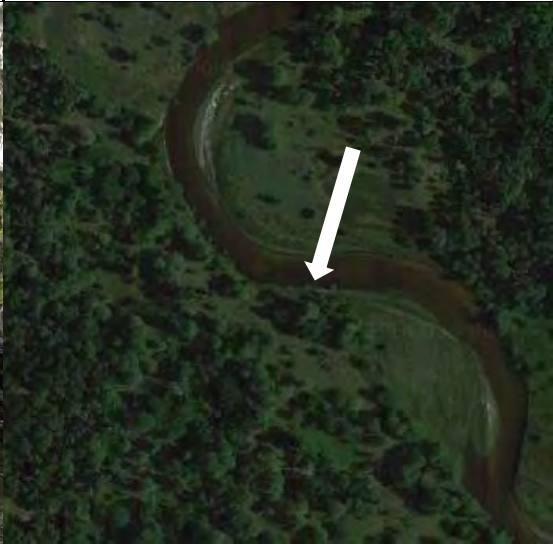
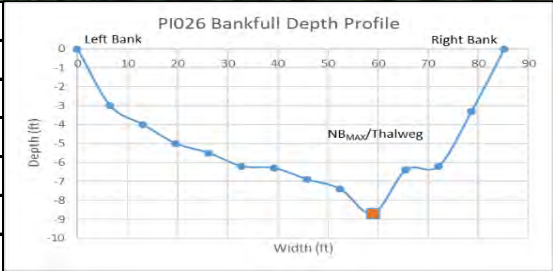
Peace River			Severity Scale: 7.5-High
Watershed: Peace River Subwatershed: Peace River Branch Latitude: 27.39195 Longitude: -81.84711			County: Hardee Site Number: PI026 Reach Length: 272 ft. Landowner: Ben Hill Griffin Inc.

Risk Factor	Ranking	Score	
Pfankuch-Channel Stability:	Poor	1.5	
Channel Alteration:	None	0	
Bank Erosion:	Mass-wasting	1.5	
BEHI:	Very High (40.81)	1.5	
Local NPSP:	Obvious Sources	1.5	
Shoring Structures:	None	0	
Pipe Discharge:	None	0	
Water Odor:	Normal	0	
Fish Passage Barrier:	None	0	
RB: Riparian Buffer:	0 ft.	0.75	
LB: Riparian Buffer:	0 ft.	0.75	
RB: Floodplain Access:	Full	0	
LB: Floodplain Access:	Full	0	
<b>Severity Scale:</b>		<b>7.5</b>	
Notes: Cattle access; 303d: Impaired - Aquatic Life Harvesting (mercury in fish tissue)			
Restoration Option 1

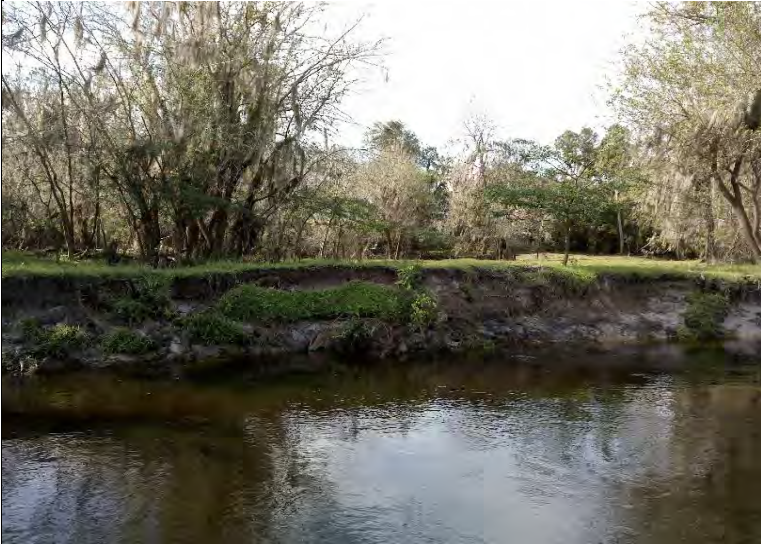
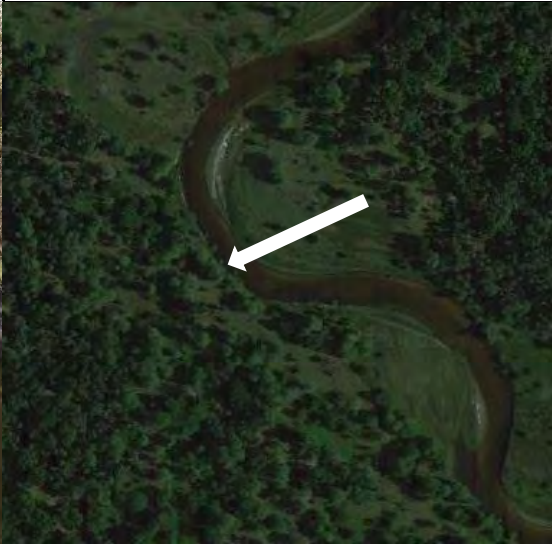
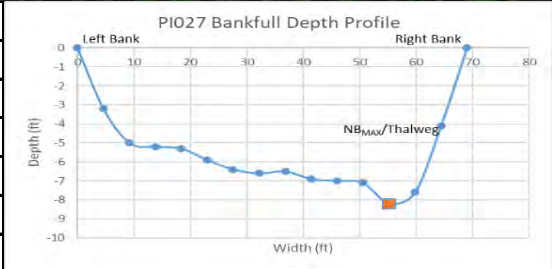
Peace River			Severity Scale: 6.25-Moderate
Watershed: Peace River Subwatershed: Peace River Branch Latitude: 27.39242 Longitude: -81.84794			County: Hardee Site Number: PI027 Reach Length: 117 ft. Landowner: Ben Hill Griffin Inc.

Risk Factor	Ranking	Score	
Pfankuch-Channel Stability:	Poor	1.5	
Channel Alteration:	None	0	
Bank Erosion:	Mass-wasting	1.5	
BEHI:	Moderate (28.39)	0.5	
Local NPSP:	Obvious Sources	1.5	
Shoring Structures:	None	0	
Pipe Discharge:	None	0	
Water Odor:	Normal	0	
Fish Passage Barrier:	None	0	
RB: Riparian Buffer:	40 ft.	0.5	
LB: Riparian Buffer:	0 ft.	0.75	
RB: Floodplain Access:	Full	0	
LB: Floodplain Access:	Full	0	
Severity Scale:		6.25	
Notes: 303d: Impaired - Aquatic Life Harvesting (mercury in fish tissue).			
Restoration Option 1

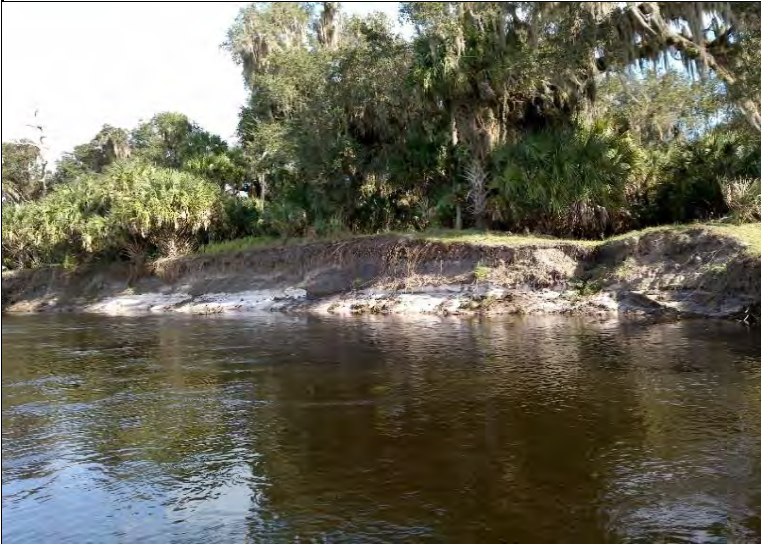
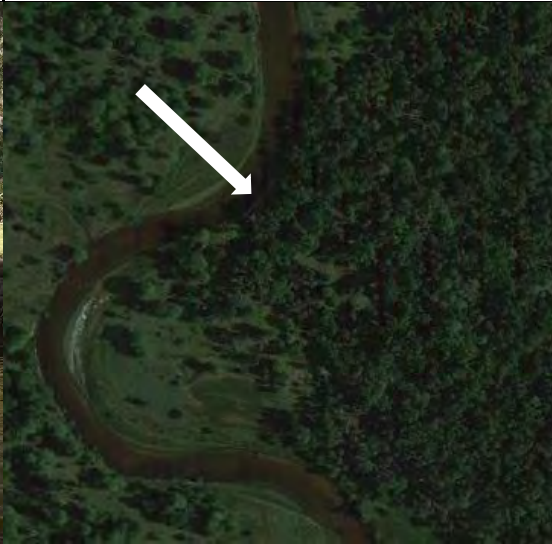
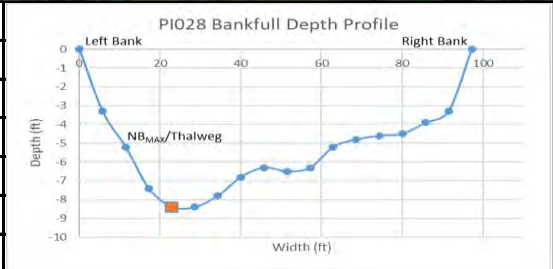
Peace River			Severity Scale: 6.75-Moderate
Watershed: Peace River Subwatershed: Peace River Branch Latitude: 27.39366 Longitude: -81.84698			County: Hardee Site Number: PI028 Reach Length: 295 ft. Landowner: Ben Hill Griffin Inc.

Risk Factor	Ranking	Score	
Pfankuch-Channel Stability:	Poor	1.5	
Channel Alteration:	None	0	
Bank Erosion:	Mass-wasting	1.5	
BEHI:	High (32.71)	1	
Local NPSP:	Obvious Sources	1.5	
Shoring Structures:	None	0	
Pipe Discharge:	None	0	
Water Odor:	Normal	0	
Fish Passage Barrier:	None	0	
RB: Riparian Buffer:	0 ft.	0.75	
LB: Riparian Buffer:	75 ft.	0.25	
RB: Floodplain Access:	Full	0	
LB: Floodplain Access:	Partial	0.25	
Severity Scale:		6.75	
Notes: Intact forested riparian buffer; 303d: Impaired - Aquatic Life Harvesting (mercury in fish mercury in fish tissue)			
Restoration Option 1

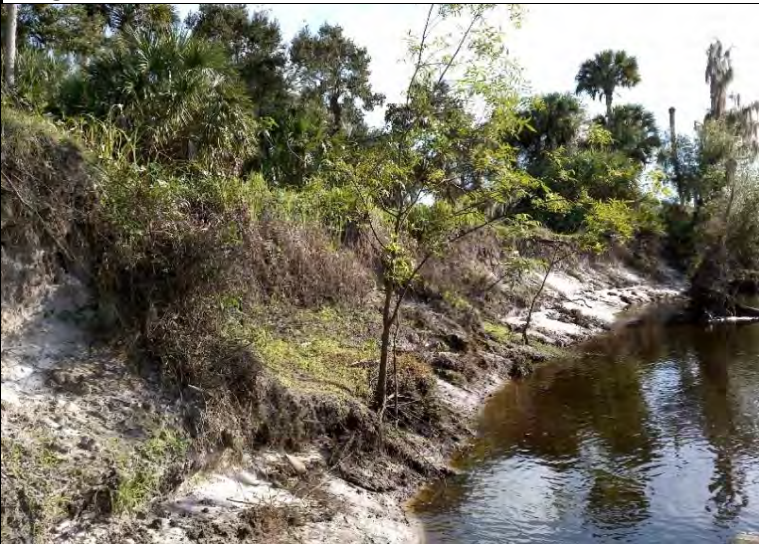
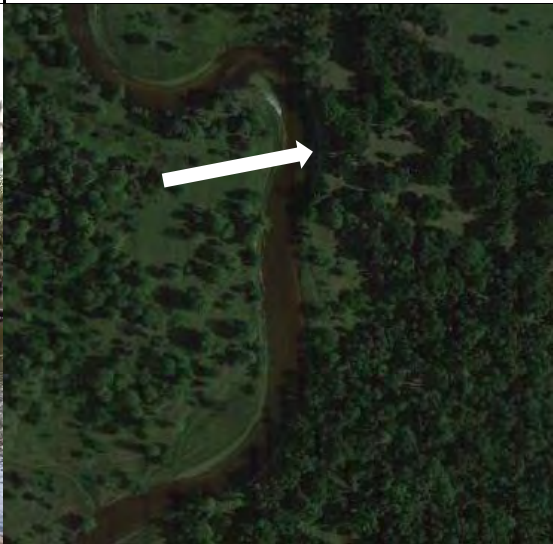
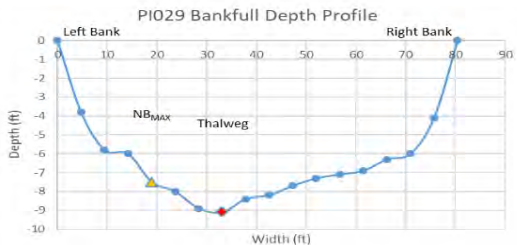
Peace River			Severity Scale: 5.5-Moderate	
Watershed: Peace River Subwatershed: Peace River Branch Latitude: 27.39568 Longitude: -81.84643			County: Hardee Site Number: PI029 Reach Length: 182 ft. Landowner: Ben Hill Griffin Inc.

Pfankuch-Channel Stability:	Poor	1.5		
Channel Alteration:	None	0		
Bank Erosion:	Active	1		
BEHI:	High (35.73)	1		
Local NPSP:	Slight Potential	0.5		
Shoring Structures:	None	0		
Pipe Discharge:	None	0		
Water Odor:	Normal	0		
Fish Passage Barrier:	None	0		
RB: Riparian Buffer:	0 ft.	0.75	<b>Additional Site Features</b> Stream Channel Woody Material: Extensive Impoundments: None Substrate Composition: Medium Sand Bank Material: Sand Near Bank Stress: Moderate RB Landuse: Pasture, Natural Forest LB Landuse: Pasture, Natural Forest	
LB: Riparian Buffer:	40 ft.	0.5		
RB: Floodplain Access:	Full	0		
LB: Floodplain Access:	Partial	0.25

<b>Severity Scale:</b>		<b>5.5</b>		
Notes: 303d: Impaired - Aquatic Life Harvesting (mercury in Fish tissue)				
Restoration Option 1

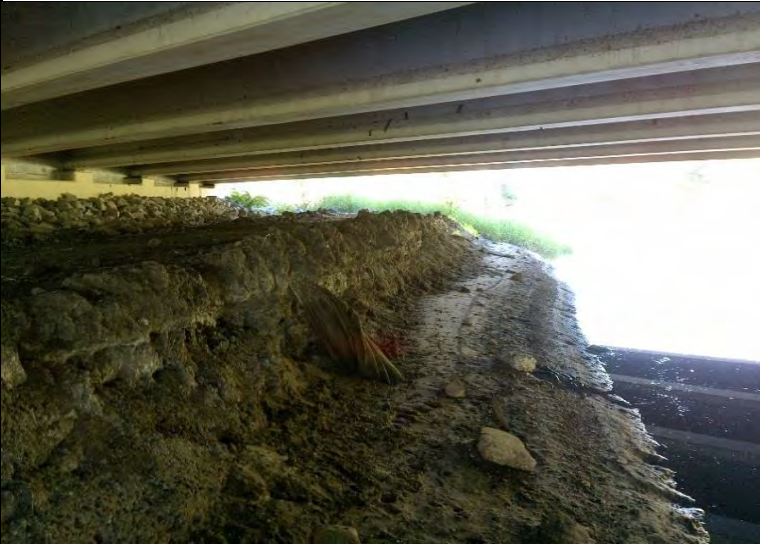
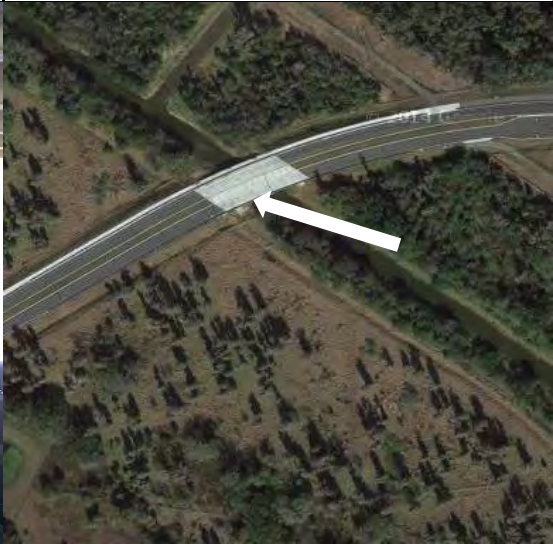
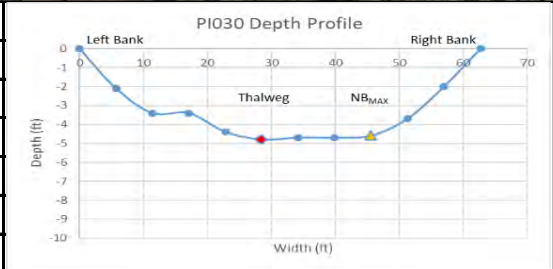
Peace River			Severity Scale: 7.0-Moderate
Watershed: Peace River Subwatershed: Lake Hancock Latitude: 27.92479 Longitude: -81.82983			County: Polk Site Number: PI030 Reach Length: 108 ft. Landowner: J K Stuart Properties LLC

Risk Factor	Ranking	Score	
Pfankuch-Channel Stability:	Good	0	
Channel Alteration:	Old Channelization	0.5	
Bank Erosion:	Active	1	
BEHI:	Extreme (47.85)	1.5	
Local NPSP:	Slight Potential	0.5	
Shoring Structures:	Present	1.5	
Pipe Discharge:	None	0	
Water Odor:	Normal	0	
Fish Passage Barrier:	None	0	
RB: Riparian Buffer:	0 ft.	0.75	
LB: Riparian Buffer:	0 ft.	0.75	
RB: Floodplain Access:	Partial	0.25	
LB: Floodplain Access:	Partial	0.25	
<b>Severity Scale:</b>		<b>7.0</b>	
Notes: Right bank near constructed wetland from Lake Hancock; 303d: Impaired - Aquatic Life Harvesting (Chlorofyll-A, DO, fecal coliform)			
Restoration Option 2

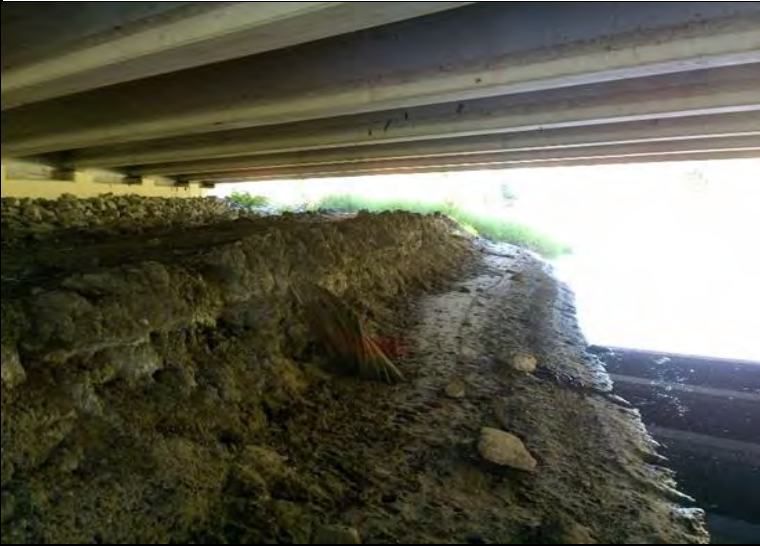
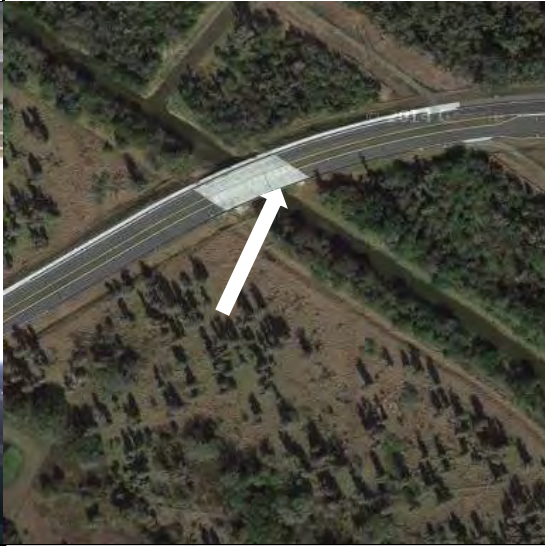
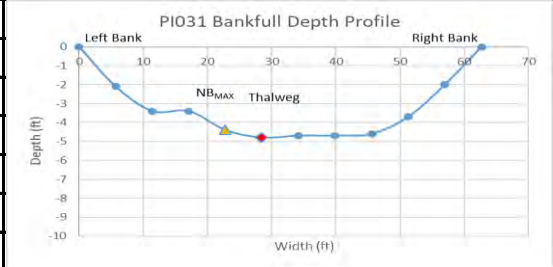
Peace River			Severity Scale: 7.0-Moderate
Watershed: Peace River Subwatershed: Lake Hancock Latitude: 27.92479 Longitude: -81.82983			County: Polk Site Number: PI031 Reach Length: 108 ft. Landowner: J K Stuart Properties LLC

Risk Factor	Ranking	Score	
Pfankuch-Channel Stability:	Good	0	
Channel Alteration:	Old Channelization	0.5	
Bank Erosion:	Active	1	
BEHI:	Very High (44.46)	1.5	
Local NPSP:	Slight Potential	0.5	
Shoring Structures:	Present	1.5	
Pipe Discharge:	None	0	
Water Odor:	Normal	0	
Fish Passage Barrier:	None	0	
RB: Riparian Buffer:	0 ft.	0.75	
LB: Riparian Buffer:	0 ft.	0.75	
RB: Floodplain Access:	Partial	0.25	
LB: Floodplain Access:	Partial	0.25	
<b>Severity Scale:</b>		<b>7.0</b>	
Notes: Left bank near constructed wetland from Lake Hancock; 303d: Impaired - Aquatic Life Harvesting (Chlorofyll-A, DO, fecal coliform)			
Restoration Option 2

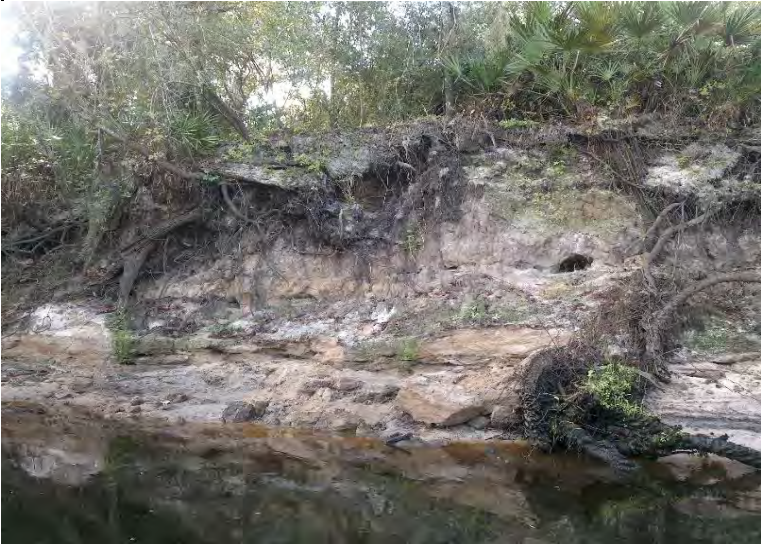
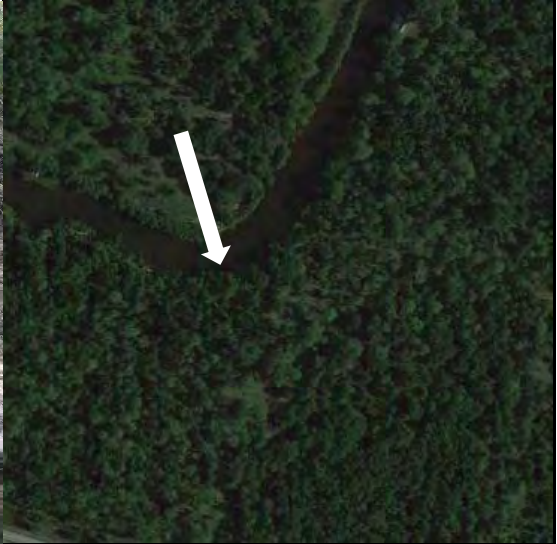
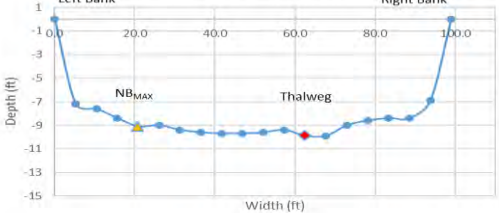
Peace River			Severity Scale: 4.0-Low
Watershed: Peace River Subwatershed: McBride Branch Latitude: 27.30298 Longitude: -81.84171			County: Desoto Site Number: PI032 Reach Length: 270 ft Landowner: Mildred Rosenthal

</div>
Pfankuch-Channel Stability:	Good	0	
Channel Alteration:	None	0	
Bank Erosion:	Mass-wasting	1.5	
BEHI:	High (38.49)	1	
Local NPSP:	Slight Potential	0.5	
Shoring Structures:	None	0	
Pipe Discharge:	None	0	
Water Odor:	Normal	0	
Fish Passage Barrier:	None	0	
RB: Riparian Buffer:	20 ft.	0.75	
LB: Riparian Buffer:	100 ft.	0	
RB: Floodplain Access:	Full	0	
LB: Floodplain Access:	Partial	0.25	
<b>Severity Scale:</b>		<b>4.0</b>	
Notes: 303d: Impaired - Aquatic Life Harvesting (fecal coliform, mercury in Fish tissue)			<b>Additional Site Features</b>
			Stream Channel Woody Material: Moderate
			Impoundments: None
			Substrate Composition: Medium Sand

Bank Material: Sand
			Near Bank Stress: Low
			RB Landuse: Pasture, Natural Forest
			LB Landuse: Natural Forest
Restoration Option 1

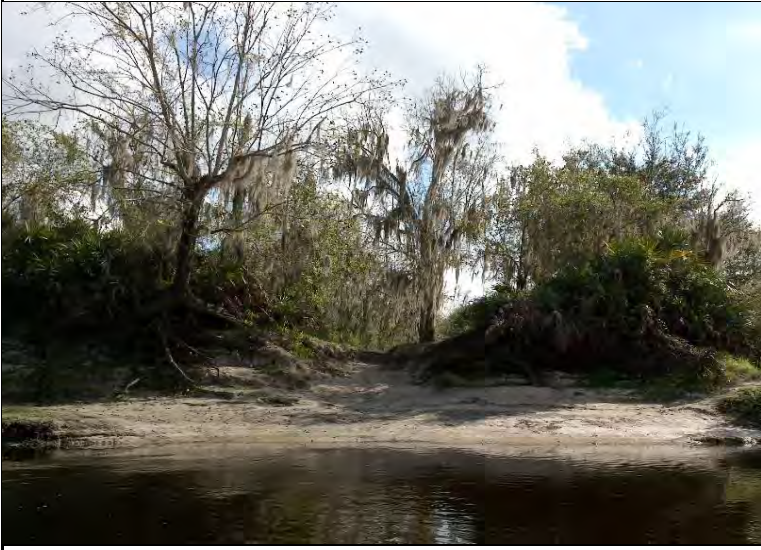
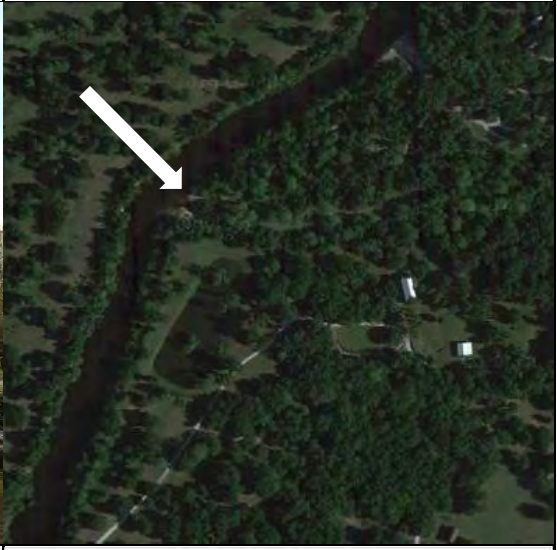
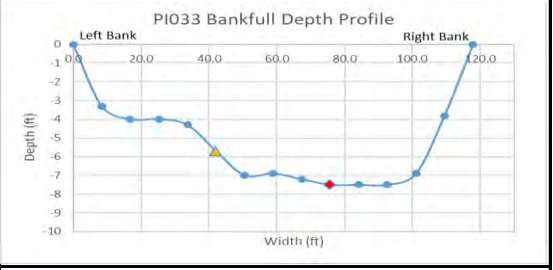
Peace River			Severity Scale: 4.0-Low
Watershed: Peace River Subwatershed: McBride Branch Latitude: 27.29677 Longitude: -81.84797			County: Desoto Site Number: PI033 Reach Length: 34 ft. Landowner: Desoto County

Pfankuch-Channel Stability:	Good	0	
Channel Alteration:	None	0	
Bank Erosion:	Active	1	
BEHI:	High (37.15)	1	
Local NPSP:	Slight Potential	0.5	
Shoring Structures:	None	0	
Pipe Discharge:	None	0	
Water Odor:	Normal	0	
Fish Passage Barrier:	None	0	
RB: Riparian Buffer:	40 ft.	0.5	Additional Site Features
LB: Riparian Buffer:	15 ft.	0.75	
RB: Floodplain Access:	Partial	0.25	
LB: Floodplain Access:	Full	0	
Severity Scale:		4.0	
Notes: Fishing access at Brownville Park; 303d: Impaired - Aquatic Life Harvesting (fecal coliform, mercury in fish tissue)			Stream Channel Woody Material: None
Restoration Option 2 or 3			Impoundments: None
			Substrate Composition: Sand, Gravel, Bedrock

Bank Material: Sand
			Near Bank Stress: Low
			RB Landuse: Pasture, Natural Forest
			LB Landuse: Recreational Use, Natural Forest

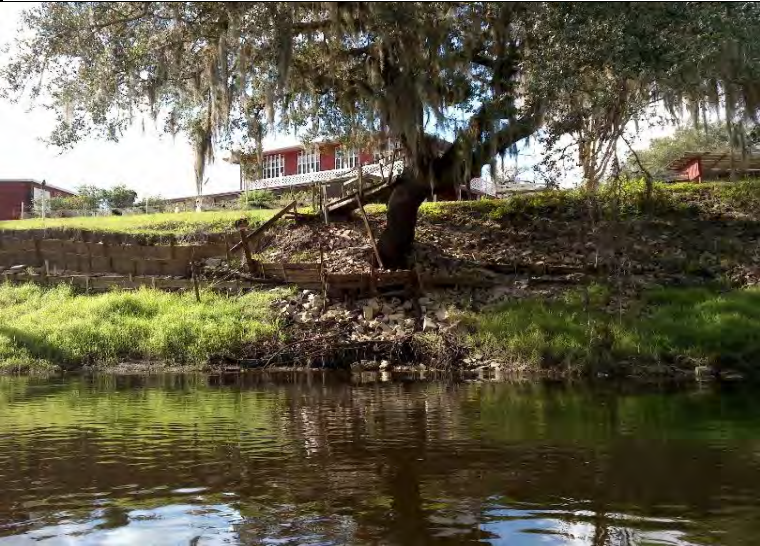
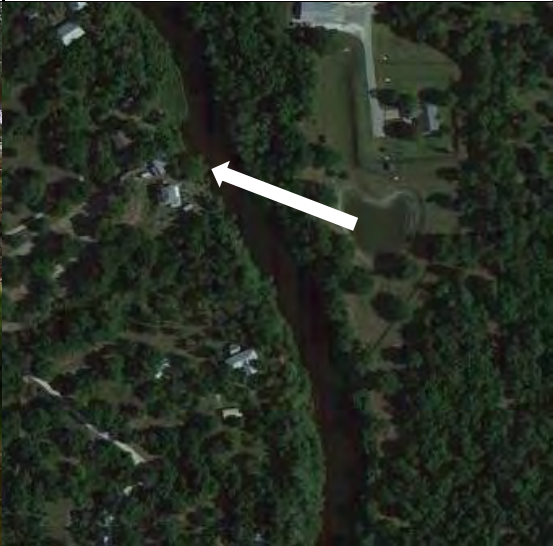
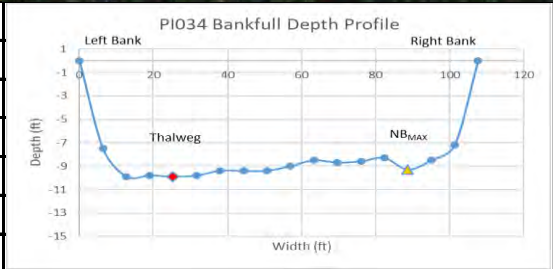
Peace River			Severity Scale: 5.0-Moderate
Watershed: Peace River Subwatershed: McBride Branch Latitude: 27.28503 Longitude: -81.85720			County: Desoto Site Number: PI034 Reach Length: 140 ft. Landowner: Rose Mary Peters

Risk Factor	Ranking	Score	
Pfankuch-Channel Stability:	Good	0	
Channel Alteration:	None	0	
Bank Erosion:	Historic	0.5	
BEHI:	High (30.63)	1	
Local NPSP:	Moderate Potential	1	
Shoring Structures:	Present	1.5	
Pipe Discharge:	None	0	
Water Odor:	Normal	0	
Fish Passage Barrier:	None	0	
RB: Riparian Buffer:	0 ft.	0.75	
LB: Riparian Buffer:	100 ft.	0	
RB: Floodplain Access:	Partial	0.25	
LB: Floodplain Access:	Full	0	
<b>Severity Scale:</b>		<b>5.0</b>	
Notes: House at top of bank; 303d: Impaired - Aquatic Life Harvesting (fecal coliform, mercury in fish tissue)			
Restoration Option 1 or 2

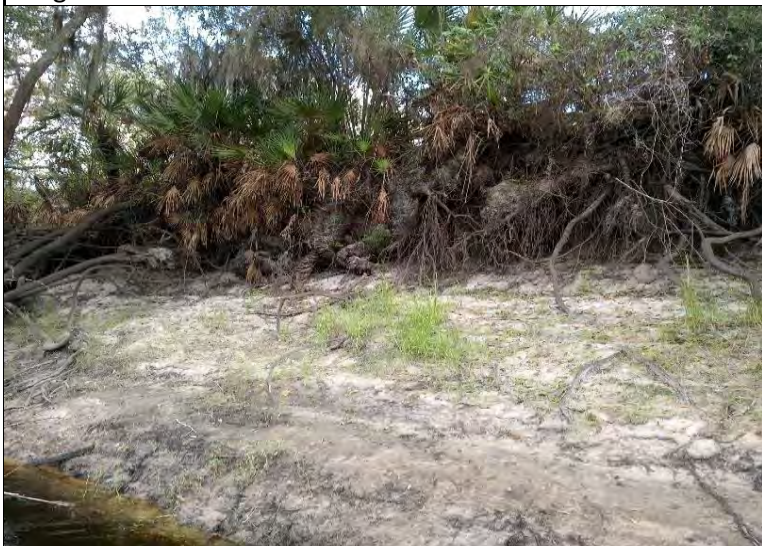
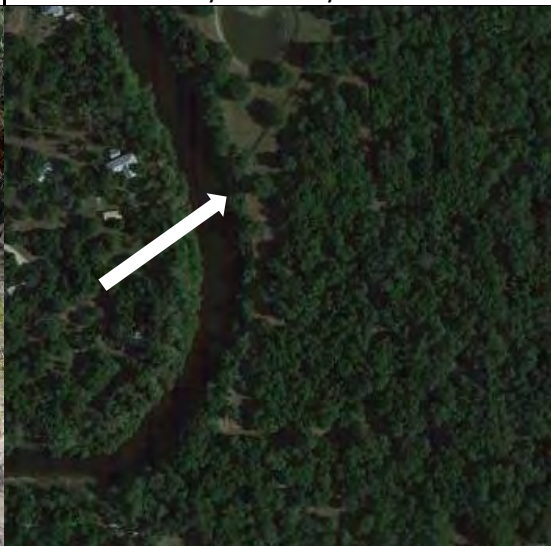
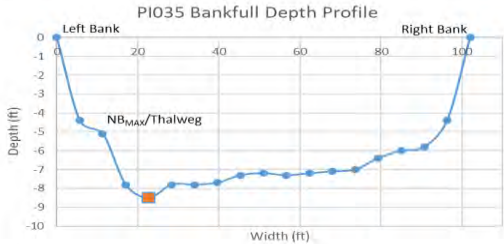
Peace River			Severity Scale: 3.25-Low	
Watershed: Peace River Subwatershed: McBride Branch Latitude: 27.28351 Longitude: -81.85602			County: Desoto Site Number: PI035 Reach Length: 95 ft. Landowner: Larry & Wendy Vinson

Pfankuch-Channel Stability:	Good	0		
Channel Alteration:	None	0		
Bank Erosion:	Active	1		
BEHI:	Moderate (29.73)	0.5		
Local NPSP:	Moderate Potential	1		
Shoring Structures:	None	0		
Pipe Discharge:	None	0		
Water Odor:	Normal	0		
Fish Passage Barrier:	None	0		
RB: Riparian Buffer:	100 ft.	0	<b>Additional Site Features</b>	
LB: Riparian Buffer:	40 ft.	0.5	Stream Channel Woody Material: Moderate	
RB: Floodplain Access:	Full	0	Impoundments: None	
LB: Floodplain Access:	Partial	0.25	Substrate Composition: Medium Sand	
Severity Scale:		3.25	Bank Material: Sand	
			Near Bank Stress: High	
			RB Landuse: Natural Forest	
			LB Landuse: Pasture, Natural Forest

Notes: 303d: Impaired - Aquatic Life Harvesting (fecal coliform, mercury in Fish tissue)				
Restoration Option 1

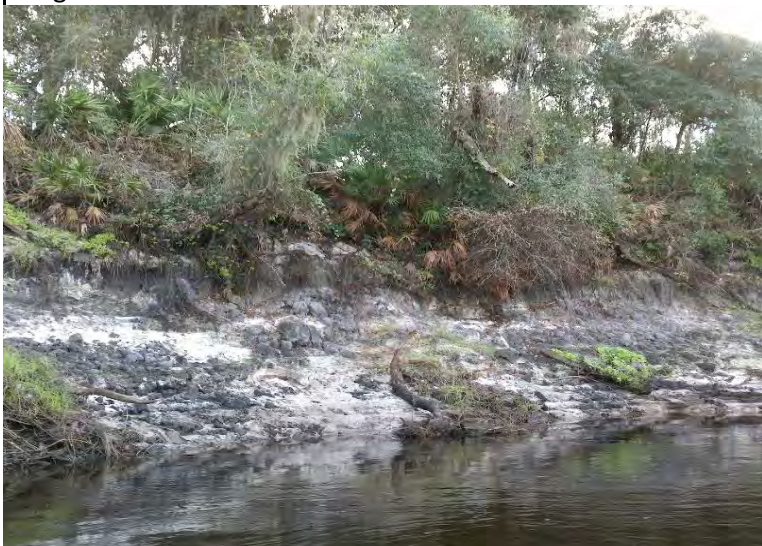
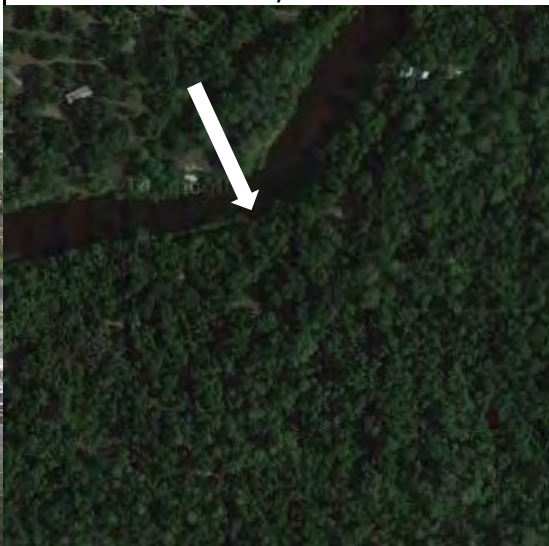
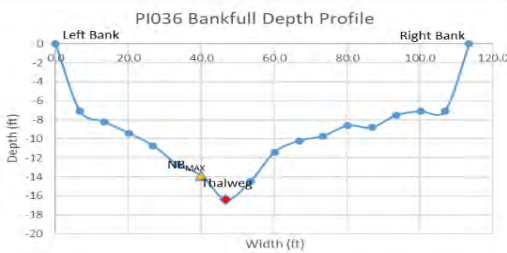
Peace River			Severity Scale: 3.25-Low	
Watershed: Peace River Subwatershed: McBride Branch Latitude: 27.26983 Longitude: -81.85934			County: Desoto Site Number: PI036 Reach Length: 55 ft. Landowner: Colleen Hyre

Pfankuch-Channel Stability:	Good	0		
Channel Alteration:	None	0		
Bank Erosion:	Mass-wasting	1.5		
BEHI:	Very High (41.19)	1.5		
Local NPSP:	No Evidence	0		
Shoring Structures:	None	0		
Pipe Discharge:	None	0		
Water Odor:	Normal	0		
Fish Passage Barrier:	None	0		
RB: Riparian Buffer:	100 ft.	0	Additional Site Features	
LB: Riparian Buffer:	100 ft.	0	Stream Channel Woody Material: Infrequent	
RB: Floodplain Access:	Full	0	Impoundments: None	
LB: Floodplain Access:	Partial	0.25	Substrate Composition: Medium Sand	
Severity Scale:		3.25	Bank Material: Sand	
			Near Bank Stress: Moderate	
			RB Landuse: Natural Forest	
			LB Landuse: Natural Forest	
Notes: 303d: Impaired - Aquatic Life Harvesting (fecal coliform, mercury in fish tissue)

Restoration Option 1

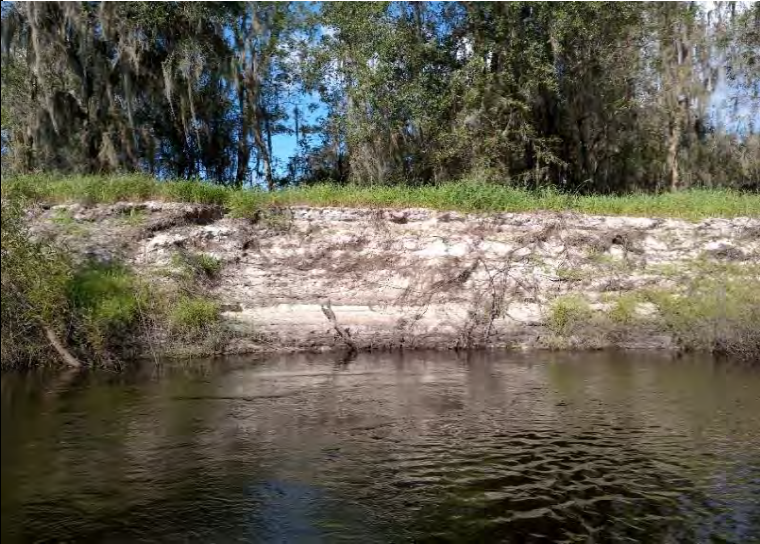
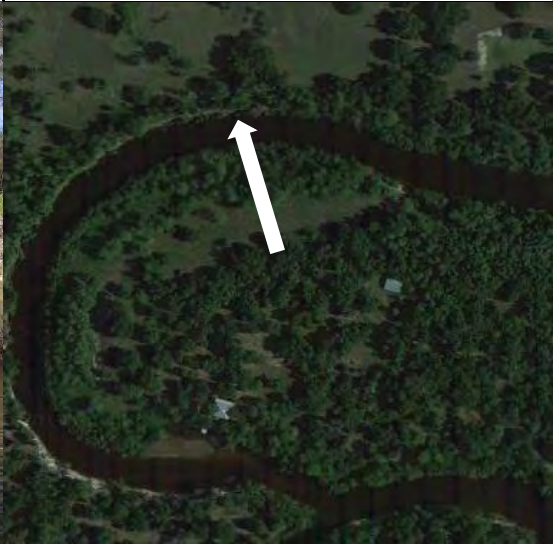
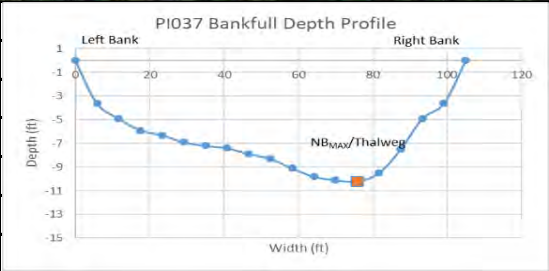
Peace River			Severity Scale: 4.0-Low
Watershed: Peace River Subwatershed: McBride Branch Latitude: 27.26996 Longitude: -81.86546			County: Desoto Site Number: PI037 Reach Length: 65 ft. Landowner: Fort Desoto LLC

Risk Factor	Ranking	Score	
Pfankuch-Channel Stability:	Good	0	
Channel Alteration:	None	0	
Bank Erosion:	Active	1	
BEHI:	Moderate (29.64)	0.5	
Local NPSP:	Obvious Sources	1.5	
Shoring Structures:	None	0	
Pipe Discharge:	None	0	<b>Additional Site Features</b> Stream Channel Woody Material: Moderate Impoundments: None Substrate Composition: Medium Sand Bank Material: Sand Near Bank Stress: High RB Landuse: Pasture, Natural Forest LB Landuse: Natural Forest
Water Odor:	Normal	0	
Fish Passage Barrier:	None	0	
RB: Riparian Buffer:	20 ft.	0.75	
LB: Riparian Buffer:	100 ft.	0	
RB: Floodplain Access:	Partial	0.25	
LB: Floodplain Access:	Full	0	
<b>Severity Scale:</b>		<b>4.0</b>	
Notes: 303d: Impaired - Aquatic Life Harvesting (fecal coliform, mercury in fish tissue)

Restoration Option 1

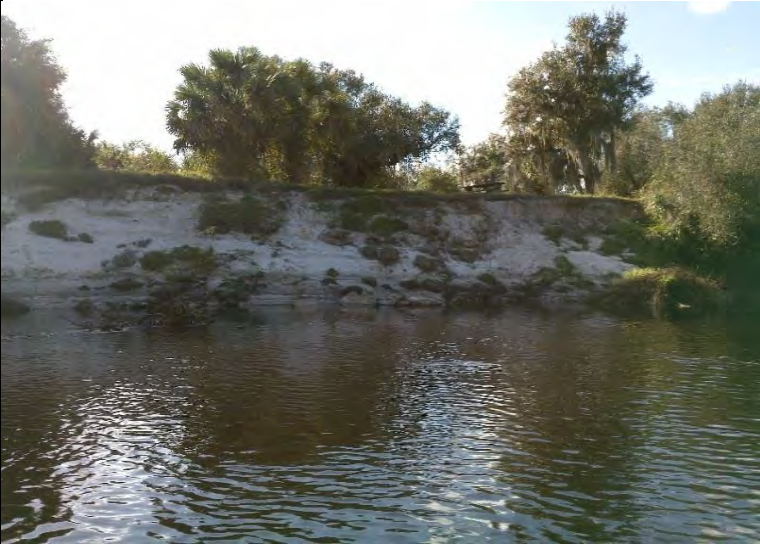
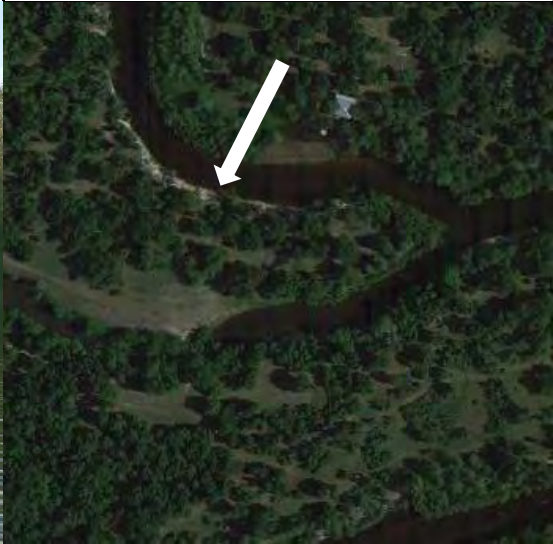
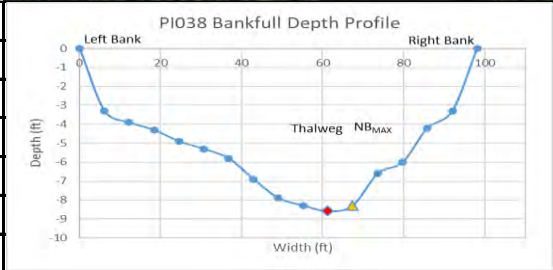
Peace River			Severity Scale: 4.5-Moderate
Watershed: Peace River Subwatershed: McBride Branch Latitude: 27.26735 Longitude: -81.86597			County: Desoto Site Number: PI038 Reach Length: 410 ft. Landowner: Charlotte Bragg

Risk Factor	Ranking	Score	
Pfankuch-Channel Stability:	Good	0	
Channel Alteration:	None	0	
Bank Erosion:	Mass-wasting	1.5	
BEHI:	Very High (43.25)	1.5	
Local NPSP:	Slight Potential	0.5	
Shoring Structures:	None	0	
Pipe Discharge:	None	0	
Water Odor:	Normal	0	
Fish Passage Barrier:	None	0	
RB: Riparian Buffer:	20 ft.	0.75	
LB: Riparian Buffer:	100 ft	0	
RB: Floodplain Access:	Partial	0.25	
LB: Floodplain Access:	Full	0	
Severity Scale:		4.5

Notes: Canoe outpost-looks like historic pasture; 303d: Impaired - Aquatic Life Harvesting (fecal coliform, mercury in fish tissue)			
Restoration Option 1

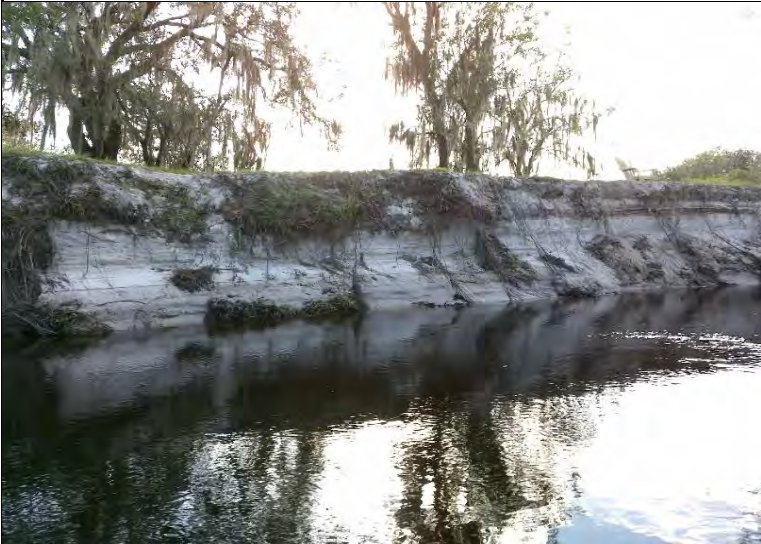
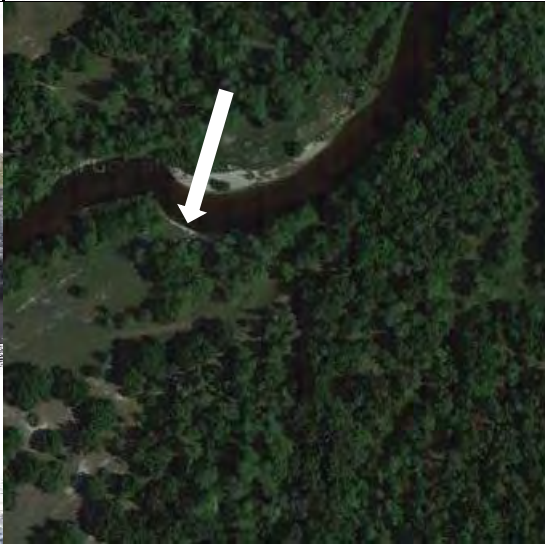
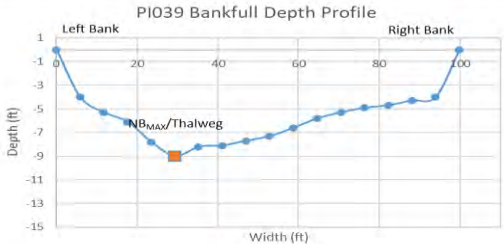
Peace River			Severity Scale: 4.0-Low
Watershed: Peace River Subwatershed: McBride Branch Latitude: 27.25678 Longitude: -81.87133			County: Desoto Site Number: PI039 Reach Length: 65 ft. Landowner: Dana & Kathy Simonson

Pfankuch-Channel Stability:	Good	0	
Channel Alteration:	None	0	
Bank Erosion:	Mass-wasting	1.5	
BEHI:	Very High (41.78)	1.5	
Local NPSP:	No Evidence	0	
Shoring Structures:	None	0	
Pipe Discharge:	None	0	
Water Odor:	Normal	0	
Fish Passage Barrier:	None	0	
RB: Riparian Buffer:	100 ft.	0	
LB: Riparian Buffer:	0 ft.	0.75	
RB: Floodplain Access:	Full	0	
LB: Floodplain Access:	Partial	0.25	
<b>Severity Scale:</b>		<b>4.0</b>	<b>Additional Site Features</b>
			Stream Channel Woody Material: Infrequent
			Impoundments: None
			Substrate Composition: Medium Sand
			Bank Material: Sand
			Near Bank Stress: High
			RB Landuse: Natural Forest
			LB Landuse: Historic Pasture, Natural Forest

Notes: 303d: Impaired - Aquatic Life Harvesting (fecal coliform, mercury in fish tissue)			
Restoration Option 1

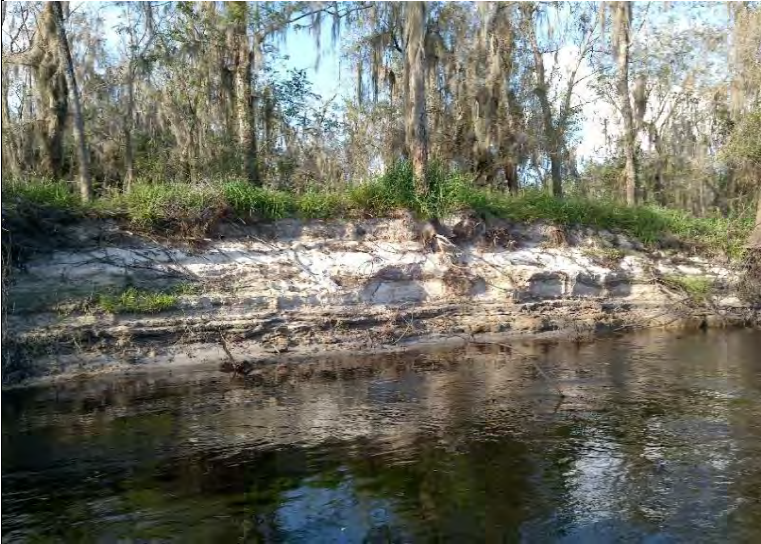
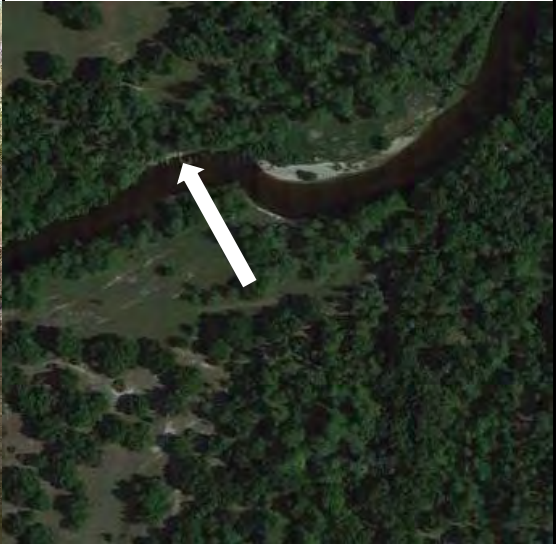
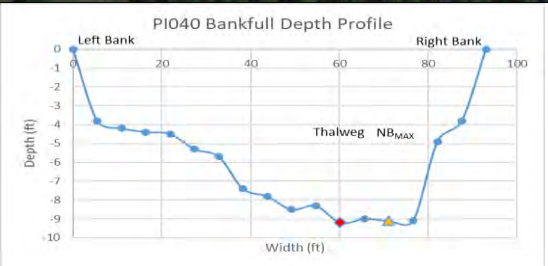
Peace River			Severity Scale: 5.25-Moderate
Watershed: Peace River Subwatershed: McBride Branch Latitude: 27.25682 Longitude: -81.87214			County: Desoto Site Number: PI040 Reach Length: 85 ft. Landowner: Elmer & Nancy Mott

Risk Factor	Ranking	Score	
Pfankuch-Channel Stability:	Good	0	
Channel Alteration:	None	0	
Bank Erosion:	Mass-wasting	1.5	
BEHI:	Very High (40.34)	1.5	
Local NPSP:	Moderate Potential	1	
Shoring Structures:	None	0	
Pipe Discharge:	None	0	
Water Odor:	Normal	0	
Fish Passage Barrier:	None	0	
RB: Riparian Buffer:	40 ft.	0.5	
LB: Riparian Buffer:	40 ft.	0.5	
RB: Floodplain Access:	Partial	0.25	
LB: Floodplain Access:	Full	0	
<b>Severity Scale:</b>		<b>5.25</b>

LB Landuse: Historic Pasture, Natural Forest
Notes: 303d: Impaired - Aquatic Life Harvesting (fecal coliform, mercury in fish tissue)			
Restoration Option 1

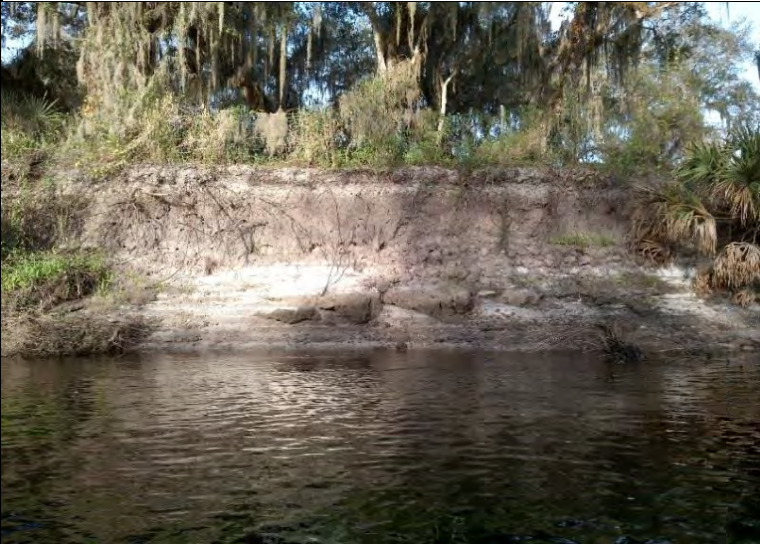
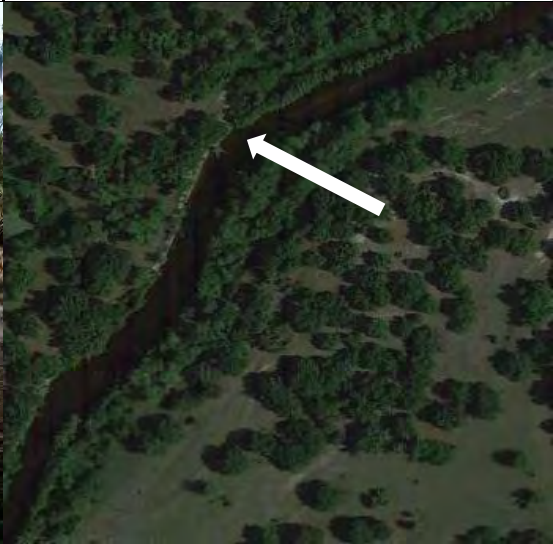
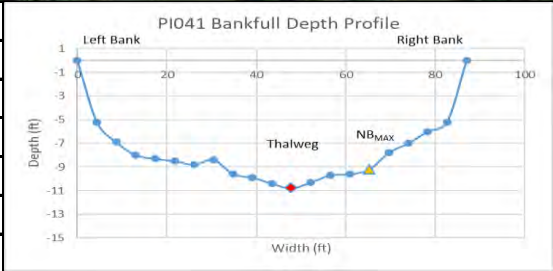
Peace River			Severity Scale: 5.0-Moderate
Watershed: Peace River Subwatershed: McBride Branch Latitude: 27.25590 Longitude: -81.87400			County: Desoto Site Number: PI041 Reach Length: 430 ft. Landowner: Constructora Limonar Inc.

Risk Factor	Ranking	Score	
Pfankuch-Channel Stability:	Good	0	
Channel Alteration:	None	0	
Bank Erosion:	Mass-wasting	1.5	
BEHI:	High (36.36)	1	
Local NPSP:	Obvious Sources	1.5	
Shoring Structures:	None	0	
Pipe Discharge:	None	0	
Water Odor:	Normal	0	
Fish Passage Barrier:	None	0	
RB: Riparian Buffer:	0 ft.	0.75	
LB: Riparian Buffer:	100 ft.	0	
RB: Floodplain Access:	Partial	0.25	
LB: Floodplain Access:	Full	0	
Severity Scale:		5.0	
Notes: 303d: Impaired - Aquatic Life Harvesting (fecal coliform, mercury in fish tissue)			
Restoration Option 1

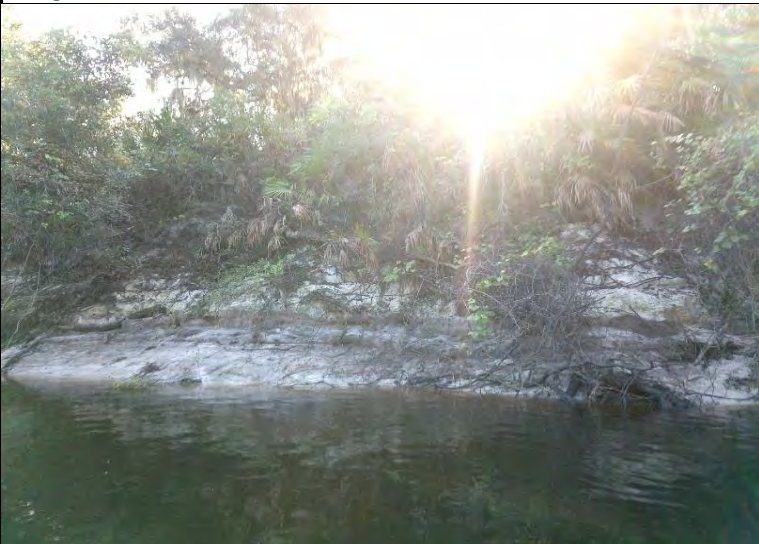
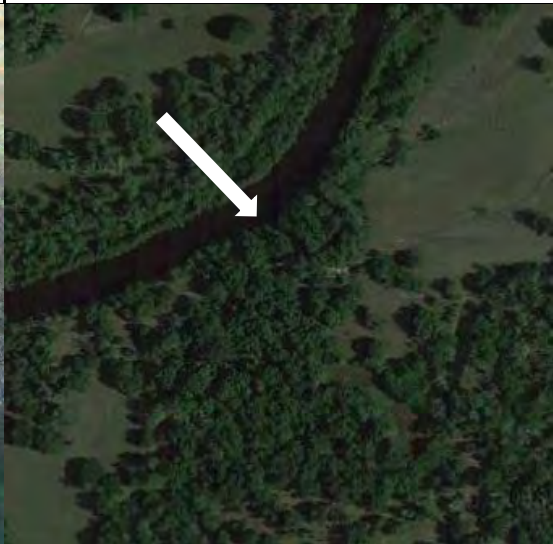
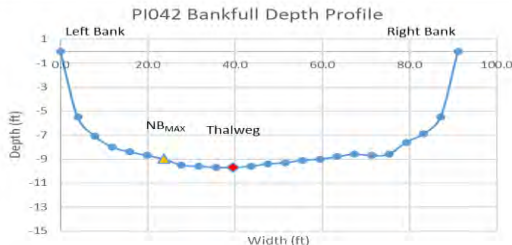
Peace River			Severity Scale: 1.75-Low	
Watershed: Peace River Subwatershed: McBride Branch Latitude: 27.25273 Longitude: -81.87607			County: Desoto Site Number: PI042 Reach Length: 160 ft. Landowner: Peace River Wildlife Sanct.

Pfankuch-Channel Stability:	Good	0		
Channel Alteration:	None	0		
Bank Erosion:	Active	1		
BEHI:	Moderate (28.16)	0.5		
Local NPSP:	No Evidence	0		
Shoring Structures:	None	0		
Pipe Discharge:	None	0		
Water Odor:	Normal	0		
Fish Passage Barrier:	None	0		
RB: Riparian Buffer:	100 ft.	0		
LB: Riparian Buffer:	100 ft.	0		
RB: Floodplain Access:	Full	0		
LB: Floodplain Access:	Partial	0.25		
Severity Scale:		1.75		
Notes: 303d: Impaired - Aquatic Life Harvesting (fecal coliform, mercury in fish tissue)			<b>Additional Site Features</b> Stream Channel Woody Material: Moderate Impoundments: None Substrate Composition: Medium Sand Bank Material: Sand Near Bank Stress: Moderate RB Landuse: Natural Forest LB Landuse: Natural Forest

Restoration Option 1
