# **Peace River and Withlacoochee River Threats Assessments and Fish Assemblage Monitoring**

**Final Report July 1, 2015 – June 30, 2019**

Submitted to Florida State Wildlife Grants Program  
August 1, 2019  
PID: 98462501284

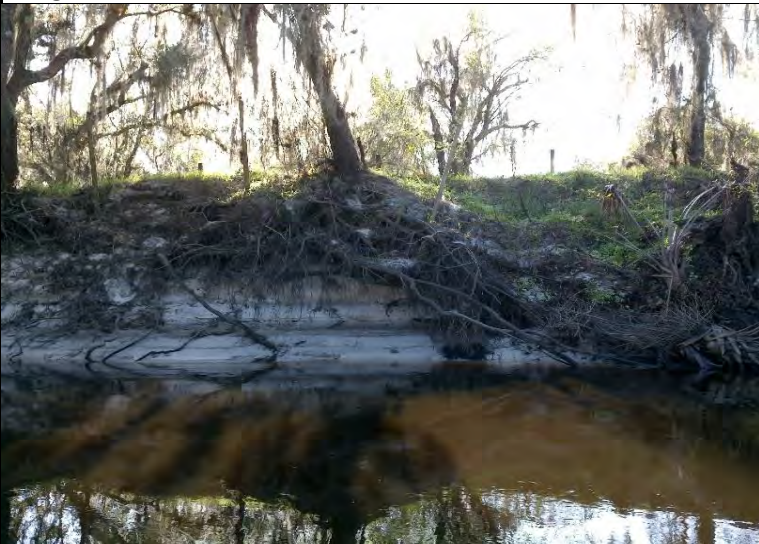
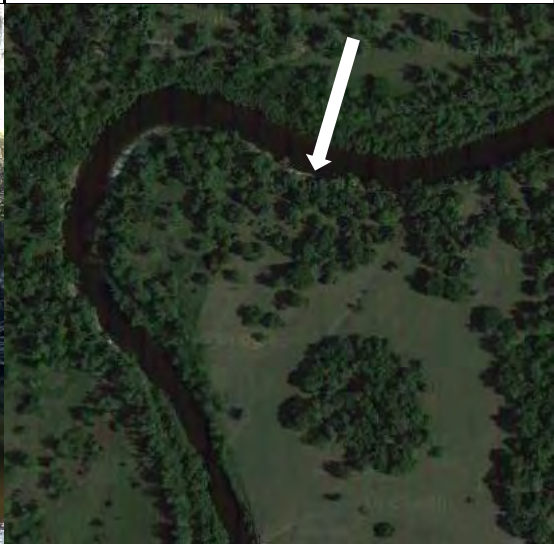
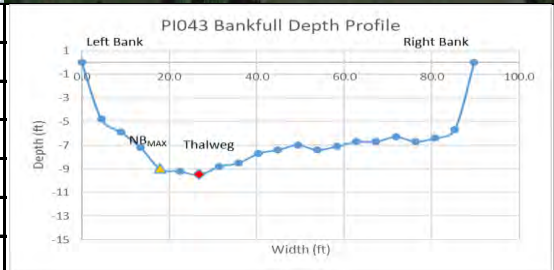
Peace River			Severity Scale: 3.75-Low	
Watershed: Peace River Subwatershed: McBride Branch Latitude: 27.25214 Longitude: -81.87852			County: Desoto Site Number: PI043 Reach Length: 145 ft. Landowner: Peace River Wildlife Sanct.

Pfankuch-Channel Stability:	Good	0		
Channel Alteration:	None	0		
Bank Erosion:	Mass-wasting	1.5		
BEHI:	Moderate (25.8)	0.5		
Local NPSP:	Moderate Potential	1		
Shoring Structures:	None	0		
Pipe Discharge:	None	0		
Water Odor:	Normal	0		
Fish Passage Barrier:	None	0		
RB: Riparian Buffer:	100 ft.	0		
LB: Riparian Buffer:	40 ft.	0.5		
RB: Floodplain Access:	Full	0		
LB: Floodplain Access:	Partial	0.25		
Severity Scale:		3.75		
			Additional Site Features	
			Stream Channel Woody Material: Moderate	
			Impoundments: None	
			Substrate Composition: Medium Sand	
			Bank Material: Sand	
			Near Bank Stress: High	
			RB Landuse: Natural Forest

LB Landuse: Pasture, Natural Forest	
Notes: Three separate sites within reach - South site worked up; 303d: Impaired - Aquatic Life				
Harvesting (fecal coliform, mercury in fish tissue)				
Restoration Option 1

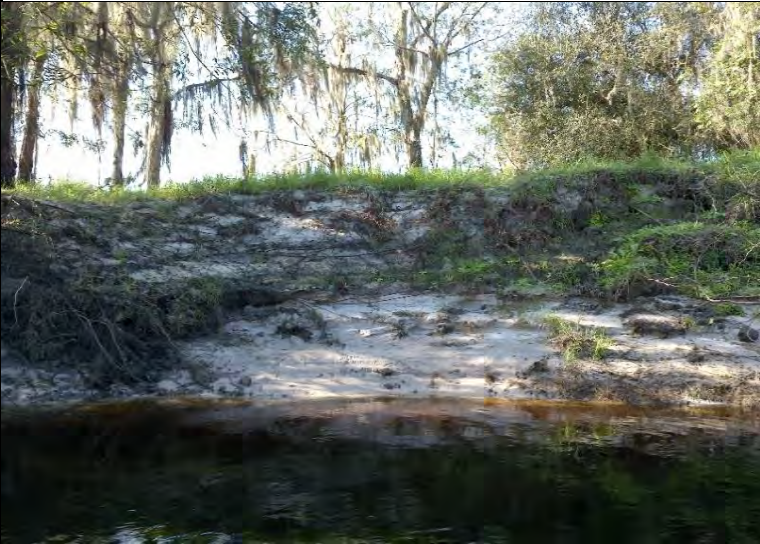
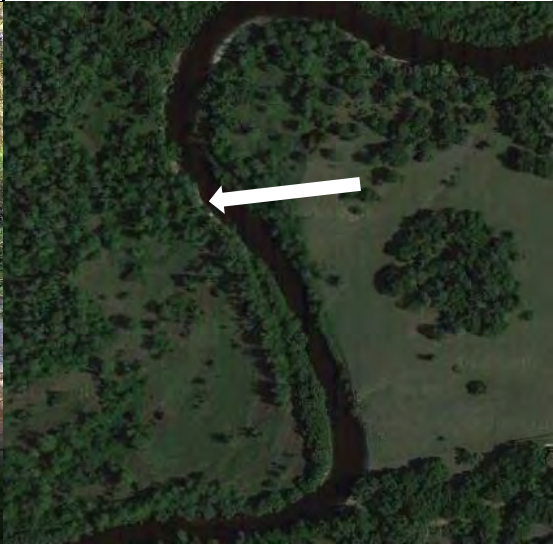
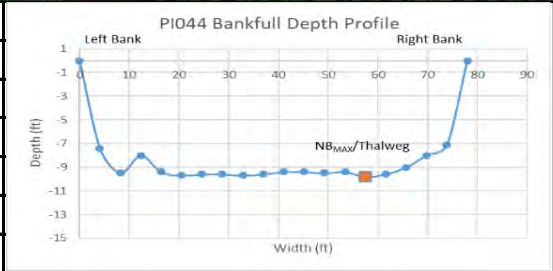
Peace River			Severity Scale: 3.0-Low
Watershed: Peace River Subwatershed: McBride Branch Latitude: 27.25112 Longitude: -81.88039			County: Desoto Site Number: PI044 Reach Length: 76 ft. Landowner: Constructora Limonar LLC

Risk Factor	Ranking	Score	
Pfankuch-Channel Stability:	Good	0	
Channel Alteration:	None	0	
Bank Erosion:	Mass-wasting	1.5	
BEHI:	Moderate (25.6)	0.5	
Local NPSP:	Slight Potential	0.5	
Shoring Structures:	None	0	
Pipe Discharge:	None	0	
Water Odor:	Normal	0	
Fish Passage Barrier:	None	0	
RB: Riparian Buffer:	40 ft.	0.5	
LB: Riparian Buffer:	100 ft.	0	
RB: Floodplain Access:	Full	0	
LB: Floodplain Access:	Full	0	
Severity Scale:		3.0	
Notes: 303d: Impaired - Aquatic Life Harvesting (fecal coliform, mercury in fish tissue)			
Restoration Option 1

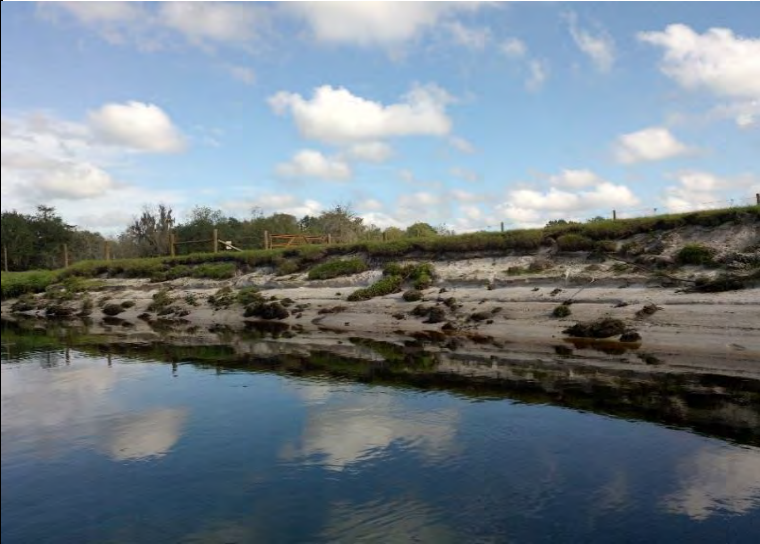
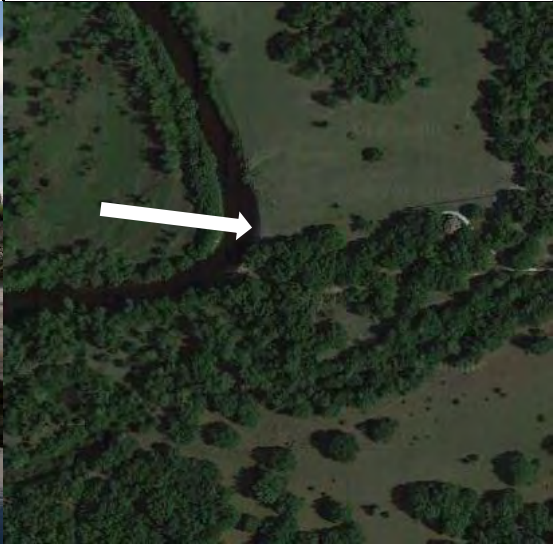
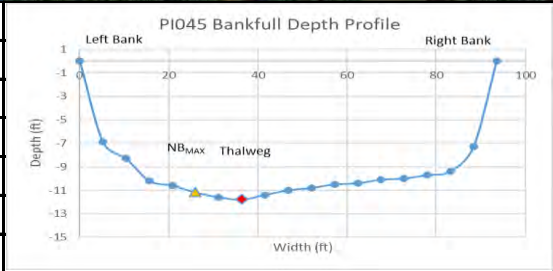
Peace River			Severity Scale: 4.75-Moderate
Watershed: Peace River Subwatershed: McBride Branch Latitude: 27.24943 Longitude: -81.87923			County: Desoto Site Number: PI045 Reach Length: 225 ft. Landowner: Zalmon Sherwood

Risk Factor	Ranking	Score	
Pfankuch-Channel Stability:	Good	0	
Channel Alteration:	None	0	
Bank Erosion:	Mass-wasting	1.5	
BEHI:	High (36.23)	1	
Local NPSP:	Obvious Sources	1.5	
Shoring Structures:	None	0	
Pipe Discharge:	None	0	
Water Odor:	Normal	0	
Fish Passage Barrier:	None	0	
RB: Riparian Buffer:	100 ft.	0	
LB: Riparian Buffer:	0 ft.	0.75	
RB: Floodplain Access:	Full	0	
LB: Floodplain Access:	Full	0	
Severity Scale:		4.75	
Notes: Cattle field on left bank with fence; No riparian zone (a few trees); 303d: Impaired - Aquatic Life Harvesting (fecal coliform, mercury in fish tissue)			
Restoration Option 1

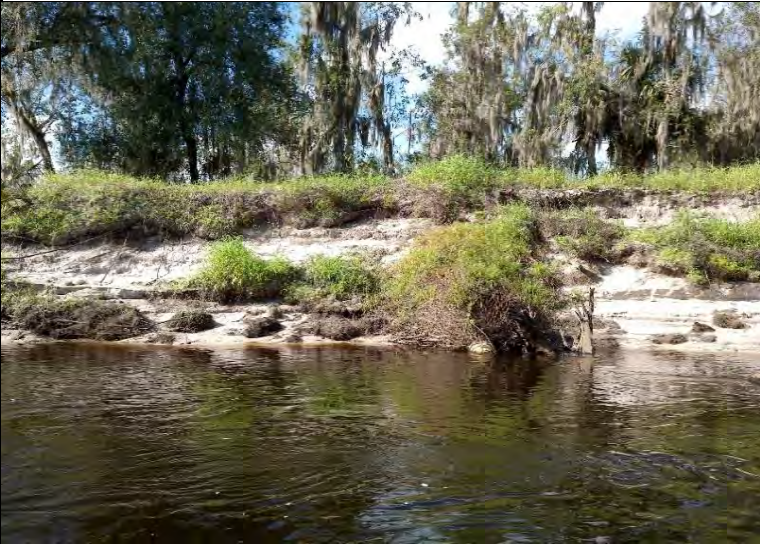
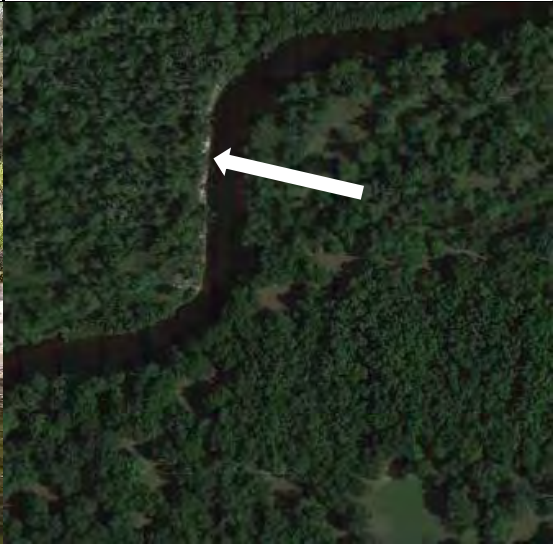
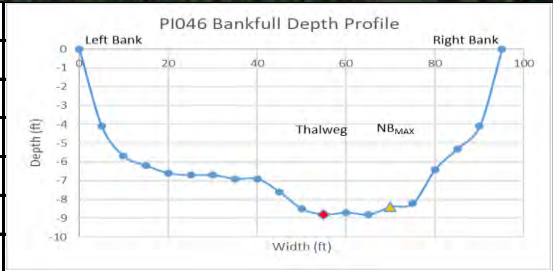
Peace River			Severity Scale: 2.5-Low
Watershed: Peace River Subwatershed: McBride Branch Latitude: 27.24745 Longitude: -81.88279			County: Desoto Site Number: PI046 Reach Length: 150 ft. Landowner: Constructora Limonar LLC

Risk Factor	Ranking	Score	
Pfankuch-Channel Stability:	Good	0	
Channel Alteration:	None	0	
Bank Erosion:	Mass-wasting	1.5	
BEHI:	High (31.38)	1	
Local NPSP:	No Evidence	0	
Shoring Structures:	None	0	
Pipe Discharge:	None	0	
Water Odor:	Normal	0	
Fish Passage Barrier:	None	0	
RB: Riparian Buffer:	100 ft.	0	
LB: Riparian Buffer:	100 ft.	0	
RB: Floodplain Access:	Full	0	
LB: Floodplain Access:	Full	0	
Severity Scale:		2.5	
Notes: 303d: Impaired - Aquatic Life Harvesting (fecal coliform, mercury in fish tissue)			
Restoration Option 1

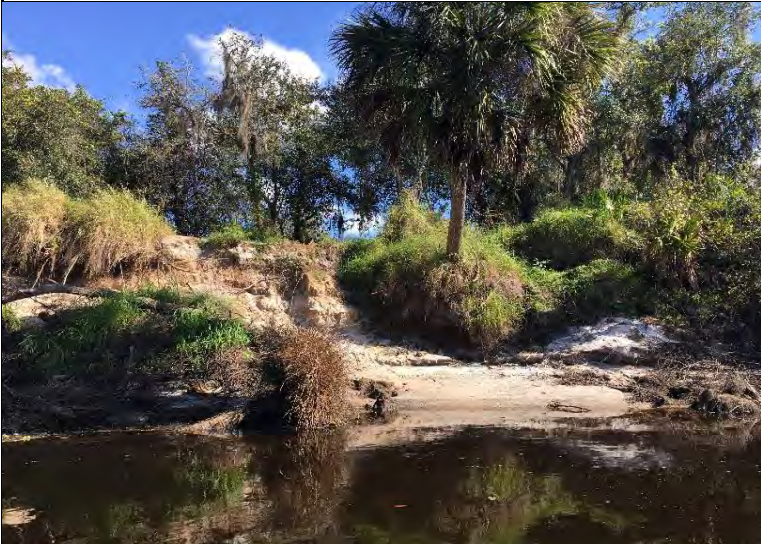
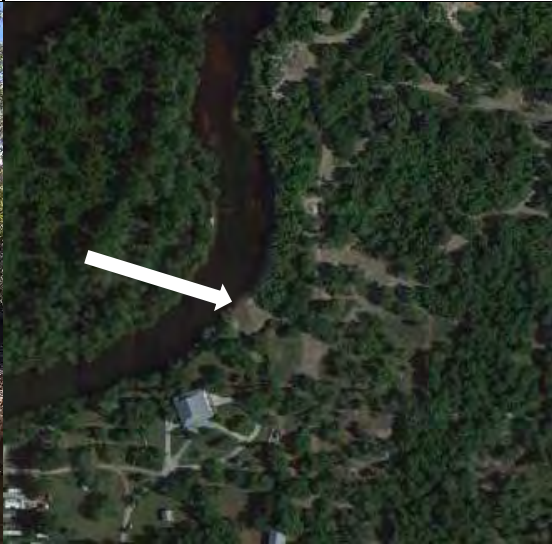
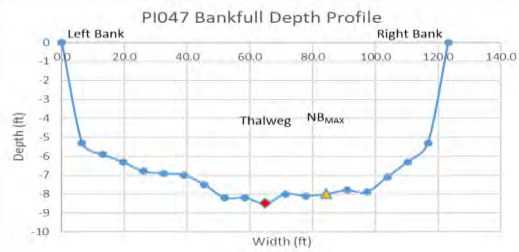
Peace River			Severity Scale: 4.0-Low
Watershed: Peace River Subwatershed: McBride Branch Latitude: 27.23230 Longitude: -81.88788			County: Desoto Site Number: PI047 Reach Length: 200 ft. Landowner: Four Marnan Inc.

Risk Factor	Ranking	Score	
Pfankuch-Channel Stability:	Good	0	
Channel Alteration:	None	0	
Bank Erosion:	Mass-wasting	1.5	
BEHI:	Moderate (29.35)	0.5	
Local NPSP:	Obvious Sources	1.5	
Shoring Structures:	None	0	
Pipe Discharge:	None	0	<b>Additional Site Features</b> Stream Channel Woody Material: Infrequent Impoundments: None Substrate Composition: Medium Sand Bank Material: Sand Near Bank Stress: Moderate RB Landuse: Natural Forest, Transportation LB Landuse: Natural Forest
Water Odor:	Normal	0	
Fish Passage Barrier:	None	0	
RB: Riparian Buffer:	70 ft.	0.25	
LB: Riparian Buffer:	100 ft.	0	
RB: Floodplain Access:	Full	0	
LB: Floodplain Access:	Partial	0.25	
<b>Severity Scale:</b>		<b>4.0</b>

Notes: Unpaved road nearby; 303d: Impaired - Aquatic Life Harvesting (fecal coliform, mercury in fish tissue)			
Restoration Option 1

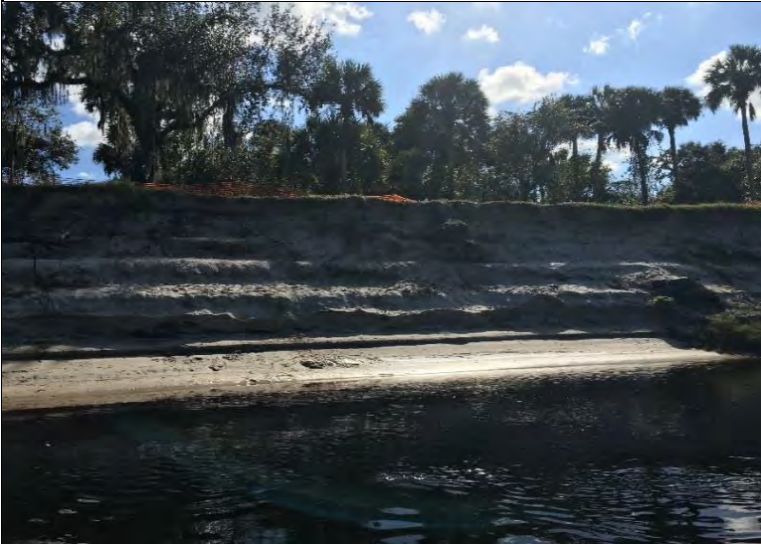
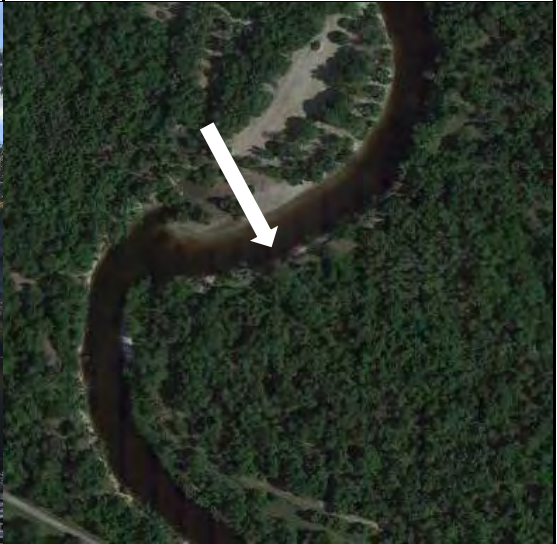
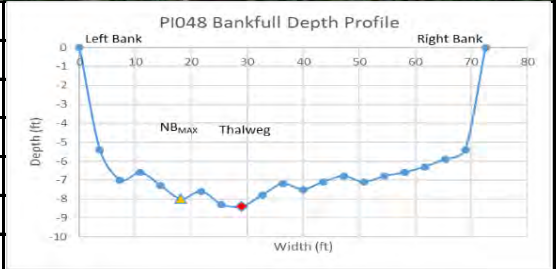
Peace River			Severity Scale: 6.25-Moderate
Watershed: Peace River Subwatershed: McBride Branch Latitude: 27.22673 Longitude: -81.88287			County: Desoto Site Number: PI048 Reach Length: 550 ft. Landowner: Desoto County

Risk Factor	Ranking	Score	
Pfankuch-Channel Stability:	Good	0	
Channel Alteration:	None	0	
Bank Erosion:	Mass-wasting	1.5	
BEHI:	Extreme (46.88)	1.5	
Local NPSP:	Moderate Potential	1	
Shoring Structures:	None	0	
Pipe Discharge:	None	0	
Water Odor:	Normal	0	
Fish Passage Barrier:	None	0	
RB: Riparian Buffer:	20 ft.	0.75	
LB: Riparian Buffer:	25 ft.	0.75	
RB: Floodplain Access:	Full	0	
LB: Floodplain Access:	None	0.75	
Severity Scale:		6.25	
Notes: Bank appears to have been rebuilt. Pipe protruding from bank feeds wetland/stream at flood stage; 303d: Impaired - Aquatic Life Harvesting (fecal coliform, mercury in fish tissue)			
Restoration Option 1

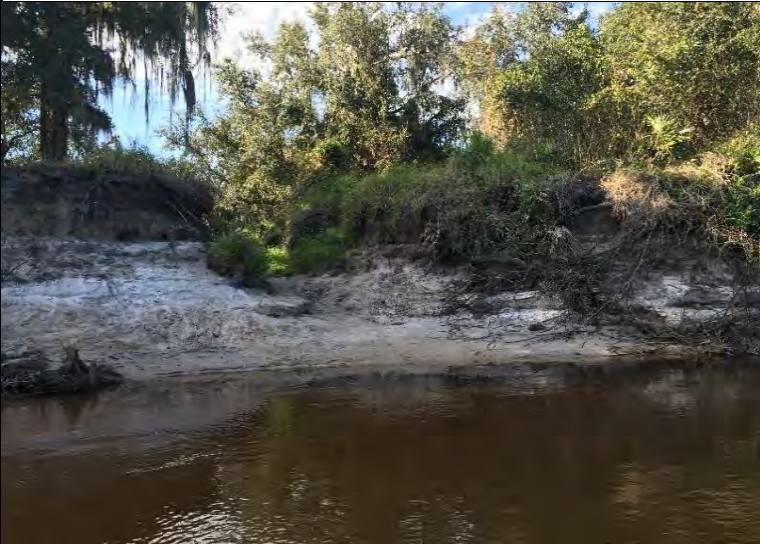
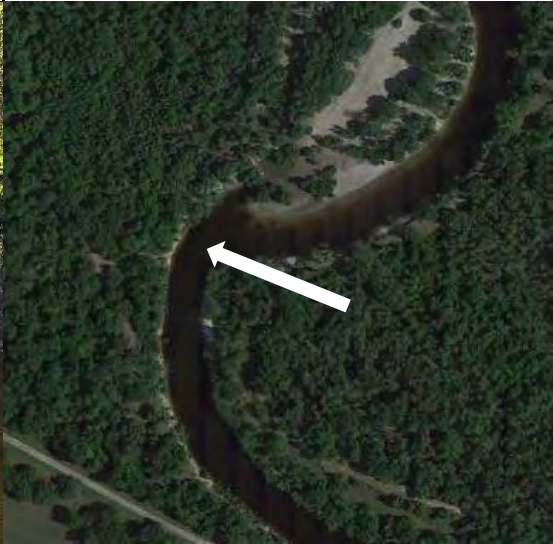
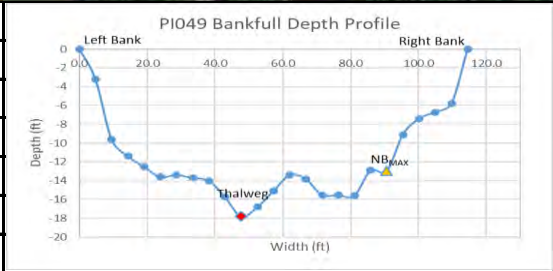
Peace River			Severity Scale: 4.0-Low
Watershed: Peace River Subwatershed: McBride Branch Latitude: 27.22636 Longitude: -81.88464			County: Desoto Site Number: PI049 Reach Length: 70 ft. Landowner: George & Jonica Lempeneau

Risk Factor	Ranking	Score	
Pfankuch-Channel Stability:	Good	0	
Channel Alteration:	None	0	
Bank Erosion:	Mass-wasting	1.5	
BEHI:	High (35.17)	1	
Local NPSP:	Slight Potential	0.5	
Shoring Structures:	None	0	
Pipe Discharge:	None	0	
Water Odor:	Normal	0	
Fish Passage Barrier:	None	0	
RB: Riparian Buffer:	0 ft.	0.75	
LB: Riparian Buffer:	100 ft.	0	
RB: Floodplain Access:	Partial	0.25	
LB: Floodplain Access:	Full	0	
Severity Scale:		4.0	
Notes: Recreational access; 303d: Impaired - Aquatic Life Harvesting (fecal coliform, mercury in fish tissue)			
Restoration Option 1

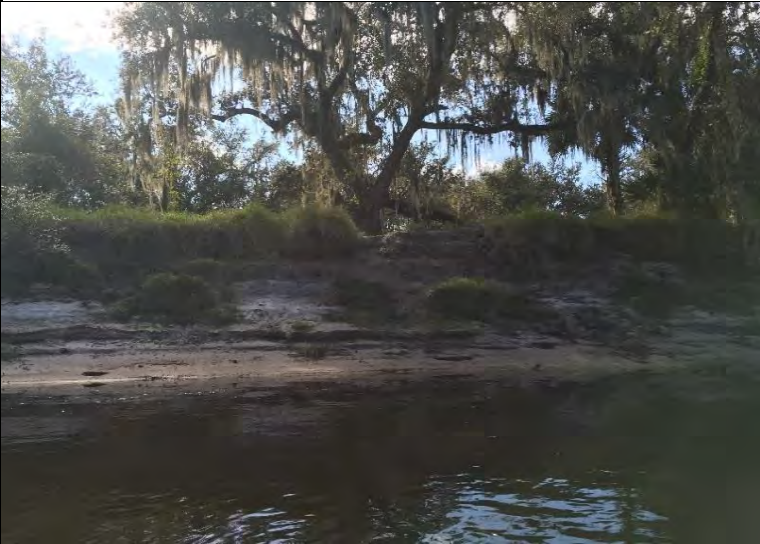
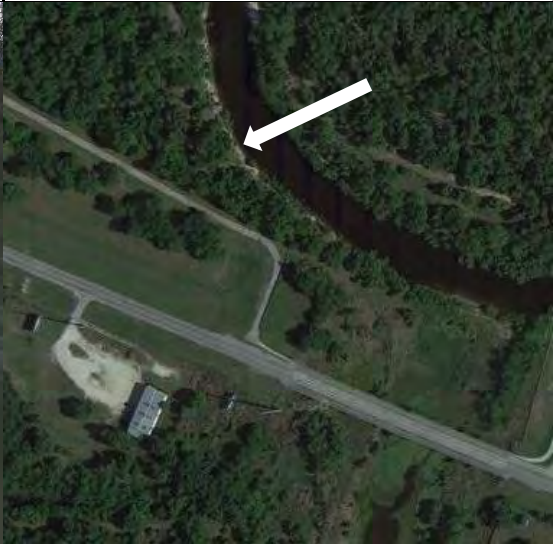
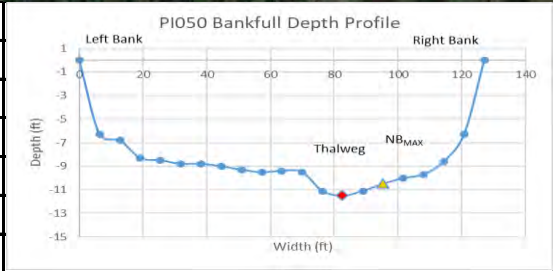
Peace River			Severity Scale: 4.25-Moderate
Watershed: Peace River Subwatershed: McBride Branch Latitude: 27.22506 Longitude: -81.88440			County: Desoto Site Number: PI050 Reach Length: 375 ft. Landowner: George & Jonica Lempeneau

Risk Factor	Ranking	Score	
Pfankuch-Channel Stability:	Good	0	
Channel Alteration:	None	0	
Bank Erosion:	Mass-wasting	1.5	
BEHI:	High (33.56)	1	
Local NPSP:	Moderate Potential	1	
Shoring Structures:	None	0	
Pipe Discharge:	None	0	
Water Odor:	Normal	0	
Fish Passage Barrier:	None	0	
RB: Riparian Buffer:	40 ft.	0.5	
LB: Riparian Buffer:	100 ft.	0	
RB: Floodplain Access:	Partial	0.25	
LB: Floodplain Access:	Full	0	
<b>Severity Scale:</b>		<b>4.25</b>	
Notes: 303d: Impaired - Aquatic Life Harvesting (fecal coliform, mercury in fish tissue)			
Restoration Option 1

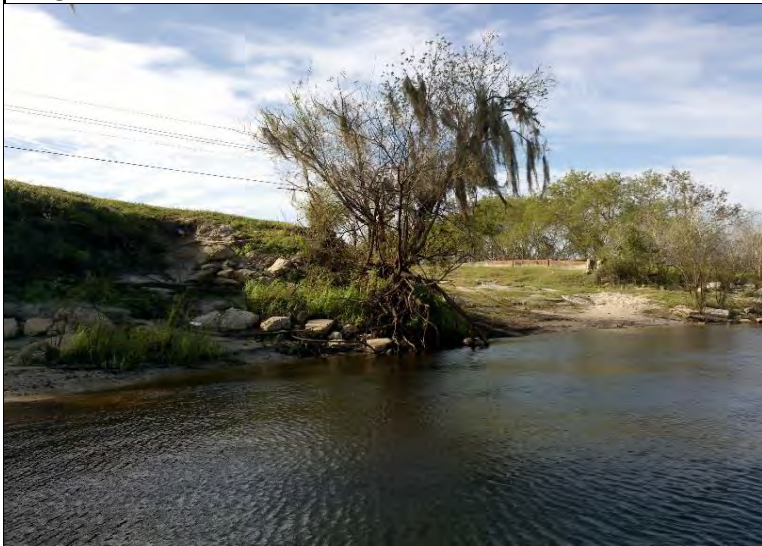
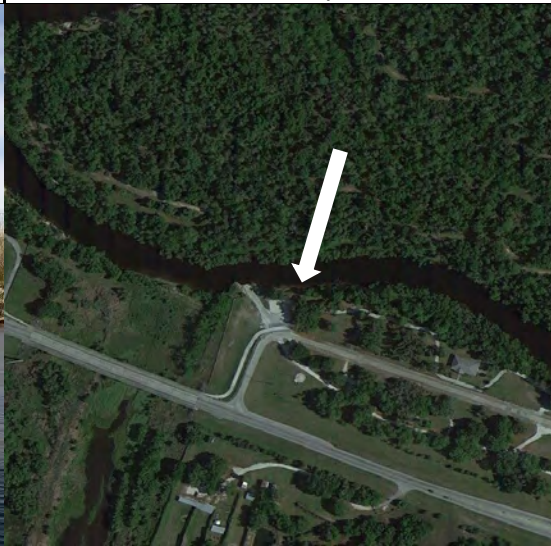
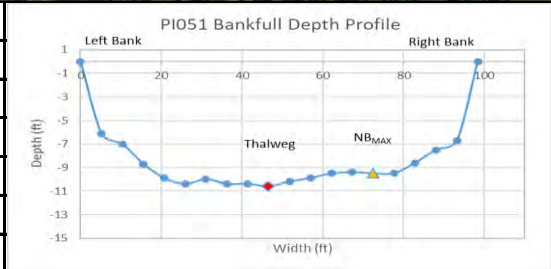
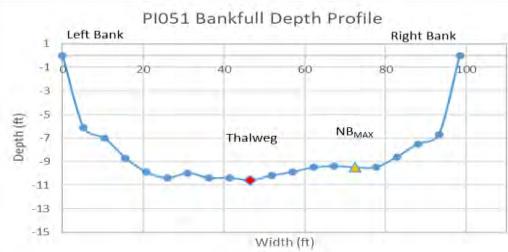
Peace River			Severity Scale: 6.5-Moderate
Watershed: Peace River Subwatershed: Johnson Lake Latitude: 27.22419 Longitude: -81.88117			County: Desoto Site Number: PI051 Reach Length: 191 ft. Landowner: Desoto County

Pfankuch-Channel Stability:	Poor	1.5	
Channel Alteration:	None	0	
Bank Erosion:	Active	1	
BEHI:	Moderate (26.57)	0.5	
Local NPSP:	Moderate Potential	1	
Shoring Structures:	Present	1.5	
Pipe Discharge:	None	0	
Water Odor:	Normal	0	
Fish Passage Barrier:	None	0	
RB: Riparian Buffer:	0 ft.	0.75	<b>Additional Site Features</b>
LB: Riparian Buffer:	100 ft.	0	Stream Channel Woody Material: Infrequent
RB: Floodplain Access:	Partial	0.25	Impoundments: None
LB: Floodplain Access:	Full	0	Substrate Composition: Medium Sand
<b>Severity Scale:</b>			Bank Material: Sand
			Near Bank Stress: Low
			RB Landuse: Recreation
			LB Landuse: Natural Forest
Notes: Boat launch at Morgan Park - Arcadia, FL; 303d: Impaired - Aquatic Life Harvesting (fecal coliform, mercury in fish tissue)

Restoration Option 1

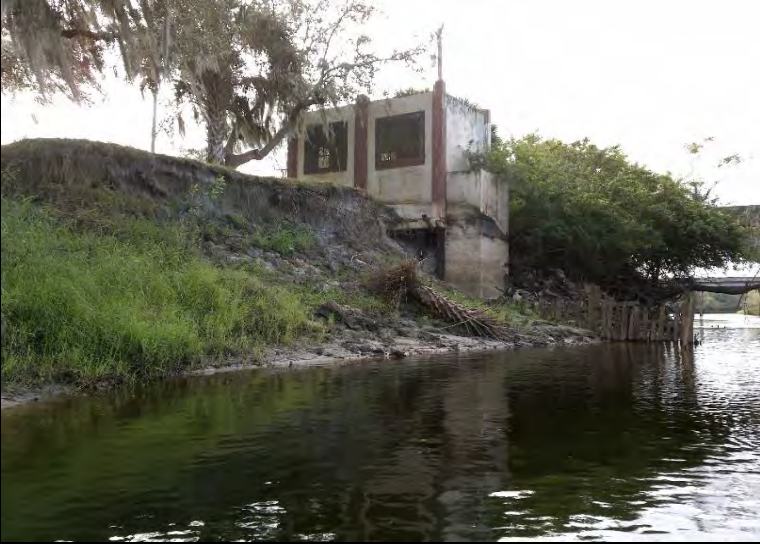
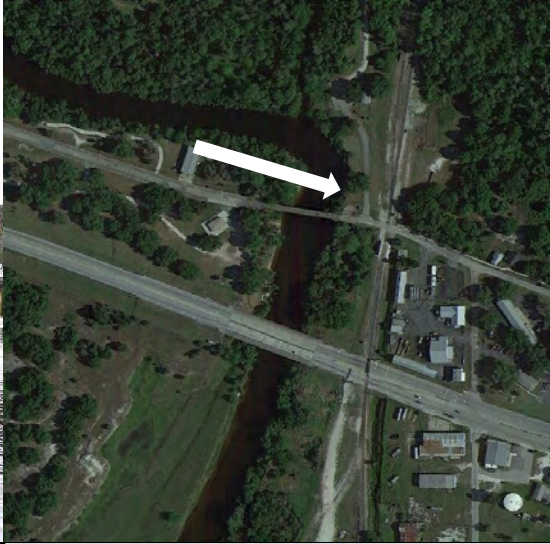
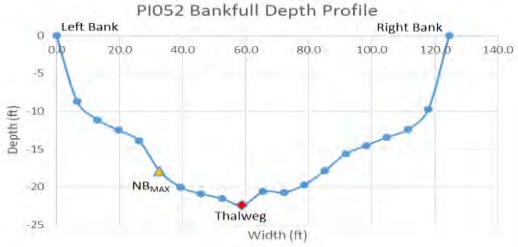
Peace River			Severity Scale: 7.5-High
Watershed: Peace River Subwatershed: Johnson Lake Latitude: 27.22274 Longitude: -81.87601			County: Desoto Site Number: PI052 Reach Length: 235 ft. Landowner: Desoto County

Pfankuch-Channel Stability:	Poor	1.5	
Channel Alteration:	None	0	
Bank Erosion:	Mass-wasting	1.5	
BEHI:	High (36.97)	1	
Local NPSP:	Moderate Potential	1	
Shoring Structures:	Present	1.5	
Pipe Discharge:	None	0	
Water Odor:	Normal	0	
Fish Passage Barrier:	None	0	
RB: Riparian Buffer:	100 ft.	0	
LB: Riparian Buffer:	0 ft.	0.75	
RB: Floodplain Access:	Full	0	
LB: Floodplain Access:	Partial	0.25	
<b>Severity Scale:</b>		<b>7.5</b>	
			Additional Site Features
			Stream Channel Woody Material: Infrequent
			Impoundments: None
			Substrate Composition: Medium Sand
			Bank Material: Sand
			Near Bank Stress: Moderate
			RB Landuse: Natural Forest, Recreation
			LB Landuse: Recreation

Notes: Morgan Park walk-in access; Rip-rap and old bridge; 303d: Impaired - Aquatic Life			
Harvesting (fecal coliform, mercury in fish tissue)			
Restoration Option 1

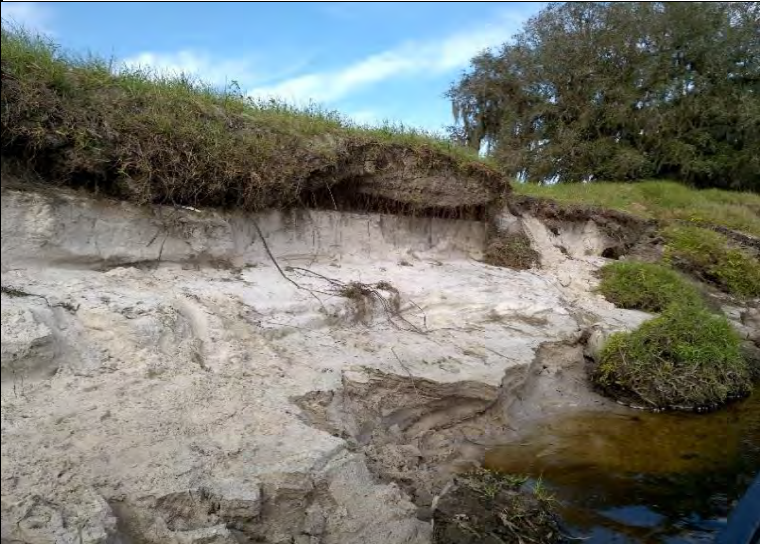
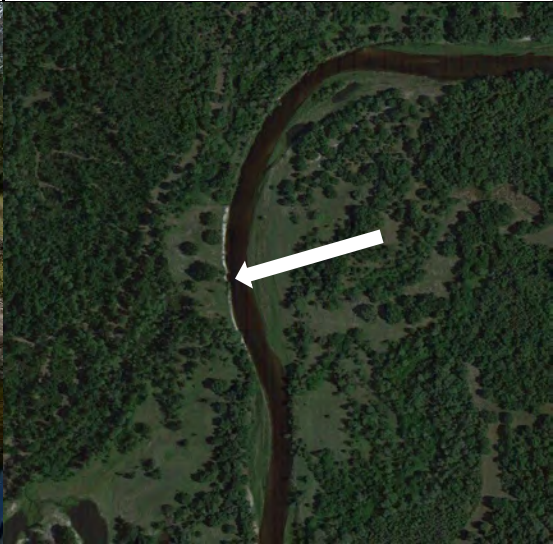
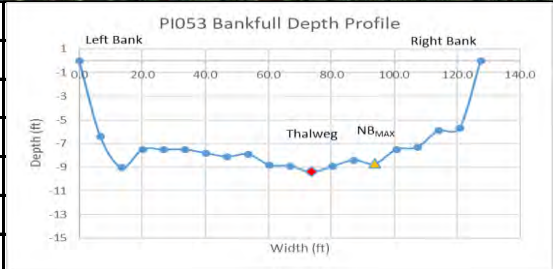
Peace River			Severity Scale: 7.0-Moderate
Watershed: Peace River Subwatershed: Johnson Lake Latitude: 27.21470 Longitude: -81.88697			County: Desoto Site Number: PI053 Reach Length: 640 ft. Landowner: Garner Grove & Cattle Co.

Risk Factor	Ranking	Score	
Pfankuch-Channel Stability:	Poor	1.5	
Channel Alteration:	None	0	
Bank Erosion:	Mass-wasting	1.5	
BEHI:	High (30.76)	1	
Local NPSP:	Obvious Sources	1.5	
Shoring Structures:	None	0	
Pipe Discharge:	None	0	
Water Odor:	Normal	0	
Fish Passage Barrier:	None	0	
RB: Riparian Buffer:	0 ft.	0.75	
LB: Riparian Buffer:	0 ft.	0.75	
RB: Floodplain Access:	Full	0	
LB: Floodplain Access:	Full	0	
<b>Severity Scale:</b>		<b>7.0</b>	
Notes: Pasture not currently active, but recently; 303d: Impaired - Aquatic Life Harvesting (fecal coliform, mercury in fish tissue)			
Restoration Option 1

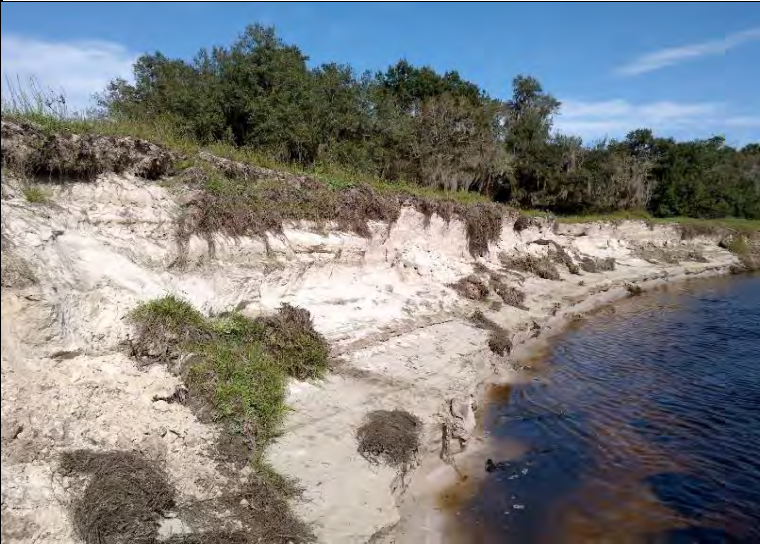
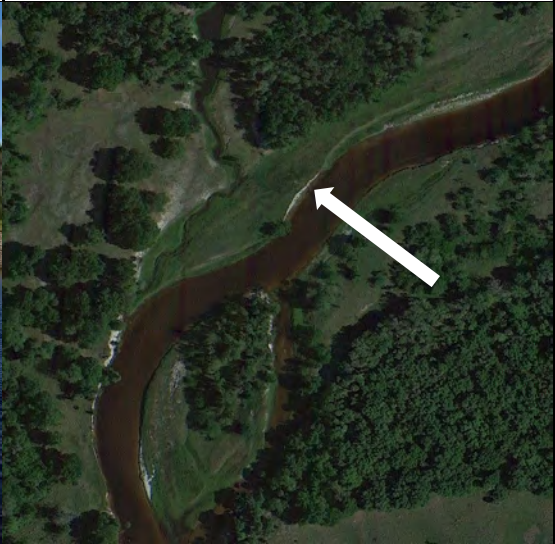
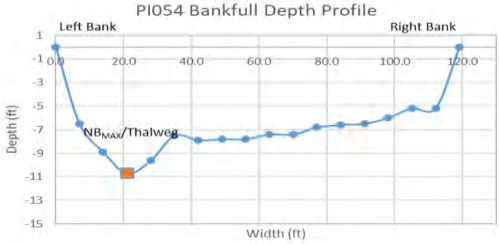
Peace River			Severity Scale: 4.75-Moderate
Watershed: Peace River Subwatershed: Johnson Lake Latitude: 27.20767 Longitude: -81.88840			County: Desoto Site Number: PI054 Reach Length: 125 ft. Landowner: Garner Grove & Cattle Co.

Pfankuch-Channel Stability:	Poor	1.5	
Channel Alteration:	None	0	
Bank Erosion:	Mass-wasting	1.5	
BEHI:	High (37.78)	1	
Local NPSP:	No Evidence	0	
Shoring Structures:	None	0	
Pipe Discharge:	None	0	
Water Odor:	Normal	0	
Fish Passage Barrier:	None	0	
RB: Riparian Buffer:	0 ft.	0.75	
LB: Riparian Buffer:	100 ft.	0	
RB: Floodplain Access:	Full	0	
LB: Floodplain Access:	Full	0	
<b>Severity Scale:</b>		<b>4.75</b>	
Notes: Notes: 303d: Impaired - Aquatic Life Harvesting (fecal coliform, mercury in fish tissue)			<b>Additional Site Features</b>
			Stream Channel Woody Material: Moderate
			Impoundments: None
			Substrate Composition: Medium Sand

Bank Material: Sand
			Near Bank Stress: High
			RB Landuse: Pasture
			LB Landuse: Natural Forest
Restoration Option 1

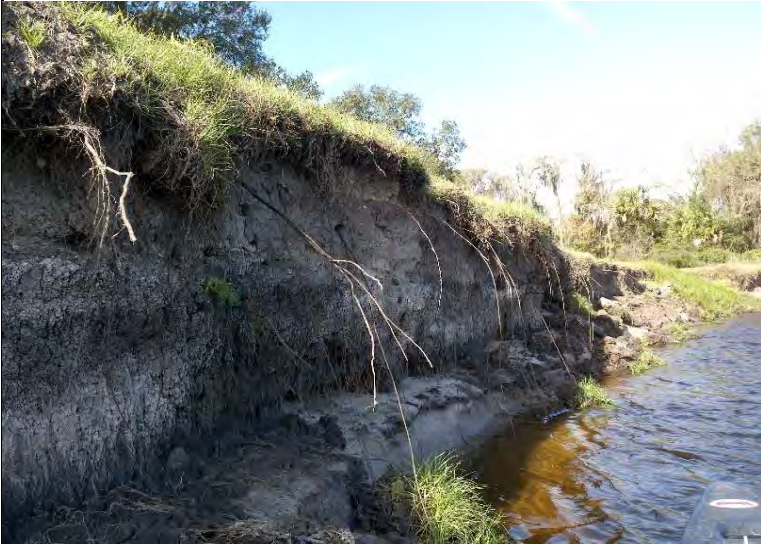
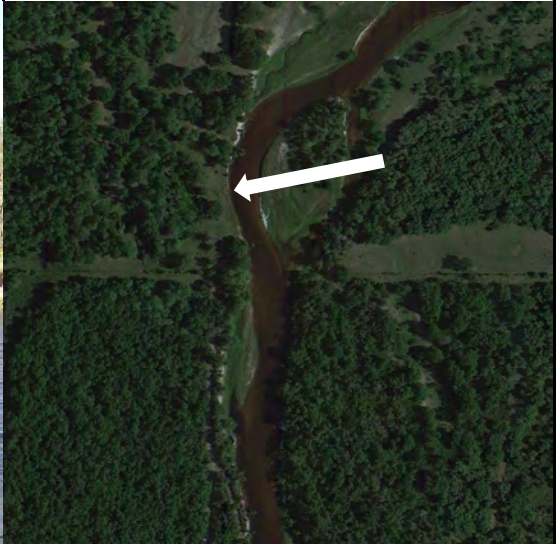
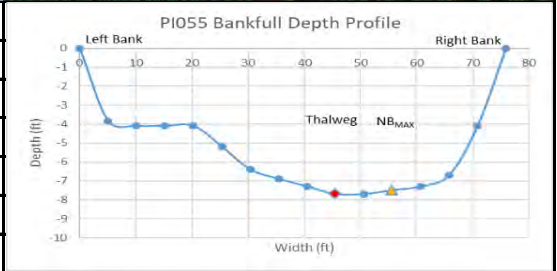
Peace River			Severity Scale: 5.75-Moderate
Watershed: Peace River Subwatershed: Johnson Lake Latitude: 27.20633 Longitude: -81.88983			County: Desoto Site Number: PI055 Reach Length: 554 ft. Landowner: Garner Grove & Cattle Co.

Risk Factor	Ranking	Score	
Pfankuch-Channel Stability:	Poor	1.5	
Channel Alteration:	None	0	
Bank Erosion:	Mass-wasting	1.5	
BEHI:	Very High (45.87)	1.5	
Local NPSP:	Slight Potential	0.5	
Shoring Structures:	None	0	
Pipe Discharge:	None	0	
Water Odor:	Normal	0	
Fish Passage Barrier:	None	0	
RB: Riparian Buffer:	0 ft.	0.75	
LB: Riparian Buffer:	100 ft.	0	
RB: Floodplain Access:	Full	0	
LB: Floodplain Access:	Full	0	
Severity Scale:		5.75	
Notes: 303d: Impaired - Aquatic Life Harvesting (fecal coliform, mercury in fish tissue)			
Restoration Option 1

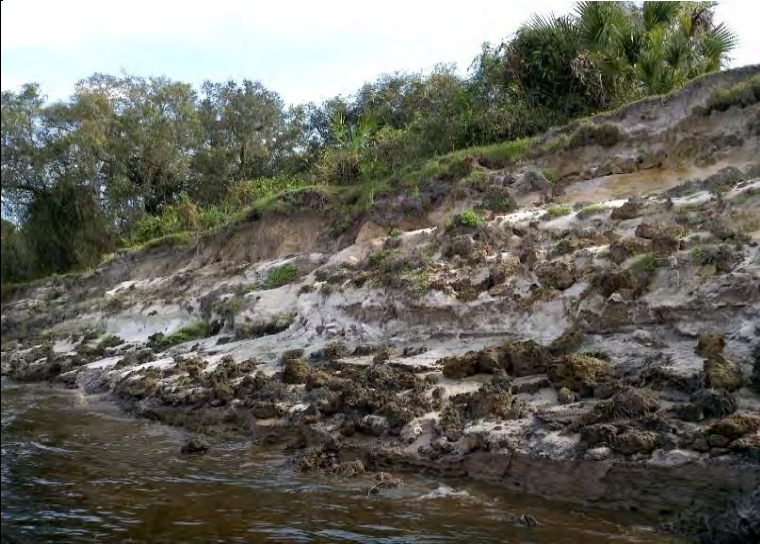
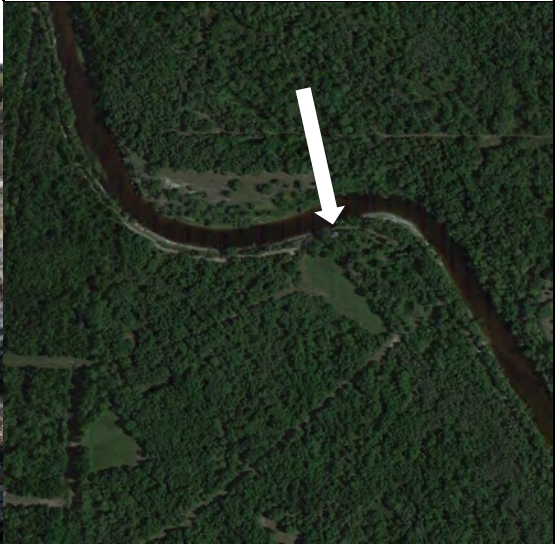
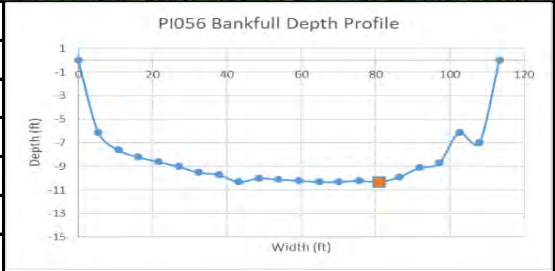
Peace River			Severity Scale: 6.25-Moderate
Watershed: Peace River Subwatershed: Johnson Lake Latitude: 27.20123 Longitude: 81.88867			County: Desoto Site Number: PI056 Reach Length: 1,439 ft. Landowner: Geraci, D.

Risk Factor	Ranking	Score	
Pfankuch-Channel Stability:	Poor	1.5	
Channel Alteration:	None	0	
Bank Erosion:	Mass-wasting	1.5	
BEHI:	High (39.54)	1	
Local NPSP:	Obvious Sources	1.5	
Shoring Structures:	None	0	
Pipe Discharge:	None	0	
Water Odor:	Normal	0	<b>Additional Site Features</b>
Fish Passage Barrier:	None	0	Stream Channel Woody Material: Moderate
RB: Riparian Buffer:	30 ft.	0.5	Impoundments: None
LB: Riparian Buffer:	100 ft.	0	Substrate Composition: Medium Sand
RB: Floodplain Access:	Partial	0.25	Bank Material: Sand
LB: Floodplain Access:	Full	0	Near Bank Stress: High
			RB Landuse: Natural Forest, Pasture
	<b>Severity Scale:</b>	<b>6.25</b>	LB Landuse: Natural Forest
Notes: 303d: Impaired - Aquatic Life Harvesting (fecal coliform, mercury in fish tissue)

Restoration Option 1

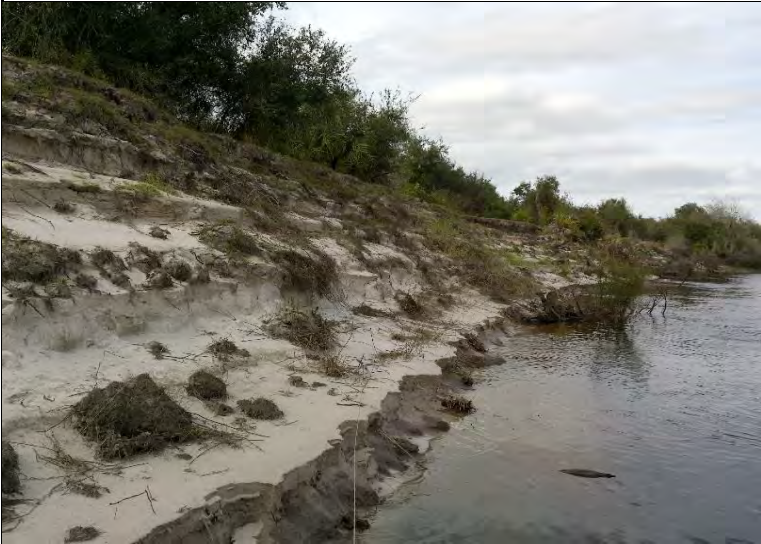
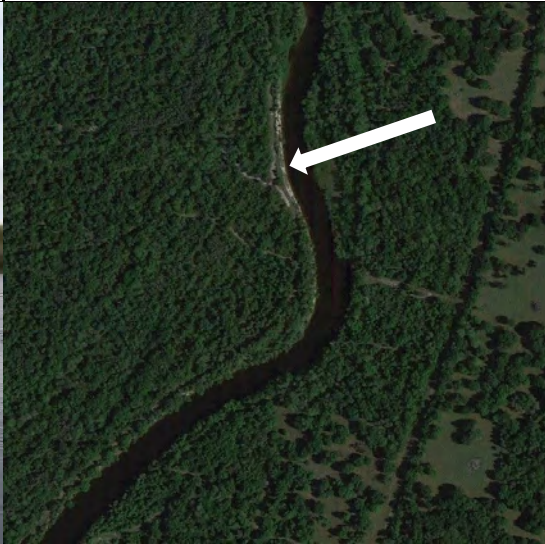
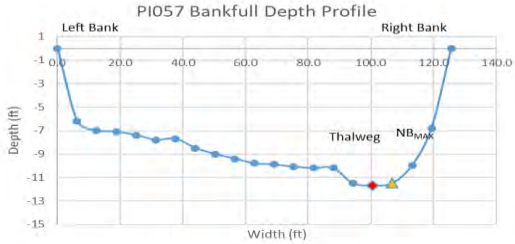
Peace River			Severity Scale: 7.75-High
Watershed: Peace River Subwatershed: Johnson Lake Latitude: 27.19366 Longitude: -81.88152			County: Desoto Site Number: PI057 Reach Length: 498 ft. Landowner: Geraci, D.

Pfankuch-Channel Stability:	Poor	1.5	
Channel Alteration:	None	0	
Bank Erosion:	Mass-wasting	1.5	
BEHI:	Very High (43.5)	1.5	
Local NPSP:	Obvious Sources	1.5	
Shoring Structures:	None	0	
Pipe Discharge:	None	0	
Water Odor:	Normal	0	
Fish Passage Barrier:	None	0	
RB: Riparian Buffer:	0 ft.	0.75	
LB: Riparian Buffer:	0 ft.	0.75	
RB: Floodplain Access:	Partial	0.25	
LB: Floodplain Access:	Full	0	
<b>Severity Scale:</b>		<b>7.75</b>	<b>Additional Site Features</b>
			Stream Channel Woody Material: Moderate
			Impoundments: None
			Substrate Composition: Medium Sand
			Bank Material: Sand
			Near Bank Stress: High
			RB Landuse: Natural Forest, Pasture
			LB Landuse: Pasture, Natural Forest

Notes: Cattle access on left bank, opposite from PD047; 303d: Impaired - Aquatic Life Harvesting (fecal coliform, mercury in fish tissue)			
Restoration Option 1

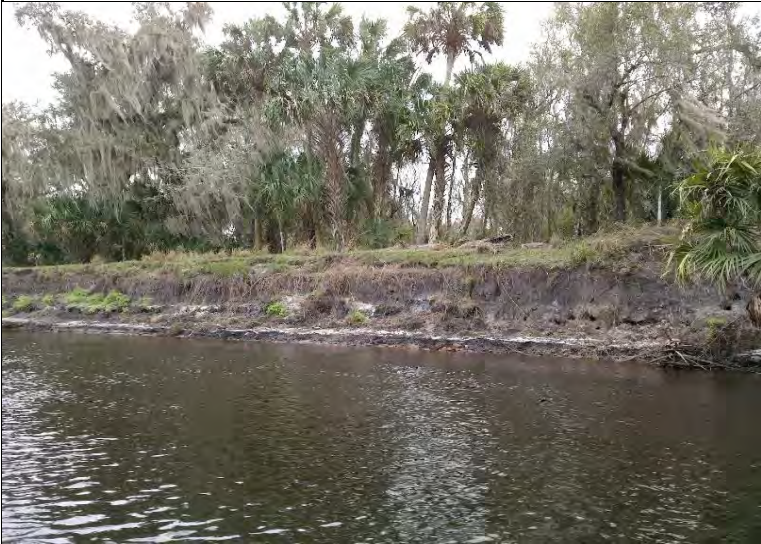
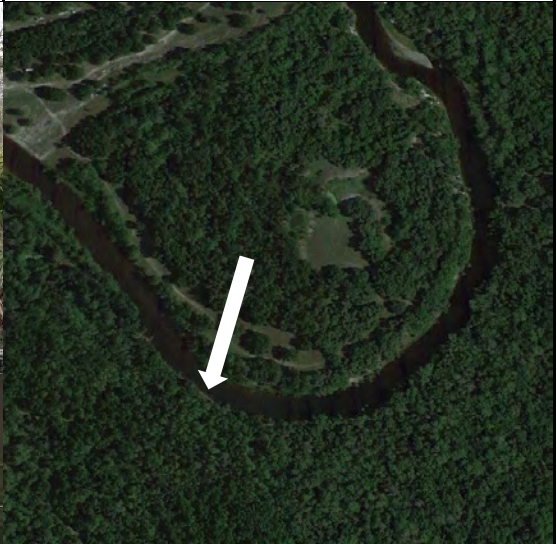
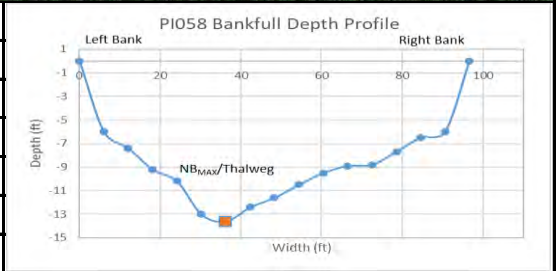
Peace River			Severity Scale: 5.5-Moderate
Watershed: Peace River Subwatershed: Johnson Lake Latitude: 27.17618 Longitude: -81.88769			County: Desoto Site Number: PI058 Reach Length: 1041 ft. Landowner: Geraci, D.

Risk Factor	Ranking	Score	
Pfankuch-Channel Stability:	Poor	1.5	
Channel Alteration:	None	0	
Bank Erosion:	Mass-wasting	1.5	
BEHI:	High (34.53)	1	
Local NPSP:	Slight Potential	0.5	
Shoring Structures:	None	0	
Pipe Discharge:	None	0	
Water Odor:	Normal	0	
Fish Passage Barrier:	None	0	
RB: Riparian Buffer:	40 ft.	0.5	
LB: Riparian Buffer:	40 ft.	0.5	
RB: Floodplain Access:	Full	0	
LB: Floodplain Access:	Full	0	
<b>Severity Scale:</b>		<b>5.5</b>	
Notes: Cattle access on opposite bank; 303d: Impaired - Aquatic Life Harvesting (fecal coliform, mercury in fish tissue)			
Restoration Option 1

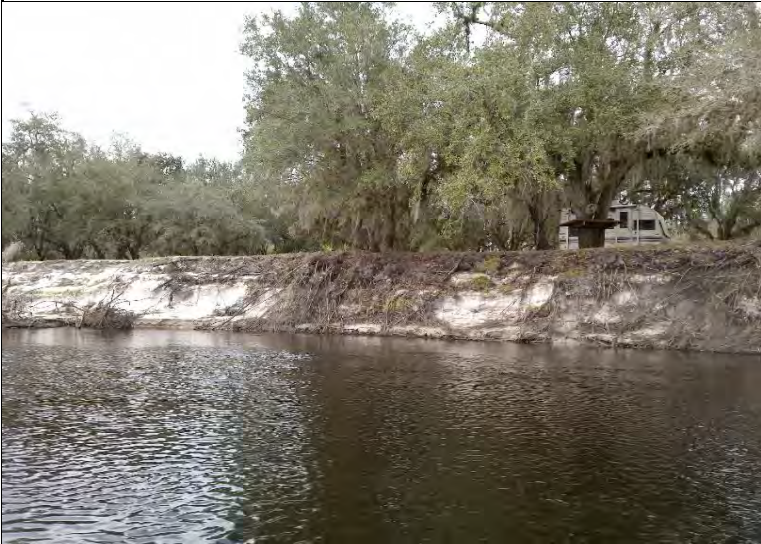
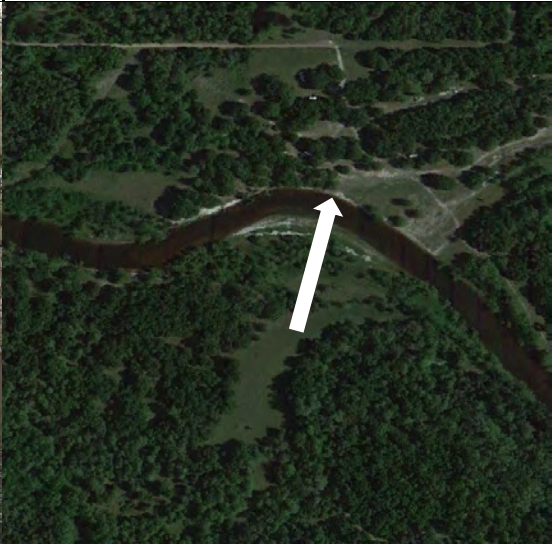
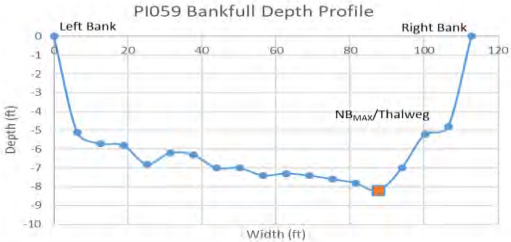
Peace River			Severity Scale: 6.0-Moderate
Watershed: Peace River Subwatershed: Johnson Lake Latitude: 27.17885 Longitude: -81.89071			County: Desoto Site Number: PI059 Reach Length: 750 ft. Landowner: Geraci, D.

Pfankuch-Channel Stability:	Poor	1.5	
Channel Alteration:	None	0	
Bank Erosion:	Active	1	
BEHI:	High (31.19)	1	
Local NPSP:	Obvious Sources	1.5	
Shoring Structures:	None	0	
Pipe Discharge:	None	0	
Water Odor:	Normal	0	
Fish Passage Barrier:	None	0	
RB: Riparian Buffer:	40 ft.	0.5	
LB: Riparian Buffer:	40 ft.	0.5	
RB: Floodplain Access:	Full	0	
LB: Floodplain Access:	Full	0	
<b>Severity Scale:</b>		<b>6.0</b>	<b>Additional Site Features</b>
			Stream Channel Woody Material: Numerous
			Impoundments: None
			Substrate Composition: Medium Sand
			Bank Material: Sand
			Near Bank Stress: High
			RB Landuse: Recreation, Natural Forest
			LB Landuse: Pasture, Natural Forest

Notes: Cattle access; 303d: Impaired - Aquatic Life Harvesting (fecal coliform, mercury in fish tissue)			
Restoration Option 1

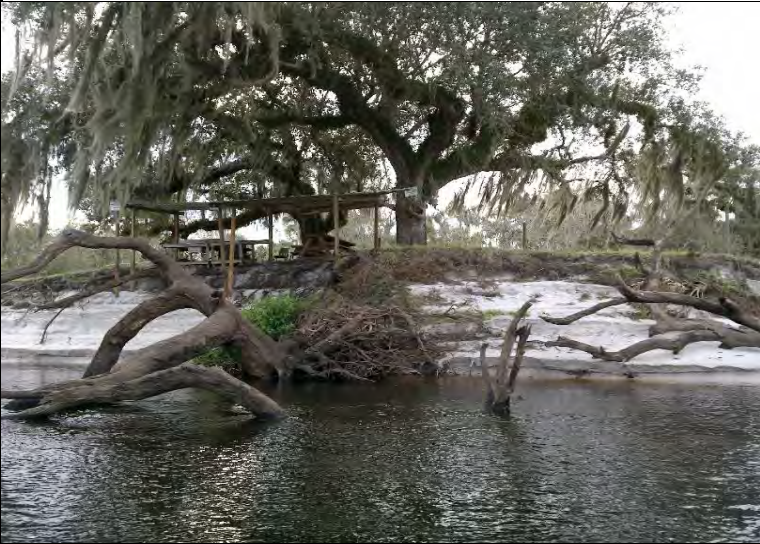
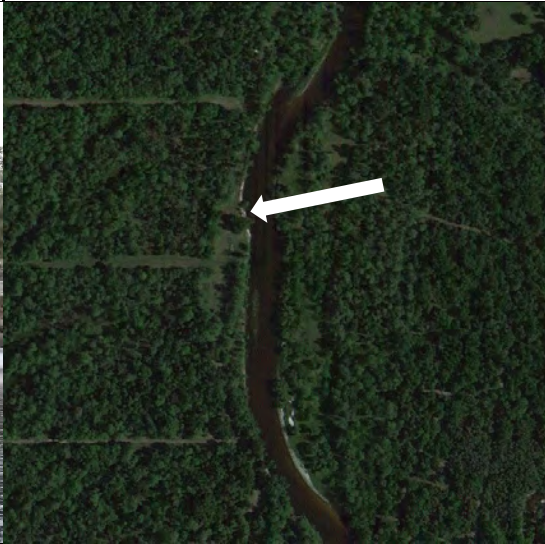
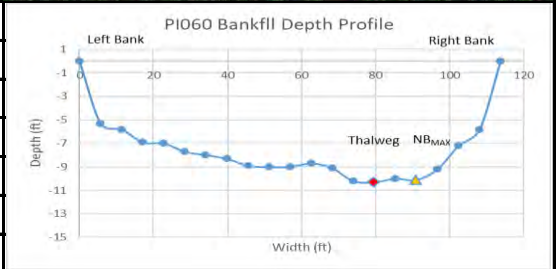
Peace River			Severity Scale: 6.25-Moderate
Watershed: Peace River Subwatershed: Johnson Lake Latitude: 27.17322 Longitude: -81.89740			County: Desoto Site Number: PI060 Reach Length: 165 ft. Landowner: Geraci, D.

Risk Factor	Ranking	Score	
Pfankuch-Channel Stability:	Poor	1.5	
Channel Alteration:	None	0	
Bank Erosion:	Active	1	
BEHI:	High (35.84)	1	
Local NPSP:	Obvious Sources	1.5	
Shoring Structures:	None	0	
Pipe Discharge:	None	0	
Water Odor:	Normal	0	
Fish Passage Barrier:	None	0	
RB: Riparian Buffer:	0 ft.	0.75	
LB: Riparian Buffer:	40 ft.	0.5	
RB: Floodplain Access:	Full	0	
LB: Floodplain Access:	Full	0	
Severity Scale:		6.25	
Notes: Hunting property w/cattle pasture; 303d: Impaired - Aquatic Life Harvesting (fecal coliform, mercury in fish tissue)			
Restoration Option 1

Additional Site Features
Stream Channel Woody Material: Moderate
Impoundments: None
Substrate Composition: Medium Sand
Bank Material: Sand
Near Bank Stress: High
RB Landuse: Pasture, Natural Forest
LB Landuse: Pasture, Natural Forest

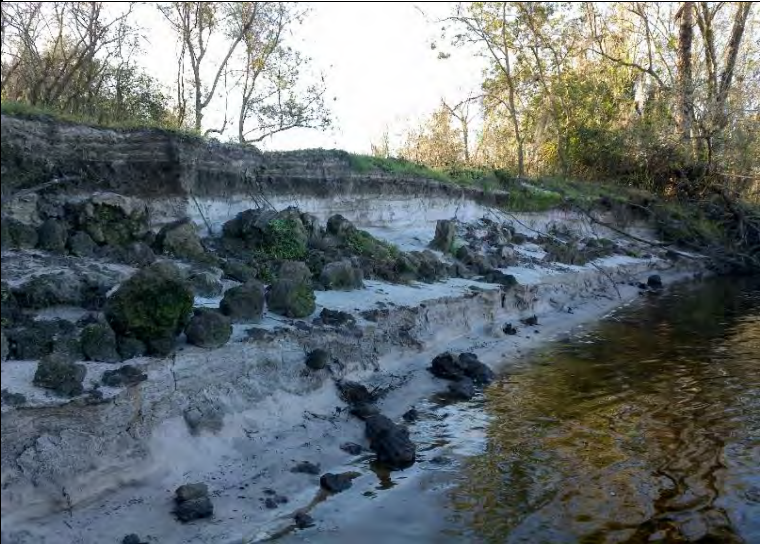
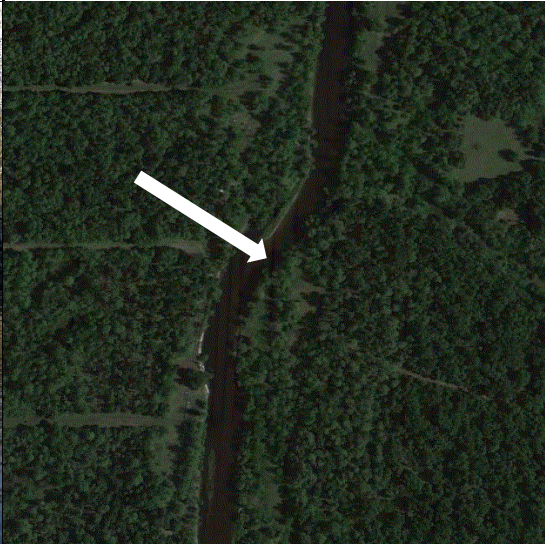
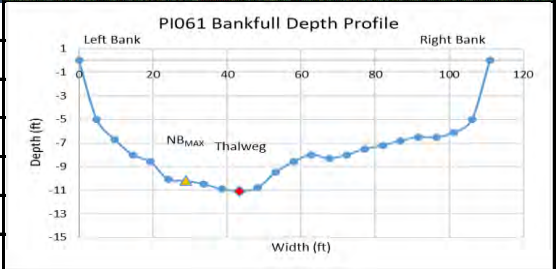
Peace River			Severity Scale: 6.25-Moderate
Watershed: Peace River Subwatershed: Johnson Lake Latitude: 27.17461 Longitude: -81.89672			County: Desoto Site Number: PI061 Reach Length: 66 ft. Landowner: Geraci, D.

Risk Factor	Ranking	Score	
Pfankuch-Channel Stability:	Poor	1.5	
Channel Alteration:	None	0	
Bank Erosion:	Active	1	
BEHI:	High (37.67)	1	
Local NPSP:	Obvious Sources	1.5	
Shoring Structures:	None	0	
Pipe Discharge:	None	0	
Water Odor:	Normal	0	
Fish Passage Barrier:	None	0	
RB: Riparian Buffer:	40 ft.	0.5	
LB: Riparian Buffer:	0 ft.	0.75	
RB: Floodplain Access:	Full	0	
LB: Floodplain Access:	Full	0	
<b>Severity Scale:</b>		<b>6.25</b>	
Notes: Cattle access; 303d: Impaired - Aquatic Life Harvesting (fecal coliform, mercury in fish tissue)			
Restoration Option 1

Additional Site Features
Stream Channel Woody Material: Moderate
Impoundments: None
Substrate Composition: Medium Sand
Bank Material: Sand
Near Bank Stress: Moderate
RB Landuse: Pasture, Natural Forest
LB Landuse: Pasture, Natural Forest

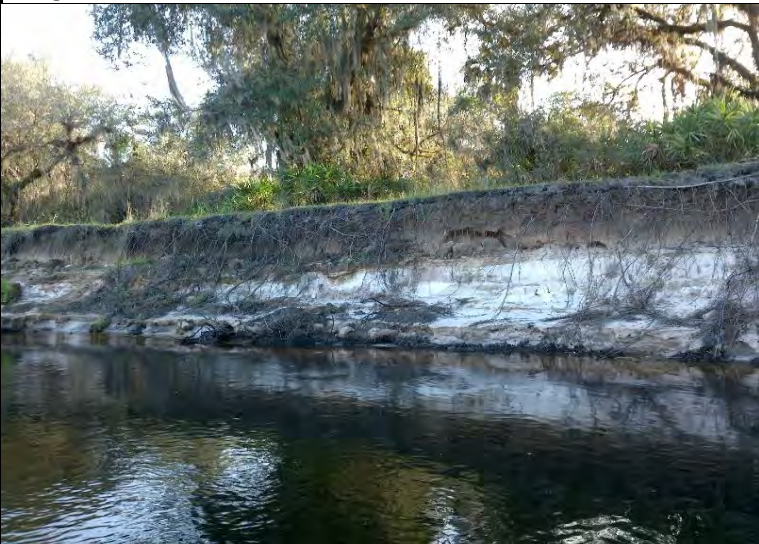
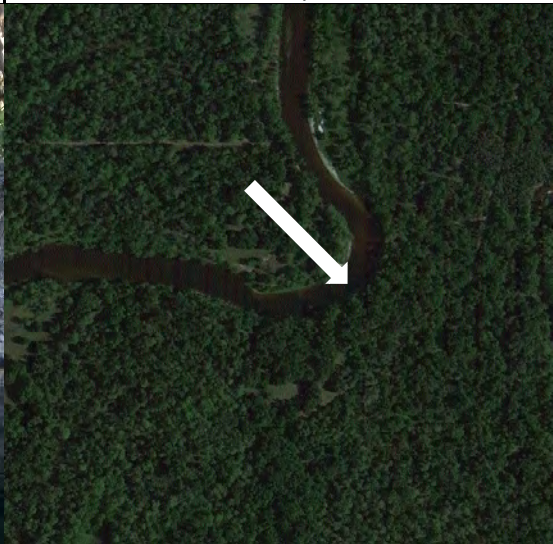
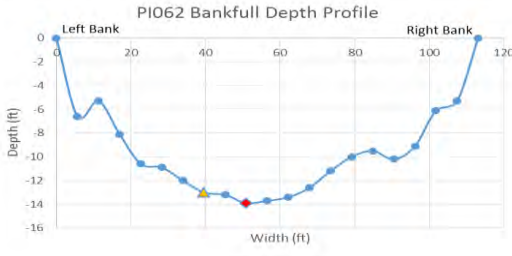
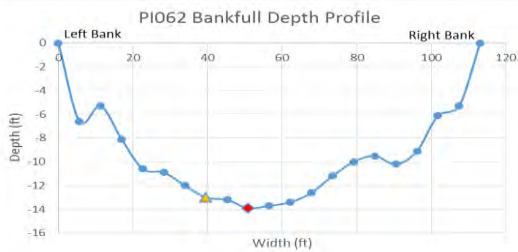
Peace River			Severity Scale: 6.25-Moderate	
Watershed: Peace River Subwatershed: Johnson Lake Latitude: 27.17010 Longitude: -81.89662			County: Desoto Site Number: PI062 Reach Length: 657 ft. Landowner: General Propeller Co.

Pfankuch-Channel Stability:	Poor	1.5		
Channel Alteration:	None	0		
Bank Erosion:	Mass-wasting	1.5		
BEHI:	High (32.25)	1		
Local NPSP:	Obvious Sources	1.5		
Shoring Structures:	None	0		
Pipe Discharge:	None	0		
Water Odor:	Normal	0		
Fish Passage Barrier:	None	0		
RB: Riparian Buffer:	100 ft.	0	<b>Additional Site Features</b>	
LB: Riparian Buffer:	40 ft.	0.5	Stream Channel Woody Material: Numerous	
RB: Floodplain Access:	Full	0	Impoundments: None	
LB: Floodplain Access:	Partial	0.25	Substrate Composition: Medium sand	
<b>Severity Scale:</b>			<b>6.25</b>	
303d: Impaired - Aquatic Life Harvesting (Mercury in Fish Tissue)			Bank Material: Sand

Restoration Option 1			Near Bank Stress: Moderate	
			RB Landuse: Natural Forest	
			LB Landuse: Pasture, Natural Forest
