# **Peace River and Withlacoochee River Threats Assessments and Fish Assemblage Monitoring**

**Final Report July 1, 2015 – June 30, 2019**

Submitted to Florida State Wildlife Grants Program  
August 1, 2019  
PID: 98462501284

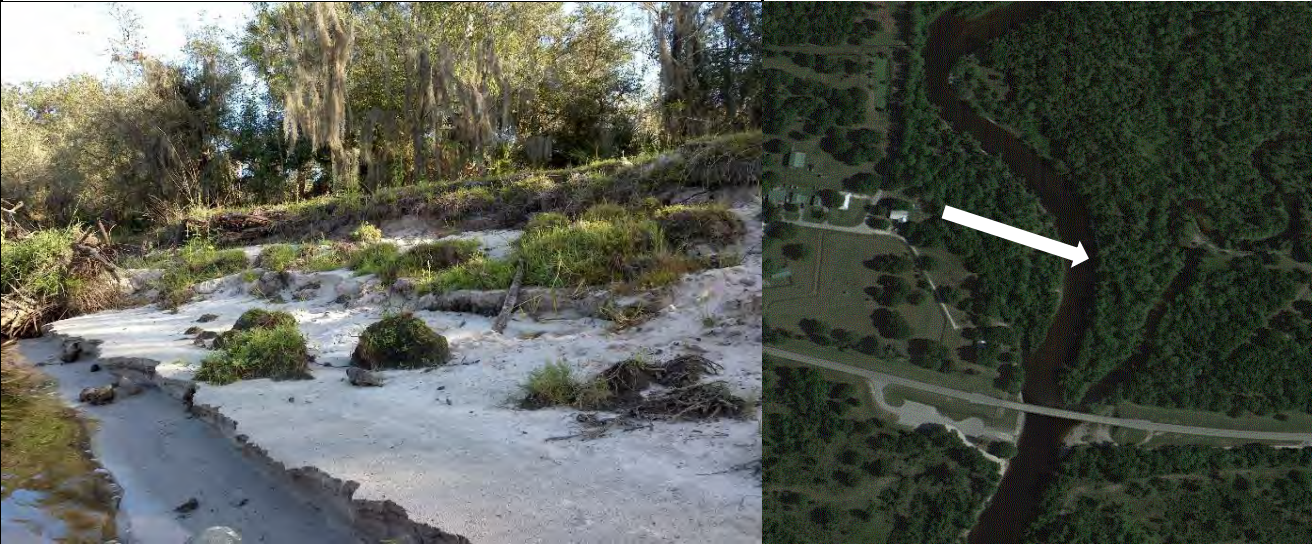
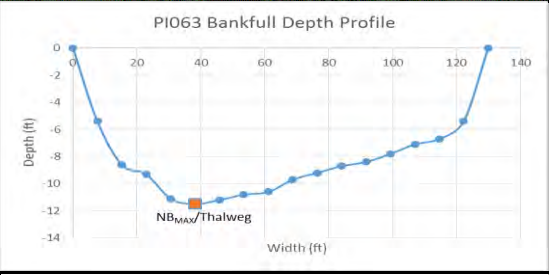
Peace River			Severity Scale: 6.0-Moderate
Watershed: Peace River Subwatershed: Johnson Lake Latitude: 27.16403 Longitude: -81.90125			County: Desoto Site Number: PI063 Reach Length: 81 ft. Landowner: Geraci, D.

Pfankuch-Channel Stability:	Poor	1.5	
Channel Alteration:	None	0	
Bank Erosion:	Mass-wasting	1.5	
BEHI:	High (35.99)	1	
Local NPSP:	Obvious Sources	1.5	
Shoring Structures:	None	0	
Pipe Discharge:	None	0	
Water Odor:	Normal	0	
Fish Passage Barrier:	None	0	
RB: Riparian Buffer:	100 ft.	0	
LB: Riparian Buffer:	40 ft.	0.5	
RB: Floodplain Access:	Full	0	
LB: Floodplain Access:	Full	0	
<b>Severity Scale:</b>		<b>6.0</b>	
			<b>Additional Site Features</b>
			Stream Channel Woody Material: Moderate
			Impoundments: None
			Substrate Composition: Medium sand
			Bank Material: Sand
			Near Bank Stress: High
			RB Landuse: Natural Forest
			LB Landuse: Natural Forest, Pasture

303d: Impaired - Aquatic Life Harvesting (Mercury in Fish Tissue)			
Restoration Option 1

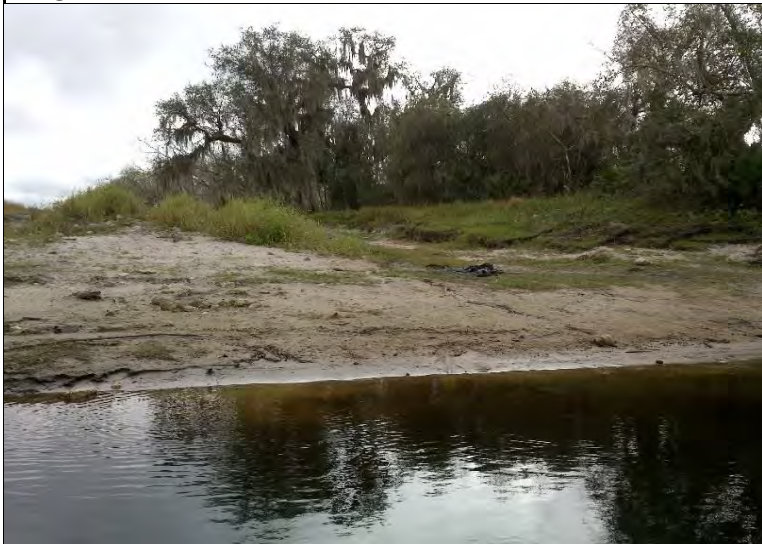
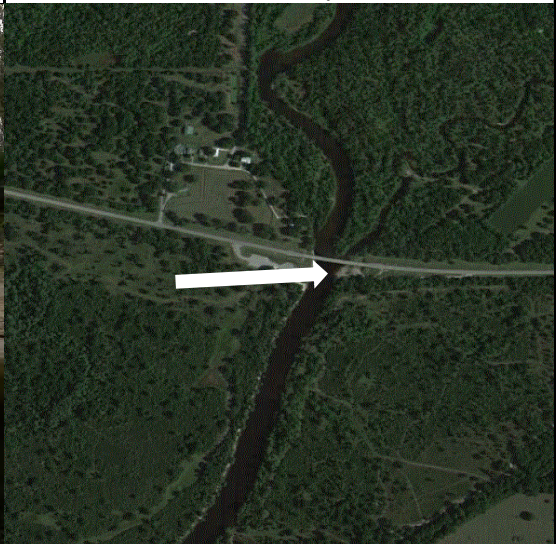
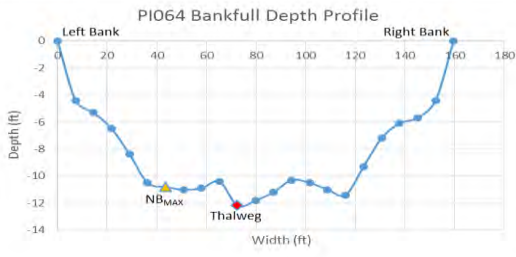
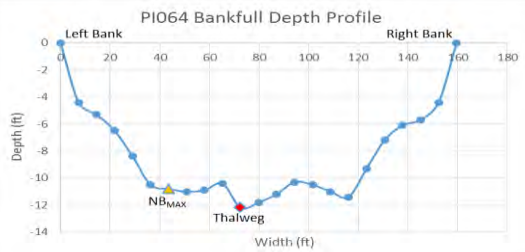
Peace River			Severity Scale: 8.75-High	
Watershed: Peace River Subwatershed: Johnson Lake Latitude: 27.16215 Longitude: -81.90158			County: Desoto Site Number: PI064 Reach Length: 178.2 ft. Landowner: Desoto County

Pfankuch-Channel Stability:	Poor	1.5		
Channel Alteration:	In Recovery	1		
Bank Erosion:	Active	1		
BEHI:	High (32.92)	1		
Local NPSP:	Moderate Potential	1		
Shoring Structures:	Present	1.5		
Pipe Discharge:	None	0		
Water Odor:	Normal	0		
Fish Passage Barrier:	None	0		
RB: Riparian Buffer:	0 ft.	0.75	<b>Additional Site Features</b> Stream Channel Woody Material: None Impoundments: None Substrate Composition: Medium Sand Bank Material: Sand Near Bank Stress: Moderate RB Landuse: Recreation, Transportation LB Landuse: Recreation, Transportation	
LB: Riparian Buffer:	0 ft.	0.75		
RB: Floodplain Access:	Partial	0.25		
LB: Floodplain Access:	Full	0

<b>Severity Scale:</b>		<b>8.75</b>		
Notes: Nocatee boat launch on right bank, used as an unpaved boat launch; 303d: Impaired - Aquatic Life Harvesting (Mercury in Fish Tissue)				
Restoration Option 2

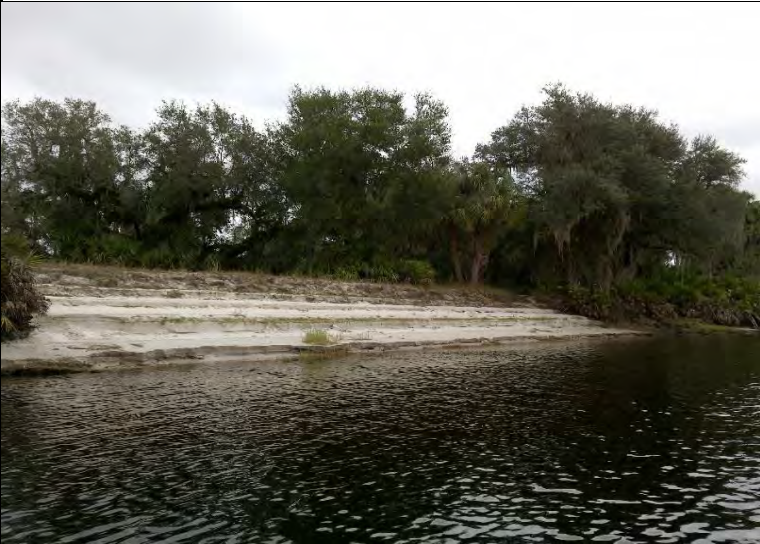
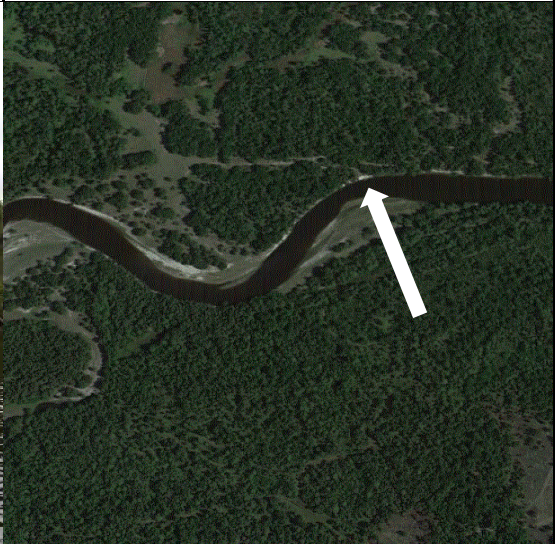
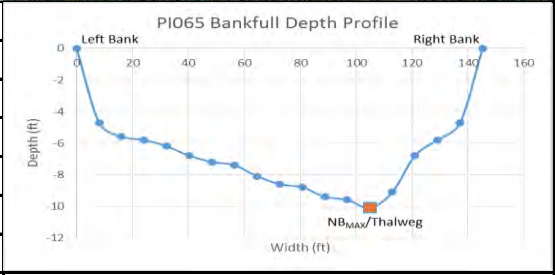
Peace River			Severity Scale: 6.25-Moderate
Watershed: Peace River Subwatershed: Johnson Lake Latitude: 27.15611 Longitude: -81.91725			County: Desoto Site Number: PI065 Reach Length: 175 ft. Landowner: Robertson Family LLC

Risk Factor	Ranking	Score	
Pfankuch-Channel Stability:	Poor	1.5	
Channel Alteration:	None	0	
Bank Erosion:	Active	1	
BEHI:	High (39.26)	1	
Local NPSP:	Obvious Sources	1.5	
Shoring Structures:	None	0	
Pipe Discharge:	None	0	
Water Odor:	Normal	0	
Fish Passage Barrier:	None	0	
RB: Riparian Buffer:	40 ft.	0.5	
LB: Riparian Buffer:	40 ft.	0.5	
RB: Floodplain Access:	Partial	0.25	
LB: Floodplain Access:	Full	0	
Severity Scale:		6.25

Additional Site Features
			Stream Channel Woody Material: Infrequent
			Impoundments: None
			Substrate Composition: Medium Sand
			Bank Material: Sand
			Near Bank Stress: High
			RB Landuse: Pasture, Natural Forest
			LB Landuse: Pasture, Natural Forest

303d: Impaired - Aquatic Life Harvesting (Mercury in Fish Tissue)			
Restoration Option 1

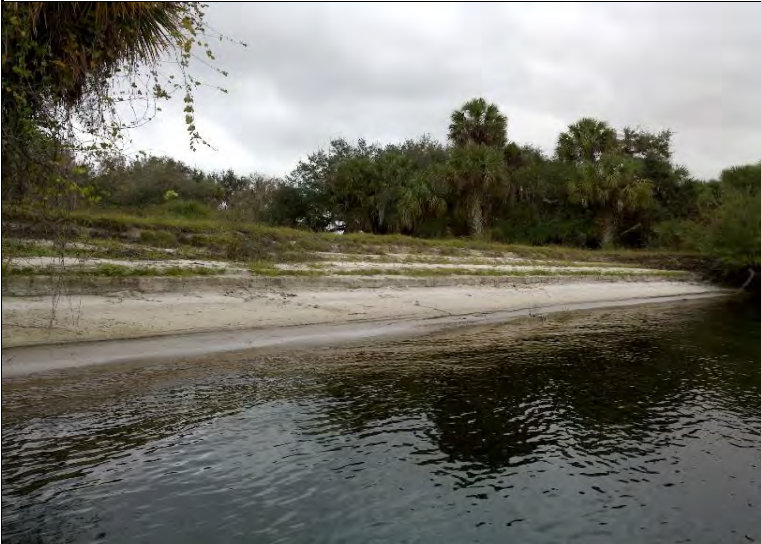
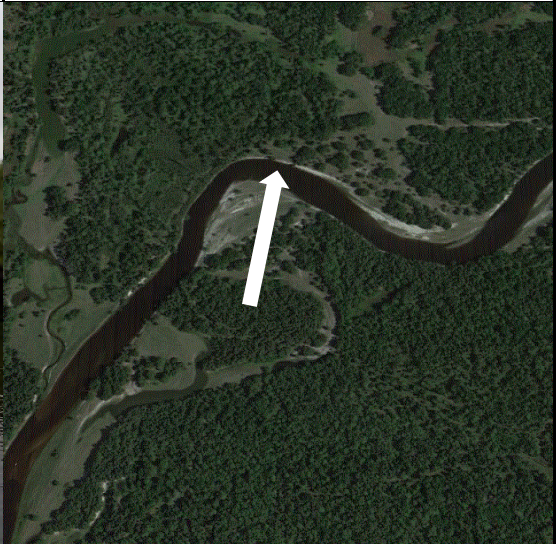
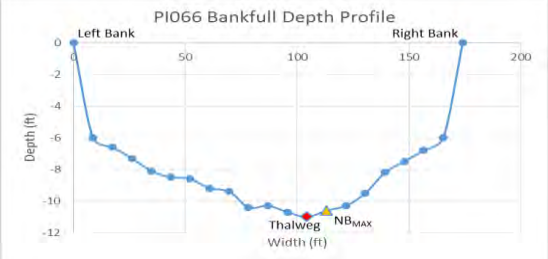
Peace River			Severity Scale: 6.25-Moderate
Watershed: Peace River Subwatershed: Johnson Lake Latitude: 27.15584 Longitude: -81.92344			County: Desoto Site Number: PI066 Reach Length: 440 ft. Landowner: Robertson Family LLC

Risk Factor	Ranking	Score	
Pfankuch-Channel Stability:	Poor	1.5	
Channel Alteration:	None	0	
Bank Erosion:	Active	1	
BEHI:	High (35.94)	1	
Local NPSP:	Obvious Sources	1.5	
Shoring Structures:	None	0	
Pipe Discharge:	None	0	
Water Odor:	Normal	0	
Fish Passage Barrier:	None	0	
RB: Riparian Buffer:	40 ft.	0.5	
LB: Riparian Buffer:	0 ft.	0.75	
RB: Floodplain Access:	Full	0	
LB: Floodplain Access:	Full	0	
<b>Severity Scale:</b>		<b>6.25</b>

<b>Additional Site Features</b>
			Stream Channel Woody Material: Infrequent
			Impoundments: None
			Substrate Composition: Medium Sand
			Bank Material: Sand
			Near Bank Stress: Moderate
			RB Landuse: Pasture, Natural Forest
			LB Landuse: Pasture, Natural Forest

Notes: No cattle seen, but may have access; Old cow patties present; 303d: Impaired - Aquatic Life			
Harvesting (Mercury in Fish Tissue)			
Restoration Option 1

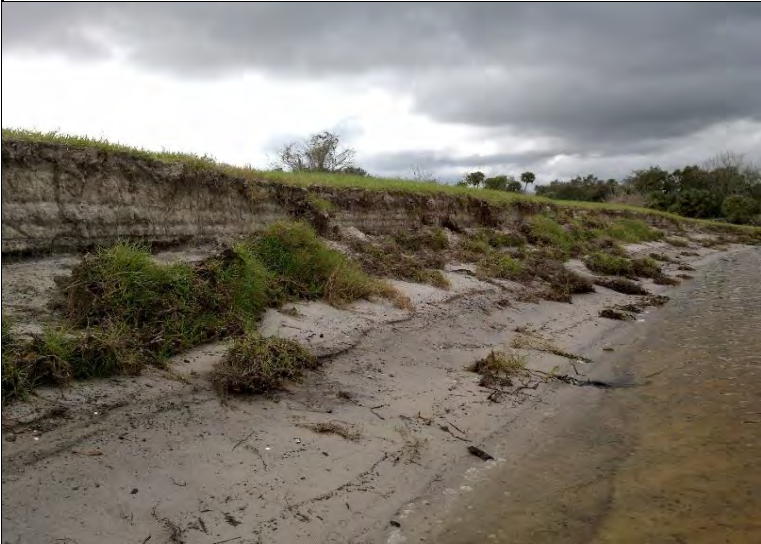
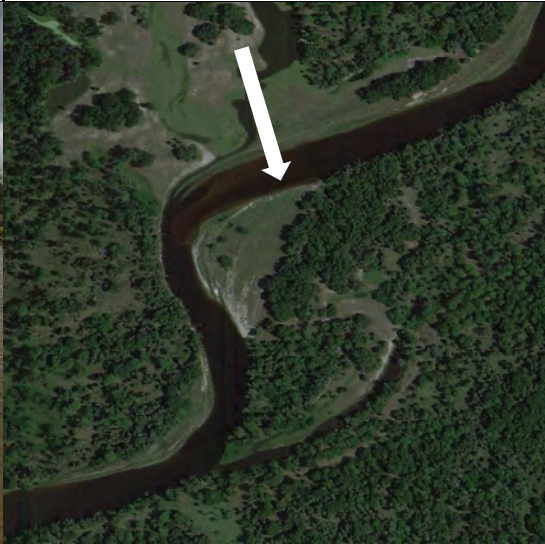
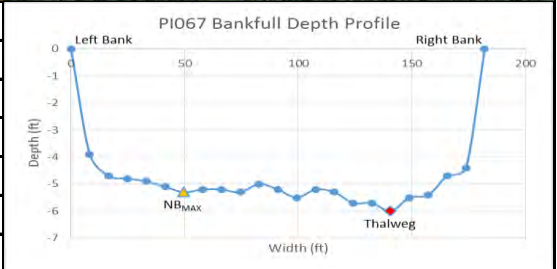
Peace River			Severity Scale: 7.0-Moderate
Watershed: Peace River Subwatershed: Johnson Lake Latitude: 27.14345 Longitude: -81.93594			County: Desoto Site Number: PI067 Reach Length: 153 ft. Landowner: Susie Robertson

Risk Factor	Ranking	Score	
Pfankuch-Channel Stability:	Poor	1.5	
Channel Alteration:	None	0	
Bank Erosion:	Mass-wasting	1.5	
BEHI:	High (32.69)	1	
Local NPSP:	Obvious Sources	1.5	
Shoring Structures:	None	0	
Pipe Discharge:	None	0	
Water Odor:	Normal	0	
Fish Passage Barrier:	None	0	
RB: Riparian Buffer:	0 ft.	0.75	
LB: Riparian Buffer:	0 ft.	0.75	
RB: Floodplain Access:	Full	0	
LB: Floodplain Access:	Full	0	
<b>Severity Scale:</b>		<b>7.0</b>	
Notes: Opposite bank of Johnson Lake, no cattle seen, fencing on opposite bank; 303d: Impaired - Aquatic Life Harvesting (Mercury in Fish Tissue)			
Restoration Option 2 or 3

Additional Site Features
Stream Channel Woody Material: None
Impoundments: None
Substrate Composition: Medium Sand
Bank Material: Sand
Near Bank Stress: High
RB Landuse: Pasture
LB Landuse: Pasture

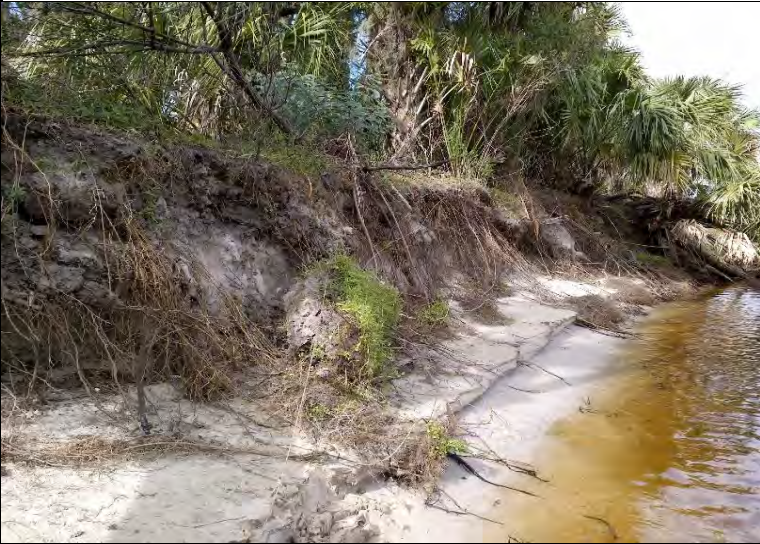
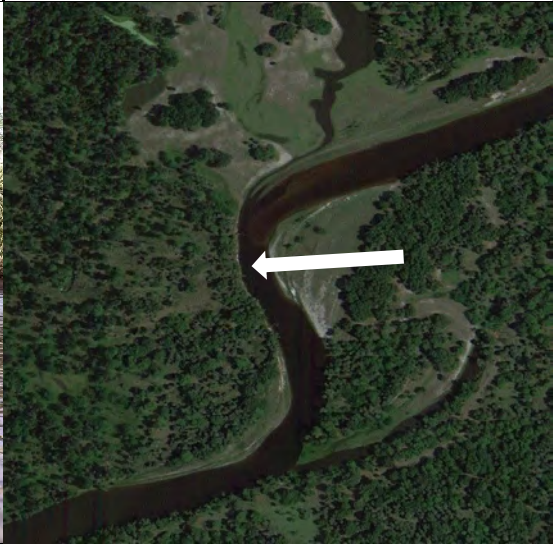
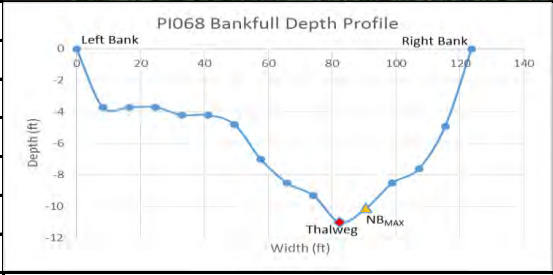
Peace River			Severity Scale: 6.25-Moderate
Watershed: Peace River Subwatershed: Johnson Lake Latitude: 27.14241 Longitude: -81.93697			County: Desoto Site Number: PI068 Reach Length: 643 ft. Landowner: Johnson Homestead LLC

Risk Factor	Ranking	Score	
Pfankuch-Channel Stability:	Poor	1.5	
Channel Alteration:	None	0	
Bank Erosion:	Mass-wasting	1.5	
BEHI:	Moderate (27.70)	0.5	
Local NPSP:	Obvious Sources	1.5	
Shoring Structures:	None	0	
Pipe Discharge:	None	0	
Water Odor:	Normal	0	
Fish Passage Barrier:	None	0	
RB: Riparian Buffer:	40 ft.	0.5	
LB: Riparian Buffer:	0 ft.	0.75	
RB: Floodplain Access:	Full	0	
LB: Floodplain Access:	Full	0	
<b>Severity Scale:</b>		<b>6.25</b>

<b>Additional Site Features</b>
			Stream Channel Woody Material: Extensive
			Impoundments: None
			Substrate Composition: Medium Sand
			Bank Material: Sand
			Near Bank Stress: High
			RB Landuse: Natural Forest, Pasture

LB Landuse: Pasture
303d: Impaired - Aquatic Life Harvesting (Mercury in Fish Tissue)			
Restoration Option 1

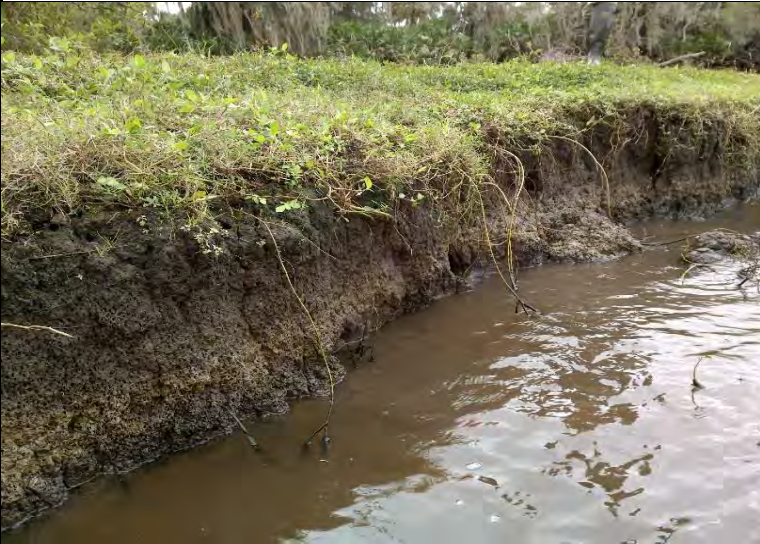
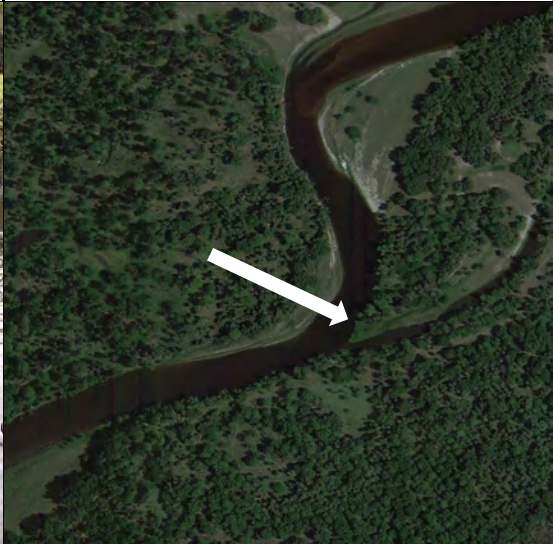
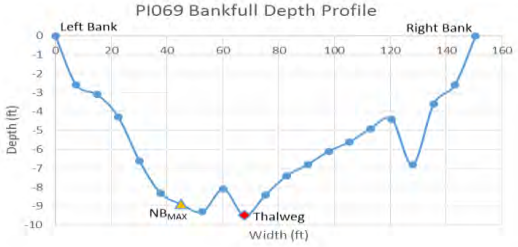
Peace River			Severity Scale: 5.75-Moderate
Watershed: Peace River Subwatershed: Johnson Lake Latitude: 27.14044 Longitude: -81.93629			County: Desoto Site Number: PI069 Reach Length: 90 ft. Landowner: Robertson, Susie

Pfankuch-Channel Stability:	Poor	1.5	
Channel Alteration:	None	0	
Bank Erosion:	Active	1	
BEHI:	High (37.80)	1	
Local NPSP:	Obvious Sources	1.5	
Shoring Structures:	None	0	
Pipe Discharge:	None	0	
Water Odor:	Normal	0	
Fish Passage Barrier:	None	0	
RB: Riparian Buffer:	100 ft.	0	
LB: Riparian Buffer:	0 ft.	0.75	
RB: Floodplain Access:	Full	0	
LB: Floodplain Access:	Full	0	
<b>Severity Scale:</b>		<b>5.75</b>	<b>Additional Site Features</b>
			Stream Channel Woody Material: Moderate
			Impoundments: None
			Substrate Composition: Medium Sand
			Bank Material: Clay
			Near Bank Stress: Moderate
			RB Landuse: Natural Forest
			LB Landuse: Pasture
303d: Impaired - Aquatic Life Harvesting (Mercury in Fish Tissue)

Restoration Option 1

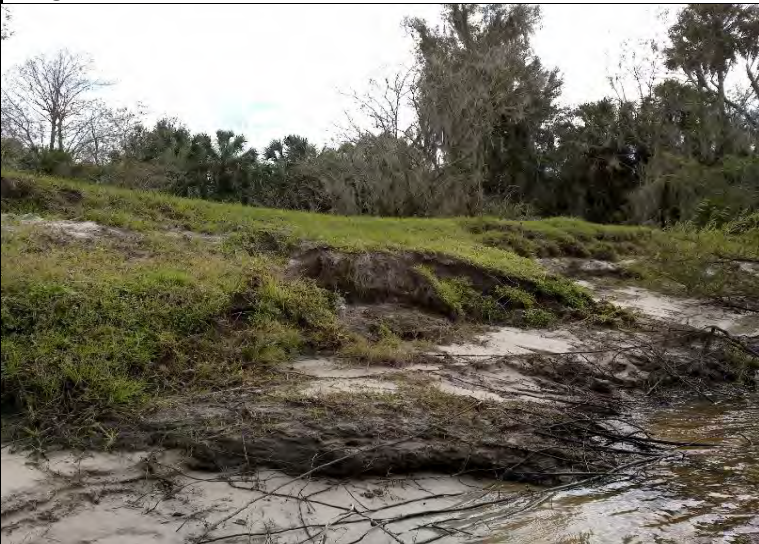
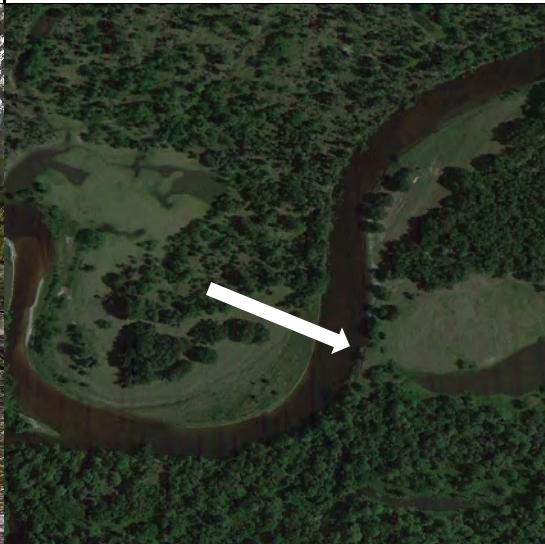
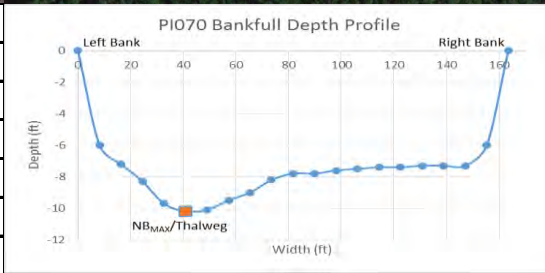
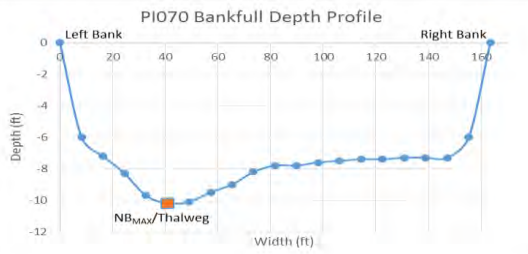
Peace River			Severity Scale: 6.5-Moderate	
Watershed: Peace River Subwatershed: Lettuce Lake Latitude: 27.13609 Longitude: -81.94119			County: Desoto Site Number: PI070 Reach Length: 303 ft. Landowner: TIITF/State of Florida

Pfankuch-Channel Stability:	Poor	1.5		
Channel Alteration:	None	0		
Bank Erosion:	Mass-wasting	1.5		
BEHI:	Moderate (29.06)	0.5		
Local NPSP:	Obvious Sources	1.5		
Shoring Structures:	None	0		
Pipe Discharge:	None	0		
Water Odor:	Normal	0		
Fish Passage Barrier:	None	0		
RB: Riparian Buffer:	0 ft.	0.75		
LB: Riparian Buffer:	0 ft.	0.75		
RB: Floodplain Access:	Full	0		
LB: Floodplain Access:	Full	0		
Severity Scale:		6.5	Additional Site Features	
Notes: Backwater pond in pasture discharging into Peace River; 303d: Impaired - Aquatic Life Harvesting (Mercury in Fish Tissue)			Stream Channel Woody Material: Moderate	
			Impoundments: None

Substrate Composition: Medium Sand	
Restoration Option 1			Bank Material: Sand	
			Near Bank Stress: High	
			RB Landuse: Pasture	
			LB Landuse: Pasture

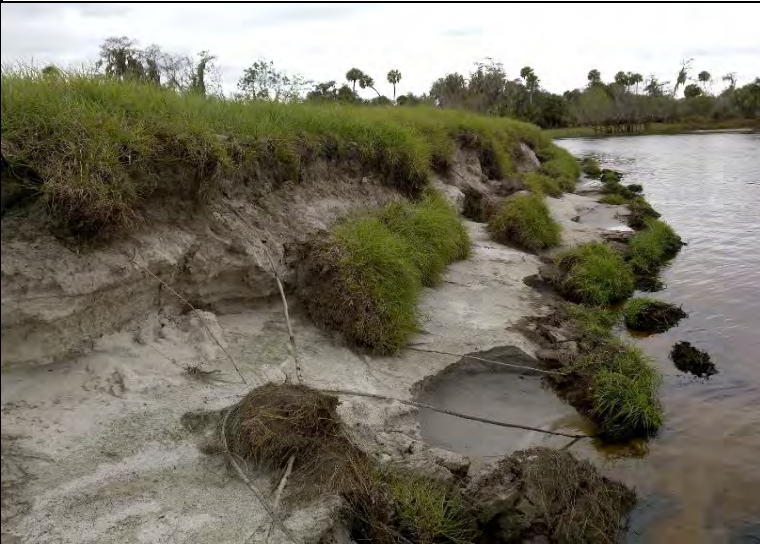
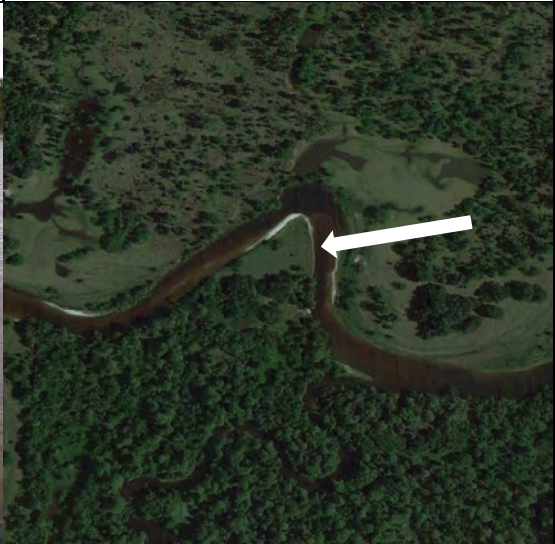
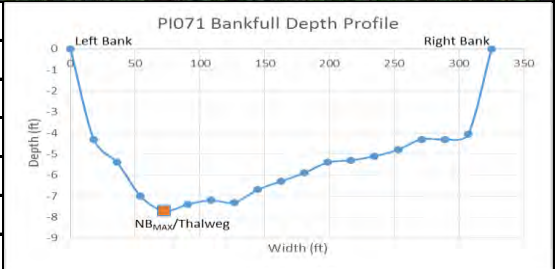
Peace River			Severity Scale: 7.0-Moderate
Watershed: Peace River Subwatershed: Lettuce Lake Latitude: 27.13669 Longitude: -81.94493			County: Desoto Site Number: PI071 Reach Length: 343 ft. Landowner: HAU II LLC

Risk Factor	Ranking	Score	
Pfankuch-Channel Stability:	Poor	1.5	
Channel Alteration:	None	0	
Bank Erosion:	Mass-wasting	1.5	
BEHI:	High (32.93)	1	
Local NPSP:	Obvious Sources	1.5	
Shoring Structures:	None	0	
Pipe Discharge:	None	0	
Water Odor:	Normal	0	
Fish Passage Barrier:	None	0	
RB: Riparian Buffer:	0 ft.	0.75	
LB: Riparian Buffer:	0 ft.	0.75	
RB: Floodplain Access:	Full	0	
LB: Floodplain Access:	Full	0	
Severity Scale:		7.0	
303d: Impaired - Aquatic Life Harvesting (Mercury in Fish Tissue)			
Restoration Option 2 or 3

Additional Site Features
Stream Channel Woody Material: Infrequent
Impoundments: None
Substrate Composition: Medium Sand
Bank Material: Sand
Near Bank Stress: High
RB Landuse: Pasture
LB Landuse: Pasture

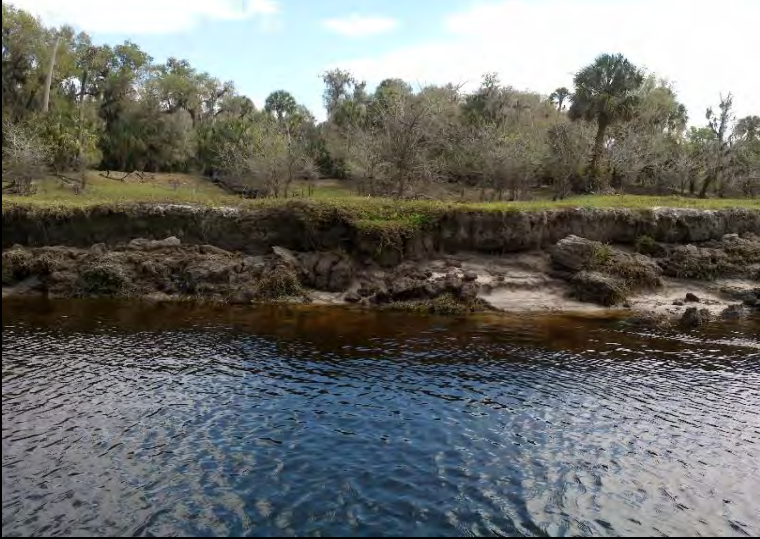
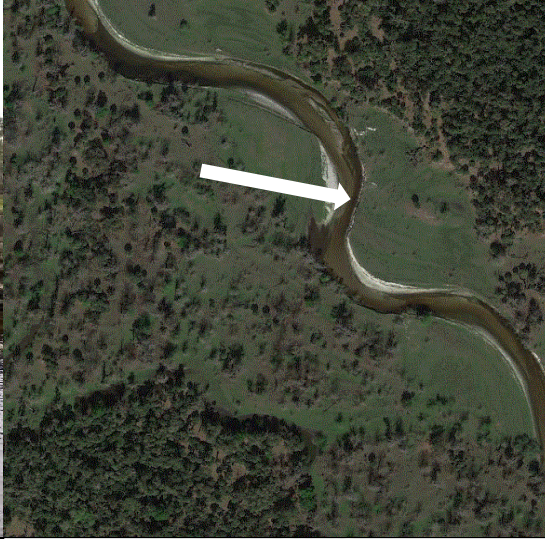
Peace River			Severity Scale: 6.5-Moderate
Watershed: Peace River Subwatershed: Peace River Branch Latitude: 27.39067 Longitude: -81.845797			County: Hardee Site Number: PI073 Reach Length: 296 ft. Landowner: Ben Hill Griffin Inc.

Pfankuch-Channel Stability:	Poor	1.5	
Channel Alteration:	None	0	
Bank Erosion:	Mass-wasting	1.5	
BEHI:	Moderate (26.0)	0.5	
Local NPSP:	Obvious Sources	1.5	
Shoring Structures:	None	0	
Pipe Discharge:	None	0	
Water Odor:	Normal	0	
Fish Passage Barrier:	None	0	
RB: Riparian Buffer:	0 ft.	0.75	
LB: Riparian Buffer:	0 ft.	0.75	
RB: Floodplain Access:	Full	0	
LB: Floodplain Access:	Full	0	
<b>Severity Scale:</b>		<b>6.5</b>	
Notes: Rapid assessment methods - BEHI estimated to be same as PI025; 303d: Impaired - Aquatic Life Harvesting (mercury in fish tissue)			<b>Additional Site Features</b>
			Stream Channel Woody Material: Infrequent
			Impoundments: None

Substrate Composition: Medium Sand
			Bank Material: Sand
			Near Bank Stress: High
			RB Landuse: Pasture
			LB Landuse: Pasture
Restoration Option 1

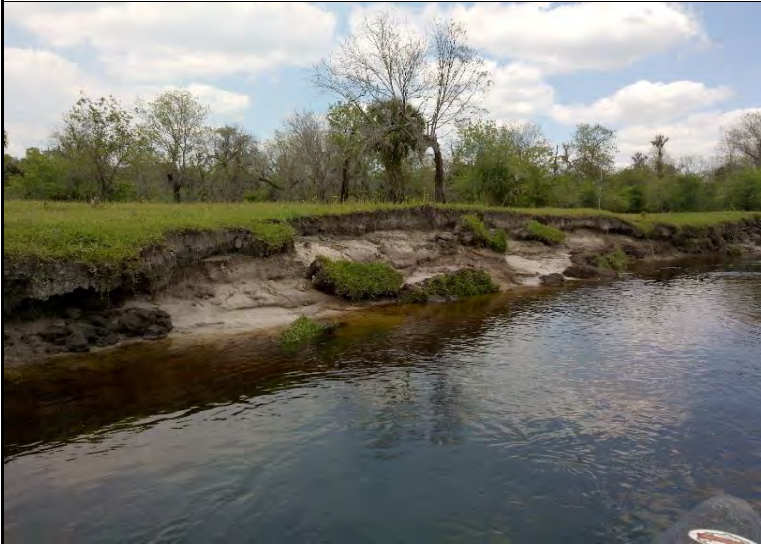
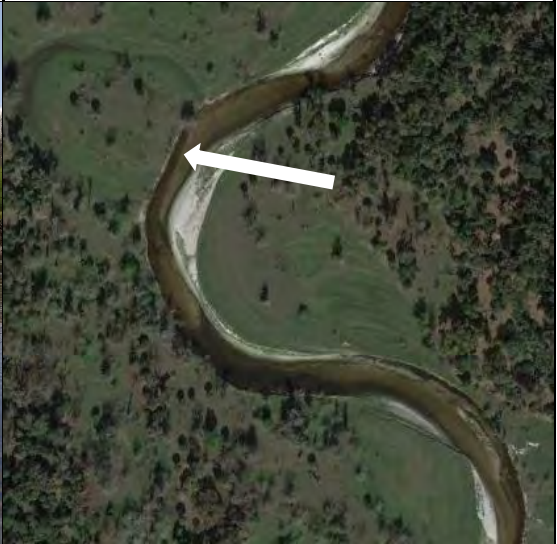
Peace River			Severity Scale: 7.0-Moderate
Watershed: Peace River Subwatershed: Peace River Branch Latitude: 27.39314 Longitude: -81.84804			County: Hardee Site Number: PI074 Reach Length: 259 ft. Landowner: Ben Hill Griffin Inc.

Risk Factor	Ranking	Score	
Pfankuch-Channel Stability:	Poor	1.5	
Channel Alteration:	None	0	
Bank Erosion:	Mass-wasting	1.5	
BEHI:	High (31.19)	1	
Local NPSP:	Obvious Sources	1.5	
Shoring Structures:	None	0	
Pipe Discharge:	None	0	
Water Odor:	Normal	0	
Fish Passage Barrier:	None	0	
RB: Riparian Buffer:	0 ft.	0.75	
LB: Riparian Buffer:	0 ft.	0.75	
RB: Floodplain Access:	Full	0	
LB: Floodplain Access:	Full	0	
<b>Severity Scale:</b>		<b>7.0</b>	
Notes: 303d: Impaired - Aquatic Life Harvesting (mercury in fish tissue)			
Restoration Option 1

Additional Site Features
Stream Channel Woody Material: Moderate
Impoundments: None
Substrate Composition: Medium Sand
Bank Material: Sand
Near Bank Stress: High
RB Landuse: Pasture
LB Landuse: Pasture

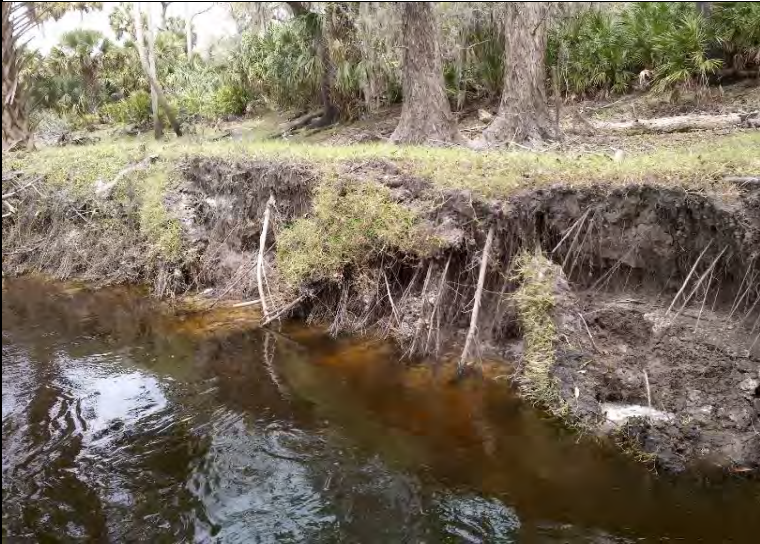
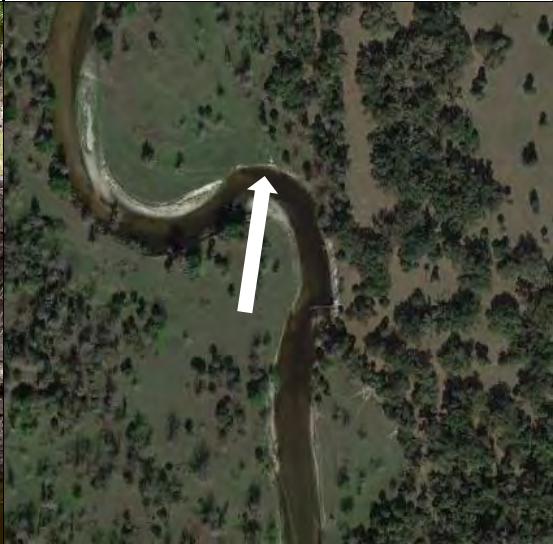
Peace River			Severity Scale: 6.25-Moderate
Watershed: Peace River Subwatershed: Peace River Branch Latitude: 27.396511 Longitude: -81.846586			County: Hardee Site Number: PI075 Reach Length: 140 ft. Landowner: Ben Hill Griffin Inc.

Risk Factor	Ranking	Score	
Pfankuch-Channel Stability:	Poor	1.5	
Channel Alteration:	None	0	
Bank Erosion:	Mass-wasting	1.5	
BEHI:	Moderate (24.78)	0.5	
Local NPSP:	Obvious Sources	1.5	
Shoring Structures:	None	0	
Pipe Discharge:	None	0	
Water Odor:	Normal	0	
Fish Passage Barrier:	None	0	
RB: Riparian Buffer:	0 ft.	0.75	
LB: Riparian Buffer:	40 ft.	0.5	
RB: Floodplain Access:	Full	0	
LB: Floodplain Access:	Full	0	
<b>Severity Scale:</b>		<b>6.25</b>	
Notes: 303d: Impaired - Aquatic Life Harvesting (mercury in fish tissue)			
Restoration Option 1

Additional Site Features	
Stream Channel Woody Material:	Infrequent
Impoundments:	None
Substrate Composition:	Medium Sand
Bank Material:	Sand
Near Bank Stress:	High
RB Landuse:	Pasture, Natural Forest
LB Landuse:	Pasture, Natural Forest

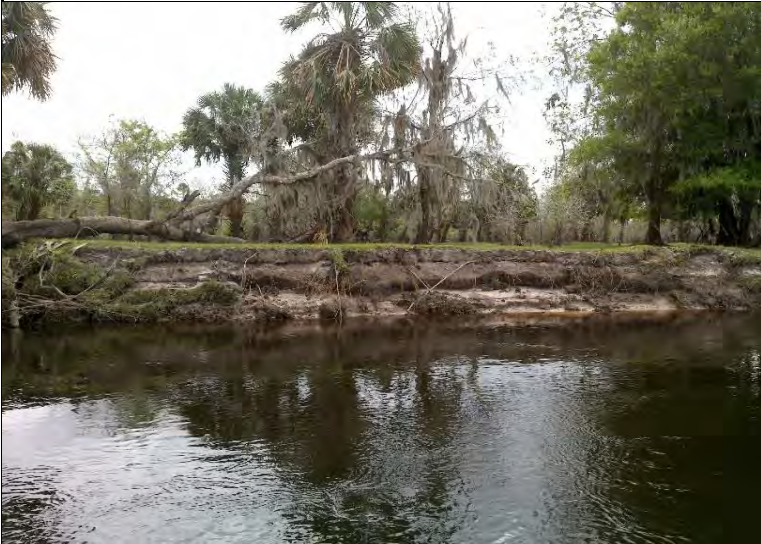
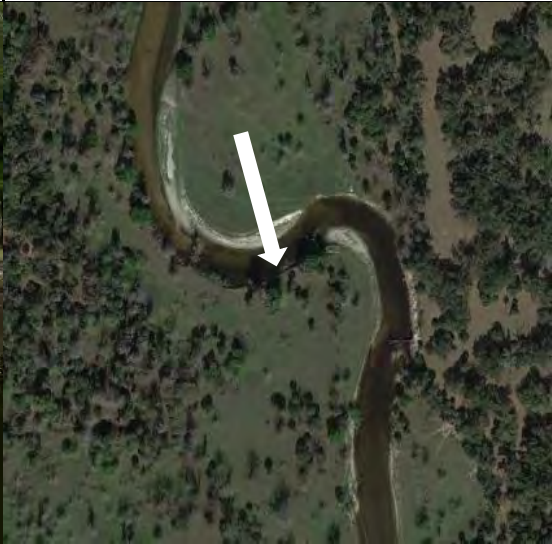
Peace River			Severity Scale: 6.75-Moderate
Watershed: Peace River Subwatershed: Peace River Branch Latitude: 27.396275 Longitude: -81.846951			County: Hardee Site Number: PI076 Reach Length: 385 ft. Landowner: Ben Hill Griffin Inc.

Risk Factor	Ranking	Score	
Pfankuch-Channel Stability:	Poor	1.5	
Channel Alteration:	None	0	
Bank Erosion:	Mass-wasting	1.5	
BEHI:	High (34.0)	1	
Local NPSP:	Obvious Sources	1.5	
Shoring Structures:	None	0	
Pipe Discharge:	None	0	
Water Odor:	Normal	0	
Fish Passage Barrier:	None	0	
RB: Riparian Buffer:	40 ft.	0.5	
LB: Riparian Buffer:	0 ft.	0.75	
RB: Floodplain Access:	Full	0	
LB: Floodplain Access:	Full	0	
<b>Severity Scale:</b>		<b>6.75</b>	
Notes: 303d: Impaired - Aquatic Life Harvesting (mercury in fish tissue)			
Restoration Option 1

Additional Site Features
Stream Channel Woody Material: Moderate
Impoundments: None
Substrate Composition: Medium Sand
Bank Material: Sand
Near Bank Stress: High
RB Landuse: Pasture, Natural Forest
LB Landuse: Pasture, Natural Forest

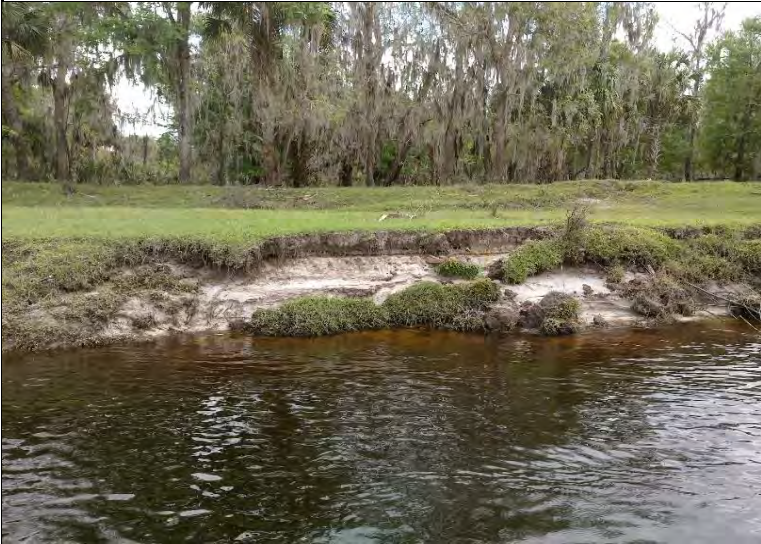
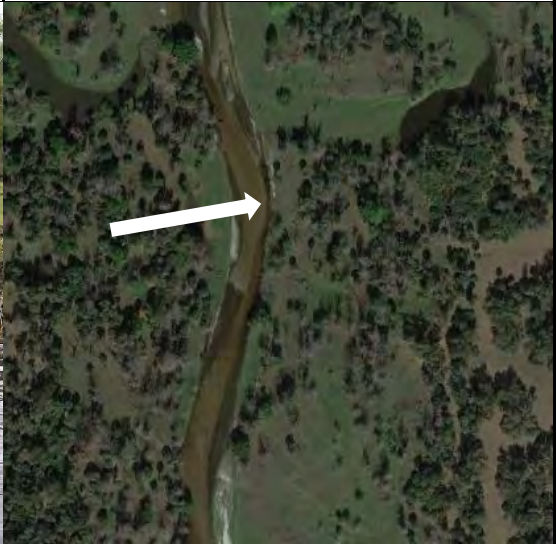
Peace River			Severity Scale: 6.0-Moderate
Watershed: Peace River Subwatershed: Peace River Branch Latitude: 27.398490 Longitude: -81.847507			County: Hardee Site Number: PI077 Reach Length: 226.2 ft. Landowner: Ben Hill Griffin Inc.

Pfankuch-Channel Stability:	Poor	1.5	
Channel Alteration:	None	0	
Bank Erosion:	Mass-wasting	1.5	
BEHI:	Moderate (23.21)	0.5	
Local NPSP:	Obvious Sources	1.5	
Shoring Structures:	None	0	
Pipe Discharge:	None	0	
Water Odor:	Normal	0	
Fish Passage Barrier:	None	0	
RB: Riparian Buffer:	40 ft.	0.5	Additional Site Features
LB: Riparian Buffer:	40 ft.	0.5	
RB: Floodplain Access:	Full	0	
LB: Floodplain Access:	Full	0	
Severity Scale:		6.0	
Notes: 303d: Impaired - Aquatic Life Harvesting (mercury in fish tissue)			Stream Channel Woody Material: Infrequent
Restoration Option 1			Impoundments: None
			Substrate Composition: Medium Sand
			Bank Material: Sand

Near Bank Stress: High
			RB Landuse: Pasture, Natural Forest
			LB Landuse: Pasture, Natural Forest

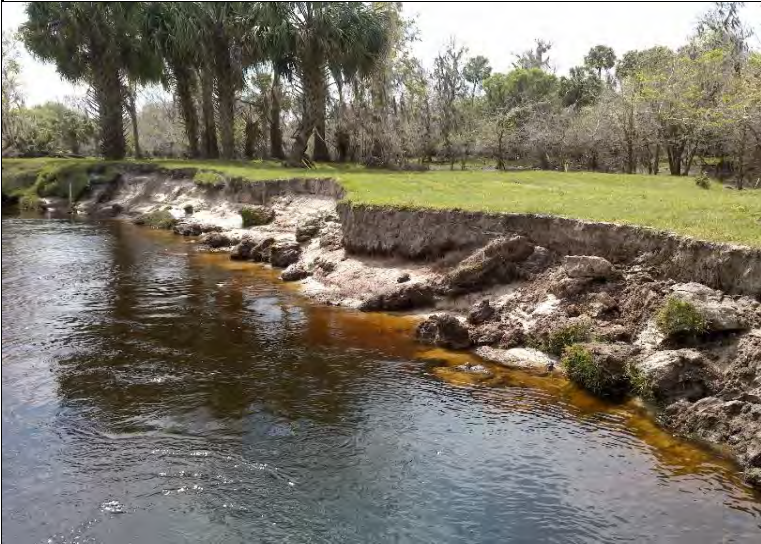
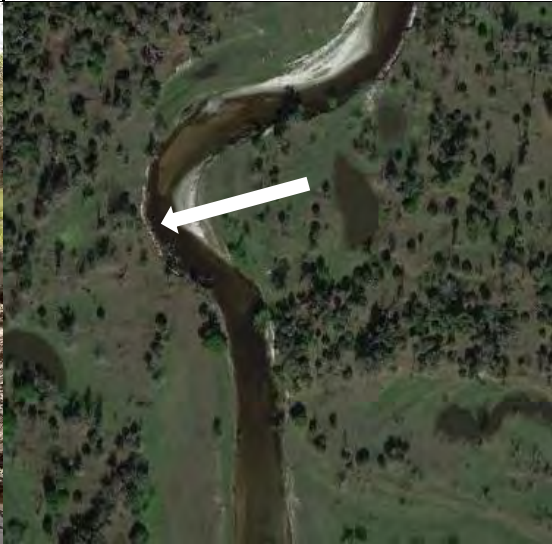
Peace River			Severity Scale: 6.5-Moderate
Watershed: Peace River Subwatershed: Peace River Branch Latitude: 27.40155 Longitude: -81.84864			County: Hardee Site Number: PI078 Reach Length: 220 ft. Landowner: Ben Hill Griffin Inc.

Risk Factor	Ranking	Score	
Pfankuch-Channel Stability:	Poor	1.5	
Channel Alteration:	None	0	
Bank Erosion:	Mass-wasting	1.5	
BEHI:	High (33.30)	1	
Local NPSP:	Obvious Sources	1.5	
Shoring Structures:	None	0	
Pipe Discharge:	None	0	<b>Additional Site Features</b> Stream Channel Woody Material: Numerous Impoundments: None Substrate Composition: Medium Sand Bank Material: Sand Near Bank Stress: High RB Landuse: Pasture, Natural Forest LB Landuse: Pasture, Natural Forest
Water Odor:	Normal	0	
Fish Passage Barrier:	None	0	
RB: Riparian Buffer:	40 ft.	0.5	
LB: Riparian Buffer:	40 ft.	0.5	
RB: Floodplain Access:	Full	0	
LB: Floodplain Access:	Full	0	
<b>Severity Scale:</b>		<b>6.5</b>

Notes: 303d: Impaired - Aquatic Life Harvesting (mercury in fish tissue)			
Restoration Option 1

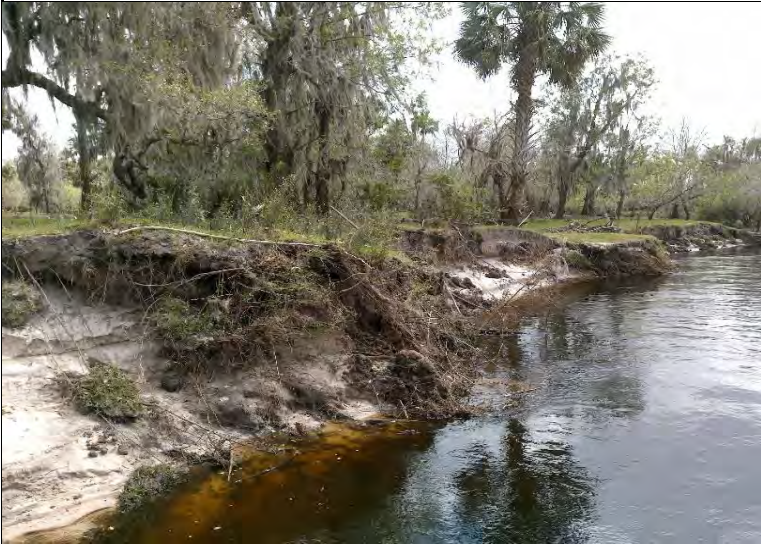
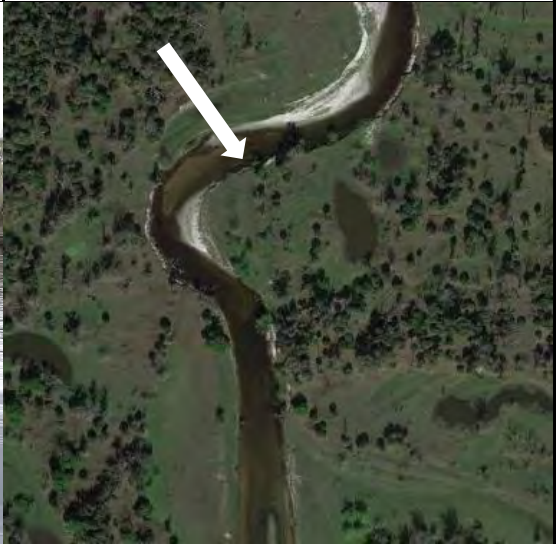
Peace River			Severity Scale: 6.75-Moderate
Watershed: Peace River Subwatershed: Peace River Branch Latitude: 27.401817 Longitude: -81.848028			County: Hardee Site Number: PI079 Reach Length: 550 ft. Landowner: Ben Hill Griffin Inc.

Risk Factor	Ranking	Score	
Pfankuch-Channel Stability:	Poor	1.5	
Channel Alteration:	None	0	
Bank Erosion:	Mass-wasting	1.5	
BEHI:	High (30.62)	1	
Local NPSP:	Obvious Sources	1.5	
Shoring Structures:	None	0	
Pipe Discharge:	None	0	
Water Odor:	Normal	0	<b>Additional Site Features</b>
Fish Passage Barrier:	None	0	Stream Channel Woody Material: Moderate
RB: Riparian Buffer:	0 ft.	0.75	Impoundments: None
LB: Riparian Buffer:	40 ft.	0.5	Substrate Composition: Medium Sand
RB: Floodplain Access:	Full	0	Bank Material: Sand
LB: Floodplain Access:	Full	0	Near Bank Stress: High
			RB Landuse: Pasture, Natural Forest
	<b>Severity Scale:</b>	<b>6.75</b>	LB Landuse: Pasture, Natural Forest

Notes: Floodplain wetland at site; 303d: Impaired - Aquatic Life Harvesting (mercury in fish tissue)			
Restoration Option 1

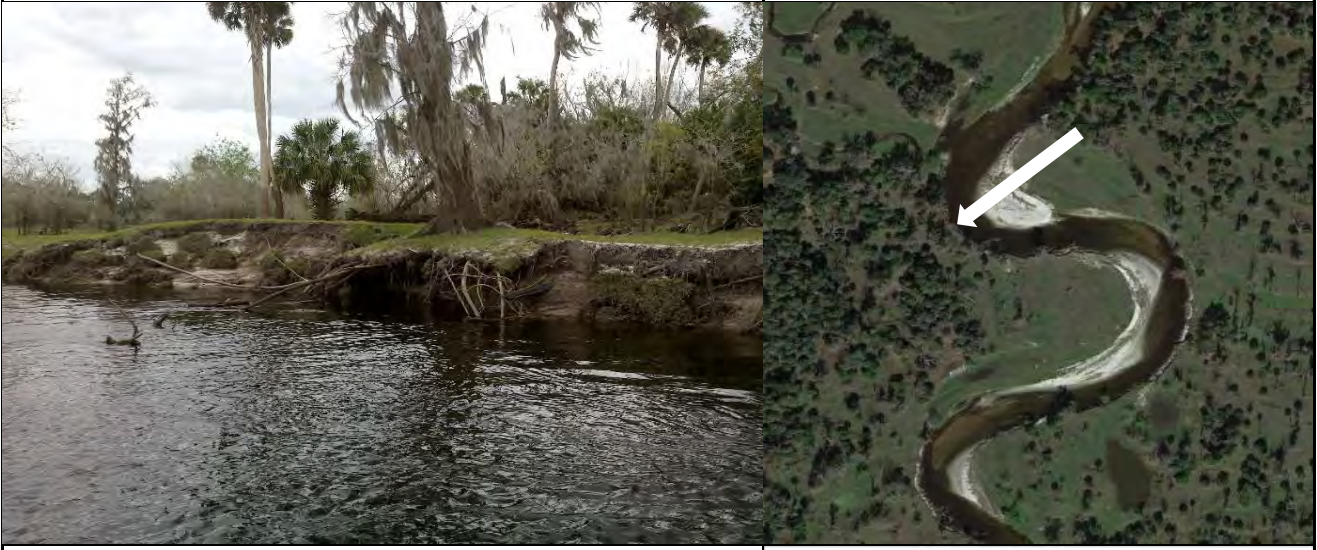
Peace River			Severity Scale: 6.25-Moderate
Watershed: Peace River Subwatershed: Peace River Branch Latitude: 27.40302 Longitude: -81.848478			County: Hardee Site Number: PI080 Reach Length: 375 ft. Landowner: Ben Hill Griffin Inc.

Pfankuch-Channel Stability:	Poor	1.5	
Channel Alteration:	None	0	
Bank Erosion:	Mass-wasting	1.5	
BEHI:	Moderate (26.43)	0.5	
Local NPSP:	Obvious Sources	1.5	
Shoring Structures:	None	0	
Pipe Discharge:	None	0	
Water Odor:	Normal	0	
Fish Passage Barrier:	None	0	
RB: Riparian Buffer:	40 ft.	0.5	
LB: Riparian Buffer:	0 ft.	0.75	
RB: Floodplain Access:	Full	0	
LB: Floodplain Access:	Full	0	
<b>Severity Scale:</b>		<b>6.25</b>	<b>Additional Site Features</b>
			Stream Channel Woody Material: Numerous
			Impoundments: None
			Substrate Composition: Medium Sand
			Bank Material: Sand
			Near Bank Stress: Moderate
			RB Landuse: Pasture, Natural Forest

LB Landuse: Pasture
Notes: 303d: Impaired - Aquatic Life Harvesting (mercury in fish tissue)			
Restoration Option 1

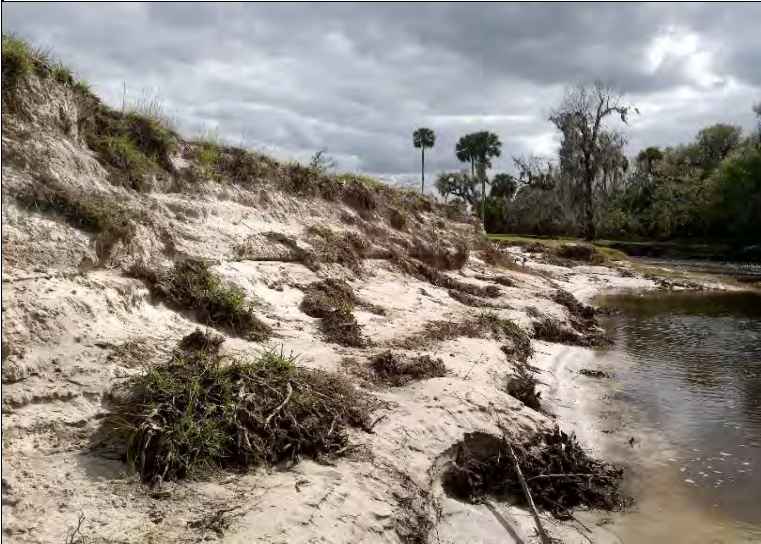
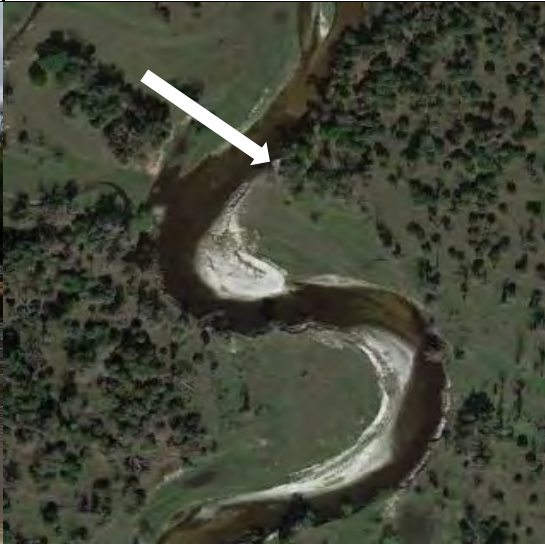
Peace River			Severity Scale: 6.25-Moderate
Watershed: Peace River Subwatershed: Peace River Branch Latitude: 27.403325 Longitude: -81.848242			County: Hardee Site Number: PI081 Reach Length: 200 ft. Landowner: Ben Hill Griffin Inc.

Pfankuch-Channel Stability:	Poor	1.5	
Channel Alteration:	None	0	
Bank Erosion:	Active	1	
BEHI:	High (36.84)	1	
Local NPSP:	Obvious Sources	1.5	
Shoring Structures:	None	0	
Pipe Discharge:	None	0	
Water Odor:	Normal	0	
Fish Passage Barrier:	None	0	
RB: Riparian Buffer:	40 ft.	0.5	
LB: Riparian Buffer:	0 ft.	0.75	
RB: Floodplain Access:	Full	0	
LB: Floodplain Access:	Full	0	
<b>Severity Scale:</b>		<b>6.25</b>	<b>Additional Site Features</b>
			Stream Channel Woody Material: Infrequent
			Impoundments: None
			Substrate Composition: Medium Sand
			Bank Material: Sand
			Near Bank Stress: Moderate
			RB Landuse: Pasture, Natural Forest
			LB Landuse: Pasture

Notes: 303d: Impaired - Aquatic Life Harvesting (mercury in fish tissue)			
Restoration Option 1 or 2

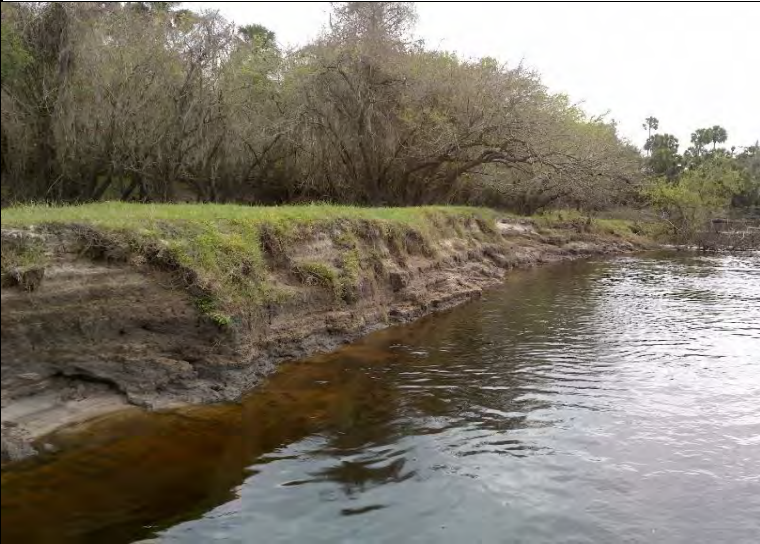
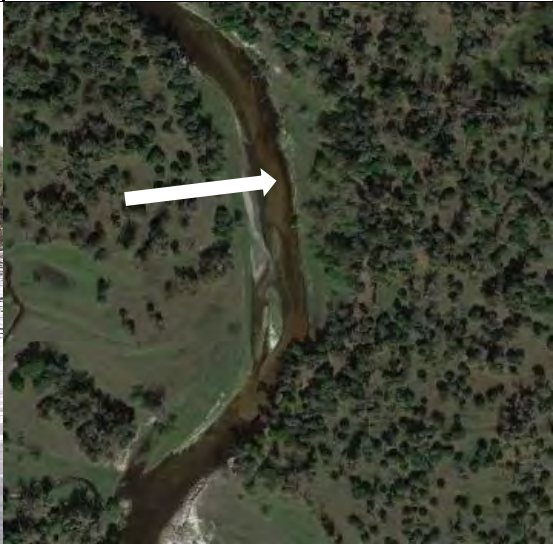
Peace River			Severity Scale: 5.5-Moderate
Watershed: Peace River Subwatershed: Peace River Branch Latitude: 27.40534 Longitude: -81.84761			County: Hardee Site Number: PI082 Reach Length: 100 ft. Landowner: Ben Hill Griffin Inc.

Pfankuch-Channel Stability:	Poor	1.5	
Channel Alteration:	None	0	
Bank Erosion:	Active	1	
BEHI:	Moderate (20.18)	0.5	
Local NPSP:	Obvious Sources	1.5	
Shoring Structures:	None	0	
Pipe Discharge:	None	0	
Water Odor:	Normal	0	
Fish Passage Barrier:	None	0	
			Additional Site Features
RB: Riparian Buffer:	40 ft.	0.5	Stream Channel Woody Material: Infrequent
LB: Riparian Buffer:	40 ft.	0.5	Impoundments: None
RB: Floodplain Access:	Full	0	Substrate Composition: Medium Sand
LB: Floodplain Access:	Full	0	Bank Material: Sandy-Clay
<b>Severity Scale:</b>			Near Bank Stress: Very High
			RB Landuse: Pasture, Natural Forest
			LB Landuse: Pasture, Natural Forest

Notes: 303d: Impaired - Aquatic Life Harvesting (mercury in fish tissue)			
Restoration Option 1

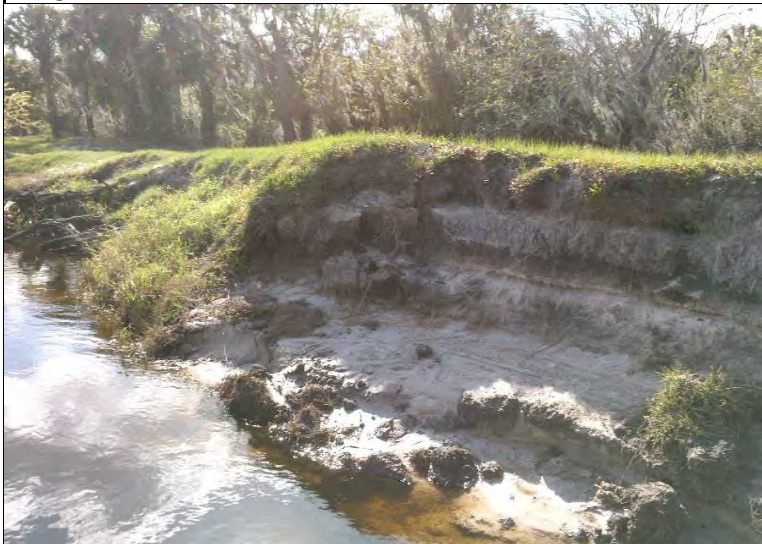
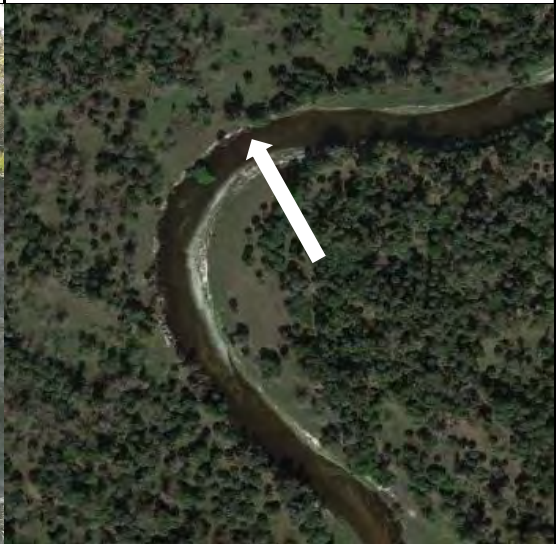
Peace River			Severity Scale: 6.0-Moderate	
Watershed: Peace River Subwatershed: Peace River Branch Latitude: 27.40795 Longitude: -81.848659			County: Hardee Site Number: PI083 Reach Length: 550 ft. Landowner: Ben Hill Griffin Inc.

Pfankuch-Channel Stability:	Poor	1.5		
Channel Alteration:	None	0		
Bank Erosion:	Mass-wasting	1.5		
BEHI:	Moderate (25.24)	0.5		
Local NPSP:	Obvious Sources	1.5		
Shoring Structures:	None	0		
Pipe Discharge:	None	0		
Water Odor:	Normal	0		
Fish Passage Barrier:	None	0		
RB: Riparian Buffer:	40 ft.	0.5	Additional Site Features	
LB: Riparian Buffer:	40 ft.	0.5	Stream Channel Woody Material: Moderate	
RB: Floodplain Access:	Full	0	Impoundments: None	
LB: Floodplain Access:	Full	0	Substrate Composition: Medium Sand	
Severity Scale: 6.0			Bank Material: Sand	
			Near Bank Stress: Moderate	
			RB Landuse: Pasture, Natural Forest	
			LB Landuse: Pasture, Natural Forest

Notes: 303d: Impaired - Aquatic Life Harvesting (mercury in fish tissue)				
Restoration Option 1

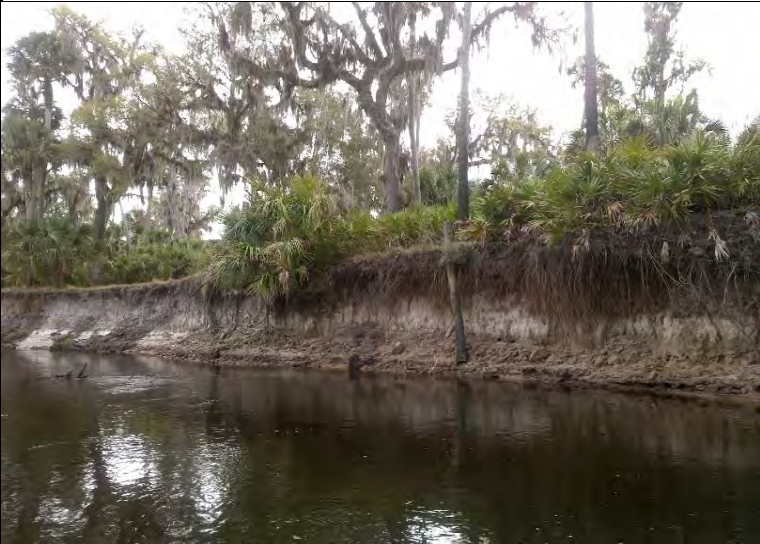
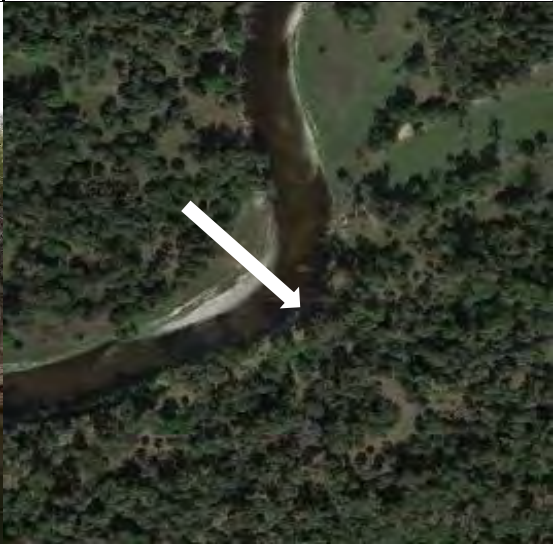
Peace River			Severity Scale: 6.0-Moderate
Watershed: Peace River Subwatershed: Peace River Branch Latitude: 27.40862 Longitude: -81.846343			County: Hardee Site Number: PI084 Reach Length: 768.1 ft. Landowner: Ben Hill Griffin Inc.

Pfankuch-Channel Stability:	Poor	1.5	
Channel Alteration:	None	0	
Bank Erosion:	Mass-wasting	1.5	
BEHI:	Moderate (27.41)	0.5	
Local NPSP:	Obvious Sources	1.5	
Shoring Structures:	None	0	
Pipe Discharge:	None	0	
Water Odor:	Normal	0	
Fish Passage Barrier:	None	0	
RB: Riparian Buffer:	40 ft.	0.5	
LB: Riparian Buffer:	50 ft.	0.25	
RB: Floodplain Access:	Full	0	
LB: Floodplain Access:	Partial	0.25	
<b>Severity Scale:</b>		<b>6.0</b>	
Notes: 303d: Impaired - Aquatic Life Harvesting (mercury in fish tissue)			<b>Additional Site Features</b>
			Stream Channel Woody Material: Moderate
			Impoundments: None
			Substrate Composition: Medium Sand

Bank Material: Sand
			Near Bank Stress: High
			RB Landuse: Natural Forest, Pasture
			LB Landuse: Natural Forest, Pasture
Restoration Option 1
