# **Peace River and Withlacoochee River Threats Assessments and Fish Assemblage Monitoring**

**Final Report July 1, 2015 – June 30, 2019**

Submitted to Florida State Wildlife Grants Program  
August 1, 2019  
PID: 98462501284

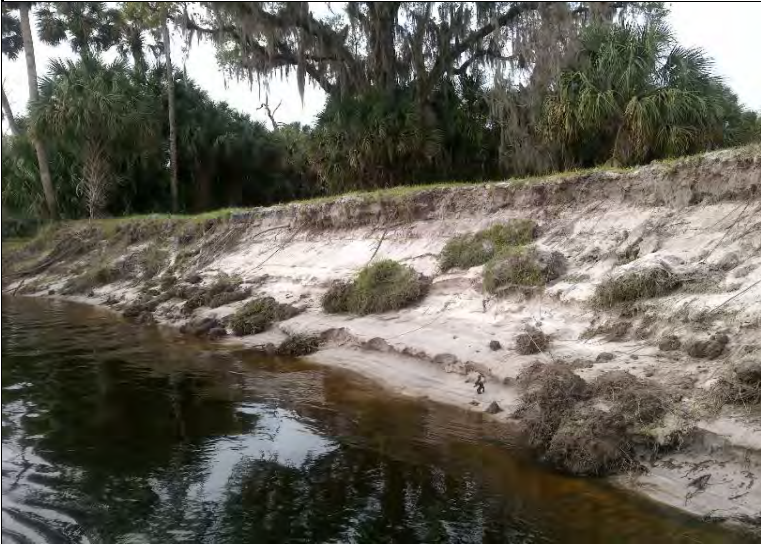
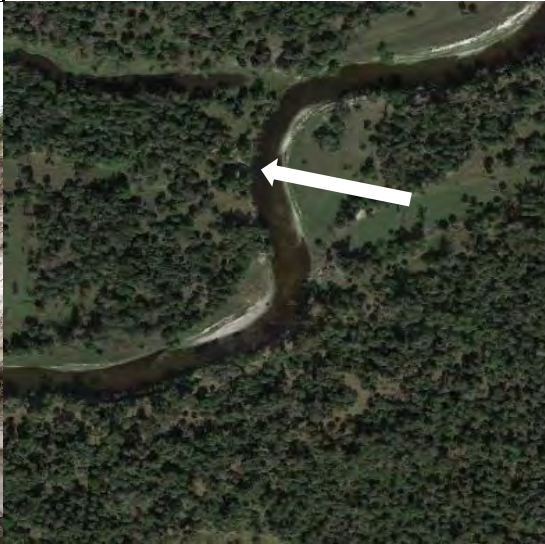
Peace River			Severity Scale: 7.0-Moderate
Watershed: Peace River Subwatershed: Peace River Branch Latitude: 27.40929 Longitude: -81.846545			County: Hardee Site Number: PI085 Reach Length: 317.3 ft. Landowner: Ben Hill Griffin Inc.

Risk Factor	Ranking	Score	
Pfankuch-Channel Stability:	Poor	1.5	
Channel Alteration:	None	0	
Bank Erosion:	Mass-wasting	1.5	
BEHI:	High (34.48)	1	
Local NPSP:	Obvious Sources	1.5	
Shoring Structures:	None	0	
Pipe Discharge:	None	0	
Water Odor:	Normal	0	<b>Additional Site Features</b>
Fish Passage Barrier:	None	0	Stream Channel Woody Material: Infrequent
RB: Riparian Buffer:	40 ft.	0.5	Impoundments: None
LB: Riparian Buffer:	0 ft.	0.75	Substrate Composition: Medium Sand
RB: Floodplain Access:	Partial	0.25	Bank Material: Sand
LB: Floodplain Access:	Full	0	Near Bank Stress: High
			RB Landuse: Pasture, Natural Forest
	<b>Severity Scale:</b>	<b>7.0</b>	LB Landuse: Pasture, Natural Forest

Notes: Palm trees falling in water just upstream; Cattle trail above bank; 303d: Impaired - Aquatic Life Harvesting (mercury in fish tissue)			
Restoration Option 1

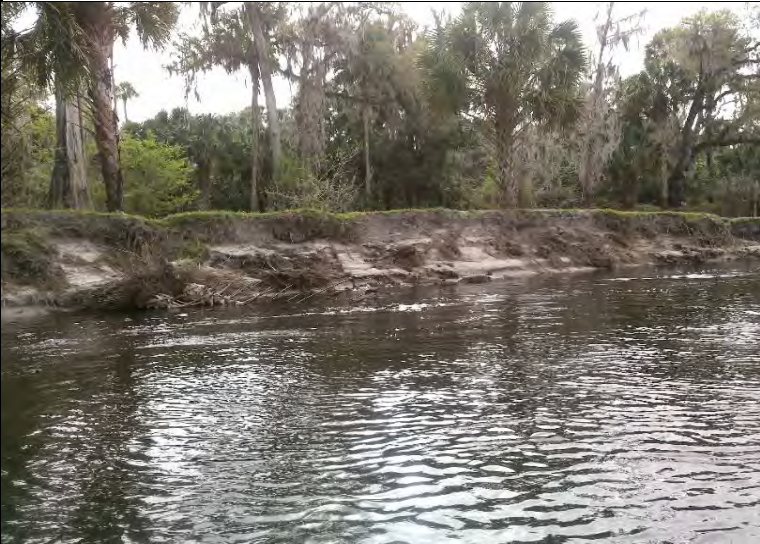
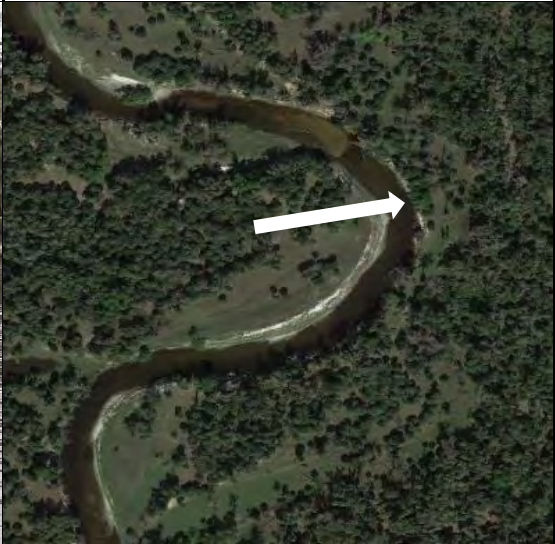
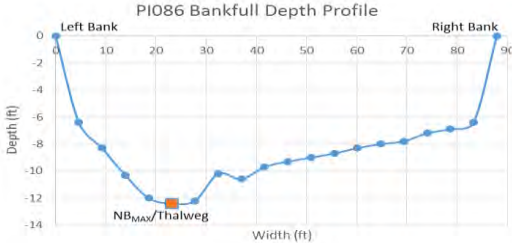
Peace River			Severity Scale: 5.5-Moderate
Watershed: Peace River Subwatershed: Peace River Branch Latitude: 27.410885 Longitude: -81.844543			County: Hardee Site Number: PI086 Reach Length: 827.4 ft. Landowner: Ben Hill Griffin Inc.

Pfankuch-Channel Stability:	Poor	1.5	
Channel Alteration:	None	0	
Bank Erosion:	Active	1	
BEHI:	Moderate (26.01)	0.5	
Local NPSP:	Obvious Sources	1.5	
Shoring Structures:	None	0	
Pipe Discharge:	None	0	
Water Odor:	Normal	0	
Fish Passage Barrier:	None	0	
RB: Riparian Buffer:	40 ft.	0.5	Additional Site Features
LB: Riparian Buffer:	40 ft.	0.5	
RB: Floodplain Access:	Full	0	
LB: Floodplain Access:	Full	0	
Severity Scale:		5.5	
Notes: 303d: Impaired - Aquatic Life Harvesting (mercury in fish tissue)			Stream Channel Woody Material: Moderate
Restoration Option 1			Impoundments: None
			Substrate Composition: Medium Sand
			Bank Material: Sand

Near Bank Stress: High
			RB Landuse: Pasture, Natural Forest
			LB Landuse: Pasture, Natural Forest

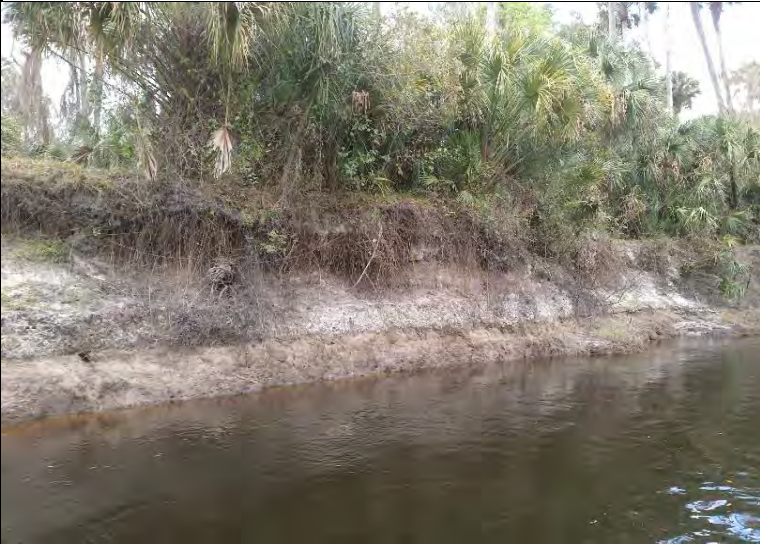
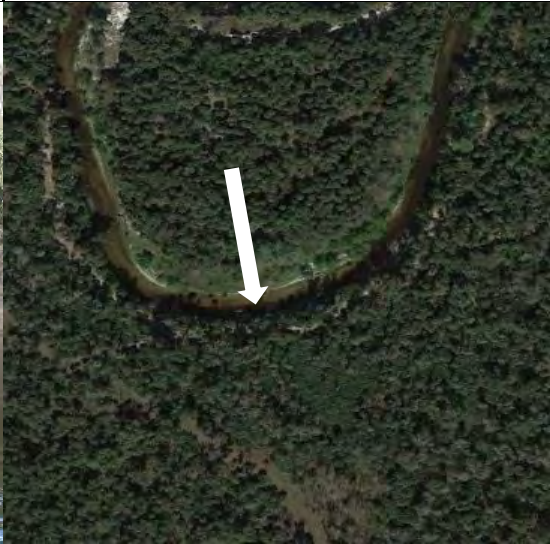
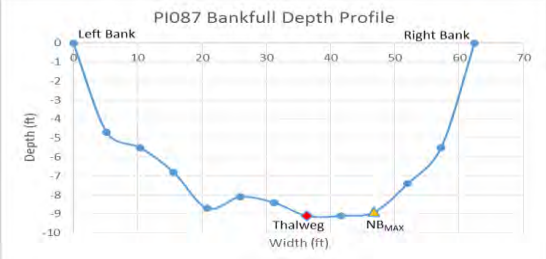
Peace River			Severity Scale: 3.75-Low	
Watershed: Peace River Subwatershed: Peace River Branch Latitude: 27.43001 Longitude: -81.84984			County: Hardee Site Number: PI087 Reach Length: 723 ft. Landowner: Ben Hill Griffin Inc.

Pfankuch-Channel Stability:	Good	0		
Channel Alteration:	None	0		
Bank Erosion:	Active	1		
BEHI:	Very High (40.17)	1.5		
Local NPSP:	Slight Potential	0.5		
Shoring Structures:	None	0		
Pipe Discharge:	None	0		
Water Odor:	Normal	0		
Fish Passage Barrier:	None	0		
RB: Riparian Buffer:	40 ft.	0.5		
LB: Riparian Buffer:	100 ft.	0		
RB: Floodplain Access:	Partial	0.25	Additional Site Features	
LB: Floodplain Access:	Full	0	Stream Channel Woody Material: Infrequent	
<b>Severity Scale: 3.75</b>			Impoundments: None	
Notes: 303d: Impaired - Aquatic Life Harvesting (mercury in fish tissue)			Substrate Composition: Medium Sand	
Restoration Option 1, restoration should be done in conjunction with sites PI282-288			Bank Material: Sand

Near Bank Stress: Moderate	
			RB Landuse: Natural Forest, Pasture	
			LB Landuse: Natural Forest

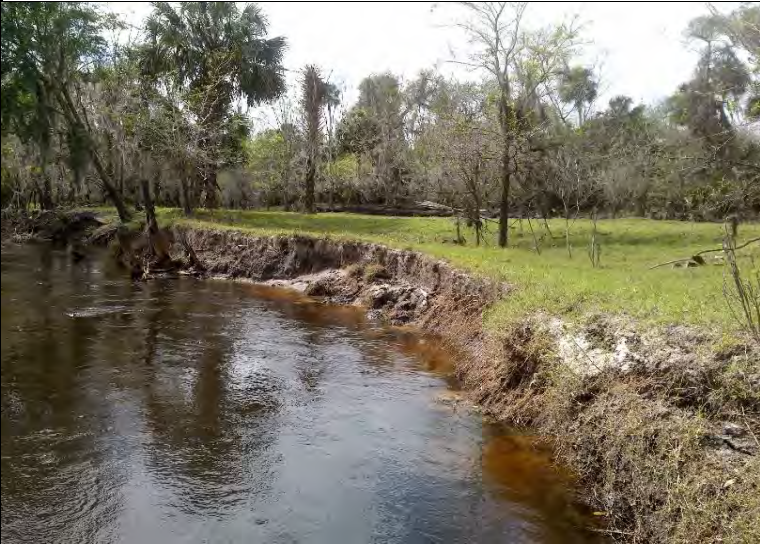
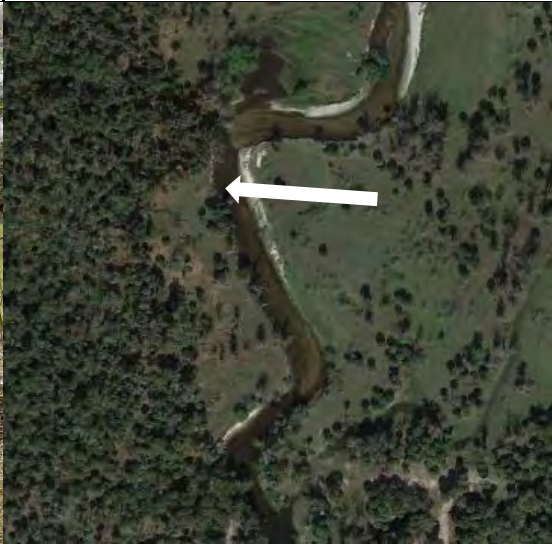
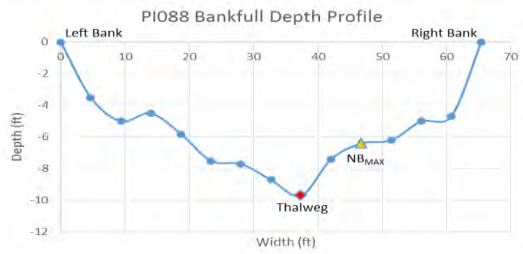
Peace River			Severity Scale: 6.0-Moderate
Watershed: Peace River Subwatershed: Peace River Branch Latitude: 27.429581 Longitude: -81.850117			County: Hardee Site Number: PI088 Reach Length: 73 ft. Landowner: Ben Hill Griffin Inc.

Pfankuch-Channel Stability:	Poor	1.5	
Channel Alteration:	None	0	
Bank Erosion:	Mass-wasting	1.5	
BEHI:	Low (8.16)	0	
Local NPSP:	Obvious Sources	1.5	
Shoring Structures:	None	0	
Pipe Discharge:	None	0	
Water Odor:	Normal	0	
Fish Passage Barrier:	None	0	
RB: Riparian Buffer:	20 ft.	0.75	
LB: Riparian Buffer:	20 ft.	0.75	
RB: Floodplain Access:	Full	0	
LB: Floodplain Access:	Full	0	
<b>Severity Scale:</b>		<b>6.0</b>	
Notes: 303d: Impaired - Aquatic Life Harvesting (mercury in fish tissue)			<b>Additional Site Features</b>
			Stream Channel Woody Material: Infrequent
			Impoundments: None
			Substrate Composition: Medium Sand
			Bank Material: Sandy-Clay

Near Bank Stress: Moderate
			RB Landuse: Pasture, Natural Forest
			LB Landuse: Pasture, Natural Forest
Restoration Option 1

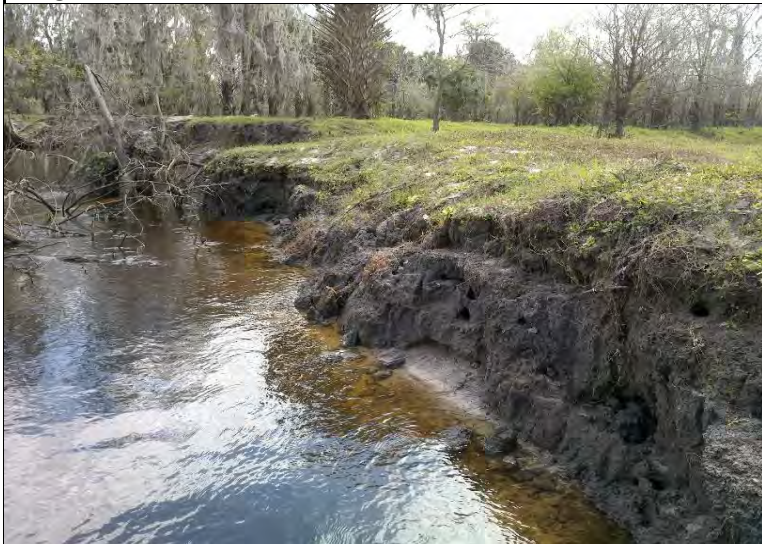
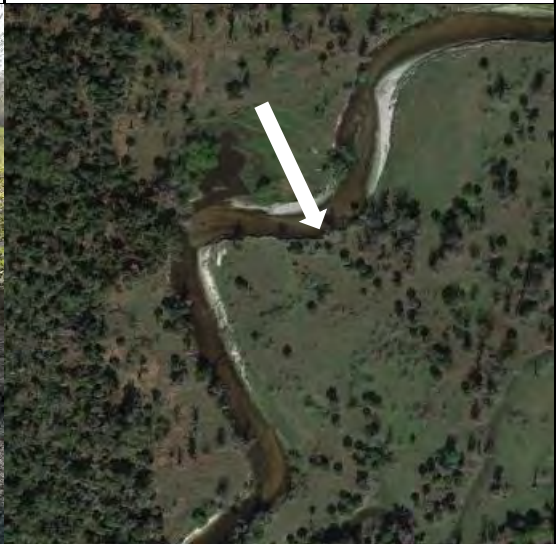
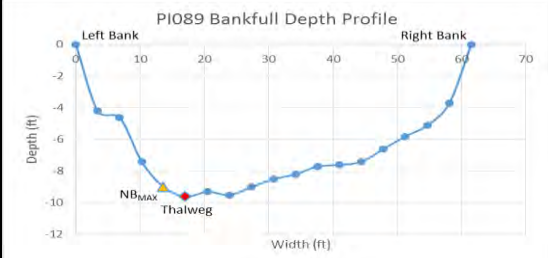
Peace River			Severity Scale: 5.75-Moderate	
Watershed: Peace River Subwatershed: Peace River Branch Latitude: 27.43007 Longitude: -81.849297			County: Hardee Site Number: PI089 Reach Length: 200 ft. Landowner: Ben Hill Griffin Inc.

Pfankuch-Channel Stability:	Poor	1.5		
Channel Alteration:	None	0		
Bank Erosion:	Active	1		
BEHI:	Moderate (26.67)	0.5		
Local NPSP:	Obvious Sources	1.5		
Shoring Structures:	None	0		
Pipe Discharge:	None	0		
Water Odor:	Normal	0		
Fish Passage Barrier:	None	0		
RB: Riparian Buffer:	0 ft.	0.75	<b>Additional Site Features</b> Stream Channel Woody Material: Moderate Impoundments: None Substrate Composition: Medium Sand Bank Material: Sandy Clay Near Bank Stress: High RB Landuse: Pasture LB Landuse: Pasture, Natural Forest	
LB: Riparian Buffer:	40 ft.	0.5		
RB: Floodplain Access:	Full	0		
LB: Floodplain Access:	Full	0		
<b>Severity Scale:</b>		<b>5.75</b>

Notes: 303d: Impaired - Aquatic Life Harvesting (mercury in fish tissue)				
Restoration Option 1

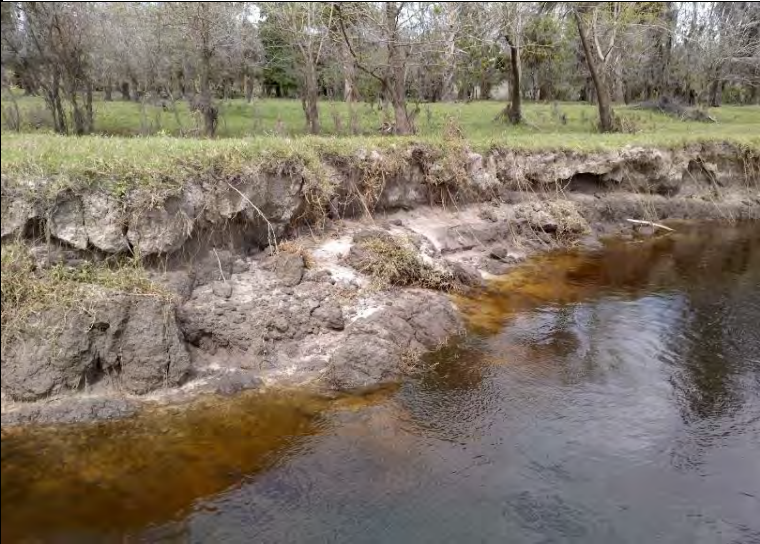
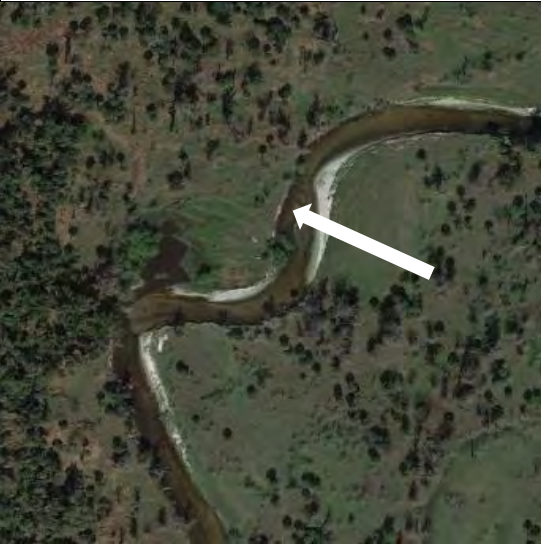
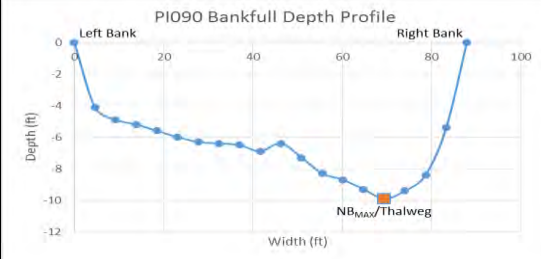
Peace River			Severity Scale: 6.5-Moderate
Watershed: Peace River Subwatershed: Peace River Branch Latitude: 27.43086 Longitude: -81.849083			County: Hardee Site Number: PI090 Reach Length: 200 ft. Landowner: Ben Hill Griffin Inc.

Pfankuch-Channel Stability:	Poor	1.5	
Channel Alteration:	None	0	
Bank Erosion:	Mass-wasting	1.5	
BEHI:	Moderate (19.87)	0.5	
Local NPSP:	Obvious Sources	1.5	
Shoring Structures:	None	0	
Pipe Discharge:	None	0	
Water Odor:	Normal	0	
Fish Passage Barrier:	None	0	
RB: Riparian Buffer:	20 ft.	0.75	
LB: Riparian Buffer:	0 ft.	0.75	
RB: Floodplain Access:	Full	0	
LB: Floodplain Access:	Full	0	
<b>Severity Scale:</b>		<b>6.5</b>	<b>Additional Site Features</b>
			Stream Channel Woody Material: Moderate
			Impoundments: None
			Substrate Composition: Medium Sand
			Bank Material: Sandy-Clay
			Near Bank Stress: High
			RB Landuse: Pasture, Natural Forest

LB Landuse: Pasture
Notes: 303d: Impaired - Aquatic Life Harvesting (mercury in fish tissue)			
Restoration Option 1

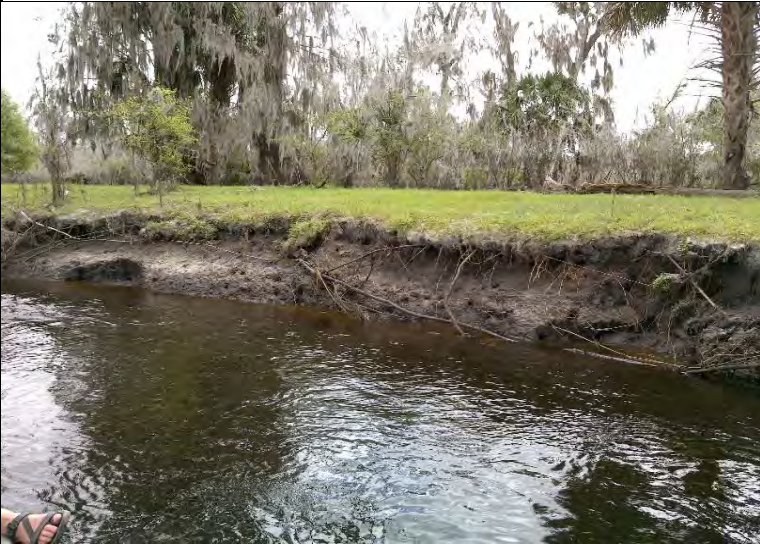
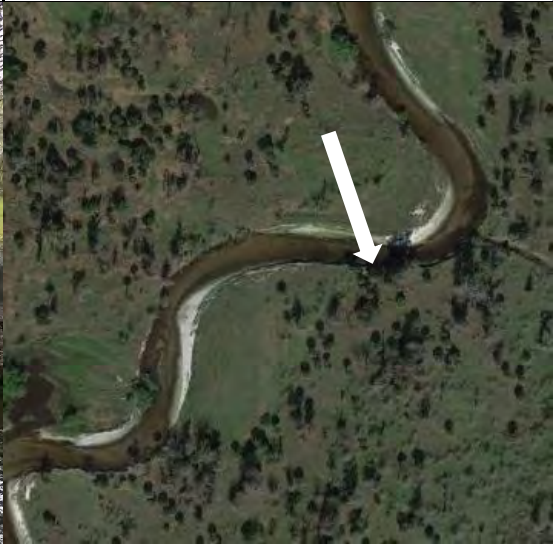
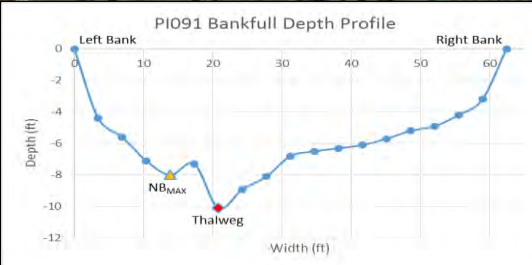
Peace River			Severity Scale: 5.25-Moderate
Watershed: Peace River Subwatershed: Peace River Branch Latitude: 27.431090 Longitude: -81.847609			County: Hardee Site Number: PI091 Reach Length: 230 ft. Landowner: Ben Hill Griffin Inc.

Risk Factor	Ranking	Score	
Pfankuch-Channel Stability:	Poor	1.5	
Channel Alteration:	None	0	
Bank Erosion:	Active	1	
BEHI:	Low (12.71)	0	
Local NPSP:	Obvious Sources	1.5	
Shoring Structures:	None	0	
Pipe Discharge:	None	0	<b>Additional Site Features</b>
Water Odor:	Normal	0	
Fish Passage Barrier:	None	0	
RB: Riparian Buffer:	20 ft.	0.75	
LB: Riparian Buffer:	40 ft.	0.5	
RB: Floodplain Access:	Full	0	Stream Channel Woody Material: Infrequent
LB: Floodplain Access:	Full	0	Impoundments: None
<b>Severity Scale: 5.25</b>			Substrate Composition: Medium Sand
			Bank Material: Sandy-Clay
			Near Bank Stress: Moderate
			RB Landuse: Pasture, Natural Forest
			LB Landuse: Pasture, Natural Forest

Notes: 303d: Impaired - Aquatic Life Harvesting (mercury in fish tissue)			
Restoration Option 1

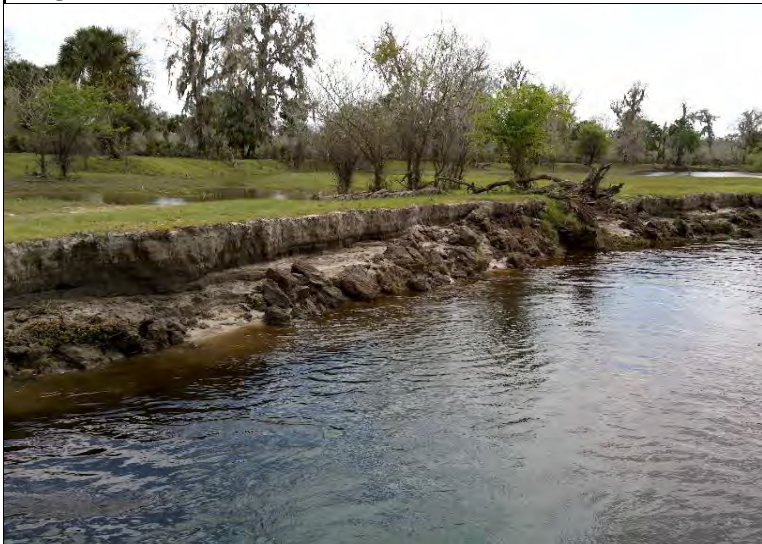
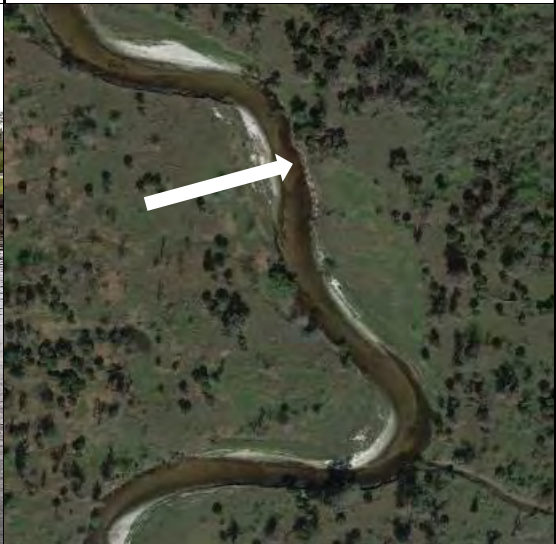
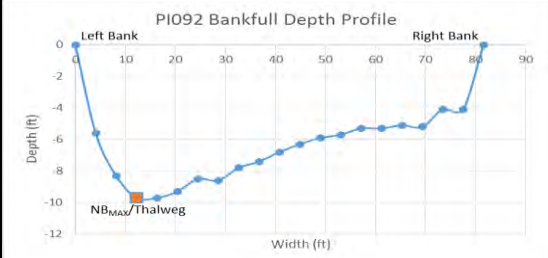
Peace River			Severity Scale: 6.0-Moderate
Watershed: Peace River Subwatershed: Peace River Branch Latitude: 27.482316 Longitude: -81.848021			County: Hardee Site Number: PI092 Reach Length: 332 ft. Landowner: Ben Hill Griffin Inc.

Pfankuch-Channel Stability:	Poor	1.5	
Channel Alteration:	None	0	
Bank Erosion:	Mass-wasting	1.5	
BEHI:	Low (18.28)	0	
Local NPSP:	Obvious Sources	1.5	
Shoring Structures:	None	0	
Pipe Discharge:	None	0	
Water Odor:	Normal	0	
Fish Passage Barrier:	None	0	
RB: Riparian Buffer:	20 ft.	0.75	
LB: Riparian Buffer:	0 ft.	0.75	
RB: Floodplain Access:	Full	0	
LB: Floodplain Access:	Full	0	
Severity Scale:		6.0	
Notes: 303d: Impaired - Aquatic Life Harvesting (mercury in fish tissue)			
Restoration Option 1

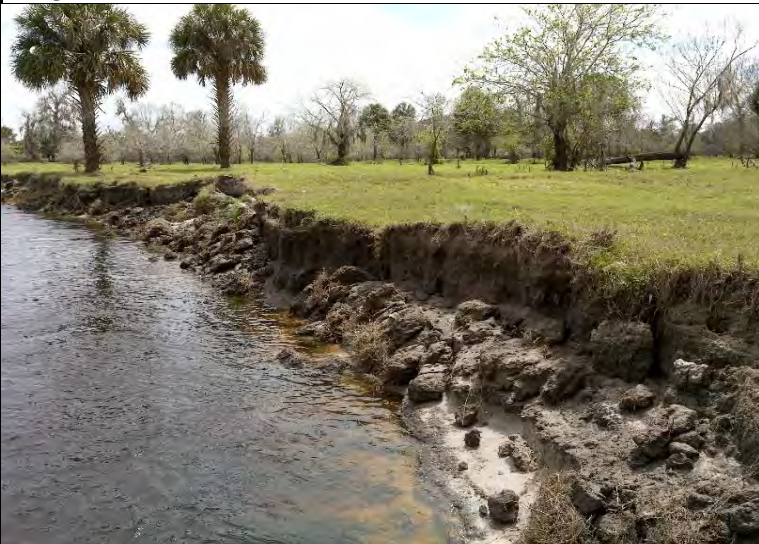
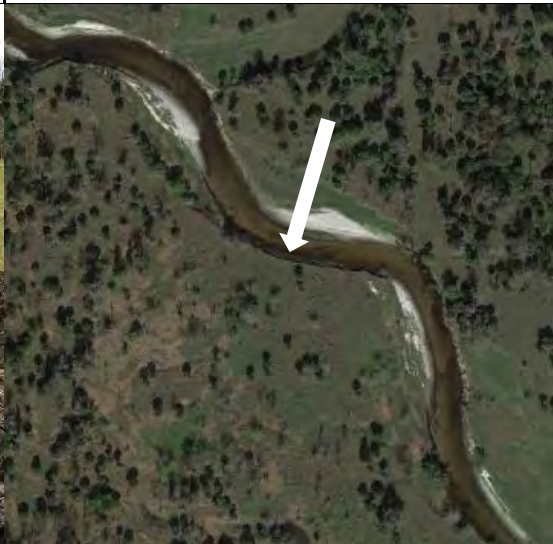
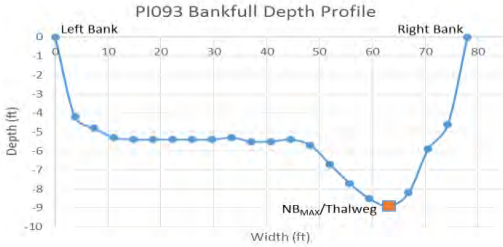
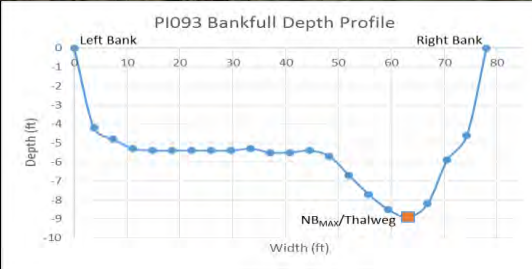
Peace River			Severity Scale: 5.5-Moderate	
Watershed: Peace River Subwatershed: Peace River Branch Latitude: 27.433157 Longitude: -81.848381			County: Hardee Site Number: PI093 Reach Length: 266 ft. Landowner: Ben Hill Griffin Inc.

Pfankuch-Channel Stability:	Poor	1.5		
Channel Alteration:	None	0		
Bank Erosion:	Mass-wasting	1.5		
BEHI:	Low (15.64)	0		
Local NPSP:	Obvious Sources	1.5		
Shoring Structures:	None	0		
Pipe Discharge:	None	0		
Water Odor:	Normal	0		
Fish Passage Barrier:	None	0		
RB: Riparian Buffer:	40 ft.	0.5	<b>Additional Site Features</b>	
LB: Riparian Buffer:	40 ft.	0.5	Stream Channel Woody Material: Infrequent	
RB: Floodplain Access:	Full	0	Impoundments: None	
LB: Floodplain Access:	Full	0	Substrate Composition: Medium Sand	
Severity Scale:			5.5	Bank Material: Sandy-Clay
				Near Bank Stress: High
				RB Landuse: Pasture, Natural Forest
				LB Landuse: Pasture, Natural Forest

Notes: 303d: Impaired - Aquatic Life Harvesting (mercury in fish tissue)				
Restoration Option 1

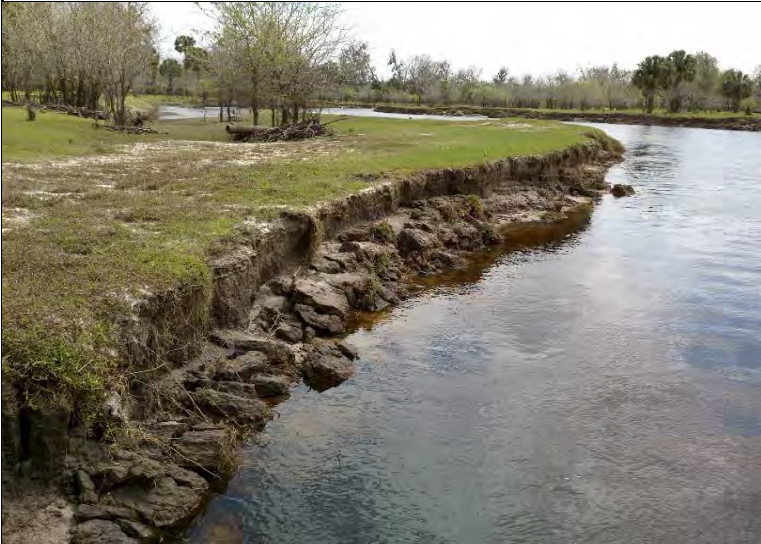
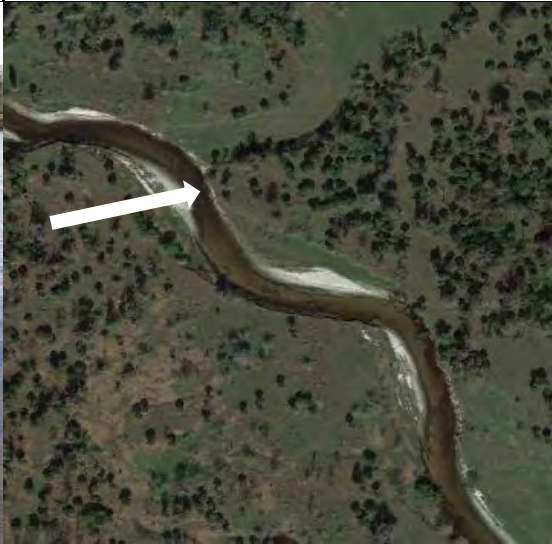
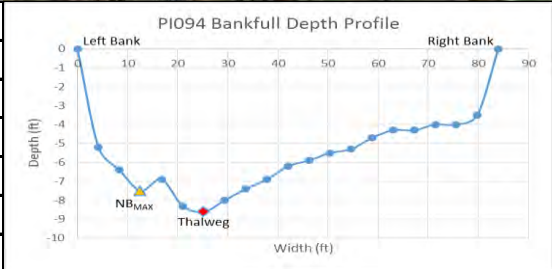
Peace River			Severity Scale: 5.5-Moderate
Watershed: Peace River Subwatershed: Peace River Branch Latitude: 27.433606 Longitude: -81.849187			County: Hardee Site Number: PI094 Reach Length: 147 ft. Landowner: Ben Hill Griffin Inc.

Risk Factor	Ranking	Score	
Pfankuch-Channel Stability:	Poor	1.5	
Channel Alteration:	None	0	
Bank Erosion:	Mass-wasting	1.5	
BEHI:	Low (17.56)	0	
Local NPSP:	Obvious Sources	1.5	
Shoring Structures:	None	0	
Pipe Discharge:	None	0	
Water Odor:	Normal	0	
Fish Passage Barrier:	None	0	
RB: Riparian Buffer:	40 ft.	0.5	
LB: Riparian Buffer:	40 ft.	0.5	
RB: Floodplain Access:	Full	0	
LB: Floodplain Access:	Full	0	
<b>Severity Scale:</b>		<b>5.5</b>	
Notes: 303d: Impaired - Aquatic Life Harvesting (mercury in fish tissue)			
Restoration Option 1

Additional Site Features
Stream Channel Woody Material: Infrequent
Impoundments: None
Substrate Composition: Medium Sand
Bank Material: Sandy-Clay
Near Bank Stress: High
RB Landuse: Pasture, Natural Forest
LB Landuse: Pasture, Natural Forest

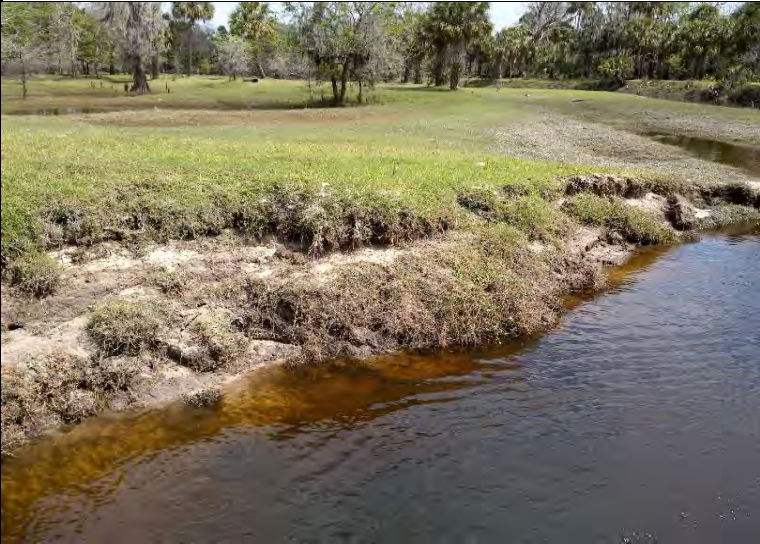
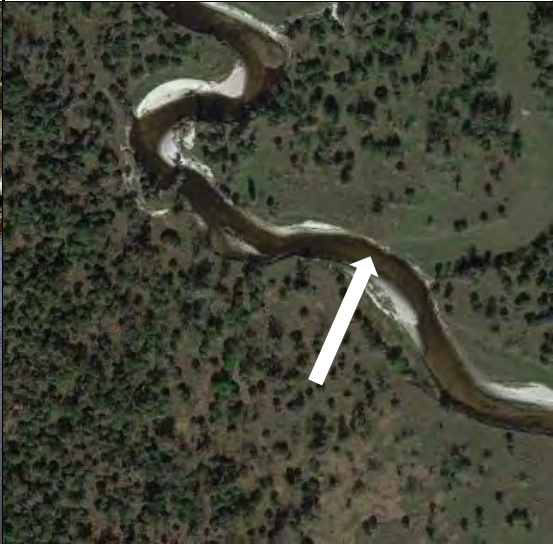
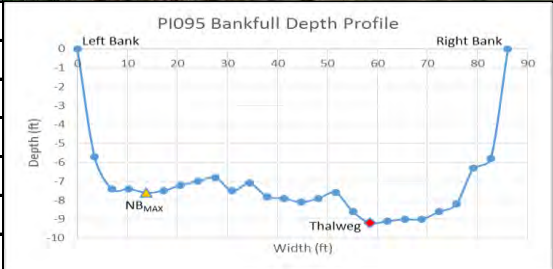
Peace River			Severity Scale: 5.5-Moderate
Watershed: Peace River Subwatershed: Peace River Branch Latitude: 27.434376 Longitude: -81.849653			County: Hardee Site Number: PI095 Reach Length: 58 ft. Landowner: Ben Hill Griffin Inc.

Risk Factor	Ranking	Score	
Pfankuch-Channel Stability:	Poor	1.5	
Channel Alteration:	None	0	
Bank Erosion:	Mass-wasting	1.5	
BEHI:	Low (4.65)	0	
Local NPSP:	Obvious Sources	1.5	
Shoring Structures:	None	0	
Pipe Discharge:	None	0	
Water Odor:	Normal	0	
Fish Passage Barrier:	None	0	
RB: Riparian Buffer:	40 ft.	0.5	
LB: Riparian Buffer:	40 ft.	0.5	
RB: Floodplain Access:	Full	0	
LB: Floodplain Access:	Full	0	
Severity Scale:		5.5	
Notes: 303d: Impaired - Aquatic Life Harvesting (mercury in fish tissue)			
Restoration Option 1

Additional Site Features	
Stream Channel Woody Material:	Infrequent
Impoundments:	None
Substrate Composition:	Medium Sand
Bank Material:	Sandy-Clay
Near Bank Stress:	High
RB Landuse:	Pasture, Natural Forest
LB Landuse:	Pasture, Natural Forest

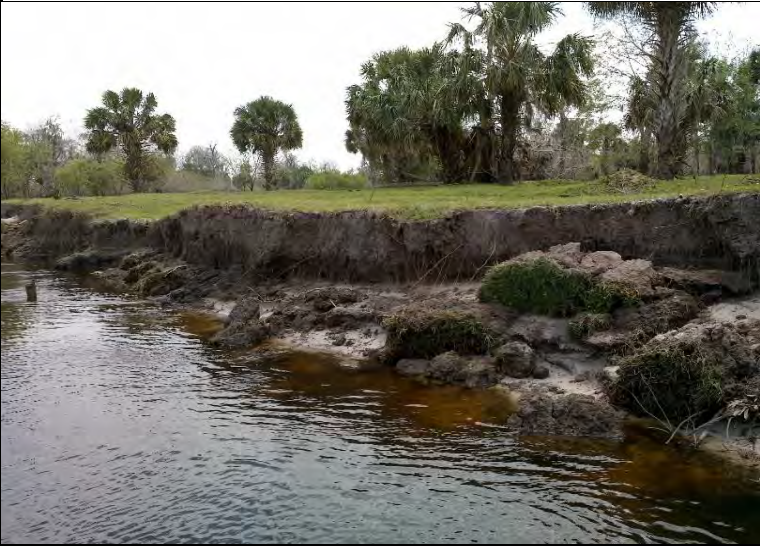
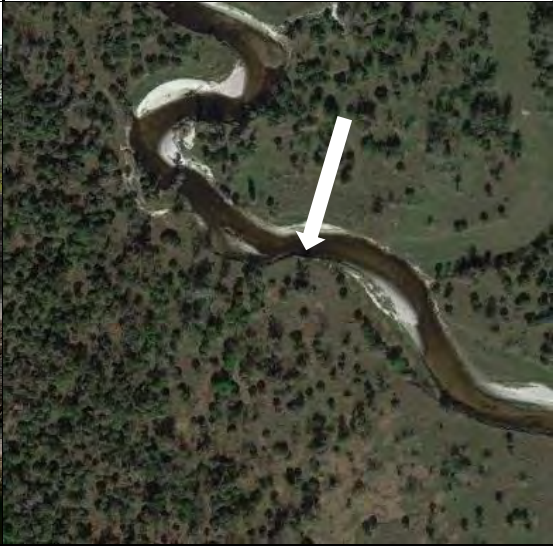
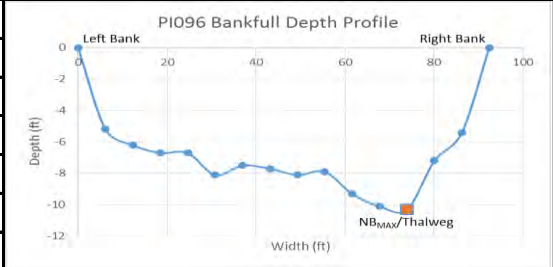
Peace River			Severity Scale: 5.5-Moderate
Watershed: Peace River Subwatershed: Peace River Branch Latitude: 27.434398 Longitude: -81.850457			County: Hardee Site Number: PI096 Reach Length: 155 ft. Landowner: Ben Hill Griffin Inc.

Risk Factor	Ranking	Score	
Pfankuch-Channel Stability:	Poor	1.5	
Channel Alteration:	None	0	
Bank Erosion:	Mass-wasting	1.5	
BEHI:	Low (10.72)	0	
Local NPSP:	Obvious Sources	1.5	
Shoring Structures:	None	0	
Pipe Discharge:	None	0	
Water Odor:	Normal	0	
Fish Passage Barrier:	None	0	
RB: Riparian Buffer:	40 ft.	0.5	
LB: Riparian Buffer:	40 ft.	0.5	
RB: Floodplain Access:	Full	0	
LB: Floodplain Access:	Full	0	
<b>Severity Scale:</b>		<b>5.5</b>	
Notes: 303d: Impaired - Aquatic Life Harvesting (mercury in fish tissue)			
Restoration Option 1

Additional Site Features
Stream Channel Woody Material: Infrequent
Impoundments: None
Substrate Composition: Medium Sand
Bank Material: Sand
Near Bank Stress: High
RB Landuse: Pasture, Natural Forest
LB Landuse: Pasture, Natural Forest

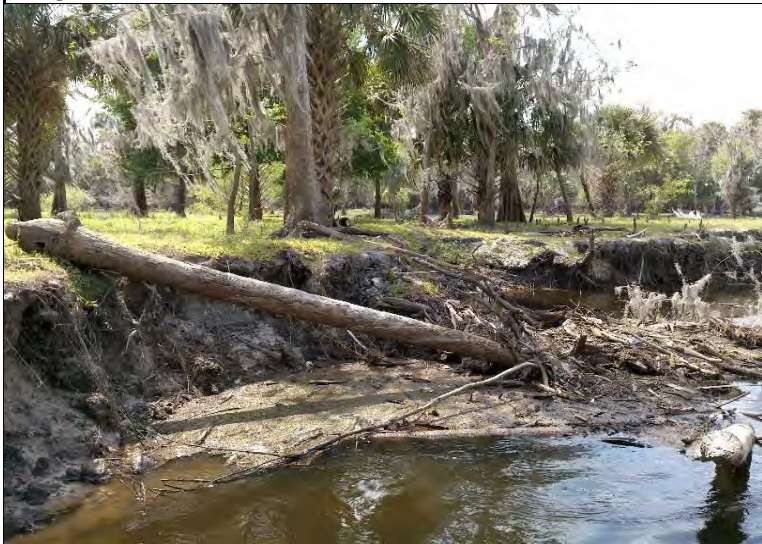
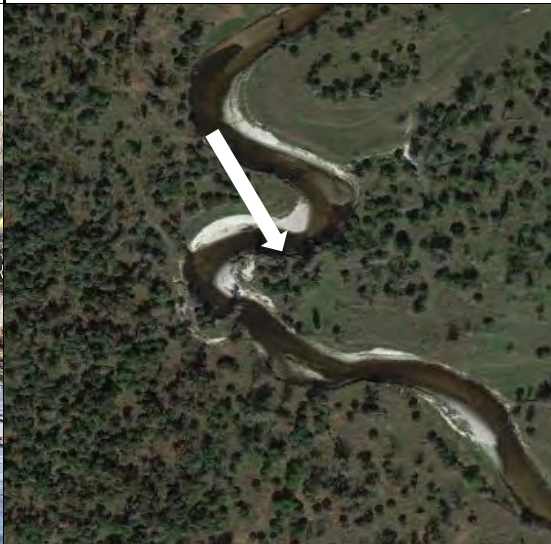
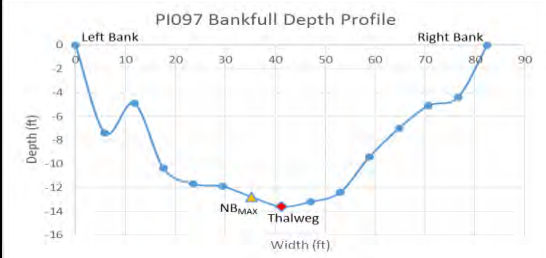
Peace River			Severity Scale: 5.5-Moderate
Watershed: Peace River Subwatershed: Peace River Branch Latitude: 27.43524 Longitude: -81.850408			County: Hardee Site Number: PI097 Reach Length: 175 ft. Landowner: Ben Hill Griffin Inc.

Pfankuch-Channel Stability:	Poor	1.5	
Channel Alteration:	None	0	
Bank Erosion:	Mass-wasting	1.5	
BEHI:	Low (15.07)	0	
Local NPSP:	Obvious Sources	1.5	
Shoring Structures:	None	0	
Pipe Discharge:	None	0	
Water Odor:	Normal	0	
Fish Passage Barrier:	None	0	
RB: Riparian Buffer:	40 ft.	0.5	<b>Additional Site Features</b> Stream Channel Woody Material: Numerous Impoundments: None Substrate Composition: Medium Sand Bank Material: Sandy-Clay Near Bank Stress: Moderate RB Landuse: Pasture, Natural Forest LB Landuse: Pasture, Natural Forest
LB: Riparian Buffer:	40 ft.	0.5	
RB: Floodplain Access:	Full	0	
LB: Floodplain Access:	Full	0	
Severity Scale:		5.5

Notes: 303d: Impaired - Aquatic Life Harvesting (mercury in fish tissue)			
Restoration Option 1

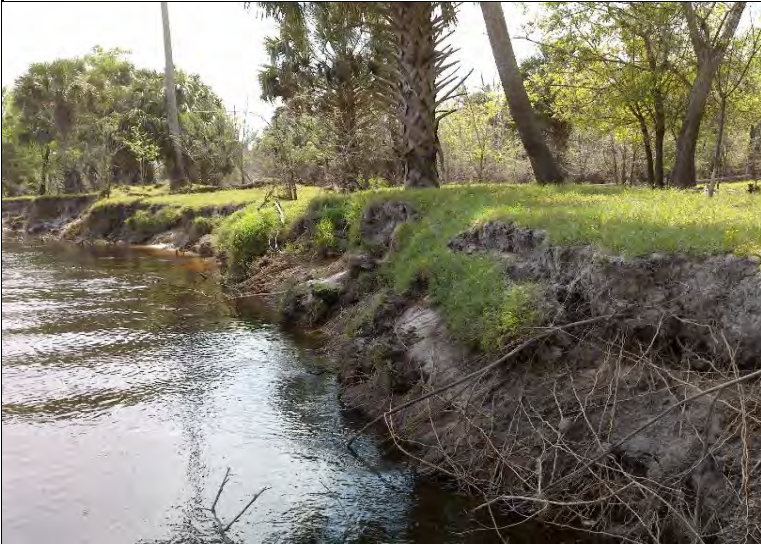
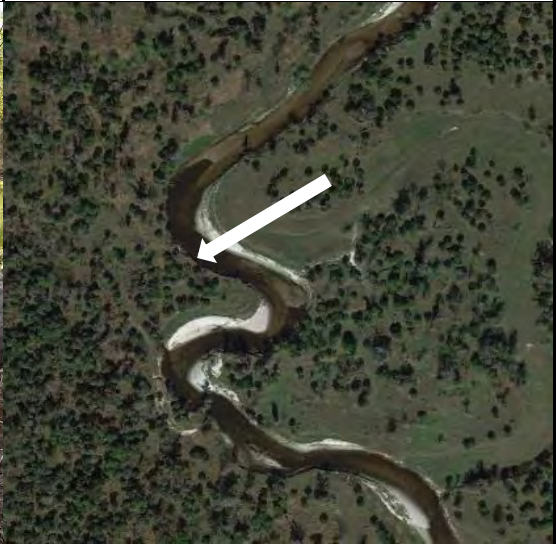
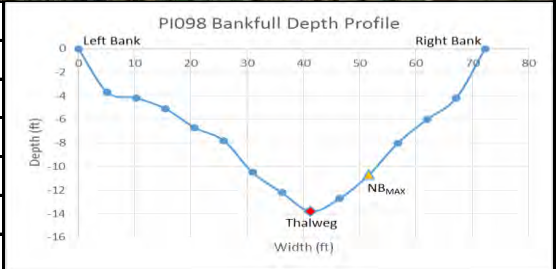
Peace River			Severity Scale: 6.75-Moderate
Watershed: Peace River Subwatershed: Peace River Branch Latitude: 27.43618 Longitude: -81.851181			County: Hardee Site Number: PI098 Reach Length: 360 ft. Landowner: Ben Hill Griffin Inc.

Risk Factor	Ranking	Score	
Pfankuch-Channel Stability:	Poor	1.5	
Channel Alteration:	None	0	
Bank Erosion:	Mass-wasting	1.5	
BEHI:	High (32.43)	1	
Local NPSP:	Obvious Sources	1.5	
Shoring Structures:	None	0	
Pipe Discharge:	None	0	
Water Odor:	Normal	0	
Fish Passage Barrier:	None	0	
RB: Riparian Buffer:	40 ft.	0.5	
LB: Riparian Buffer:	20 ft.	0.75	
RB: Floodplain Access:	Full	0	
LB: Floodplain Access:	Full	0	
<b>Severity Scale:</b>		<b>6.75</b>	
Notes: 303d: Impaired - Aquatic Life Harvesting (mercury in fish tissue)			
Restoration Option 1

Additional Site Features
Stream Channel Woody Material: Infrequent
Impoundments: None
Substrate Composition: Medium Sand
Bank Material: Sand
Near Bank Stress: Moderate
RB Landuse: Pasture, Natural Forest
LB Landuse: Pasture, Natural Forest

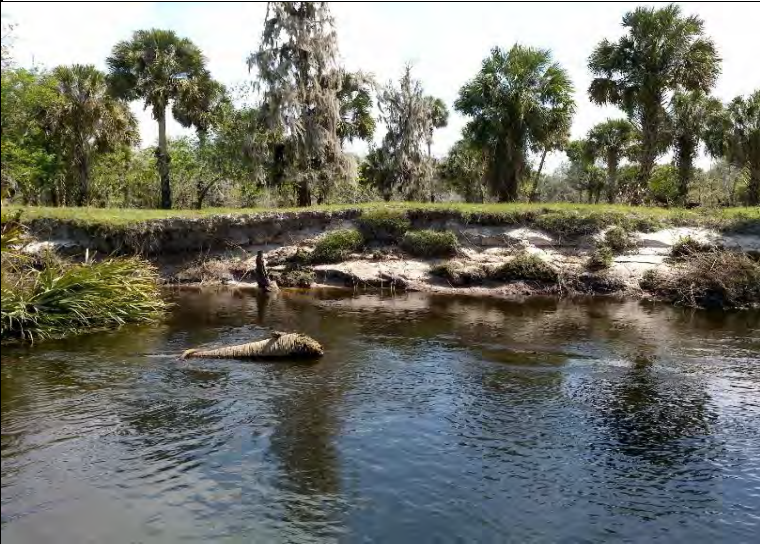
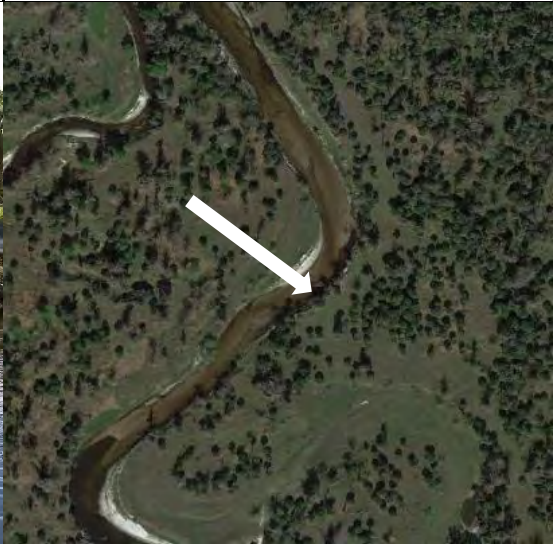
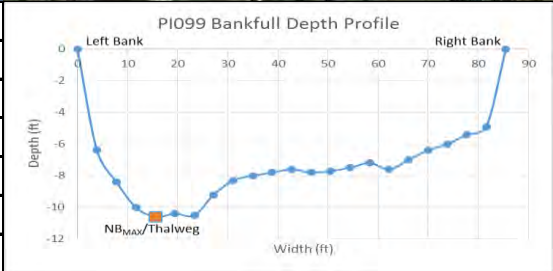
Peace River			Severity Scale: 6.75-Moderate
Watershed: Peace River Subwatershed: Peace River Branch Latitude: 27.43765 Longitude: -81.849396			County: Hardee Site Number: PI099 Reach Length: 215 ft. Landowner: Ben Hill Griffin Inc.

Risk Factor	Ranking	Score	
Pfankuch-Channel Stability:	Poor	1.5	
Channel Alteration:	None	0	
Bank Erosion:	Mass-wasting	1.5	
BEHI:	High (30.47)	1	
Local NPSP:	Obvious Sources	1.5	
Shoring Structures:	None	0	
Pipe Discharge:	None	0	
Water Odor:	Normal	0	
Fish Passage Barrier:	None	0	
RB: Riparian Buffer:	20 ft.	0.75	
LB: Riparian Buffer:	40 ft.	0.5	
RB: Floodplain Access:	Full	0	
LB: Floodplain Access:	Full	0	
<b>Severity Scale:</b>		<b>6.75</b>	
Notes: 303d: Impaired - Aquatic Life Harvesting (mercury in fish tissue)			
Restoration Option 1

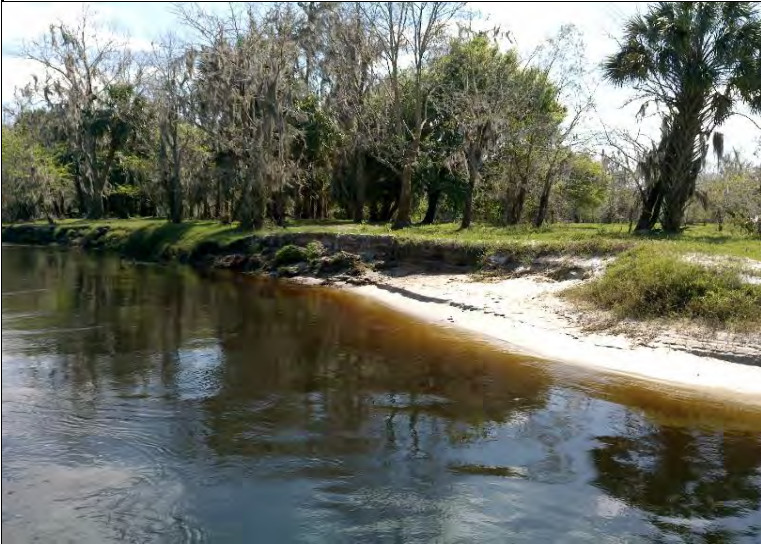
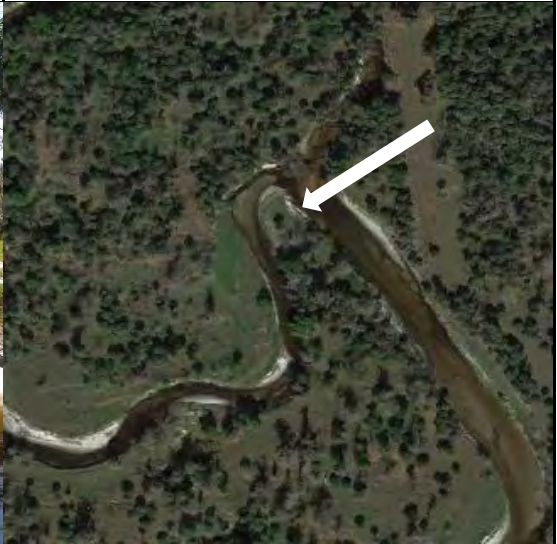
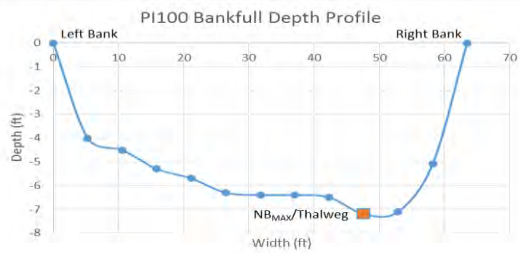
Peace River			Severity Scale: 5.5-Moderate
Watershed: Peace River Subwatershed: Peace River Branch Latitude: 27.43953 Longitude: -81.850649			County: Hardee Site Number: PI100 Reach Length: 220 ft. Landowner: Ben Hill Griffin Inc.

Additional Site Features
Stream Channel Woody Material: Moderate
Impoundments: None
Substrate Composition: Medium Sand
Bank Material: Sand
Near Bank Stress: High
RB Landuse: Pasure, Natural Forest
LB Landuse: Pasture, Natural Forest

Risk Factor	Ranking	Score	
Pfankuch-Channel Stability:	Poor	1.5	
Channel Alteration:	None	0	
Bank Erosion:	Mass-wasting	1.5	
BEHI:	Moderate	0.5	
Local NPSP:	Obvious Sources	1.5	
Shoring Structures:	None	0	
Pipe Discharge:	None	0	<b>Additional Site Features</b> Stream Channel Woody Material: Infrequent Impoundments: None Substrate Composition: Medium Sand Bank Material: Sand Near Bank Stress: High RB Landuse: Pasture, Natural Forest LB Landuse: Natural Forest, Pasture
Water Odor:	Normal	0	
Fish Passage Barrier:	None	0	
RB: Riparian Buffer:	40 ft.	0.5	
LB: Riparian Buffer:	100 ft.	0	
RB: Floodplain Access:	Full	0	
LB: Floodplain Access:	Full	0	
<b>Severity Scale:</b>		<b>5.5</b>

Notes: *Rapid assessment made for BEHI score. Score calculated based on similar sites in the area; 303d: Impaired - Aquatic Life Harvesting (mercury in fish tissue)			
Restoration Option 1

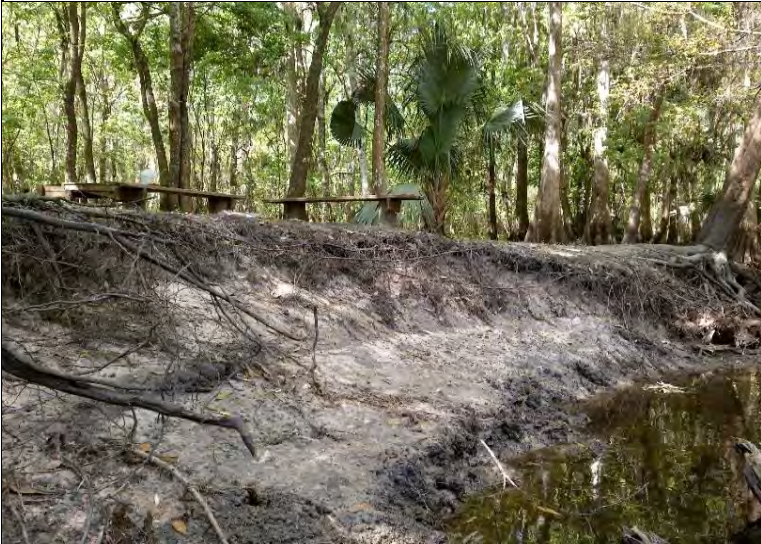
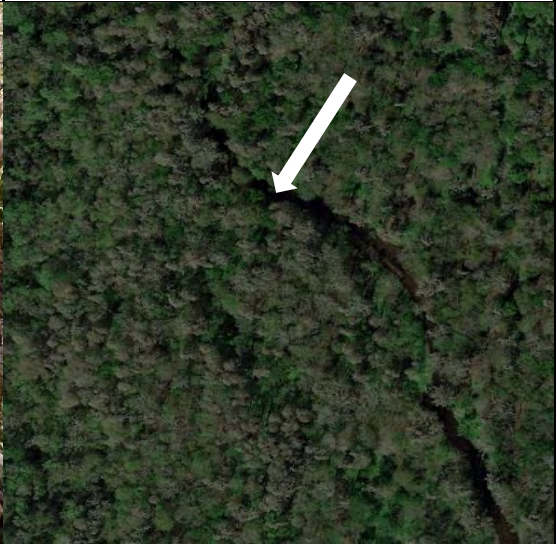
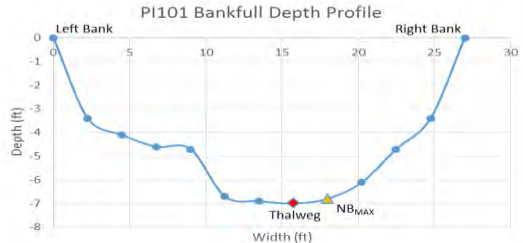
Peace River			Severity Scale: 2.0-Low
Watershed: Peace River Subwatershed: Bear Branch Latitude: 27.75824 Longitude: -81.78014			County: Polk Site Number: PI101 Reach Length: 18 ft. Landowner: Melvin Pyatt Lastinger

Pfankuch-Channel Stability:	Good	0	
Channel Alteration:	None	0	
Bank Erosion:	Active	1	
BEHI:	Moderate (29.57)	0.5	
Local NPSP:	Slight Potential	0.5	
Shoring Structures:	None	0	
Pipe Discharge:	None	0	
Water Odor:	Normal	0	
Fish Passage Barrier:	None	0	
RB: Riparian Buffer:	100 ft.	0	
LB: Riparian Buffer:	100 ft.	0	
RB: Floodplain Access:	Full	0	
LB: Floodplain Access:	Full	0	
<b>Severity Scale:</b>		<b>2.0</b>	
Notes: 303d: Impaired - Aquatic Life Harvesting (DO, fecal coliform, mercury in fish tissue)			<b>Additional Site Features</b>
			Stream Channel Woody Material: Moderate
			Impoundments: None
			Substrate Composition: Medium Sand
			Bank Material: Sand

Near Bank Stress: Moderate
			RB Landuse: Natural Forest
			LB Landuse: Natural Forest
Restoration Option 1

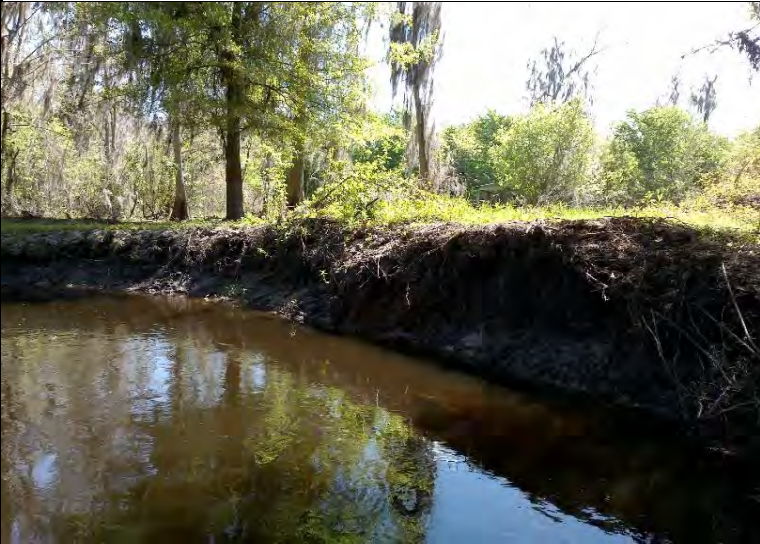
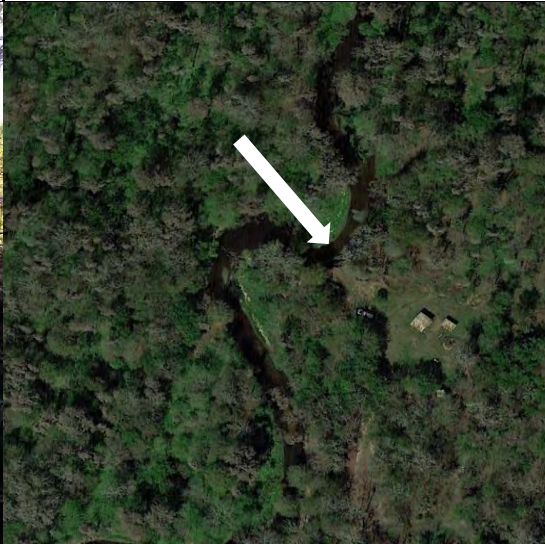
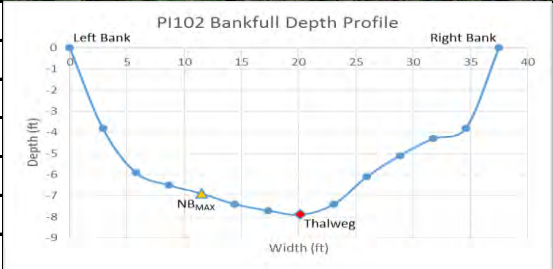
Peace River			Severity Scale: 1.75-Low
Watershed: Peace River Subwatershed: Bear Branch Latitude: 27.75553 Longitude: -81.77912			County: Polk Site Number: PI102 Reach Length: 43 ft. Landowner: L M Lanier

Risk Factor	Ranking	Score	
Pfankuch-Channel Stability:	Good	0	
Channel Alteration:	None	0	
Bank Erosion:	Active	1	
BEHI:	Low (16.24)	0	
Local NPSP:	No Evidence	0	
Shoring Structures:	None	0	
Pipe Discharge:	None	0	
Water Odor:	Normal	0	
Fish Passage Barrier:	None	0	
RB: Riparian Buffer:	100 ft.	0	
LB: Riparian Buffer:	0 ft.	0.75	
RB: Floodplain Access:	Full	0	
LB: Floodplain Access:	Full	0	
<b>Severity Scale:</b>		<b>1.75</b>	
Notes: Mowed access road with several pole barns; 303d: Impaired - Aquatic Life Harvesting (DO, fecal coliform, mercury in fish tissue)			
Restoration Option 1

Additional Site Features
Stream Channel Woody Material: Infrequent
Impoundments: None
Substrate Composition: Medium Sand
Bank Material: Sandy-Clay
Near Bank Stress: Moderate
RB Landuse: Natural Forest
LB Landuse: Access Road, Natural Forest

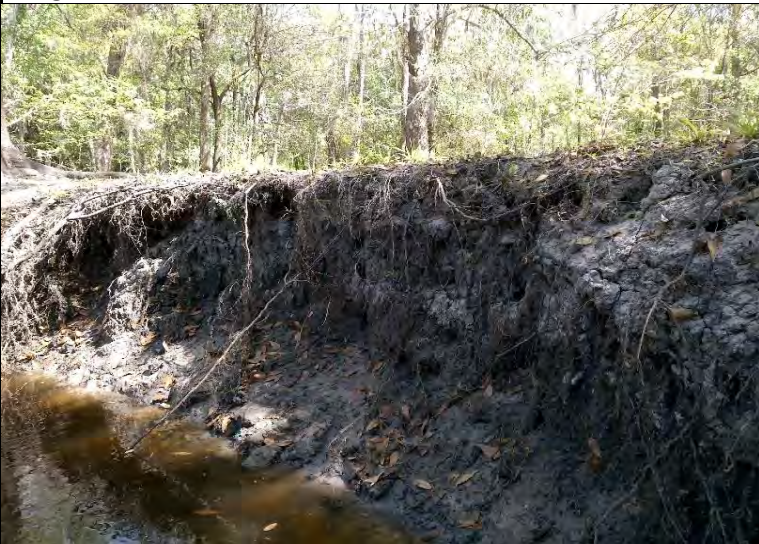
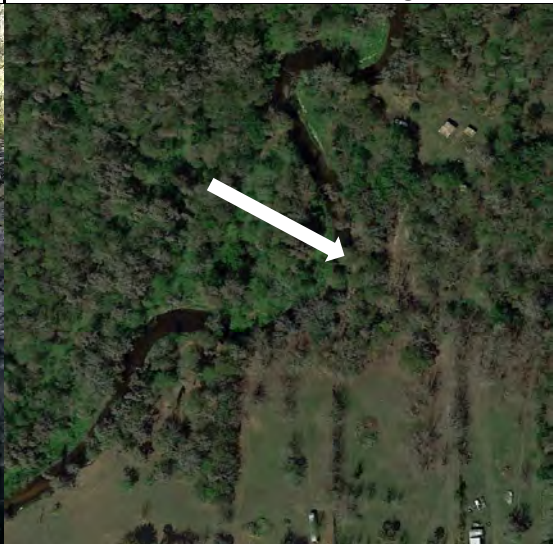
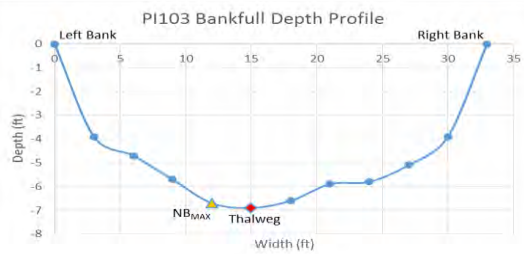
Peace River			Severity Scale: 2.0-Low	
Watershed: Peace River Subwatershed: Bear Branch Latitude: 27.75451 Longitude: -81.77927			County: Polk Site Number: PI103 Reach Length: 16 ft. Landowner: Richard Truman Vaughn

Pfankuch-Channel Stability:	Good	0		
Channel Alteration:	None	0		
Bank Erosion:	Active	1		
BEHI:	Low (16.92)	0		
Local NPSP:	Slight Potential	0.5		
Shoring Structures:	None	0		
Pipe Discharge:	None	0		
Water Odor:	Normal	0		
Fish Passage Barrier:	None	0		
RB: Riparian Buffer:	100 ft.	0	<b>Additional Site Features</b> Stream Channel Woody Material: Infrequent Impoundments: None Substrate Composition: Medium Sand Bank Material: Sandy-Clay Near Bank Stress: Moderate RB Landuse: Natural Forest LB Landuse: Residential, Natural Forest	
LB: Riparian Buffer:	40 ft.	0.5		
RB: Floodplain Access:	Full	0		
LB: Floodplain Access:	Full	0		
Severity Scale:		2.0

Notes: Light recreational use with grill, benches, etc.; 303d: Impaired - Aquatic Life Harvesting (DO, fecal coliform, mercury in fish tissue)				
Restoration Option 1

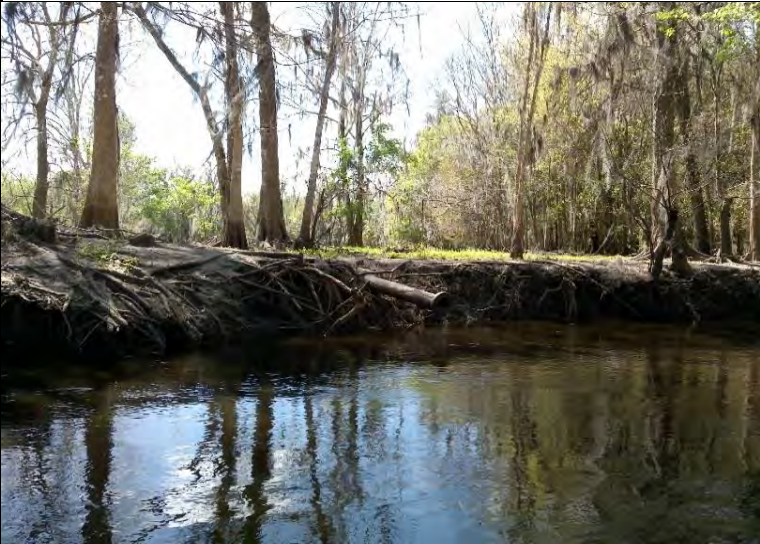
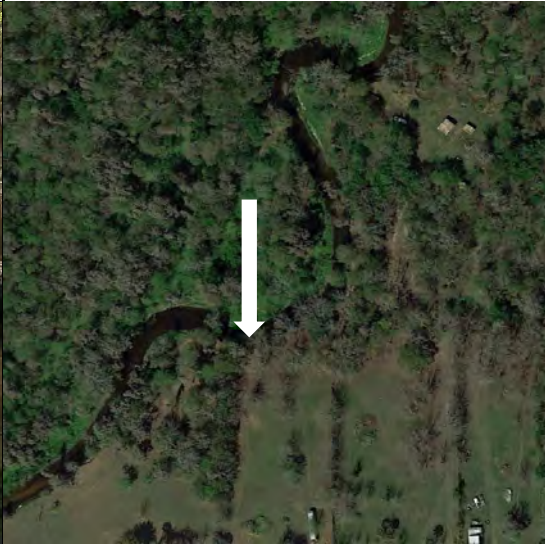
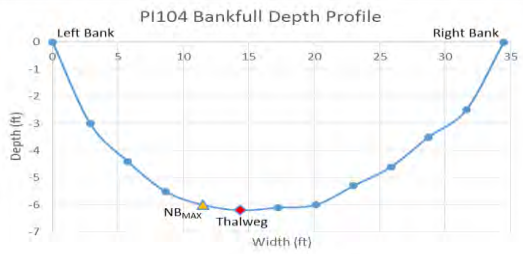
Peace River			Severity Scale: 5.0-Moderate
Watershed: Bear Branch Subwatershed: Peace River Latitude: 27.75436 Longitude: -81.77931			County: Polk Site Number: PI104 Reach Length: 155 ft. Landowner: Lusby Properties Inc.

Pfankuch-Channel Stability:	Good	0	
Channel Alteration:	None	0	
Bank Erosion:	Active	1	
BEHI:	Low*	0	
Local NPSP:	Slight Potential	0.5	
Shoring Structures:	Present	1.5	
Pipe Discharge:	Present	1.5	
Water Odor:	Normal	0	
Fish Passage Barrier:	None	0	
RB: Riparian Buffer:	100 ft.	0	
LB: Riparian Buffer:	40 ft.	0.5	
RB: Floodplain Access:	Full	0	
LB: Floodplain Access:	Full	0	
<b>Severity Scale:</b>		<b>5.0</b>	
Notes: *Rapid assessment made for BEHI score; Score calculated based on similar sites in the area; Light recreational use at residence; 303d: Impaired - Aquatic Life Harvesting (DO, fecal coliform, mercury in fish tissue)			
Restoration Option 1
