# **Peace River and Withlacoochee River Threats Assessments and Fish Assemblage Monitoring**

**Final Report July 1, 2015 – June 30, 2019**

Submitted to Florida State Wildlife Grants Program  
August 1, 2019  
PID: 98462501284

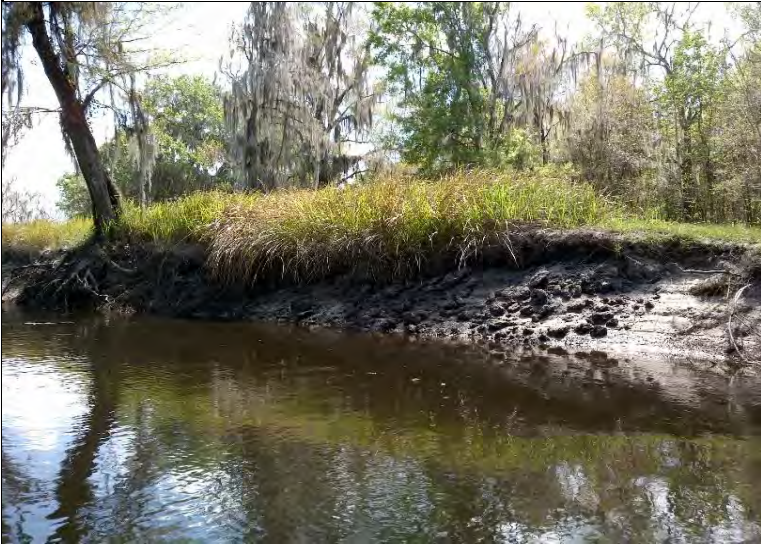
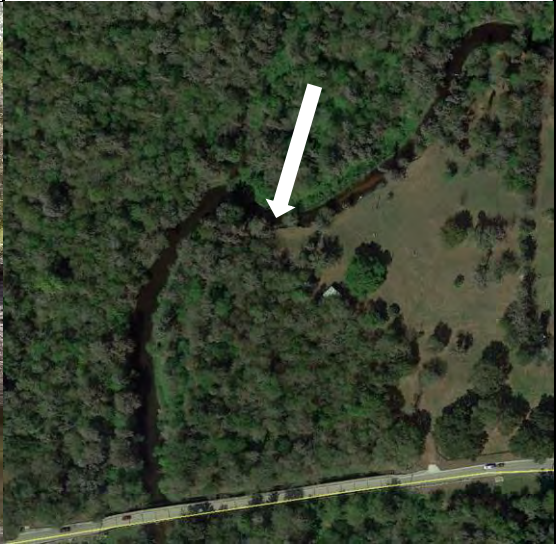
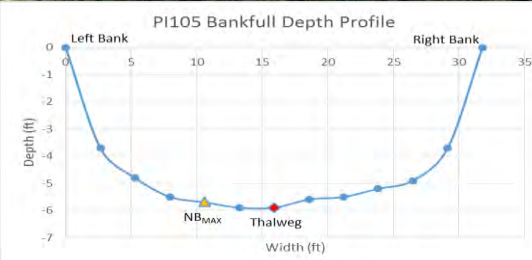
Peace River			Severity Scale: 3.75-Low
Watershed: Peace River Subwatershed: Bear Branch Latitude: 27.75331 Longitude: -81.78107			County: Polk Site Number: PI105 Reach Length: 128 ft. Landowner: Lusby Properties Inc.

Risk Factor	Ranking	Score	
Pfankuch-Channel Stability:	Good	0	
Channel Alteration:	None	0	
Bank Erosion:	Mass-wasting	1.5	
BEHI:	High (33.22)	1	
Local NPSP:	Slight Potential	0.5	
Shoring Structures:	None	0	
Pipe Discharge:	None	0	
Water Odor:	Normal	0	
Fish Passage Barrier:	None	0	
RB: Riparian Buffer:	100 ft.	0	
LB: Riparian Buffer:	20 ft.	0.75	
RB: Floodplain Access:	Full	0	
LB: Floodplain Access:	Full	0	
<b>Severity Scale:</b>		<b>3.75</b>	
Notes: 303d: Impaired - Aquatic Life Harvesting (DO, fecal coliform, mercury in fish tissue)			
Restoration Option 1

Additional Site Features
Stream Channel Woody Material: Infrequent
Impoundments: None
Substrate Composition: Medium Sand
Bank Material: Sand
Near Bank Stress: Low
RB Landuse: Natural Forest
LB Landuse: Residential, Natural Forest

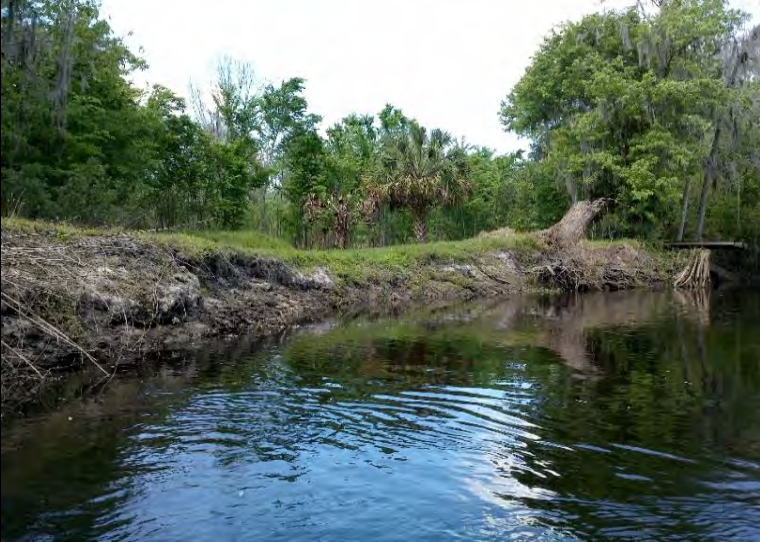
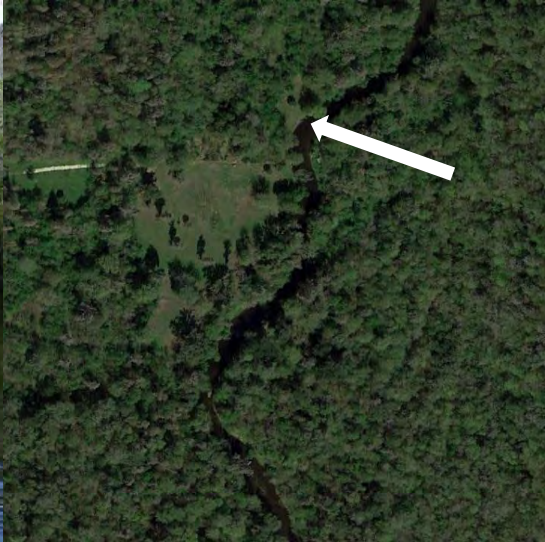
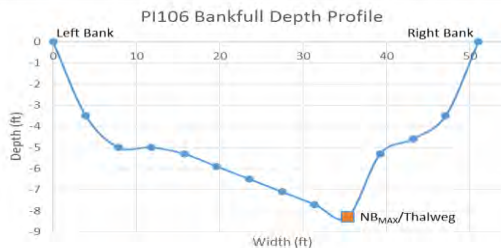
Peace River			Severity Scale: 3.0-Low
Watershed: Peace River Subwatershed: Bear Branch Latitude: 27.72794 Longitude: -81.78960			County: Polk Site Number: PI106 Reach Length: 91 ft. Landowner: Charles W Graves

Risk Factor	Ranking	Score	
Pfankuch-Channel Stability:	Good	0	
Channel Alteration:	None	0	
Bank Erosion:	Mass-wasting	1.5	
BEHI:	Moderate (29.61)	0.5	
Local NPSP:	Slight Potential	0.5	
Shoring Structures:	None	0	
Pipe Discharge:	None	0	<b>Additional Site Features</b> Stream Channel Woody Material: Moderate Impoundments: None Substrate Composition: Medium Sand Bank Material: Sand Near Bank Stress: High RB Landuse: Residential, Natural Forest LB Landuse: Natural Forest
Water Odor:	Normal	0	
Fish Passage Barrier:	None	0	
RB: Riparian Buffer:	40 ft.	0.5	
LB: Riparian Buffer:	100 ft.	0	
RB: Floodplain Access:	Full	0	
LB: Floodplain Access:	Full	0	
<b>Severity Scale:</b>		<b>3.0</b>	
Notes: Mowed grass up to bank, residential property with a rope swing; 303d: Impaired - Aquatic Life Harvesting (DO, fecal coliform, mercury in fish tissue)

Restoration Option 1

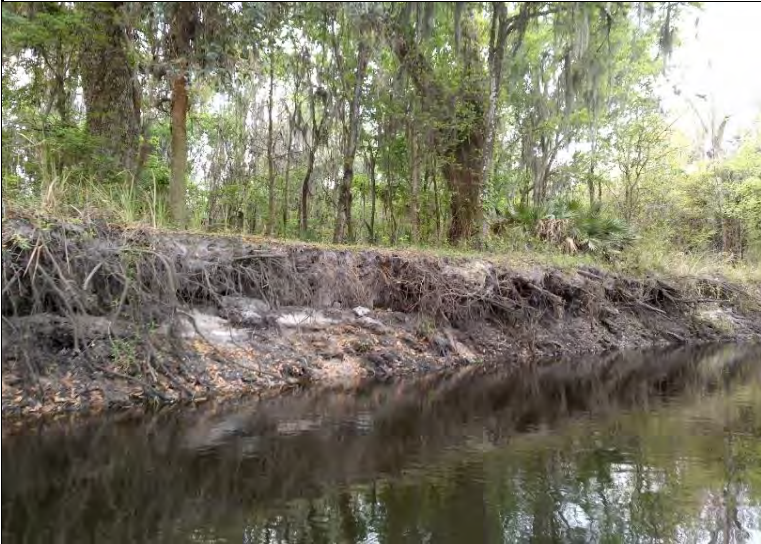
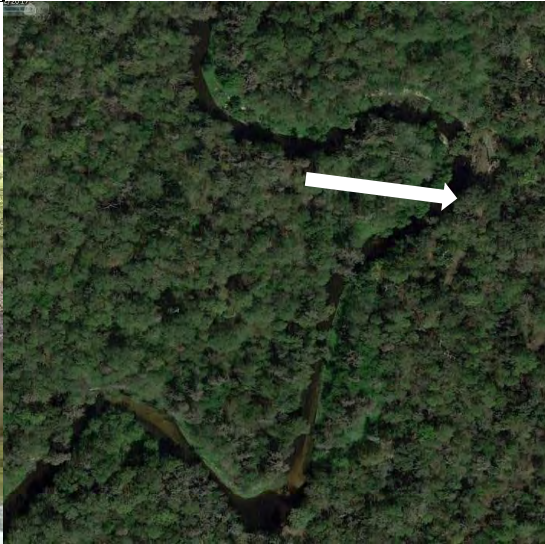
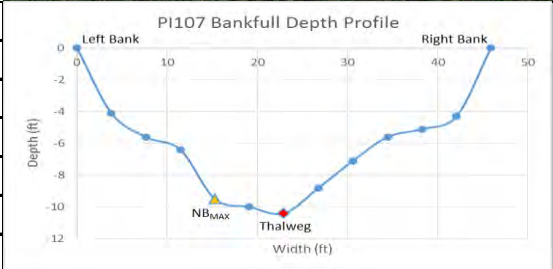
Peace River			Severity Scale: 2.5-Low
Watershed: Peace River Subwatershed: Bear Branch Latitude: 27.71740 Longitude: -81.79385			County: Polk Site Number: PI107 Reach Length: 122 ft. Landowner: Polk County

Risk Factor	Ranking	Score	
Pfankuch-Channel Stability:	Good	0	
Channel Alteration:	None	0	
Bank Erosion:	Mass-wasting	1.5	
BEHI:	Moderate (24.90)	0.5	
Local NPSP:	No Evidence	0	
Shoring Structures:	None	0	
Pipe Discharge:	None	0	
Water Odor:	Normal	0	
Fish Passage Barrier:	None	0	
RB: Riparian Buffer:	100 ft.	0	
LB: Riparian Buffer:	40 ft.	0.5	
RB: Floodplain Access:	Full	0	
LB: Floodplain Access:	Full	0	
<b>Severity Scale:</b>		<b>2.5</b>	
Notes: 303d: Impaired - Aquatic Life Harvesting (mercury in fish tissue)			
Restoration Option 1

Additional Site Features
Stream Channel Woody Material: Moderate
Impoundments: None
Substrate Composition: Medium Sand
Bank Material: Sandy-Clay
Near Bank Stress: Low
RB Landuse: Natural Forest
LB Landuse: Natural Forest, Residential

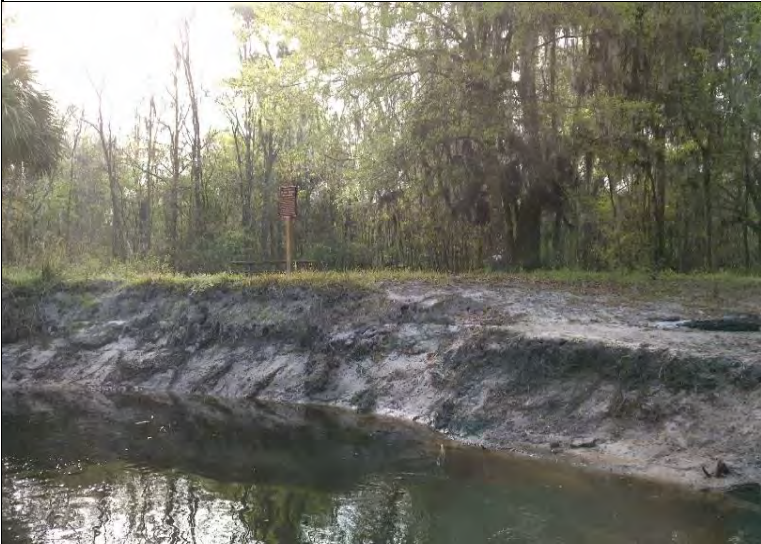
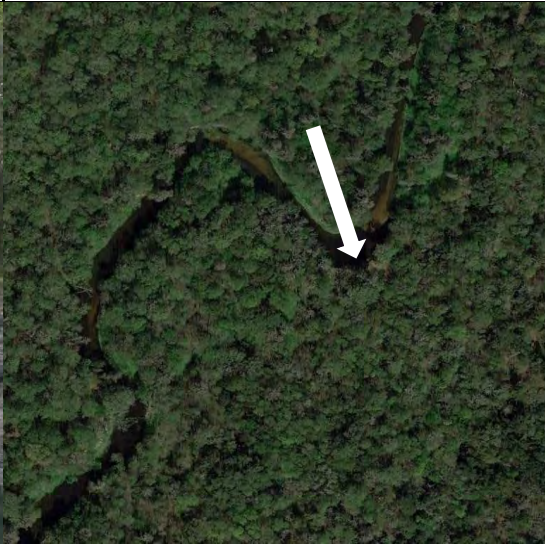
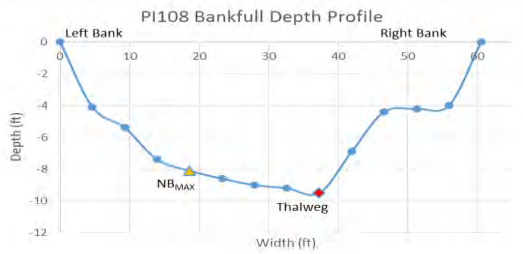
Peace River			Severity Scale: 2.5-Low
Watershed: Peace River Subwatershed: Bear Branch Latitude: 27.71584 Longitude: -81.79470			County: Polk Site Number: PI108 Reach Length: 40 ft. Landowner: Polk County

Pfankuch-Channel Stability:	Good	0	
Channel Alteration:	None	0	
Bank Erosion:	Active	1	
BEHI:	High (35.22)	1	
Local NPSP:	No Evidence	0	
Shoring Structures:	None	0	
Pipe Discharge:	None	0	
Water Odor:	Normal	0	
Fish Passage Barrier:	None	0	
RB: Riparian Buffer:	100 ft.	0	
LB: Riparian Buffer:	40 ft.	0.5	
RB: Floodplain Access:	Full	0	
LB: Floodplain Access:	Full	0	
<b>Severity Scale:</b>		<b>2.5</b>	
Notes: 303d: Impaired - Aquatic Life Harvesting (mercury in fish tissue)			<b>Additional Site Features</b>
			Stream Channel Woody Material: Infrequent
			Impoundments: None
			Substrate Composition: Medium Sand
			Bank Material: Sand
			Near Bank Stress: Moderate
			RB Landuse: Natural Forest

LB Landuse: Natural Forest, Recreational Use
Restoration Option 1

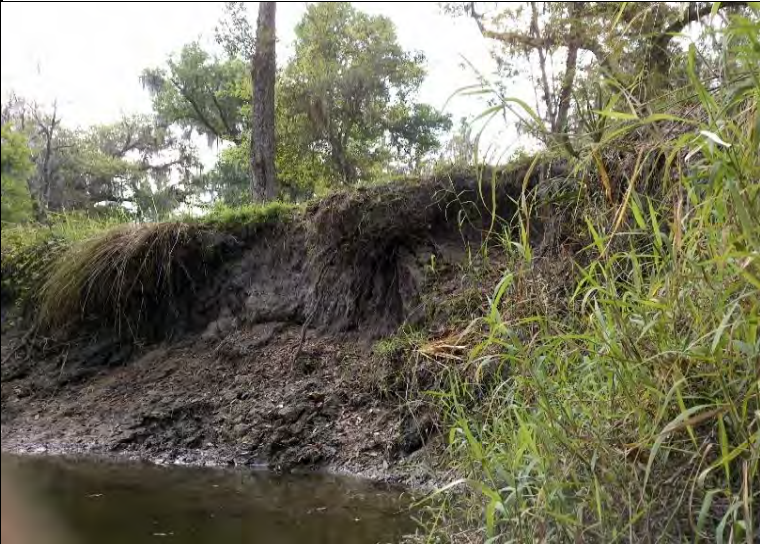
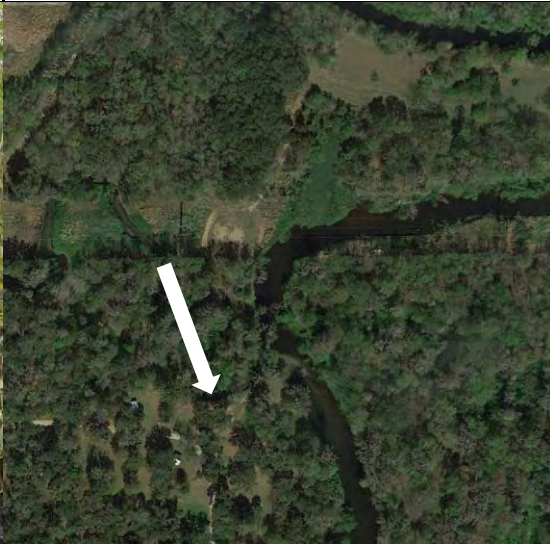
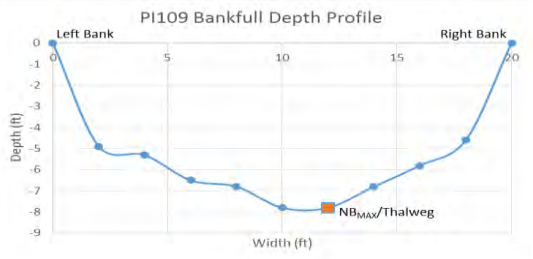
Whidden Creek			Severity Scale: 2.75-Low
Watershed: Peace River Subwatershed: Thompson Branch Latitude: 27.70726 Longitude: -81.80038			County: Polk Site Number: PI109 Reach Length: 11 ft. Landowner: Florida Rangers Inc

Pfankuch-Channel Stability:	Good	0	
Channel Alteration:	None	0	
Bank Erosion:	Active	1	
BEHI:	Moderate (est*)	0.5	
Local NPSP:	Slight Potential	0.5	
Shoring Structures:	None	0	
Pipe Discharge:	None	0	
Water Odor:	Normal	0	
Fish Passage Barrier:	None	0	
RB: Riparian Buffer:	20 ft.	0.75	
LB: Riparian Buffer:	100 ft.	0	
RB: Floodplain Access:	Full	0	
LB: Floodplain Access:	Full	0	
<b>Severity Scale:</b>		<b>2.75</b>	
			<b>Additional Site Features</b>
			Stream Channel Woody Material: Infrequent
			Impoundments: None
			Substrate Composition: Medium Sand
			Bank Material: Sand
			Near Bank Stress: Moderate
			RB Landuse: Residential, Natural Forest
			LB Landuse: Natural Forest

Notes: *Rapid assessment made for BEHI score; Score calculated based on similar sites in the			
area; Spring backwater off main channel, Widden Creek; 303d: Impaired - DO, nutrients, TSS,			
turbidity (2002)			
Restoration Option 1

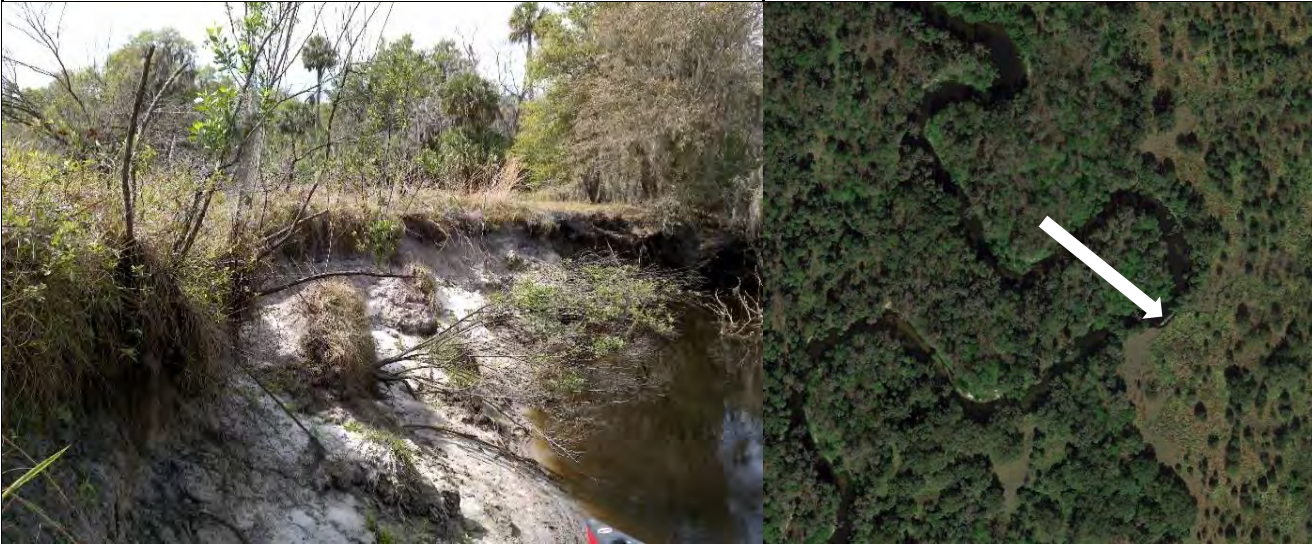
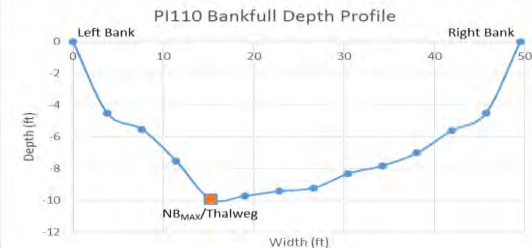
Peace River			Severity Scale: 3.0-Low
Watershed: Peace River Subwatershed: Thompson Branch Latitude: 27.67304 Longitude: -81.80288			County: Polk Site Number: PI110 Reach Length: 53 ft. Landowner: TIITF/DEP

Pfankuch-Channel Stability:	Good	0	
Channel Alteration:	None	0	
Bank Erosion:	Mass-wasting	1.5	
BEHI:	High (37.78)	1	
Local NPSP:	No Evidence	0	
Shoring Structures:	None	0	
Pipe Discharge:	None	0	
Water Odor:	Normal	0	
Fish Passage Barrier:	None	0	
RB: Riparian Buffer:	100 ft.	0	
LB: Riparian Buffer:	40 ft.	0.5	
RB: Floodplain Access:	Full	0	
LB: Floodplain Access:	Full	0	
<b>Severity Scale:</b>		<b>3.0</b>	<b>Additional Site Features</b>
			Stream Channel Woody Material: Moderate
			Impoundments: None
			Substrate Composition: Medium Sand
			Bank Material: Sand
			Near Bank Stress: High
			RB Landuse: Natural Forest
			LB Landuse: Reclaimed Field
Notes: 303d: Impaired - Aquatic Life Harvesting (mercury in fish tissue)

Restoration Option 1

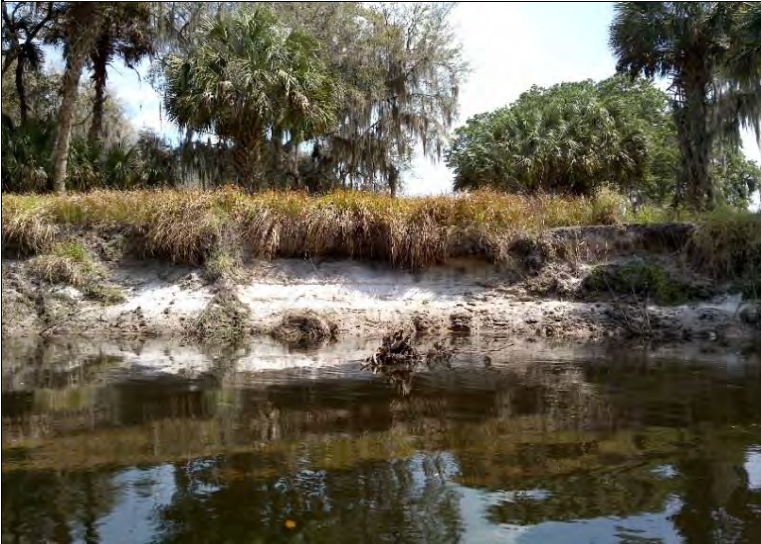
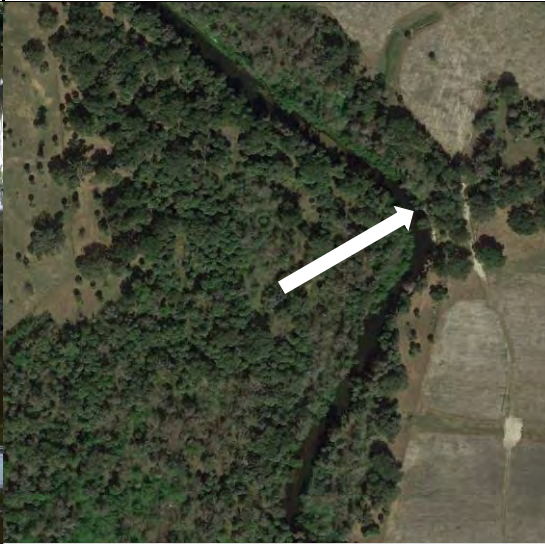
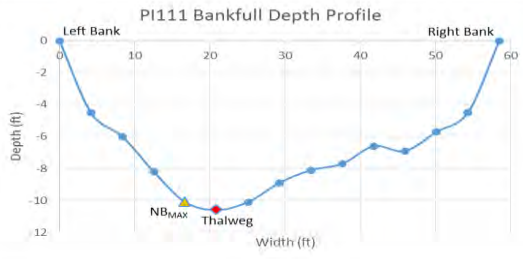
Peace River			Severity Scale: 3.5-Low
Watershed: Peace River Subwatershed: Thompson Branch Latitude: 27.65416 Longitude: -81.79932			County: Polk Site Number: PI111 Reach Length: 47 ft. Landowner: Durrance & Sons LLC

Pfankuch-Channel Stability:	Good	0	
Channel Alteration:	None	0	
Bank Erosion:	Mass-wasting	1.5	
BEHI:	High (36.00)	1	
Local NPSP:	Slight Potential	0.5	
Shoring Structures:	None	0	
Pipe Discharge:	None	0	
Water Odor:	Normal	0	
Fish Passage Barrier:	None	0	
RB: Riparian Buffer:	100 ft.	0	
LB: Riparian Buffer:	40 ft.	0.5	
RB: Floodplain Access:	Full	0	
LB: Floodplain Access:	Full	0	
<b>Severity Scale:</b>		<b>3.5</b>	
Notes: Fenced off pasture approx. 40 ft. from bank with light use; 303d: Impaired - Aquatic Life			<b>Additional Site Features</b>
Harvesting (mercury in fish tissue)			Stream Channel Woody Material: Moderate
			Impoundments: None
			Substrate Composition: Medium Sand

Bank Material: Sand
			Near Bank Stress: Moderate
			RB Landuse: Natural Forest
			LB Landuse: Natural Forest, Pasture
Restoration Option 1

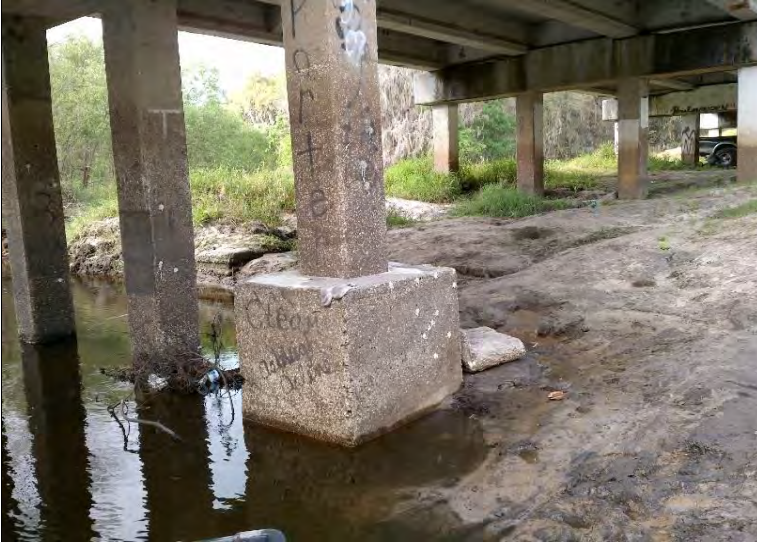
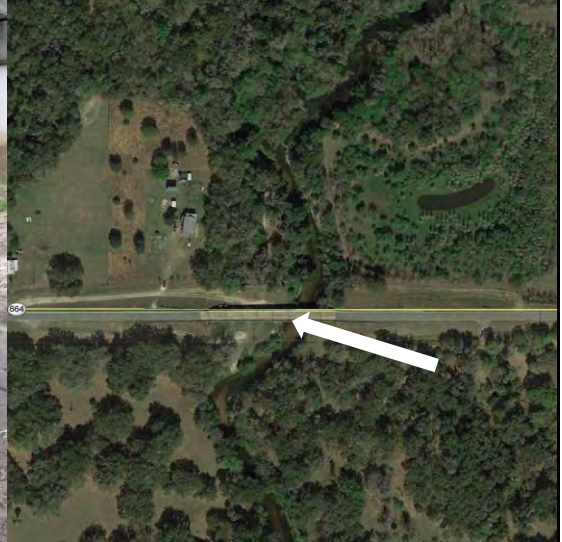
Reach Length: 36 ft.

Landowner: Florida DOT

Risk Factor	Ranking	Score
Pfankuch-Channel Stability:	Good	0
Channel Alteration:	Historic	0.5
Bank Erosion:	Active	1
BEHI:	Very High (40.52)	1.5
Local NPSP:	Moderate Potential	1
Shoring Structures:	None	0
Pipe Discharge:	None	0
Water Odor:	Normal	0
Fish Passage Barrier:	None	0
RB: Riparian Buffer:	0 ft.	0.75
LB: Riparian Buffer:	0 ft.	0.75
RB: Floodplain Access:	Full	0
LB: Floodplain Access:	Partial	0.25
<b>Severity Scale:</b>		<b>5.75</b>

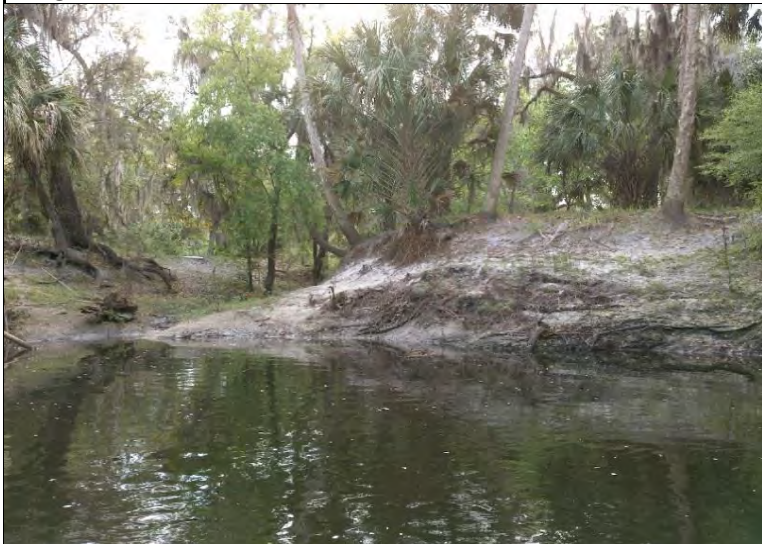
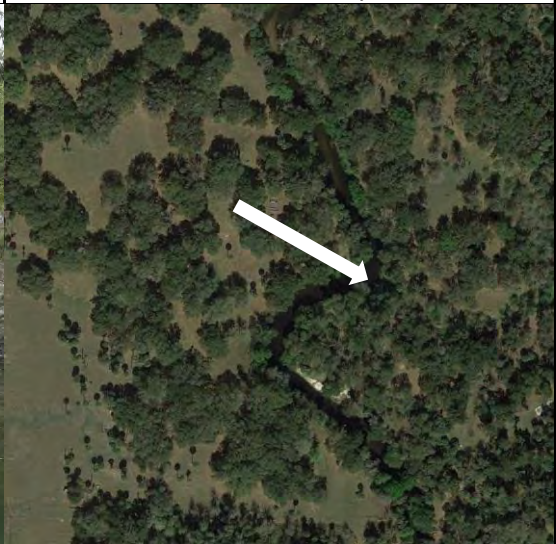
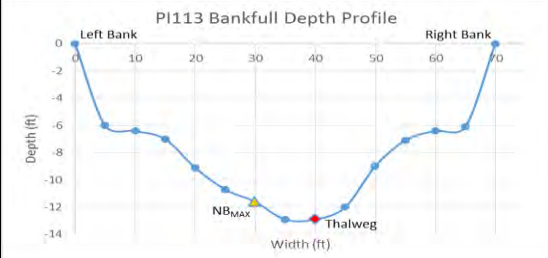
Peace River			Severity Scale: 4.5-Moderate	
Watershed: Peace River Subwatershed: Thompson Branch Latitude: 27.64386 Longitude: -81.80202			County: Hardee Site Number: PI113 Reach Length: 33 ft. Landowner: Thomas F & Mary E Haffer

Pfankuch-Channel Stability:	Good	0		
Channel Alteration:	None	0		
Bank Erosion:	Active	1		
BEHI:	Moderate (27.81)	0.5		
Local NPSP:	Obvious Sources	1.5		
Shoring Structures:	None	0		
Pipe Discharge:	None	0		
Water Odor:	Normal	0		
Fish Passage Barrier:	None	0		
RB: Riparian Buffer:	40 ft.	0.5	Additional Site Features	
LB: Riparian Buffer:	40 ft.	0.5	Stream Channel Woody Material: Infrequent	
RB: Floodplain Access:	Partial	0.25	Impoundments: None	
LB: Floodplain Access:	Partial	0.25	Substrate Composition: Medium sand	
Severity Scale:		4.5	Bank Material: Sand	
Notes: Cattle access point; 303d: Impaired - Aquatic Life Harvesting (mercury in fish tissue)			Near Bank Stress: Low

Restoration Option 2 or 3			RB Landuse: Pasture, Natural Forest	
			LB Landuse: Natural Forest, Pasture

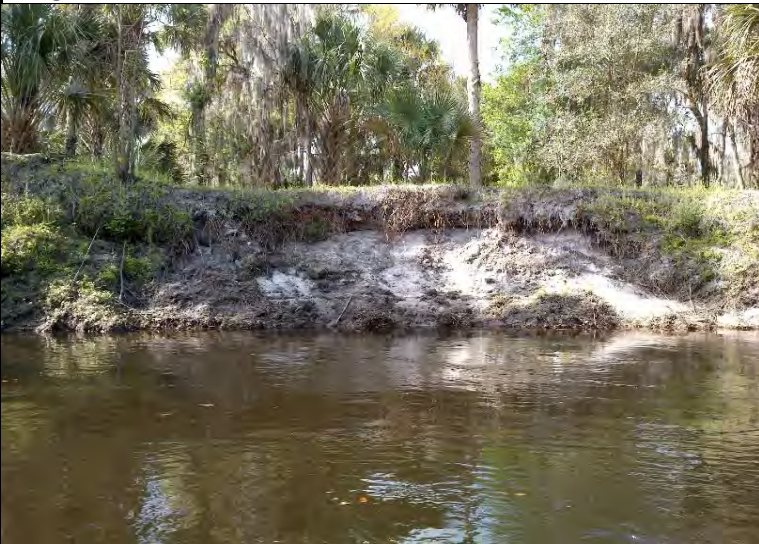
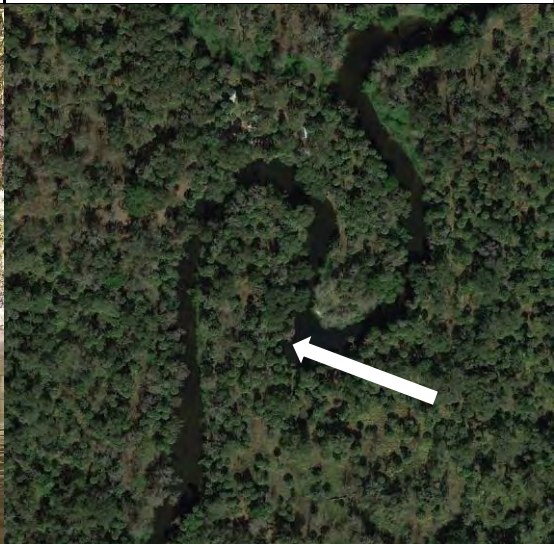
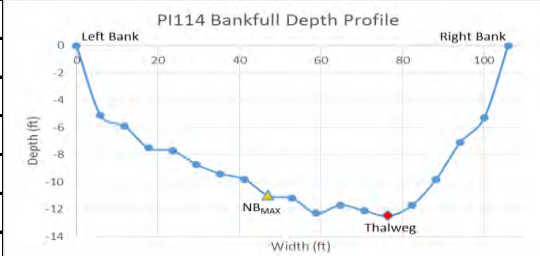
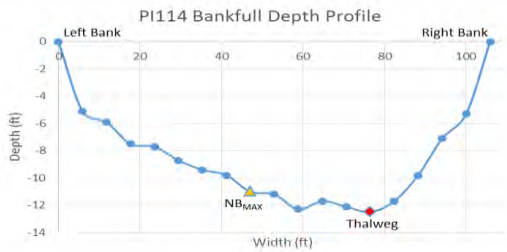
Peace River			Severity Scale: 2.75-Low	
Watershed: Peace River Subwatershed: Thompson Branch Latitude: 27.63439 Longitude: -81.80106			County: Hardee Site Number: PI114 Reach Length: 61 ft. Landowner: Mosaic Fertilizer LLC

Pfankuch-Channel Stability:	Good	0		
Channel Alteration:	None	0		
Bank Erosion:	Active	1		
BEHI:	Moderate (27.41)	0.5		
Local NPSP:	Slight Potential	0.5		
Shoring Structures:	None	0		
Pipe Discharge:	None	0		
Water Odor:	Normal	0		
Fish Passage Barrier:	None	0		
RB: Riparian Buffer:	100 ft.	0	<b>Additional Site Features</b>	
LB: Riparian Buffer:	40 ft.	0.5	Stream Channel Woody Material: Moderate	
RB: Floodplain Access:	Full	0	Impoundments: None	
LB: Floodplain Access:	Partial	0.25	Substrate Composition: Medium sand	
<b>Severity Scale:</b>			Bank Material: Sand	
			Near Bank Stress: Low	
			RB Landuse: Natural Forest	
			LB Landuse: Natural Forest, Pasture

Notes: 303d: Impaired - Aquatic Life Harvesting (mercury in fish tissue)				
Restoration Option 1

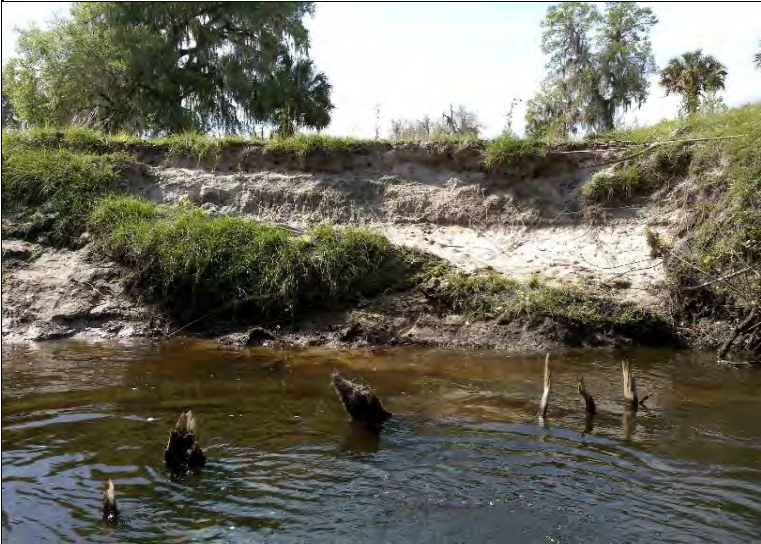
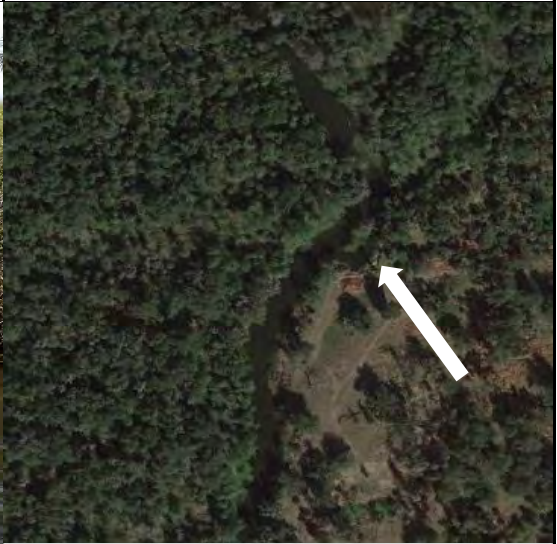
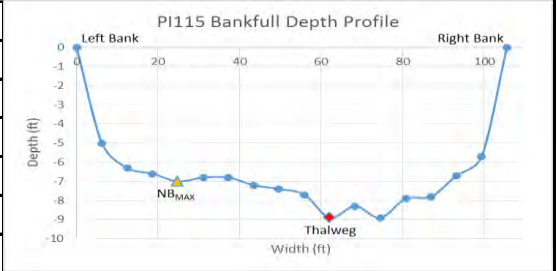
Peace River			Severity Scale: 2.5-Low
Watershed: Peace River Subwatershed: Thompson Branch Latitude: 27.63149 Longitude: -81.80100			County: Hardee Site Number: PI115 Reach Length: 97 ft. Landowner: Mosaic Fertilizer LLC

Risk Factor	Ranking	Score	
Pfankuch-Channel Stability:	Good	0	
Channel Alteration:	None	0	
Bank Erosion:	Active	1	
BEHI:	Moderate (22.30)	0.5	
Local NPSP:	Slight Potential	0.5	
Shoring Structures:	None	0	
Pipe Discharge:	None	0	
Water Odor:	Normal	0	
Fish Passage Barrier:	None	0	
RB: Riparian Buffer:	100 ft.	0	
LB: Riparian Buffer:	40 ft.	0.5	
RB: Floodplain Access:	Full	0	
LB: Floodplain Access:	Full	0	
Severity Scale:		2.5	
Notes: Island just below bankfull at site; 303d: Impaired - Aquatic Life Harvesting (mercury in fish tissue)			
Restoration Option 1

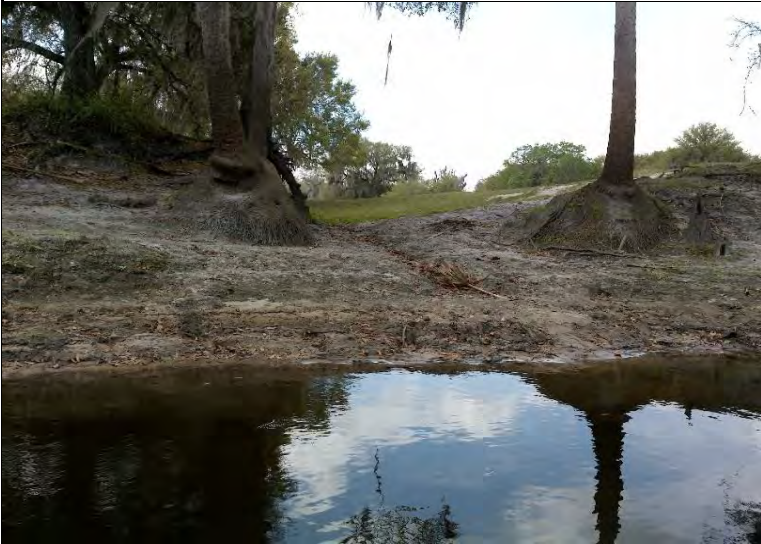
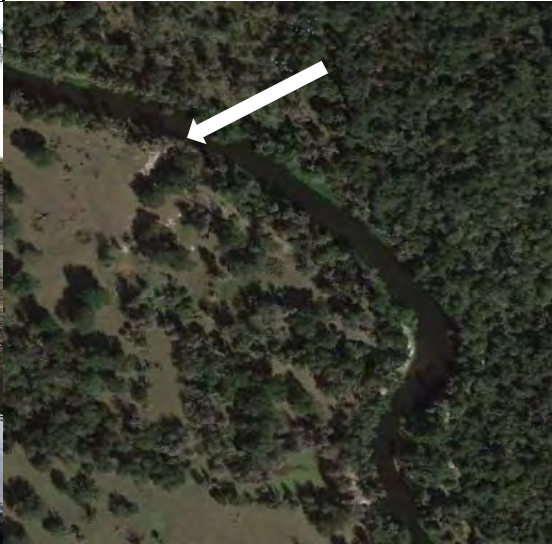
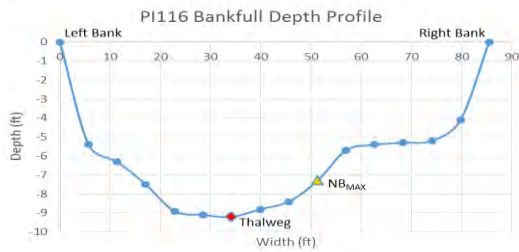
Peace River			Severity Scale: 4.5-Moderate
Watershed: Peace River Subwatershed: Thompson Branch Latitude: 27.61238 Longitude: -81.79617			County: Hardee Site Number: PI116 Reach Length: 36 ft. Landowner: Bernadette Albritton

Risk Factor	Ranking	Score	
Pfankuch-Channel Stability:	Good	0	
Channel Alteration:	None	0	
Bank Erosion:	Active	1	
BEHI:	High (30.22)	1	
Local NPSP:	Obvious Sources	1.5	
Shoring Structures:	None	0	
Pipe Discharge:	None	0	<b>Additional Site Features</b>
Water Odor:	Normal	0	Stream Channel Woody Material: Infrequent
Fish Passage Barrier:	None	0	Impoundments: None
RB: Riparian Buffer:	20 ft.	0.75	Substrate Composition: Medium sand
LB: Riparian Buffer:	100 ft.	0	Bank Material: Sand
RB: Floodplain Access:	Full	0	Near Bank Stress: Low
LB: Floodplain Access:	Partial	0.25	RB Landuse: Pasture, Natural Forest
<b>Severity Scale:</b>		<b>4.5</b>	LB Landuse: Natural Forest
Notes: Cattle access point; 303d: Impaired - Aquatic Life Harvesting (mercury in fish tissue)

Restoration Option 2 or 3

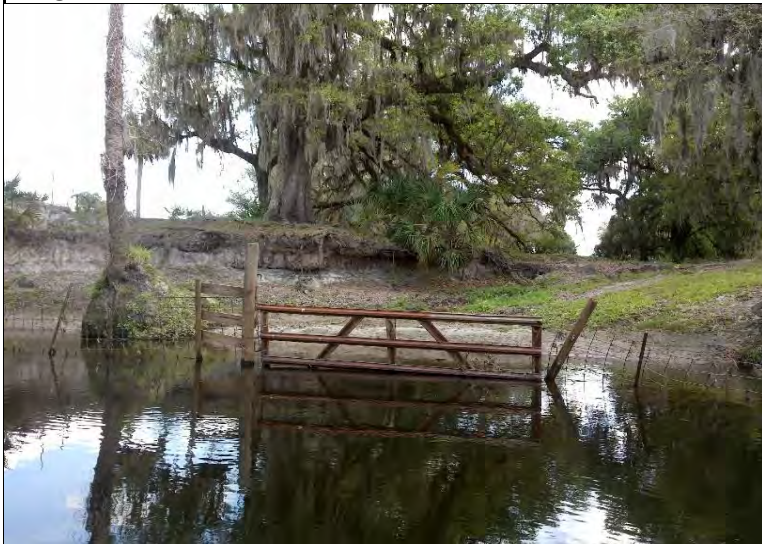
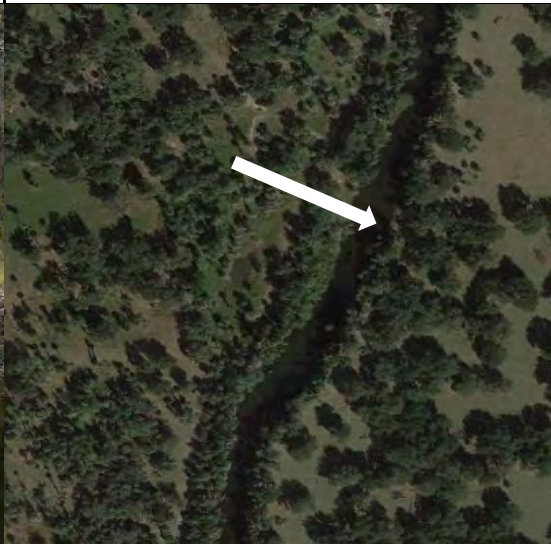
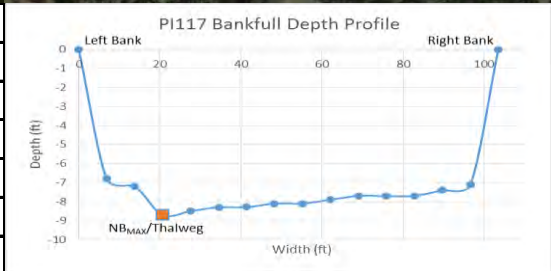
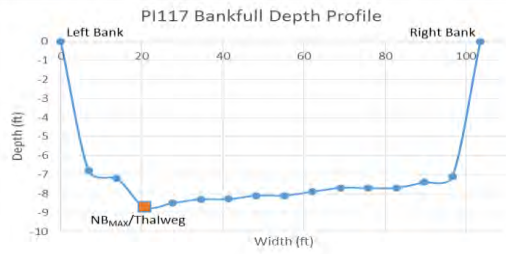
Peace River			Severity Scale: 5.0-Moderate
Watershed: Peace River Subwatershed: Thompson Branch Latitude: 27.60484 Longitude: -81.79549			County: Hardee Site Number: PI117 Reach Length: 63 ft. Landowner: Mosaic Fertilizer LLC

Pfankuch-Channel Stability:	Good	0	
Channel Alteration:	None	0	
Bank Erosion:	Active	1	
BEHI:	High (32.98)	1	
Local NPSP:	Obvious Sources	1.5	
Shoring Structures:	None	0	
Pipe Discharge:	None	0	
Water Odor:	Normal	0	
Fish Passage Barrier:	None	0	
RB: Riparian Buffer:	40 ft.	0.5	<b>Additional Site Features</b>
LB: Riparian Buffer:	0 ft.	0.75	Stream Channel Woody Material: Infrequent
RB: Floodplain Access:	Full	0	Impoundments: None
LB: Floodplain Access:	Partial	0.25	Substrate Composition: Medium sand
<b>Severity Scale:</b>			Bank Material: Sand
			Near Bank Stress: High
			RB Landuse: Pasture, Natural Forest
			LB Landuse: Pasture, Natural Forest

Notes: 303d: Impaired - Aquatic Life Harvesting (mercury in fish tissue)			
Restoration Option 2 or 3

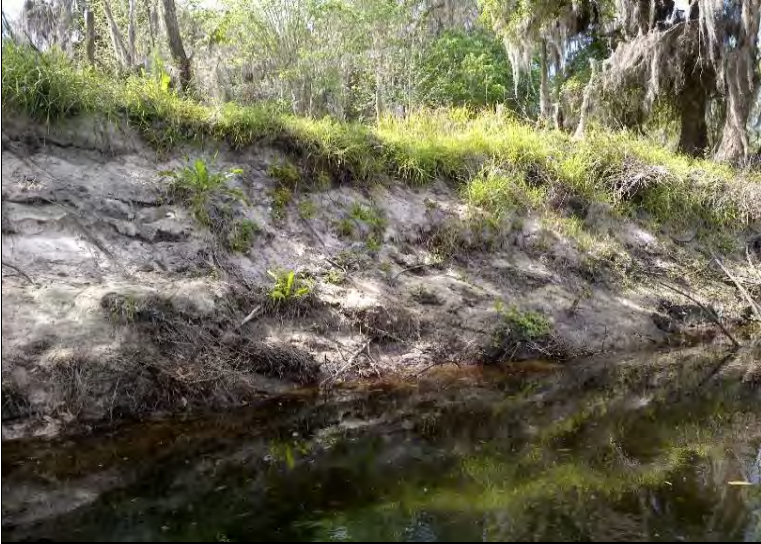
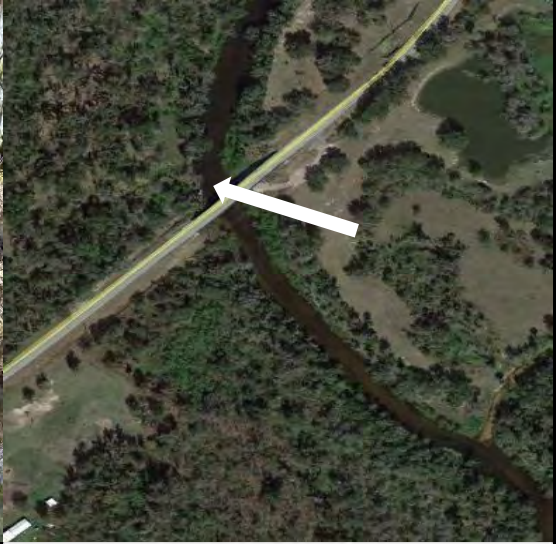
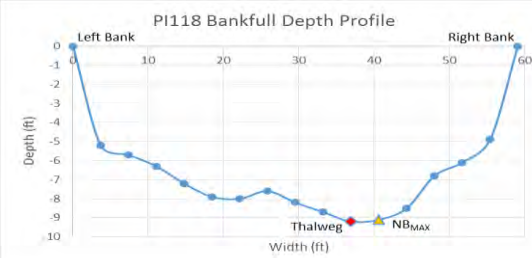
Peace River			Severity Scale: 4.25-Moderate
Watershed: Peace River Subwatershed: Thompson Branch Latitude: 27.57612 Longitude: -81.80466			County: Hardee Site Number: PI118 Reach Length: 54 ft. Landowner: Cynthia C. Parrish

Risk Factor	Ranking	Score	
Pfankuch-Channel Stability:	Good	0	
Channel Alteration:	None	0	
Bank Erosion:	Active	1	
BEHI:	High (32.37)	1	
Local NPSP:	Obvious Sources	1.5	
Shoring Structures:	None	0	
Pipe Discharge:	None	0	
Water Odor:	Normal	0	
Fish Passage Barrier:	None	0	
RB: Riparian Buffer:	40 ft.	0.5	
LB: Riparian Buffer:	100 ft.	0	
RB: Floodplain Access:	Partial	0.25	
LB: Floodplain Access:	Full	0	
<b>Severity Scale:</b>		<b>4.25</b>	
Notes: 303d: Impaired - Aquatic Life Harvesting (mercury in fish tissue)			
Restoration Option 1

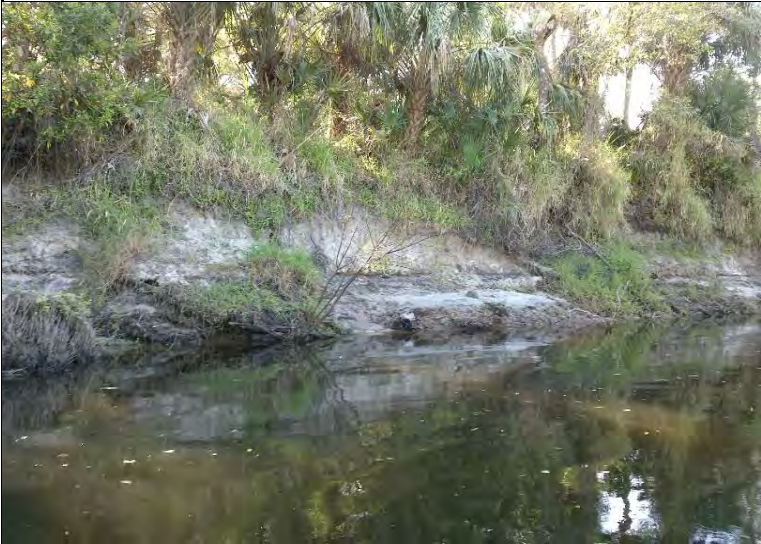
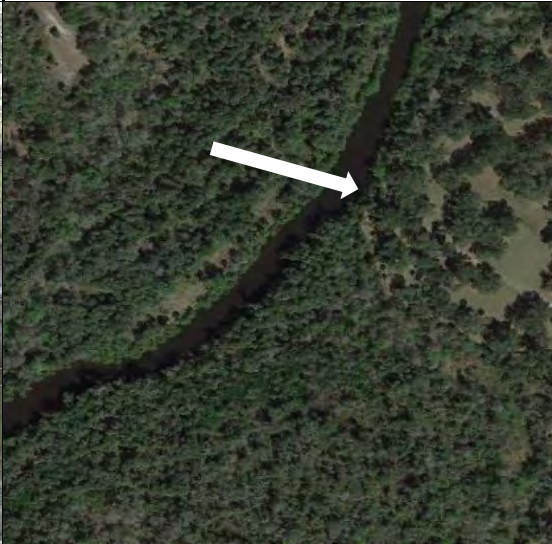
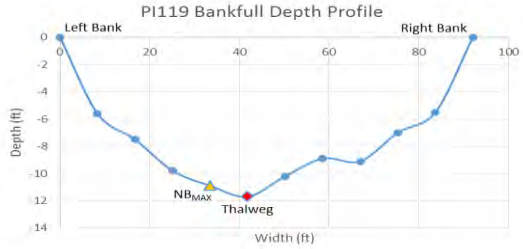
Peace River			Severity Scale: 3.5-Low
Watershed: Peace River Subwatershed: Thompson Branch Latitude: 27.55495 Longitude: -81.79050			County: Hardee Site Number: PI119 Reach Length: 20 ft. Landowner: Bagwell Plantation Florida

Pfankuch-Channel Stability:	Good	0	
Channel Alteration:	None	0	
Bank Erosion:	Mass-wasting	1.5	
BEHI:	High (34.49)	1	
Local NPSP:	Slight Potential	0.5	
Shoring Structures:	None	0	
Pipe Discharge:	None	0	
Water Odor:	Normal	0	
Fish Passage Barrier:	None	0	
RB: Riparian Buffer:	100 ft.	0	
LB: Riparian Buffer:	40 ft.	0.5	
RB: Floodplain Access:	Full	0	
LB: Floodplain Access:	Full	0	
<b>Severity Scale:</b>		<b>3.5</b>	
Notes: 303d: Impaired - Aquatic Life Harvesting (mercury in fish tissue), Chlorophyll-A			<b>Additional Site Features</b>
			Stream Channel Woody Material: Infrequent
			Impoundments: None
			Substrate Composition: Medium sand
			Bank Material: Sand

Near Bank Stress: Moderate
			RB Landuse: Natural Forest
			LB Landuse: Pasture, Natural Forest
Restoration Option 1

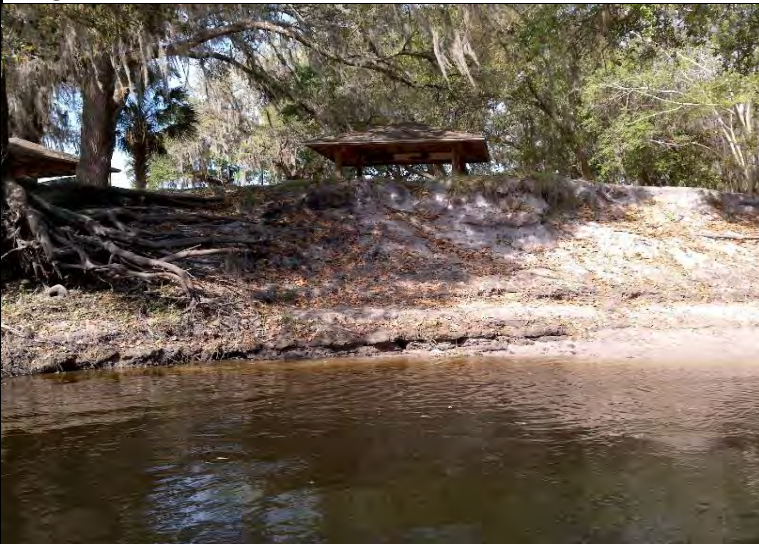
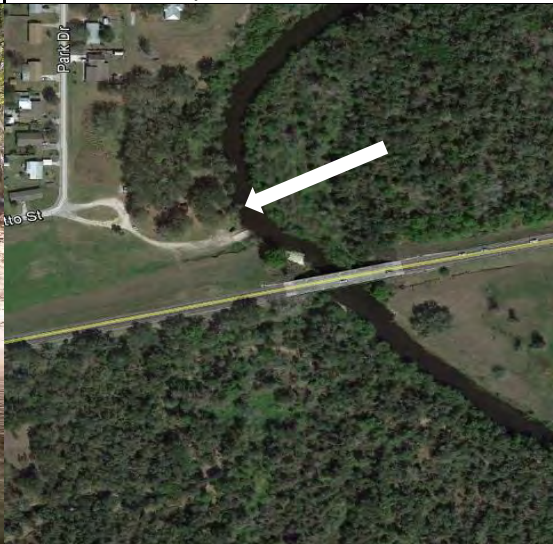
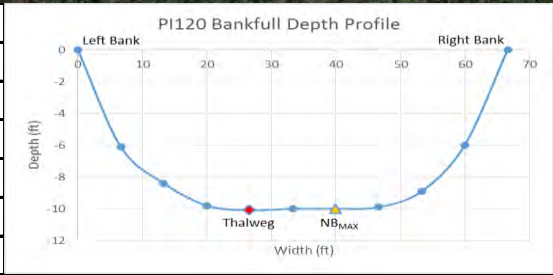
Peace River			Severity Scale: 3.25-Low	
Watershed: Peace River Subwatershed: Thompson Branch Latitude: 27.55145 Longitude: -81.79446			County: Hardee Site Number: PI120 Reach Length: 141 ft. Landowner: City of Wauchula

Pfankuch-Channel Stability:	Good	0		
Channel Alteration:	None	0		
Bank Erosion:	Active	1		
BEHI:	High (33.79)	1		
Local NPSP:	Slight Potential	0.5		
Shoring Structures:	None	0		
Pipe Discharge:	None	0		
Water Odor:	Normal	0		
Fish Passage Barrier:	None	0		
RB: Riparian Buffer:	0 ft.	0.75	<b>Additional Site Features</b>	
LB: Riparian Buffer:	100 ft.	0	Stream Channel Woody Material: Infrequent	
RB: Floodplain Access:	Full	0	Impoundments: None	
LB: Floodplain Access:	Full	0	Substrate Composition: Medium sand	
<b>Severity Scale:</b>			<b>3.25</b>	
Notes: At Wauchula Riverside Park: recreation area with pavillions, benches, etc.; 303d:			Bank Material: Sand

Impaired - Aquatic Life Harvesting (mercury in fish tissue), Chlorophyll-A			Near Bank Stress: Low	
Restoration Option 2 or 3			RB Landuse: Recreation	
			LB Landuse: Natural Forest

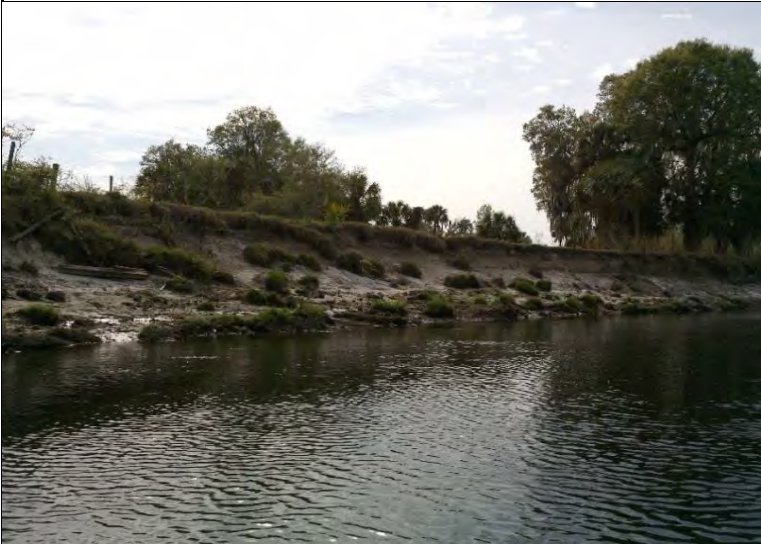
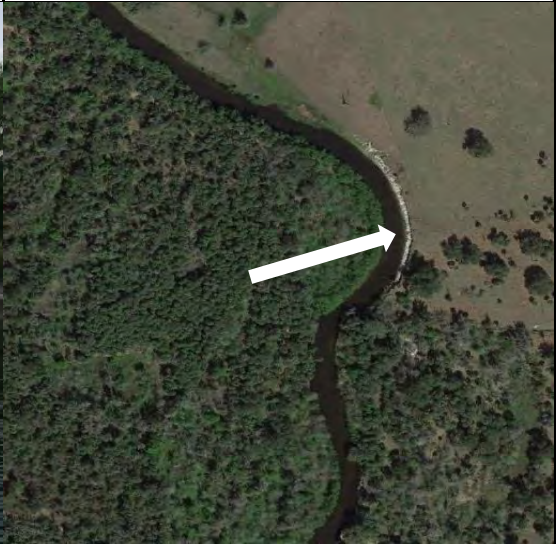
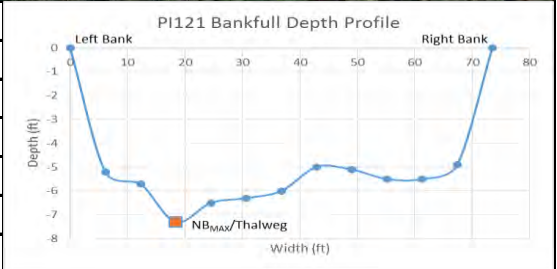
Peace River			Severity Scale: 5.0-Moderate
Watershed: Peace River Subwatershed: Thompson Branch Latitude: 27.54890 Longitude: -81.79136			County: Hardee Site Number: PI121 Reach Length: 558 ft. Landowner: Pamela Wiggins Garner et al

Risk Factor	Ranking	Score	
Pfankuch-Channel Stability:	Good	0	
Channel Alteration:	None	0	
Bank Erosion:	Mass-wasting	1.5	
BEHI:	High (38.95)	1	
Local NPSP:	Obvious Sources	1.5	
Shoring Structures:	None	0	
Pipe Discharge:	None	0	
Water Odor:	Normal	0	
Fish Passage Barrier:	None	0	
RB: Riparian Buffer:	100 ft.	0	
LB: Riparian Buffer:	0 ft.	0.75	
RB: Floodplain Access:	Full	0	
LB: Floodplain Access:	Partial	0.25	
Severity Scale:		5.0	
Notes: 303d: Impaired - Aquatic Life Harvesting (mercury in fish tissue), Chlorophyll-A			
Restoration Option 1

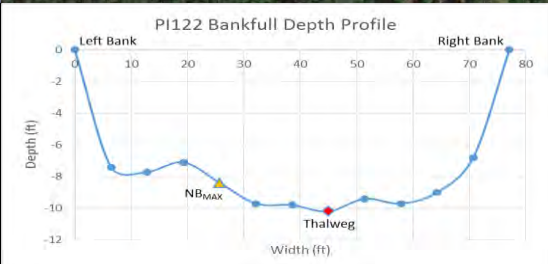
Peace River			Severity Scale: 3.75-Low	
Watershed: Peace River Subwatershed: Thompson Branch Latitude: 27.54599 Longitude: -81.79134			County: Hardee Site Number: PI122 Reach Length: 334 ft. Landowner: Burnett OMA

Pfankuch-Channel Stability:	Good	0		
Channel Alteration:	None	0		
Bank Erosion:	Active	1		
BEHI:	Moderate (25.59)	0.5		
Local NPSP:	Obvious Sources	1.5		
Shoring Structures:	None	0		
Pipe Discharge:	None	0		
Water Odor:	Normal	0		
Fish Passage Barrier:	None	0		
RB: Riparian Buffer:	100 ft.	0		
LB: Riparian Buffer:	40 ft.	0.5		
RB: Floodplain Access:	Full	0		
LB: Floodplain Access:	Partial	0.25		
Severity Scale:		3.75	Additional Site Features	
			Stream Channel Woody Material: Numerous	
			Impoundments: None	
			Substrate Composition: Medium sand	
			Bank Material: Sand	
			Near Bank Stress: Low	
			RB Landuse: Natural Forest	
			LB Landuse: Pasture, Natural Forest

Notes: 303d: Impaired - Aquatic Life Harvesting (mercury in fish tissue), Chlorophyll-A				
Restoration Option 1

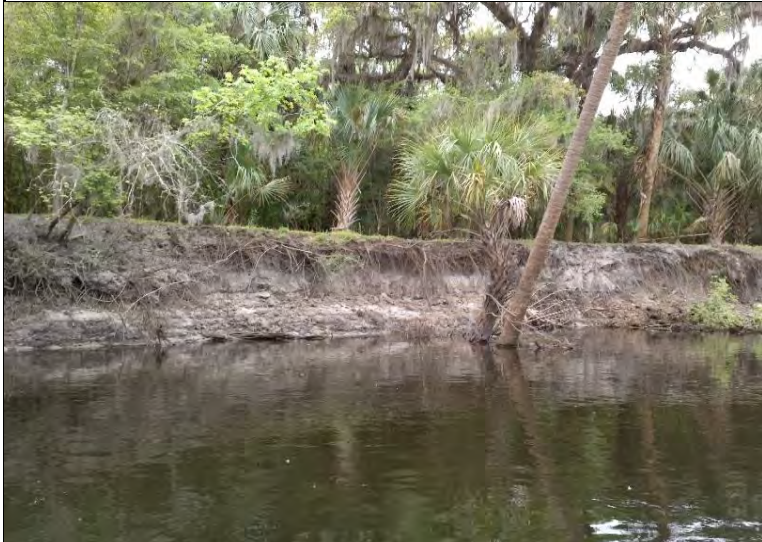
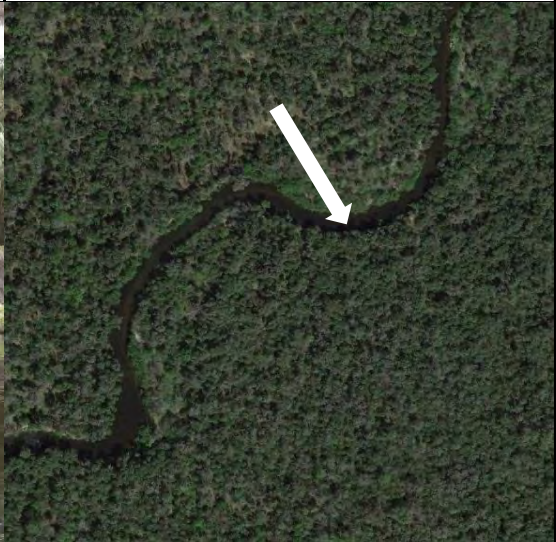
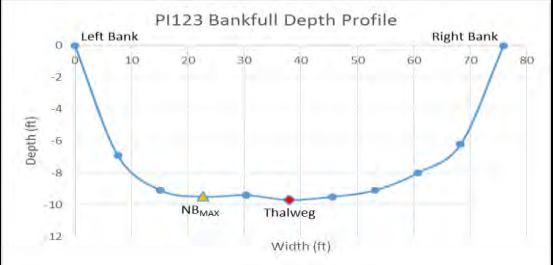
Peace River			Severity Scale: 1.75-Low	
Watershed: Peace River Subwatershed: Troublesome Creek Latitude: 27.51118 Longitude: -81.79462			County: Hardee Site Number: PI123 Reach Length: 610 ft. Landowner: EIP Florida LLC

Pfankuch-Channel Stability:	Good	0		
Channel Alteration:	None	0		
Bank Erosion:	Active	1		
BEHI:	Moderate (24.70)	0.5		
Local NPSP:	No Evidence	0		
Shoring Structures:	None	0		
Pipe Discharge:	None	0		
Water Odor:	Normal	0		
Fish Passage Barrier:	None	0		
RB: Riparian Buffer:	100 ft.	0		
LB: Riparian Buffer:	100 ft.	0		
RB: Floodplain Access:	Full	0		
LB: Floodplain Access:	Partial	0.25		
Severity Scale:		1.75		
			Additional Site Features	
			Stream Channel Woody Material: Moderate	
			Impoundments: None	
			Substrate Composition: Medium sand	
			Bank Material: Sandy clay	
			Near Bank Stress: Low	
			RB Landuse: Natural Forest	
			LB Landuse: Natural Forest

Notes: 303d: Impaired - Aquatic Life Harvesting (mercury in fish tissue), Chlorophyll-A				
Restoration Option 1

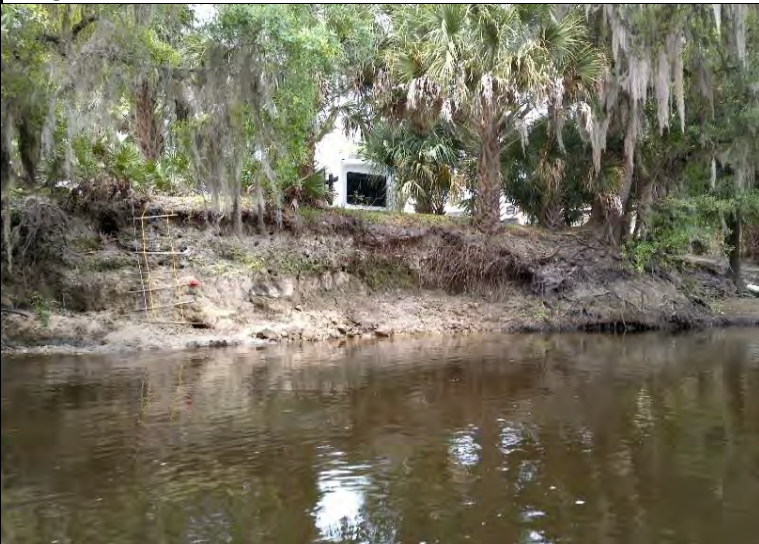
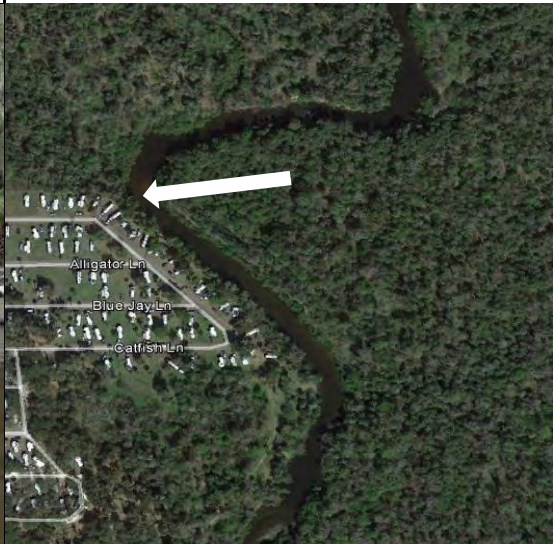
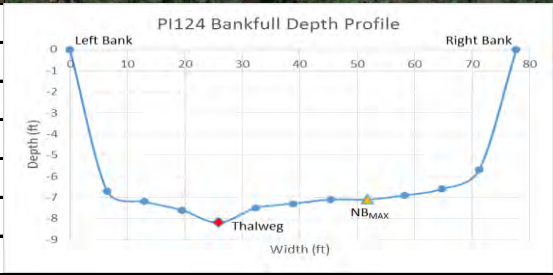
Peace River			Severity Scale: 3.5-Low	
Watershed: Peace River Subwatershed: Troublesome Creek Latitude: 27.50804 Longitude: -81.79772			County: Hardee Site Number: PI124 Reach Length: 192 ft. Landowner: M H C Peace River LLC

Pfankuch-Channel Stability:	Good	0		
Channel Alteration:	None	0		
Bank Erosion:	Active	1		
BEHI:	Moderate (21.85)	0.5		
Local NPSP:	Moderate Potential	1		
Shoring Structures:	None	0		
Pipe Discharge:	None	0		
Water Odor:	Normal	0		
Fish Passage Barrier:	None	0		
RB: Riparian Buffer:	0 ft.	0.75		
LB: Riparian Buffer:	100 ft.	0		
RB: Floodplain Access:	Partial	0.25		
LB: Floodplain Access:	Full	0		
Severity Scale:		3.5		
			Additional Site Features	
			Stream Channel Woody Material: Infrequent	
			Impoundments: None	
			Substrate Composition: Medium sand	
			Bank Material: Sandstone	
			Near Bank Stress: Low	
			RB Landuse: Recreation	
			LB Landuse: Natural Forest

Notes: 303d: Impaired - Aquatic Life Harvesting (mercury in fish tissue), Chlorophyll-A				
Restoration Option 1
