# **Peace River and Withlacoochee River Threats Assessments and Fish Assemblage Monitoring**

**Final Report July 1, 2015 – June 30, 2019**

Submitted to Florida State Wildlife Grants Program  
August 1, 2019  
PID: 98462501284

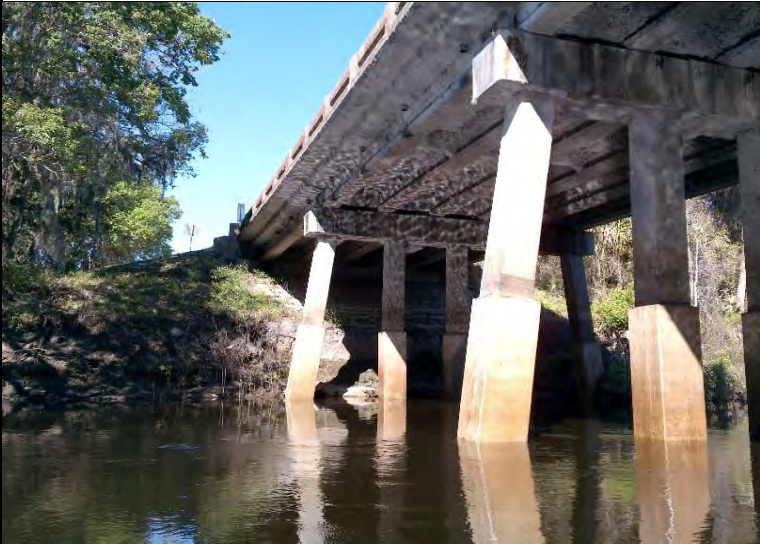
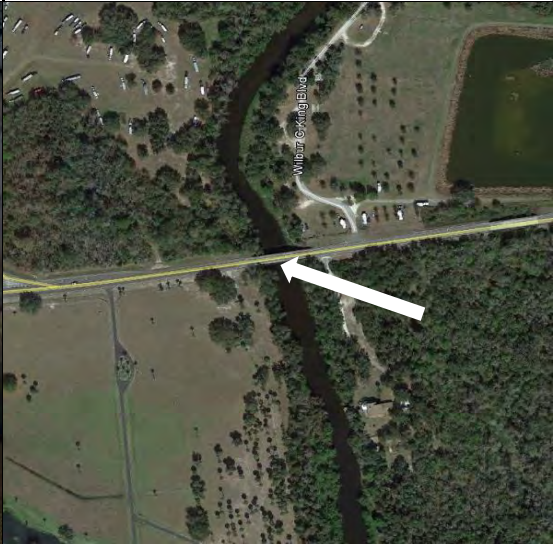
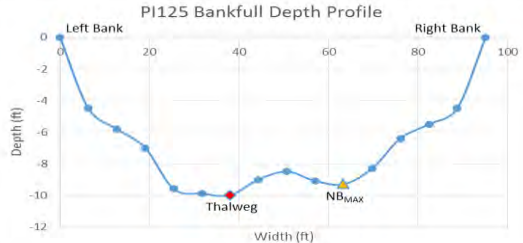
Peace River			Severity Scale: 7.5-High
Watershed: Peace River Subwatershed: Troublesome Creek Latitude: 27.49880 Longitude: -81.81047			County: Hardee Site Number: PI125 Reach Length: 40 ft. Landowner: Florida DOT

Pfankuch-Channel Stability:	Poor	1.5	
Channel Alteration:	Historic	0.5	
Bank Erosion:	Active	1	
BEHI:	Moderate (21.84)	0.5	
Local NPSP:	Moderate Potential	1	
Shoring Structures:	Present	1.5	
Pipe Discharge:	None	0	
Water Odor:	Normal	0	
Fish Passage Barrier:	None	0	
RB: Riparian Buffer:	40 ft.	0.5	
LB: Riparian Buffer:	40 ft.	0.5	
RB: Floodplain Access:	Partial	0.25	
LB: Floodplain Access:	Partial	0.25	
<b>Severity Scale:</b>		<b>7.5</b>	Additional Site Features
			Stream Channel Woody Material: Infrequent
			Impoundments: None
			Substrate Composition: Medium sand
			Bank Material: Bedrock/sandstone
			Near Bank Stress: Low
			RB Landuse: Transportation, Natural Forest

LB Landuse: Transportation, Natural Forest
Notes: 303d: Impaired - Aquatic Life Harvesting (mercury in fish tissue), Chlorophyll-A			
Restoration Option 2

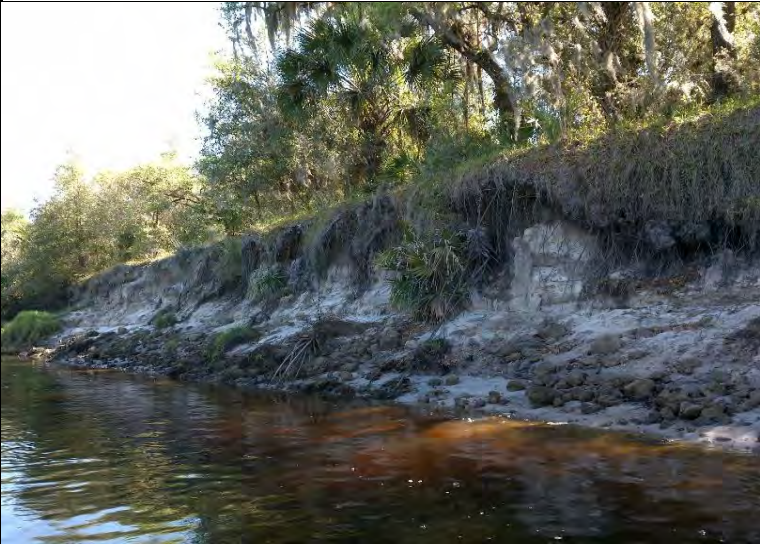
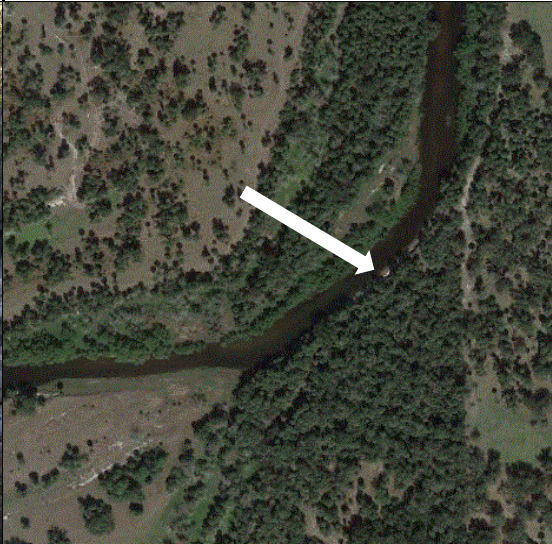
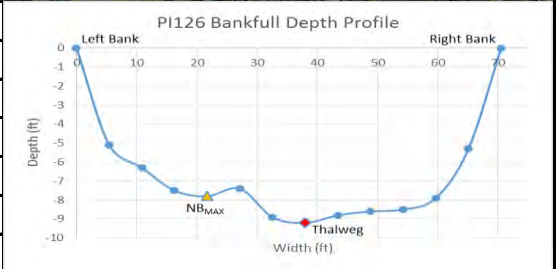
Peace River			Severity Scale: 4.25-Moderate
Watershed: Peace River Subwatershed: Troublesome Creek Latitude: 27.49041 Longitude: -81.80960			County: Hardee Site Number: PI126 Reach Length: 180 ft. Landowner: L&J Citrus and Cattle LLC

Risk Factor	Ranking	Score	
Pfankuch-Channel Stability:	Poor	1.5	
Channel Alteration:	None	0	
Bank Erosion:	Mass-wasting	1.5	
BEHI:	High (34.36)	1	
Local NPSP:	No evidence	0	
Shoring Structures:	None	0	
Pipe Discharge:	None	0	
Water Odor:	Normal	0	
Fish Passage Barrier:	None	0	
RB: Riparian Buffer:	100 ft.	0	
LB: Riparian Buffer:	100 ft.	0	
RB: Floodplain Access:	Full	0	
LB: Floodplain Access:	Partial	0.25	
Severity Scale:		4.25	
Notes: 303d: Impaired - Aquatic Life Harvesting (mercury in fish tissue), Chlorophyll-A			
Restoration Option 1

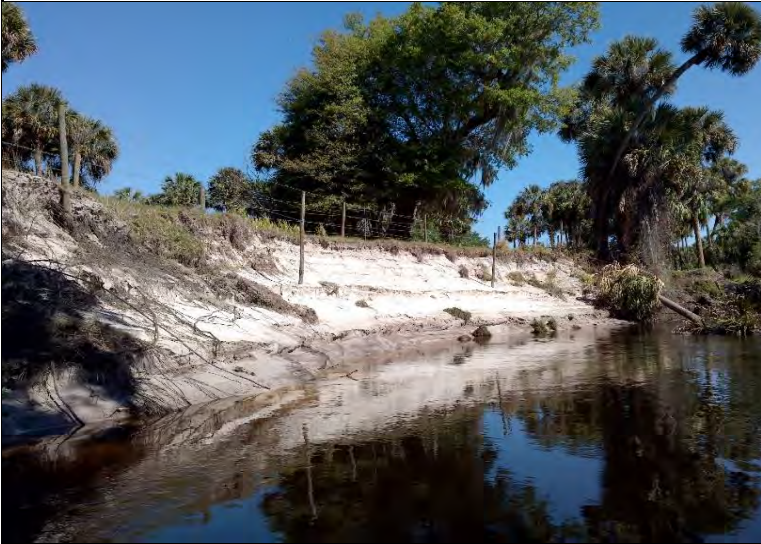
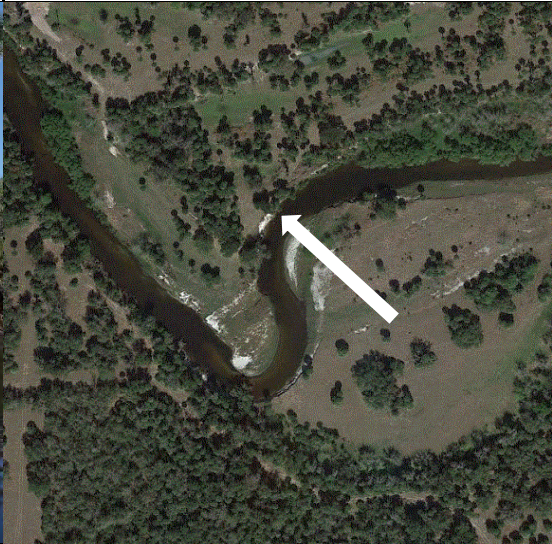
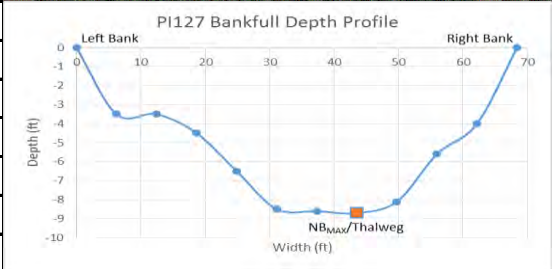
Peace River			Severity Scale: 7.0-Moderate
Watershed: Peace River Subwatershed: Troublesome Creek Latitude: 27.48925 Longitude: -81.81301			County: Hardee Site Number: PI127 Reach Length: 85 ft. Landowner: M&R Cattle Co LLC

Risk Factor	Ranking	Score	
Pfankuch-Channel Stability:	Poor	1.5	
Channel Alteration:	None	0	
Bank Erosion:	Active	1	
BEHI:	Very High (40.33)	1.5	
Local NPSP:	Obvious Sources	1.5	
Shoring Structures:	None	0	
Pipe Discharge:	None	0	
Water Odor:	Normal	0	
Fish Passage Barrier:	None	0	
RB: Riparian Buffer:	0 ft.	0.75	
LB: Riparian Buffer:	40 ft.	0.5	
RB: Floodplain Access:	Partial	0.25	
LB: Floodplain Access:	Full	0	
<b>Severity Scale:</b>		<b>7.0</b>	
Notes: 303d: Impaired - Aquatic Life Harvesting (mercury in fish tissue), Chlorophyll-A			
Restoration Option 1, best to restore along with PI28, PI129 and PI183

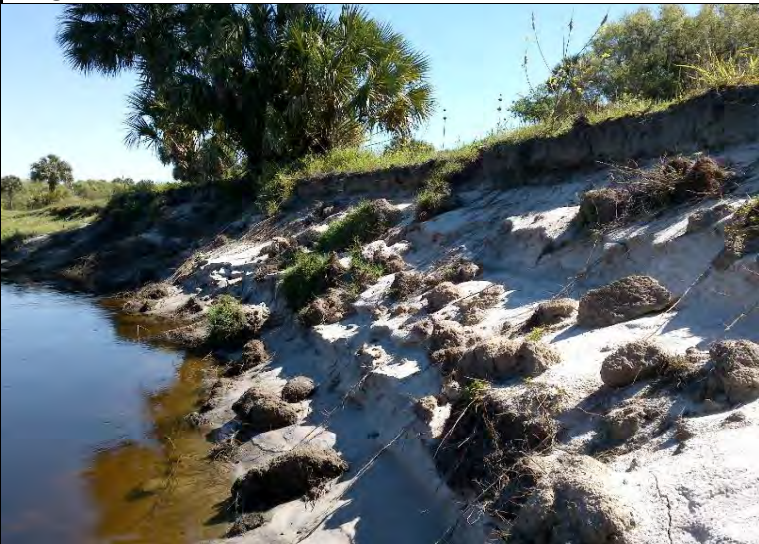
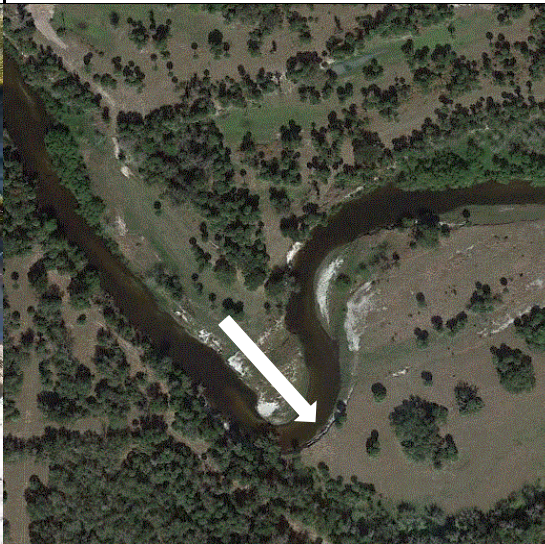
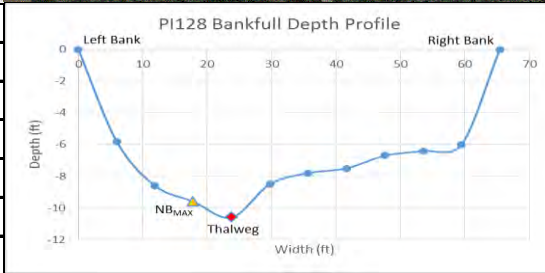
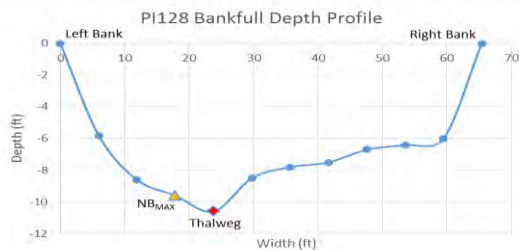
Peace River			Severity Scale: 6.5-Moderate	
Watershed: Peace River Subwatershed: Troublesome Creek Latitude: 27.48799 Longitude: -81.81319			County: Hardee Site Number: PI128 Reach Length: 155 ft. Landowner: L&J Citrus and Cattle LLC

Pfankuch-Channel Stability:	Poor	1.5		
Channel Alteration:	None	0		
Bank Erosion:	Mass-wasting	1.5		
BEHI:	High (38.51)	1		
Local NPSP:	Obvious Sources	1.5		
Shoring Structures:	None	0		
Pipe Discharge:	None	0		
Water Odor:	Normal	0		
Fish Passage Barrier:	None	0		
RB: Riparian Buffer:	100 ft.	0	<b>Additional Site Features</b>	
LB: Riparian Buffer:	0 ft.	0.75	Stream Channel Woody Material: Infrequent	
RB: Floodplain Access:	Full	0	Impoundments: None	
LB: Floodplain Access:	Partial	0.25	Substrate Composition: Medium sand	
Severity Scale:		6.5	Bank Material: Sand	
			Near Bank Stress: Moderate	
			RB Landuse: Natural Forest	
			LB Landuse: Pasture

Notes: Cattle trail on top of bank with no fencing; Split up downstream site and this site b/c of large change in bank height; Notes: 303d: Impaired - Aquatic Life Harvesting (mercury in fish tissue), Chlorophyll-A				
Restoration Option 1, best to restore along with PI27, PI129 and PI183

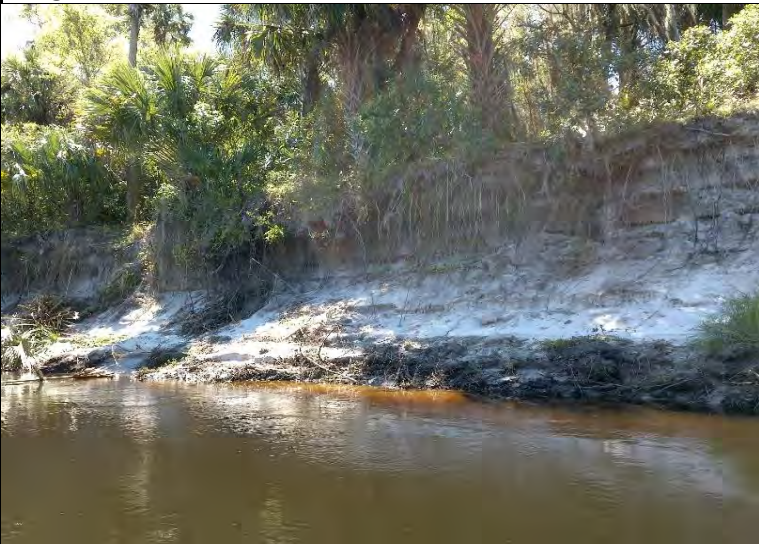
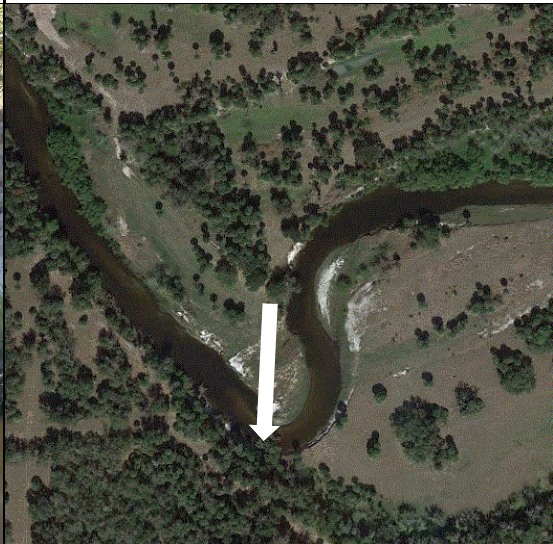
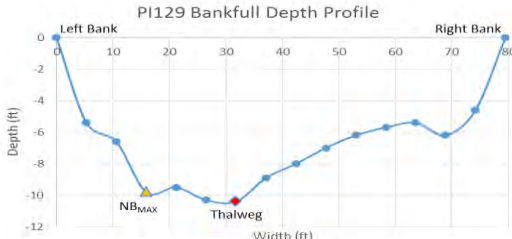
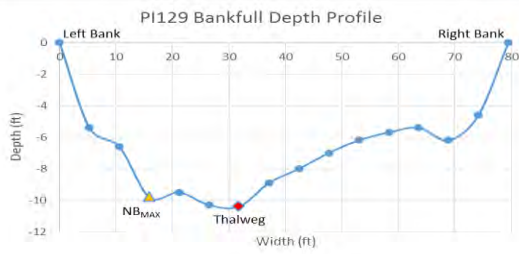
Peace River			Severity Scale: 4.25-Moderate	
Watershed: Peace River Subwatershed: Troublesome Creek Latitude: 27.48812 Longitude: -81.81322			County: Hardee Site Number: PI129 Reach Length: 115 ft. Landowner: L&J Citrus and Cattle LLC

Pfankuch-Channel Stability:	Poor	1.5		
Channel Alteration:	None	0		
Bank Erosion:	Active	1		
BEHI:	High (36.12)	1		
Local NPSP:	Slight Potential	0.5		
Shoring Structures:	None	0		
Pipe Discharge:	None	0		
Water Odor:	Normal	0		
Fish Passage Barrier:	None	0		
RB: Riparian Buffer:	100 ft.	0	<b>Additional Site Features</b>	
LB: Riparian Buffer:	100 ft.	0	Stream Channel Woody Material: Extensive	
RB: Floodplain Access:	Full	0	Impoundments: None	
LB: Floodplain Access:	Partial	0.25	Substrate Composition: Medium sand	
<b>Severity Scale:</b>			<b>4.25</b>	
Notes: 303d: Impaired - Aquatic Life Harvesting (mercury in fish tissue), Chlorophyll-A			Bank Material: Sand

Restoration Option 1, best to restore along with PI27, PI128 and PI183			Near Bank Stress: Moderate	
			RB Landuse: Natural Forest	
			LB Landuse: Natural Forest

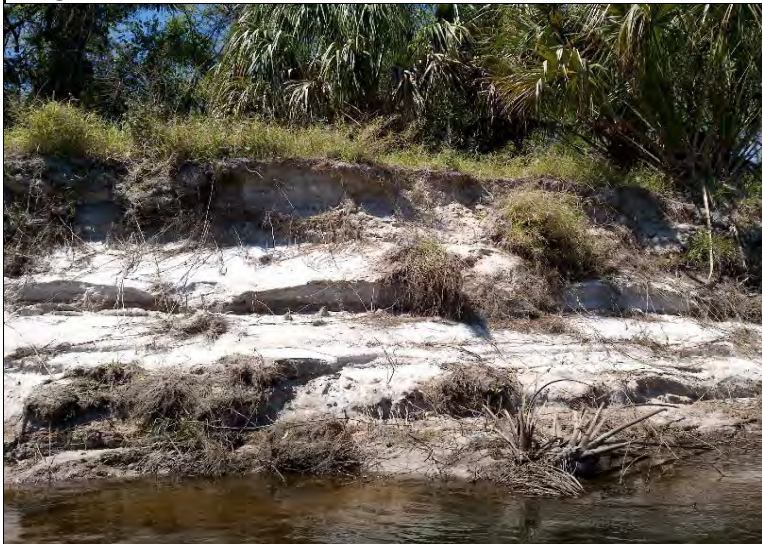
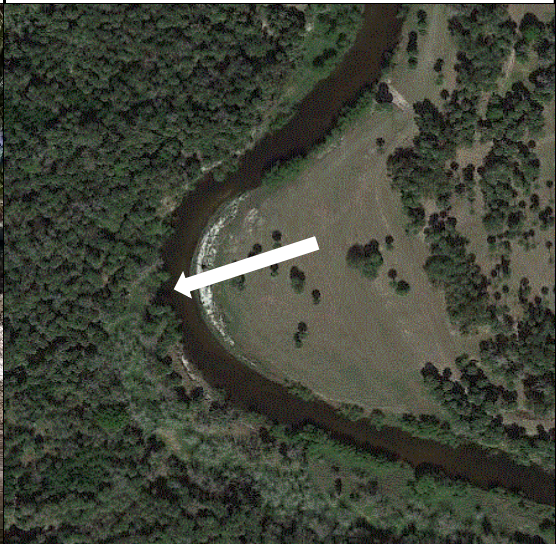
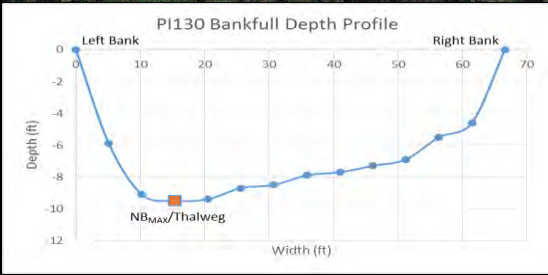
Peace River			Severity Scale: 6.0-Moderate	
Watershed: Peace River Subwatershed: Troublesome Creek Latitude: 27.49135 Longitude: -81.81748			County: Hardee Site Number: PI130 Reach Length: 35 ft. Landowner: L&J Citrus and Cattle LLC

Pfankuch-Channel Stability:	Poor	1.5		
Channel Alteration:	None	0		
Bank Erosion:	Mass-wasting	1.5		
BEHI:	High (32.41)	1		
Local NPSP:	Slight Potential	0.5		
Shoring Structures:	None	0		
Pipe Discharge:	None	0		
Water Odor:	Normal	0		
			Additional Site Features	
Fish Passage Barrier:	None	0	Stream Channel Woody Material: Moderate	
RB: Riparian Buffer:	0 ft.	0.75	Impoundments: None	
LB: Riparian Buffer:	40 ft.	0.5	Substrate Composition: Medium sand	
RB: Floodplain Access:	Full	0	Bank Material: Sand	
LB: Floodplain Access:	Partial	0.25	Near Bank Stress: High	
Severity Scale:		6.0	RB Landuse: Pasture	
LB Landuse: Natural Forest, Pasture

Notes: 303d: Impaired - Aquatic Life Harvesting (mercury in fish tissue), Chlorophyll-A				
Restoration Option 1

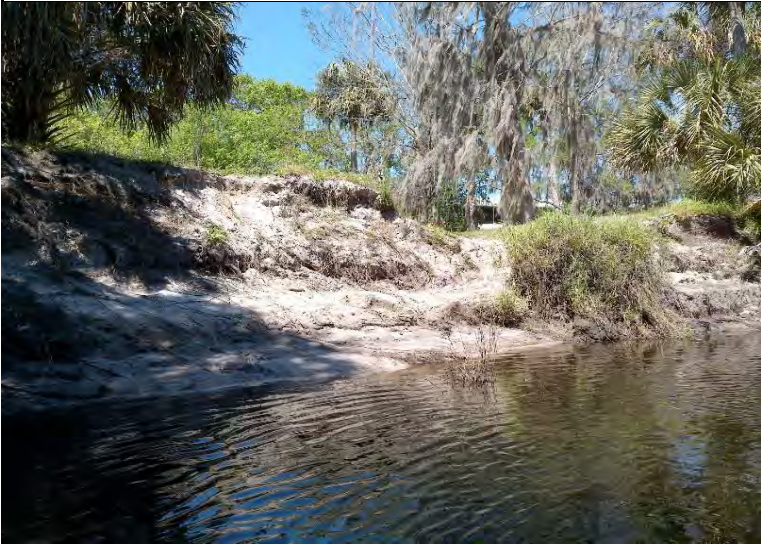
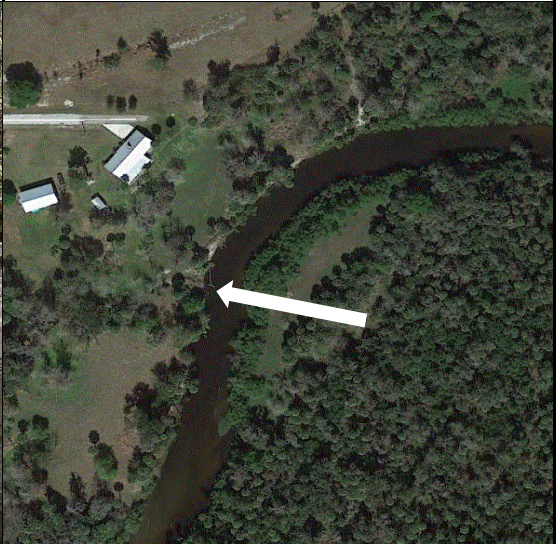
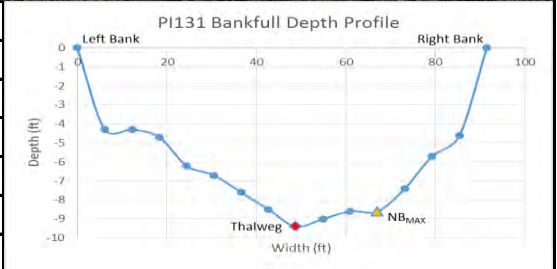
Peace River			Severity Scale: 4.25-Moderate
Watershed: Peace River Subwatershed: Troublesome Creek Latitude: 27.49175 Longitude: -81.82163			County: Hardee Site Number: PI131 Reach Length: 60 ft. Landowner: Lucille Crawford

Risk Factor	Ranking	Score	
Pfankuch-Channel Stability:	Poor	1.5	
Channel Alteration:	None	0	
Bank Erosion:	Active	1	
BEHI:	Moderate (27.23)	0.5	
Local NPSP:	Slight Potential	0.5	
Shoring Structures:	None	0	
Pipe Discharge:	None	0	
Water Odor:	Normal	0	
Fish Passage Barrier:	None	0	
RB: Riparian Buffer:	0 ft.	0.75	
LB: Riparian Buffer:	100 ft.	0	
RB: Floodplain Access:	Full	0	
LB: Floodplain Access:	Full	0	
<b>Severity Scale:</b>		<b>4.25</b>	
Notes: 303d: Impaired - Aquatic Life Harvesting (mercury in fish tissue), Chlorophyll-A			
Restoration Option 1

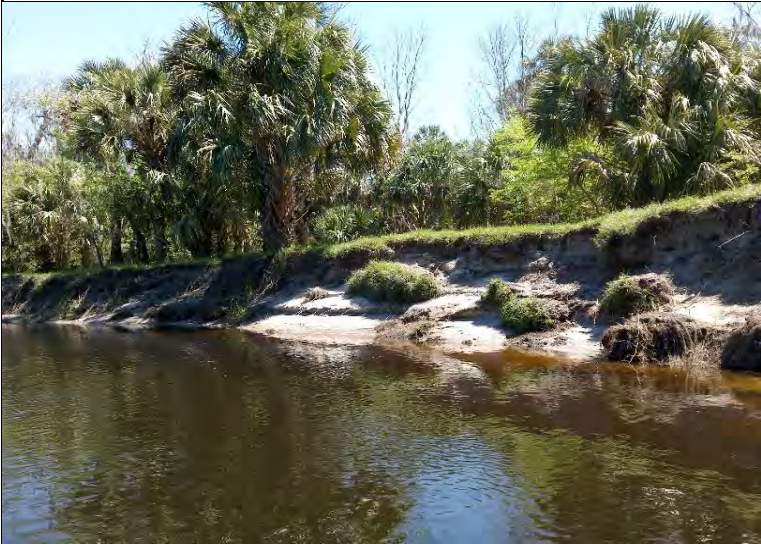
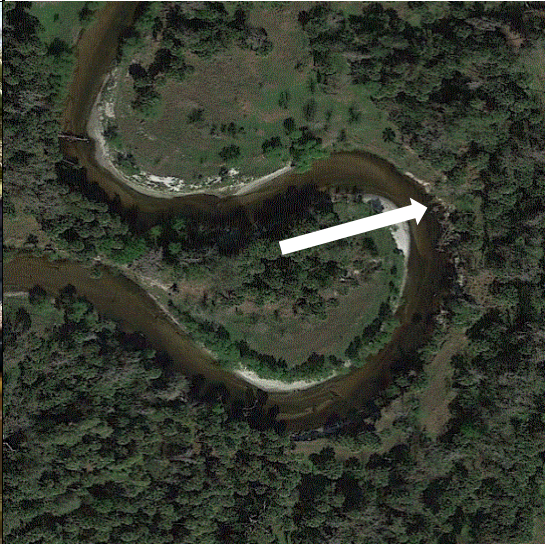
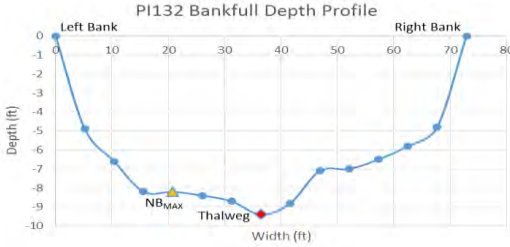
Peace River			Severity Scale: 5.5-Moderate
Watershed: Peace River Subwatershed: Troublesome Creek Latitude: 27.47944 Longitude: -81.82955			County: Hardee Site Number: PI132 Reach Length: 420 ft. Landowner: Frederick Willard D Jr Trustee

Pfankuch-Channel Stability:	Poor	1.5	
Channel Alteration:	None	0	
Bank Erosion:	Mass-wasting	1.5	
BEHI:	Moderate (25.98)	0.5	
Local NPSP:	Obvious Sources	1.5	
Shoring Structures:	None	0	
Pipe Discharge:	None	0	
Water Odor:	Normal	0	
Fish Passage Barrier:	None	0	
RB: Riparian Buffer:	100 ft.	0	
LB: Riparian Buffer:	40 ft.	0.5	
RB: Floodplain Access:	Full	0	
LB: Floodplain Access:	Full	0	
<b>Severity Scale:</b>		<b>5.5</b>	<b>Additional Site Features</b>
			Stream Channel Woody Material: Moderate
			Impoundments: None
			Substrate Composition: Medium sand
			Bank Material: Sand
			Near Bank Stress: Moderate
			RB Landuse: Natural Forest

LB Landuse: Natural Forest, Pasture
Notes: 303d: Impaired - Aquatic Life Harvesting (mercury in fish tissue), Chlorophyll-A			
Restoration Option 1, the Peace River is cutting a new channel and forming an oxbow, in this case the best option would be to cut the channel for the river and stabilize with toewood. This should be done in conjunction with sites PI196 and PI197

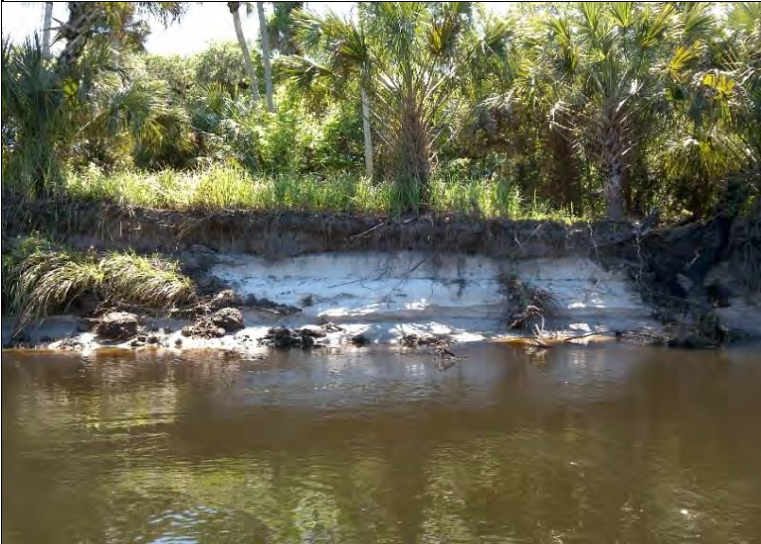
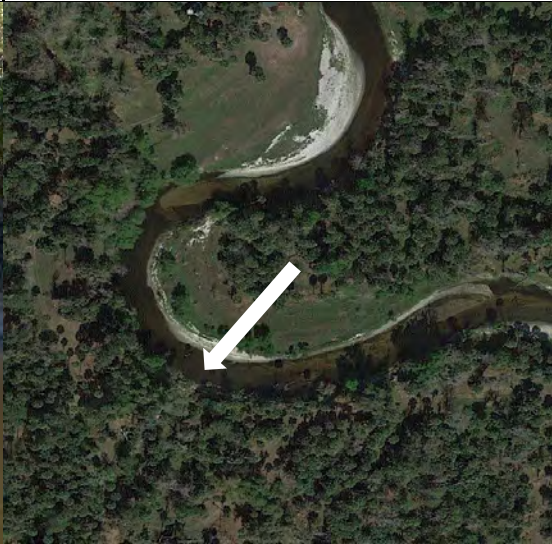
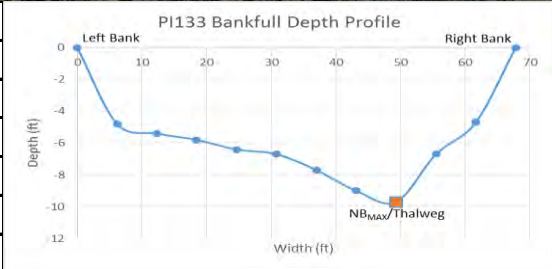
Peace River			Severity Scale: 6.25-Moderate
Watershed: Peace River Subwatershed: Troublesome Creek Latitude: 27.47492 Longitude: -81.83322			County: Hardee Site Number: PI133 Reach Length: 300 ft. Landowner: Frederick Willard D Jr Trustee

Risk Factor	Ranking	Score	
Pfankuch-Channel Stability:	Poor	1.5	
Channel Alteration:	None	0	
Bank Erosion:	Mass-wasting	1.5	
BEHI:	High (34.52)	1	
Local NPSP:	Obvious Sources	1.5	
Shoring Structures:	None	0	
Pipe Discharge:	None	0	
Water Odor:	Normal	0	
Fish Passage Barrier:	None	0	
RB: Riparian Buffer:	100 ft.	0	
LB: Riparian Buffer:	40 ft.	0.5	
RB: Floodplain Access:	Partial	0.25	
LB: Floodplain Access:	Full	0	
<b>Severity Scale:</b>		<b>6.25</b>	
Notes: 303d: Impaired - Aquatic Life Harvesting (mercury in fish tissue), Chlorophyll-A			
Restoration Option 1

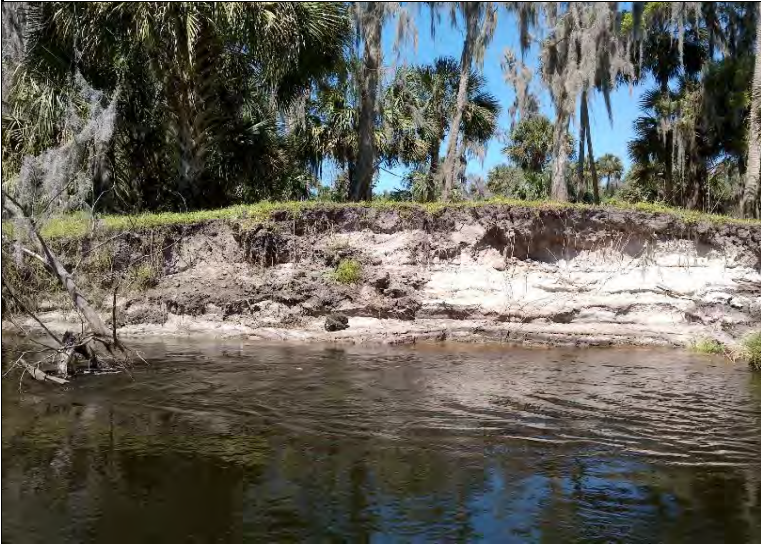
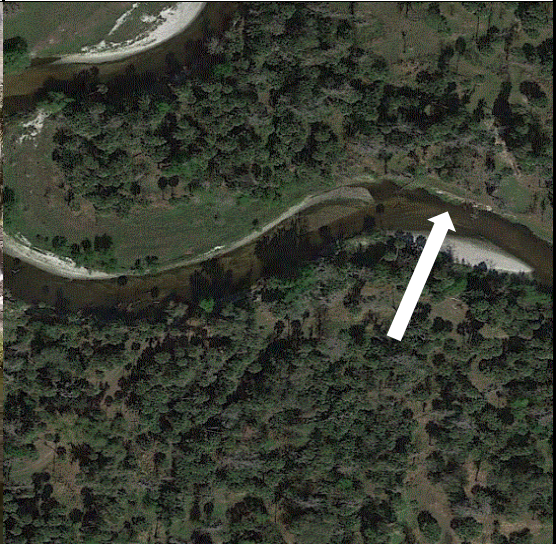
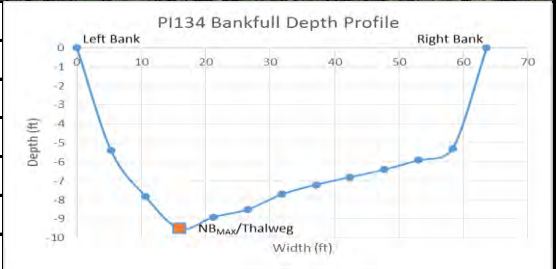
Peace River			Severity Scale: 6.75-Moderate
Watershed: Peace River Subwatershed: Troublesome Creek Latitude: 27.47526 Longitude: -81.83175			County: Hardee Site Number: PI134 Reach Length: 50 ft. Landowner: Frederick Willard D Jr Trustee

Risk Factor	Ranking	Score	
Pfankuch-Channel Stability:	Poor	1.5	
Channel Alteration:	None	0	
Bank Erosion:	Mass-wasting	1.5	
BEHI:	Very High (40.35)	1.5	
Local NPSP:	Obvious Sources	1.5	
Shoring Structures:	None	0	
Pipe Discharge:	None	0	
Water Odor:	Normal	0	
Fish Passage Barrier:	None	0	
RB: Riparian Buffer:	100 ft.	0	
LB: Riparian Buffer:	40 ft.	0.5	
RB: Floodplain Access:	Partial	0.25	
LB: Floodplain Access:	Full	0	
<b>Severity Scale:</b>		<b>6.75</b>	
Notes: 303d: Impaired - Aquatic Life Harvesting (mercury in fish tissue), Chlorophyll-A			
Restoration Option 1

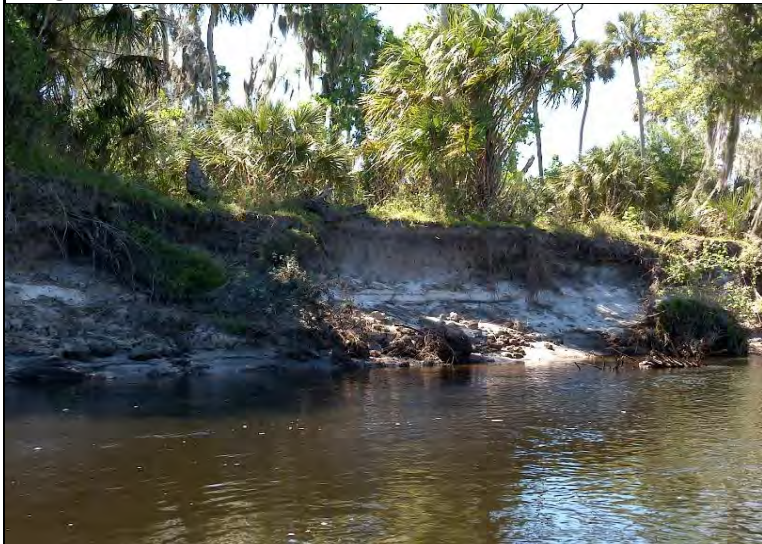
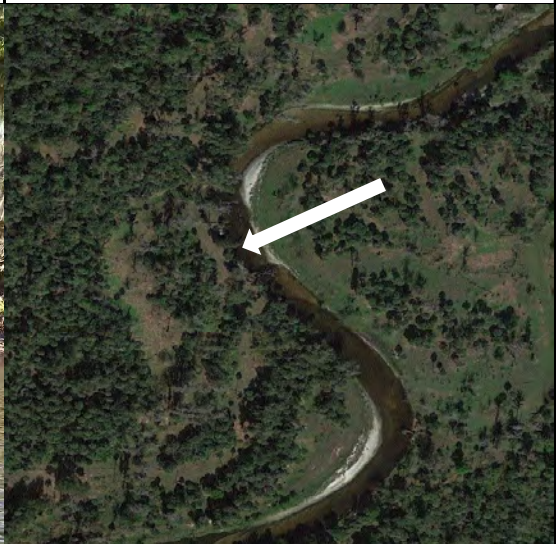
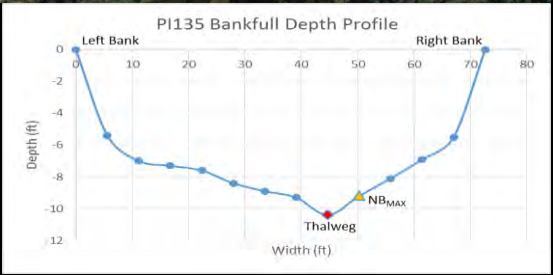
Peace River			Severity Scale: 6.5-Moderate	
Watershed: Peace River Subwatershed: Troublesome Creek Latitude: 27.47164 Longitude: -81.83285			County: Hardee Site Number: PI135 Reach Length: 120 ft. Landowner: Frederick Willard D Jr

Pfankuch-Channel Stability:	Poor	1.5		
Channel Alteration:	None	0		
Bank Erosion:	Mass-wasting	1.5		
BEHI:	High (38.50)	1		
Local NPSP:	Obvious Sources	1.5		
Shoring Structures:	None	0		
Pipe Discharge:	None	0		
Water Odor:	Normal	0		
Fish Passage Barrier:	None	0		
RB: Riparian Buffer:	60 ft.	0.25	Additional Site Features	
LB: Riparian Buffer:	40 ft.	0.5	Stream Channel Woody Material: Numerous	
RB: Floodplain Access:	Partial	0.25	Impoundments: None	
LB: Floodplain Access:	Full	0	Substrate Composition: Medium sand	
Severity Scale:		6.5	Bank Material: Sand	
			Near Bank Stress: Moderate	
			RB Landuse: Natural Forest, Pasture	
			LB Landuse: Natural Forest, Pasture

Notes: 303d: Impaired - Aquatic Life Harvesting (mercury in fish tissue), Chlorophyll-A				
Restoration Option 1

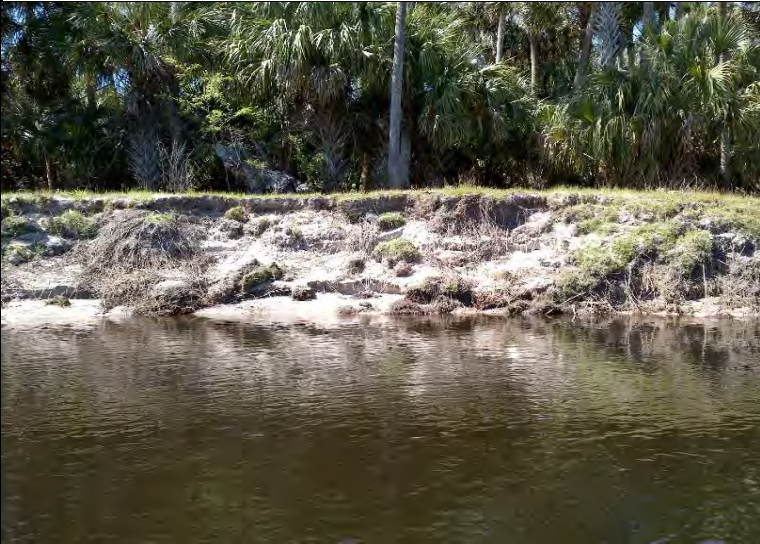
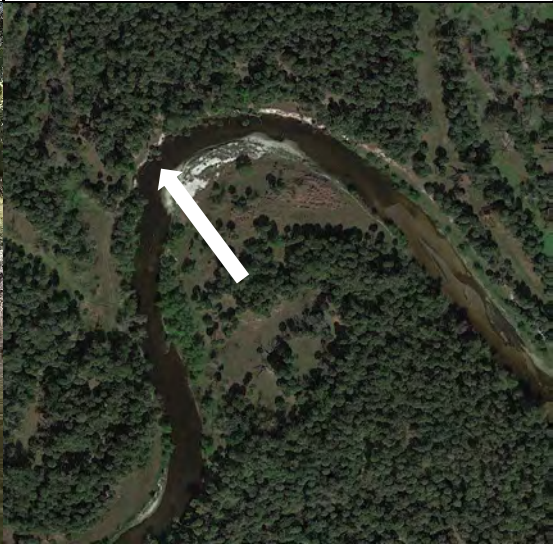
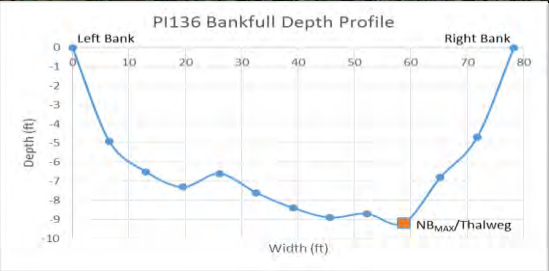
Peace River			Severity Scale: 5.0-Moderate
Watershed: Peace River Subwatershed: Troublesome Creek Latitude: 27.47189 Longitude: -81.83989			County: Hardee Site Number: PI136 Reach Length: 300 ft. Landowner: Frederick Willard D Jr

Risk Factor	Ranking	Score	
Pfankuch-Channel Stability:	Poor	1.5	
Channel Alteration:	None	0	
Bank Erosion:	Active	1	
BEHI:	Moderate (27.13)	0.5	
Local NPSP:	Obvious Sources	1.5	
Shoring Structures:	None	0	
Pipe Discharge:	None	0	<b>Additional Site Features</b> Stream Channel Woody Material: Numerous Impoundments: None Substrate Composition: Medium sand Bank Material: Sand Near Bank Stress: High RB Landuse: Natural Forest LB Landuse: Pasture, Natural Forest
Water Odor:	Normal	0	
Fish Passage Barrier:	None	0	
RB: Riparian Buffer:	100 ft.	0	
LB: Riparian Buffer:	40 ft.	0.5	
RB: Floodplain Access:	Full	0	
LB: Floodplain Access:	Full	0	
<b>Severity Scale:</b>		<b>5.0</b>

Notes: 303d: Impaired - Aquatic Life Harvesting (mercury in fish tissue), Chlorophyll-A			
Restoration Option 1

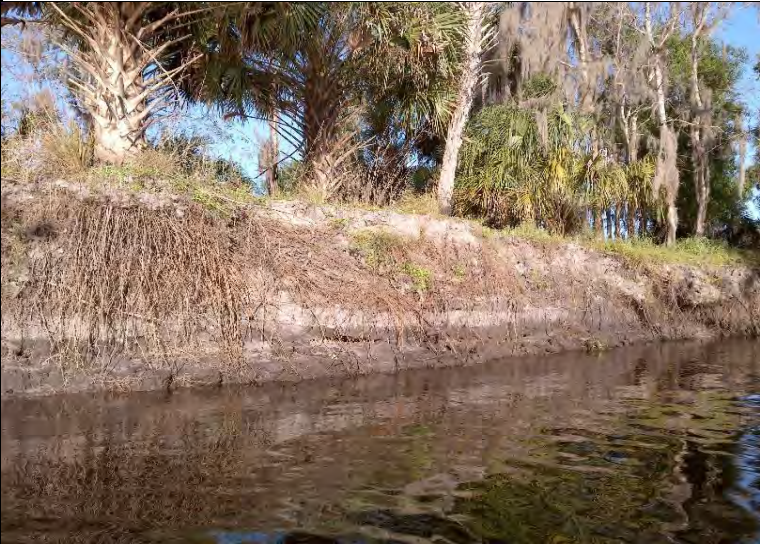
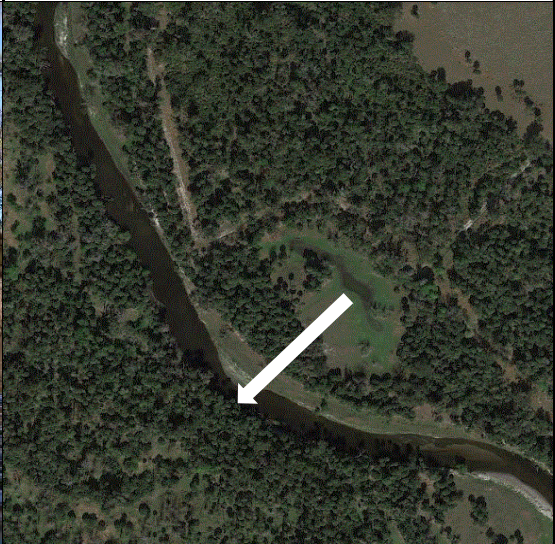
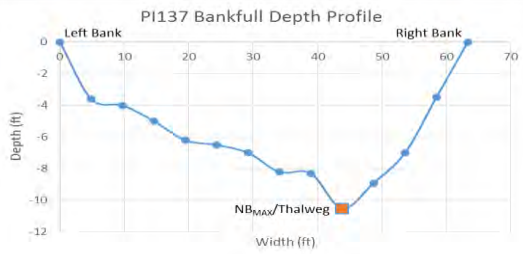
Peace River			Severity Scale: 5.75-Moderate
Watershed: Peace River Subwatershed: Troublesome Creek Latitude: 27.46087 Longitude: -81.84898			County: Hardee Site Number: PI137 Reach Length: 100 ft. Landowner: 3-C Ranch Limited

Pfankuch-Channel Stability:	Poor	1.5	
Channel Alteration:	None	0	
Bank Erosion:	Active	1	
BEHI:	High (36.12)	1	
Local NPSP:	Obvious Sources	1.5	
Shoring Structures:	None	0	
Pipe Discharge:	None	0	
Water Odor:	Normal	0	
Fish Passage Barrier:	None	0	
RB: Riparian Buffer:	40 ft.	0.5	
LB: Riparian Buffer:	100 ft.	0	
RB: Floodplain Access:	Partial	0.25	
LB: Floodplain Access:	Full	0	
<b>Severity Scale:</b>		<b>5.75</b>	
Notes: 303d: Impaired - Aquatic Life Harvesting (mercury in fish tissue), Chlorophyll-A			
Restoration Option 1

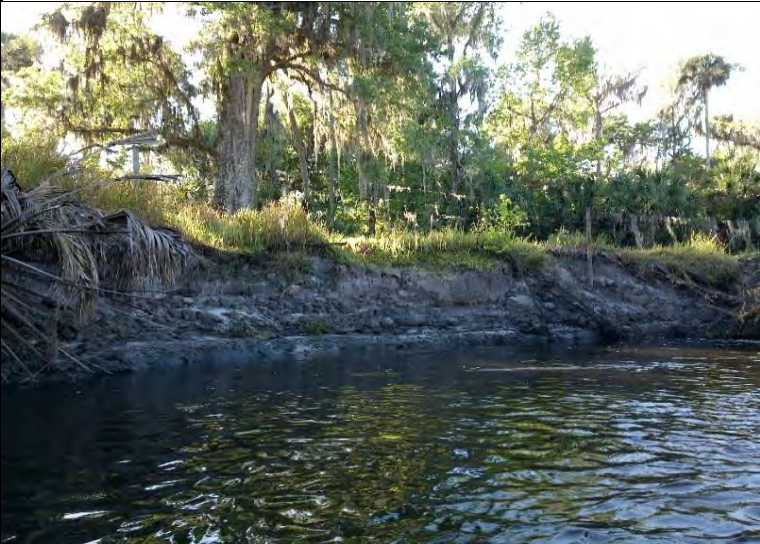
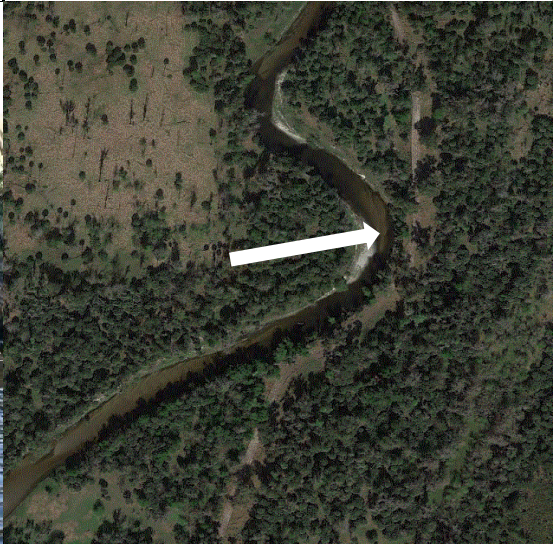
Peace River			Severity Scale: 5.75-Moderate
Watershed: Peace River Subwatershed: Troublesome Creek Latitude: 27.45183 Longitude: -81.84489			County: Hardee Site Number: PI138 Reach Length: 230 ft. Landowner: Ben Hill Griffin Inc

Risk Factor	Ranking	Score	
Pfankuch-Channel Stability:	Poor	1.5	
Channel Alteration:	None	0	
Bank Erosion:	Active	1	
BEHI:	High (32.67)	1	
Local NPSP:	Obvious Sources	1.5	
Shoring Structures:	None	0	
Pipe Discharge:	None	0	<b>Additional Site Features</b> Stream Channel Woody Material: Numerous Impoundments: None Substrate Composition: Medium sand Bank Material: Sand Near Bank Stress: High RB Landuse: Natural Forest LB Landuse: Pasture, Natural Forest
Water Odor:	Normal	0	
Fish Passage Barrier:	None	0	
RB: Riparian Buffer:	100 ft.	0	
LB: Riparian Buffer:	40 ft.	0.5	
RB: Floodplain Access:	Full	0	
LB: Floodplain Access:	Partial	0.25	
<b>Severity Scale:</b>		<b>5.75</b>

Notes: 303d: Impaired - Aquatic Life Harvesting (mercury in fish tissue), Chlorophyll-A			
Restoration Option 1

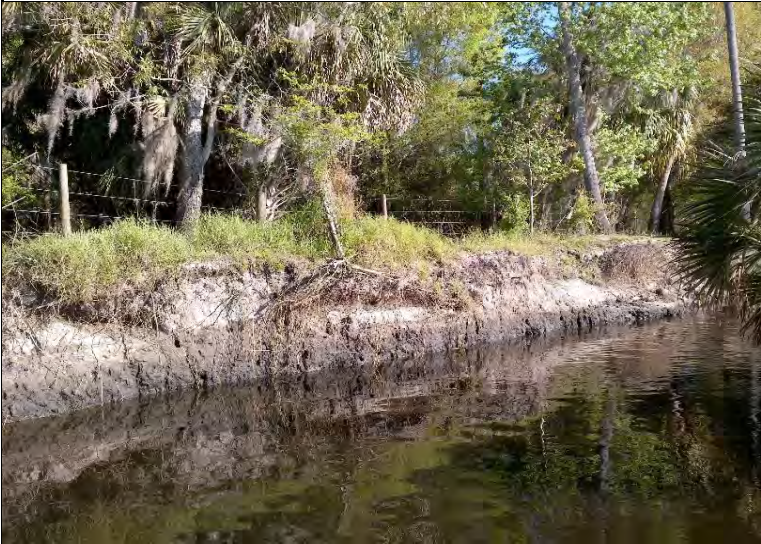
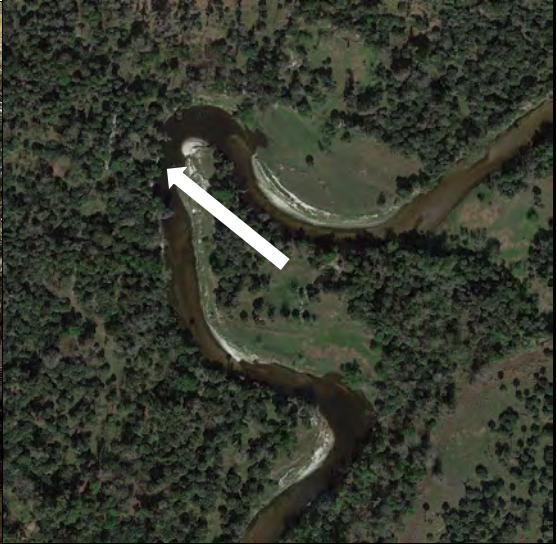
Peace River			Severity Scale: 5.25-Moderate
Watershed: Peace River Subwatershed: Troublesome Creek Latitude: 27.45022 Longitude: -81.84930			County: Hardee Site Number: PI139 Reach Length: 100 ft. Landowner: Ben Hill Griffin Inc

Risk Factor	Ranking	Score	
Pfankuch-Channel Stability:	Poor	1.5	
Channel Alteration:	None	0	
Bank Erosion:	Active	1	
BEHI:	High (36.65)	1	
Local NPSP:	Obvious Sources	1.5	
Shoring Structures:	None	0	
Pipe Discharge:	None	0	
Water Odor:	Normal	0	
Fish Passage Barrier:	None	0	
RB: Riparian Buffer:	60 ft.	0.25	
LB: Riparian Buffer:	100 ft.	0	
RB: Floodplain Access:	Full	0	
LB: Floodplain Access:	Full	0	
<b>Severity Scale:</b>		<b>5.25</b>	
Notes: 303d: Impaired - Aquatic Life Harvesting (mercury in fish tissue), Chlorophyll-A			
Restoration Option 1

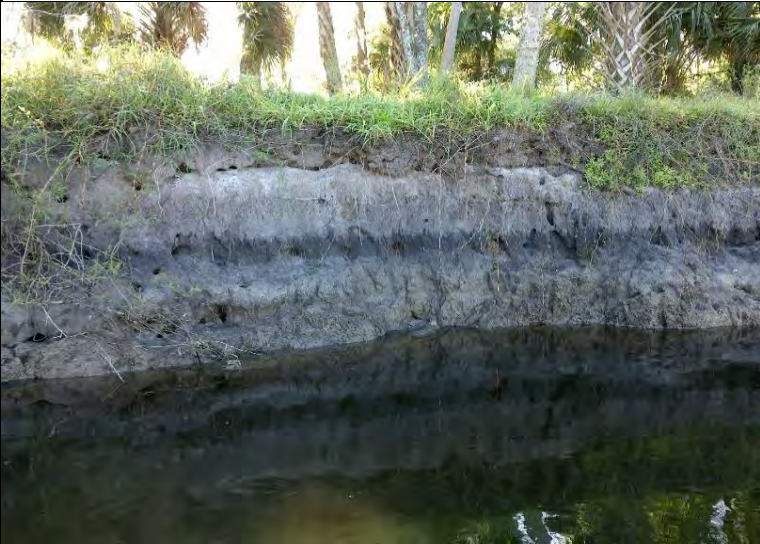
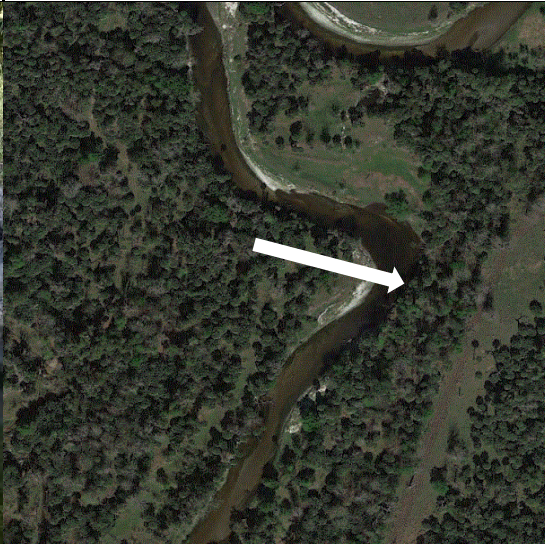
Peace River			Severity Scale: 3.75-Low
Watershed: Peace River Subwatershed: Troublesome Creek Latitude: 27.44865 Longitude: -81.84810			County: Hardee Site Number: PI140 Reach Length: 150 ft. Landowner: Ben Hill Griffin Inc

Pfankuch-Channel Stability:	Poor	1.5	
Channel Alteration:	None	0	
Bank Erosion:	Active	1	
BEHI:	Moderate (27.04)	0.5	
Local NPSP:	Slight Potential	0.5	
Shoring Structures:	None	0	
Pipe Discharge:	None	0	
Water Odor:	Normal	0	
Fish Passage Barrier:	None	0	
RB: Riparian Buffer:	100 ft.	0	
LB: Riparian Buffer:	60 ft.	0.25	
RB: Floodplain Access:	Full	0	
LB: Floodplain Access:	Full	0	
<b>Severity Scale:</b>		<b>3.75</b>	Additional Site Features
			Stream Channel Woody Material: Numerous
			Impoundments: None
			Substrate Composition: Medium sand
			Bank Material: Clay
			Near Bank Stress: High
			RB Landuse: Natural Forest
			LB Landuse: Natural Forest, Pasture

Notes: Cattle fence approx. 73 yds from river; 303d: Impaired - Aquatic Life Harvesting (mercury in fish tissue)			
Restoration Option 1

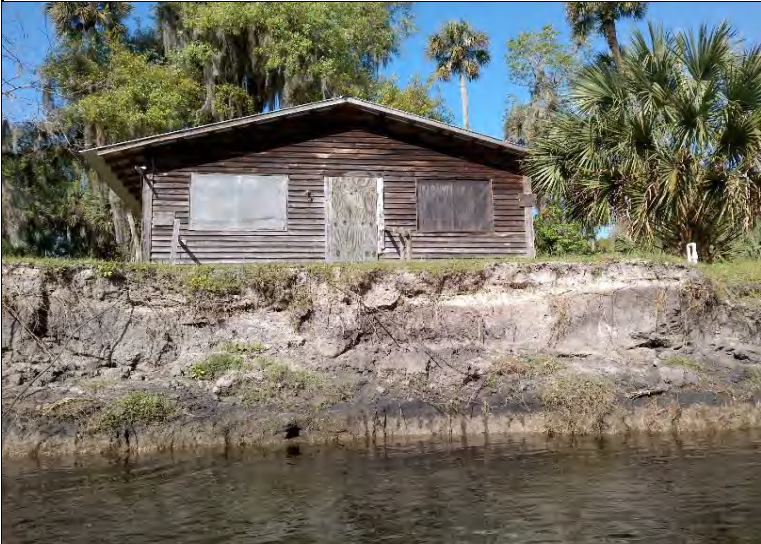
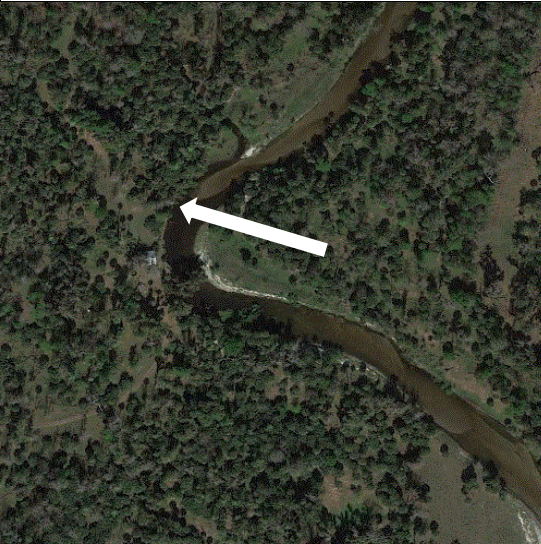
Peace River			Severity Scale: 5.75-Moderate
Watershed: Peace River Subwatershed: Troublesome Creek Latitude: 27.44617 Longitude: -81.85040			County: Hardee Site Number: PI141 Reach Length: 270 ft. Landowner: Mosaic Fertilizer LLC

Risk Factor	Ranking	Score	
Pfankuch-Channel Stability:	Poor	1.5	
Channel Alteration:	None	0	
Bank Erosion:	Mass-wasting	1.5	
BEHI:	Moderate (20.89)	0.5	
Local NPSP:	Obvious Sources	1.5	
Shoring Structures:	None	0	
Pipe Discharge:	None	0	
Water Odor:	Normal	0	
Fish Passage Barrier:	None	0	
RB: Riparian Buffer:	0 ft.	0.75	
LB: Riparian Buffer:	100 ft.	0	
RB: Floodplain Access:	Full	0	
LB: Floodplain Access:	Full	0	
Severity Scale:		5.75	
Notes: Wood house on river, probably not used; 303d: Impaired - Aquatic Life Harvesting (mercury in fish tissue)			
Restoration Option 1

Additional Site Features	
Stream Channel Woody Material:	Numerous
Impoundments:	None
Substrate Composition:	Medium sand
Bank Material:	Sandy clay
Near Bank Stress:	High
RB Landuse:	Pasture, Natural Forest
LB Landuse:	Natural Forest

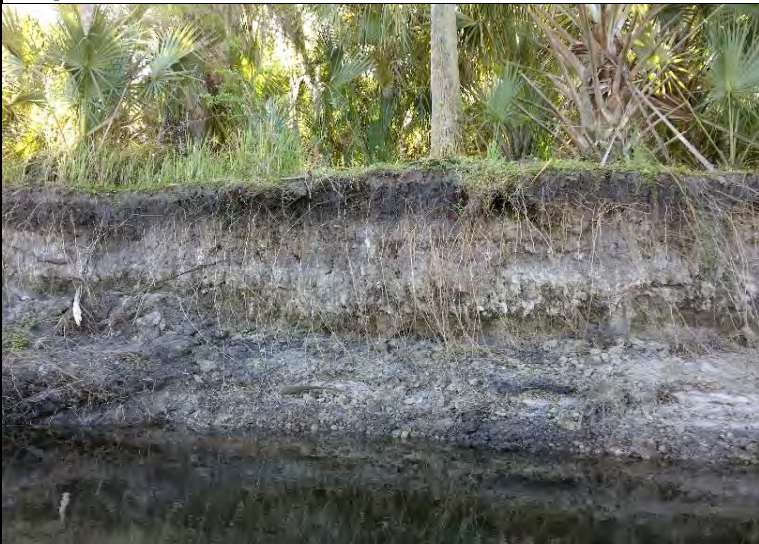
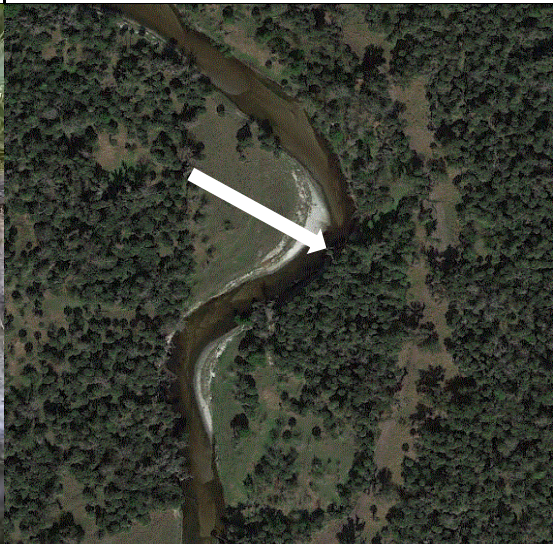
Peace River			Severity Scale: 3.75-Low	
Watershed: Peace River Subwatershed: Troublesome Creek Latitude: 27.44409 Longitude: -81.84810			County: Hardee Site Number: PI142 Reach Length: 230 ft. Landowner: Ben Hill Griffin Inc

Pfankuch-Channel Stability:	Poor	1.5		
Channel Alteration:	None	0		
Bank Erosion:	Mass-wasting	1.5		
BEHI:	Moderate (23.86)	0.5		
Local NPSP:	No evidence	0		
Shoring Structures:	None	0		
Pipe Discharge:	None	0		
Water Odor:	Normal	0		
Fish Passage Barrier:	None	0		
RB: Riparian Buffer:	100 ft.	0	<b>Additional Site Features</b>	
LB: Riparian Buffer:	100 ft.	0	Stream Channel Woody Material: Numerous	
RB: Floodplain Access:	Full	0	Impoundments: None	
LB: Floodplain Access:	Partial	0.25	Substrate Composition: Medium sand	
Severity Scale: 3.75			Bank Material: Sandy clay	
			Near Bank Stress: Moderate	
			RB Landuse: Natural Forest	
			LB Landuse: Natural Forest

Notes: 303d: Impaired - Aquatic Life Harvesting (mercury in fish tissue)				
Restoration Option 1

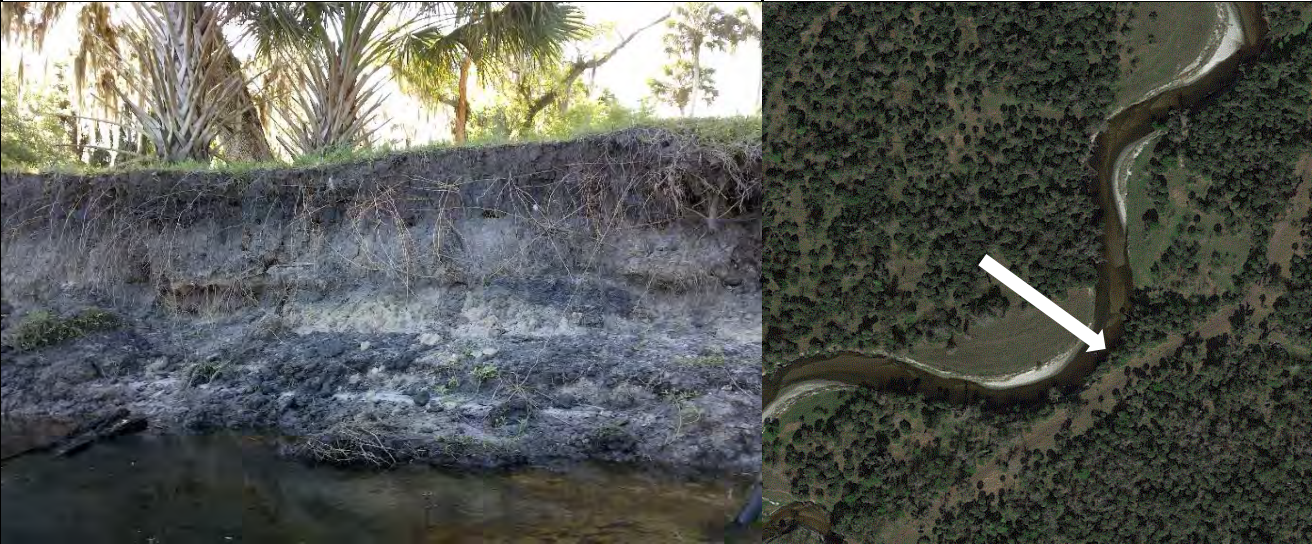
Peace River			Severity Scale: 5.5-Moderate
Watershed: Peace River Subwatershed: Troublesome Creek Latitude: 27.44213 Longitude: -81.84900			County: Hardee Site Number: PI143 Reach Length: 150 ft. Landowner: Ben Hill Griffin Inc

Pfankuch-Channel Stability:	Poor	1.5	
Channel Alteration:	None	0	
Bank Erosion:	Mass-wasting	1.5	
BEHI:	Moderate (22.27)	0.5	
Local NPSP:	Obvious Sources	1.5	
Shoring Structures:	None	0	
Pipe Discharge:	None	0	
Water Odor:	Normal	0	
Fish Passage Barrier:	None	0	
RB: Riparian Buffer:	100 ft.	0	
LB: Riparian Buffer:	40 ft.	0.5	
RB: Floodplain Access:	Full	0	
LB: Floodplain Access:	Full	0	
Severity Scale:		5.5	<b>Additional Site Features</b> Stream Channel Woody Material: Extensive Impoundments: None Substrate Composition: Medium sand Bank Material: Sandy clay Near Bank Stress: Moderate RB Landuse: Natural Forest LB Landuse: Pasture, Natural Forest

Notes: Fenced out cattle; 303d: Impaired - Aquatic Life Harvesting (mercury in fish tissue)			
Restoration Option 1

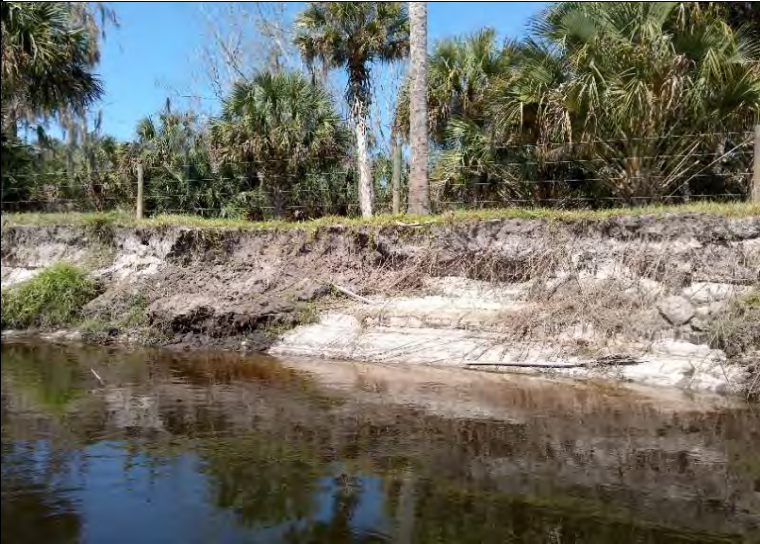
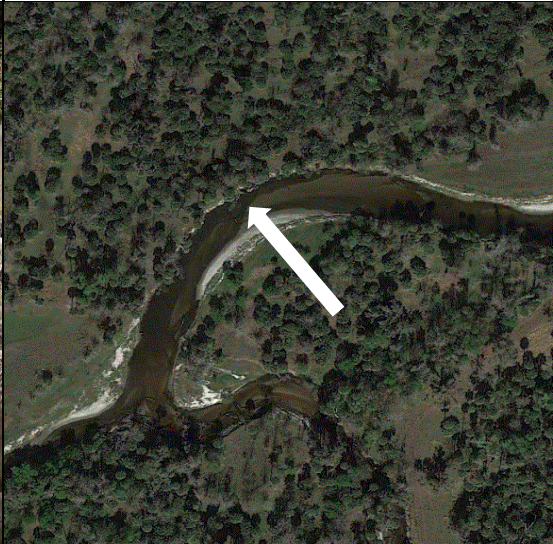
Peace River			Severity Scale: 6.0-Moderate
Watershed: Peace River Subwatershed: Troublesome Creek Latitude: 27.44179 Longitude: -81.85090			County: Hardee Site Number: PI144 Reach Length: 140 ft. Landowner: Ben Hill Griffin Inc/Mosaic

Risk Factor	Ranking	Score	
Pfankuch-Channel Stability:	Poor	1.5	
Channel Alteration:	None	0	
Bank Erosion:	Mass-wasting	1.5	
BEHI:	High (31.35)	1	
Local NPSP:	Obvious Sources	1.5	
Shoring Structures:	None	0	
Pipe Discharge:	None	0	
Water Odor:	Normal	0	
Fish Passage Barrier:	None	0	
RB: Riparian Buffer:	40 ft.	0.5	
LB: Riparian Buffer:	100 ft.	0	
RB: Floodplain Access:	Full	0	
LB: Floodplain Access:	Full	0	
Severity Scale:		6.0	
Notes: Fenced out cattle; 303d: Impaired - Aquatic Life Harvesting (mercury in fish tissue)			
Restoration Option 1

Additional Site Features
Stream Channel Woody Material: Numerous
Impoundments: None
Substrate Composition: Medium sand
Bank Material: Sand
Near Bank Stress: High
RB Landuse: Pasture, Natural Forest
LB Landuse: Natural Forest

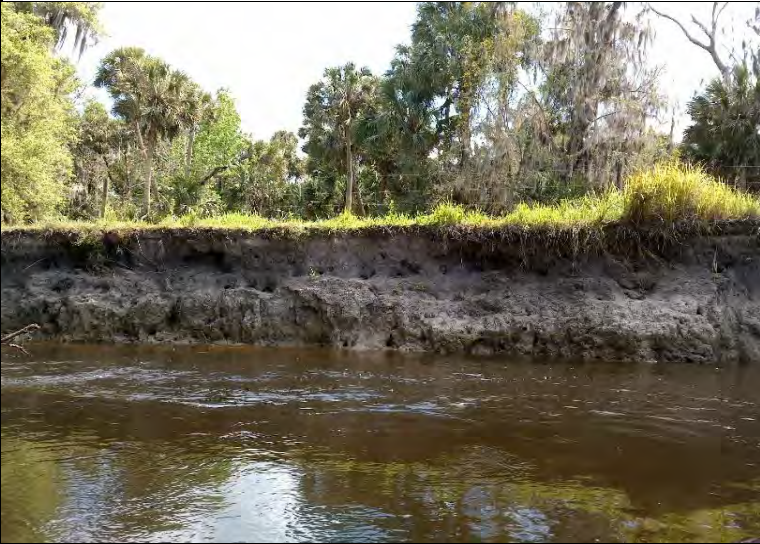
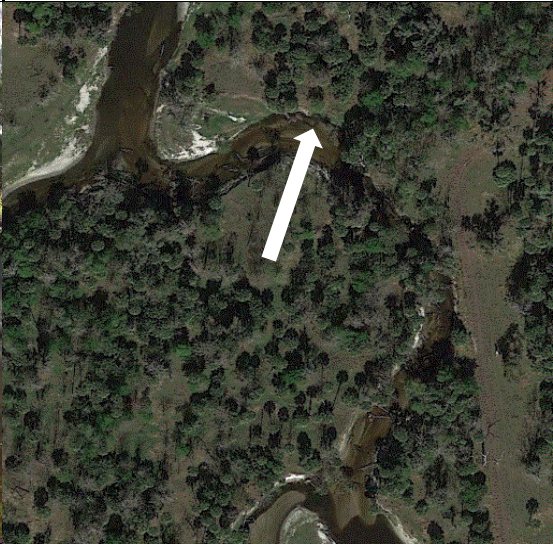
Peace River			Severity Scale: 5.5-Moderate
Watershed: Peace River Subwatershed: Troublesome Creek Latitude: 27.44098 Longitude: -81.85070			County: Hardee Site Number: PI145 Reach Length: 340 ft. Landowner: Ben Hill Griffin Inc

Risk Factor	Ranking	Score	
Pfankuch-Channel Stability:	Poor	1.5	
Channel Alteration:	None	0	
Bank Erosion:	Active	1	
BEHI:	Moderate (27.06)	0.5	
Local NPSP:	Obvious Sources	1.5	
Shoring Structures:	None	0	
Pipe Discharge:	None	0	
Water Odor:	Normal	0	
Fish Passage Barrier:	None	0	
RB: Riparian Buffer:	40 ft.	0.5	
LB: Riparian Buffer:	40 ft.	0.5	
RB: Floodplain Access:	Full	0	
LB: Floodplain Access:	Full	0	
Severity Scale:		5.5	
Notes: 303d: Impaired - Aquatic Life Harvesting (mercury in fish tissue)			
Restoration Option 1

Additional Site Features
Stream Channel Woody Material: Numerous
Impoundments: None
Substrate Composition: Medium sand
Bank Material: Clay
Near Bank Stress: High
RB Landuse: Natural Forest, Pasture
LB Landuse: Pasture, Natural Forest
