# **Peace River and Withlacoochee River Threats Assessments and Fish Assemblage Monitoring**

**Final Report July 1, 2015 – June 30, 2019**

Submitted to Florida State Wildlife Grants Program  
August 1, 2019  
PID: 98462501284

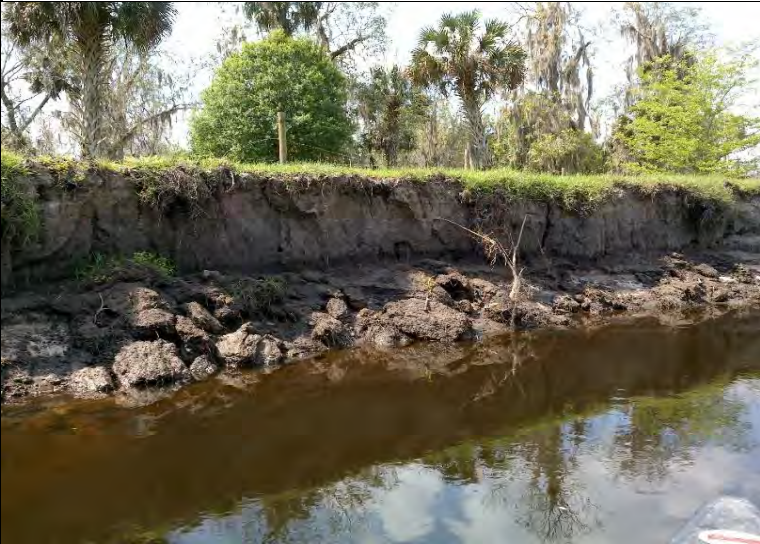
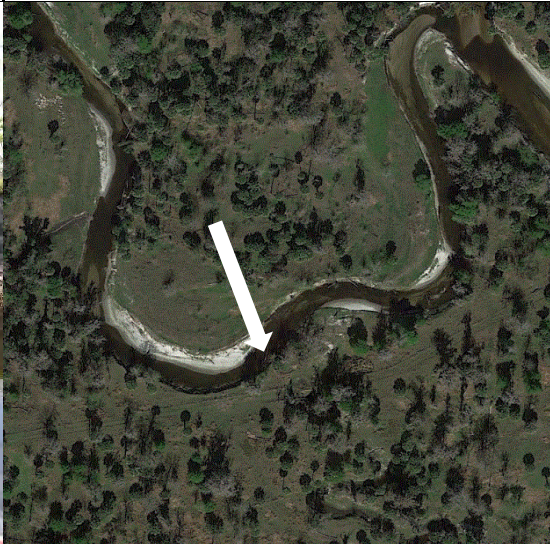
Peace River			Severity Scale: 6.25-Moderate
Watershed: Peace River Subwatershed: Troublesome Creek Latitude: 27.43816 Longitude: -81.85160			County: Hardee Site Number: PI146 Reach Length: 200 ft. Landowner: Ben Hill Griffin Inc

Risk Factor	Ranking	Score	
Pfankuch-Channel Stability:	Poor	1.5	
Channel Alteration:	None	0	
Bank Erosion:	Mass-wasting	1.5	
BEHI:	Moderate (23.76)	0.5	
Local NPSP:	Obvious Sources	1.5	
Shoring Structures:	None	0	
Pipe Discharge:	None	0	<b>Additional Site Features</b> Stream Channel Woody Material: Infrequent Impoundments: None Substrate Composition: Medium sand Bank Material: Sandy clay Near Bank Stress: High RB Landuse: Pasture, Natural Forest LB Landuse: Pasture, Natural Forest
Water Odor:	Normal	0	
Fish Passage Barrier:	None	0	
RB: Riparian Buffer:	0 ft.	0.75	
LB: Riparian Buffer:	40 ft.	0.5	
RB: Floodplain Access:	Full	0	
LB: Floodplain Access:	Full	0	
<b>Severity Scale:</b>		<b>6.25</b>

Notes: Right bank of right fork (looking DS) around island; Fenced out cattle; 303d: Impaired - Aquatic Life Harvesting (mercury in fish tissue)			
Restoration Option 1

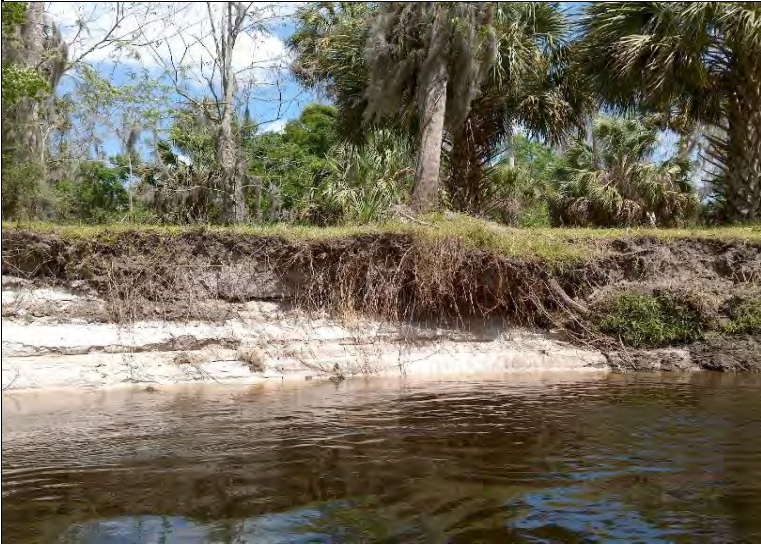
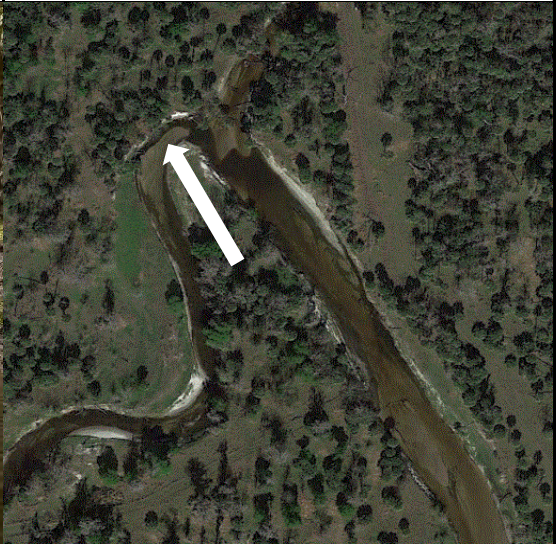
Peace River			Severity Scale: 6.5-Moderate
Watershed: Peace River Subwatershed: Troublesome Creek Latitude: 27.43961 Longitude: -81.85090			County: Hardee Site Number: PI147 Reach Length: 100 ft. Landowner: Ben Hill Griffin Inc

Pfankuch-Channel Stability:	Poor	1.5	
Channel Alteration:	None	0	
Bank Erosion:	Mass-wasting	1.5	
BEHI:	High (35.74)	1	
Local NPSP:	Obvious Sources	1.5	
Shoring Structures:	None	0	
Pipe Discharge:	None	0	
Water Odor:	Normal	0	
Fish Passage Barrier:	None	0	
RB: Riparian Buffer:	40 ft.	0.5	
LB: Riparian Buffer:	40 ft.	0.5	
RB: Floodplain Access:	Full	0	
LB: Floodplain Access:	Full	0	
<b>Severity Scale:</b>		<b>6.5</b>	
			<b>Additional Site Features</b>
			Stream Channel Woody Material: Moderate
			Impoundments: None
			Substrate Composition: Medium sand
			Bank Material: Sand
			Near Bank Stress: High
			RB Landuse: Natural Forest, Pasture
			LB Landuse: Natural Forest, Pasture

Notes: Left bank of right fork (looking DS) around island; 303d: Impaired - Aquatic Life Harvesting (mercury in fish tissue)			
Restoration Option 1

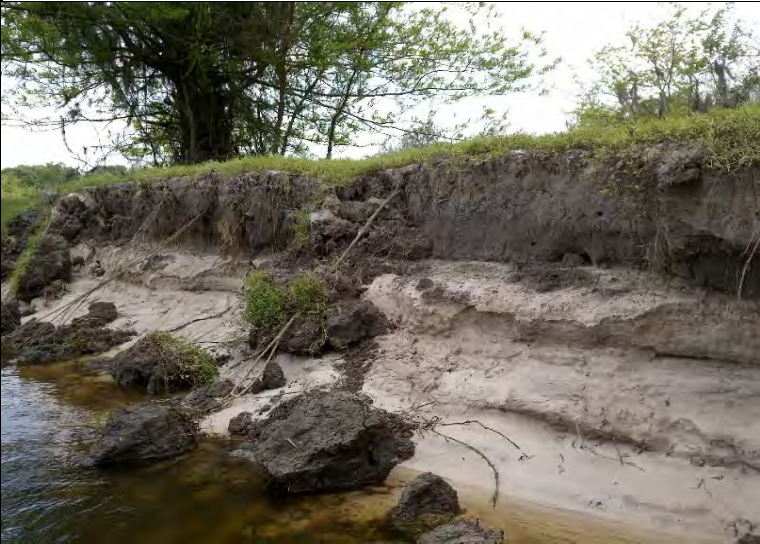
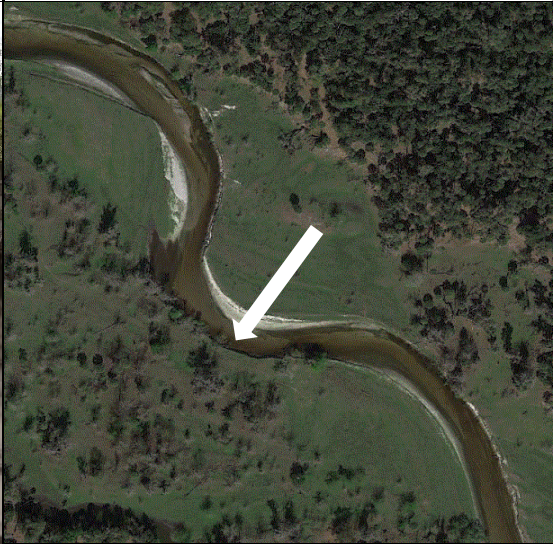
Peace River			Severity Scale: 7.25-Moderate
Watershed: Peace River Subwatershed: Peace River Branch Latitude: 27.39033 Longitude: -81.84560			County: Hardee Site Number: PI148 Reach Length: 100 ft. Landowner: Ben Hill Griffin Inc

Pfankuch-Channel Stability:	Poor	1.5	
Channel Alteration:	None	0	
Bank Erosion:	Mass-wasting	1.5	
BEHI:	Very High (41.79)	1.5	
Local NPSP:	Obvious Sources	1.5	
Shoring Structures:	None	0	
Pipe Discharge:	None	0	
Water Odor:	Normal	0	
Fish Passage Barrier:	None	0	
RB: Riparian Buffer:	0 ft.	0.75	
LB: Riparian Buffer:	40 ft.	0.5	
RB: Floodplain Access:	Full	0	
LB: Floodplain Access:	Full	0	
<b>Severity Scale:</b>		<b>7.25</b>	<b>Additional Site Features</b>
			Stream Channel Woody Material: Moderate
			Impoundments: None
			Substrate Composition: Medium sand
			Bank Material: Sand
			Near Bank Stress: Moderate
			RB Landuse: Pasture, Natural Forest

LB Landuse: Pasture, Natural Forest
Notes: 303d: Impaired - Aquatic Life Harvesting (mercury in fish tissue)			
Restoration Option 1

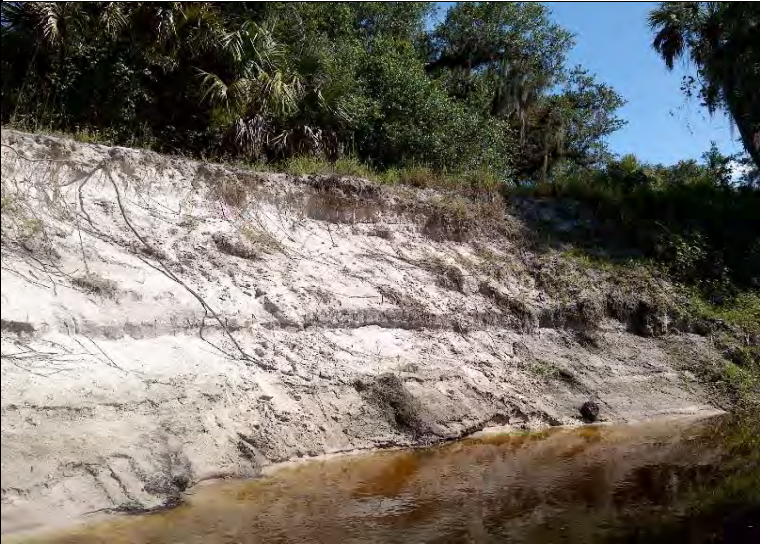
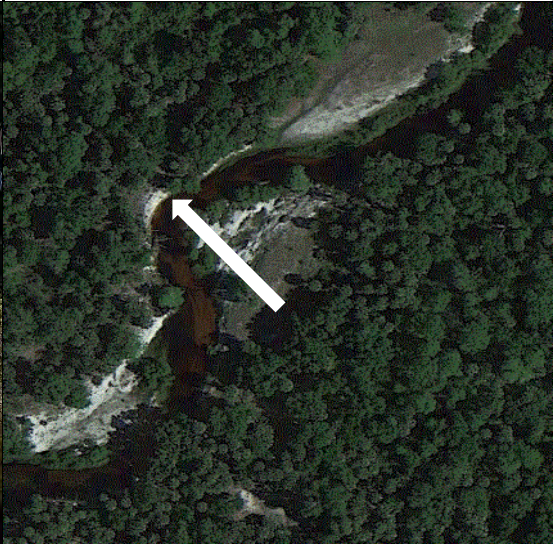
Horse Creek			Severity Scale: 2.25-Low
Watershed: Peace River Subwatershed: Horse Creek Latitude: 27.15109 Longitude: -81.96756			County: Desoto Site Number: PI149 Reach Length: 64 ft. Landowner: TITF/State of Florida

Risk Factor	Ranking	Score	
Pfankuch-Channel Stability:	Good	0	
Channel Alteration:	None	0	
Bank Erosion:	Active	1	
BEHI:	High (33.32)	1	
Local NPSP:	No Evidence	0	
Shoring Structures:	None	0	
Pipe Discharge:	None	0	
Water Odor:	Normal	0	
Fish Passage Barrier:	None	0	
RB: Riparian Buffer:	100 ft.	0	
LB: Riparian Buffer:	100 ft.	0	
RB: Floodplain Access:	Partial	0.25	
LB: Floodplain Access:	Full	0	
<b>Severity Scale:</b>		<b>2.25</b>	
Notes: 303d: Impaired - Public Water Supply (BOD, DO)			
Restoration Option 1

Additional Site Features	
Stream Channel Woody Material:	Infrequent
Impoundments:	None
Substrate Composition:	Fine Sand
Bank Material:	Sand
Near Bank Stress:	Moderate
RB Landuse:	Natural forest
LB Landuse:	Natural forest

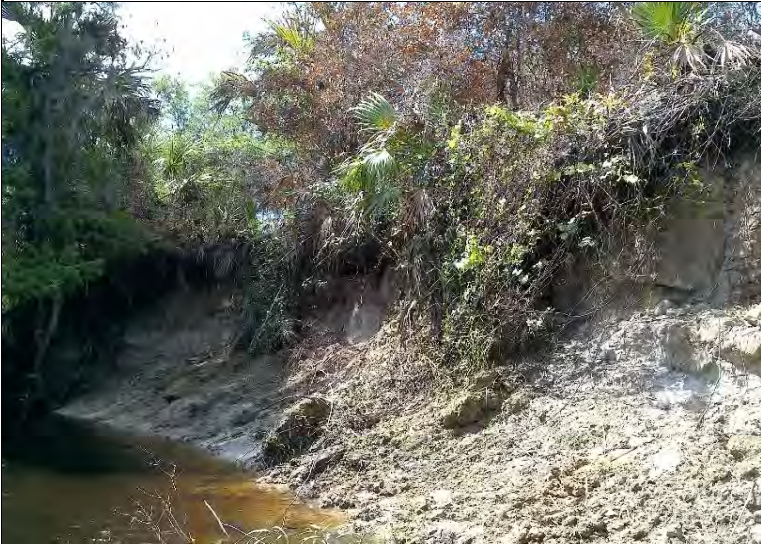
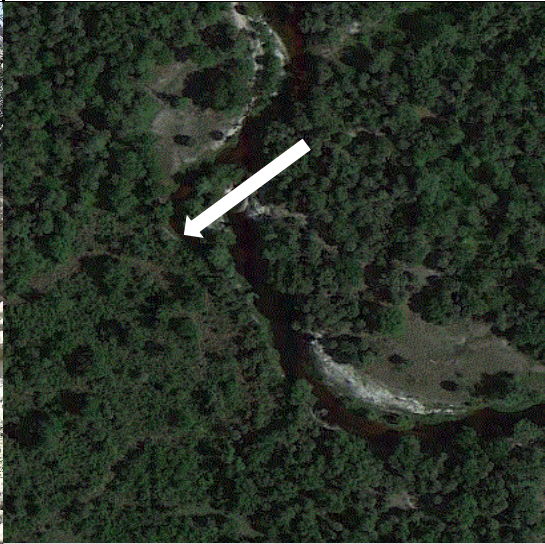
Horse Creek			Severity Scale: 2.25-Low	
Watershed: Peace River Subwatershed: Horse Creek Latitude: 27.14805 Longitude: -81.96825			County: Desoto Site Number: PI150 Reach Length: 48 ft. Landowner: TITF/State of Florida

Pfankuch-Channel Stability:	Good	0		
Channel Alteration:	None	0		
Bank Erosion:	Active	1		
BEHI:	High (37.91)	1		
Local NPSP:	No Evidence	0		
Shoring Structures:	None	0		
Pipe Discharge:	None	0		
Water Odor:	Normal	0		
Fish Passage Barrier:	None	0		
RB: Riparian Buffer:	100 ft.	0	<b>Additional Site Features</b>	
LB: Riparian Buffer:	100 ft.	0	Stream Channel Woody Material: Moderate	
RB: Floodplain Access:	Partial	0.25	Impoundments: None	
LB: Floodplain Access:	Full	0	Substrate Composition: Fine Sand	
<b>Severity Scale:</b>		<b>2.25</b>	Bank Material: Sand	
Notes: Some clay in bank, freshly burned right bank on Forest Service land; 303d: Impaired - Public water supply (BOD, DO)			Near Bank Stress: Moderate

Restoration Option 1			RB Landuse: Natural Forest	
			LB Landuse: Natural Forest

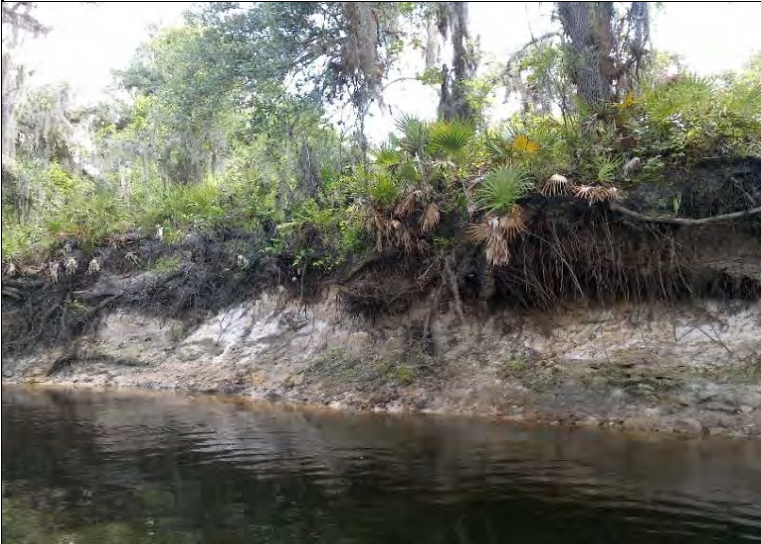
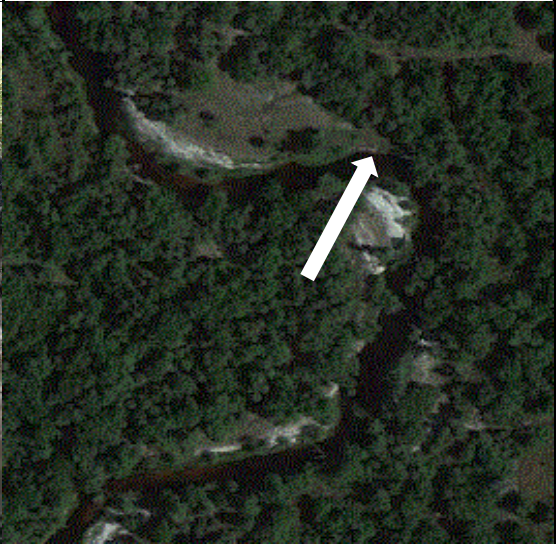
Horse Creek			Severity Scale: 2.25-Low	
Watershed: Peace River Subwatershed: Horse Creek Latitude: 27.14731 Longitude: -81.96651			County: Desoto Site Number: PI151 Reach Length: 94 ft. Landowner: TITF/State of Florida

Pfankuch-Channel Stability:	Good	0		
Channel Alteration:	None	0		
Bank Erosion:	Active	1		
BEHI:	High (37.59)	1		
Local NPSP:	No Evidence	0		
Shoring Structures:	None	0		
Pipe Discharge:	None	0		
Water Odor:	Normal	0		
Fish Passage Barrier:	None	0		
RB: Riparian Buffer:	100 ft.	0	<b>Additional Site Features</b>	
LB: Riparian Buffer:	100 ft.	0	Stream Channel Woody Material: Infrequent	
RB: Floodplain Access:	Full	0	Impoundments: None	
LB: Floodplain Access:	Partial	0.25	Substrate Composition: Medium Sand	
<b>Severity Scale:</b>		<b>2.25</b>	Bank Material: Sand	
Notes: Some sand stone and clay in bank; 303d: Impaired - Public Water Supply (BOD, DO)			Near Bank Stress: Moderate

Restoration Option 1			RB Landuse: Natural Forest	
			LB Landuse: Natural Forest

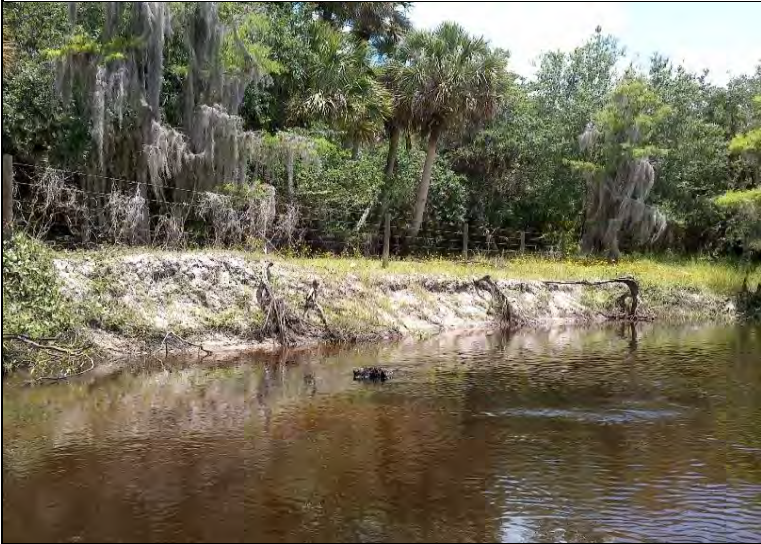
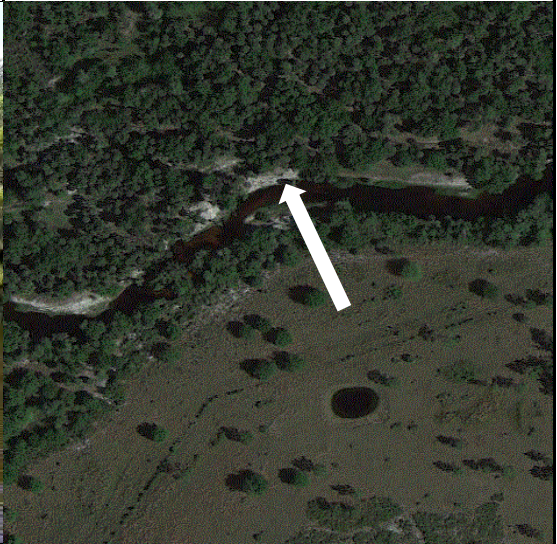
Horse Creek			Severity Scale: 3.5-Low
Watershed: Peace River Subwatershed: Horse Creek Latitude: 27.12882 Longitude: -81.97503			County: Desoto Site Number: PI152 Reach Length: 58 ft. Landowner: Janene Cline

Pfankuch-Channel Stability:	Good	0	
Channel Alteration:	None	0	
Bank Erosion:	Active	1	
BEHI:	Moderate (21.35)	0.5	
Local NPSP:	Obvious Sources	1.5	
Shoring Structures:	None	0	
Pipe Discharge:	None	0	
Water Odor:	Normal	0	
Fish Passage Barrier:	None	0	
RB: Riparian Buffer:	40 ft.	0.5	
LB: Riparian Buffer:	100 ft.	0	
RB: Floodplain Access:	Full	0	
LB: Floodplain Access:	Full	0	
<b>Severity Scale:</b>		<b>3.5</b>	<b>Additional Site Features</b>
			Stream Channel Woody Material: Moderate
			Impoundments: None
			Substrate Composition: Medium Sand
			Bank Material: Sand
			Near Bank Stress: High
			RB Landuse: Pasture, Natural Forest
			LB Landuse: Natural Forest
Notes: Cattle pasture on right bank-cattle fenced out of creek; 303d: Impaired - Public Water

Supply (BOD, DO)			
Restoration Option 1

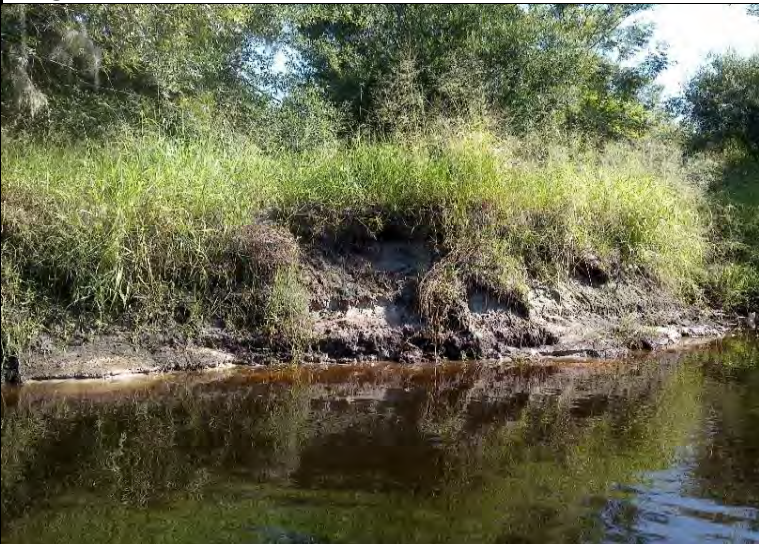
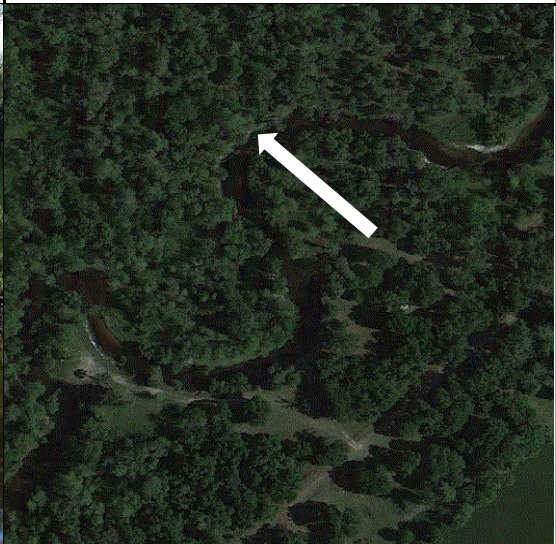
Joshua Creek			Severity Scale: 3.25-Low			
Watershed: Peace River Subwatershed: Lower Joshua Creek Latitude: 27.16516 Longitude: -81.89936			County: Desoto Site Number: PI153 Reach Length: 53 ft. Landowner: D Geraci

Pfankuch-Channel Stability:	N/A	0				
Channel Alteration:	None	0				
Bank Erosion:	Active	1				
BEHI:	Moderate (25.43)	0.5				
Local NPSP:	Obvious Sources	1.5				
Shoring Structures:	None	0				
Pipe Discharge:	None	0				
Water Odor:	Normal	0				
Fish Passage Barrier:	None	0				
RB: Riparian Buffer:	70 ft.	0.25	<b>Additional Site Features</b> Stream Channel Woody Material: Extensive Impoundments: Woody material jams Substrate Composition: Fine sand Bank Material: Sand Near Bank Stress: Moderate RB Landuse: Natural forest, pasture LB Landuse: Natural forest			
LB: Riparian Buffer:	100 ft.	0				
RB: Floodplain Access:	Full	0				
LB: Floodplain Access:	Full	0

<b>Severity Scale:</b>		<b>3.25</b>				
Notes: Debris jam above site; Cattle fenced out of area; 303d: Impaired-Aquatic Life Harvesting (DO)						
Restoration Option 1 or 2

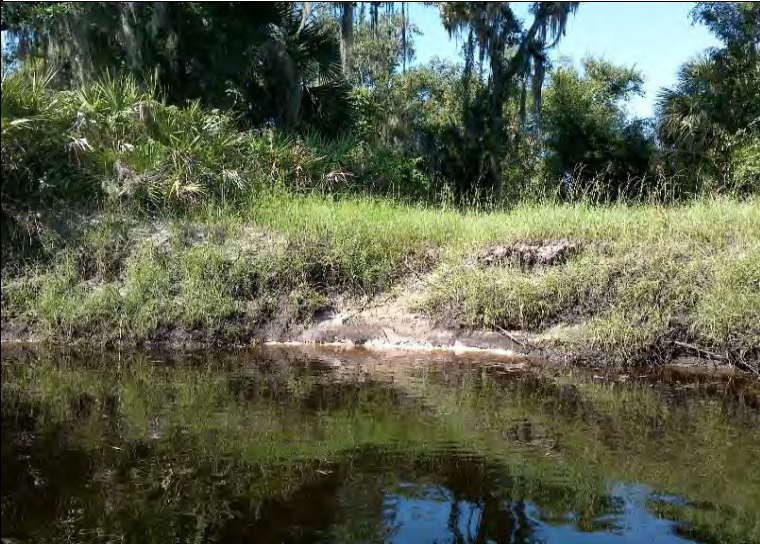
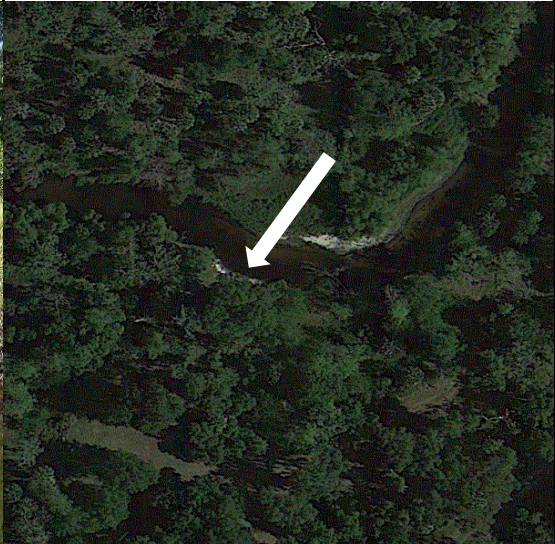
Joshua Creek			Severity Scale: 3.0-Low
Watershed: Peace River Subwatershed: Lower Joshua Creek Latitude: 27.16509 Longitude: -81.89852			County: Desoto Site Number: PI154 Reach Length: 15 ft. Landowner: Daniel C & Karry L Voss

Pfankuch-Channel Stability:	Good	0	
Channel Alteration:	None	0	
Bank Erosion:	Active	1	
BEHI:	Moderate (21.90)	0.5	
Local NPSP:	Obvious Sources	1.5	
Shoring Structures:	None	0	
Pipe Discharge:	None	0	
Water Odor:	Normal	0	
Fish Passage Barrier:	None	0	
RB: Riparian Buffer:	100 ft.	0	
LB: Riparian Buffer:	100 ft.	0	
RB: Floodplain Access:	Full	0	
LB: Floodplain Access:	Full	0	
Severity Scale:		3.0	Additional Site Features
			Stream Channel Woody Material: Infrequent
			Impoundments: None
			Substrate Composition: Fine sand
			Bank Material: Sand
			Near Bank Stress: Moderate
			RB Landuse: Natural Forest
			LB Landuse: Natural Forest
303d: Impaired - Aquatic Life Harvesting (DO)

Restoration Option 1 or 2

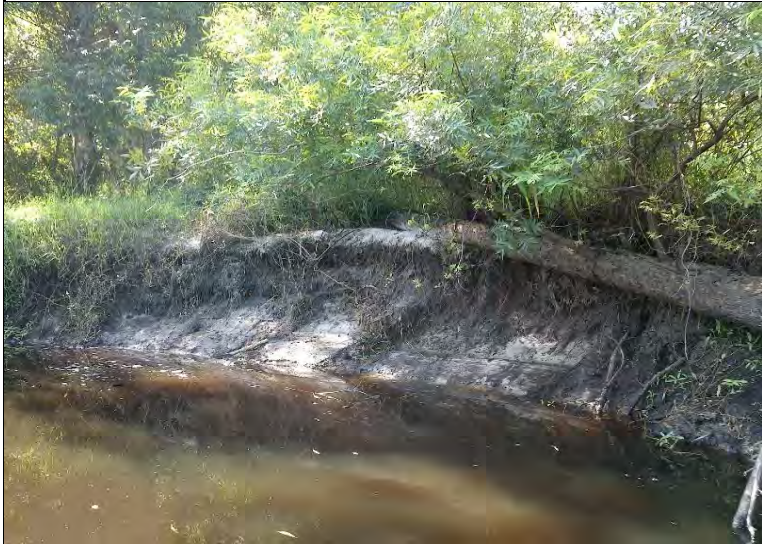
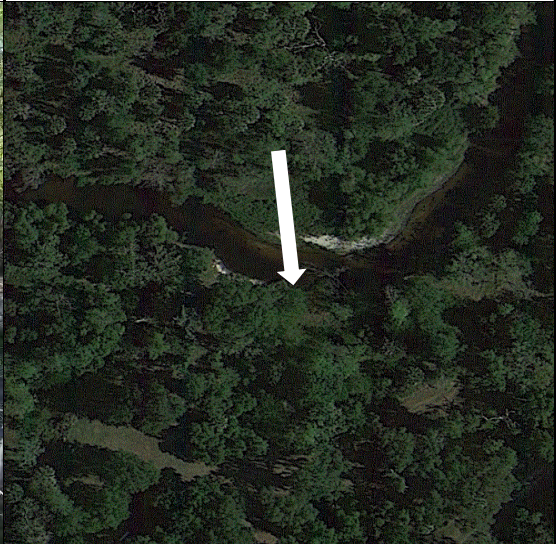
Joshua Creek			Severity Scale: 3.0-Low	
Watershed: Peace River Subwatershed: Lower Joshua Creek Latitude: 27.16502 Longitude: -81.89826			County: Desoto Site Number: PI155 Reach Length: 75 ft. Landowner: Daniel C. & Karry L. Voss

Pfankuch-Channel Stability:	Good	0		
Channel Alteration:	None	0		
Bank Erosion:	Active	1		
BEHI:	Moderate (23.64)	0.5		
Local NPSP:	Obvious Sources	1.5		
Shoring Structures:	None	0		
Pipe Discharge:	None	0		
Water Odor:	Normal	0		
Fish Passage Barrier:	None	0		
RB: Riparian Buffer:	100 ft.	0		
LB: Riparian Buffer:	100 ft.	0		
RB: Floodplain Access:	Full	0		
LB: Floodplain Access:	Full	0		
Severity Scale:		3.0	Additional Site Features	
			Stream Channel Woody Material: Infrequent	
			Impoundments: None	
			Substrate Composition: Fine sand	
			Bank Material: Sand	
			Near Bank Stress: Moderate	
			RB Landuse: Natural Forest	
			LB Landuse: Natural Forest

303d: Impaired - Aquatic Life Harvesting (DO)				
Restoration Option 1

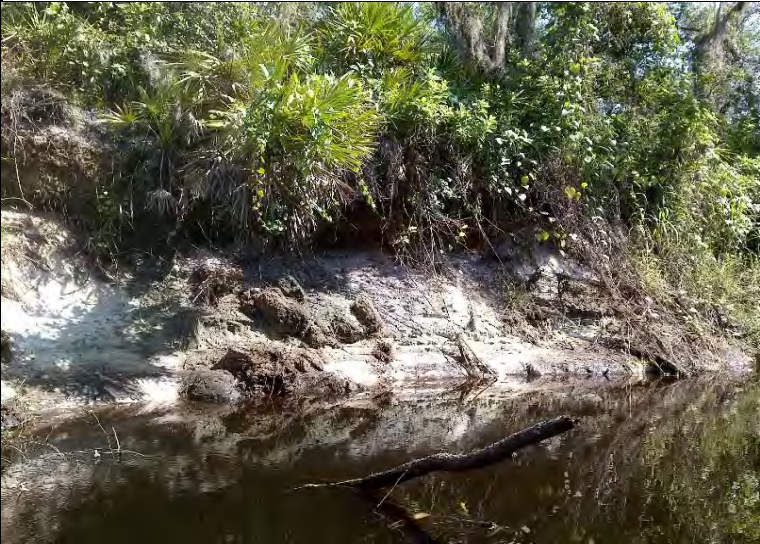
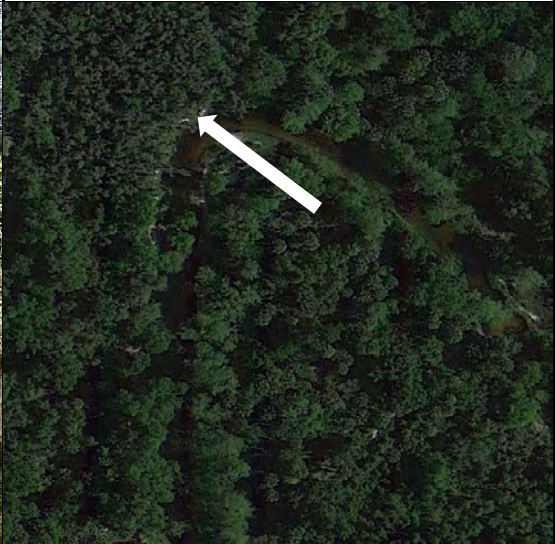
Joshua Creek			Severity Scale: 4.0-Low
Watershed: Peace River Subwatershed: Lower Joshua Creek Latitude: 27.17074 Longitude: -81.89489			County: Desoto Site Number: PI156 Reach Length: 37 ft. Landowner: D D & TR Geraci

Pfankuch-Channel Stability:	Good	0	
Channel Alteration:	None	0	
Bank Erosion:	Mass-wasting	1.5	
BEHI:	High (33.07)	1	
Local NPSP:	Obvious Sources	1.5	
Shoring Structures:	None	0	
Pipe Discharge:	None	0	
Water Odor:	None	0	
Fish Passage Barrier:	None	0	
RB: Riparian Buffer:	100 ft.	0	
LB: Riparian Buffer:	100 ft.	0	
RB: Floodplain Access:	Full	0	
LB: Floodplain Access:	Full	0	
<b>Severity Scale:</b>		<b>4.0</b>	<b>Additional Site Features</b>
			Stream Channel Woody Material: Extensive
			Impoundments: None
			Substrate Composition: Fine sand
			Bank Material: Sand
			Near Bank Stress: Moderate
			RB Landuse: Natural Forest
			LB Landuse: Natural Forest

303d: Impaired - Aquatic Life Harvesting (DO)			
Restoration Option 1

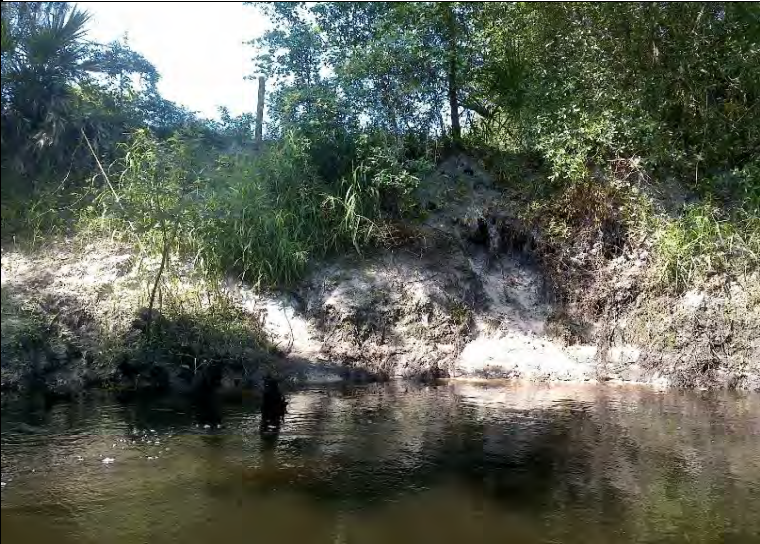
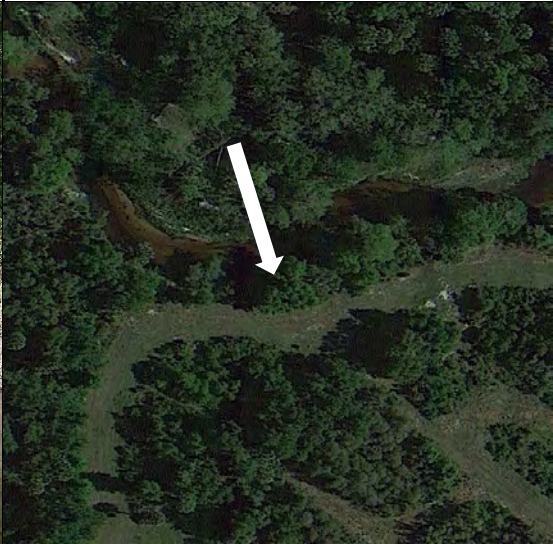
Joshua Creek			Severity Scale: 3.5-Low
Watershed: Peace River Subwatershed: Lower Joshua Creek Latitude: 27.16977 Longitude: -81.89349			County: Desoto Site Number: PI157 Reach Length: 102 ft. Landowner: Daniel C. & Karry L. Voss

Pfankuch-Channel Stability:	Good	0	
Channel Alteration:	None	0	
Bank Erosion:	Active	1	
BEHI:	Moderate (27.81)	0.5	
Local NPSP:	Obvious Sources	1.5	
Shoring Structures:	None	0	
Pipe Discharge:	None	0	
Water Odor:	Normal	0	
Fish Passage Barrier:	None	0	
RB: Riparian Buffer:	100 ft.	0	
LB: Riparian Buffer:	40 ft.	0.5	
RB: Floodplain Access:	Full	0	
LB: Floodplain Access:	Full	0	
<b>Severity Scale:</b>		<b>3.5</b>	<b>Additional Site Features</b>
			Stream Channel Woody Material: Moderate
			Impoundments: None
			Substrate Composition: Fine sand
			Bank Material: Sand
			Near Bank Stress: Low
			RB Landuse: Natural forest
			LB Landuse: Pasture, Natural forest

303d: Impaired - Aquatic Life Harvesting (DO)			
Restoration Option 1

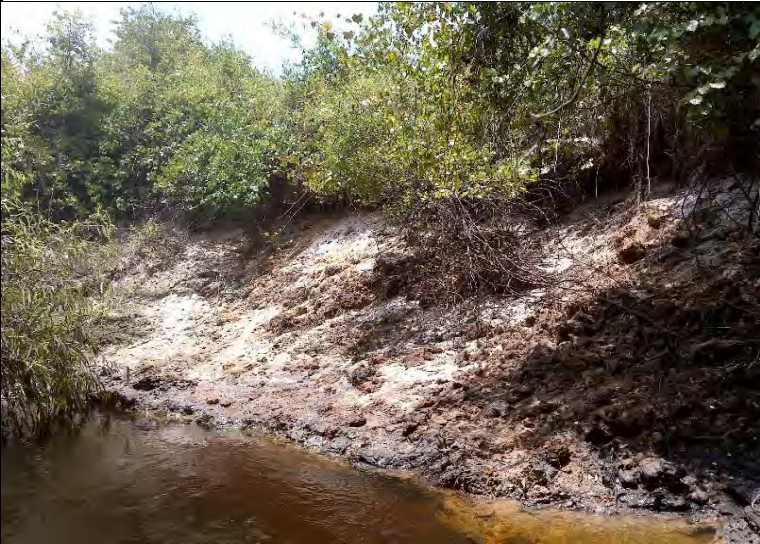
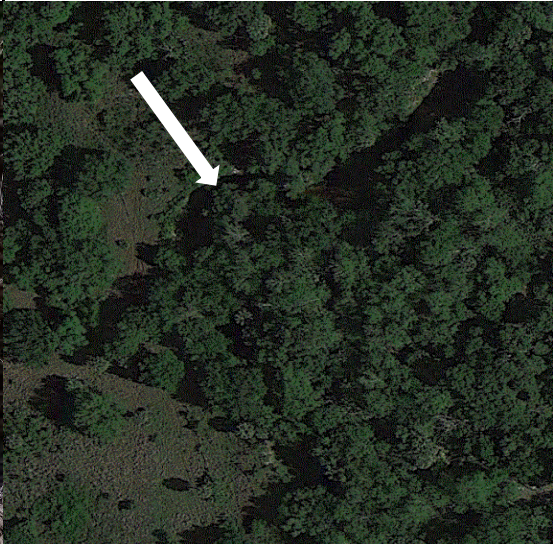
Joshua Creek			Severity Scale: 4.25-Moderate
Watershed: Peace River Subwatershed: Lower Joshua Creek Latitude: 27.16935 Longitude: -81.88608			County: Desoto Site Number: PI158 Reach Length: 85 ft. Landowner: Desoto Co. Block Plant LLC

Risk Factor	Ranking	Score	
Pfankuch-Channel Stability:	Good	0	
Channel Alteration:	None	0	
Bank Erosion:	Mass-wasting	1.5	
BEHI:	High (32.37)	1	
Local NPSP:	Moderate Potential	1	
Shoring Structures:	None	0	
Pipe Discharge:	None	0	
Water Odor:	Normal	0	
Fish Passage Barrier:	None	0	
RB: Riparian Buffer:	100 ft.	0	
LB: Riparian Buffer:	40 ft.	0.5	
RB: Floodplain Access:	Full	0	
LB: Floodplain Access:	Partial	0.25	
Severity Scale:		4.25	
303d: Impaired - Aquatic Life Harvesting (DO)			
Restoration Option 1

Additional Site Features
Stream Channel Woody Material: Moderate
Impoundments: None
Substrate Composition: Medium sand
Bank Material: Sand with a clay layer
Near Bank Stress: Low
RB Landuse: Natural Forest
LB Landuse: Natural forest, Pasture

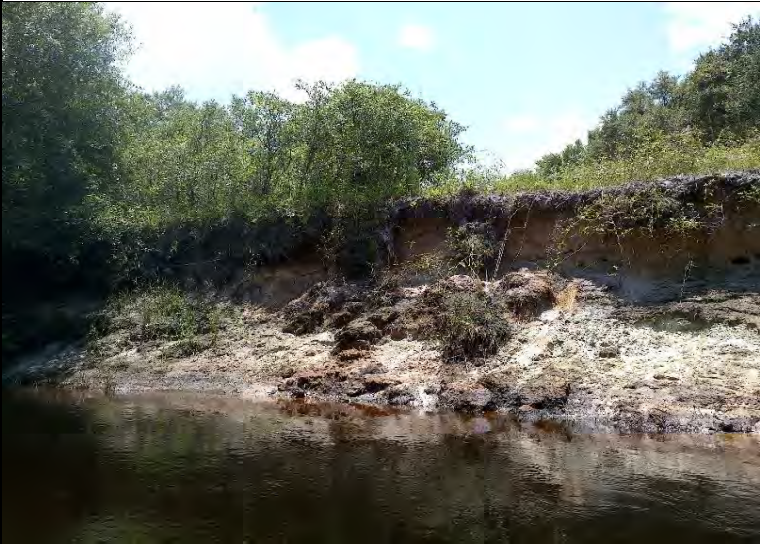
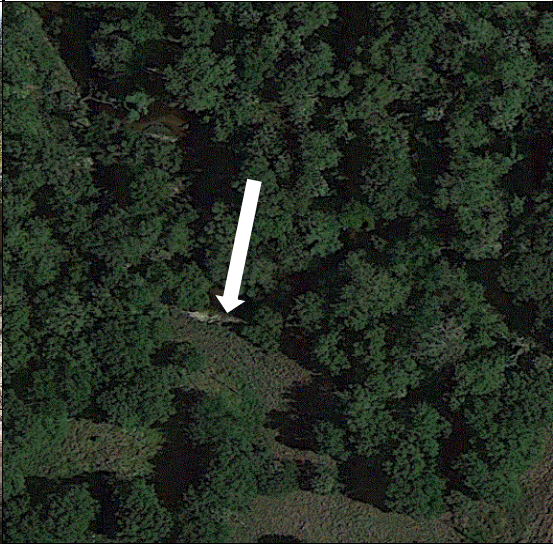
Joshua Creek			Severity Scale: 4.75-Moderate
Watershed: Peace River Subwatershed: Lower Joshua Creek Latitude: 27.16794 Longitude: -81.88448			County: Desoto Site Number: PI159 Reach Length: 90 ft. Landowner: Desoto Co. Block Plant LLC

Risk Factor	Ranking	Score	
Pfankuch-Channel Stability:	Good	0	
Channel Alteration:	None	0	
Bank Erosion:	Mass-wasting	1.5	
BEHI:	High (39.50)	1	
Local NPSP:	Obvious Sources	1.5	
Shoring Structures:	None	0	
Pipe Discharge:	None	0	
Water Odor:	Normal	0	
Fish Passage Barrier:	None	0	
RB: Riparian Buffer:	100 ft.	0	
LB: Riparian Buffer:	40 ft.	0.5	
RB: Floodplain Access:	Full	0	
LB: Floodplain Access:	Partial	0.25	
Severity Scale:		4.75	
303d: Impaired - Aquatic Life Harvesting (DO)			
Restoration Option 1

Additional Site Features
Stream Channel Woody Material: Extensive
Impoundments: None
Substrate Composition: Fine Sand
Bank Material: Sand
Near Bank Stress: Moderate
RB Landuse: Natural Forest
LB Landuse: Natural Forest, Pasture

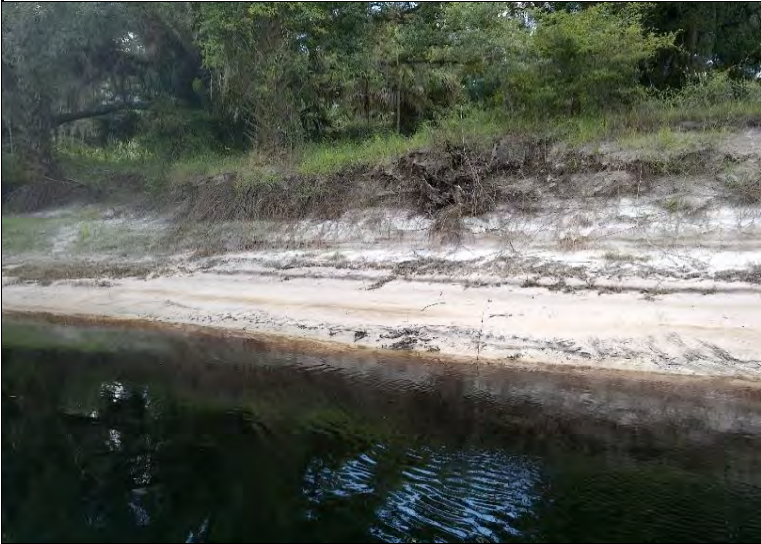
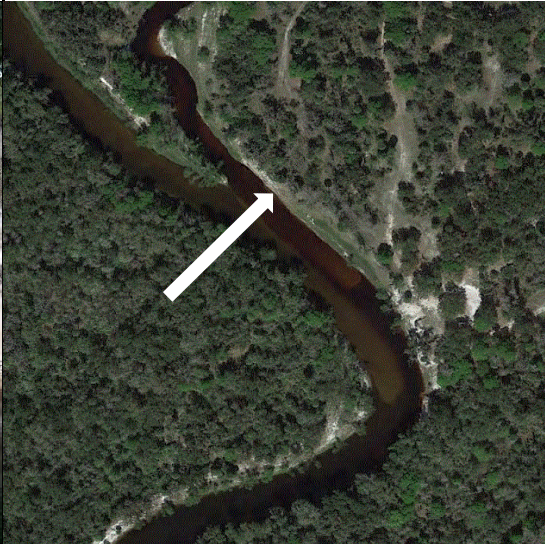
Peace River			Severity Scale: 3.5-Low
Watershed: Peace River Subwatershed: Peace River Branch Latitude: 27.34915 Longitude: -81.82518			County: Hardee Site Number: PI160 Reach Length: 150 ft. Landowner: Limestone Ranch, LLC

Pfankuch-Channel Stability:	Good	0	
Channel Alteration:	None	0	
Bank Erosion:	Active	1	
BEHI:	Moderate (29.10)	0.5	
Local NPSP:	Obvious Sources	1.5	
Shoring Structures:	None	0	
Pipe Discharge:	None	0	
Water Odor:	Normal	0	
Fish Passage Barrier:	None	0	
RB: Riparian Buffer:	100 ft.	0	
LB: Riparian Buffer:	50 ft.	0.25	
RB: Floodplain Access:	Partial	0.25	
LB: Floodplain Access:	Full	0	
<b>Severity Scale:</b>		<b>3.5</b>	<b>Additional Site Features</b>
			Stream Channel Woody Material: Infrequent
			Impoundments: None
			Substrate Composition: Medium Sand
			Bank Material: Sand
			Near Bank Stress: Low
			RB Landuse: Natural Forest
			LB Landuse: Pasture, Natural Forest

Notes: Cattle fenced out; Site is located at the confluence of the Peace River and Charlie Creek;			
303d: Impaired - Aquatic Life Harvesting (fecal coliform, mercury in fish tissue)			
Restoration Option 1

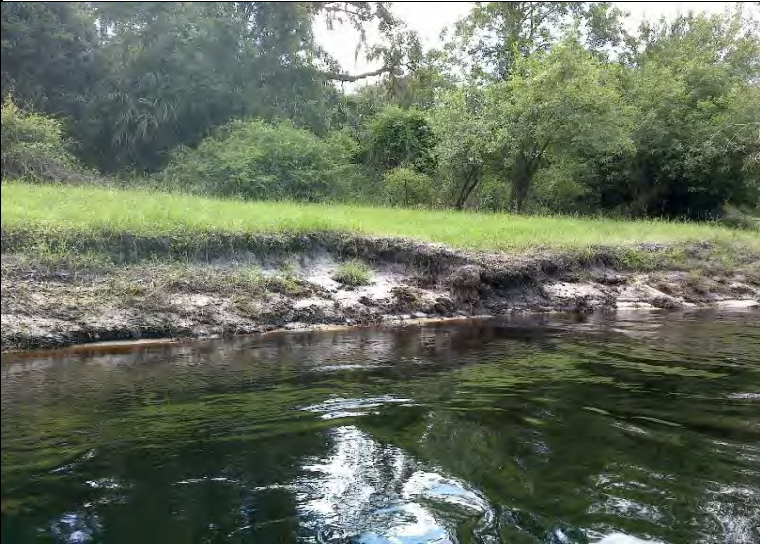
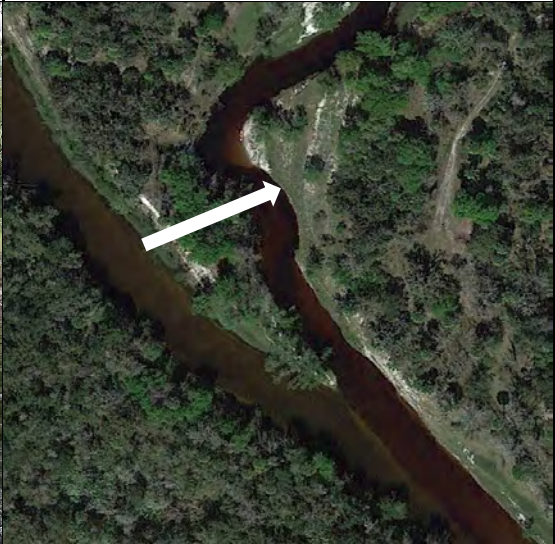
Charlie Creek			Severity Scale: 4.0-Low
Watershed: Peace River Subwatershed: Lower Charlie Creek Latitude: 27.35010 Longitude: -81.82582			County: Hardee Site Number: PI161 Reach Length: 95 ft. Landowner: Limestone Ranch, LLC

Pfankuch-Channel Stability:	Good	0	
Channel Alteration:	None	0	
Bank Erosion:	Active	1	
BEHI:	High (30.20)	1	
Local NPSP:	Obvious Sources	1.5	
Shoring Structures:	None	0	
Pipe Discharge:	None	0	
Water Odor:	Normal	0	
Fish Passage Barrier:	None	0	
RB: Riparian Buffer:	100 ft.	0	
LB: Riparian Buffer:	40 ft.	0.5	
RB: Floodplain Access:	Full	0	
LB: Floodplain Access:	Full	0	
Severity Scale:		4.0	<b>Additional Site Features</b> Stream Channel Woody Material: Infrequent Impoundments: None Substrate Composition: Medium Sand Bank Material: Sand Near Bank Stress: Moderate RB Landuse: Natural Forest LB Landuse: Natural Forest, Pasture
303d: Impaired - Fecal Coliform

Restoration Option 1

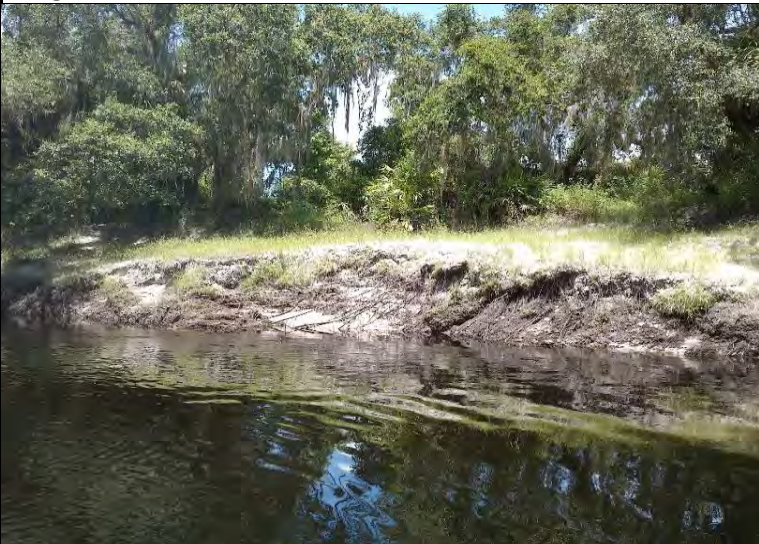
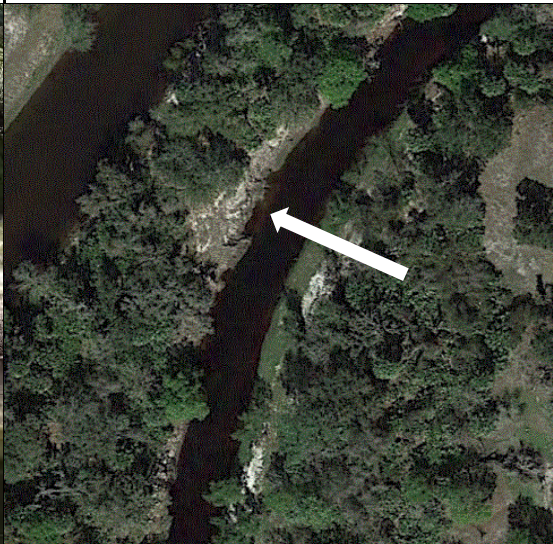
Charlie Creek			Severity Scale: 4.0-Low	
Watershed: Peace River Subwatershed: Lower Charlie Creek Latitude: 27.35389 Longitude: -81.82513			County: Hardee Site Number: PI162 Reach Length: 78 ft. Landowner: Limestone Ranch, LLC

Pfankuch-Channel Stability:	Good	0		
Channel Alteration:	None	0		
Bank Erosion:	Mass-wasting	1.5		
BEHI:	Moderate (27.20)	0.5		
Local NPSP:	Obvious Sources	1.5		
Shoring Structures:	None	0		
Pipe Discharge:	None	0		
Water Odor:	Normal	0		
Fish Passage Barrier:	None	0		
RB: Riparian Buffer:	100 ft.	0		
LB: Riparian Buffer:	50 ft.	0.25		
RB: Floodplain Access:	Partial	0.25		
LB: Floodplain Access:	Full	0		
Severity Scale:		4.0	Additional Site Features	
			Stream Channel Woody Material: Moderate	
			Impoundments: None	
			Substrate Composition: Medium Sand	
			Bank Material: Sand	
			Near Bank Stress: Low	
			RB Landuse: Natural Forest	
			LB Landuse: Natural Forest, Pasture

303d: Impaired - Fecal Coliform				
Restoration Option 1

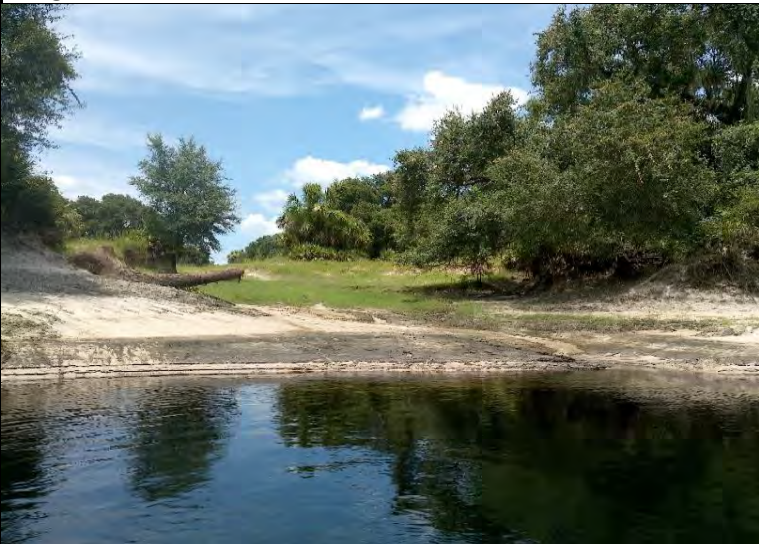
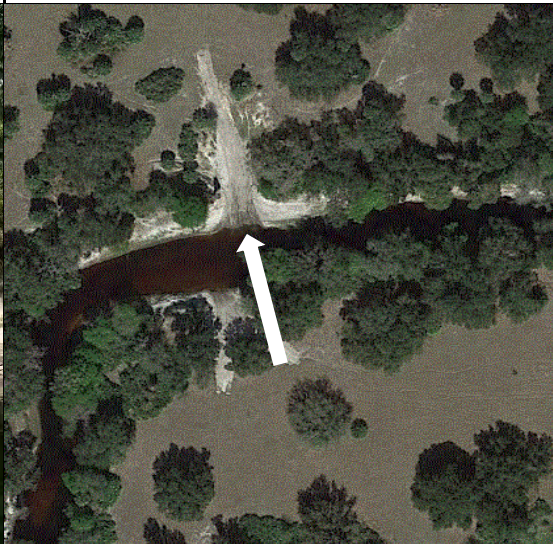
Charlie Creek			Severity Scale: 5.0-Moderate	
Watershed: Peace River Subwatershed: Lower Charlie Creek Latitude: 27.35803 Longitude: -81.81849			County: Hardee Site Number: PI163 Reach Length: 78 ft. Landowner: Ben Hill Griffin Inc.

Pfankuch-Channel Stability:	Good	0		
Channel Alteration:	None	0		
Bank Erosion:	Active	1		
BEHI:	High (39.90)	1		
Local NPSP:	Obvious Sources	1.5		
Shoring Structures:	None	0		
Pipe Discharge:	None	0		
Water Odor:	Normal	0		
Fish Passage Barrier:	None	0		
RB: Riparian Buffer:	0 ft.	0.75		
LB: Riparian Buffer:	0 ft.	0.75		
RB: Floodplain Access:	Full	0		
LB: Floodplain Access:	Full	0		
Severity Scale:		5.0	Additional Site Features	
			Stream Channel Woody Material: Infrequent	
			Impoundments: None	
			Substrate Composition: Medium Sand	
			Bank Material: Sand	
			Near Bank Stress: Very High	
			RB Landuse: Pasture, Natural Forest	
			LB Landuse: Pasture, Natural Forest

303d: Impaired - Fecal Coliform				
Restoration Option 2

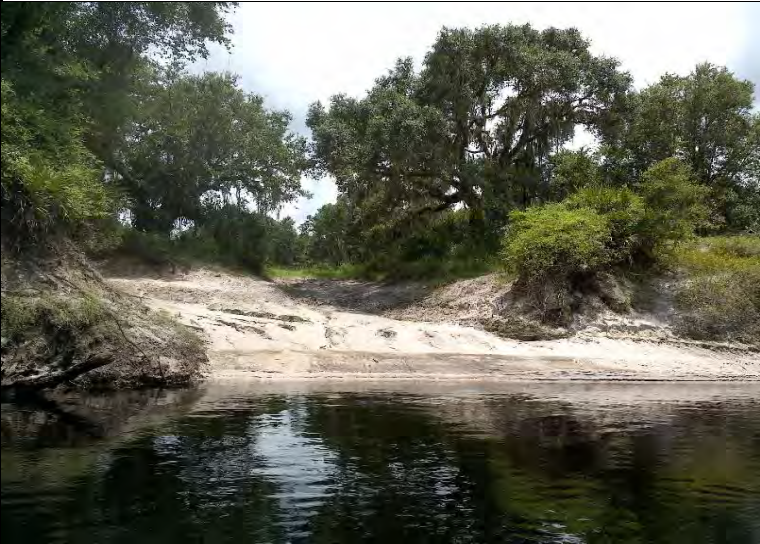
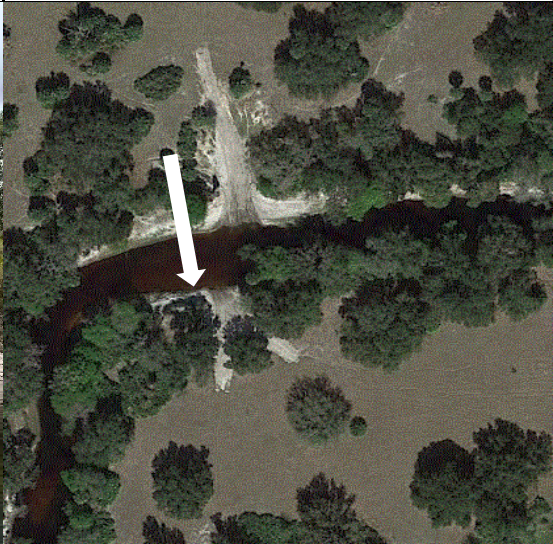
Charlie Creek			Severity Scale: 5.5-Moderate
Watershed: Peace River Subwatershed: Lower Charlie Creek Latitude: 27.35789 Longitude: -81.81869			County: Hardee Site Number: PI164 Reach Length: 50 ft. Landowner: Ben Hill Griffin Inc.

Pfankuch-Channel Stability:	Good	0	
Channel Alteration:	None	0	
Bank Erosion:	Active	1	
BEHI:	Extreme (47.10)	1.5	
Local NPSP:	Obvious Sources	1.5	
Shoring Structures:	None	0	
Pipe Discharge:	None	0	
Water Odor:	Normal	0	
Fish Passage Barrier:	None	0	
RB: Riparian Buffer:	0 ft.	0.75	
LB: Riparian Buffer:	0 ft.	0.75	
RB: Floodplain Access:	Full	0	
LB: Floodplain Access:	Full	0	
<b>Severity Scale:</b>		<b>5.5</b>	<b>Additional Site Features</b>
			Stream Channel Woody Material: Infrequent
			Impoundments: None
			Substrate Composition: Medium Sand
			Bank Material: Sand
			Near Bank Stress: Very High
			RB Landuse: Pasture
			LB Landuse: Pasture, Natural forest

Notes: Cattle access point; Cow patties present; 303d: Impaired - Fecal Coliform			
Restoration Option 2

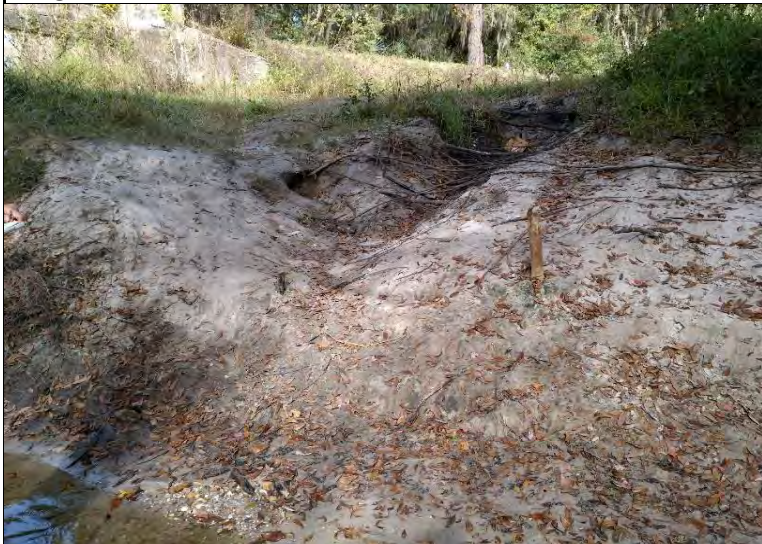
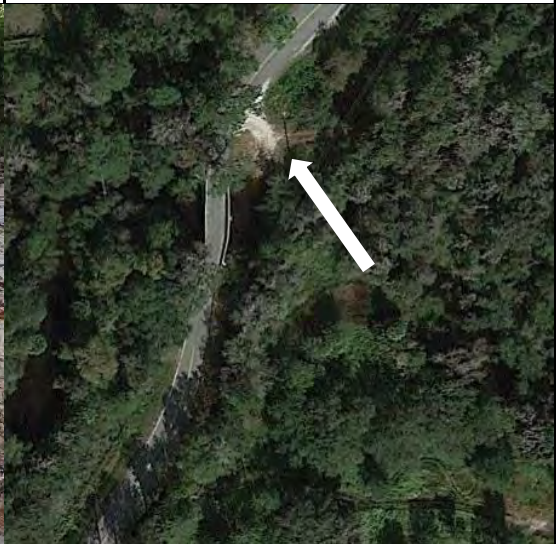
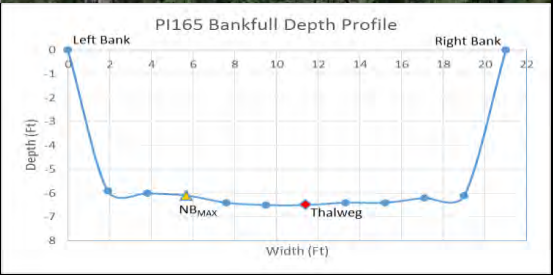
Payne Creek			Severity Scale: 3.25-Low																																														
Watershed: Peace River Subwatershed: Lower Payne Creek Latitude: 27.62053 Longitude: -81.84277			County: Hardee Site Number: PI165 Reach Length: 13 ft. Landowner: MOSAIC FERTILIZER LLC

Risk Factor	Ranking	Score	Pfankuch-Channel Stability:	Good	0	Channel Alteration:	None	0	Bank Erosion:	Active	1	BEHI:	High (31.83)	1	Local NPSP:	Slight Potential	0.5	Shoring Structures:	None	0	Pipe Discharge:	None	0	Water Odor:	Normal	0	Fish Passage Barrier:	None	0	RB: Riparian Buffer:	100 ft.	0	LB: Riparian Buffer:	0 ft.	0.75	RB: Floodplain Access:	Full	0	LB: Floodplain Access:	Full	0	Severity Scale:		3.25

Risk Factor	Ranking	Score																																															
Pfankuch-Channel Stability:	Good	0																																															
Channel Alteration:	None	0																																															
Bank Erosion:	Active	1																																															
BEHI:	High (31.83)	1																																															
Local NPSP:	Slight Potential	0.5																																															
Shoring Structures:	None	0																																															
Pipe Discharge:	None	0																																															
Water Odor:	Normal	0																																															
Fish Passage Barrier:	None	0																																															
RB: Riparian Buffer:	100 ft.	0																																															
LB: Riparian Buffer:	0 ft.	0.75																																															
RB: Floodplain Access:	Full	0																																															
LB: Floodplain Access:	Full	0																																															
Severity Scale:		3.25																																															
			<b>Additional Site Features</b>																																														
			Stream Channel Woody Material: Infrequent																																														
			Impoundments: None																																														
			Substrate Composition: Fine Sand/Gravel																																														
			Bank Material: Sand																																														
			Near Bank Stress: Low																																														
			RB Landuse: Natural Forest																																														
			LB Landuse: Recreational																																														
Notes: Road crossing just upstream; 303d: NA																																																	
Restoration Option 2 or 3

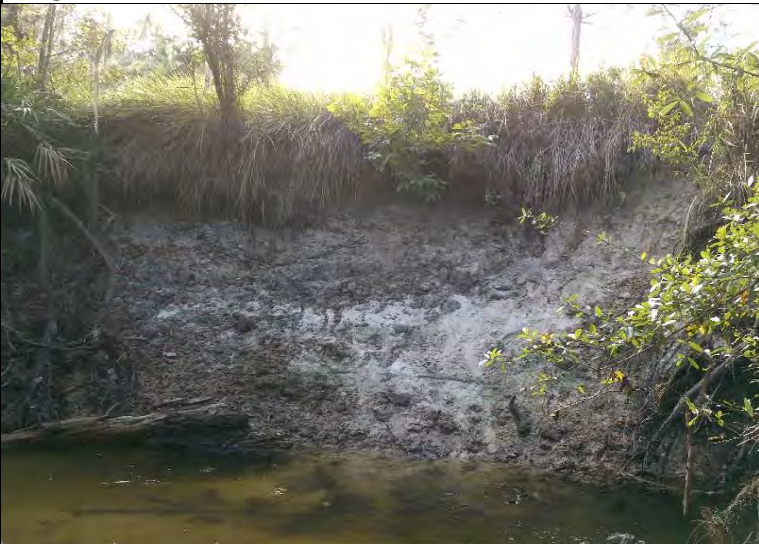
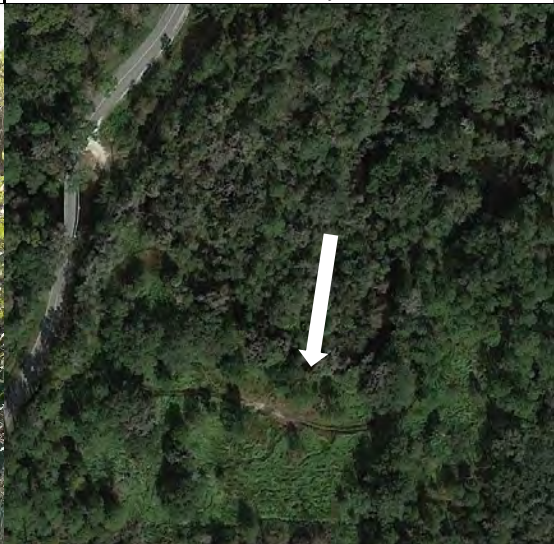
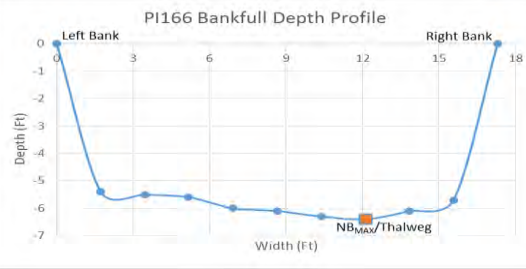
Payne Creek			Severity Scale: 3.75-Low	
Watershed: Peace River Subwatershed: Lower Payne Creek Latitude: 27.61997 Longitude: -81.84184			County: Hardee Site Number: PI166 Reach Length: 41 ft. Landowner: Hardee County BBC

Pfankuch-Channel Stability:	Good	0		
Channel Alteration:	None	0		
Bank Erosion:	Mass-wasting	1.5		
BEHI:	Moderate (23.47)	0.5		
Local NPSP:	Moderate Potential	1		
Shoring Structures:	None	0		
Pipe Discharge:	None	0		
Water Odor:	Normal	0		
Fish Passage Barrier:	None	0		
RB: Riparian Buffer:	40 ft.	0.5		
LB: Riparian Buffer:	100 ft.	0		
RB: Floodplain Access:	Partial	0.25		
LB: Floodplain Access:	Full	0		
Severity Scale:		3.75	Additional Site Features	
			Stream Channel Woody Material: Moderate	
			Impoundments: None	
			Substrate Composition: Fine Sand	
			Bank Material: Sand/Clay	
			Near Bank Stress: High	
			RB Landuse: Pasture, Natural Forest

LB Landuse: Natural Forest	
Notes: 303d: NA				
Restoration Option 1
