# **Peace River and Withlacoochee River Threats Assessments and Fish Assemblage Monitoring**

**Final Report July 1, 2015 – June 30, 2019**

Submitted to Florida State Wildlife Grants Program  
August 1, 2019  
PID: 98462501284

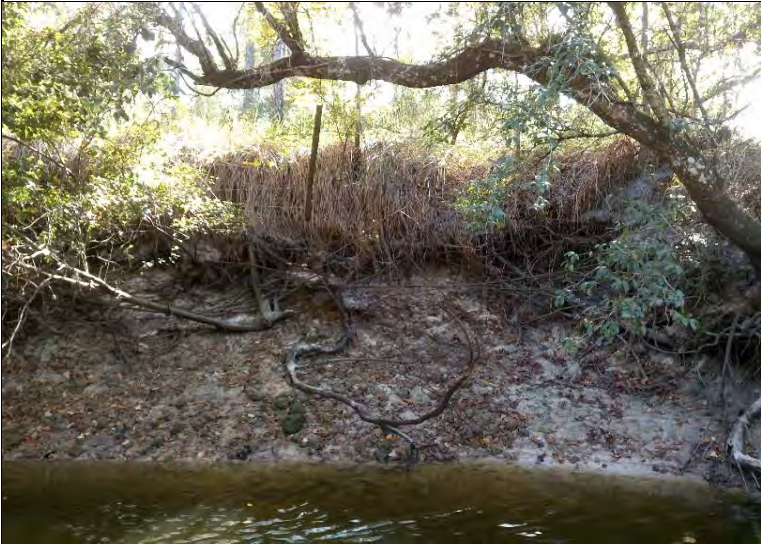
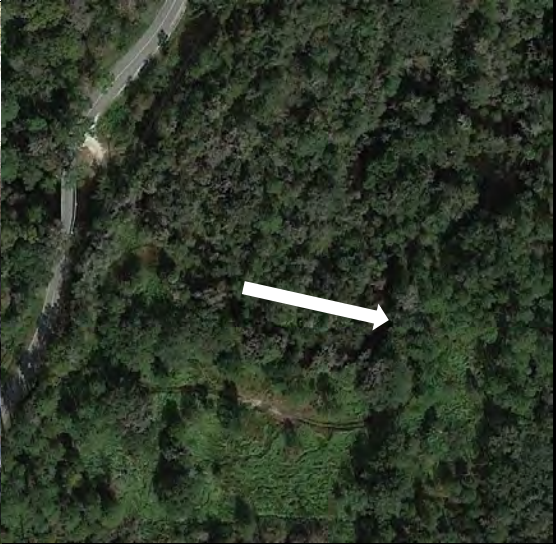
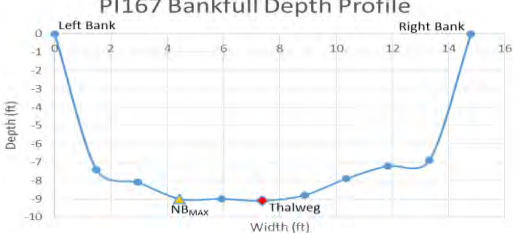
Payne Creek			Severity Scale: 2.75-Low
Watershed: Peace River Subwatershed: Lower Payne Creek Latitude: 27.62005 Longitude: -81.84152			County: Hardee Site Number: PI167 Reach Length: 20 ft. Landowner: Hardee County BBC

</div>
Pfankuch-Channel Stability:	Good	0	
Channel Alteration:	None	0	
Bank Erosion:	Active	1	
BEHI:	Low (18.59)	0	
Local NPSP:	Moderate Potential	1	
Shoring Structures:	None	0	
Pipe Discharge:	None	0	
Water Odor:	Normal	0	
Fish Passage Barrier:	None	0	
RB: Riparian Buffer:	40 ft.	0.5	
LB: Riparian Buffer:	100 ft.	0	
RB: Floodplain Access:	Partial	0.25	
LB: Floodplain Access:	Full	0	
<b>Severity Scale:</b>		<b>2.75</b>	<b>Additional Site Features</b> Stream Channel Woody Material: Moderate Impoundments: None Substrate Composition: Medium Sand Bank Material: Sand/Clay Near Bank Stress: Moderate RB Landuse: Natural Forest, Pasture LB Landuse: Natural Forest

Notes: 303d: Impaired - coliforms, nutrients			
Restoration Option 1

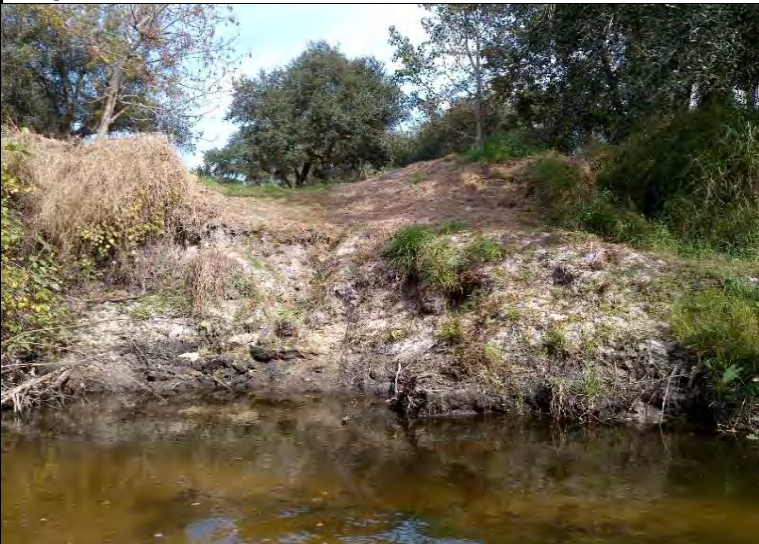
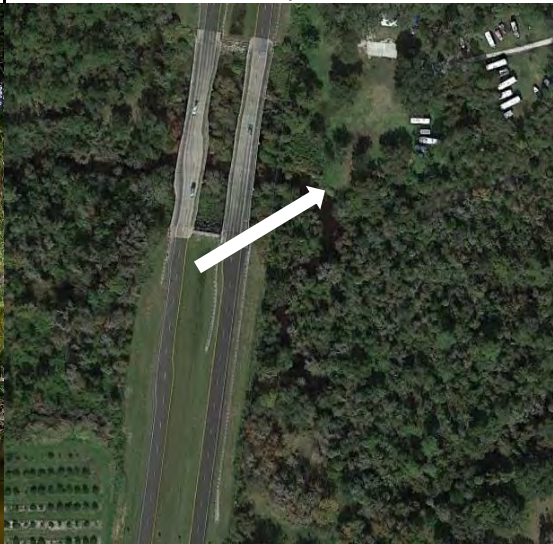
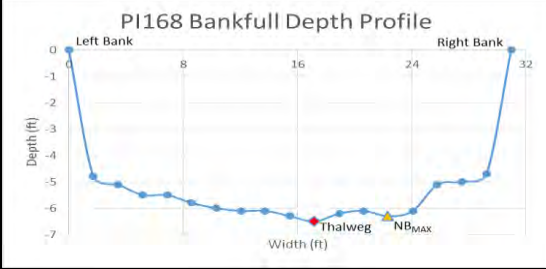
Payne Creek			Severity Scale: 3.25-Low	
Watershed: Peace River Subwatershed: Lower Payne Creek Latitude: 27.62031 Longitude: -81.82484			County: Hardee Site Number: PI168 Reach Length: 28 ft. Landowner: Wilder Corporation of DE

Pfankuch-Channel Stability:	Good	0		
Channel Alteration:	None	0		
Bank Erosion:	Active	1		
BEHI:	High (35.75)	1		
Local NPSP:	Slight Potential	0.5		
Shoring Structures:	None	0		
Pipe Discharge:	None	0		
Water Odor:	Normal	0		
Fish Passage Barrier:	None	0		
RB: Riparian Buffer:	100 ft.	0	<b>Additional Site Features</b>	
LB: Riparian Buffer:	40 ft.	0.5	Stream Channel Woody Material: Moderate	
RB: Floodplain Access:	Full	0	Impoundments: None	
LB: Floodplain Access:	Partial	0.25	Substrate Composition: Medium Sand	
Severity Scale:			Bank Material: Sand	
			Near Bank Stress: Moderate	
			RB Landuse: Natural Forest	
			LB Landuse: Residential, Natural Forest

Notes: 303d: NA				
Restoration Option 1

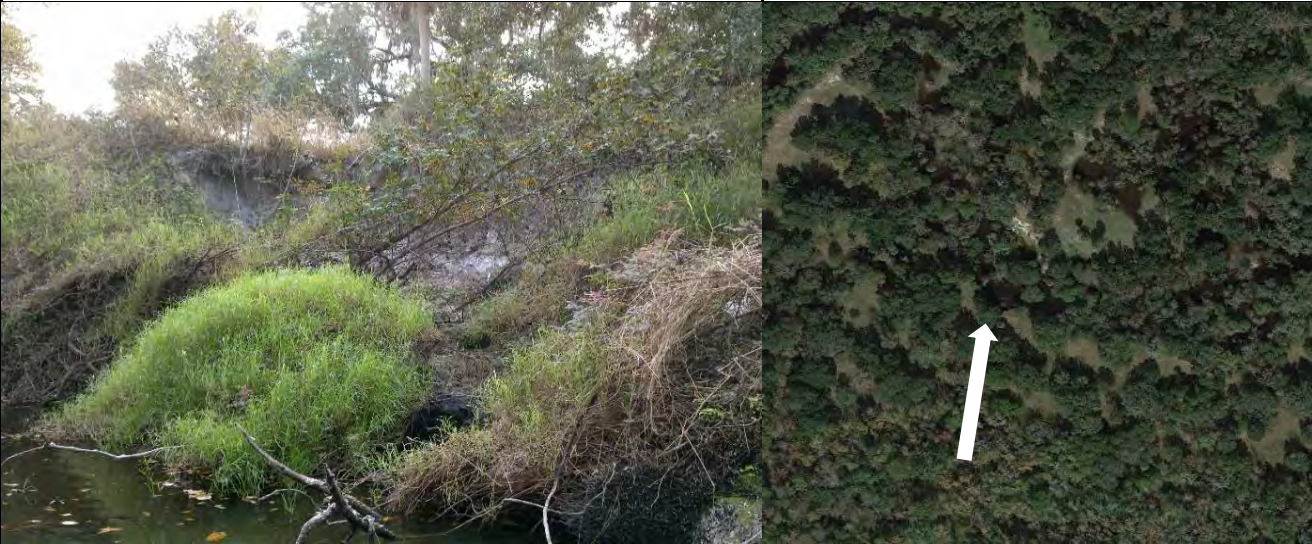
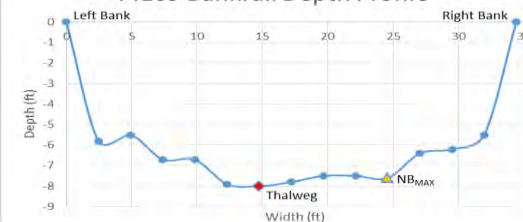
Payne Creek			Severity Scale: 5.25-Moderate
Watershed: Peace River Subwatershed: Lower Payne Creek Latitude: 27.61895 Longitude: -81.82192			County: Hardee Site Number: PI169 Reach Length: 30 ft. Landowner: Gary Delatorre

</div>
Pfankuch-Channel Stability:	Good	0	
Channel Alteration:	None	0	
Bank Erosion:	Mass-wasting	1.5	
BEHI:	High (31.44)	1	
Local NPSP:	Obvious Sources	1.5	
Shoring Structures:	None	0	
Pipe Discharge:	None	0	
Water Odor:	Normal	0	
Fish Passage Barrier:	None	0	
RB: Riparian Buffer:	40 ft.	0.5	
LB: Riparian Buffer:	40 ft.	0.5	
RB: Floodplain Access:	Partial	0.25	
LB: Floodplain Access:	Full	0	
<b>Severity Scale:</b>		<b>5.25</b>	
Notes: Cattle fencing falling into stream; 303d: NA			<b>Additional Site Features</b>
			Stream Channel Woody Material: Numerous
			Impoundments: None
			Substrate Composition: Medium Sand
			Bank Material: Sand

Near Bank Stress: Low
			RB Landuse: Pasture, Natural Forest
			LB Landuse: Pasture, Natural Forest
Restoration Option 1

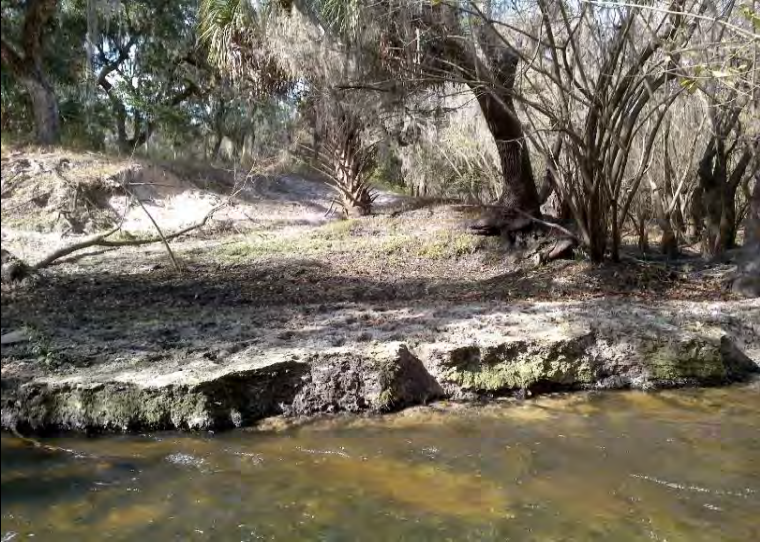
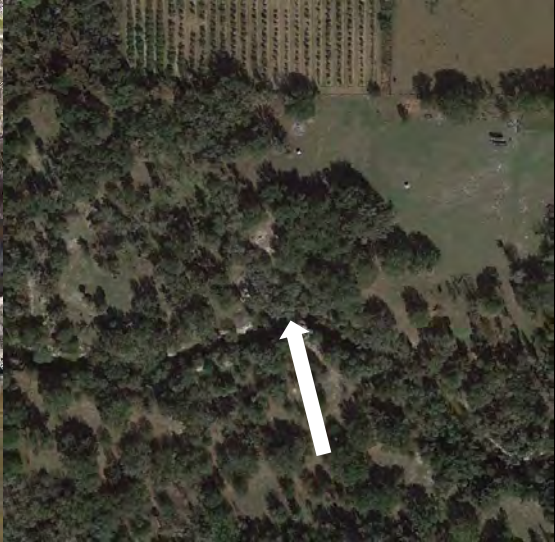
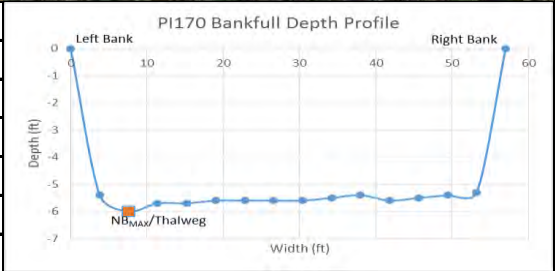
Payne Creek			Severity Scale: 4.75-Moderate
Watershed: Peace River Subwatershed: Lower Payne Creek Latitude: 27.61920 Longitude: -81.82048			County: Hardee Site Number: PI170 Reach Length: 55 ft. Landowner: Loyd M & Jane F Larramore

Risk Factor	Ranking	Score	
Pfankuch-Channel Stability:	Good	0	
Channel Alteration:	None	0	
Bank Erosion:	Active	1	
BEHI:	High (36.76)	1	
Local NPSP:	Obvious Sources	1.5	
Shoring Structures:	None	0	
Pipe Discharge:	None	0	
Water Odor:	Normal	0	
Fish Passage Barrier:	None	0	
RB: Riparian Buffer:	40 ft.	0.5	
LB: Riparian Buffer:	0 ft.	0.75	
RB: Floodplain Access:	Full	0	
LB: Floodplain Access:	Full	0	
Severity Scale:		4.75	
Notes: 303d: NA			
Restoration Option 1

Additional Site Features
Stream Channel Woody Material: Infrequent
Impoundments: None
Substrate Composition: Limestone
Bank Material: Sand
Near Bank Stress: Very High
RB Landuse: Pasture, Natural Forest
LB Landuse: Pasture, Natural Forest

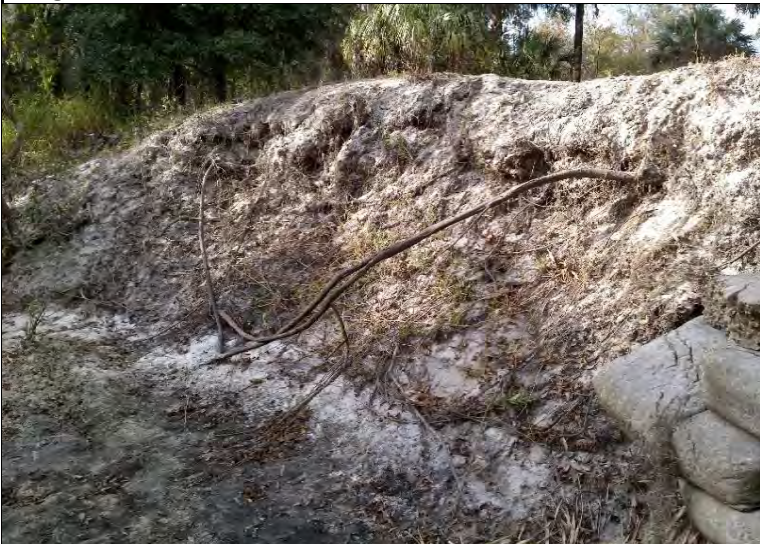
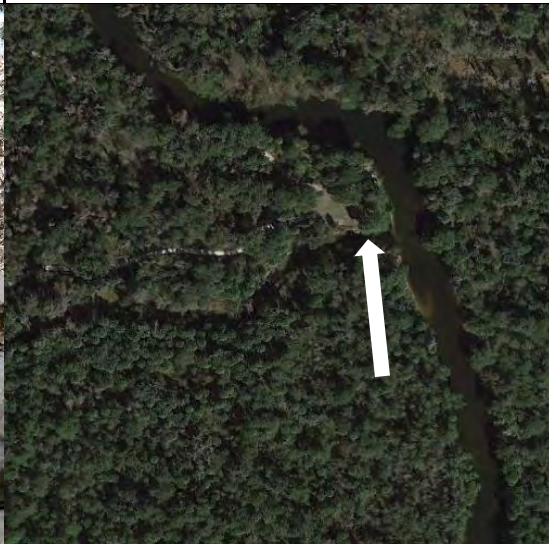
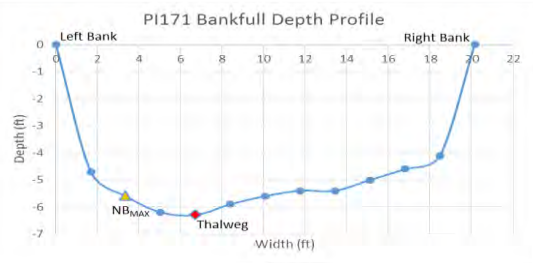
Payne Creek			Severity Scale: 3.5-Low	
Watershed: Peace River Subwatershed: Lower Payne Creek Latitude: 27.61920 Longitude: -81.82048			County: Hardee Site Number: PI171 Reach Length: 55 ft. Landowner: TIITF/ DIV REC & PARKS

Pfankuch-Channel Stability:	Good	0		
Channel Alteration:	None	0		
Bank Erosion:	Active	1		
BEHI:	Moderate (28.86)	0.5		
Local NPSP:	No Evidence	0		
Shoring Structures:	Present	1.5		
Pipe Discharge:	None	0		
Water Odor:	Normal	0		
Fish Passage Barrier:	None	0		
RB: Riparian Buffer:	100 ft.	0		
LB: Riparian Buffer:	40 ft.	0.5		
RB: Floodplain Access:	Full	0		
LB: Floodplain Access:	Full	0		
Severity Scale:		3.5		
Notes: 303d: NA			Additional Site Features	
Restoration Option 1			Stream Channel Woody Material: Infrequent	
			Impoundments: None	
			Substrate Composition: Medium Sand	
			Bank Material: Sand	
			Near Bank Stress: High	
			RB Landuse: Natural Forest

LB Landuse: State Park, Natural Forest

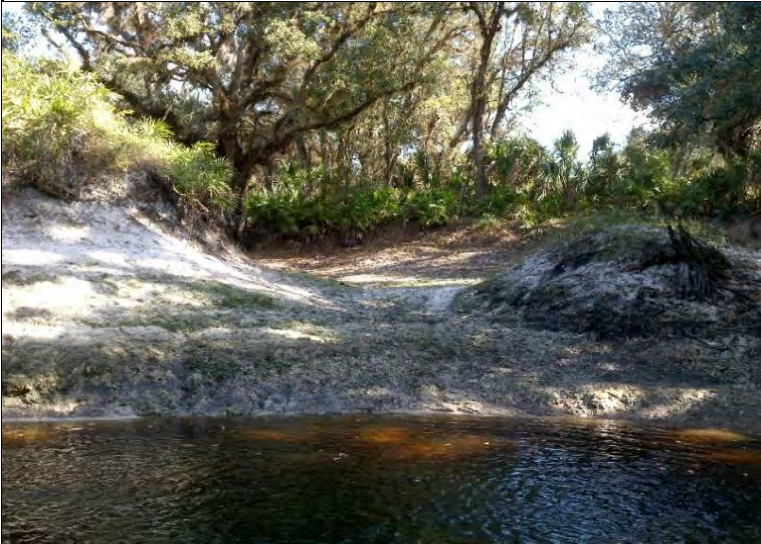
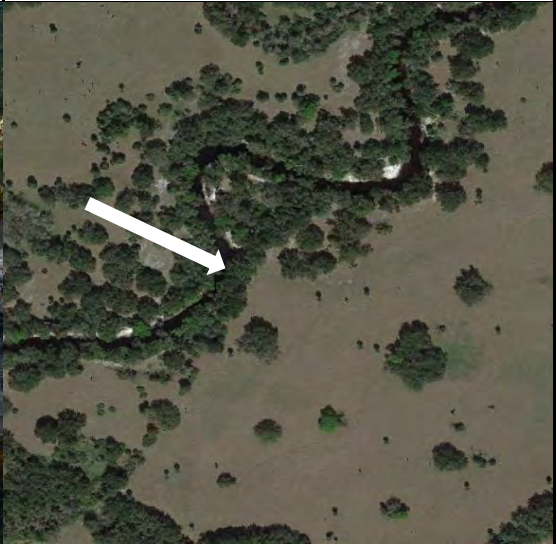
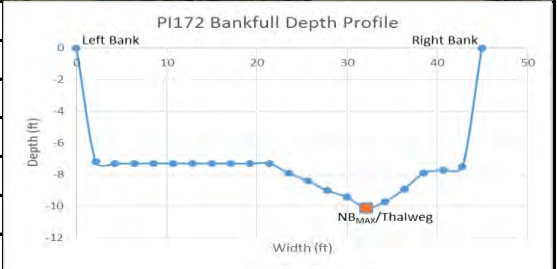
Charlie Creek			Severity Scale: 5.0-Moderate
Watershed: Peace River Subwatershed: Lower Charlie Creek Latitude: 27.35881 Longitude: -81.81635			County: Hardee Site Number: PI172 Reach Length: 48 ft. Landowner: Ben Hill Griffin Inc.

Risk Factor	Ranking	Score	
Pfankuch-Channel Stability:	Good	0	
Channel Alteration:	None	0	
Bank Erosion:	Active	1	
BEHI:	Very High (42.06)	1.5	
Local NPSP:	Obvious Sources	1.5	
Shoring Structures:	None	0	
Pipe Discharge:	None	0	
Water Odor:	Normal	0	
Fish Passage Barrier:	None	0	
RB: Riparian Buffer:	100 ft.	0	
LB: Riparian Buffer:	40 ft.	0.5	
RB: Floodplain Access:	Partial	0.25	
LB: Floodplain Access:	Partial	0.25	
Severity Scale:		5.0	
303d: Impaired - Fecal Coliform			
Restoration Option 1

Additional Site Features
Stream Channel Woody Material: Infrequent
Impoundments: None
Substrate Composition: Medium Sand
Bank Material: Sand
Near Bank Stress: High
RB Landuse: Natural Forest, Pasture
LB Landuse: Pasture, Natural Forest

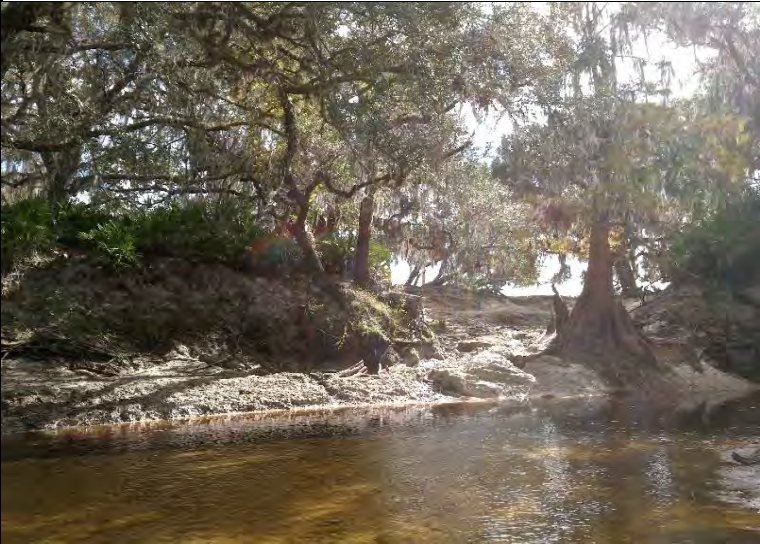
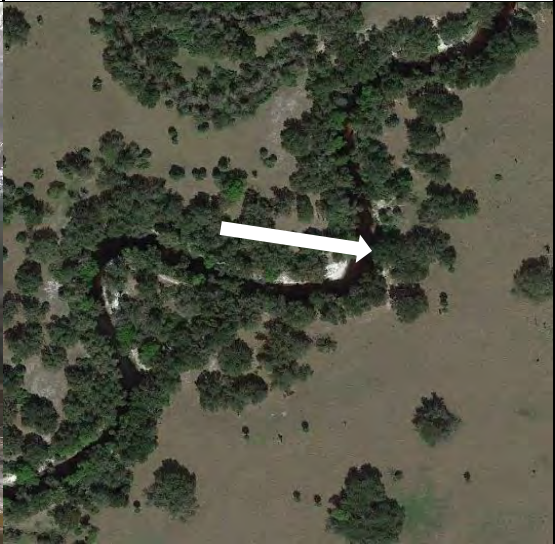
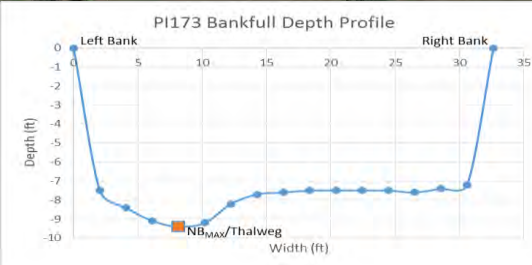
Charlie Creek			Severity Scale: 4.75-Moderate
Watershed: Peace River Subwatershed: Lower Charlie Creek Latitude: 27.36011 Longitude: -81.81487			County: Hardee Site Number: PI173 Reach Length: 173 ft. Landowner: Ben Hill Griffin Inc.

Risk Factor	Ranking	Score	
Pfankuch-Channel Stability:	Good	0	
Channel Alteration:	None	0	
Bank Erosion:	Active	1	
BEHI:	High (35.78)	1	
Local NPSP:	Obvious Sources	1.5	
Shoring Structures:	None	0	
Pipe Discharge:	None	0	<b>Additional Site Features</b> Stream Channel Woody Material: Moderate Impoundments: None Substrate Composition: Medium Sand Bank Material: Sand Near Bank Stress: High RB Landuse: Natural Forest LB Landuse: Pasture, Natural Forest
Water Odor:	Normal	0	
Fish Passage Barrier:	None	0	
RB: Riparian Buffer:	100 ft.	0	
LB: Riparian Buffer:	20 ft.	0.75	
RB: Floodplain Access:	Partial	0.25	
LB: Floodplain Access:	Partial	0.25	
<b>Severity Scale:</b>		<b>4.75</b>

303d: Impaired - Fecal Coliform			
Restoration Option 1

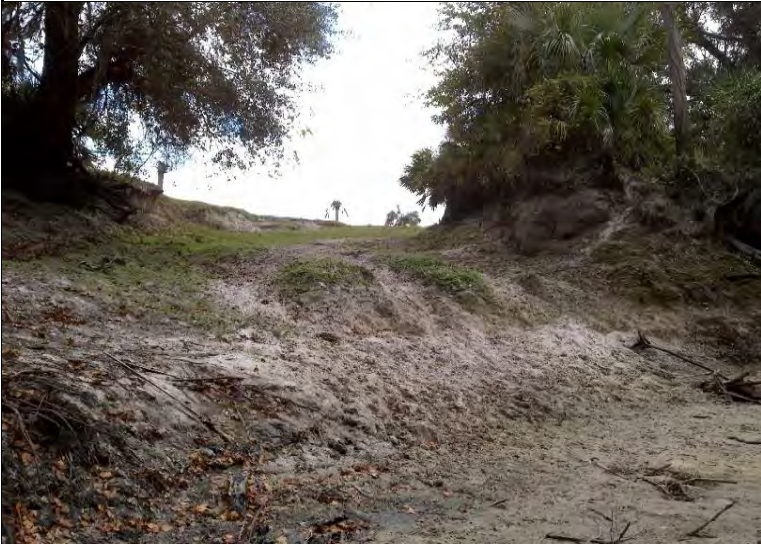
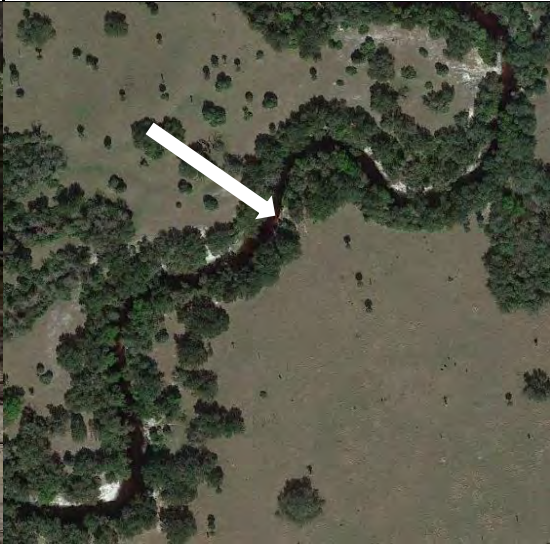
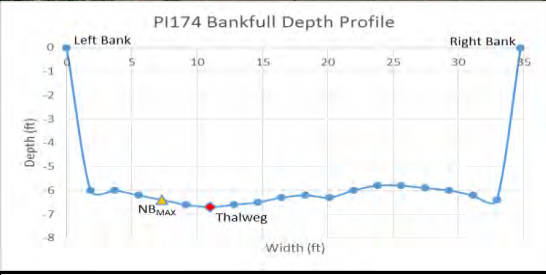
Charlie Creek			Severity Scale: 5.75-Moderate
Watershed: Peace River Subwatershed: Lower Charlie Creek Latitude: 27.36153 Longitude: -81.81394			County: Hardee Site Number: PI174 Reach Length: 19 ft. Landowner: Ben Hill Griffin Inc.

Pfankuch-Channel Stability:	Good	0	
Channel Alteration:	None	0	
Bank Erosion:	Active	1	
BEHI:	Very High (41.75)	1.5	
Local NPSP:	Obvious Sources	1.5	
Shoring Structures:	None	0	
Pipe Discharge:	None	0	
Water Odor:	Normal	0	
Fish Passage Barrier:	None	0	
RB: Riparian Buffer:	40 ft.	0.5	
LB: Riparian Buffer:	0 ft.	0.75	
RB: Floodplain Access:	Partial	0.25	
LB: Floodplain Access:	Partial	0.25	
<b>Severity Scale:</b>		<b>5.75</b>	<b>Additional Site Features</b>
			Stream Channel Woody Material: Infrequent
			Impoundments: None
			Substrate Composition: Medium Sand
			Bank Material: Sand
			Near Bank Stress: High
			RB Landuse: Pasture, Natural Forest

LB Landuse: Pasture
303d: Impaired - Fecal Coliform			
Restoration Option 1 or 2

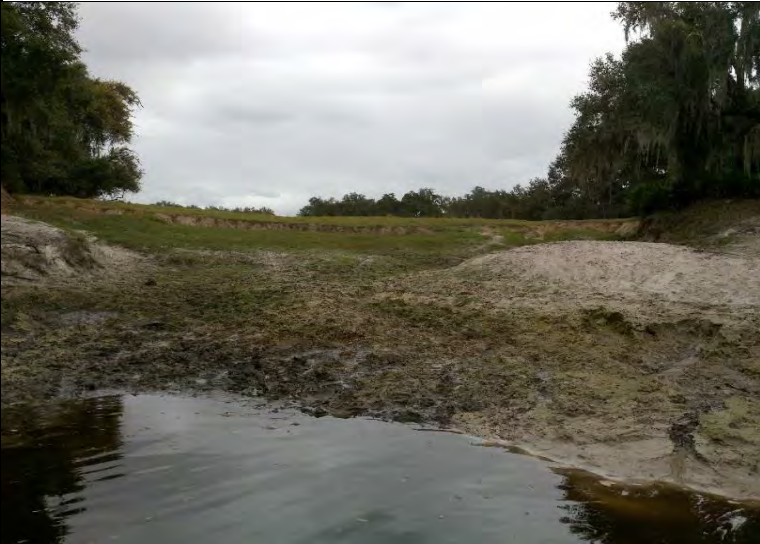
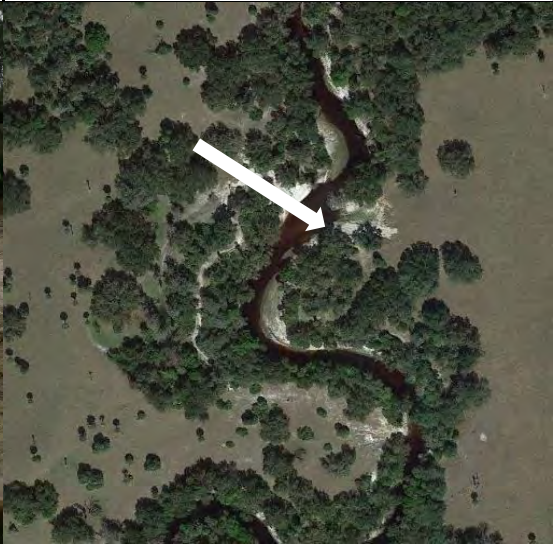
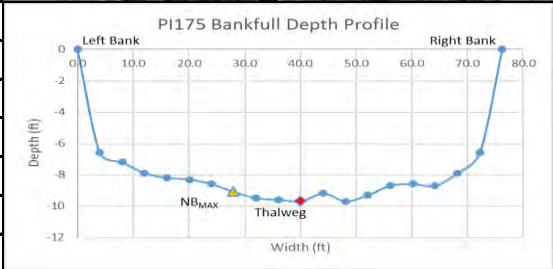
Charlie Creek			Severity Scale: 5.0-Moderate
Watershed: Peace River Subwatershed: Lower Charlie Creek Latitude: 27.36371 Longitude: -81.81294			County: Hardee Site Number: PI175 Reach Length: 88 ft. Landowner: Ben Hill Griffin Inc.

Risk Factor	Ranking	Score	
Pfankuch-Channel Stability:	Good	0	
Channel Alteration:	None	0	
Bank Erosion:	Active	1	
BEHI:	High (37.73)	1	
Local NPSP:	Obvious Sources	1.5	
Shoring Structures:	None	0	
Pipe Discharge:	None	0	
Water Odor:	Normal	0	
Fish Passage Barrier:	None	0	
RB: Riparian Buffer:	0 ft.	0.75	
LB: Riparian Buffer:	0 ft.	0.75	
RB: Floodplain Access:	Full	0	
LB: Floodplain Access:	Full	0	
<b>Severity Scale:</b>		<b>5.0</b>	
303d: Impaired - Fecal Coliform			
Restoration Option 2 or 3

Additional Site Features
Stream Channel Woody Material: Infrequent
Impoundments: None
Substrate Composition: Silt/Medium Sand
Bank Material: Sand
Near Bank Stress: Low
RB Landuse: Pasture, Natural Forest
LB Landuse: Pasture

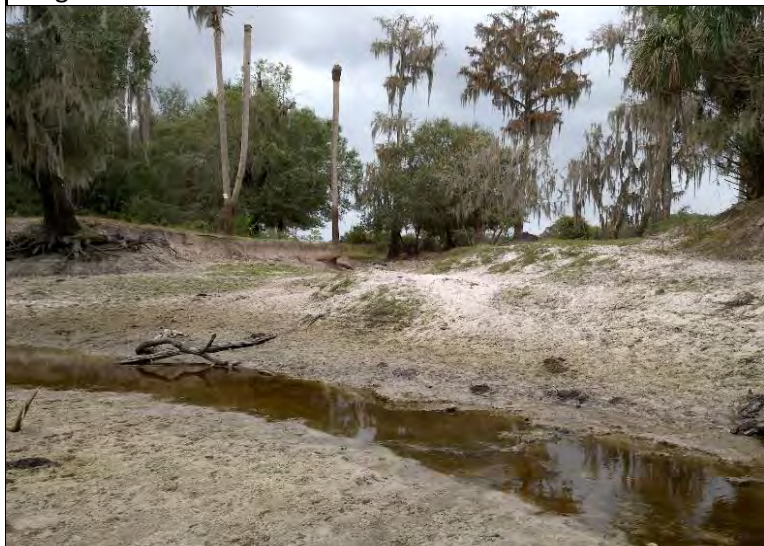
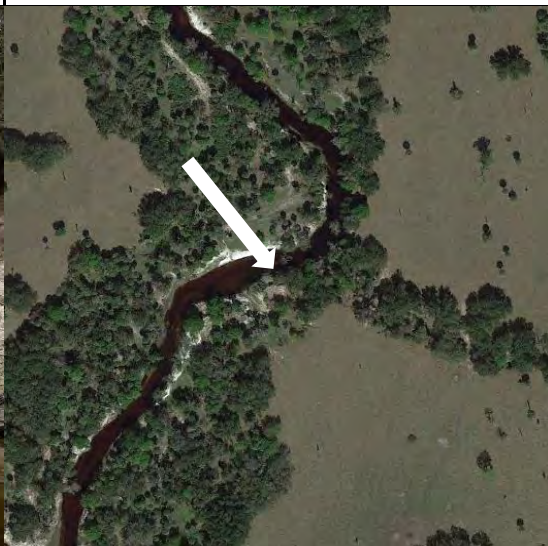
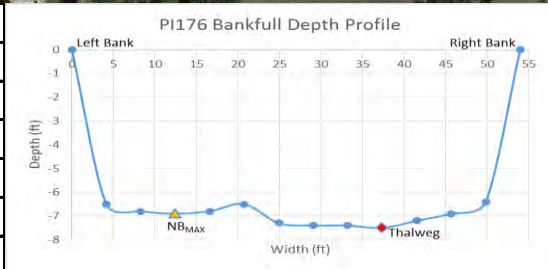
Risk Factor	Ranking	Score
Pfankuch-Channel Stability:	Good	0
Channel Alteration:	None	0
Bank Erosion:	Active	1
BEHI:	High (39.12)	1
Local NPSP:	Obvious Sources	1.5
Shoring Structures:	None	0
Pipe Discharge:	None	0
Water Odor:	Normal	0
Fish Passage Barrier:	None	0
RB: Riparian Buffer:	40 ft.	0.5
LB: Riparian Buffer:	40 ft.	0.5
RB: Floodplain Access:	Full	0
LB: Floodplain Access:	Partial	0.25
Severity Scale:		4.75

Additional Site Features
Stream Channel Woody Material: Infrequent
Impoundments: None
Substrate Composition: Medium Sand
Bank Material: Sand/Limestone
Near Bank Stress: Low
RB Landuse: Pasture, Natural Forest
LB Landuse: Pasture, Natural Forest

303d: Impaired - Fecal Coliform

Restoration Option 2 or 3

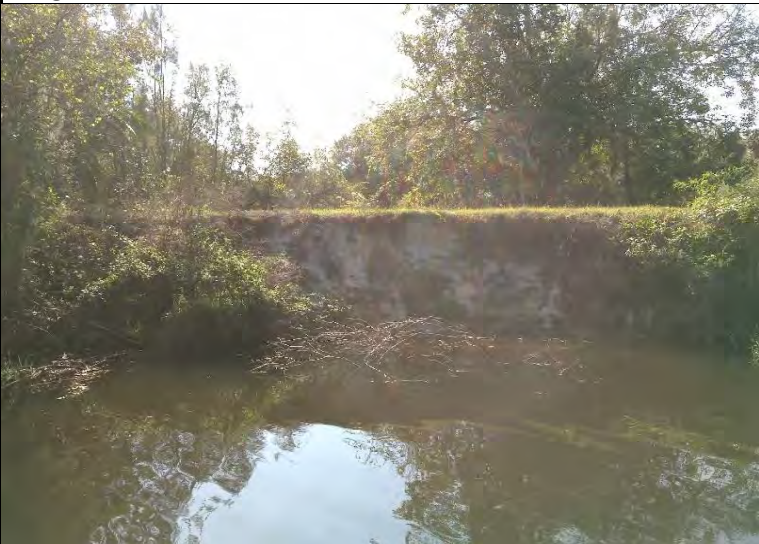
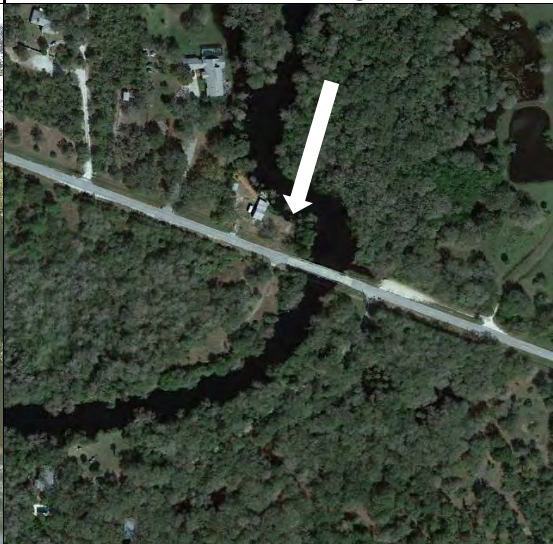
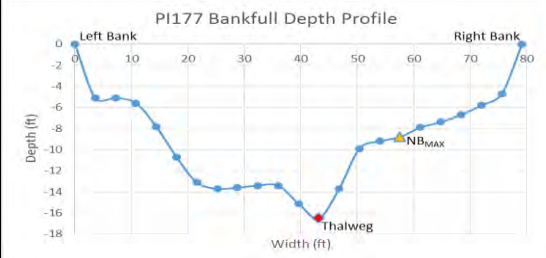
Prairie Creek			Severity Scale: 3.5-Low	
Watershed: Peace River Subwatershed: Lower Prairie Creek Latitude: 26.99107 Longitude: -81.89481			County: Charlotte Site Number: PI177 Reach Length: 20 ft. Landowner: Scott B Weinberg

Pfankuch-Channel Stability:	Good	0		
Channel Alteration:	None	0		
Bank Erosion:	Active	1		
BEHI:	High (35.49)	1		
Local NPSP:	Slight Potential	0.5		
Shoring Structures:	None	0		
Pipe Discharge:	None	0		
Water Odor:	Normal	0		
Fish Passage Barrier:	None	0		
RB: Riparian Buffer:	0 ft.	0.75	<b>Additional Site Features</b> Stream Channel Woody Material: Moderate Impoundments: None Substrate Composition: Medium Sand Bank Material: Sand Near Bank Stress: Moderate RB Landuse: Residential LB Landuse: Natural Forest	
LB: Riparian Buffer:	100 ft.	0		
RB: Floodplain Access:	Partial	0.25		
LB: Floodplain Access:	Full	0		
<b>Severity Scale:</b>		<b>3.5</b>

Notes: 303d: Impaired - Public water supply (DO, TDS)				
Restoration Option 1

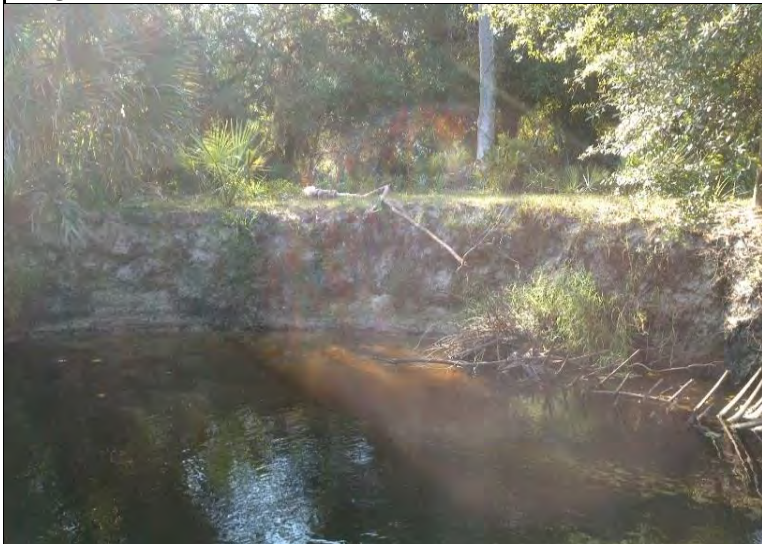
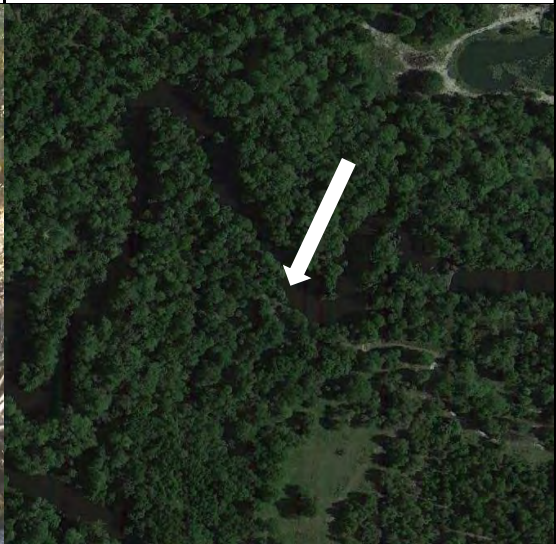
Prairie Creek			Severity Scale: 2.0-Low	
Watershed:Peace River Subwatershed: Lower Prairie Creek Latitude: 26.99524 Longitude: -81.89378			County: Charlotte Site Number: PI178 Reach Length: 24 ft. Landowner: OTTOCARS LLC

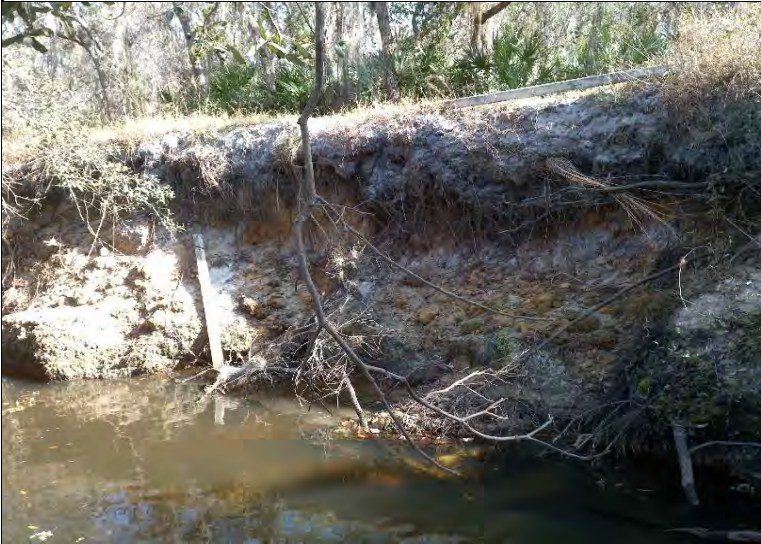
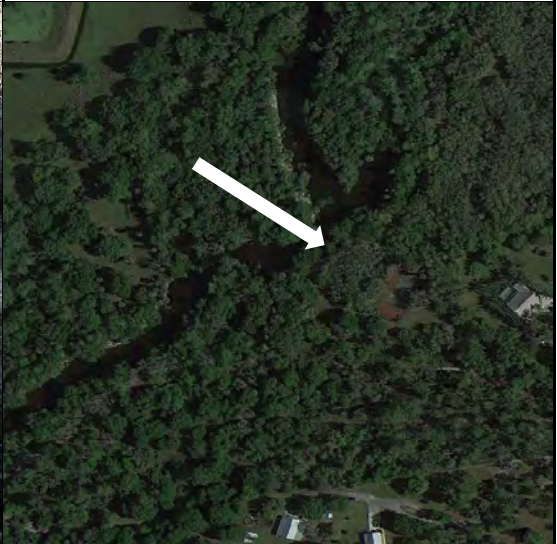
Prairie Creek			Severity Scale: 3.0-Low
Watershed: Peace River Subwatershed: Lower Prairie Creek Latitude: 26.99965 Longitude: -81.88410			County: Charlotte Site Number: PI179 Reach Length: 40 ft. Landowner: Prairie Creek Park

Pfankuch-Channel Stability:	Good	0	
Channel Alteration:	None	0	
Bank Erosion:	Mass-wasting	1.5	
BEHI:	High (32.97)	1	
Local NPSP:	No evidence	0	
Shoring Structures:	None	0	
Pipe Discharge:	None	0	
Water Odor:	Normal	0	
Fish Passage Barrier:	None	0	
RB: Riparian Buffer:	100 ft.	0	
LB: Riparian Buffer:	40 ft.	0.5	
RB: Floodplain Access:	Full	0	
LB: Floodplain Access:	Full	0	
Severity Scale:		3.0	<b>Additional Site Features</b> Stream Channel Woody Material: Infrequent Impoundments: None Substrate Composition: Medium Sand Bank Material: Sand Near Bank Stress: High RB Landuse: Natural Forest LB Landuse: Natural Forest, Recreation
Notes: 303d: Impaired - Public water supply (DO, TDS)

Restoration Option 1

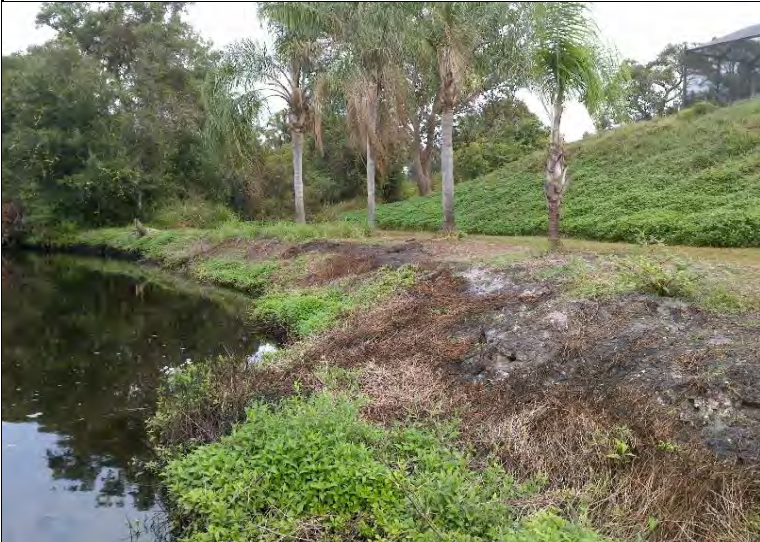
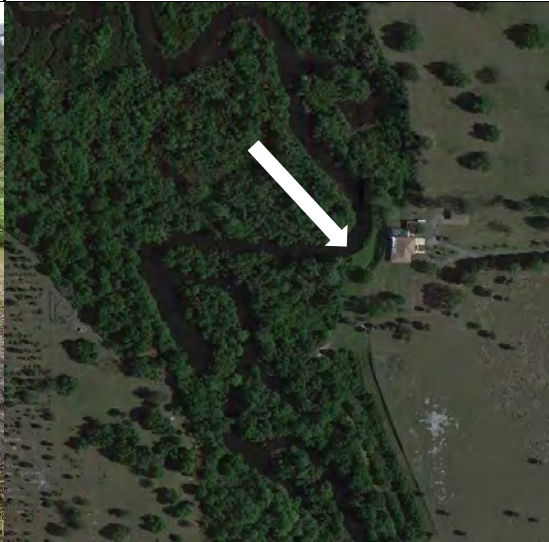
Myrtle Slough			Severity Scale: 4.75-Moderate	
Watershed: Peace River Subwatershed: Myrtle Slough Latitude: 26.97209 Longitude: -81.94208			County: Charlotte Site Number: PI180 Reach Length: 90 ft. Landowner: Hooijkaas Frank & AH TRS

Pfankuch-Channel Stability:	Good	0		
Channel Alteration:	None	0		
Bank Erosion:	Mass-wasting	1.5		
BEHI:	Moderate (25.48)	0.5		
Local NPSP:	Slight Potential	0.5		
Shoring Structures:	None	0		
Pipe Discharge:	Present	1.5		
Water Odor:	Normal	0		
Fish Passage Barrier:	None	0		
RB: Riparian Buffer:	0 ft.	0.75		
LB: Riparian Buffer:	100 ft.	0		
RB: Floodplain Access:	Full	0		
LB: Floodplain Access:	Full	0		
Severity Scale:		4.75		
Notes: Tidally influenced; 303d: Impaired - Aquatic life harvesting (DO, fecal, coliform, iron, mercury in fish tissue)			Additional Site Features	
			Stream Channel Woody Material: Infrequent	
Restoration Option 1			Impoundments: None

Substrate Composition: Medium Sand	
			Bank Material: Sand	
			Near Bank Stress: Moderate	
			RB Landuse: Natural Forest	
			LB Landuse: Residential

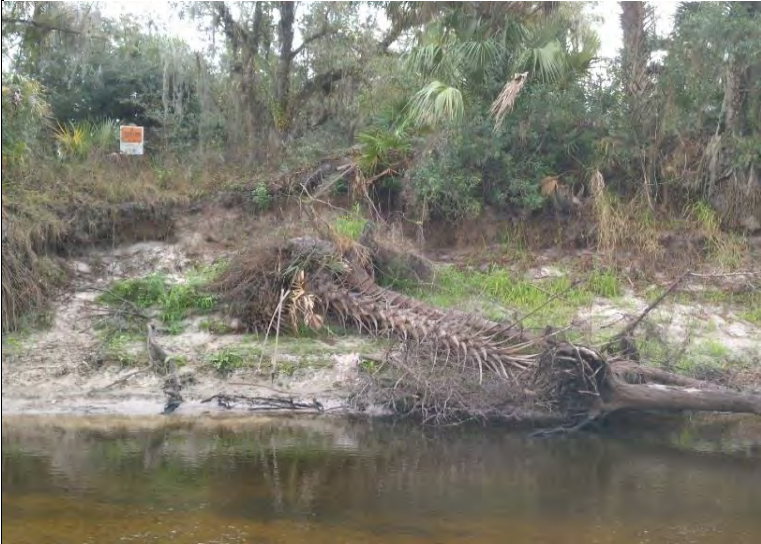
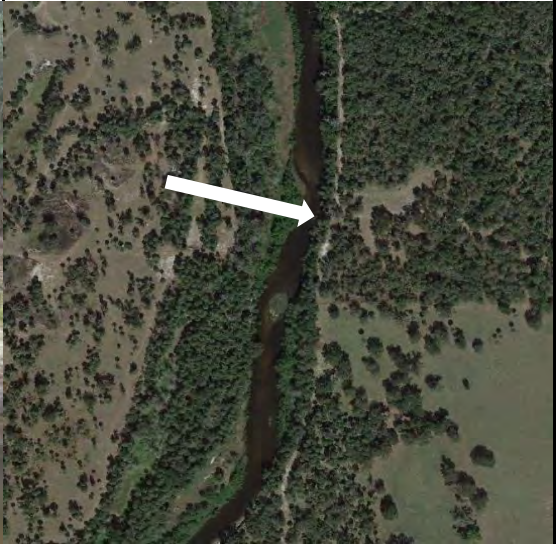
Peace River			Severity Scale: 5.25-Moderate
Watershed: Peace River Subwatershed: Troublesome Creek Latitude: 27.49326 Longitude: -81.80888			County: Hardee Site Number: PI181 Reach Length: 110 ft. Landowner: Kalhil Faryt as Trustee

Pfankuch-Channel Stability:	Poor	1.5	
Channel Alteration:	None	0	
Bank Erosion:	Active	1	
BEHI:	Moderate (29.58)	0.5	
Local NPSP:	Obvious Sources	1.5	
Shoring Structures:	None	0	
Pipe Discharge:	None	0	
Water Odor:	Normal	0	
Fish Passage Barrier:	None	0	
RB: Riparian Buffer:	100 ft.	0	
LB: Riparian Buffer:	40 ft.	0.5	
RB: Floodplain Access:	Full	0	
LB: Floodplain Access:	Partial	0.25	
<b>Severity Scale:</b>		<b>5.25</b>	
Notes: 303d: Impaired - Aquatic Life Harvesting (mercury in fish tissue), Chlorophyll-A			
Restoration Option 1

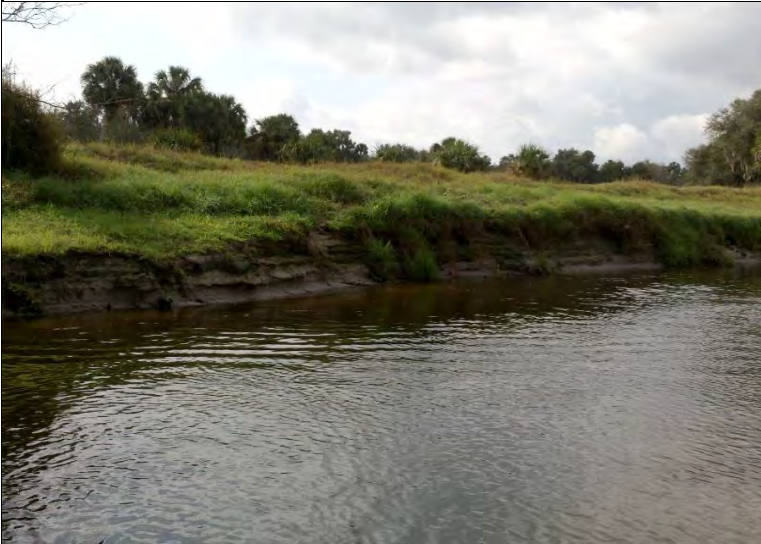
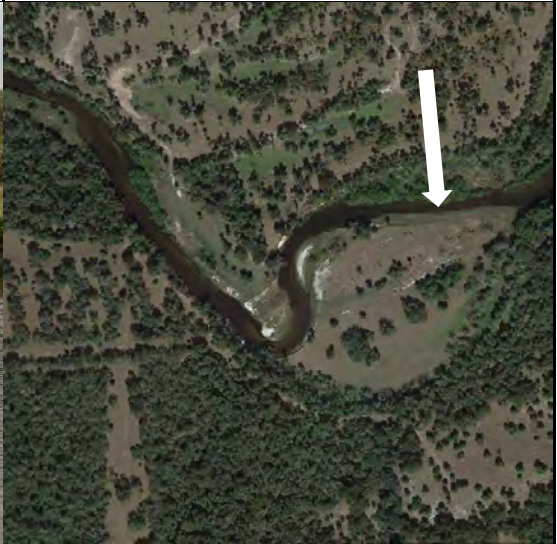
Peace River			Severity Scale: 6.25-Moderate
Watershed: Peace River Subwatershed: Troublesome Creek Latitude: 27.48955 Longitude: -81.81084			County: Hardee Site Number: PI182 Reach Length: 440 ft. Landowner: L & J Citrus and Cattle LLC

Pfankuch-Channel Stability:	Poor	1.5	
Channel Alteration:	None	0	
Bank Erosion:	Mass-wasting	1.5	
BEHI:	High (33.67)	1	
Local NPSP:	Obvious Sources	1.5	
Shoring Structures:	None	0	
Pipe Discharge:	None	0	
Water Odor:	Normal	0	
Fish Passage Barrier:	None	0	
RB: Riparian Buffer:	100 ft.	0	
LB: Riparian Buffer:	0 ft.	0.75	
RB: Floodplain Access:	Full	0	
LB: Floodplain Access:	Full	0	
<b>Severity Scale:</b>		<b>6.25</b>	<b>Additional Site Features</b>
			Stream Channel Woody Material: Infrequent
			Impoundments: None
			Substrate Composition: Medium Sand
			Bank Material: Sand
			Near Bank Stress: High
			RB Landuse: Natural Forest
			LB Landuse: Pasture, Natural Forest

Notes: 303d: Impaired - Aquatic Life Harvesting (mercury in fish tissue), Chlorophyll-A			
Restoration Option 1

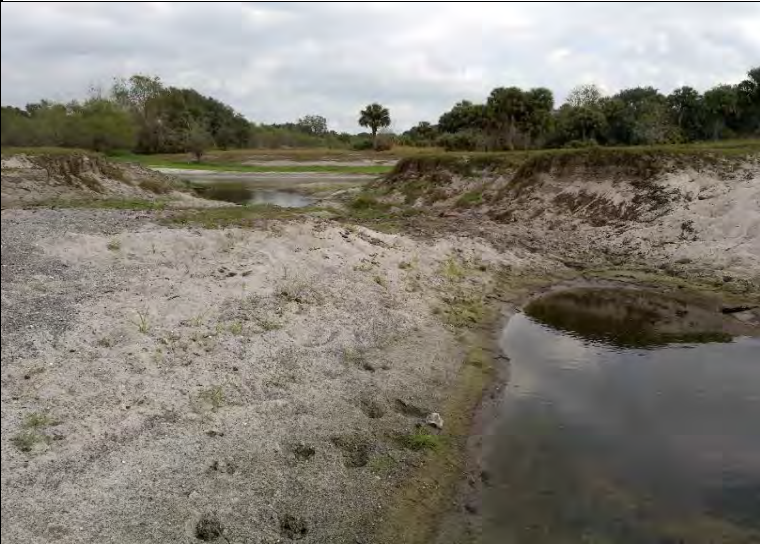
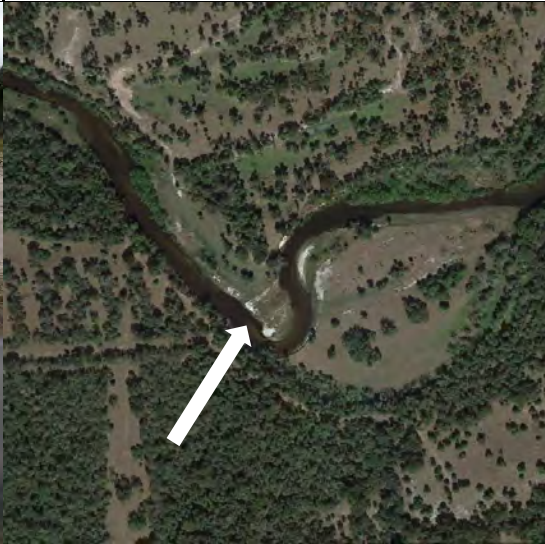
Peace River			Severity Scale: 6.0-Moderate
Watershed: Peace River Subwatershed: Troublesome Creek Latitude: 27.48875 Longitude: -81.81387			County: Hardee Site Number: PI183 Reach Length: 570 ft. Landowner: M & R Cattle Co. LLC

Pfankuch-Channel Stability:	Poor	1.5	
Channel Alteration:	None	0	
Bank Erosion:	Active	1	
BEHI:	High (37.49)	1	
Local NPSP:	Obvious Sources	1.5	
Shoring Structures:	None	0	
Pipe Discharge:	None	0	
Water Odor:	Normal	0	
Fish Passage Barrier:	None	0	
RB: Riparian Buffer:	0 ft.	0.75	
LB: Riparian Buffer:	100 ft.	0	
RB: Floodplain Access:	Full	0	
LB: Floodplain Access:	Partial	0.25	
<b>Severity Scale:</b>		<b>6.0</b>	<b>Additional Site Features</b>
			Stream Channel Woody Material: Numerous
			Impoundments: None
			Substrate Composition: Medium Sand
			Bank Material: Sand
			Near Bank Stress: Low
			RB Landuse: Pasture
			LB Landuse: Natural Forest

Notes: 303d: Impaired - Aquatic Life Harvesting (mercury in fish tissue), Chlorophyll-A			
Restoration Option 1, best to restore along with sites PI27, PI128 and PI129

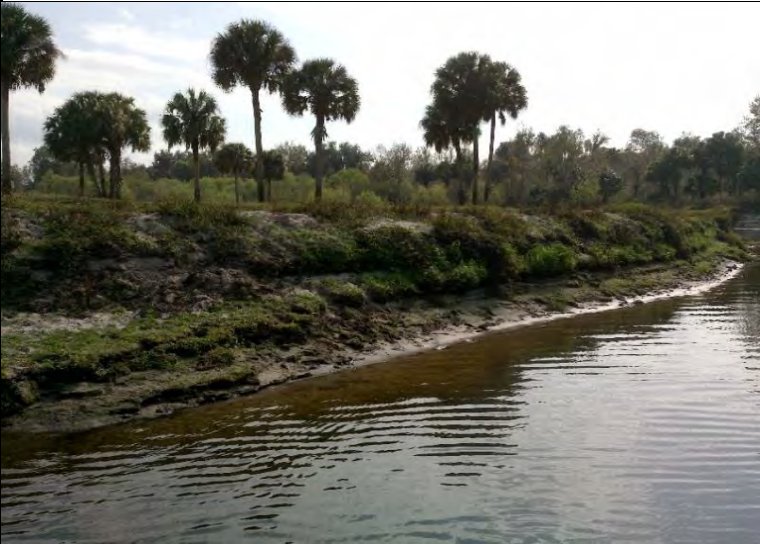
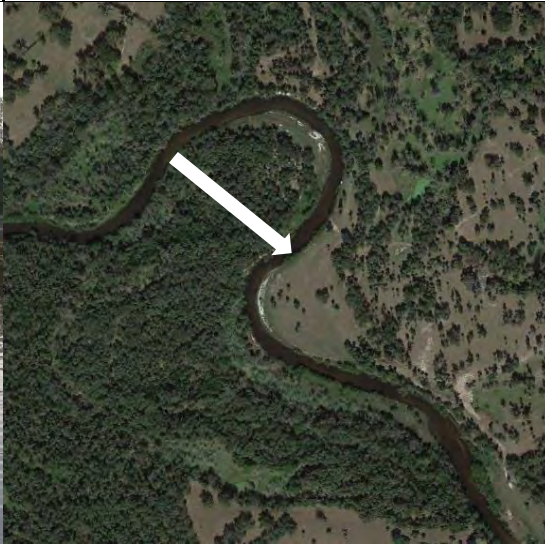
Peace River			Severity Scale: 5.75-Moderate
Watershed: Peace River Subwatershed: Troublesome Creek Latitude: 27.49222 Longitude: -81.81722			County: Hardee Site Number: PI184 Reach Length: 860 ft. Landowner: M & R Cattle Co. LLC

Risk Factor	Ranking	Score	
Pfankuch-Channel Stability:	Poor	1.5	
Channel Alteration:	None	0	
Bank Erosion:	Active	1	
BEHI:	Moderate (29.54)	0.5	
Local NPSP:	Obvious Sources	1.5	
Shoring Structures:	None	0	
Pipe Discharge:	None	0	
Water Odor:	Normal	0	
Fish Passage Barrier:	None	0	
RB: Riparian Buffer:	0 ft.	0.75	
LB: Riparian Buffer:	60 ft.	0.25	
RB: Floodplain Access:	Full	0	
LB: Floodplain Access:	Partial	0.25	
<b>Severity Scale:</b>		<b>5.75</b>	
Notes: 303d: Impaired - Aquatic Life Harvesting (mercury in fish tissue), Chlorophyll-A			
Restoration Option 1, best to restored along with site PI278

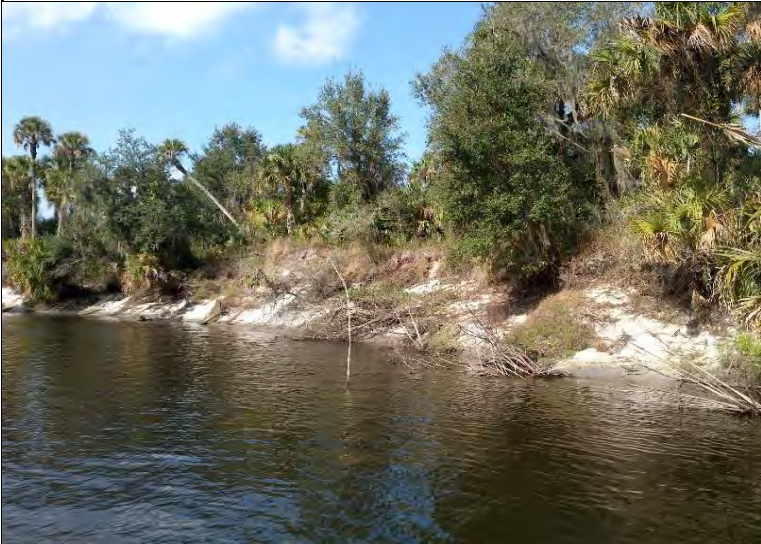
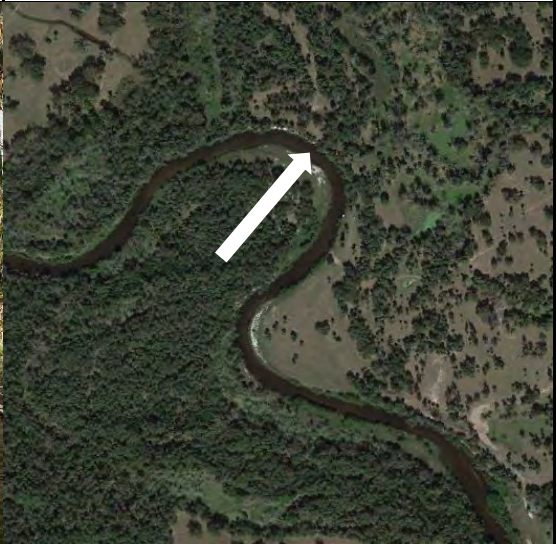
Peace River			Severity Scale: 5.75-Moderate
Watershed: Peace River Subwatershed: Troublesome Creek Latitude: 27.49405 Longitude: -81.81743			County: Hardee Site Number: PI185 Reach Length: 410 ft. Landowner: M & R Cattle Co. LLC

Pfankuch-Channel Stability:	Poor	1.5	
Channel Alteration:	None	0	
Bank Erosion:	Active	1	
BEHI:	Moderate (28.94)	0.5	
Local NPSP:	Obvious Sources	1.5	
Shoring Structures:	None	0	
Pipe Discharge:	None	0	
Water Odor:	Normal	0	
Fish Passage Barrier:	None	0	
RB: Riparian Buffer:	40 ft.	0.5	
LB: Riparian Buffer:	0 ft.	0.75	
RB: Floodplain Access:	Full	0	
LB: Floodplain Access:	Full	0	
<b>Severity Scale:</b>		<b>5.75</b>	<b>Additional Site Features</b>
			Stream Channel Woody Material: Numerous
			Impoundments: None
			Substrate Composition: Medium Sand
			Bank Material: Sand
			Near Bank Stress: High
			RB Landuse: Pasture, Natural Forest
			LB Landuse: Pasture

Notes: 303d: Impaired - Aquatic Life Harvesting (mercury in fish tissue), Chlorophyll-A			
Restoration Option 1

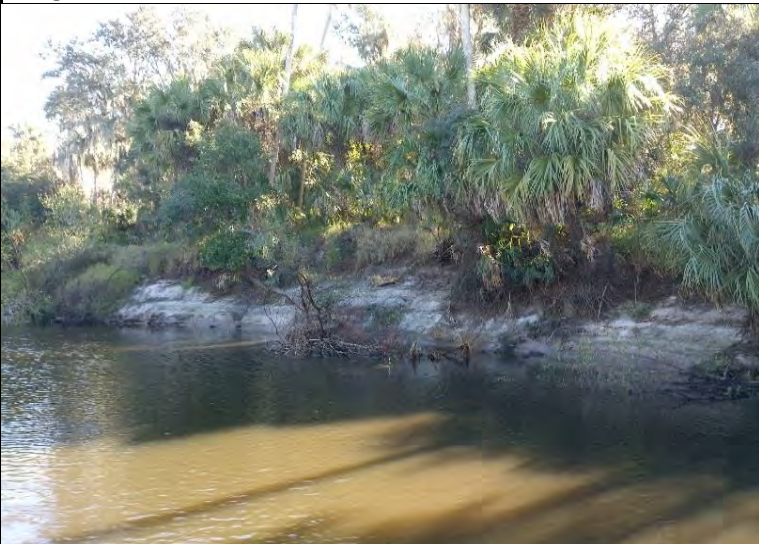
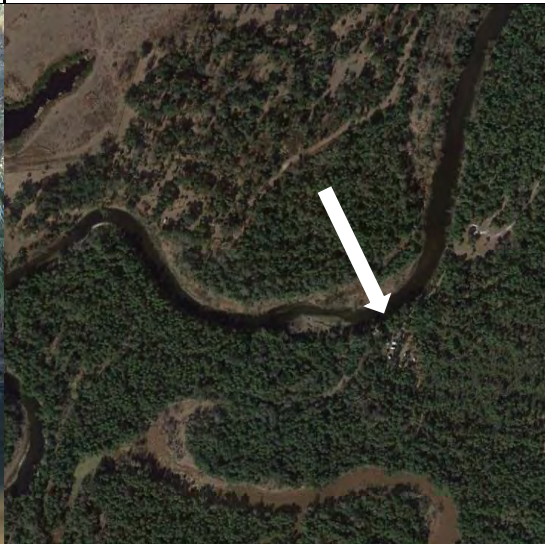
Peace River			Severity Scale: 4.0-Low	
Watershed: Peace River Subwatershed: Troublesome Creek Latitude: 27.48674 Longitude: -81.82354			County: Hardee Site Number: PI186 Reach Length: 200 ft. Landowner: L & J Citrus and Cattle LLC

Pfankuch-Channel Stability:	Poor	1.5		
Channel Alteration:	None	0		
Bank Erosion:	Active	1		
BEHI:	High (34.68)	1		
Local NPSP:	No Evidence	0		
Shoring Structures:	None	0		
Pipe Discharge:	None	0		
Water Odor:	Normal	0		
Fish Passage Barrier:	None	0		
RB: Riparian Buffer:	100 ft.	0		
LB: Riparian Buffer:	60 ft.	0.25		
RB: Floodplain Access:	Full	0		
LB: Floodplain Access:	Partial	0.25		
Severity Scale:		4.0	Additional Site Features	
			Stream Channel Woody Material: Moderate	
			Impoundments: None	
			Substrate Composition: Medium Sand	
			Bank Material: Sand	
			Near Bank Stress: High	
			RB Landuse: Natural Forest	
			LB Landuse: Natural Forest, Residential

Notes: 303d: Impaired - Aquatic Life Harvesting (mercury in fish tissue), Chlorophyll-A				
Restoration Option 1

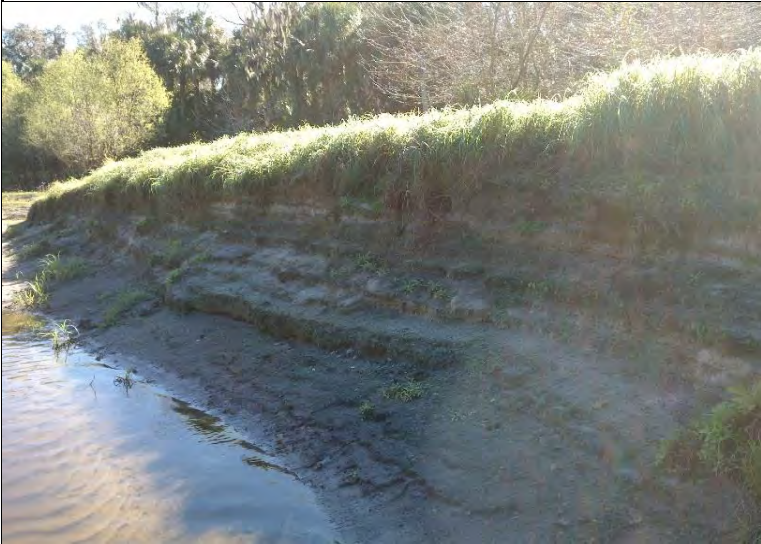
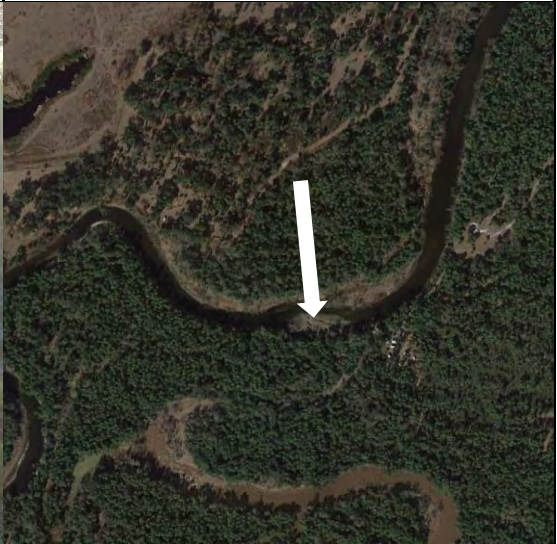
Peace River			Severity Scale: 3.25-Low	
Watershed: Peace River Subwatershed: Troublesome Creek Latitude: 27.48634 Longitude: -81.82451			County: Hardee Site Number: PI187 Reach Length: 115 ft. Landowner: Griffin Fannie Race & Others

Pfankuch-Channel Stability:	Poor	1.5		
Channel Alteration:	None	0		
Bank Erosion:	Active	1		
BEHI:	Moderate (29.27)	0.5		
Local NPSP:	No Evidence	0		
Shoring Structures:	None	0		
Pipe Discharge:	None	0		
Water Odor:	Normal	0		
Fish Passage Barrier:	None	0		
RB: Riparian Buffer:	100 ft.	0		
LB: Riparian Buffer:	60 ft.	0.25		
RB: Floodplain Access:	Full	0	<b>Additional Site Features</b>	
LB: Floodplain Access:	Full	0		
<b>Severity Scale:</b>		<b>3.25</b>	Stream Channel Woody Material: Infrequent	
Notes: 303d: Impaired - Aquatic Life Harvesting (mercury in fish tissue), Chlorophyll-A  Restoration Option 2 or 3			Impoundments: None	
			Substrate Composition: Medium Sand

Bank Material: Sand	
			Near Bank Stress: Low	
			RB Landuse: Natural Forest	
			LB Landuse: Natural Forest, Residential
