# **Peace River and Withlacoochee River Threats Assessments and Fish Assemblage Monitoring**

**Final Report July 1, 2015 – June 30, 2019**

Submitted to Florida State Wildlife Grants Program  
August 1, 2019  
PID: 98462501284

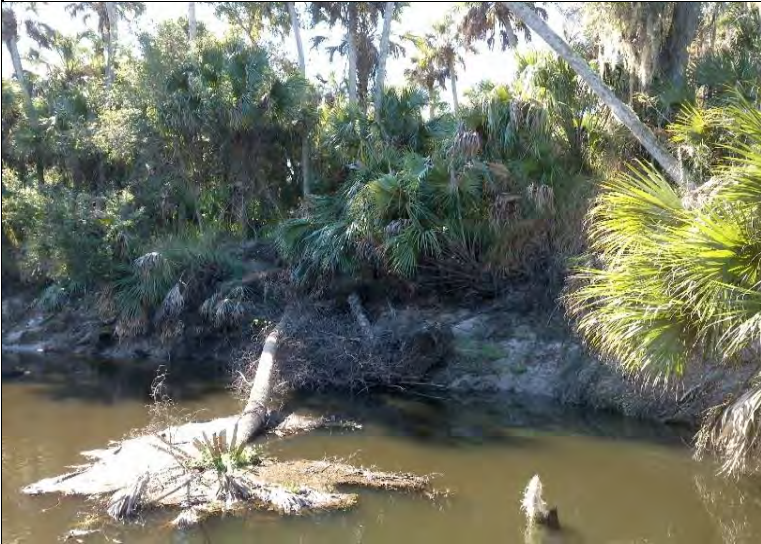
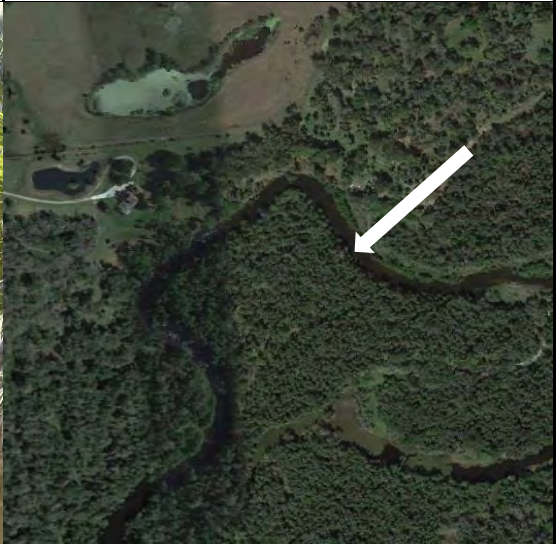
Peace River			Severity Scale: 3.25-Low	
Watershed: Peace River Subwatershed: Troublesome Creek Latitude: 27.48640 Longitude: -81.82580			County: Hardee Site Number: PI188 Reach Length: 525 ft. Landowner: Clarence Wendell Cole

Pfankuch-Channel Stability:	Poor	1.5		
Channel Alteration:	None	0		
Bank Erosion:	Active	1		
BEHI:	Moderate (28.04)	0.5		
Local NPSP:	No Evidence	0		
Shoring Structures:	None	0		
Pipe Discharge:	None	0		
Water Odor:	Normal	0		
Fish Passage Barrier:	None	0		
RB: Riparian Buffer:	100 ft.	0		
LB: Riparian Buffer:	100 ft.	0		
RB: Floodplain Access:	Full	0	Additional Site Features	
LB: Floodplain Access:	Partial	0.25		
Severity Scale:		3.25	Stream Channel Woody Material: Numerous	
Notes: 303d: Impaired - Aquatic Life Harvesting (mercury in fish tissue), Chlorophyll-A			Impoundments: None	
			Substrate Composition: Medium Sand	
			Bank Material: Sand

Near Bank Stress: High	
Restoration Option 1			RB Landuse: Natural Forest	
			LB Landuse: Natural Forest

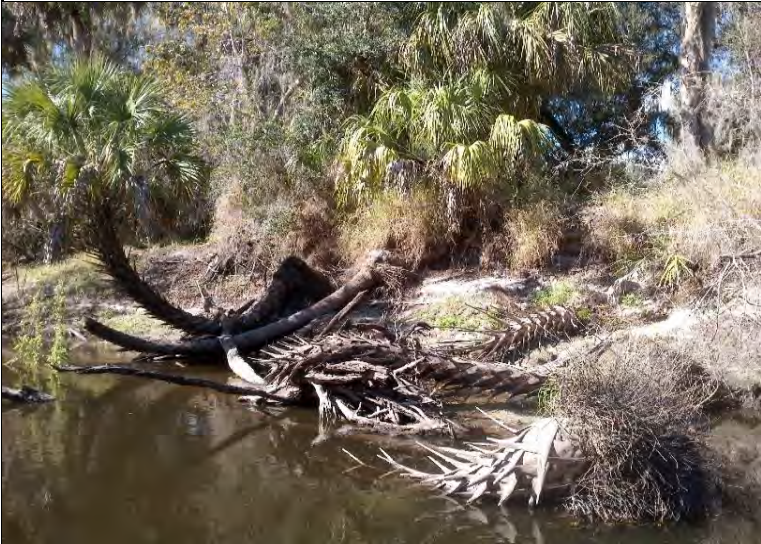
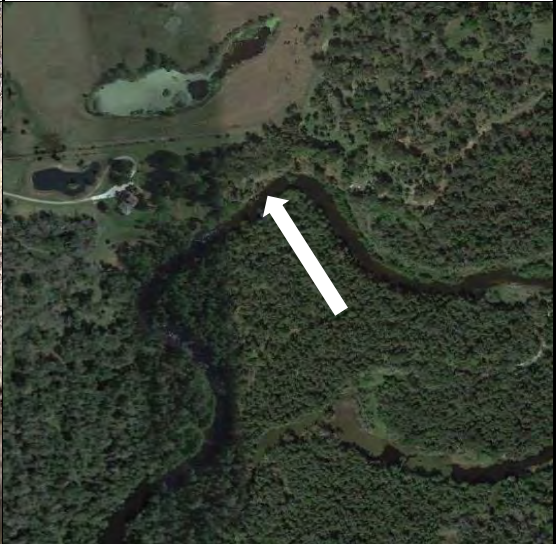
Peace River			Severity Scale: 5.5-Moderate
Watershed: Peace River Subwatershed: Troublesome Creek Latitude: 27.48732 Longitude: -81.82758			County: Hardee Site Number: PI189 Reach Length: 125 ft. Landowner: Clarence Wendell Cole

Pfankuch-Channel Stability:	Poor	1.5	
Channel Alteration:	None	0	
Bank Erosion:	Active	1	
BEHI:	Moderate (28.31)	0.5	
Local NPSP:	Obvious Sources	1.5	
Shoring Structures:	None	0	
Pipe Discharge:	None	0	
Water Odor:	Normal	0	
Fish Passage Barrier:	None	0	
RB: Riparian Buffer:	40 ft.	0.5	Additional Site Features
LB: Riparian Buffer:	100 ft.	0	
RB: Floodplain Access:	Partial	0.25	
LB: Floodplain Access:	Partial	0.25	
Severity Scale:		5.5	
Notes: 303d: Impaired - Aquatic Life Harvesting (mercury in fish tissue), Chlorophyll-A			
Restoration Option 1

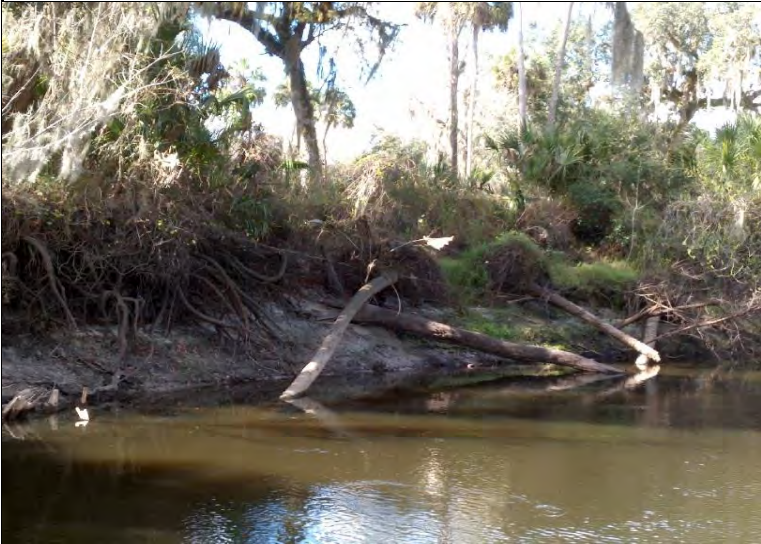
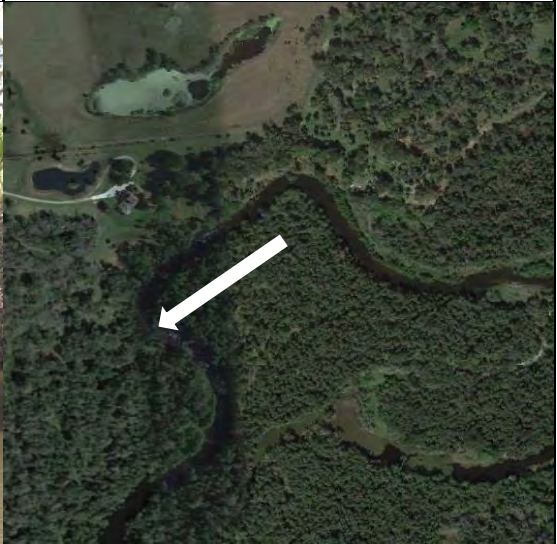
Peace River			Severity Scale: 5.25-Moderate
Watershed: Peace River Subwatershed: Troublesome Creek Latitude: 27.48574 Longitude: -81.82845			County: Hardee Site Number: PI190 Reach Length: 175 ft. Landowner: Clarence Wendell Cole

Risk Factor	Ranking	Score	
Pfankuch-Channel Stability:	Poor	1.5	
Channel Alteration:	None	0	
Bank Erosion:	Active	1	
BEHI:	Moderate (25.20)	0.5	
Local NPSP:	Obvious Sources	1.5	
Shoring Structures:	None	0	
Pipe Discharge:	None	0	<b>Additional Site Features</b> Stream Channel Woody Material: Numerous Impoundments: None Substrate Composition: Medium Sand Bank Material: Sand Near Bank Stress: Low RB Landuse: Pasture, Natural Forest LB Landuse: Natural Forest
Water Odor:	Normal	0	
Fish Passage Barrier:	None	0	
RB: Riparian Buffer:	40 ft.	0.5	
LB: Riparian Buffer:	100 ft.	0	
RB: Floodplain Access:	Partial	0.25	
LB: Floodplain Access:	Full	0	
<b>Severity Scale:</b>		<b>5.25</b>

Notes: 303d: Impaired - Aquatic Life Harvesting (mercury in fish tissue), Chlorophyll-A			
Restoration Option 1

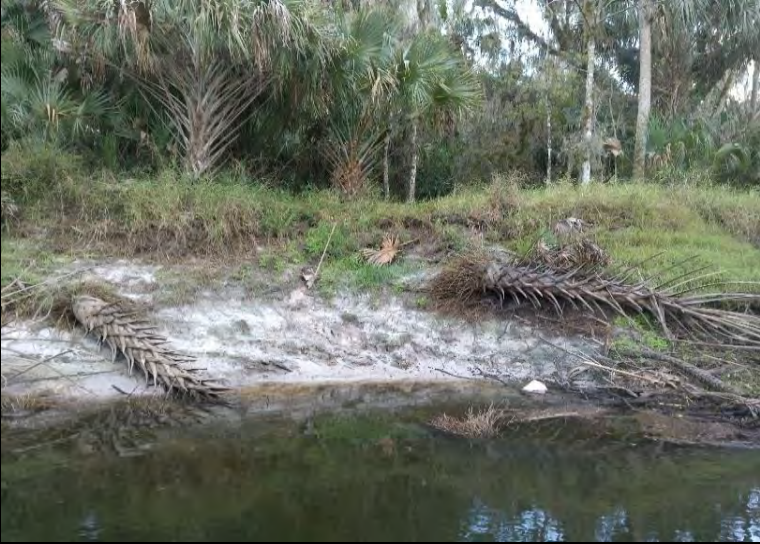
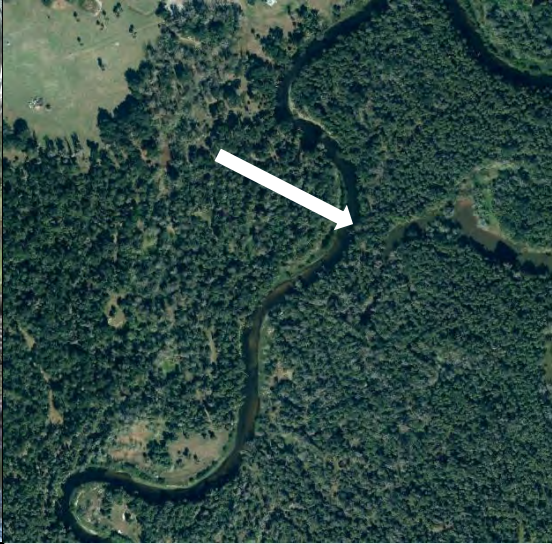
Peace River			Severity Scale: 3.0-Low
Watershed: Peace River Subwatershed: Troublesome Creek Latitude: 27.48396 Longitude: -81.82889			County: Hardee Site Number: PI191 Reach Length: 675 ft. Landowner: Frederick Willard D Jr.

Pfankuch-Channel Stability:	Poor	1.5	
Channel Alteration:	None	0	
Bank Erosion:	Active	1	
BEHI:	Moderate (24.67)	0.5	
Local NPSP:	No Evidence	0	
Shoring Structures:	None	0	
Pipe Discharge:	None	0	
Water Odor:	Normal	0	
Fish Passage Barrier:	None	0	
RB: Riparian Buffer:	100 ft.	0	
LB: Riparian Buffer:	100 ft.	0	
RB: Floodplain Access:	Full	0	
LB: Floodplain Access:	Full	0	
<b>Severity Scale:</b>		<b>3.0</b>	
Notes: 303d: Impaired - Aquatic Life Harvesting (mercury in fish tissue), Chlorophyll-A			
Restoration Option 1

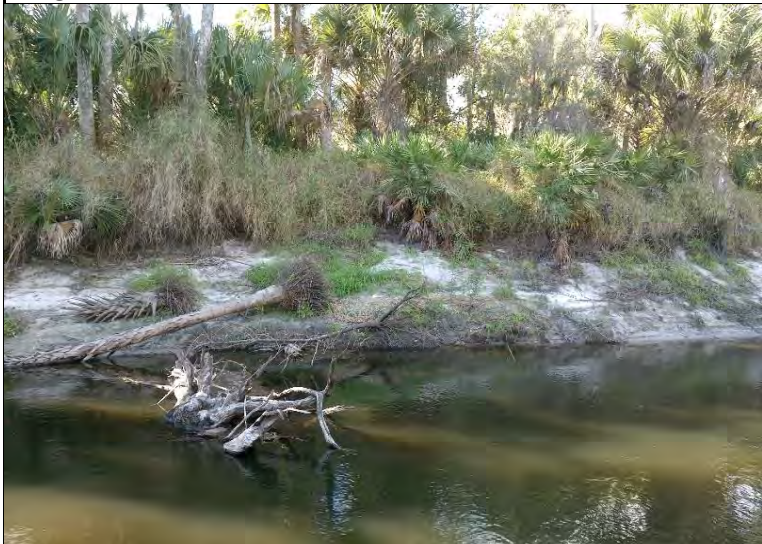
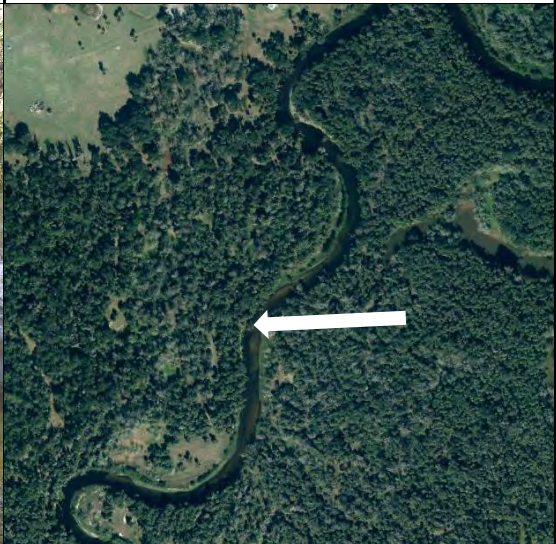
Peace River			Severity Scale: 3.75-Low
Watershed: Peace River Subwatershed: Troublesome Creek Latitude: 27.48372 Longitude: -81.82909			County: Hardee Site Number: PI192 Reach Length: 245 ft. Landowner: Frederick Willard D Jr.

Pfankuch-Channel Stability:	Poor	1.5	
Channel Alteration:	None	0	
Bank Erosion:	Active	1	
BEHI:	High (31.44)	1	
Local NPSP:	No Evidence	0	
Shoring Structures:	None	0	
Pipe Discharge:	None	0	
Water Odor:	Normal	0	
Fish Passage Barrier:	None	0	
RB: Riparian Buffer:	100 ft.	0	Additional Site Features
LB: Riparian Buffer:	100 ft.	0	Stream Channel Woody Material: Numerous
RB: Floodplain Access:	Partial	0.25	Impoundments: None
LB: Floodplain Access:	Full	0	Substrate Composition: Medium Sand
Severity Scale: 3.75			Bank Material: Sand
			Near Bank Stress: Moderate
			RB Landuse: Natural Forest
			LB Landuse: Natural Forest
Notes: 303d: Impaired - Aquatic Life Harvesting (mercury in fish tissue), Chlorophyll-A

Restoration Option 1

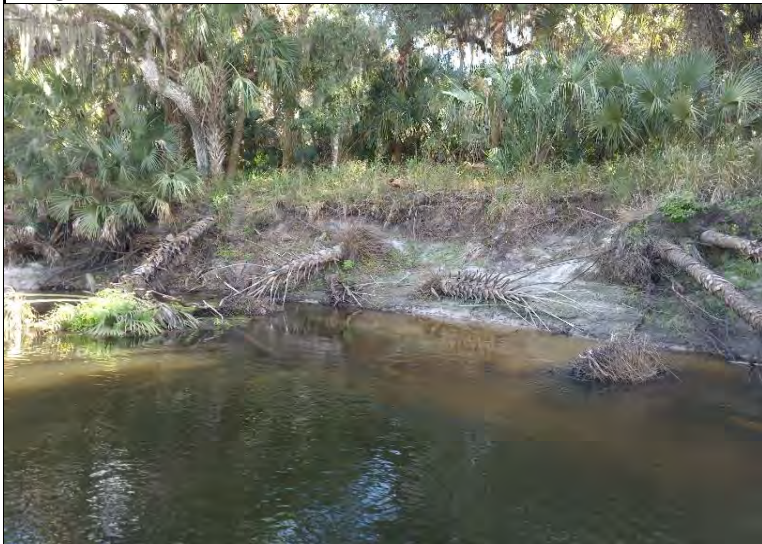
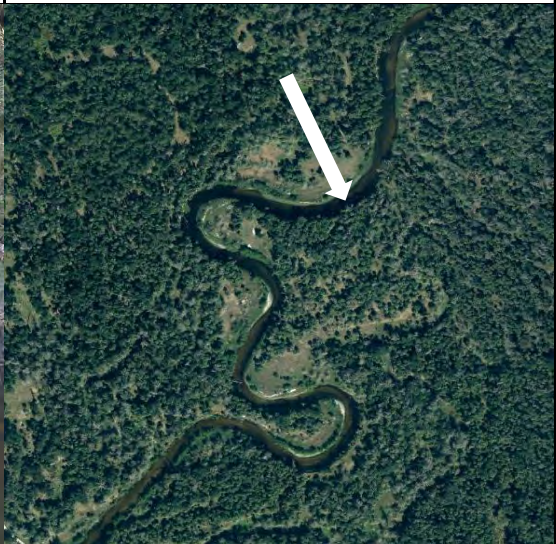
Peace River			Severity Scale: 3.75-Low	
Watershed: Peace River Subwatershed: Troublesome Creek Latitude: 27.48186 Longitude: -81.83077			County: Hardee Site Number: PI193 Reach Length: 580 ft. Landowner: Frederick Willard D Jr.

Pfankuch-Channel Stability:	Poor	1.5		
Channel Alteration:	None	0		
Bank Erosion:	Active	1		
BEHI:	Moderate (28.16)	0.5		
Local NPSP:	No Evidence	0		
Shoring Structures:	None	0		
Pipe Discharge:	None	0		
Water Odor:	Normal	0		
Fish Passage Barrier:	None	0		
			Additional Site Features	
RB: Riparian Buffer:	40 ft.	0.5	Stream Channel Woody Material: Numerous	
LB: Riparian Buffer:	100 ft.	0	Impoundments: None	
RB: Floodplain Access:	Full	0	Substrate Composition: Medium Sand	
LB: Floodplain Access:	Partial	0.25	Bank Material: Sand	
			Near Bank Stress: High	
			RB Landuse: Pasture, Natural Forest	
			LB Landuse: Natural Forest	
Severity Scale: 3.75

Notes: 303d: Impaired - Aquatic Life Harvesting (mercury in fish tissue), Chlorophyll-A				
Restoration Option 1

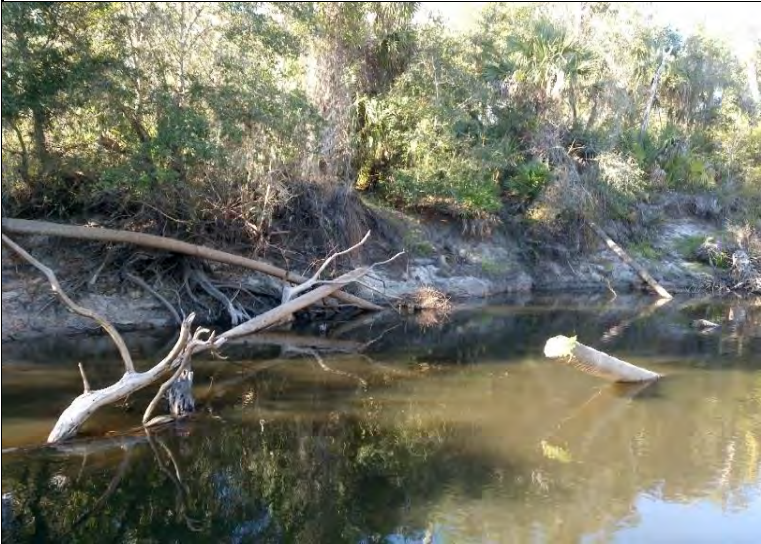
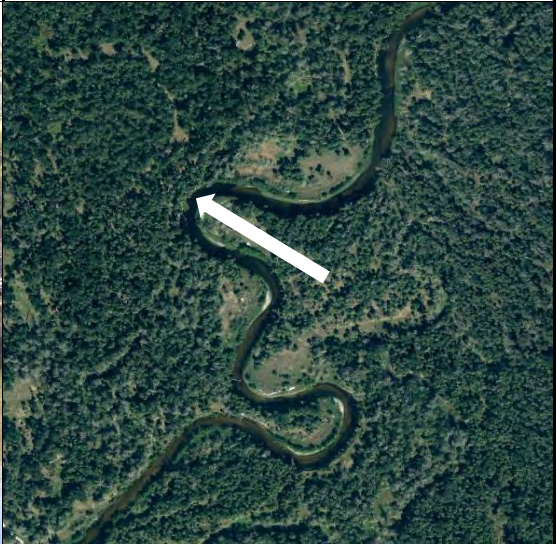
Peace River			Severity Scale: 4.5-Moderate
Watershed: Peace River Subwatershed: Troublesome Creek Latitude: 27.48113 Longitude: -81.83076			County: Hardee Site Number: PI194 Reach Length: 500 ft. Landowner: Frederick Willard D Jr.

Pfankuch-Channel Stability:	Poor	1.5	
Channel Alteration:	None	0	
Bank Erosion:	Active	1	
BEHI:	Moderate (27.38)	0.5	
Local NPSP:	Slight Potential	0.5	
Shoring Structures:	None	0	
Pipe Discharge:	None	0	
Water Odor:	Normal	0	
Fish Passage Barrier:	None	0	
			Additional Site Features
RB: Riparian Buffer:	60 ft.	0.25	Stream Channel Woody Material: Extensive
LB: Riparian Buffer:	40 ft.	0.5	Impoundments: None
RB: Floodplain Access:	Partial	0.25	Substrate Composition: Medium Sand
LB: Floodplain Access:	Full	0	Bank Material: Sand
<b>Severity Scale:</b>			Near Bank Stress: Low
			RB Landuse: Natural Forest, Recreation
			LB Landuse: Natural Forest, Pasture

Notes: 303d: Impaired - Aquatic Life Harvesting (mercury in fish tissue), Chlorophyll-A			
Restoration Option 1

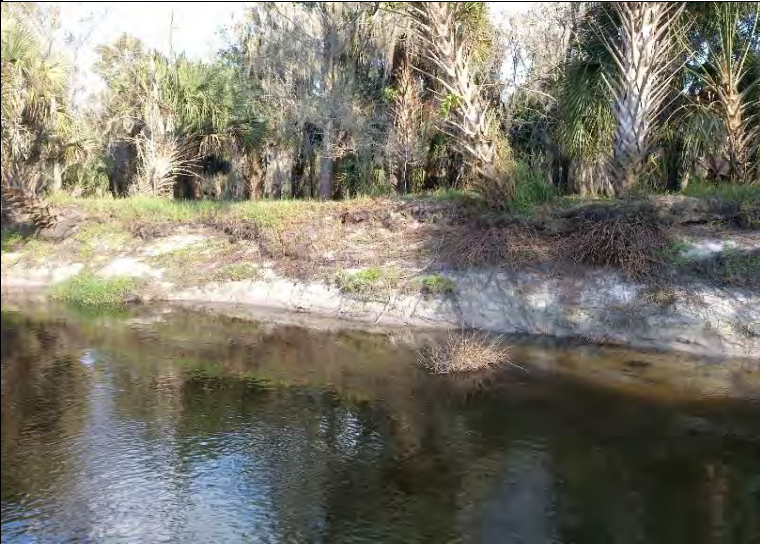
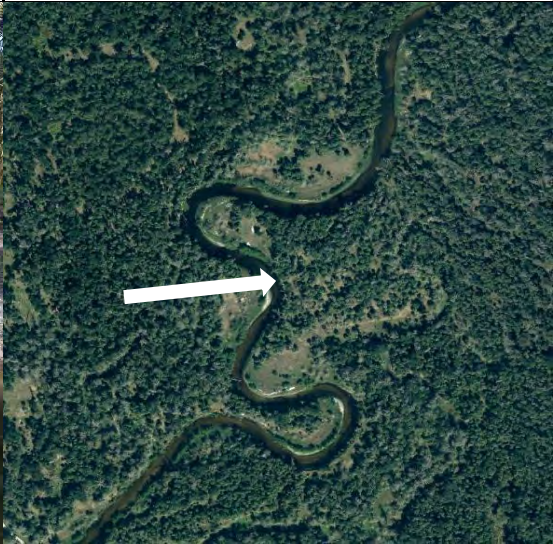
Peace River			Severity Scale: 5.5-Moderate
Watershed: Peace River Subwatershed: Troublesome Creek Latitude: 27.48042 Longitude: -81.83052			County: Hardee Site Number: PI195 Reach Length: 180 ft. Landowner: Frederick Willard D Jr.

Risk Factor	Ranking	Score	
Pfankuch-Channel Stability:	Poor	1.5	
Channel Alteration:	None	0	
Bank Erosion:	Active	1	
BEHI:	Moderate (23.83)	0.5	
Local NPSP:	Obvious Sources	1.5	
Shoring Structures:	None	0	
Pipe Discharge:	None	0	<b>Additional Site Features</b> Stream Channel Woody Material: Moderate Impoundments: None Substrate Composition: Medium Sand Bank Material: Sand Near Bank Stress: Moderate RB Landuse: Natural Forest, Pasture LB Landuse: Natural Forest, Pasture
Water Odor:	Normal	0	
Fish Passage Barrier:	None	0	
RB: Riparian Buffer:	40 ft.	0.5	
LB: Riparian Buffer:	40 ft.	0.5	
RB: Floodplain Access:	Full	0	
LB: Floodplain Access:	Full	0	
<b>Severity Scale:</b>		<b>5.5</b>

Notes: 303d: Impaired - Aquatic Life Harvesting (mercury in fish tissue), Chlorophyll-A			
Restoration Option 1

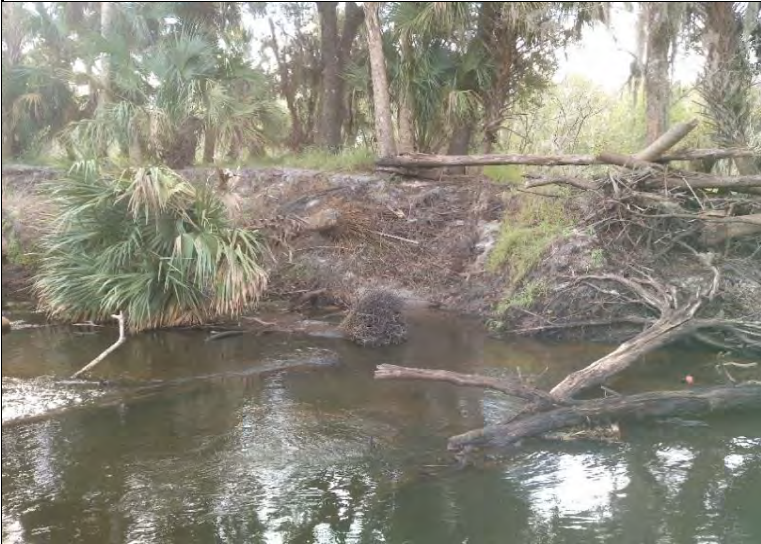
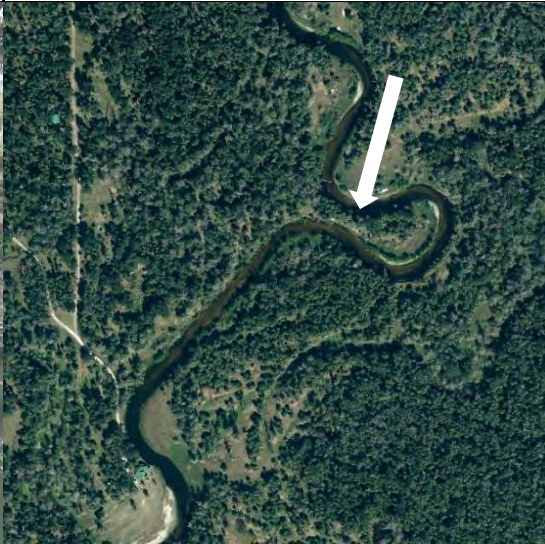
Peace River			Severity Scale: 5.0-Moderate
Watershed: Peace River Subwatershed: Troublesome Creek Latitude: 27.47971 Longitude: -81.83095			County: Hardee Site Number: PI196 Reach Length: 390 ft. Landowner: Frederick Willard D Jr.

Risk Factor	Ranking	Score	
Pfankuch-Channel Stability:	Poor	1.5	
Channel Alteration:	None	0	
Bank Erosion:	Active	1	
BEHI:	Moderate (25.55)	0.5	
Local NPSP:	Moderate Potential	1	
Shoring Structures:	None	0	
Pipe Discharge:	None	0	
Water Odor:	Normal	0	
Fish Passage Barrier:	None	0	
RB: Riparian Buffer:	60 ft.	0.25	
LB: Riparian Buffer:	40 ft.	0.5	
RB: Floodplain Access:	Partial	0.25	
LB: Floodplain Access:	Full	0	
<b>Severity Scale:</b>		<b>5.0</b>	
Notes: 303d: Impaired - Aquatic Life Harvesting (mercury in fish tissue), Chlorophyll-A			
Restoration Option 1, the Peace River is cutting a new channel and forming an oxbow, in this case the best option would be to cut the channel for the river and stabilize with toewood. This should be done in conjunction with sites PI132 and PI197

Additional Site Features
Stream Channel Woody Material: Extensive
Impoundments: None
Substrate Composition: Medium Sand
Bank Material: Sand
Near Bank Stress: High
RB Landuse: Natural Forest, Pasture
LB Landuse: Pasture, Natural Forest

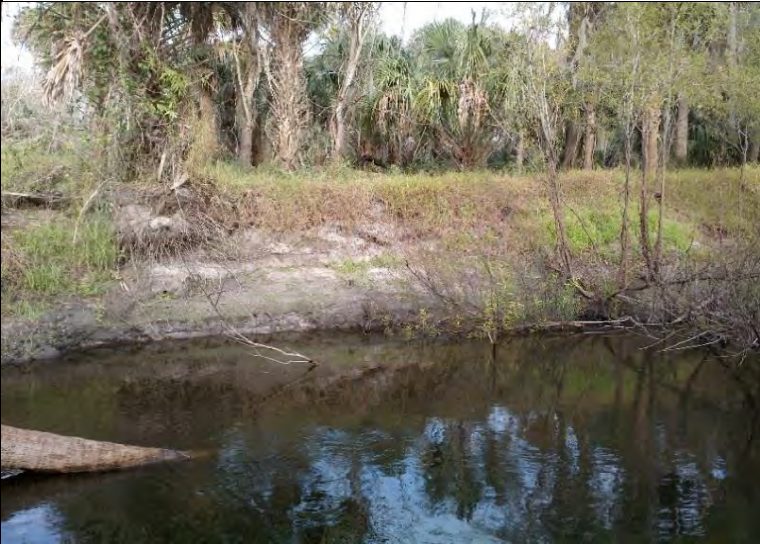
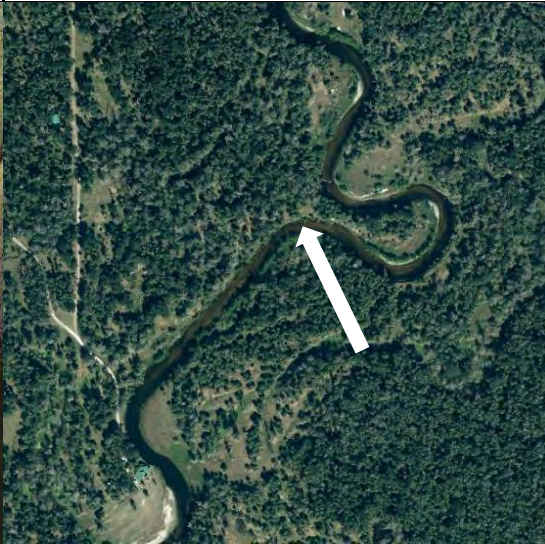
Peace River			Severity Scale: 5.0-Moderate
Watershed: Peace River Subwatershed: Troublesome Creek Latitude: 27.47883 Longitude: -81.83163			County: Hardee Site Number: PI197 Reach Length: 280 ft. Landowner: Frederick Willard D Jr.

Risk Factor	Ranking	Score	
Pfankuch-Channel Stability:	Poor	1.5	
Channel Alteration:	None	0	
Bank Erosion:	Active	1	
BEHI:	Moderate (24.85)	0.5	
Local NPSP:	Moderate Potential	1	
Shoring Structures:	None	0	
Pipe Discharge:	None	0	
Water Odor:	Normal	0	
Fish Passage Barrier:	None	0	
RB: Riparian Buffer:	60 ft.	0.25	
LB: Riparian Buffer:	40 ft.	0.5	
RB: Floodplain Access:	Partial	0.25	
LB: Floodplain Access:	Full	0	
<b>Severity Scale:</b>		<b>5.0</b>	
Notes: 303d: Impaired - Aquatic Life Harvesting (mercury in fish tissue), Chlorophyll-A			
Restoration Option 1, the Peace River is cutting a new channel and forming an oxbow, in this case the best option would be to cut the channel for the river and stabilize with toewood. This should be done in conjunction with sites PI132 and PI196

Additional Site Features
Stream Channel Woody Material: Moderate
Impoundments: None
Substrate Composition: Medium Sand
Bank Material: Sand
Near Bank Stress: High
RB Landuse: Natural Forest, Pasture
LB Landuse: Pasture, Natural Forest

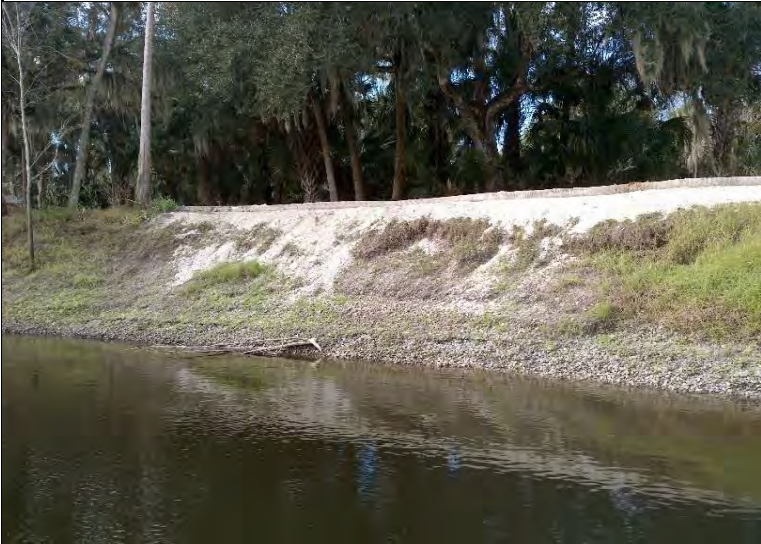
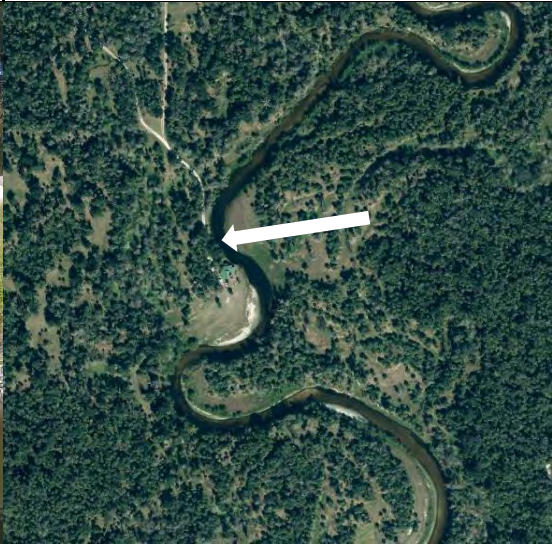
Peace River			Severity Scale: 9.25-High
Watershed: Peace River Subwatershed: Troublesome Creek Latitude: 27.47731 Longitude: -81.83303			County: Hardee Site Number: PI198 Reach Length: 300 ft. Landowner: Frederick Willard D Jr.

Risk Factor	Ranking	Score	
Pfankuch-Channel Stability:	Poor	1.5	
Channel Alteration:	None	0	
Bank Erosion:	Active	1	
BEHI:	Moderate (29.33)	0.5	
Local NPSP:	Obvious Sources	1.5	
Shoring Structures:	Present	1.5	
Pipe Discharge:	Present	1.5	
Water Odor:	Normal	0	
Fish Passage Barrier:	None	0	
RB: Riparian Buffer:	0 ft.	0.75	
LB: Riparian Buffer:	0 ft.	0.75	
RB: Floodplain Access:	Partial	0.25	
LB: Floodplain Access:	Full	0	
<b>Severity Scale:</b>		<b>9.25</b>	
Notes: 303d: Impaired - Aquatic Life Harvesting (mercury in fish tissue), Chlorophyll-A			
Restoration Option 1

Additional Site Features
Stream Channel Woody Material: Infrequent
Impoundments: None
Substrate Composition: Medium Sand
Bank Material: Sand
Near Bank Stress: Moderate
RB Landuse: Residential, Natural Forest
LB Landuse: Pasture

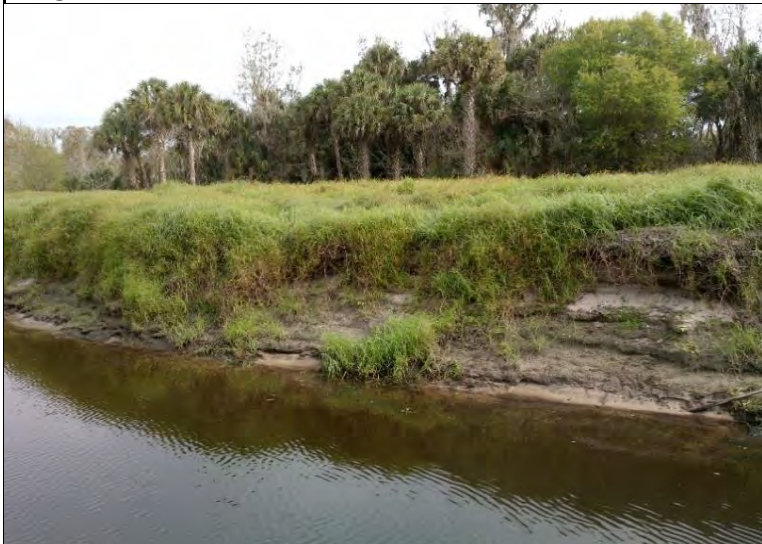
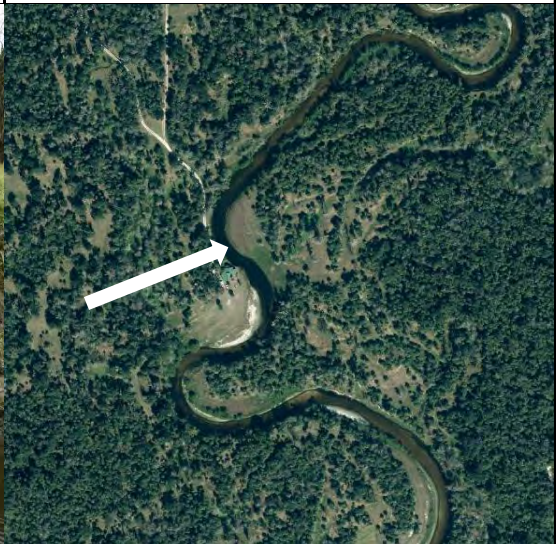
Peace River			Severity Scale: 6.25-Moderate
Watershed: Peace River Subwatershed: Troublesome Creek Latitude: 27.47634 Longitude: -81.83235			County: Hardee Site Number: PI199 Reach Length: 500 ft. Landowner: Frederick Willard D Jr.

Pfankuch-Channel Stability:	Poor	1.5	
Channel Alteration:	None	0	
Bank Erosion:	Active	1	
BEHI:	Moderate (24.77)	0.5	
Local NPSP:	Obvious Sources	1.5	
Shoring Structures:	None	0	
Pipe Discharge:	None	0	
Water Odor:	Normal	0	
Fish Passage Barrier:	None	0	
			Additional Site Features
RB: Riparian Buffer:	0 ft.	0.75	Stream Channel Woody Material: Infrequent
LB: Riparian Buffer:	0 ft.	0.75	Impoundments: None
RB: Floodplain Access:	Partial	0.25	Substrate Composition: Medium Sand
LB: Floodplain Access:	Full	0	Bank Material: Sand
			Near Bank Stress: Low
			RB Landuse: Residential, Natural Forest
			LB Landuse: Pasture
<b>Severity Scale:</b>			<b>6.25</b>

Notes: 303d: Impaired - Aquatic Life Harvesting (mercury in fish tissue), Chlorophyll-A			
Restoration Option 3

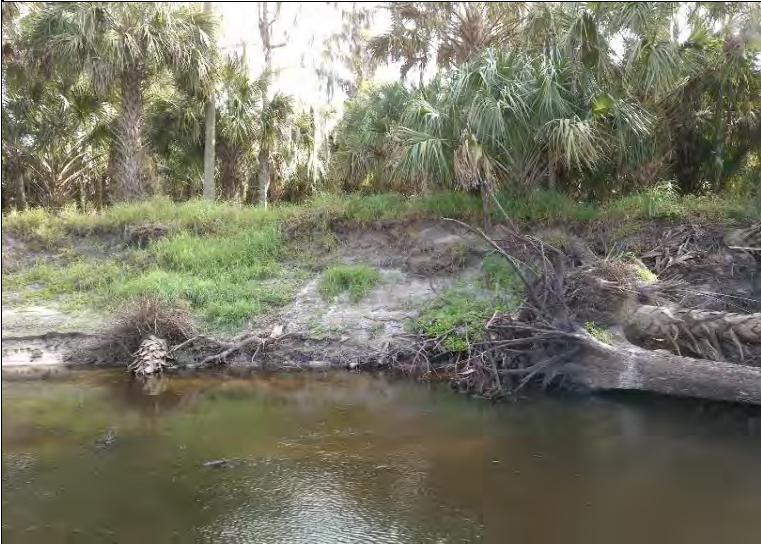
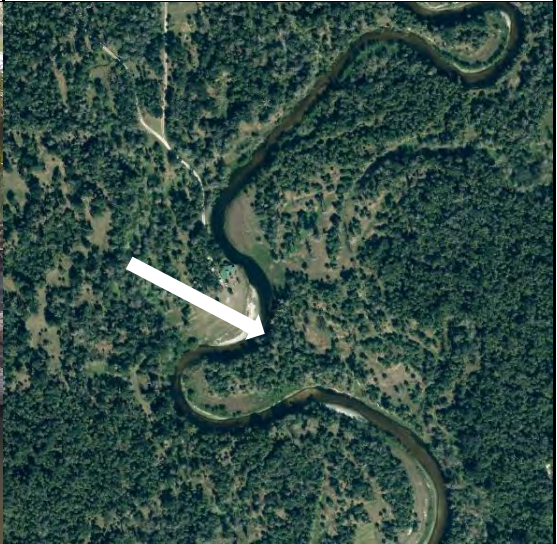
Peace River			Severity Scale: 6.5-Moderate
Watershed: Peace River Subwatershed: Troublesome Creek Latitude: 27.47624 Longitude: -81.83244			County: Hardee Site Number: PI200 Reach Length: 370 ft. Landowner: Frederick Willard D Jr.

Risk Factor	Ranking	Score	
Pfankuch-Channel Stability:	Poor	1.5	
Channel Alteration:	None	0	
Bank Erosion:	Active	1	
BEHI:	High (30.59)	1	
Local NPSP:	Obvious Sources	1.5	
Shoring Structures:	None	0	
Pipe Discharge:	None	0	
Water Odor:	Normal	0	
Fish Passage Barrier:	None	0	
RB: Riparian Buffer:	0 ft.	0.75	
LB: Riparian Buffer:	40 ft.	0.5	
RB: Floodplain Access:	Partial	0.25	
LB: Floodplain Access:	Full	0	
<b>Severity Scale:</b>		<b>6.5</b>	
Notes: 303d: Impaired - Aquatic Life Harvesting (mercury in fish tissue), Chlorophyll-A			
Restoration Option 1

Additional Site Features
Stream Channel Woody Material: Extensive
Impoundments: None
Substrate Composition: Medium Sand
Bank Material: Sand
Near Bank Stress: Moderate
RB Landuse: Residential, Natural Forest
LB Landuse: Pasture

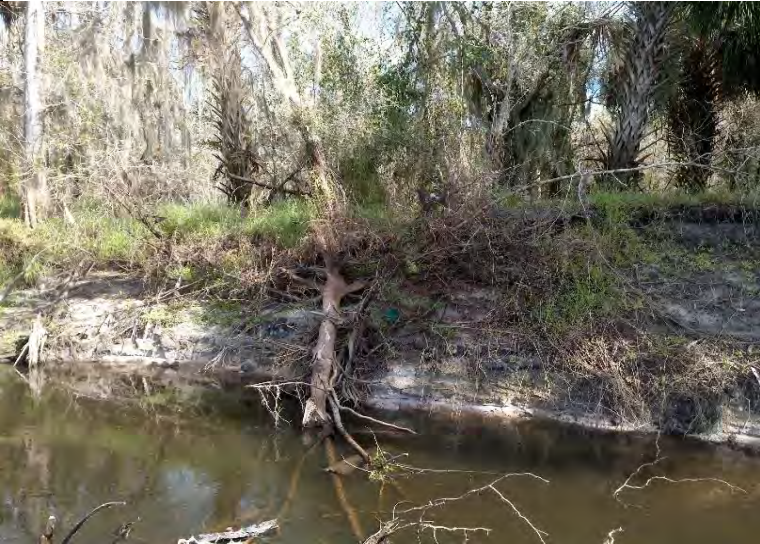
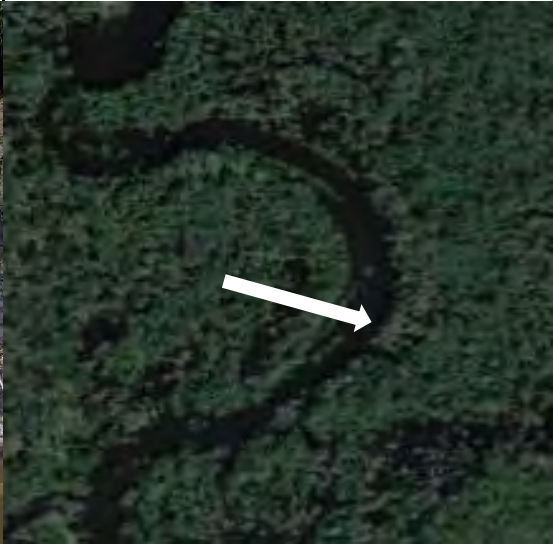
Peace River			Severity Scale: 5.75-Moderate
Watershed: Peace River Subwatershed: Troublesome Creek Latitude: 27.47472 Longitude: -81.83076			County: Hardee Site Number: PI201 Reach Length: 1300 ft. Landowner: Frederick Willard D Jr.

Risk Factor	Ranking	Score	
Pfankuch-Channel Stability:	Poor	1.5	
Channel Alteration:	None	0	
Bank Erosion:	Active	1	
BEHI:	Moderate (25.49)	0.5	
Local NPSP:	Obvious Sources	1.5	
Shoring Structures:	None	0	
Pipe Discharge:	None	0	
Water Odor:	Normal	0	
Fish Passage Barrier:	None	0	
RB: Riparian Buffer:	0 ft.	0.75	
LB: Riparian Buffer:	40 ft.	0.5	
RB: Floodplain Access:	Full	0	
LB: Floodplain Access:	Full	0	
Severity Scale:		5.75	
Notes: 303d: Impaired - Aquatic Life Harvesting (mercury in fish tissue), Chlorophyll-A			
Restoration Option 1

Additional Site Features
Stream Channel Woody Material: Numerous
Impoundments: None
Substrate Composition: Medium Sand
Bank Material: Medium Sand
Near Bank Stress: Low
RB Landuse: Pasture, Natural Forest
LB Landuse: Pasture, Natural Forest

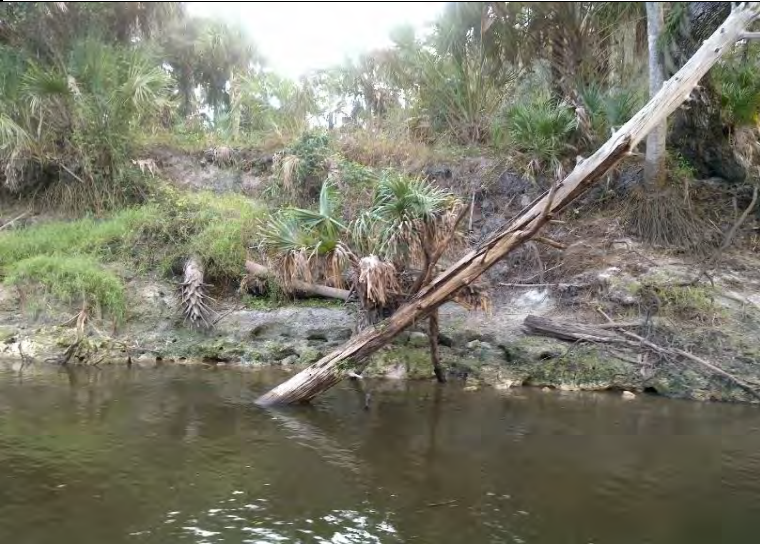
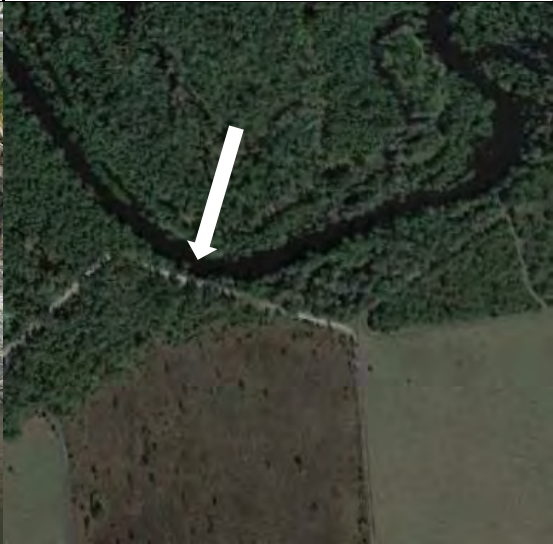
Peace River			Severity Scale: 5.0-Moderate
Watershed: Peace River Subwatershed: Troublesome Creek Latitude: 27.46955 Longitude: -81.83663			County: Hardee Site Number: PI202 Reach Length: 280 ft. Landowner: Ben Hill Griffin Inc.

Risk Factor	Ranking	Score	
Pfankuch-Channel Stability:	Poor	1.5	
Channel Alteration:	None	0	
Bank Erosion:	Active	1	
BEHI:	Low (17.80)	0	
Local NPSP:	Obvious Sources	1.5	
Shoring Structures:	None	0	
Pipe Discharge:	None	0	
Water Odor:	Normal	0	
Fish Passage Barrier:	None	0	
RB: Riparian Buffer:	100 ft.	0	
LB: Riparian Buffer:	20 ft.	0.75	
RB: Floodplain Access:	Full	0	
LB: Floodplain Access:	Partial	0.25	
Severity Scale:		5.0	
Notes: 303d: Impaired - Aquatic Life Harvesting (mercury in fish tissue), Chlorophyll-A			
Restoration Option 1

Additional Site Features
Stream Channel Woody Material: Numerous
Impoundments: None
Substrate Composition: Medium Sand
Bank Material: Sandy-Clay
Near Bank Stress: Moderate
RB Landuse: Natural Forest
LB Landuse: Pasture, Road, Natural Forest

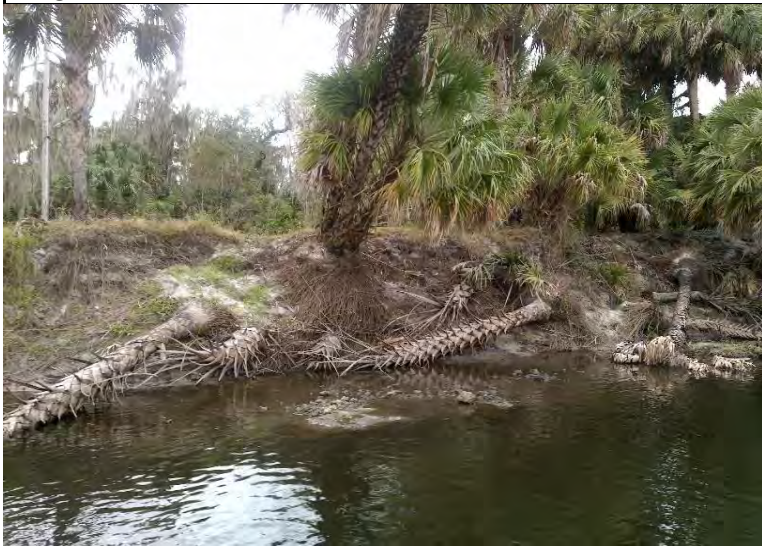
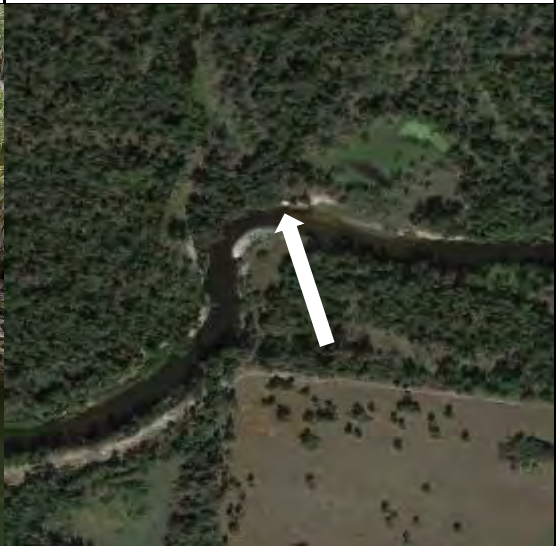
Peace River			Severity Scale: 6.0-Moderate	
Watershed: Peace River Subwatershed: Troublesome Creek Latitude: 27.47041 Longitude: -81.84447			County: Hardee Site Number: PI203 Reach Length: 340 ft. Landowner: 3-C Ranch Limited

Pfankuch-Channel Stability:	Poor	1.5		
Channel Alteration:	None	0		
Bank Erosion:	Active	1		
BEHI:	Moderate (26.46)	0.5		
Local NPSP:	Obvious Sources	1.5		
Shoring Structures:	None	0		
Pipe Discharge:	None	0		
Water Odor:	Normal	0		
Fish Passage Barrier:	No	0		
RB: Riparian Buffer:	40 ft.	0.5		
LB: Riparian Buffer:	20 ft.	0.75		
RB: Floodplain Access:	Partial	0.25		
LB: Floodplain Access:	Full	0		
Severity Scale:		6.0	Additional Site Features	
			Stream Channel Woody Material: Numerous	
			Impoundments: None	
			Substrate Composition: Medium Sand	
			Bank Material: Medium Sand	
			Near Bank Stress: Moderate	
			RB Landuse: Pasture, Natural Forest

LB Landuse: Natural Forest, Pasture	
Notes: 303d: Impaired - Aquatic Life Harvesting (mercury in fish tissue), Chlorophyll-A				
Restoration Option 1

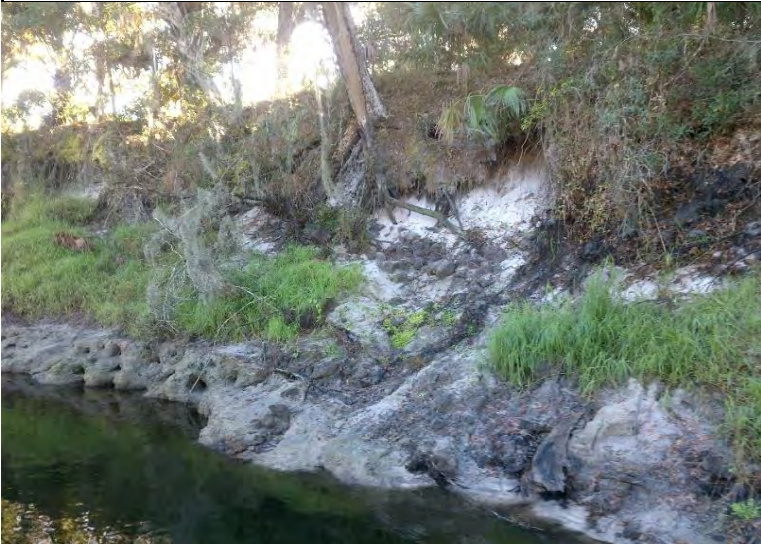
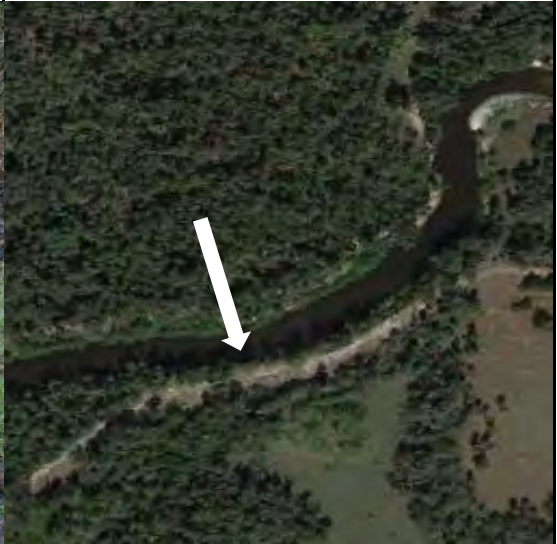
Peace River			Severity Scale: 6.0-Moderate
Watershed: Peace River Subwatershed: Troublesome Creek Latitude: 27.46877 Longitude: -81.84647			County: Hardee Site Number: PI204 Reach Length: 330 ft. Landowner: Ben Hill Griffin Inc.

Risk Factor	Ranking	Score	
Pfankuch-Channel Stability:	Poor	1.5	
Channel Alteration:	None	0	
Bank Erosion:	Mass-wasting	1.5	
BEHI:	Moderate (24.28)	0.5	
Local NPSP:	Obvious Sources	1.5	
Shoring Structures:	None	0	
Pipe Discharge:	None	0	
Water Odor:	Normal	0	<b>Additional Site Features</b>
Fish Passage Barrier:	None	0	Stream Channel Woody Material: Moderate
RB: Riparian Buffer:	100 ft.	0	Impoundments: None
LB: Riparian Buffer:	20 ft.	0.75	Substrate Composition: Medium Sand
RB: Floodplain Access:	Full	0	Bank Material: Sandy-Clay
LB: Floodplain Access:	Partial	0.25	Near Bank Stress: High
			RB Landuse: Natural Forest
	<b>Severity Scale:</b>	<b>6.0</b>	LB Landuse: Pasture, Natural Forest

Notes: 303d: Impaired - Aquatic Life Harvesting (mercury in fish tissue), Chlorophyll-A			
Restoration Option 1 or 2

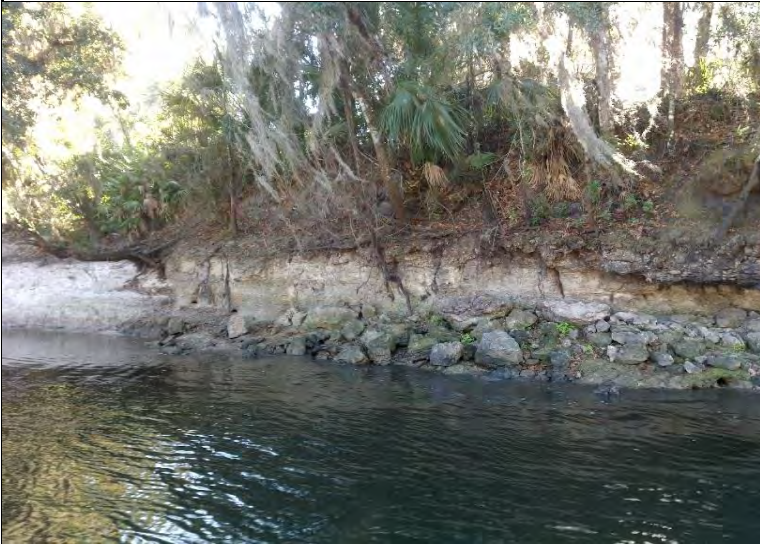
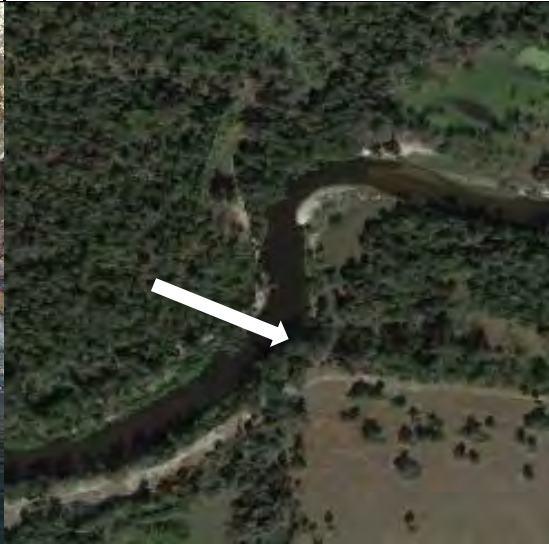
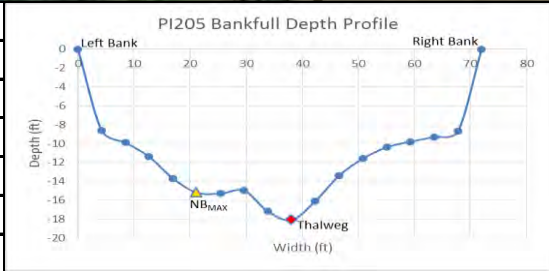
Peace River			Severity Scale: 5.25-Moderate																																														
Watershed: Peace River Subwatershed: Troublesome Creek Latitude: 27.46925 Longitude: -81.84528			County: Hardee Site Number: PI205 Reach Length: 115 ft. Landowner: Ben Hill Griffin Inc.

Risk Factor	Ranking	Score	Pfankuch-Channel Stability:	Poor	1.5	Channel Alteration:	None	0	Bank Erosion:	Mass-wasting	1.5	BEHI:	Moderate (26.02)	0.5	Local NPSP:	Moderate Potential	1	Shoring Structures:	None	0	Pipe Discharge:	None	0	Water Odor:	Normal	0	Fish Passage Barrier:	None	0	RB: Riparian Buffer:	100 ft.	0	LB: Riparian Buffer:	40 ft.	0.5	RB: Floodplain Access:	Full	0	LB: Floodplain Access:	Partial	0.25	Severity Scale:		5.25

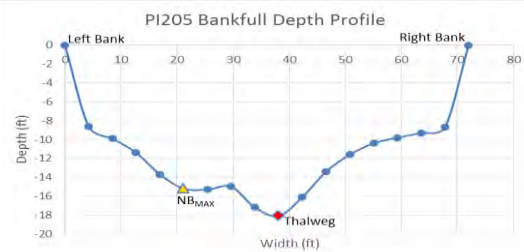
Risk Factor	Ranking	Score																																															
Pfankuch-Channel Stability:	Poor	1.5																																															
Channel Alteration:	None	0																																															
Bank Erosion:	Mass-wasting	1.5																																															
BEHI:	Moderate (26.02)	0.5																																															
Local NPSP:	Moderate Potential	1																																															
Shoring Structures:	None	0																																															
Pipe Discharge:	None	0																																															
Water Odor:	Normal	0																																															
Fish Passage Barrier:	None	0																																															
RB: Riparian Buffer:	100 ft.	0																																															
LB: Riparian Buffer:	40 ft.	0.5																																															
RB: Floodplain Access:	Full	0																																															
LB: Floodplain Access:	Partial	0.25																																															
Severity Scale:		5.25																																															
			<b>Additional Site Features</b>																																														
			Stream Channel Woody Material: Infrequent																																														
			Impoundments: None																																														
			Substrate Composition: Medium Sand																																														
			Bank Material: Sandy-Clay																																														
			Near Bank Stress: Low																																														
			RB Landuse: Natural Forest																																														
			LB Landuse: Pasture, Natural Forest																																														
Notes: 303d: Impaired - Aquatic Life Harvesting (mercury in fish tissue), Chlorophyll-A																																																	
Restoration Option 2, low erosion rates due to clay and bedrock for the majority of the site, however beach area with rope swing should be stabilized on the upstream section

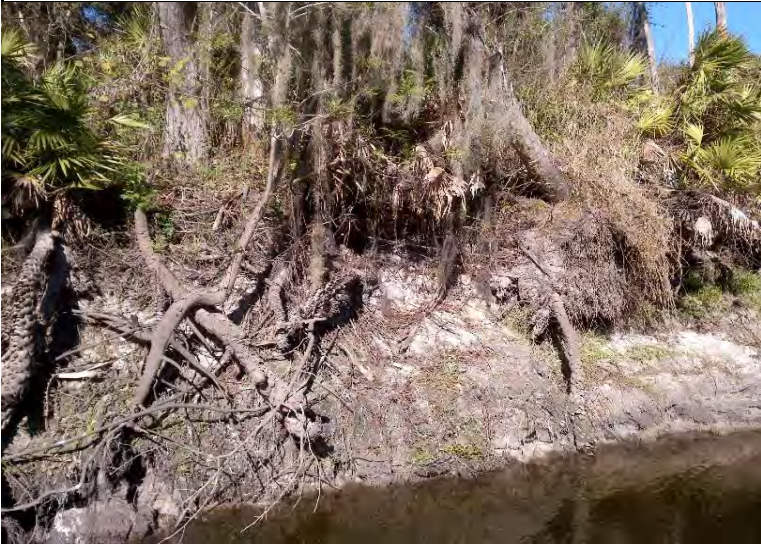
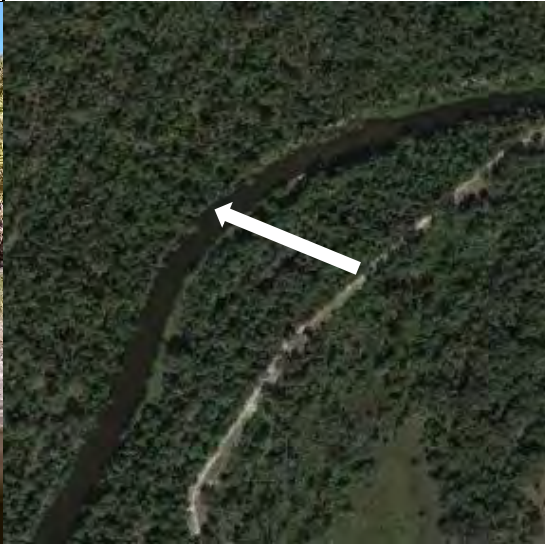
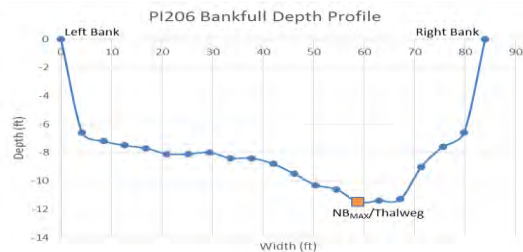
Peace River			Severity Scale: 5.25-Moderate
Watershed: Peace River Subwatershed: Troublesome Creek Latitude: 27.46711 Longitude: -81.84932			County: Hardee Site Number: PI206 Reach Length: 440 ft. Landowner: 3-C Ranch Limited

Risk Factor	Ranking	Score	
Pfankuch-Channel Stability:	Poor	1.5	
Channel Alteration:	None	0	
Bank Erosion:	Active	1	
BEHI:	Moderate (26.84)	0.5	
Local NPSP:	Obvious Sources	1.5	
Shoring Structures:	None	0	
Pipe Discharge:	None	0	<b>Additional Site Features</b> Stream Channel Woody Material: Moderate Impoundments: None Substrate Composition: Medium Sand Bank Material: Medium Sand Near Bank Stress: High RB Landuse: Natural Forest, Pasture LB Landuse: Natural Forest, Pasture
Water Odor:	Normal	0	
Fish Passage Barrier:	None	0	
RB: Riparian Buffer:	40 ft.	0.5	
LB: Riparian Buffer:	100 ft.	0	
RB: Floodplain Access:	Partial	0.25	
LB: Floodplain Access:	Full	0	
<b>Severity Scale:</b>		<b>5.25</b>

Notes: 303d: Impaired - Aquatic Life Harvesting (mercury in fish tissue), Chlorophyll-A			
Restoration Option 1

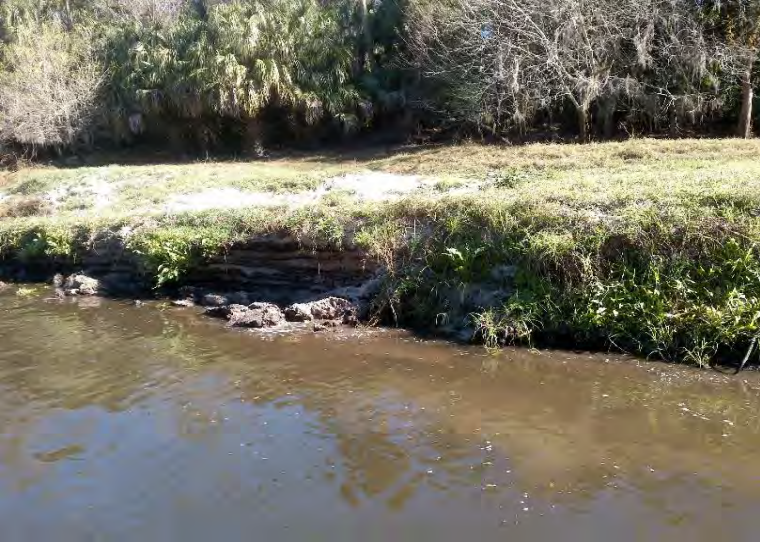
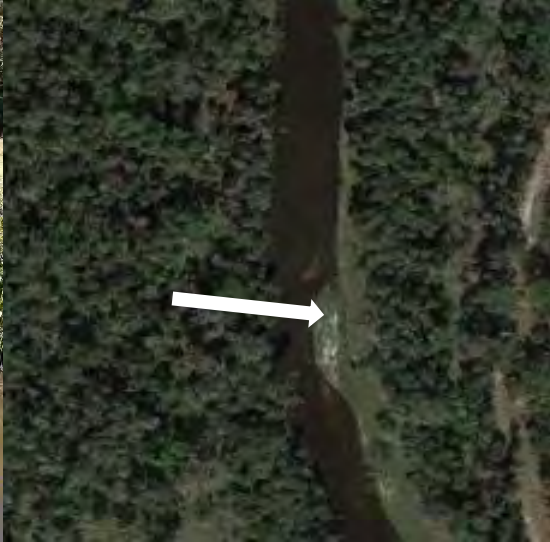
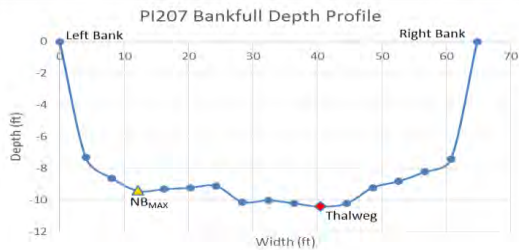
Peace River			Severity Scale: 6.25-Moderate
Watershed: Peace River Subwatershed: Troublesome Creek Latitude: 27.46292 Longitude: -81.84989			County: Hardee Site Number: PI207 Reach Length: 100 ft. Landowner: Ben Hill Griffin Inc.

Risk Factor	Ranking	Score	
Pfankuch-Channel Stability:	Poor	1.5	
Channel Alteration:	None	0	
Bank Erosion:	Mass-wasting	1.5	
BEHI:	Moderate (24.91)	0.5	
Local NPSP:	Obvious Sources	1.5	
Shoring Structures:	None	0	
Pipe Discharge:	None	0	
Water Odor:	Normal	0	
Fish Passage Barrier:	None	0	
RB: Riparian Buffer:	60 ft.	0.25	
LB: Riparian Buffer:	0 ft.	0.75	
RB: Floodplain Access:	Partial	0.25	
LB: Floodplain Access:	Full	0	
<b>Severity Scale:</b>		<b>6.25</b>	
Notes: 303d: Impaired - Aquatic Life Harvesting (mercury in fish tissue), Chlorophyll-A			
Restoration Option 2 or 3

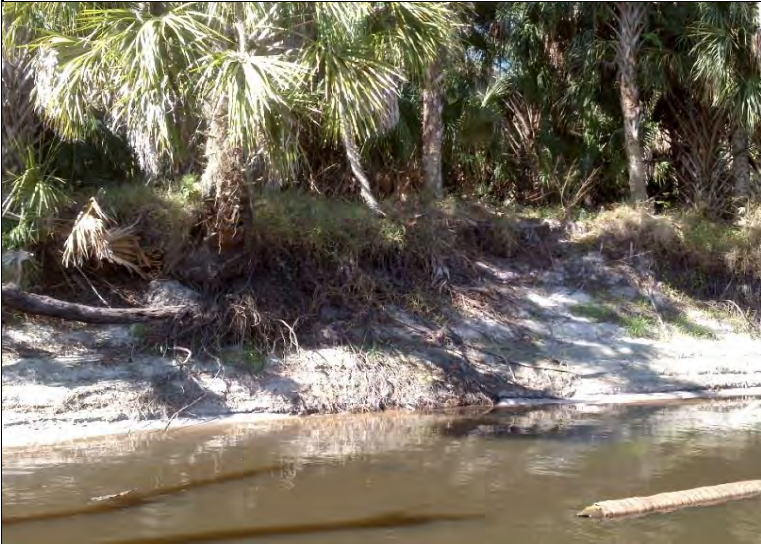
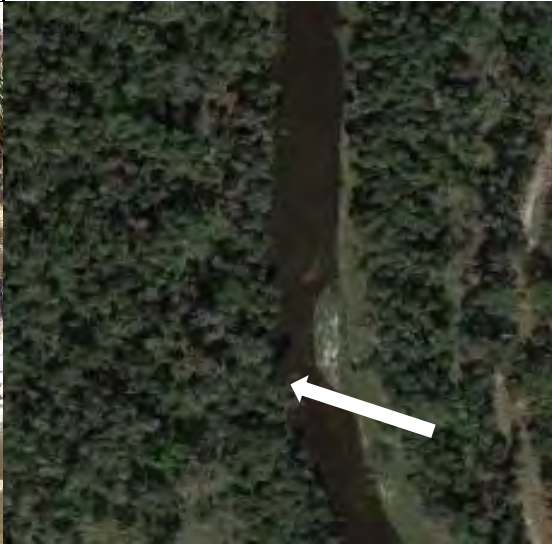
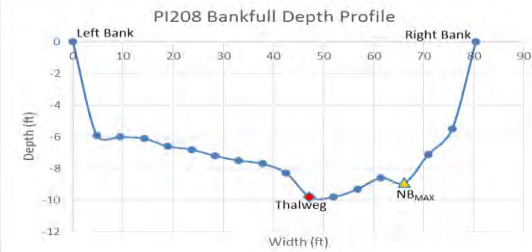
Peace River			Severity Scale: 5.5-Moderate
Watershed: Peace River Subwatershed: Troublesome Creek Latitude: 27.46318 Longitude: -81.85001			County: Hardee Site Number: PI208 Reach Length: 500 ft. Landowner: 3-C Ranch Limited

Risk Factor	Ranking	Score	
Pfankuch-Channel Stability:	Poor	1.5	
Channel Alteration:	None	0	
Bank Erosion:	Active	1	
BEHI:	Moderate (26.80)	0.5	
Local NPSP:	Obvious Sources	1.5	
Shoring Structures:	None	0	
Pipe Discharge:	None	0	
Water Odor:	Normal	0	
Fish Passage Barrier:	None	0	
RB: Riparian Buffer:	60 ft.	0.25	
LB: Riparian Buffer:	40 ft.	0.5	
RB: Floodplain Access:	Partial	0.25	
LB: Floodplain Access:	Full	0	
Severity Scale:		5.5	
Notes: 303d: Impaired - Aquatic Life Harvesting (mercury in fish tissue), Chlorophyll-A			
Restoration Option 1
