# **Peace River and Withlacoochee River Threats Assessments and Fish Assemblage Monitoring**

**Final Report July 1, 2015 – June 30, 2019**

Submitted to Florida State Wildlife Grants Program  
August 1, 2019  
PID: 98462501284

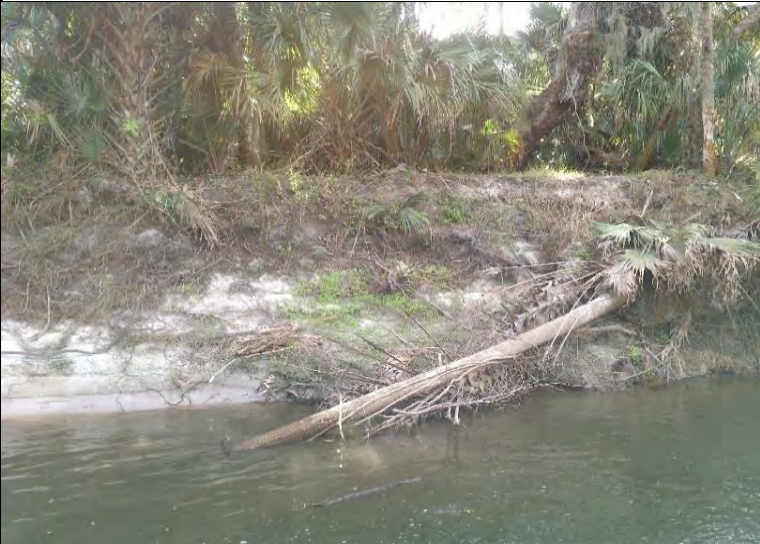
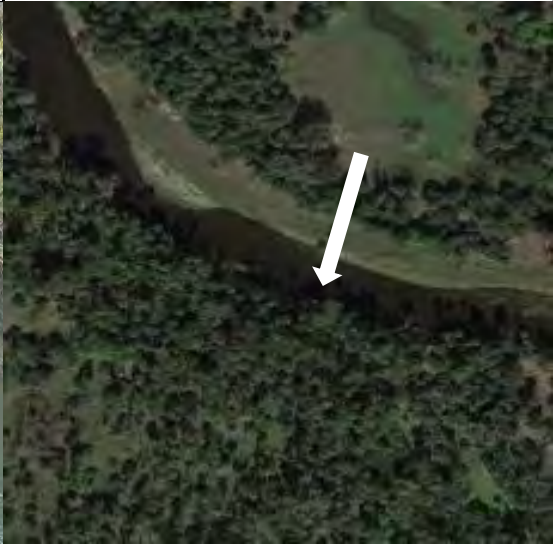
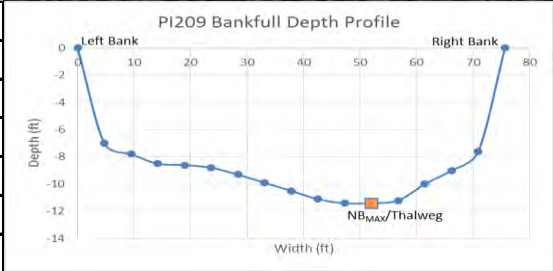
Peace River			Severity Scale: 6.25-Moderate
Watershed: Peace River Subwatershed: Troublesome Creek Latitude: 27.46065 Longitude: -81.84869			County: Hardee Site Number: PI209 Reach Length: 575 ft. Landowner: 3-C Ranch Limited*

Risk Factor	Ranking	Score	
Pfankuch-Channel Stability:	Poor	1.5	
Channel Alteration:	None	0	
Bank Erosion:	Active	1	
BEHI:	High (34.03)	1	
Local NPSP:	Obvious Sources	1.5	
Shoring Structures:	None	0	
Pipe Discharge:	None	0	
Water Odor:	Normal	0	
Fish Passage Barrier:	None	0	
RB: Riparian Buffer:	60 ft.	0.25	
LB: Riparian Buffer:	0 ft.	0.75	
RB: Floodplain Access:	Partial	0.25	
LB: Floodplain Access:	Full	0	
<b>Severity Scale:</b>		<b>6.25</b>	
Notes: 303d: Impaired - Aquatic Life Harvesting (mercury in fish tissue), Chlorophyll-A			
Restoration Option 1

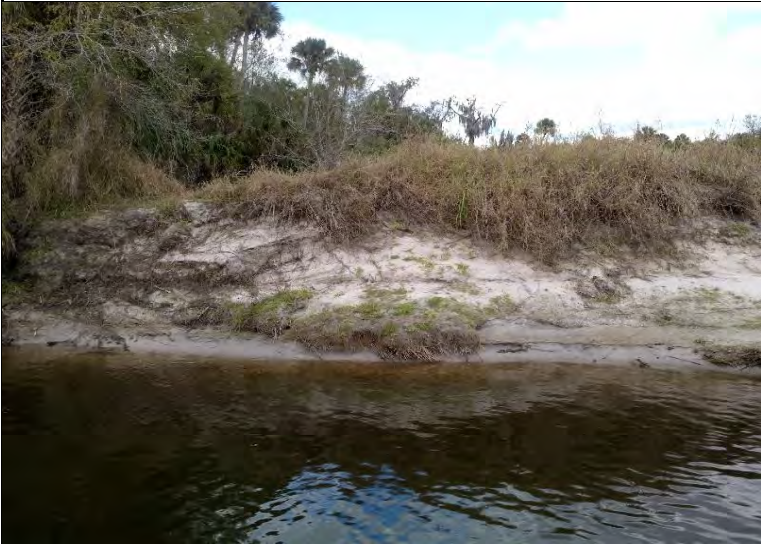
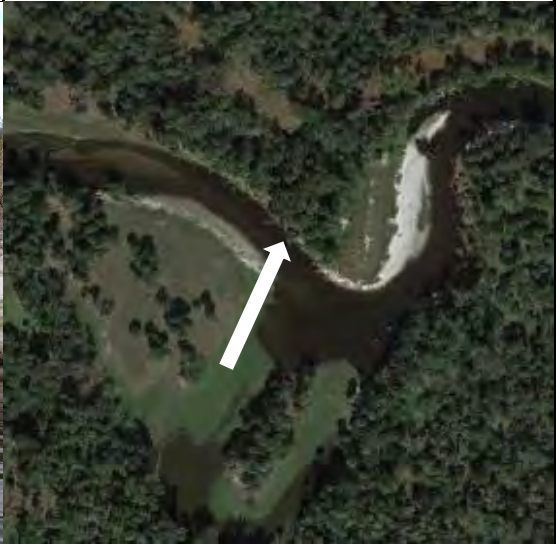
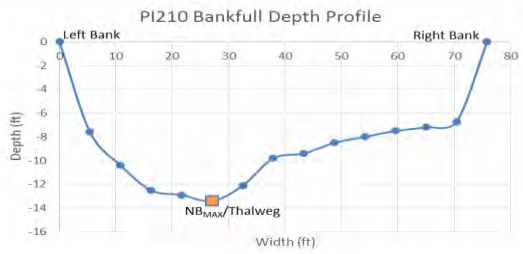
Peace River			Severity Scale: 5.75-Moderate
Watershed: Peace River Subwatershed: Troublesome Creek Latitude: 27.4595 Longitude: -81.84586			County: Hardee Site Number: PI210 Reach Length: 310 ft. Landowner: Ben Hill Griffin Inc.

Pfankuch-Channel Stability:	Poor	1.5	
Channel Alteration:	None	0	
Bank Erosion:	Active	1	
BEHI:	Moderate (23.80)	0.5	
Local NPSP:	Obvious Sources	1.5	
Shoring Structures:	None	0	
Pipe Discharge:	None	0	
Water Odor:	Normal	0	
Fish Passage Barrier:	None	0	
RB: Riparian Buffer:	0 ft.	0.75	
LB: Riparian Buffer:	60 ft.	0.25	
RB: Floodplain Access:	Full	0	
LB: Floodplain Access:	Partial	0.25	
<b>Severity Scale:</b>		<b>5.75</b>	
Notes: 303d: Impaired - Aquatic Life Harvesting (mercury in fish tissue), Chlorophyll-A			<b>Additional Site Features</b>
			Stream Channel Woody Material: Numerous
			Impoundments: None
			Substrate Composition: Medium Sand

Bank Material: Medium Sand
			Near Bank Stress: Moderate
			RB Landuse: Pasture
			LB Landuse: Natural Forest, Pasture
Restoration Option 1

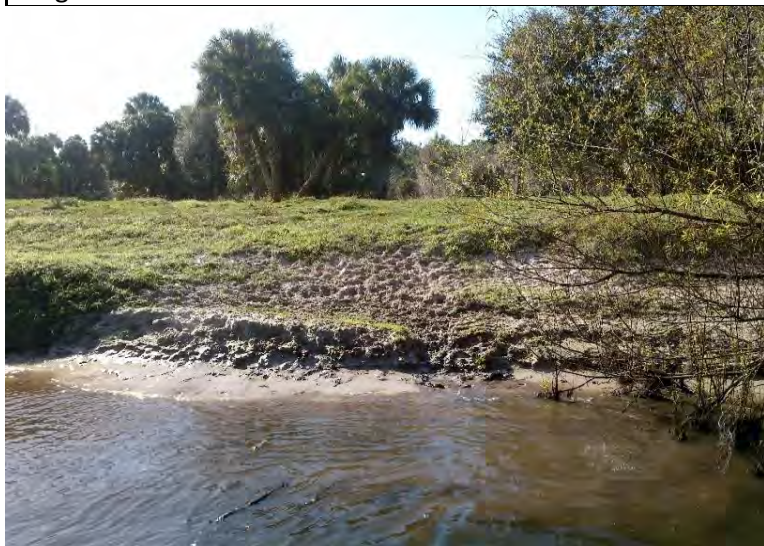
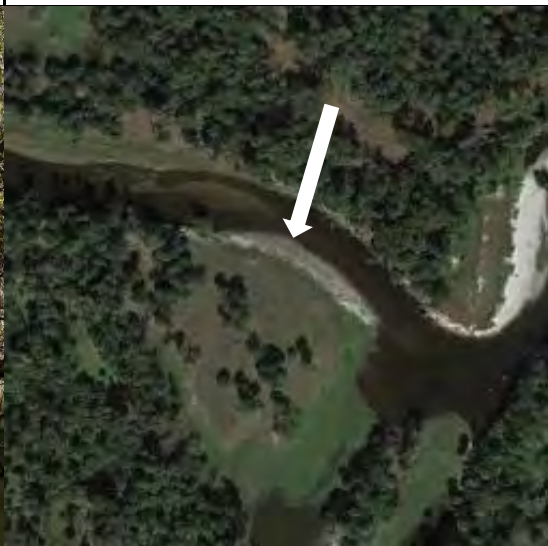
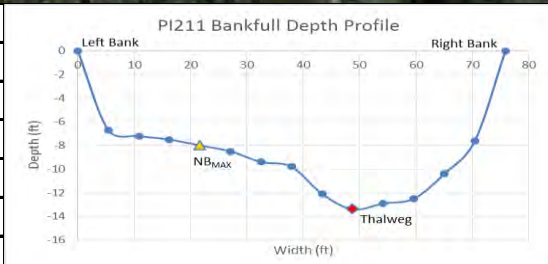
County: Hardee  
Site Number: PI211  
Reach Length: 240 ft.  
Landowner: Ben Hill Griffin Inc.

Risk Factor	Ranking	Score
Pfankuch-Channel Stability:	Poor	1.5
Channel Alteration:	None	0
Bank Erosion:	Active	1
BEHI:	Moderate (22.60)	0.5
Local NPSP:	Obvious Sources	1.5
Shoring Structures:	None	0
Pipe Discharge:	None	0
Water Odor:	Normal	0
Fish Passage Barrier:	None	0
RB: Riparian Buffer:	0 ft.	0.75
LB: Riparian Buffer:	60 ft.	0.25
RB: Floodplain Access:	Full	0
LB: Floodplain Access:	Partial	0.25
<b>Severity Scale:</b>		<b>5.75</b>

Restoration Option 2 or 3

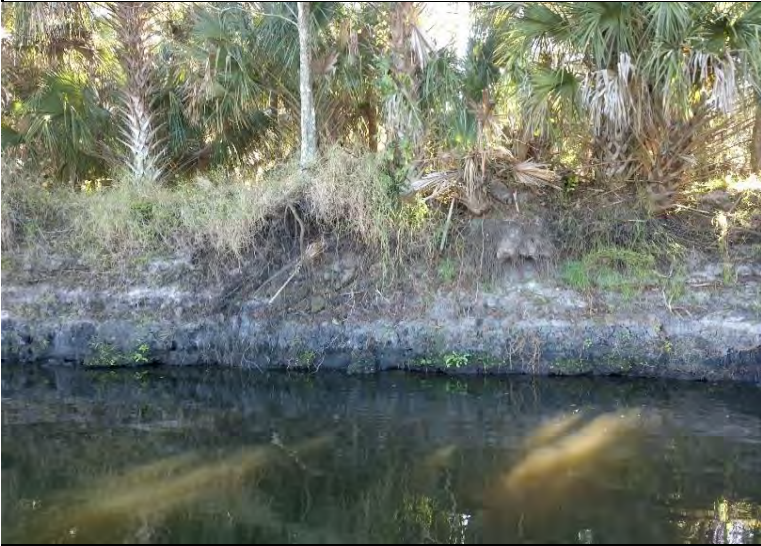
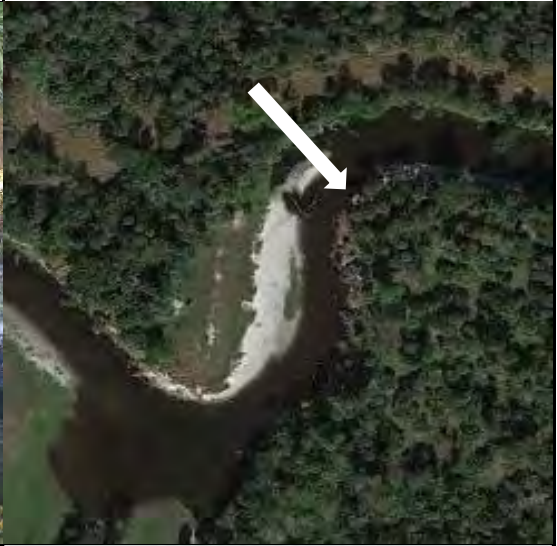
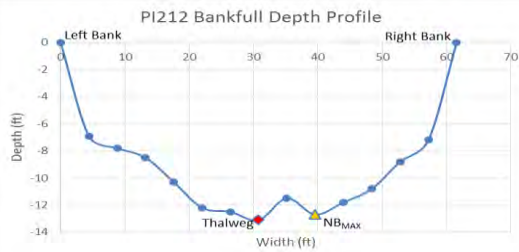
Peace River			Severity Scale: 5.75-Moderate
Watershed: Peace River Subwatershed: Troublesome Creek Latitude: 27.45934 Longitude: -81.84586			County: Hardee Site Number: PI212 Reach Length: 470 ft. Landowner: Ben Hill Griffin Inc.

Risk Factor	Ranking	Score	
Pfankuch-Channel Stability:	Poor	1.5	
Channel Alteration:	None	0	
Bank Erosion:	Active	1	
BEHI:	Moderate (26.50)	0.5	
Local NPSP:	Obvious Sources	1.5	
Shoring Structures:	None	0	
Pipe Discharge:	None	0	<b>Additional Site Features</b> Stream Channel Woody Material: Dominating Impoundments: None Substrate Composition: Medium Sand Bank Material: Medium Sand Near Bank Stress: Moderate RB Landuse: Natural Forest, Pasture LB Landuse: Pasture, Natural Forest
Water Odor:	Normal	0	
Fish Passage Barrier:	None	0	
RB: Riparian Buffer:	60 ft.	0.25	
LB: Riparian Buffer:	0 ft.	0.75	
RB: Floodplain Access:	Partial	0.25	
LB: Floodplain Access:	Full	0	
<b>Severity Scale:</b>		<b>5.75</b>

Notes: 303d: Impaired - Aquatic Life Harvesting (mercury in fish tissue), Chlorophyll-A			
Restoration Option 1

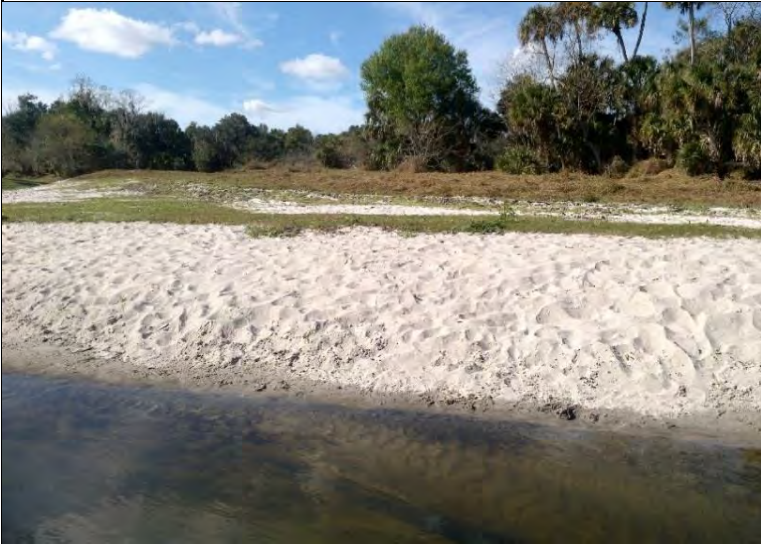
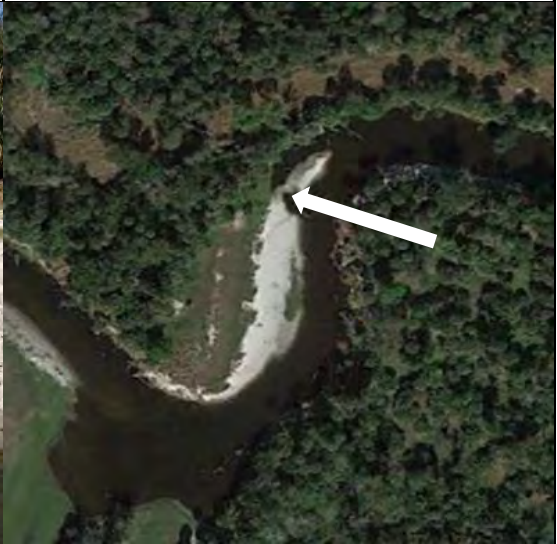
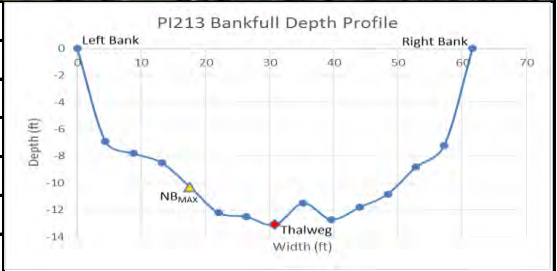
Peace River			Severity Scale: 6.25-Moderate
Watershed: Peace River Subwatershed: Troublesome Creek Latitude: 27.4603 Longitude: -81.84536			County: Hardee Site Number: PI213 Reach Length: 310 ft. Landowner: Ben Hill Griffin Inc.

Risk Factor	Ranking	Score	
Pfankuch-Channel Stability:	Poor	1.5	
Channel Alteration:	None	0	
Bank Erosion:	Active	1	
BEHI:	High (31.99)	1	
Local NPSP:	Obvious Sources	1.5	
Shoring Structures:	None	0	
Pipe Discharge:	None	0	
Water Odor:	Normal	0	
Fish Passage Barrier:	None	0	
RB: Riparian Buffer:	60 ft.	0.25	
LB: Riparian Buffer:	0 ft.	0.75	
RB: Floodplain Access:	Partial	0.25	
LB: Floodplain Access:	Full	0	
<b>Severity Scale:</b>		<b>6.25</b>	
Notes: 303d: Impaired - Aquatic Life Harvesting (mercury in fish tissue), Chlorophyll-A			
Restoration Option 2 or 3

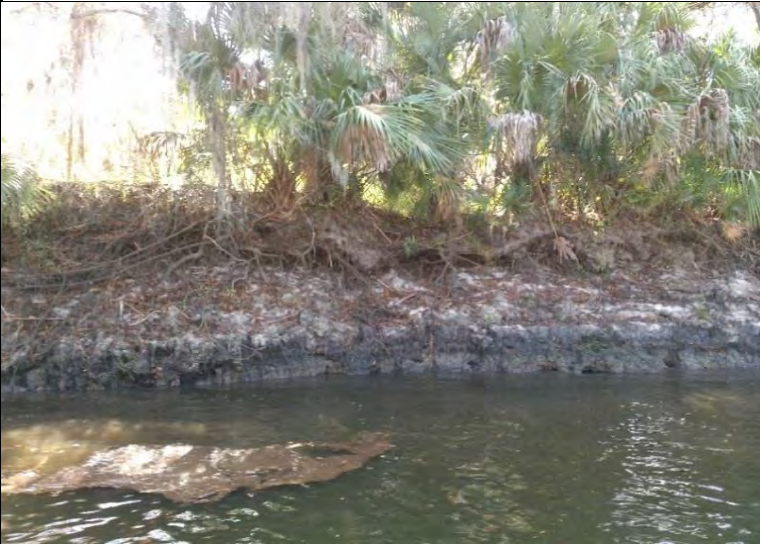
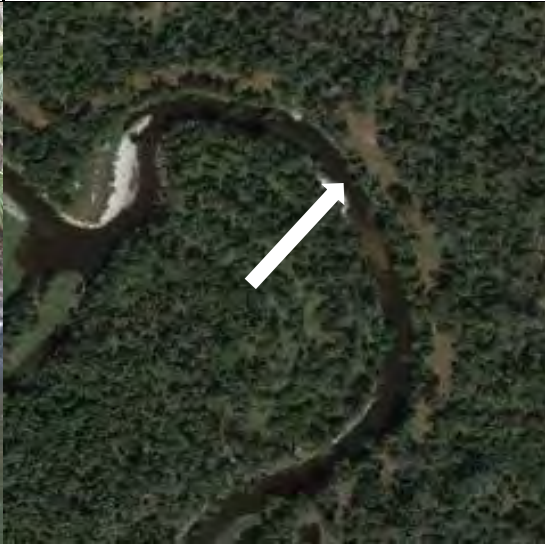
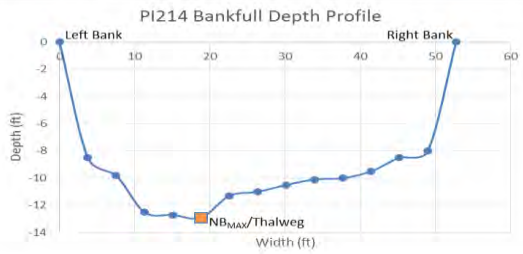
Peace River			Severity Scale: 5.5-Moderate
Watershed: Peace River Subwatershed: Troublesome Creek Latitude: 27.45781 Longitude: -81.84464			County: Hardee Site Number: PI214 Reach Length: 1300 ft. Landowner: Ben Hill Griffin Inc.

Risk Factor	Ranking	Score	
Pfankuch-Channel Stability:	Poor	1.5	
Channel Alteration:	None	0	
Bank Erosion:	Active	1	
BEHI:	Moderate (27.07)	0.5	
Local NPSP:	Obvious Sources	1.5	
Shoring Structures:	None	0	
Pipe Discharge:	None	0	
Water Odor:	Normal	0	
Fish Passage Barrier:	None	0	
RB: Riparian Buffer:	40 ft.	0.5	
LB: Riparian Buffer:	40 ft.	0.5	
RB: Floodplain Access:	Full	0	
LB: Floodplain Access:	Full	0	
<b>Severity Scale:</b>		<b>5.5</b>	
Notes: 303d: Impaired - Aquatic Life Harvesting (mercury in fish tissue), Chlorophyll-A			
Restoration Option 1

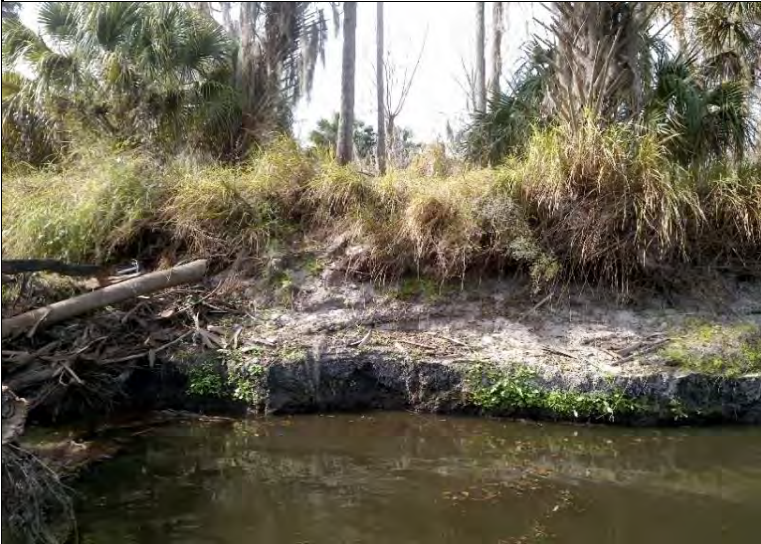
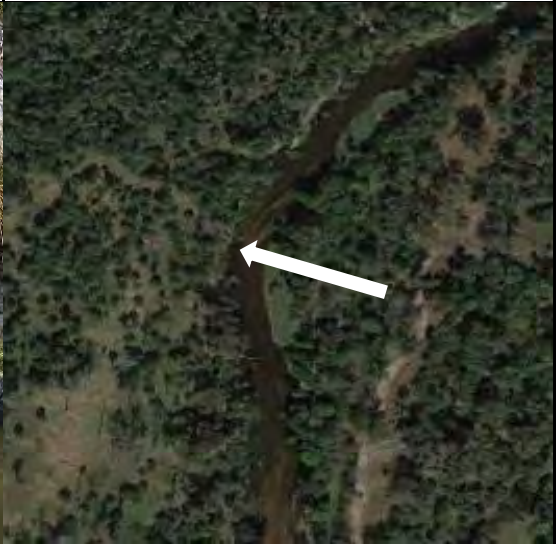
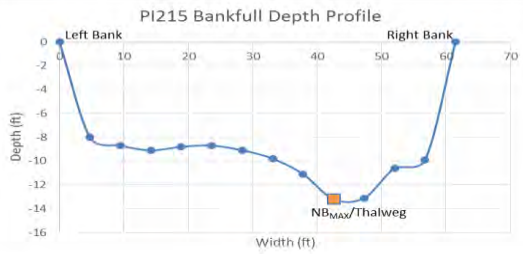
Peace River			Severity Scale: 5.25-Moderate
Watershed: Peace River Subwatershed: Troublesome Creek Latitude: 27.45677 Longitude: -81.84559			County: Hardee Site Number: PI215 Reach Length: 270 ft. Landowner: Ben Hill Griffin Inc.*

Pfankuch-Channel Stability:	Poor	1.5	
Channel Alteration:	None	0	
Bank Erosion:	Active	1	
BEHI:	Moderate (28.21)	0.5	
Local NPSP:	Obvious Sources	1.5	
Shoring Structures:	None	0	
Pipe Discharge:	None	0	
Water Odor:	Normal	0	
Fish Passage Barrier:	None	0	
RB: Riparian Buffer:	40 ft.	0.5	Additional Site Features
LB: Riparian Buffer:	60 ft.	0.25	
RB: Floodplain Access:	Full	0	
LB: Floodplain Access:	Full	0	
Severity Scale:		5.25	
Notes: 303d: Impaired - Aquatic Life Harvesting (mercury in fish tissue), Chlorophyll-A			
Restoration Option 1

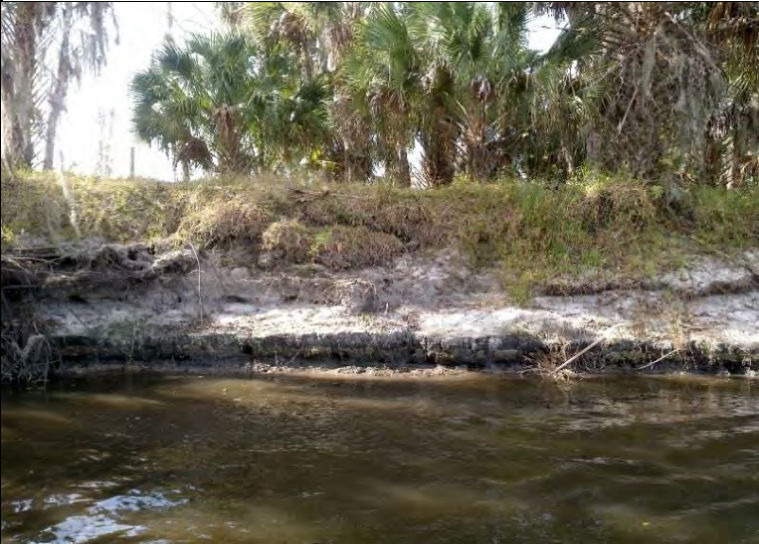
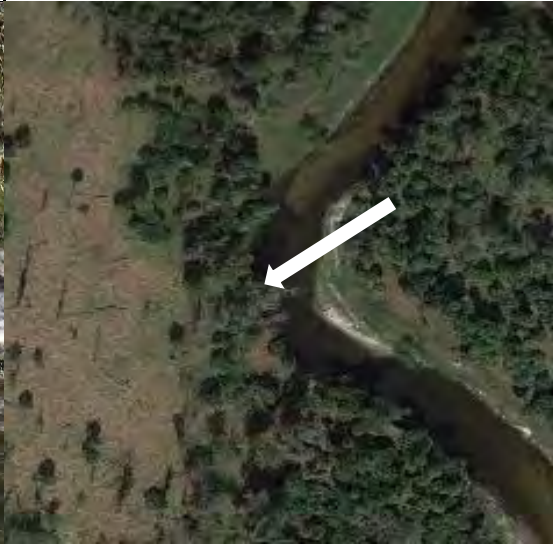
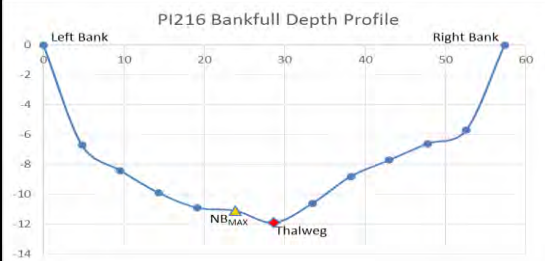
Peace River			Severity Scale: 6.5-Moderate		
Watershed: Peace River Subwatershed: Troublesome Creek Latitude: 27.45237 Longitude: -81.84543			County: Hardee Site Number: PI216 Reach Length: 310 ft. Landowner: Mosaic Fertilizer LLC

Pfankuch-Channel Stability:	Poor	1.5			
Channel Alteration:	None	0			
Bank Erosion:	Mass-wasting	1.5			
BEHI:	High (34.21)	1			
Local NPSP:	Obvious Sources	1.5			
Shoring Structures:	None	0			
Pipe Discharge:	None	0			
Water Odor:	Normal	0			
Fish Passage Barrier:	None	0			
RB: Riparian Buffer:	40 ft.	0.5			
LB: Riparian Buffer:	60 ft.	0.25			
RB: Floodplain Access:	Partial	0.25			
LB: Floodplain Access:	Full	0			
Severity Scale:		6.5	Additional Site Features		
			Stream Channel Woody Material: Moderate		
			Impoundments: None		
			Substrate Composition: Medium Sand		
			Bank Material: Medium Sand		
			Near Bank Stress: Moderate		
			RB Landuse: Pasture, Natural Forest

LB Landuse: Natural Forest, Pasture		
Notes: 303d: Impaired - Aquatic Life Harvesting (mercury in fish tissue), Chlorophyll-A					
Restoration Option 1

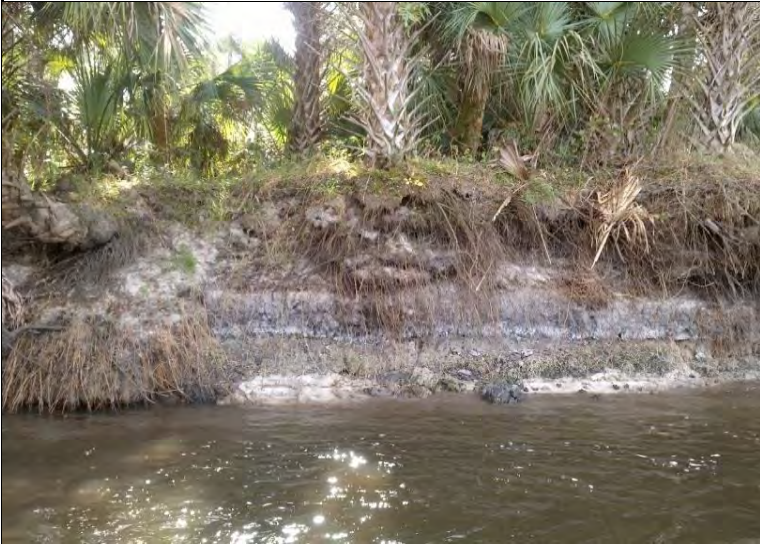
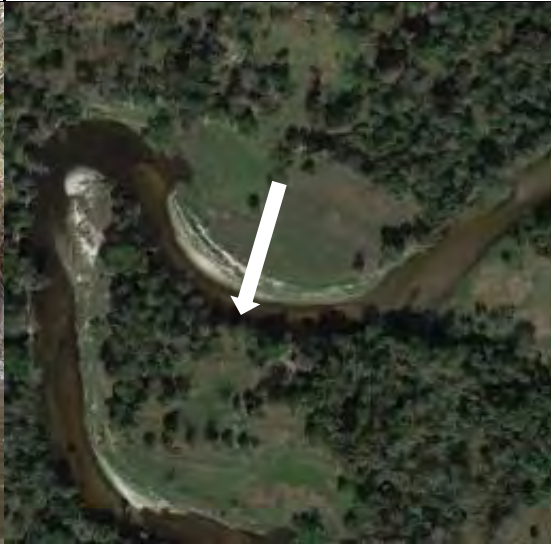
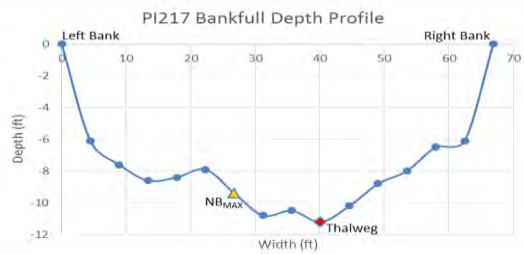
Peace River			Severity Scale: 5.5-Moderate	
Watershed: Peace River Subwatershed: Troublsome Creek Latitude: 27.44989 Longitude: -81.8479			County: Hardee Site Number: PI217 Reach Length: 480 ft. Landowner: Ben Hill Griffin Inc.

Pfankuch-Channel Stability:	Poor	1.5		
Channel Alteration:	None	0		
Bank Erosion:	Active	1		
BEHI:	Moderate (23.93)	0.5		
Local NPSP:	Obvious Sources	1.5		
Shoring Structures:	None	0		
Pipe Discharge:	None	0		
Water Odor:	Normal	0		
Fish Passage Barrier:	None	0		
RB: Riparian Buffer:	40 ft.	0.5		
LB: Riparian Buffer:	40 ft.	0.5		
RB: Floodplain Access:	Full	0		
LB: Floodplain Access:	Full	0		
Severity Scale:		5.5	Additional Site Features	
Notes: 303d: Impaired - Aquatic Life Harvesting (mercury in fish tissue), Chlorophyll-A			Stream Channel Woody Material: Extensive	
Restoration Option 1			Impoundments: None	
			Substrate Composition: Medium Sand

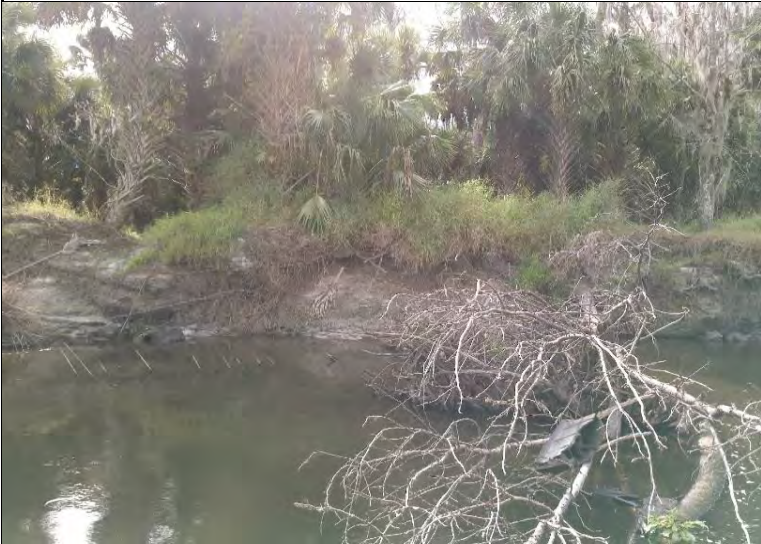
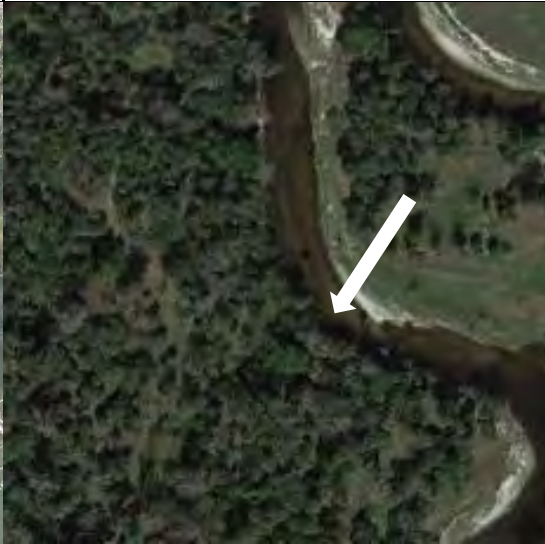
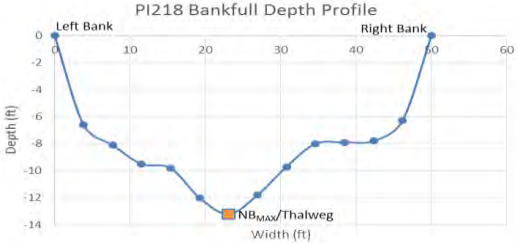
Peace River			Severity Scale: 6.0-Moderate
Watershed: Peace River Subwatershed: Troublesome Creek Latitude: 27.44898 Longitude: -81.84872			County: Hardee Site Number: PI218 Reach Length: 163 ft. Landowner: Mosaic Fertilizer LLC

Risk Factor	Ranking	Score	
Pfankuch-Channel Stability:	Poor	1.5

Channel Alteration:	None	0	
Bank Erosion:	Active	1	
BEHI:	High (30.81)	1	
Local NPSP:	Obvious Sources	1.5	
Shoring Structures:	None	0	
Pipe Discharge:	None	0	Additional Site Features
Water Odor:	Normal	0	Stream Channel Woody Material: Extensive
Fish Passage Barrier:	None	0	Impoundments: None
RB: Riparian Buffer:	40 ft.	0.5	Substrate Composition: Medium Sand
LB: Riparian Buffer:	40 ft.	0.5	Bank Material: Medium Sand
RB: Floodplain Access:	Full	0	Near Bank Stress: Moderate
LB: Floodplain Access:	Full	0	RB Landuse: Natural Forest, Pasture
<b>Severity Scale:</b>		<b>6.0</b>	LB Landuse: Pasture, Natural Forest

Notes: 303d: Impaired - Aquatic Life Harvesting (mercury in fish tissue)			
Restoration Option 1

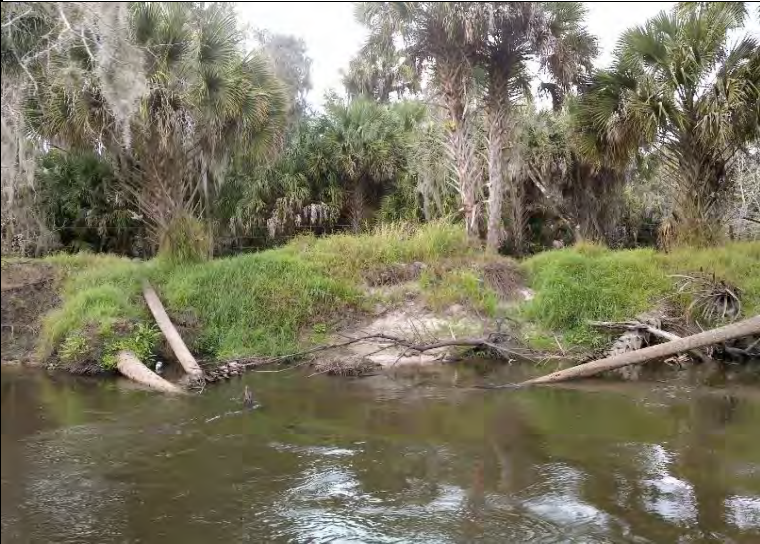
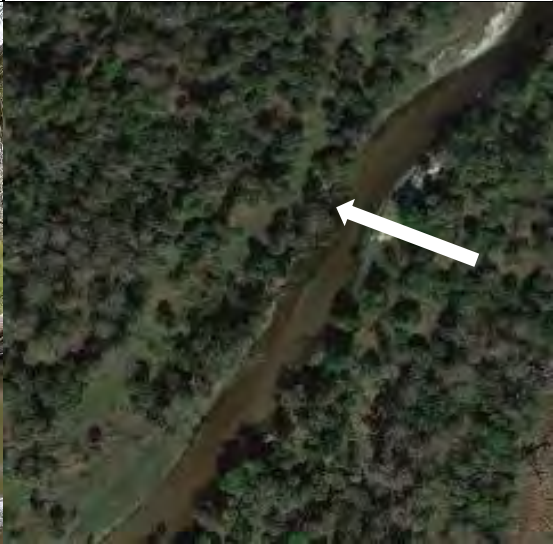
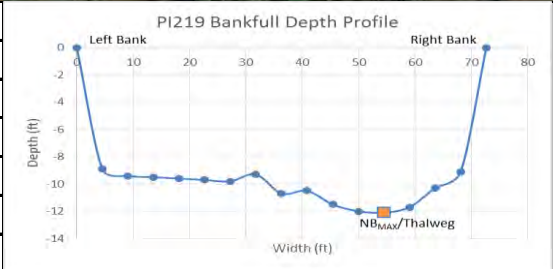
Peace River			Severity Scale: 5.0-Moderate
Watershed: Peace River Subwatershed: Troublesome Creek Latitude: 27.44765 Longitude: -81.84893			County: Hardee Site Number: PI219 Reach Length: 110 ft. Landowner: Mosaic Fertilizer LLC

Risk Factor	Ranking	Score	
Pfankuch-Channel Stability:	Poor	1.5	
Channel Alteration:	None	0	
Bank Erosion:	Active	1	
BEHI:	Low (18.34)	0	
Local NPSP:	Obvious Sources	1.5	
Shoring Structures:	None	0	
Pipe Discharge:	None	0	
Water Odor:	Normal	0	
Fish Passage Barrier:	None	0	
RB: Riparian Buffer:	40 ft.	0.5	
LB: Riparian Buffer:	40 ft.	0.5	
RB: Floodplain Access:	Full	0	
LB: Floodplain Access:	Full	0	
Severity Scale:		5.0	
Notes: 303d: Impaired - Aquatic Life Harvesting (mercury in fish tissue)			
Restoration Option 1

Additional Site Features	
Stream Channel Woody Material:	Numerous
Impoundments:	None
Substrate Composition:	Medium Sand
Bank Material:	Medium Sand
Near Bank Stress:	High
RB Landuse:	Pasture, Natural Forest
LB Landuse:	Pasture, Natural Forest

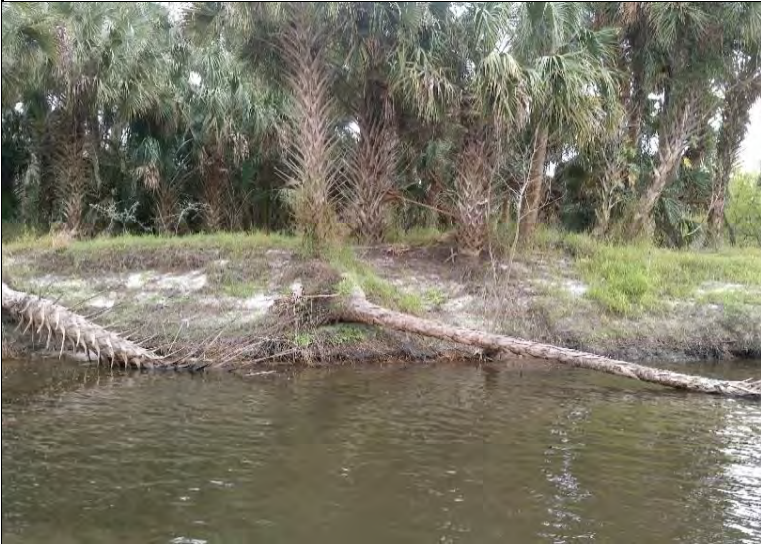
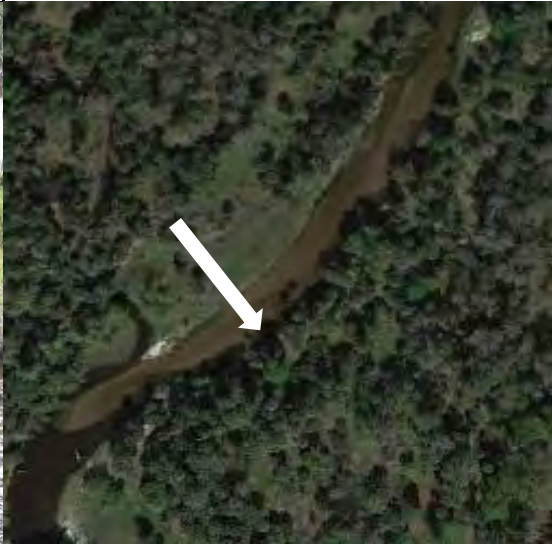
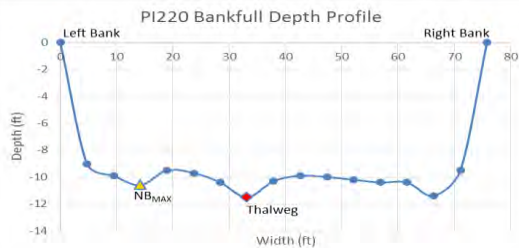
Peace River			Severity Scale: 5.5-Moderate
Watershed: Peace River Subwatershed: Troublesome Creek Latitude: 27.44713 Longitude: -81.84915			County: Hardee Site Number: PI220 Reach Length: 500 ft. Landowner: Ben Hill Griffin Inc.

Risk Factor	Ranking	Score	
Pfankuch-Channel Stability:	Poor	1.5	
Channel Alteration:	None	0	
Bank Erosion:	Active	1	
BEHI:	Moderate (20.02)	0.5	
Local NPSP:	Obvious Sources	1.5	
Shoring Structures:	None	0	
Pipe Discharge:	None	0	
Water Odor:	Normal	0	
Fish Passage Barrier:	None	0	
RB: Riparian Buffer:	40 ft.	0.5	
LB: Riparian Buffer:	40 ft.	0.5	
RB: Floodplain Access:	Full	0	
LB: Floodplain Access:	Full	0	
<b>Severity Scale:</b>		<b>5.5</b>	
Notes: 303d: Impaired - Aquatic Life Harvesting (mercury in fish tissue)			
Restoration Option 1

Additional Site Features
Stream Channel Woody Material: Numerous
Impoundments: None
Substrate Composition: Medium Sand
Bank Material: Medium Sand
Near Bank Stress: Moderate
RB Landuse: Pasture, Natural Forest
LB Landuse: Pasture, Natural Forest

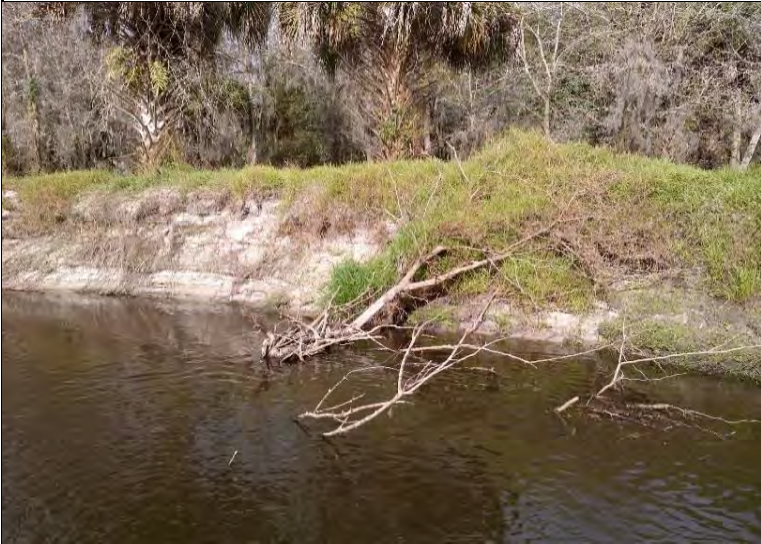
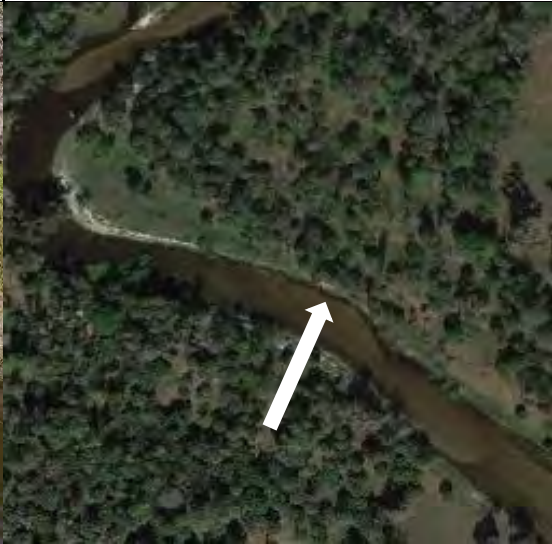
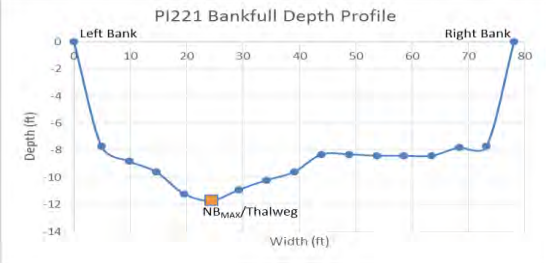
Peace River			Severity Scale: 5.5-Moderate
Watershed: Peace River Subwatershed: Troublesome Creek Latitude: 27.44525 Longitude: -81.84908			County: Hardee Site Number: PI221 Reach Length: 95 ft. Landowner: Ben Hill Griffin Inc.

Pfankuch-Channel Stability:	Poor	1.5	
Channel Alteration:	None	0	
Bank Erosion:	Active	1	
BEHI:	Moderate (21.98)	0.5	
Local NPSP:	Obvious Sources	1.5	
Shoring Structures:	None	0	
Pipe Discharge:	None	0	
Water Odor:	Normal	0	
Fish Passage Barrier:	None	0	
RB: Riparian Buffer:	40 ft.	0.5	
LB: Riparian Buffer:	40 ft.	0.5	
RB: Floodplain Access:	Full	0	
LB: Floodplain Access:	Full	0	
<b>Severity Scale:</b>		<b>5.5</b>	
Notes: 303d: Impaired - Aquatic Life Harvesting (mercury in fish tissue)			<b>Additional Site Features</b>
			Stream Channel Woody Material: Moderate
			Impoundments: None
			Substrate Composition: Medium Sand
			Bank Material: Medium Sand

Near Bank Stress: High
			RB Landuse: Natural Forest, Pasture
			LB Landuse: Natural Forest, Pasture
Restoration Option 1

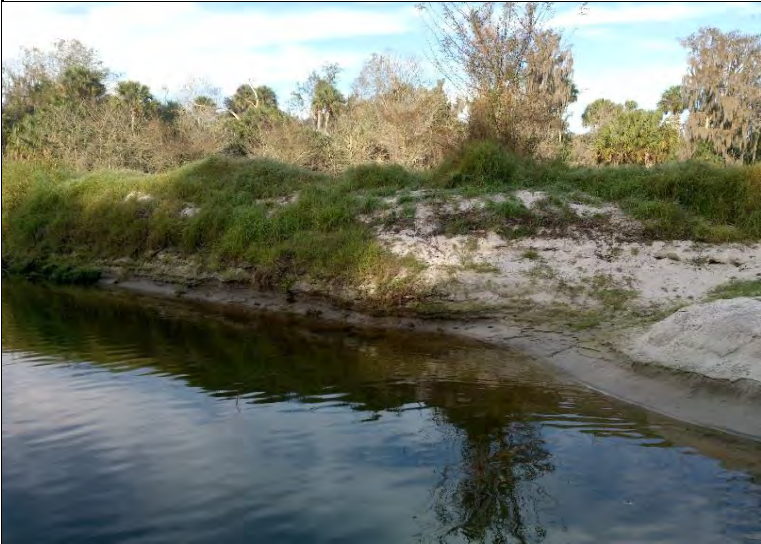
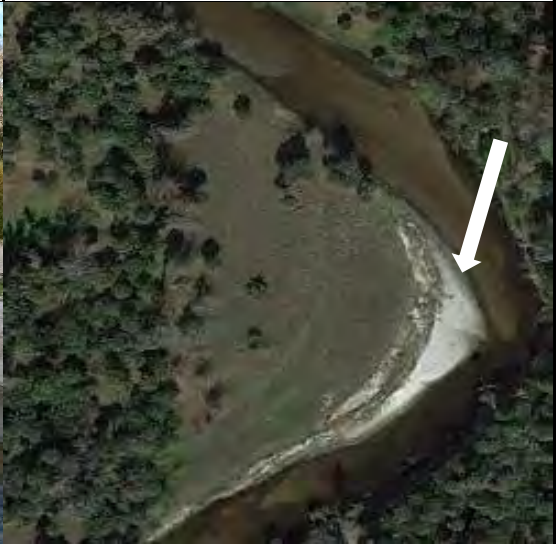
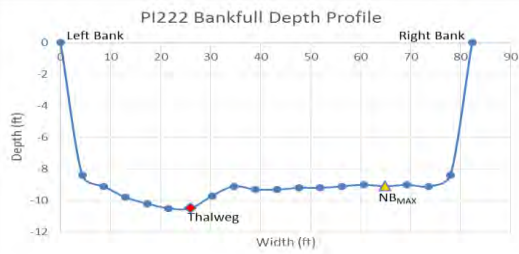
Peace River			Severity Scale: 5.75-Moderate
Watershed: Peace River Subwatershed: Troublesome Creek Latitude: 27.44486 Longitude: -81.84874			County: Hardee Site Number: PI222 Reach Length: 103 ft. Landowner: Mosaic Fertilizer LLC

Risk Factor	Ranking	Score	
Pfankuch-Channel Stability:	Poor	1.5	
Channel Alteration:	None	0	
Bank Erosion:	Active	1	
BEHI:	Moderate (20.26)	0.5	
Local NPSP:	Obvious Sources	1.5	
Shoring Structures:	None	0	
Pipe Discharge:	None	0	<b>Additional Site Features</b> Stream Channel Woody Material: Infrequent Impoundments: None Substrate Composition: Medium Sand Bank Material: Medium Sand Near Bank Stress: Low RB Landuse: Pasture, Natural Forest LB Landuse: Pasture, Natural Forest
Water Odor:	Normal	0	
Fish Passage Barrier:	None	0	
RB: Riparian Buffer:	0 ft.	0.75	
LB: Riparian Buffer:	40 ft.	0.5	
RB: Floodplain Access:	Full	0	
LB: Floodplain Access:	Full	0	
<b>Severity Scale:</b>		<b>5.75</b>

Notes: 303d: Impaired - Aquatic Life Harvesting (mercury in fish tissue)			
Restoration Option 2 or 3

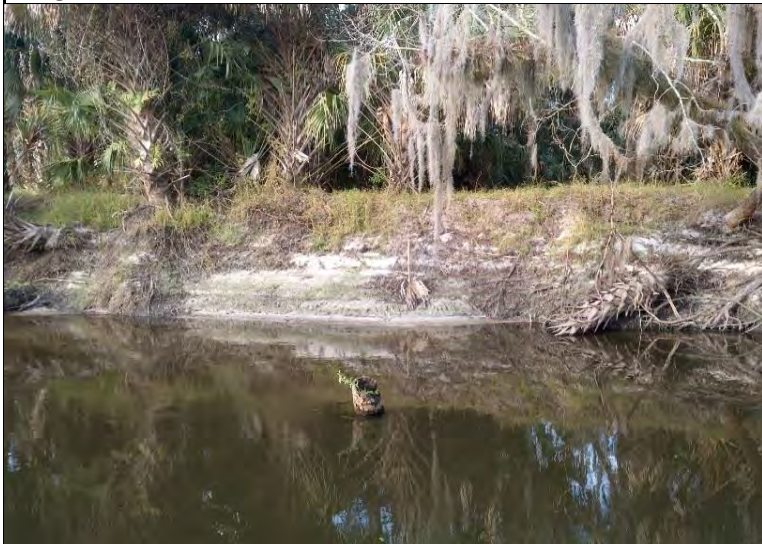
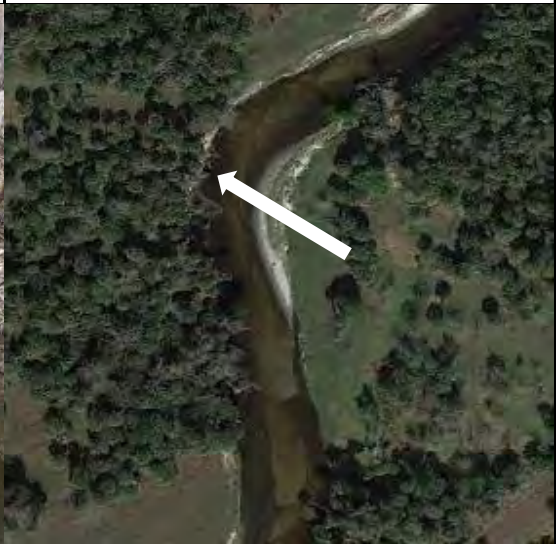
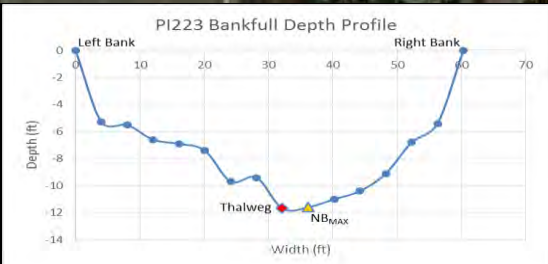
Peace River			Severity Scale: 6.0-Moderate	
Watershed: Peace River Subwatershed: Troublesome Creek Latitude: 27.44345 Longitude: -81.84898			County: Hardee Site Number: PI223 Reach Length: 340 ft. Landowner: Mosaic Fertilizer LLC

Pfankuch-Channel Stability:	Poor	1.5		
Channel Alteration:	None	0		
Bank Erosion:	Mass-wasting	1.5		
BEHI:	Moderate (26.70)	0.5		
Local NPSP:	Obvious Sources	1.5		
Shoring Structures:	None	0		
Pipe Discharge:	None	0		
Water Odor:	Normal	0		
Fish Passage Barrier:	None	0		
RB: Riparian Buffer:	40 ft.	0.5		
LB: Riparian Buffer:	40 ft.	0.5		
RB: Floodplain Access:	Full	0		
LB: Floodplain Access:	Full	0		
Severity Scale:		6.0	Additional Site Features	
			Stream Channel Woody Material: Numerous	
			Impoundments: None	
			Substrate Composition: Medium Sand	
			Bank Material: Medium Sand	
			Near Bank Stress: Moderate	
			RB Landuse: Pasture, Natural Forest

LB Landuse: Pasture, Natural Forest	
Notes: 303d: Impaired - Aquatic Life Harvesting (mercury in fish tissue)				
Restoration Option 1

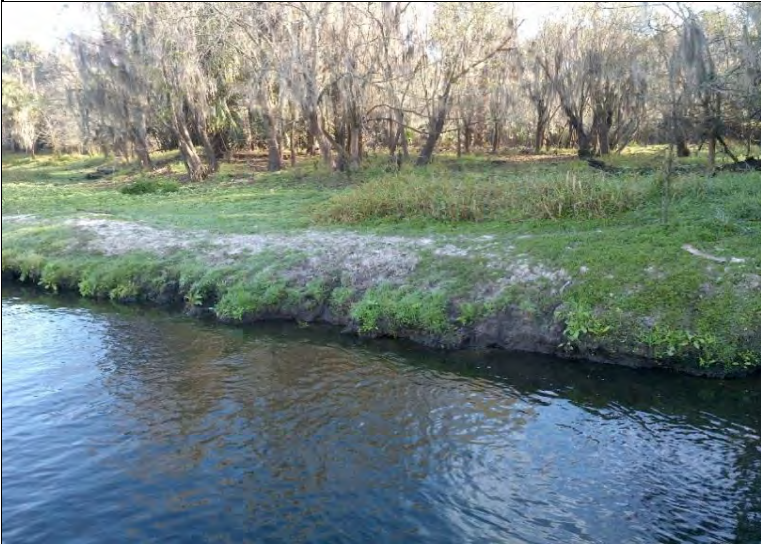
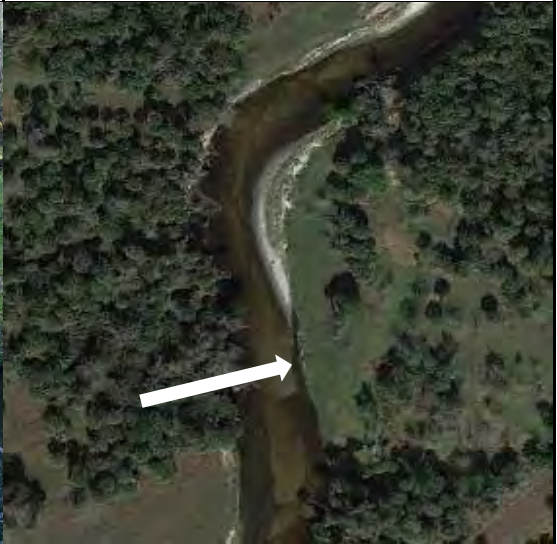
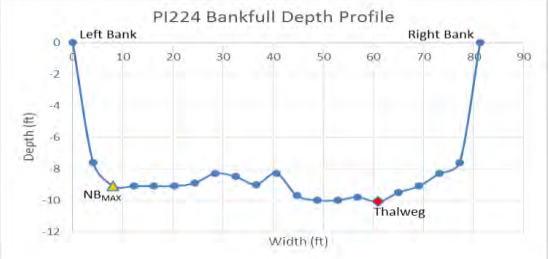
Peace River			Severity Scale: 6.0-Moderate
Watershed: Peace River Subwatershed: Troublesome Creek Latitude: 27.44236 Longitude: -81.84879			County: Hardee Site Number: PI224 Reach Length: 110 ft. Landowner: Ben Hill Griffin Inc.

Pfankuch-Channel Stability:	Poor	1.5	
Channel Alteration:	None	0	
Bank Erosion:	Mass-wasting	1.5	
BEHI:	Moderate (22.93)	0.5	
Local NPSP:	Obvious Sources	1.5	
Shoring Structures:	None	0	
Pipe Discharge:	None	0	
Water Odor:	Normal	0	
Fish Passage Barrier:	None	0	
RB: Riparian Buffer:	40 ft.	0.5	
LB: Riparian Buffer:	40 ft.	0.5	
RB: Floodplain Access:	Full	0	
LB: Floodplain Access:	Full	0	
<b>Severity Scale:</b>		<b>6.0</b>	
Notes: 303d: Impaired - Aquatic Life Harvesting (mercury in fish tissue)			<b>Additional Site Features</b>
			Stream Channel Woody Material: Infrequent
			Impoundments: None
			Substrate Composition: Medium Sand
			Bank Material: Medium Sand

Near Bank Stress: Low
			RB Landuse: Pasture, Natural Forest
			LB Landuse: Pasture, Natural Forest
Restoration Option 2 or 3

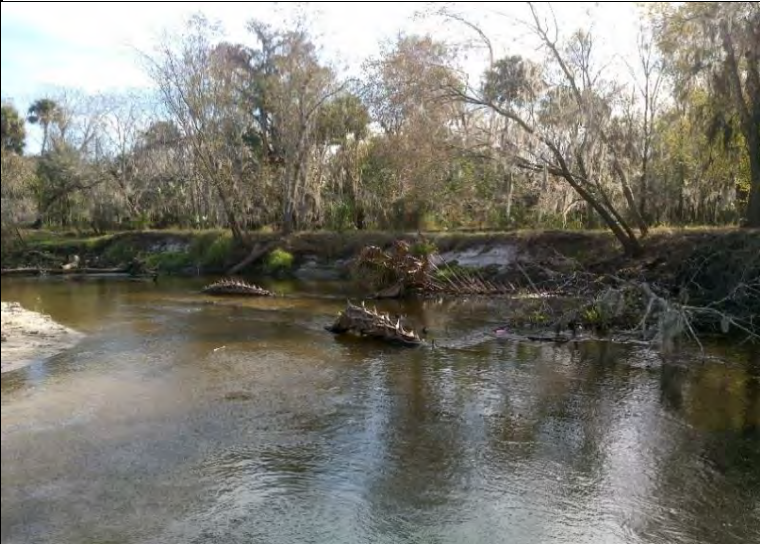
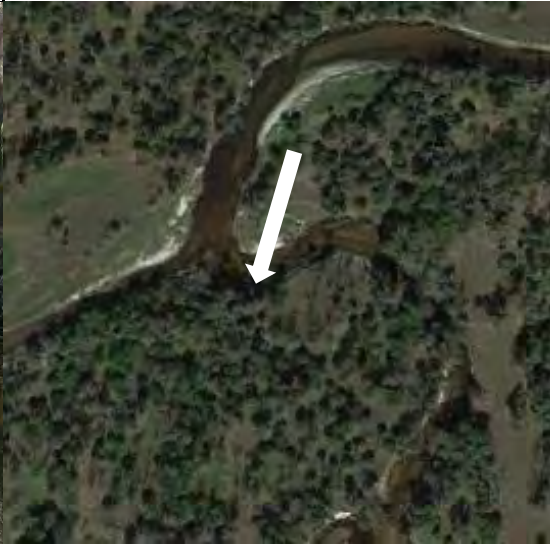
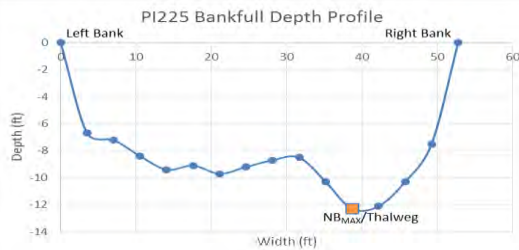
Peace River			Severity Scale: 5.5-Moderate
Watershed: Peace River Subwatershed: Troublesome Creek Latitude: 27.44063 Longitude: -81.85172			County: Hardee Site Number: PI225 Reach Length: 400 ft. Landowner: Ben Hill Griffin Inc.

Risk Factor	Ranking	Score	
Pfankuch-Channel Stability:	Poor	1.5	
Channel Alteration:	None	0	
Bank Erosion:	Active	1	
BEHI:	Moderate (23.69)	0.5	
Local NPSP:	Obvious Sources	1.5	
Shoring Structures:	None	0	
Pipe Discharge:	None	0	
Water Odor:	Normal	0	
Fish Passage Barrier:	None	0	
RB: Riparian Buffer:	40 ft.	0.5	
LB: Riparian Buffer:	40 ft.	0.5	
RB: Floodplain Access:	Full	0	
LB: Floodplain Access:	Full	0	
<b>Severity Scale:</b>		<b>5.5</b>	
Notes: 303d: Impaired - Aquatic Life Harvesting (mercury in fish tissue)			
Restoration Option 1, due to a recent river avulsion, the best course of action would be to stabilize one channel (would need to increase bankfull cross-sectional area) and create wetland habitat with the other channel

Additional Site Features
Stream Channel Woody Material: Dominating
Impoundments: Woody Material Jams
Substrate Composition: Medium Sand
Bank Material: Medium Sand
Near Bank Stress: High
RB Landuse: Natural Forest, Pasture
LB Landuse: Pasture, Natural Forest

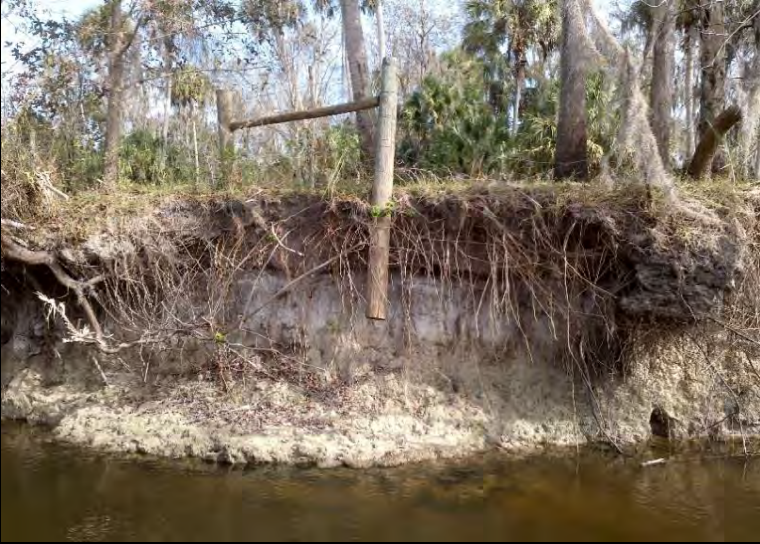
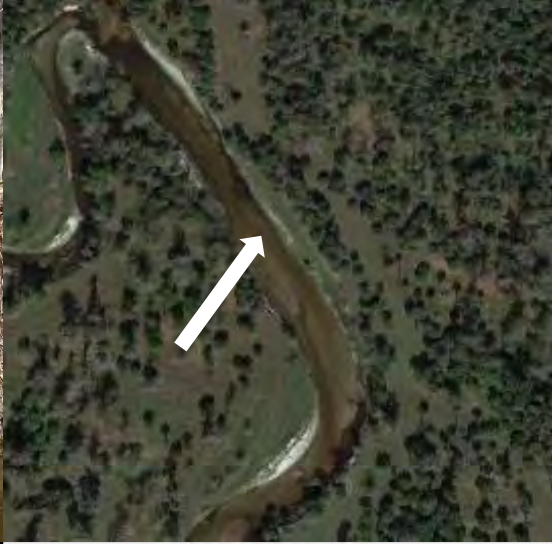
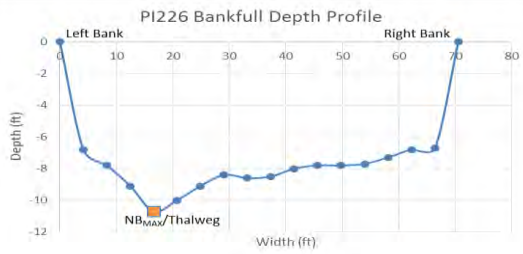
Peace River			Severity Scale: 6.0-Moderate
Watershed: Peace River Subwatershed: Peace River Branch Latitude: 27.43903 Longitude: -81.85005			County: Hardee Site Number: PI226 Reach Length: 180 ft. Landowner: Ben Hill Griffin Inc.

Pfankuch-Channel Stability:	Poor	1.5	
Channel Alteration:	None	0	
Bank Erosion:	Mass-wasting	1.5	
BEHI:	Moderate (25.83)	0.5	
Local NPSP:	Obvious Sources	1.5	
Shoring Structures:	None	0	
Pipe Discharge:	None	0	
Water Odor:	Normal	0	
Fish Passage Barrier:	None	0	
RB: Riparian Buffer:	40 ft.	0.5	Additional Site Features
LB: Riparian Buffer:	40 ft.	0.5	
RB: Floodplain Access:	Full	0	
LB: Floodplain Access:	Full	0	
Severity Scale:		6.0	
Notes: 303d: Impaired - Aquatic Life Harvesting (mercury in fish tissue)			Stream Channel Woody Material: Infrequent
Restoration Option 1			Impoundments: None
			Substrate Composition: Medium Sand
			Bank Material: Medium Sand

Near Bank Stress: High
			RB Landuse: Pasture, Natural Forest
			LB Landuse: Pasture, Natural Forest

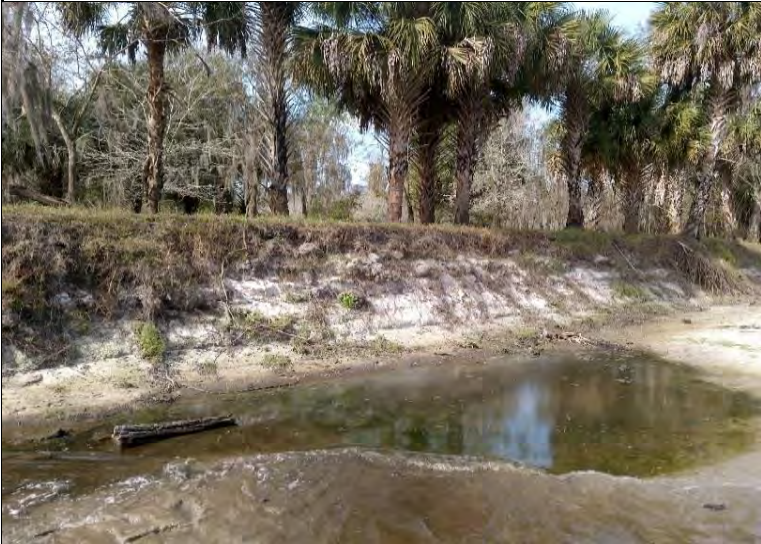
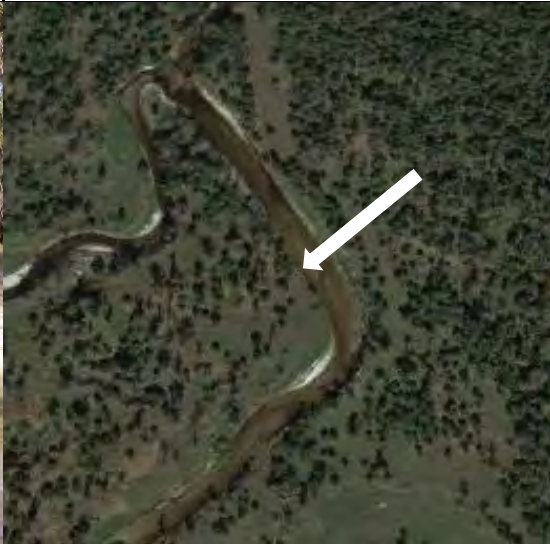
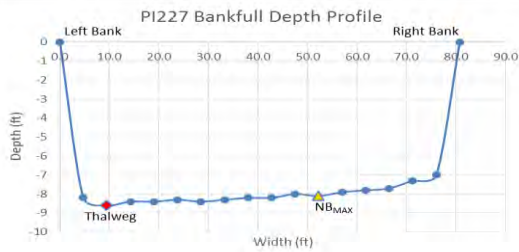
Peace River			Severity Scale: 5.75-Moderate
Watershed: Peace River Subwatershed: Peace River Branch Latitude: 27.43796 Longitude: -81.84948			County: Hardee Site Number: PI227 Reach Length: 250 ft. Landowner: Ben Hill Griffin Inc.

Risk Factor	Ranking	Score	
Pfankuch-Channel Stability:	Poor	1.5	
Channel Alteration:	None	0	
Bank Erosion:	Active	1	
BEHI:	Moderate (27.45)	0.5	
Local NPSP:	Obvious Sources	1.5	
Shoring Structures:	None	0	
Pipe Discharge:	None	0	<b>Additional Site Features</b> Stream Channel Woody Material: Infrequent Impoundments: None Substrate Composition: Medium Sand Bank Material: Medium Sand Near Bank Stress: Low RB Landuse: Pasture, Natural Forest LB Landuse: Pasture, Natural Forest
Water Odor:	Normal	0	
Fish Passage Barrier:	None	0	
RB: Riparian Buffer:	20 ft.	0.75	
LB: Riparian Buffer:	40 ft.	0.5	
RB: Floodplain Access:	Full	0	
LB: Floodplain Access:	Full	0	
<b>Severity Scale:</b>		<b>5.75</b>

Notes: 303d: Impaired - Aquatic Life Harvesting (mercury in fish tissue)			
Restoration Option 2 or 3

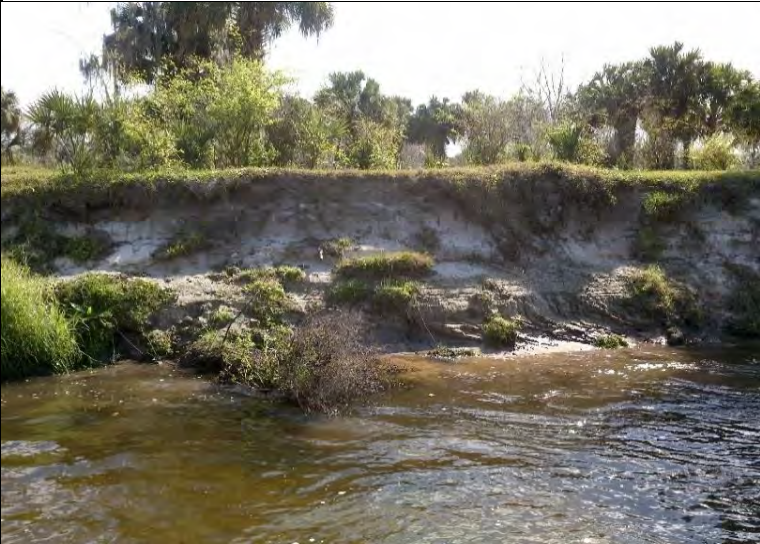
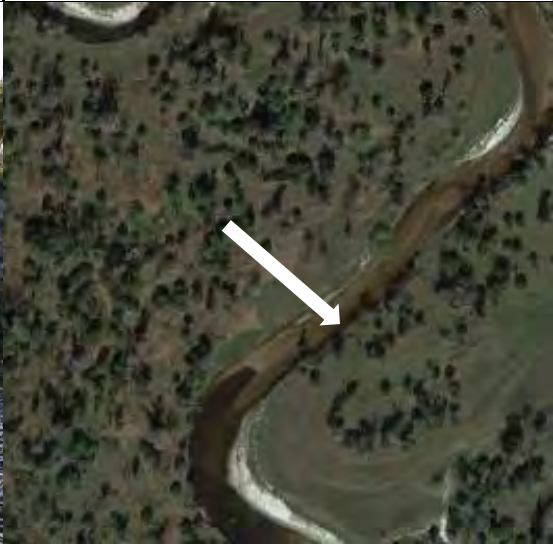
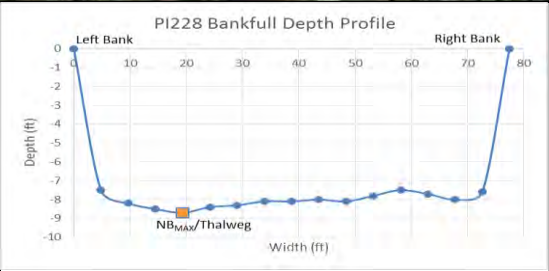
Peace River			Severity Scale: 6.0-Moderate
Watershed: Peace River Subwatershed: Peace River Branch Latitude: 27.43678 Longitude: -81.85035			County: Hardee Site Number: PI228 Reach Length: 115 ft. Landowner: Ben Hill Griffin Inc.

Risk Factor	Ranking	Score	
Pfankuch-Channel Stability:	Poor	1.5	
Channel Alteration:	None	0	
Bank Erosion:	Active	1	
BEHI:	Moderate (28.82)	0.5	
Local NPSP:	Obvious Sources	1.5	
Shoring Structures:	None	0	
Pipe Discharge:	None	0	<b>Additional Site Features</b> Stream Channel Woody Material: Moderate Impoundments: None Substrate Composition: Medium Sand Bank Material: Medium Sand Near Bank Stress: High RB Landuse: Pasture, Natural Forest LB Landuse: Pasture, Natural Forest
Water Odor:	Normal	0	
Fish Passage Barrier:	None	0	
RB: Riparian Buffer:	20 ft.	0.75	
LB: Riparian Buffer:	20 ft.	0.75	
RB: Floodplain Access:	Full	0	
LB: Floodplain Access:	Full	0	
<b>Severity Scale:</b>		<b>6.0</b>

Notes: 303d: Impaired - Aquatic Life Harvesting (mercury in fish tissue)			
Restoration Option 1
