# **Peace River and Withlacoochee River Threats Assessments and Fish Assemblage Monitoring**

**Final Report July 1, 2015 – June 30, 2019**

Submitted to Florida State Wildlife Grants Program  
August 1, 2019  
PID: 98462501284

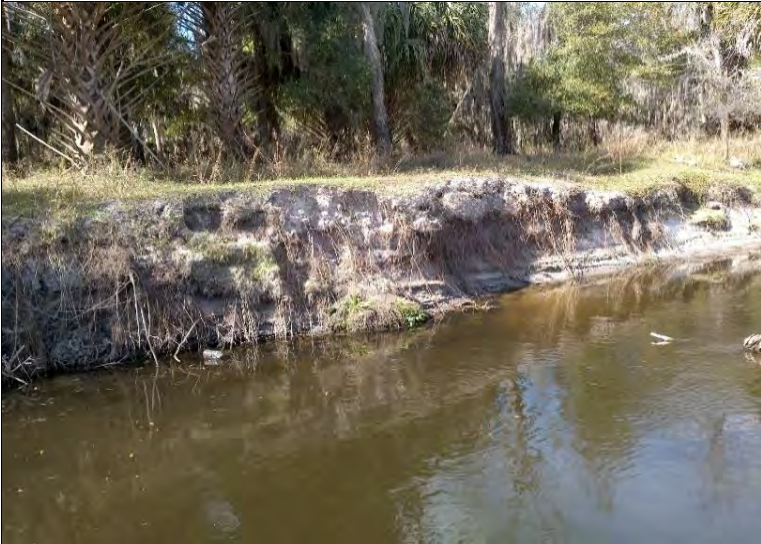
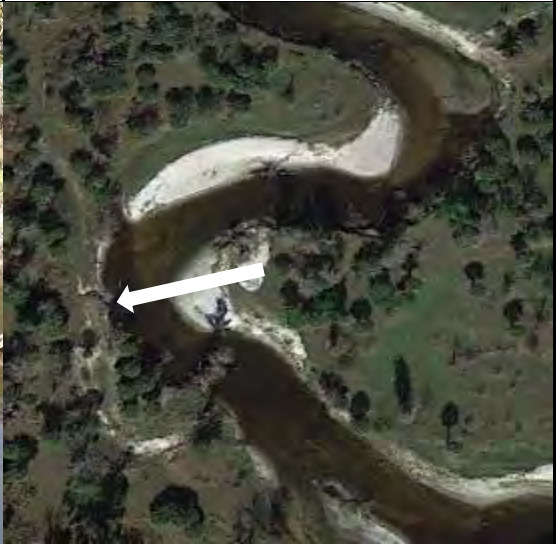
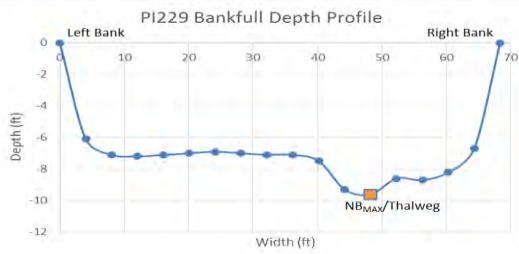
Peace River			Severity Scale: 5.75-Moderate
Watershed: Peace River Subwatershed: Peace River Branch Latitude: 27.43516 Longitude: -81.85123			County: Hardee Site Number: PI229 Reach Length: 240 ft. Landowner: Ben Hill Griffin Inc.

Risk Factor	Ranking	Score	
Pfankuch-Channel Stability:	Poor	1.5	
Channel Alteration:	None	0	
Bank Erosion:	Active	1	
BEHI:	Moderate (28.69)	0.5	
Local NPSP:	Obvious Sources	1.5	
Shoring Structures:	None	0	
Pipe Discharge:	None	0	<b>Additional Site Features</b> Stream Channel Woody Material: Dominating Impoundments: Woody Material Jams Substrate Composition: Medium Sand Bank Material: Medium Sand Near Bank Stress: High RB Landuse: Natural Forest, Pasture LB Landuse: Pasture, Natural Forest
Water Odor:	Normal	0	
Fish Passage Barrier:	None	0	
RB: Riparian Buffer:	40 ft.	0.5	
LB: Riparian Buffer:	20 ft.	0.75	
RB: Floodplain Access:	Full	0	
LB: Floodplain Access:	Full	0

<b>Severity Scale:</b>		<b>5.75</b>	
Notes: 303d: Impaired - Aquatic Life Harvesting (mercury in fish tissue)			
Restoration Option 1

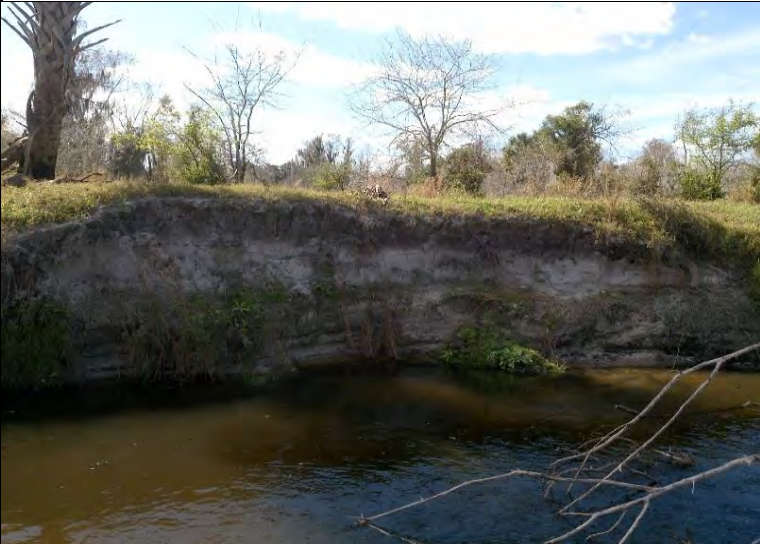
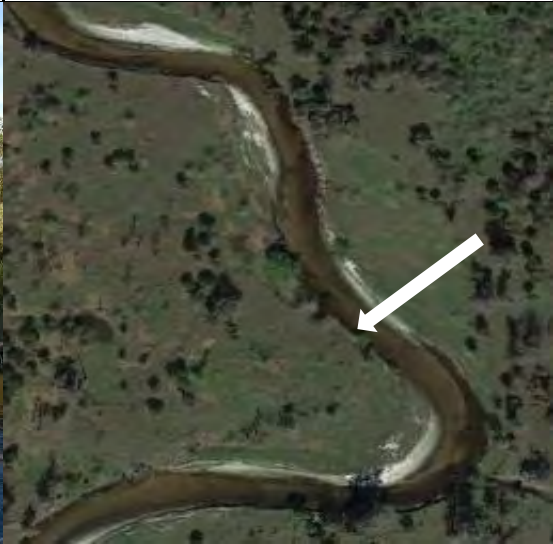
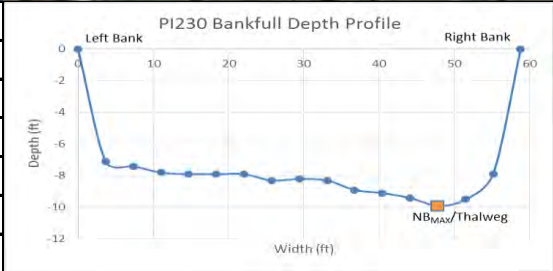
Peace River			Severity Scale: 6.0-Moderate
Watershed: Peace River Subwatershed: Peace River Branch Latitude: 27.43205 Longitude: -81.84804			County: Hardee Site Number: PI230 Reach Length: 215 ft. Landowner: Ben Hill Griffin Inc.

Risk Factor	Ranking	Score	
Pfankuch-Channel Stability:	Poor	1.5	
Channel Alteration:	None	0	
Bank Erosion:	Active	1	
BEHI:	Moderate (27.52)	0.5	
Local NPSP:	Obvious Sources	1.5	
Shoring Structures:	None	0	
Pipe Discharge:	None	0	
Water Odor:	Normal	0	
Fish Passage Barrier:	None	0	
RB: Riparian Buffer:	20 ft.	0.75	
LB: Riparian Buffer:	20 ft.	0.75	
RB: Floodplain Access:	Full	0	
LB: Floodplain Access:	Full	0	
<b>Severity Scale:</b>		<b>6.0</b>	
Notes: 303d: Impaired - Aquatic Life Harvesting (mercury in fish tissue)			
Restoration Option 1

Additional Site Features
Stream Channel Woody Material: Infrequent
Impoundments: None
Substrate Composition: Medium Sand
Bank Material: Medium Sand
Near Bank Stress: High
RB Landuse: Pasture, Natural Forest
LB Landuse: Pasture, Natural Forest

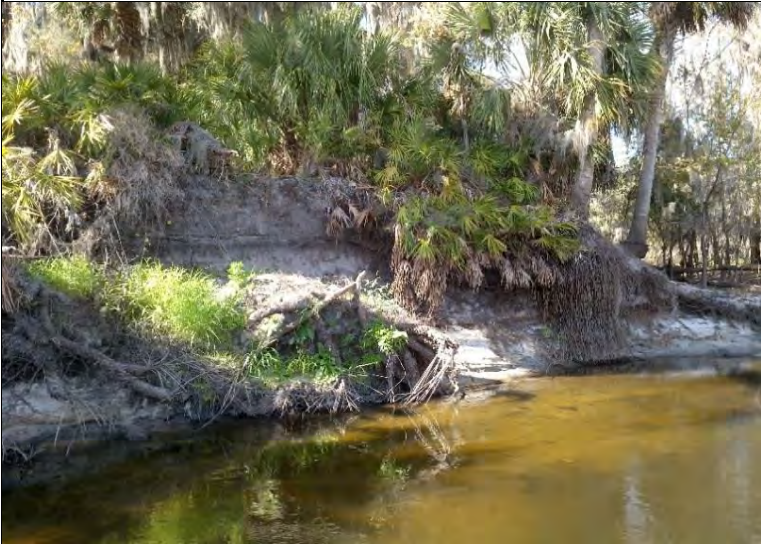
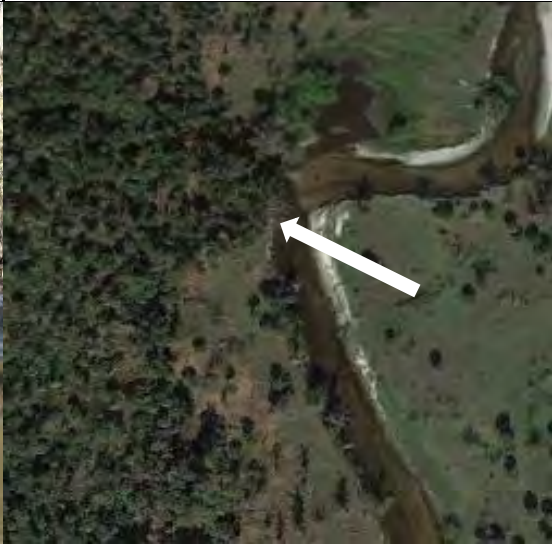
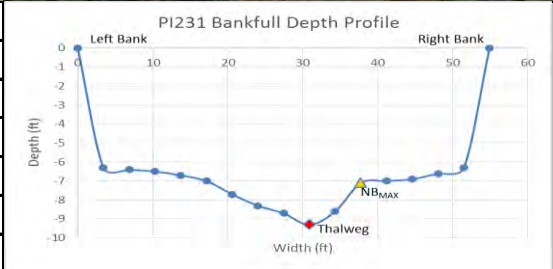
Peace River			Severity Scale: 7.0-Moderate
Watershed: Peace River Subwatershed: Peace River Branch Latitude: 27.42975 Longitude: -81.85018			County: Hardee Site Number: PI231 Reach Length: 80 ft. Landowner: Ben Hill Griffin Inc.

Risk Factor	Ranking	Score	
Pfankuch-Channel Stability:	Poor	1.5	
Channel Alteration:	None	0	
Bank Erosion:	Mass-wasting	1.5	
BEHI:	High (30.90)	1	
Local NPSP:	Obvious Sources	1.5	
Shoring Structures:	None	0	
Pipe Discharge:	None	0	
Water Odor:	Normal	0	
Fish Passage Barrier:	None	0	
RB: Riparian Buffer:	40 ft.	0.5	
LB: Riparian Buffer:	0 ft.	0.75	
RB: Floodplain Access:	Partial	0.25	
LB: Floodplain Access:	Full	0	
<b>Severity Scale:</b>		<b>7.0</b>	
Notes: 303d: Impaired - Aquatic Life Harvesting (mercury in fish tissue)			
Restoration Option 1

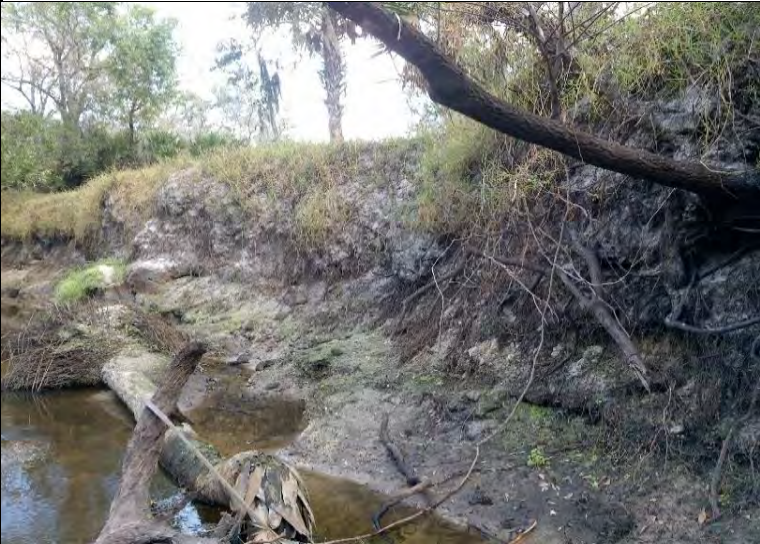
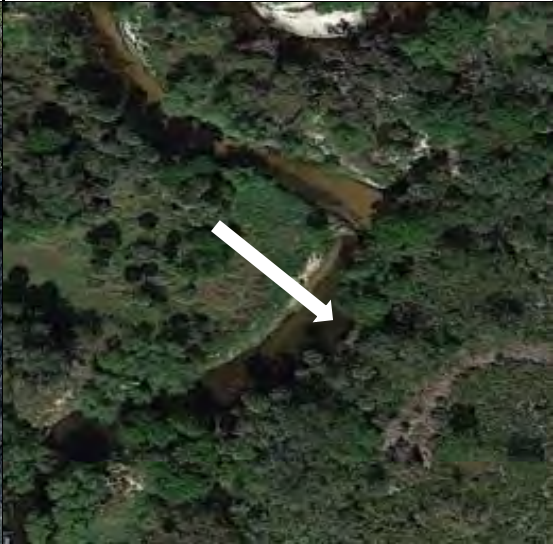
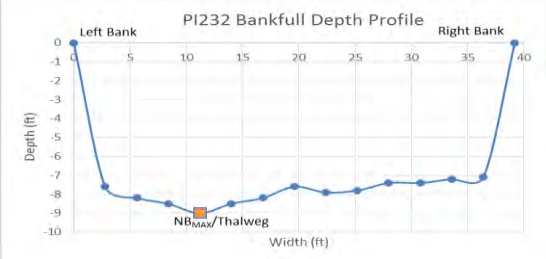
Prairie Creek			Severity Scale: 5.5-Moderate
Watershed: Peace River Subwatershed: Lower Prairie Creek Latitude: 27.02671 Longitude: -81.87023			County: Charlotte Site Number: PI232 Reach Length: 361 ft. Landowner: Charlotte County

Pfankuch-Channel Stability:	Fair	1	
Channel Alteration:	None	0	
Bank Erosion:	Active	1	
BEHI:	Moderate (28.25)	0.5	
Local NPSP:	Obvious Sources	1.5	
Shoring Structures:	None	0	
Pipe Discharge:	None	0	
Water Odor:	Normal	0	
Fish Passage Barrier:	None	0	
RB: Riparian Buffer:	20 ft.	0.75	
LB: Riparian Buffer:	40 ft.	0.5	
RB: Floodplain Access:	Full	0	
LB: Floodplain Access:	Partial	0.25	
<b>Severity Scale:</b>		<b>5.5</b>	
Notes: 303d: Impaired - Public Water Supply (DO & TDS)			Additional Site Features
			Stream Channel Woody Material: Numerous
			Impoundments: None
			Substrate Composition: Medium Sand
			Bank Material: Medium Sand
			Near Bank Stress: High

RB Landuse: Pasture, Natural Forest
			LB Landuse: Pasture, Natural Forest
Restoration Option 1

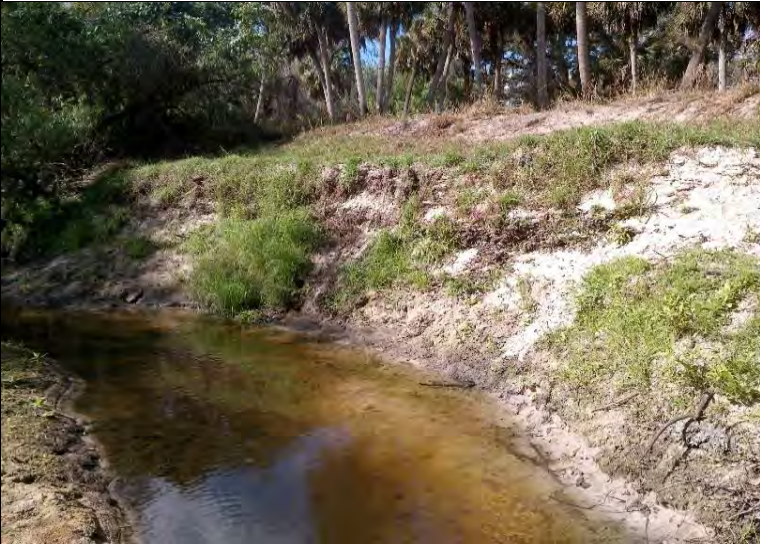
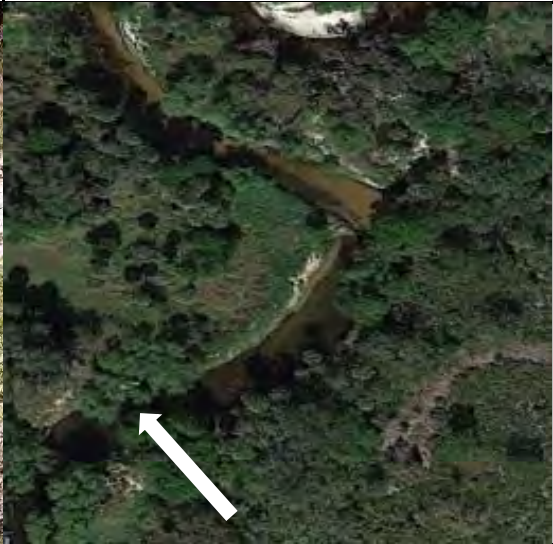
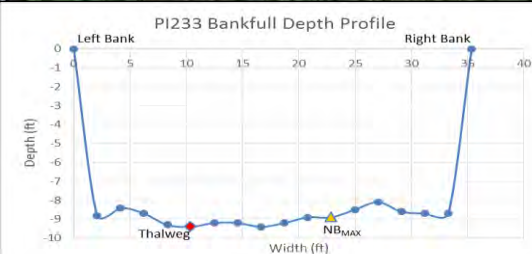
Prairie Creek			Severity Scale: 6.0-Moderate
Watershed: Peace River Subwatershed: Lower Prairie Creek Latitude: 27.02689 Longitude: -81.87008			County: Charlotte Site Number: PI233 Reach Length: 57 ft. Landowner: Charlotte County

Risk Factor	Ranking	Score	
Pfankuch-Channel Stability:	Fair	1	
Channel Alteration:	None	0	
Bank Erosion:	Active	1	
BEHI:	High (31.63)	1	
Local NPSP:	Obvious Sources	1.5	
Shoring Structures:	None	0	
Pipe Discharge:	None	0	<b>Additional Site Features</b>
Water Odor:	Normal	0	Stream Channel Woody Material: Moderate
Fish Passage Barrier:	None	0	Impoundments: None
RB: Riparian Buffer:	0 ft.	0.75	Substrate Composition: Medium Sand
LB: Riparian Buffer:	20 ft.	0.75	Bank Material: Medium Sand
RB: Floodplain Access:	Full	0	Near Bank Stress: Low
LB: Floodplain Access:	Full	0	RB Landuse: Pasture, Natural Forest
<b>Severity Scale:</b>		<b>6.0</b>	LB Landuse: Pasture, Natural Forest

Notes: 303d: Impaired - Public Water Supply (DO & TDS)			
Restoration Option 1

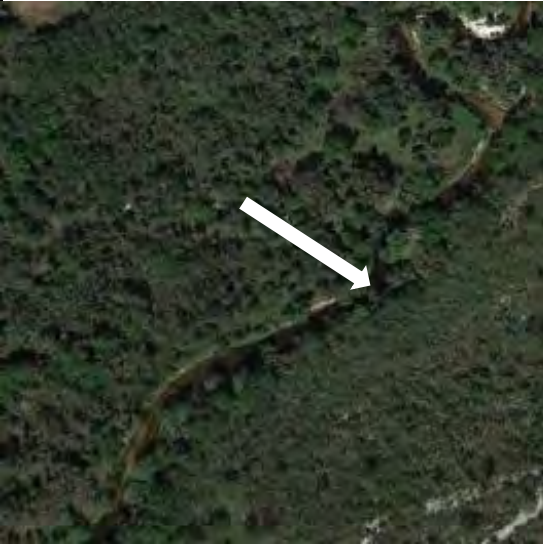
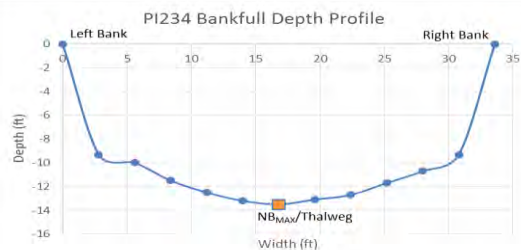
Prairie Creek			Severity Scale: 5.25-Moderate
Watershed: Peace River Subwatershed: Lower Prairie Creek Latitude: 27.02649 Longitude: -81.87019 *NO PHOTOS			County: Charlotte Site Number: PI234 Reach Length: 38 ft. Landowner: Charlotte County

Risk Factor	Ranking	Score	
Pfankuch-Channel Stability:	Fair	1	
Channel Alteration:	None	0	
Bank Erosion:	Active	1	
BEHI:	High (32.09)	1	
Local NPSP:	Obvious Sources	1.5	
Shoring Structures:	None	0	
Pipe Discharge:	None	0	<b>Additional Site Features</b> Stream Channel Woody Material: Moderate Impoundments: None Substrate Composition: Medium Sand Bank Material: Medium Sand Near Bank Stress: Moderate RB Landuse: Natural Forest, Pasture LB Landuse: Natural Forest, Pasture
Water Odor:	Normal	0	
Fish Passage Barrier:	None	0	
RB: Riparian Buffer:	60 ft.	0.25	
LB: Riparian Buffer:	40 ft.	0.5	
RB: Floodplain Access:	Full	0	
LB: Floodplain Access:	Full	0	
<b>Severity Scale:</b>		<b>5.25</b>

Notes: 303d: Impaired - Public Water Supply (DO & TDS)			
Restoration Option 1

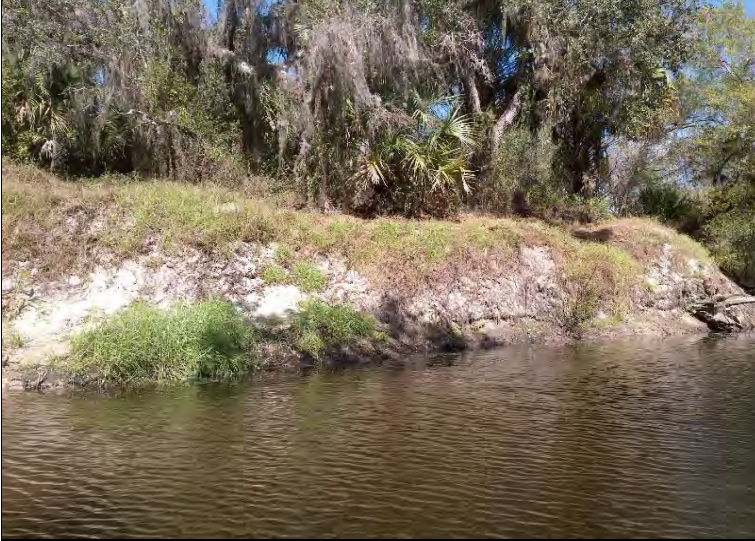
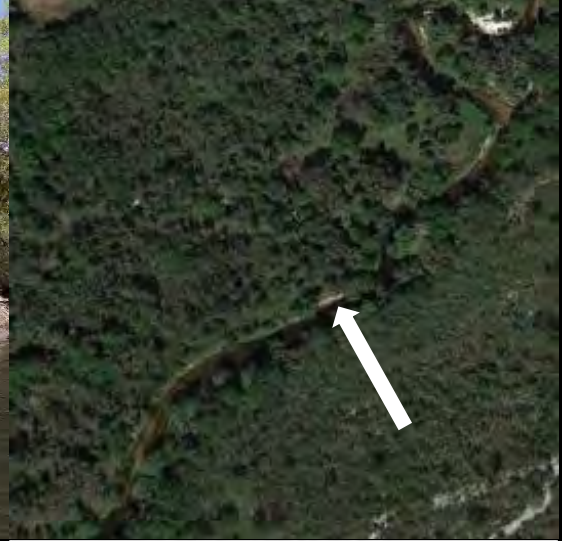
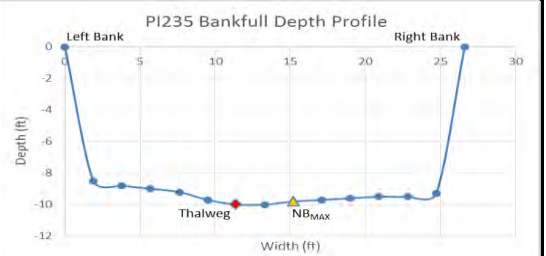
## Prairie Creek

Severity Scale: 4.75-Moderate

Risk Factor	Ranking	Score
Pfankuch-Channel Stability:	Fair	1
Channel Alteration:	None	0
Bank Erosion:	Active	1
BEHI:	Moderate (24.39)	0.5
Local NPSP:	Obvious Sources	1.5
Shoring Structures:	None	0
Pipe Discharge:	None	0
Water Odor:	Normal	0
Fish Passage Barrier:	None	0
RB: Riparian Buffer:	40 ft.	0.5
LB: Riparian Buffer:	100 ft.	0
RB: Floodplain Access:	Full	0
LB: Floodplain Access:	Partial	0.25
<b>Severity Scale:</b>		<b>4.75</b>

Restoration Option 2 or 3

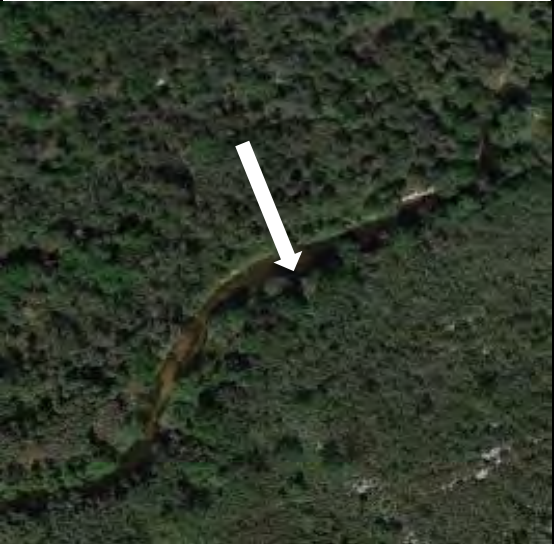
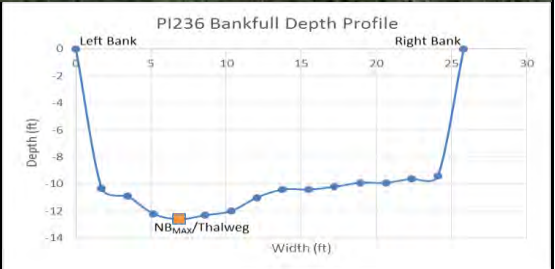
Prairie Creek			Severity Scale: 3.0-Low
Watershed: Peace River Subwatershed: Lower Prairie Creek Latitude: 27.02628 Longitude: -81.87071 *NO PHOTOS			County: Charlotte Site Number: PI236 Reach Length: 167 ft. Landowner: Charlotte County

Risk Factor	Ranking	Score	
Pfankuch-Channel Stability:	Fair	1	
Channel Alteration:	None	0	
Bank Erosion:	Active	1	
BEHI:	Moderate (27.91)	0.5	
Local NPSP:	Slight Potential	0.5	
Shoring Structures:	None	0	
Pipe Discharge:	None	0	
Water Odor:	Normal	0	
Fish Passage Barrier:	None	0	
RB: Riparian Buffer:	100 ft.	0	
LB: Riparian Buffer:	100 ft.	0	
RB: Floodplain Access:	Full	0	
LB: Floodplain Access:	Full	0	
Severity Scale:		3.0	
Notes: 303d: Impaired - Public Water Supply (DO & TDS)			
Restoration Option 1

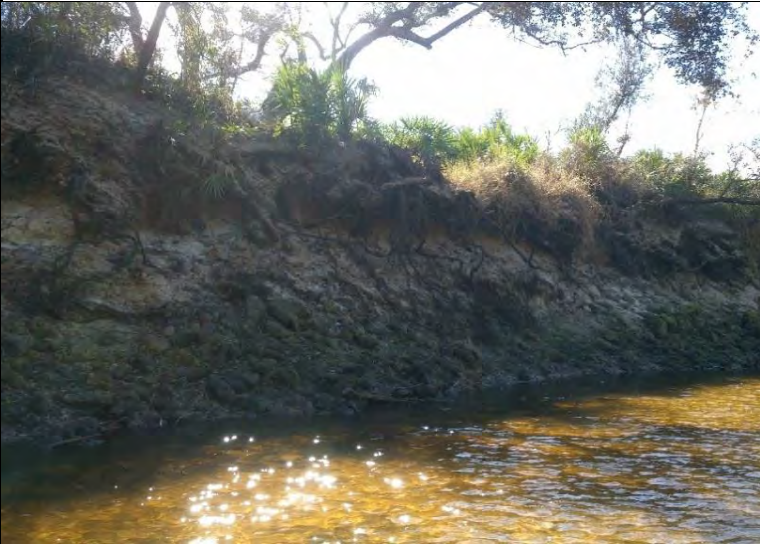
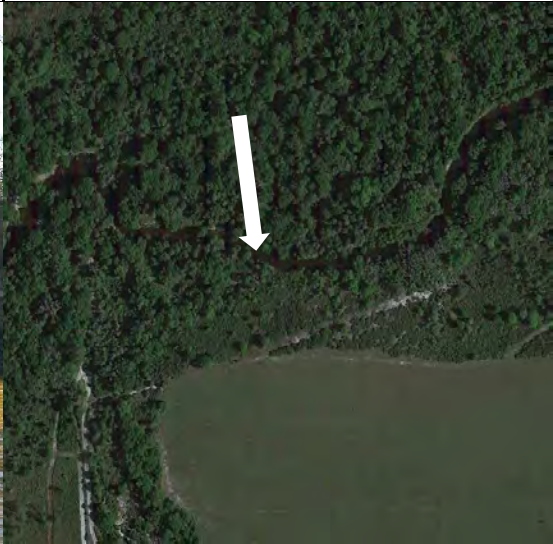
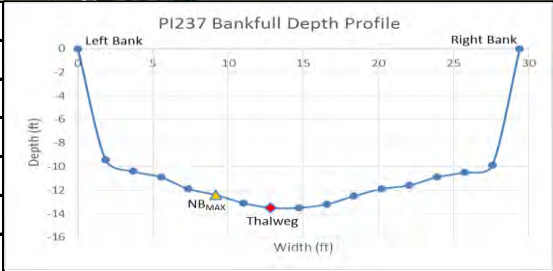
Prairie Creek			Severity Scale: 4.75-Moderate
Watershed: Peace River Subwatershed: Lower Prairie Creek Latitude: 27.02512 Longitude: -81.87305			County: Charlotte Site Number: PI237 Reach Length: 544 ft. Landowner: Charlotte County

Risk Factor	Ranking	Score	
Pfankuch-Channel Stability:	Fair	1	
Channel Alteration:	None	0	
Bank Erosion:	Mass-wasting	1.5	
BEHI:	Very High (40.07)	1.5	
Local NPSP:	No Evidence	0	
Shoring Structures:	None	0	
Pipe Discharge:	None	0	
Water Odor:	Normal	0	
Fish Passage Barrier:	None	0	
RB: Riparian Buffer:	40 ft.	0.5	
LB: Riparian Buffer:	100 ft.	0	
RB: Floodplain Access:	Full	0	
LB: Floodplain Access:	Partial	0.25	
<b>Severity Scale:</b>		<b>4.75</b>	
Notes: 303d: Impaired - Public Water Supply (DO & TDS)			
Restoration Option 1

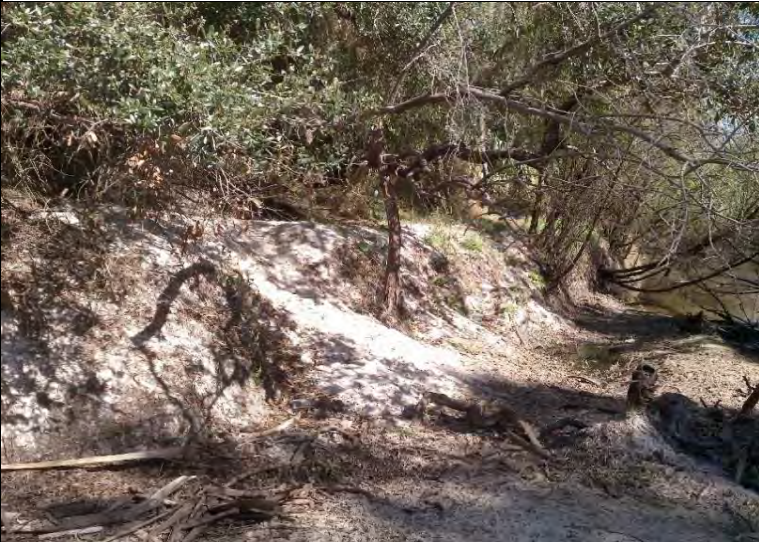
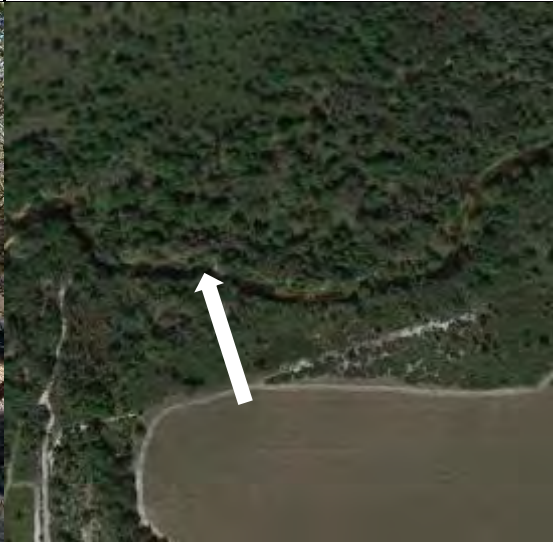
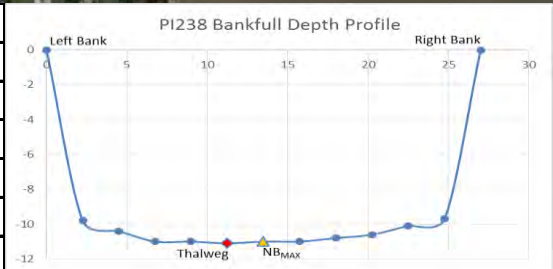
Prairie Creek			Severity Scale: 5.0-Moderate	
Watershed: Peace River Subwatershed: Lower Prairie Creek Latitude: 27.02537 Longitude: -81.87377			County: Charlotte Site Number: PI238 Reach Length: 163 ft. Landowner: Charlotte County

Pfankuch-Channel Stability:	Fair	1		
Channel Alteration:	None	0		
Bank Erosion:	Active	1		
BEHI:	High (30.80)	1		
Local NPSP:	Obvious Sources	1.5		
Shoring Structures:	None	0		
Pipe Discharge:	None	0		
Water Odor:	Normal	0		
Fish Passage Barrier:	None	0		
RB: Riparian Buffer:	40 ft.	0.5	<b>Additional Site Features</b> Stream Channel Woody Material: Dominating Impoundments: Woody Material Jams Substrate Composition: Medium Sand Bank Material: Medium Sand Near Bank Stress: Low RB Landuse:Natural Forest, Pasture LB Landuse: Natural Forest	
LB: Riparian Buffer:	100 ft.	0		
RB: Floodplain Access:	Full	0		
LB: Floodplain Access:	Full	0

Severity Scale:		5.0		
Notes: 303d: Impaired - Public Water Supply (DO & TDS)				
Restoration Option 1

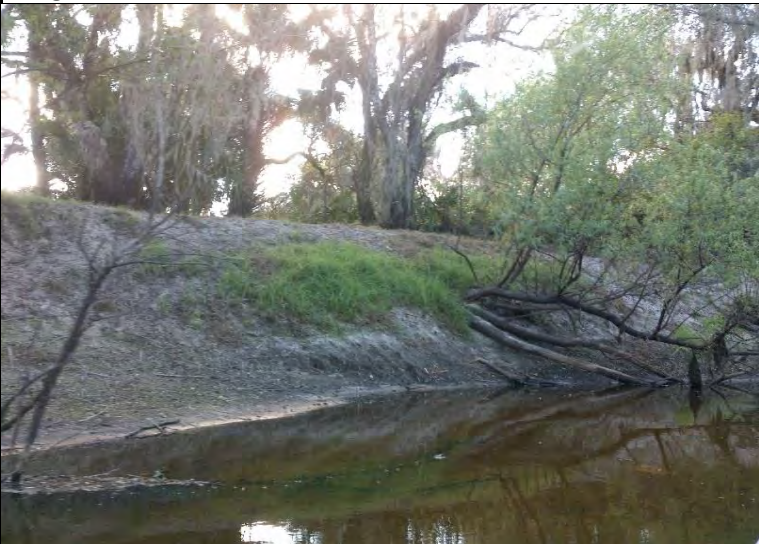
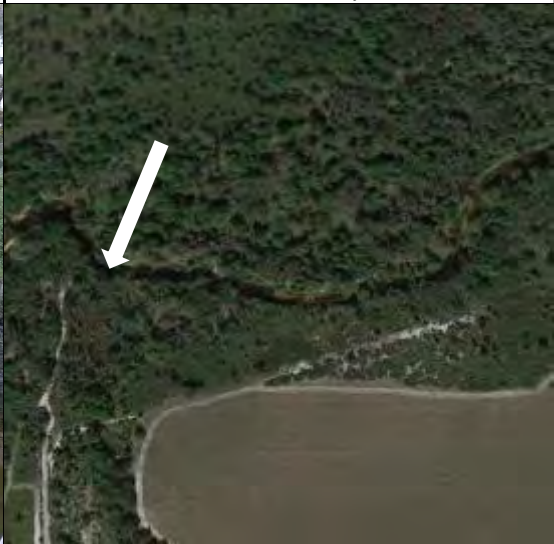
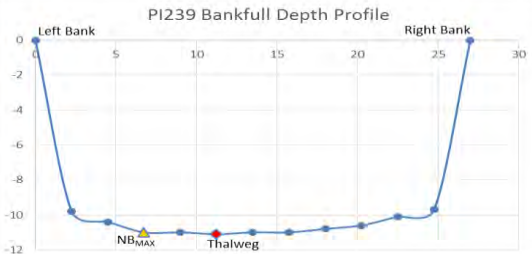
Prairie Creek			Severity Scale: 5.0-Moderate		
Watershed: Peace River Subwatershed: Lower Prairie Creek Latitude: 27.02525 Longitude: -81.87362			County: Charlotte Site Number: PI239 Reach Length: 324 ft. Landowner: Charlotte County

Pfankuch-Channel Stability:	Fair	1			
Channel Alteration:	None	0			
Bank Erosion:	Active	1			
BEHI:	High (31.23)	1			
Local NPSP:	Obvious Sources	1.5			
Shoring Structures:	None	0			
Pipe Discharge:	None	0			
Water Odor:	Normal	0			
Fish Passage Barrier:	None	0			
RB: Riparian Buffer:	40 ft.	0.5			
LB: Riparian Buffer:	100 ft.	0			
RB: Floodplain Access:	Full	0			
LB: Floodplain Access:	Full	0			
Severity Scale:		5.0			
Notes: 303d: Impaired - Public Water Supply (DO & TDS)			Additional Site Features		
			Stream Channel Woody Material: Dominating		
			Impoundments: Woody Material Jams		
			Substrate Composition: Medium Sand		
			Bank Material: Medium Sand

Near Bank Stress: Moderate		
			RB Landuse: Natural Forest, Pasture		
			LB Landuse: Natural Forest		
Restoration Option 1

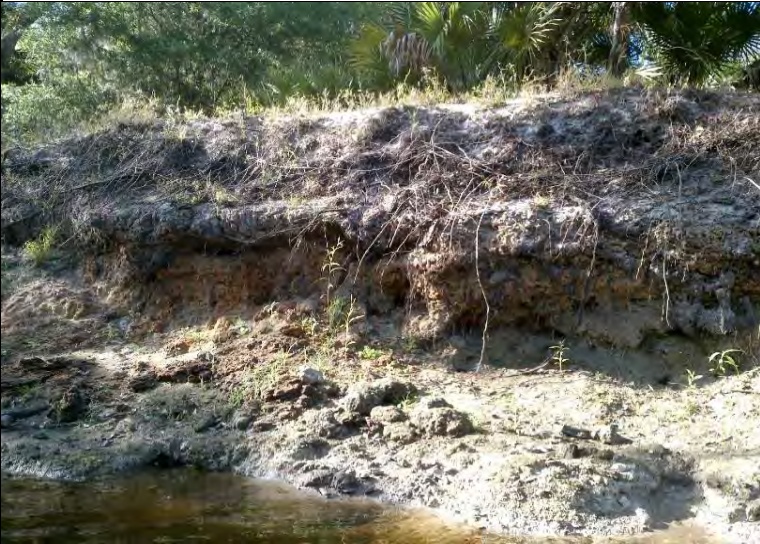
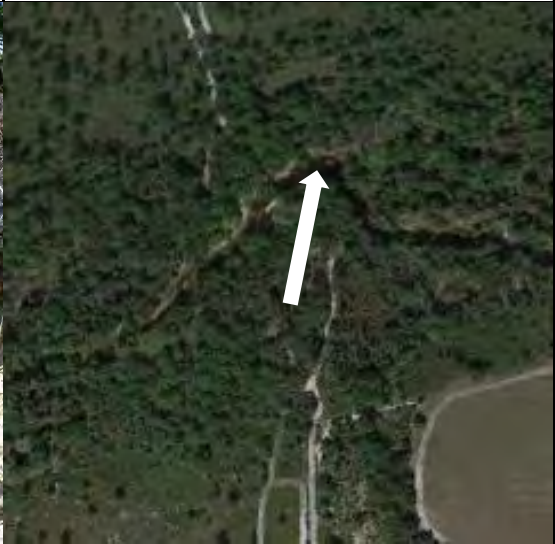
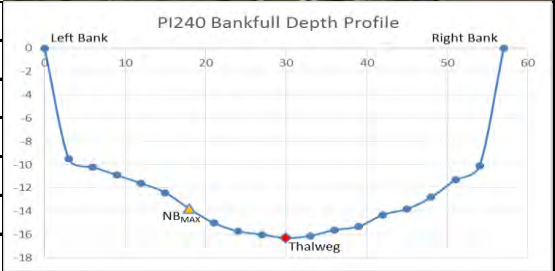
Prairie Creek			Severity Scale: 5.25-Moderate
Watershed: Peace River Subwatershed: Lower Prairie Creek Latitude: 27.02578 Longitude: -81.87451			County: Charlotte Site Number: PI240 Reach Length: 168 ft. Landowner: Charlotte County

Risk Factor	Ranking	Score	
Pfankuch-Channel Stability:	Fair	1	
Channel Alteration:	None	0	
Bank Erosion:	Active	1	
BEHI:	High (29.59)	1	
Local NPSP:	Obvious Sources	1.5	
Shoring Structures:	None	0	
Pipe Discharge:	None	0	
Water Odor:	Normal	0	
Fish Passage Barrier:	None	0	
RB: Riparian Buffer:	40 ft.	0.5	
LB: Riparian Buffer:	100 ft.	0	
RB: Floodplain Access:	Full	0	
LB: Floodplain Access:	Partial	0.25	
Severity Scale:		5.25	
Notes: 303d: Impaired - Public Water Supply (DO & TDS)			
Restoration Option 1

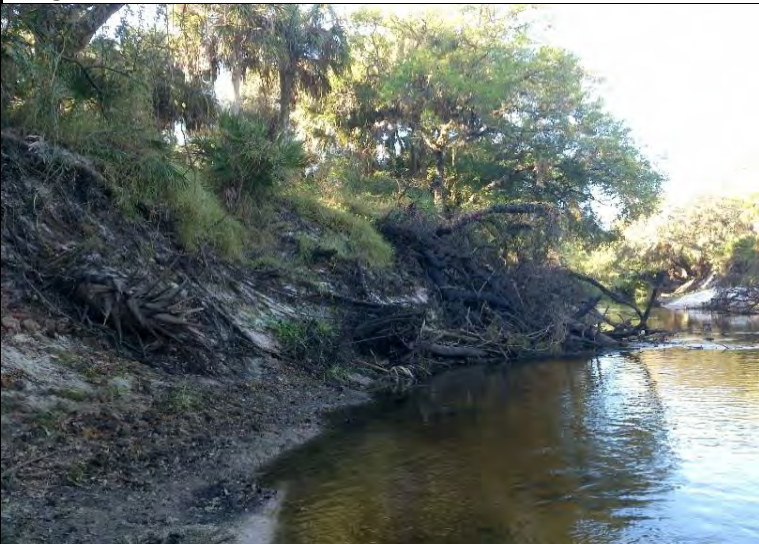
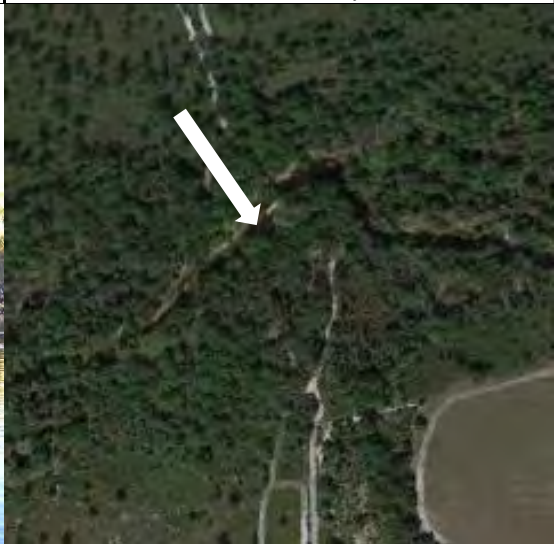
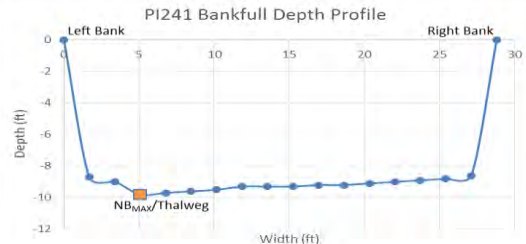
Prairie Creek			Severity Scale: 5.0-Moderate	
Watershed: Peace River Subwatershed: Lower Prairie Creek Latitude: 27.02535 Longitude: -81.8748			County: Charlotte Site Number: PI241 Reach Length: 320 ft. Landowner: Charlotte County

Pfankuch-Channel Stability:	Fair	1		
Channel Alteration:	None	0		
Bank Erosion:	Active	1		
BEHI:	Moderate (23.99)	0.5		
Local NPSP:	Obvious Sources	1.5		
Shoring Structures:	None	0		
Pipe Discharge:	None	0		
Water Odor:	Normal	0		
Fish Passage Barrier:	None	0		
RB: Riparian Buffer:	40 ft.	0.5	<b>Additional Site Features</b>	
LB: Riparian Buffer:	40 ft.	0.5	Stream Channel Woody Material: Numerous	
RB: Floodplain Access:	Full	0	Impoundments: None	
LB: Floodplain Access:	Full	0	Substrate Composition: Medium Sand	
<b>Severity Scale:</b>			Bank Material: Medium Sand	
			Near Bank Stress: High	
			RB Landuse: Natural Forest, Pasture	
			LB Landuse: Natural Forest, Pasture

Notes: 303d: Impaired - Public Water Supply (DO & TDS)				
Restoration Option 1

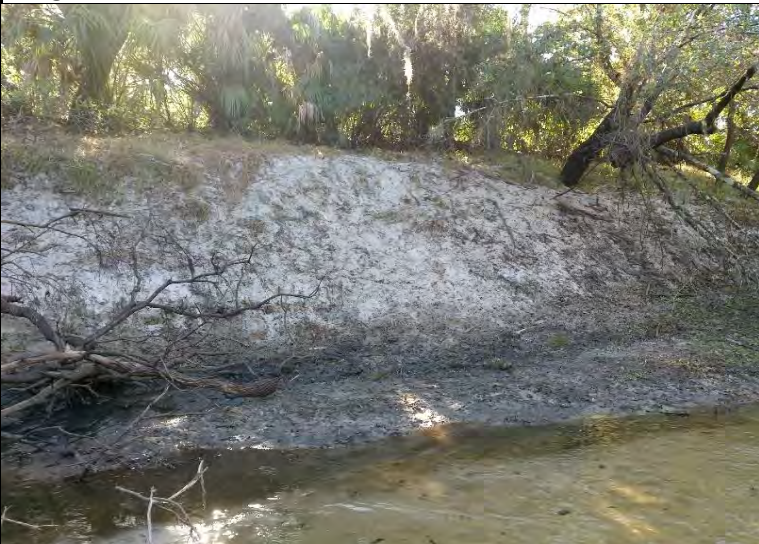
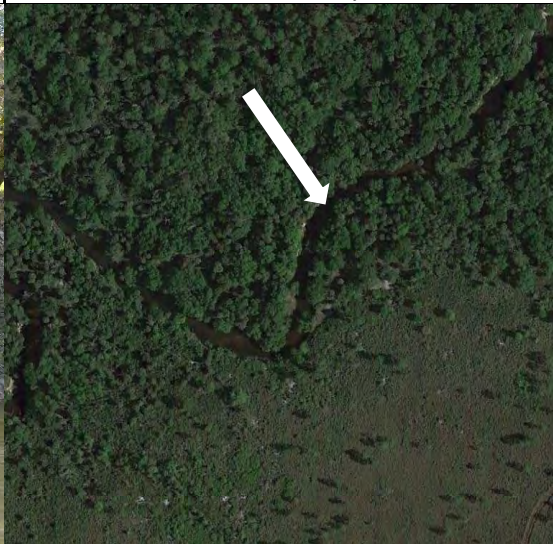
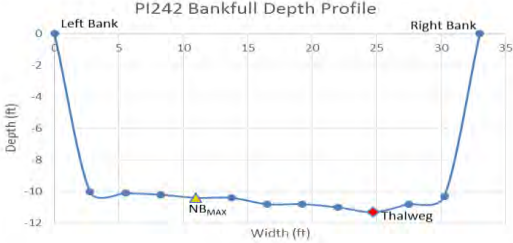
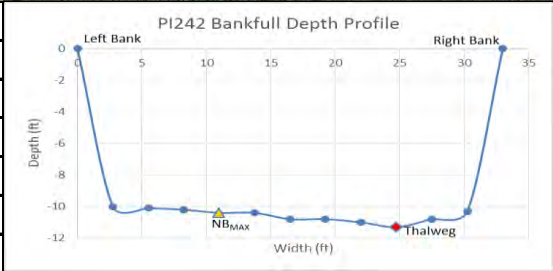
Prairie Creek			Severity Scale: 5.0-Moderate
Watershed: Peace River Subwatershed: Lower Prairie Creek Latitude: 27.02417 Longitude: -81.87665			County: Charlotte Site Number: PI242 Reach Length: 86 ft. Landowner: Charlotte County

Pfankuch-Channel Stability:	Fair	1	
Channel Alteration:	None	0	
Bank Erosion:	Active	1	
BEHI:	High (38.22)	1	
Local NPSP:	Obvious Sources	1.5	
Shoring Structures:	None	0	
Pipe Discharge:	None	0	
Water Odor:	Normal	0	
Fish Passage Barrier:	None	0	
RB: Riparian Buffer:	100 ft.	0	<b>Additional Site Features</b>
LB: Riparian Buffer:	40 ft.	0.5	Stream Channel Woody Material: Moderate
RB: Floodplain Access:	Full	0	Impoundments: None
LB: Floodplain Access:	Full	0	Substrate Composition: Medium Sand
<b>Severity Scale:</b>			Bank Material: Medium Sand
			Near Bank Stress: Low
			RB Landuse: Natural Forest
			LB Landuse: Pasture, Natural Forest
Notes: 303d: Impaired - Public Water Supply (DO & TDS)

Restoration Option 2 or 3

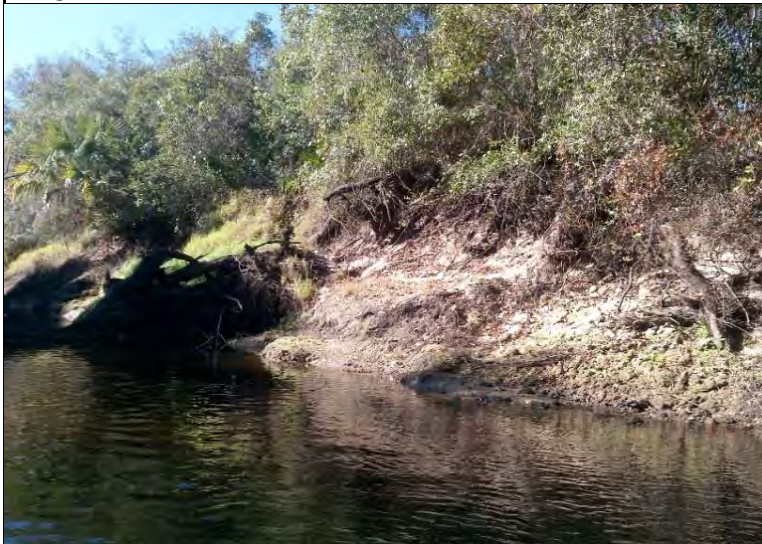
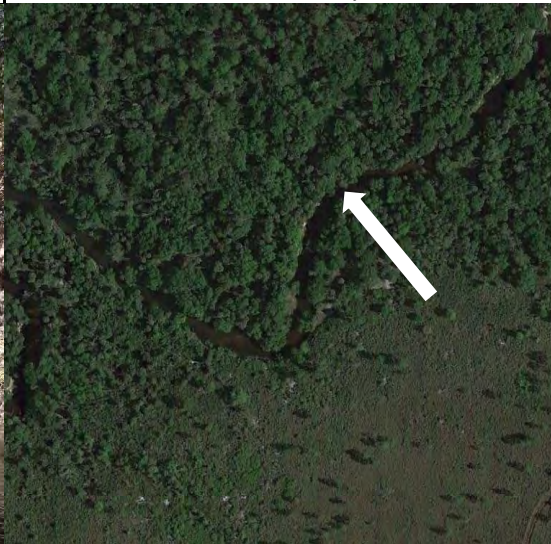
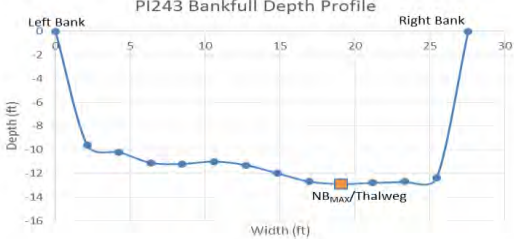
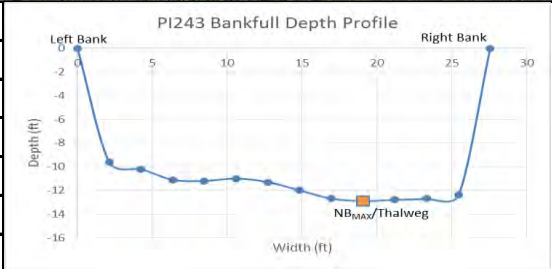
Prairie Creek			Severity Scale: 3.5-Low	
Watershed: Peace River Subwatershed: Lower Prairie Creek Latitude: 27.02417 Longitude: -81.87665			County: Charlotte Site Number: PI243 Reach Length: 61 ft. Landowner: Charlotte County

Pfankuch-Channel Stability:	Fair	1		
Channel Alteration:	None	0		
Bank Erosion:	Active	1		
BEHI:	Moderate (27.66)	0.5		
Local NPSP:	No Evidence	0		
Shoring Structures:	None	0		
Pipe Discharge:	None	0		
Water Odor:	Normal	0		
Fish Passage Barrier:	None	0		
RB: Riparian Buffer:	60 ft.	0.25		
LB: Riparian Buffer:	40 ft.	0.5		
RB: Floodplain Access:	Partial	0.25	<b>Additional Site Features</b> Stream Channel Woody Material: Extensive Impoundments: None Substrate Composition: Medium Sand Bank Material: Medium Sand Near Bank Stress: High RB Landuse: Natural Forest, Pasture LB Landuse: Pasture, Natural Forest

LB: Floodplain Access:	Full	0		
<b>Severity Scale:</b>		<b>3.5</b>		
Notes: 303d: Impaired - Public Water Supply (DO & TDS)				
Restoration Option 1

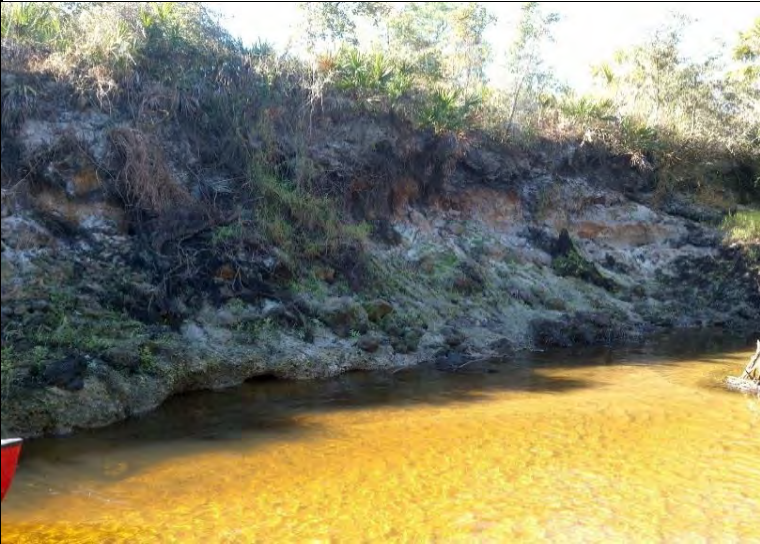
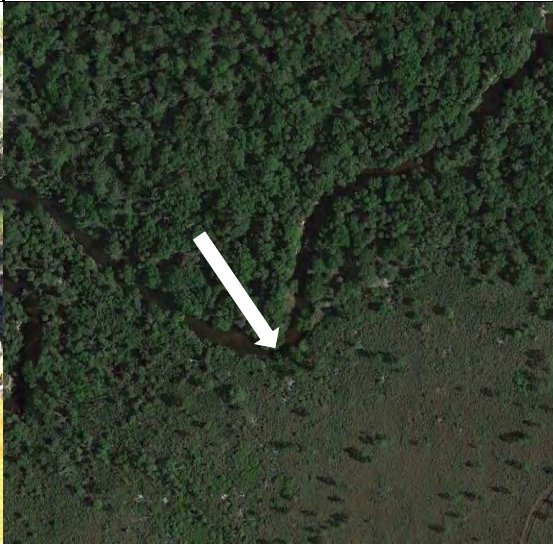
Prairie Creek			Severity Scale: 3.5-Low
Watershed: Peace River Subwatershed: Lower Prairie Creek Latitude: 27.02369 Longitude: -81.87673			County: Charlotte Site Number: PI244 Reach Length: 205 ft. Landowner: Charlotte County

Risk Factor	Ranking	Score	
Pfankuch-Channel Stability:	Fair	1	
Channel Alteration:	None	0	
Bank Erosion:	Mass-wasting	1.5	
BEHI:	High (38.5)	1	
Local NPSP:	No Evidence	0	
Shoring Structures:	None	0	
Pipe Discharge:	None	0	
Water Odor:	Normal	0	
Fish Passage Barrier:	None	0	
RB: Riparian Buffer:	100 ft.	0	
LB: Riparian Buffer:	100 ft.	0	
RB: Floodplain Access:	Full	0	
LB: Floodplain Access:	Full	0	
Severity Scale:		3.5	
Notes: 303d: Impaired - Public Water Supply (DO & TDS)			
Restoration Option 1

Additional Site Features
Stream Channel Woody Material: Moderate
Impoundments: None
Substrate Composition: Medium Sand
Bank Material: Medium Sand
Near Bank Stress: High
RB Landuse: Natural Forest
LB Landuse: Natural Forest

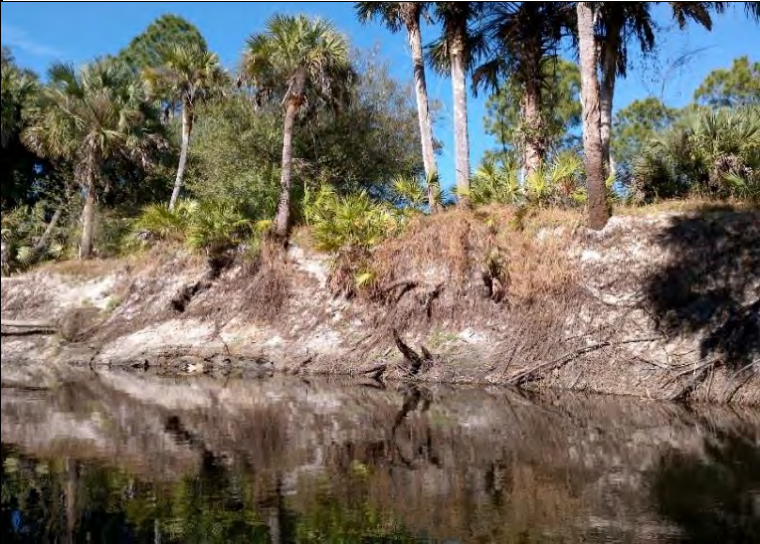
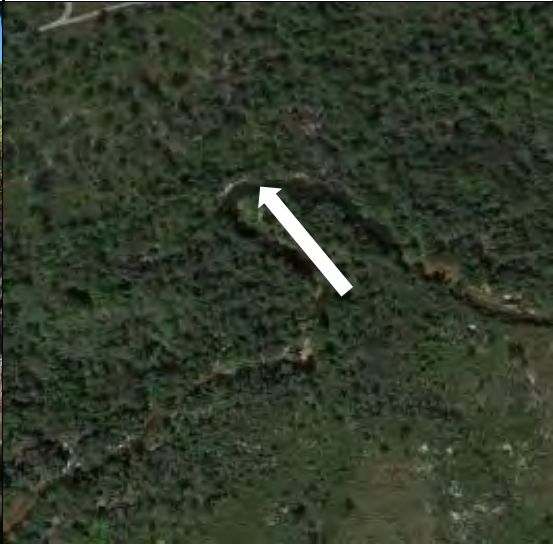
Prairie Creek			Severity Scale: 4.0-Low
Watershed: Peace River Subwatershed: Lower Prairie Creek Latitude: 27.02447 Longitude: -81.87859			County: Charlotte Site Number: PI245 Reach Length: 414 ft. Landowner: Charlotte County

Risk Factor	Ranking	Score	
Pfankuch-Channel Stability:	Fair	1	
Channel Alteration:	None	0	
Bank Erosion:	Active	1	
BEHI:	Moderate (26.27)	0.5	
Local NPSP:	Obvious Sources	1.5	
Shoring Structures:	None	0	
Pipe Discharge:	None	0	<b>Additional Site Features</b> Stream Channel Woody Material: Numerous Impoundments: None Substrate Composition: Medium Sand Bank Material: Medium Sand Near Bank Stress: Moderate RB Landuse: Natural Forest LB Landuse: Natural Forest
Water Odor:	Normal	0	
Fish Passage Barrier:	None	0	
RB: Riparian Buffer:	100 ft.	0	
LB: Riparian Buffer:	100 ft.	0	
RB: Floodplain Access:	Full	0	
LB: Floodplain Access:	Full	0	
<b>Severity Scale:</b>		<b>4.0</b>	
Notes: 303d: Impaired - Public Water Supply (DO & TDS)

Restoration Option 1

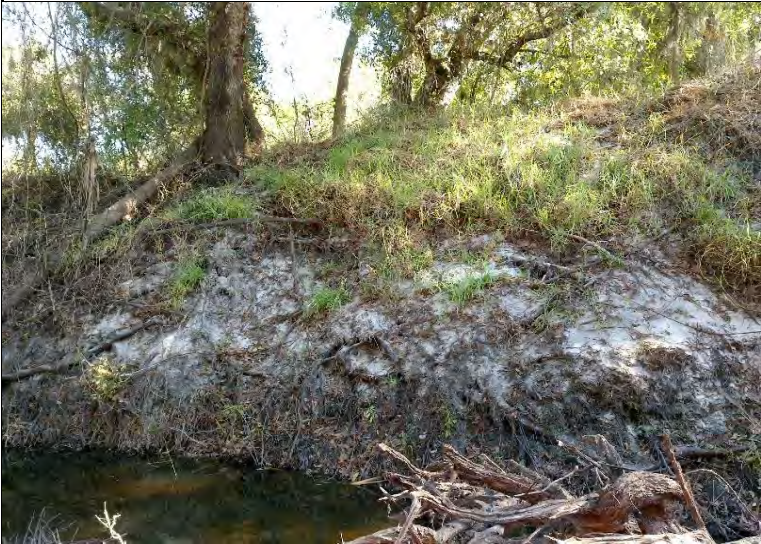
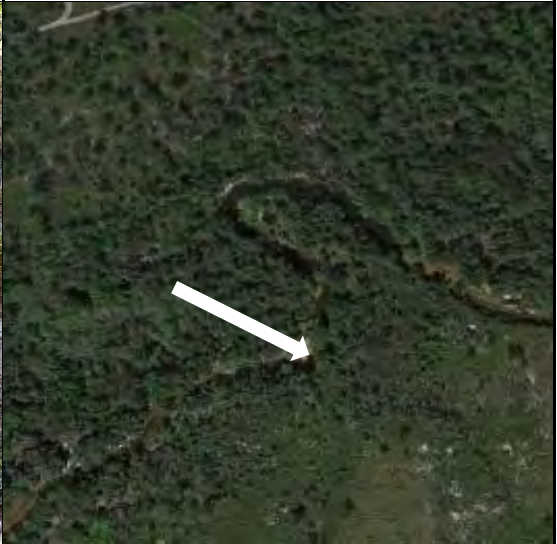
Prairie Creek			Severity Scale: 4.0-Low
Watershed: Peace River Subwatershed: Lower Prairie Creek Latitude: 27.0231 Longitude: -81.87903			County: Charlotte Site Number: PI246 Reach Length: 460 ft. Landowner: Charlotte County

Pfankuch-Channel Stability:	Fair	1	
Channel Alteration:	None	0	
Bank Erosion:	Active	1	
BEHI:	Moderate (28.55)	0.5	
Local NPSP:	Obvious Sources	1.5	
Shoring Structures:	None	0	
Pipe Discharge:	None	0	
Water Odor:	Normal	0	
Fish Passage Barrier:	None	0	
RB: Riparian Buffer:	100 ft.	0	
LB: Riparian Buffer:	100 ft.	0	
RB: Floodplain Access:	Full	0	
LB: Floodplain Access:	Full	0	
<b>Severity Scale:</b>		<b>4.0</b>	<b>Additional Site Features</b>
			Stream Channel Woody Material: Extensive
			Impoundments: Woody Material Jams
			Substrate Composition: Medium Sand
			Bank Material: Medium Sand
			Near Bank Stress: Low
			RB Landuse: Natural Forest
			LB Landuse: Natural Forest

Notes: 303d: Impaired - Public Water Supply (DO & TDS)			
Restoration Option 1

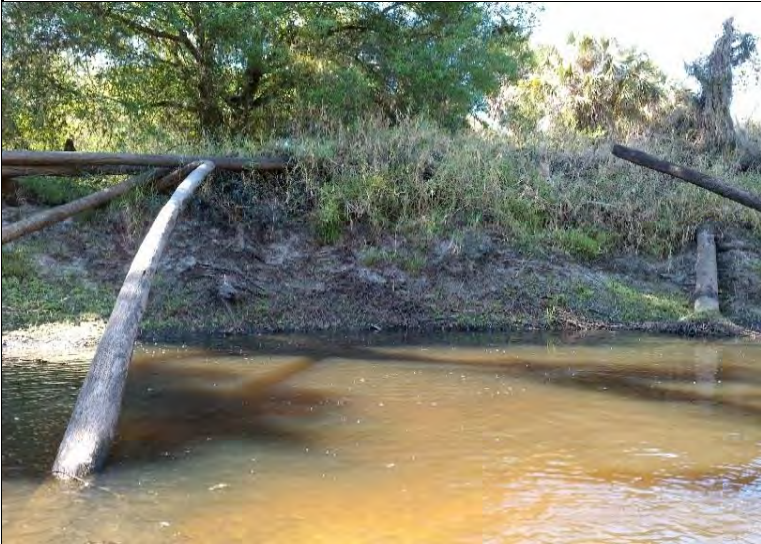
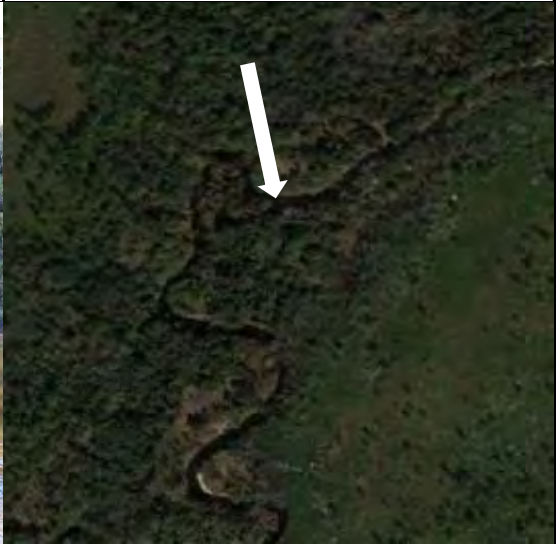
Prairie Creek			Severity Scale: 2.5-Low
Watershed: Peace River Subwatershed: Lower Prairie Creek Latitude: 27.02211 Longitude: -81.88142			County: Charlotte Site Number: PI247 Reach Length: 393 ft. Landowner: Charlotte County

Pfankuch-Channel Stability:	Fair	1	
Channel Alteration:	None	0	
Bank Erosion:	Active	1	
BEHI:	Moderate (27.36)	0.5	
Local NPSP:	No Evidence	0	
Shoring Structures:	None	0	
Pipe Discharge:	None	0	
Water Odor:	Normal	0	
Fish Passage Barrier:	None	0	
RB: Riparian Buffer:	100 ft.	0	
LB: Riparian Buffer:	100 ft.	0	
RB: Floodplain Access:	Full	0	
LB: Floodplain Access:	Full	0	
<b>Severity Scale:</b>		<b>2.5</b>	<b>Additional Site Features</b>
			Stream Channel Woody Material: Extensive
			Impoundments: None
			Substrate Composition: Medium Sand
			Bank Material: Medium Sand
			Near Bank Stress: Moderate
			RB Landuse: Natural Forest
			LB Landuse: Natural Forest

Notes: 303d: Impaired - Public Water Supply (DO & TDS)			
Restoration Option 1

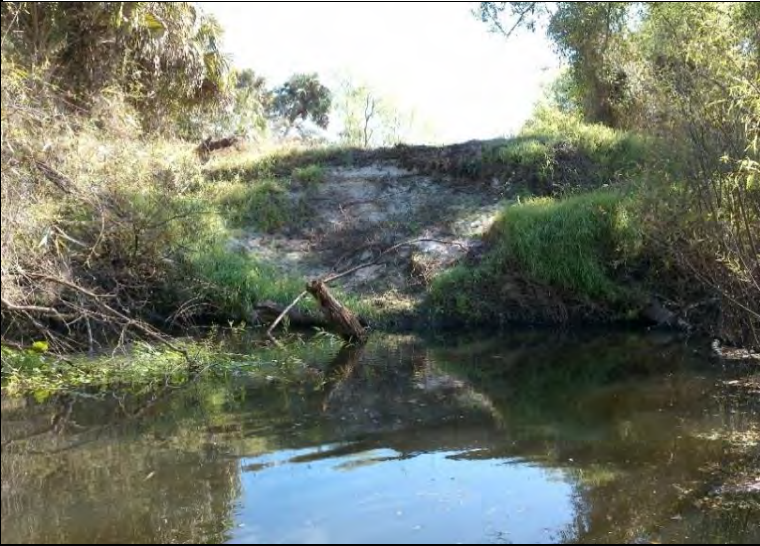
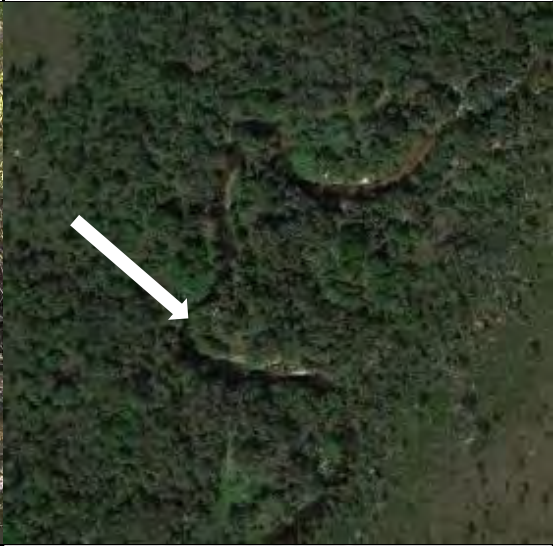
Prairie Creek			Severity Scale: 3.0-Low
Watershed: Peace River Subwatershed: Lower Prairie Creek Latitude: 27.02118 Longitude: -81.88196			County: Charlotte Site Number: PI248 Reach Length: 57 ft. Landowner: Charlotte County

Pfankuch-Channel Stability:	Fair	1	
Channel Alteration:	None	0	
Bank Erosion:	Active	1	
BEHI:	High (33.60)	1	
Local NPSP:	No Evidence	0	
Shoring Structures:	None	0	
Pipe Discharge:	None	0	
Water Odor:	Normal	0	
Fish Passage Barrier:	None	0	
RB: Riparian Buffer:	100 ft.	0	Additional Site Features
LB: Riparian Buffer:	100 ft.	0	
RB: Floodplain Access:	Full	0	
LB: Floodplain Access:	Full	0	
Severity Scale:		3.0	
Notes: 303d: Impaired - Public Water Supply (DO & TDS)			Stream Channel Woody Material: Dominating
Restoration Option 1			Impoundments: Woody Material Jams
			Substrate Composition: Medium Sand
			Bank Material: Sand
			Near Bank Stress: Moderate

RB Landuse: Natural Forest
			LB Landuse: Pasture

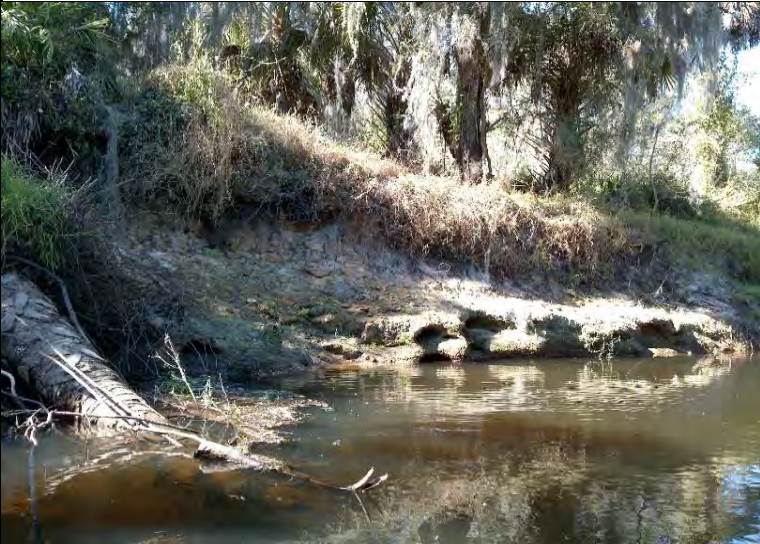
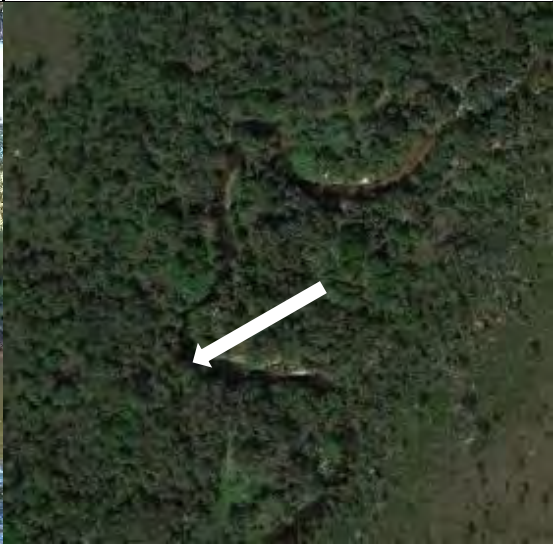
Prairie Creek			Severity Scale: 3.0-Low
Watershed: Peace River Subwatershed: Lower Prairie Creek Latitude: 27.02103 Longitude: -81.8821			County: Charlotte Site Number: PI249 Reach Length: 210 ft. Landowner: Charlotte County

Risk Factor	Ranking	Score	
Pfankuch-Channel Stability:	Fair	1	
Channel Alteration:	None	0	
Bank Erosion:	Active	1	
BEHI:	High (35.89)	1	
Local NPSP:	No Evidence	0	
Shoring Structures:	None	0	
Pipe Discharge:	None	0	
Water Odor:	Normal	0	
Fish Passage Barrier:	None	0	
RB: Riparian Buffer:	100 ft.	0	
LB: Riparian Buffer:	100 ft.	0	
RB: Floodplain Access:	Full	0	
LB: Floodplain Access:	Full	0	
<b>Severity Scale:</b>		<b>3.0</b>	
Notes: 303d: Impaired - Public Water Supply (DO & TDS)			
Restoration Option 1

Additional Site Features
Stream Channel Woody Material: Numerous
Impoundments: None
Substrate Composition: Medium Sand
Bank Material: Sand
Near Bank Stress: Moderate
RB Landuse: Natural Forest
LB Landuse: Natural Forest
