# **Peace River and Withlacoochee River Threats Assessments and Fish Assemblage Monitoring**

**Final Report July 1, 2015 – June 30, 2019**

Submitted to Florida State Wildlife Grants Program  
August 1, 2019  
PID: 98462501284

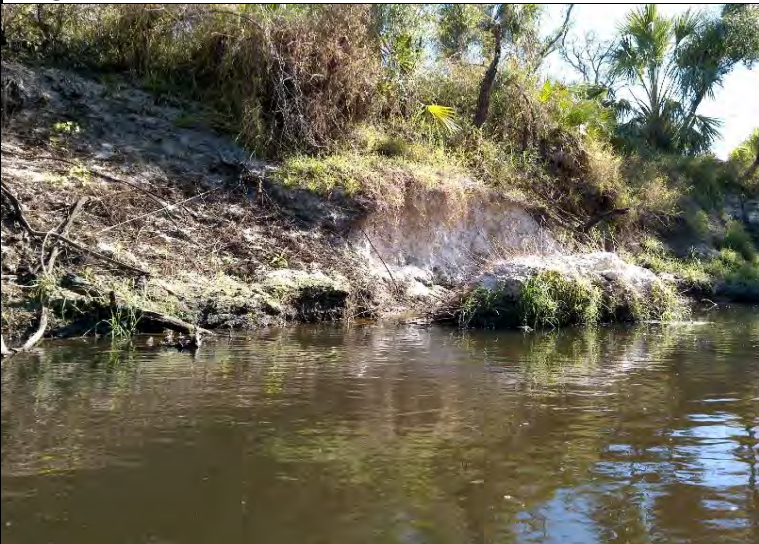
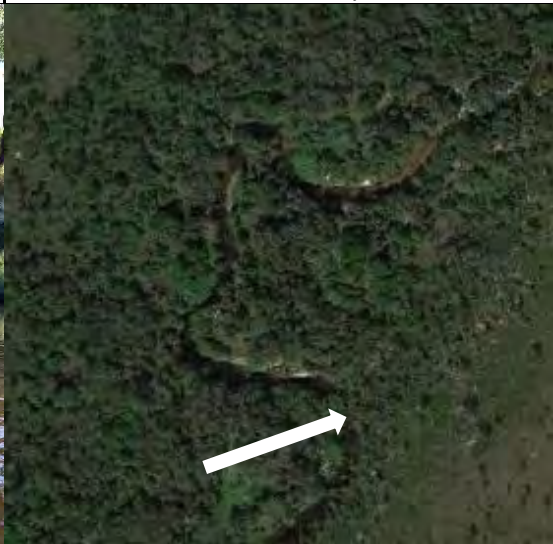
Prairie Creek			Severity Scale: 3.5-Low	
Watershed: Peace River Subwatershed: Lower Prairie Creek Latitude: 27.0203 Longitude: -81.88099			County: Charlotte Site Number: PI250 Reach Length: 264 ft. Landowner: Charlotte County

Pfankuch-Channel Stability:	Poor	1		
Channel Alteration:	None	0		
Bank Erosion:	Mass-wasting	1.5		
BEHI:	High (34.69)	1		
Local NPSP:	No Evidence	0		
Shoring Structures:	None	0		
Pipe Discharge:	None	0		
Water Odor:	Normal	0		
Fish Passage Barrier:	None	0		
RB: Riparian Buffer:	100 ft.	0		
LB: Riparian Buffer:	100 ft.	0		
RB: Floodplain Access:	Full	0		
LB: Floodplain Access:	Full	0		
Severity Scale:		3.5	Additional Site Features	
			Stream Channel Woody Material: Numerous	
			Impoundments: None	
			Substrate Composition: Medium Sand	
			Bank Material: Sand	
			Near Bank Stress: Moderate	
			RB Landuse: Natural Forest	
			LB Landuse: Natural Forest

Notes: 303d: Impaired - Public Water Supply (DO & TDS)				
Restoration Option 1

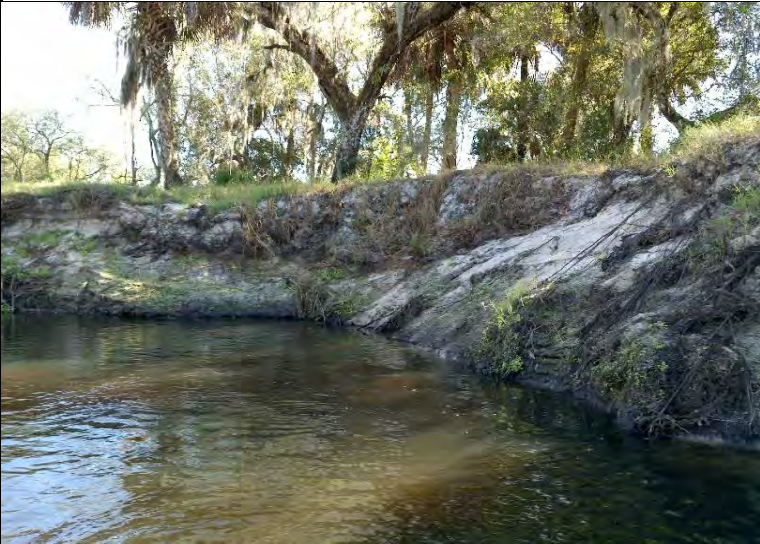
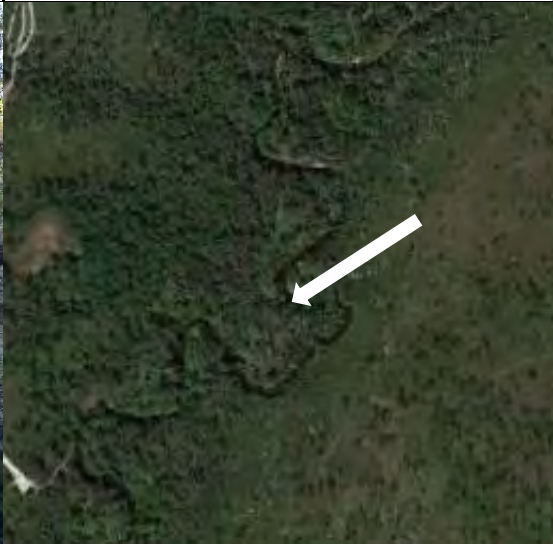
Prairie Creek			Severity Scale: 3.0-Low
Watershed: Peace River Subwatershed: Lower Prairie Creek Latitude: 27.01931 Longitude: -81.88133			County: Charlotte Site Number: PI251 Reach Length: 36 ft. Landowner: Charlotte County

Risk Factor	Ranking	Score	
Pfankuch-Channel Stability:	Fair	1	
Channel Alteration:	None	0	
Bank Erosion:	Active	1	
BEHI:	High (34.05)	1	
Local NPSP:	No evidence	0	
Shoring Structures:	None	0	
Pipe Discharge:	None	0	
Water Odor:	Normal	0	
Fish Passage Barrier:	None	0	
RB: Riparian Buffer:	100 ft.	0	
LB: Riparian Buffer:	100 ft.	0	
RB: Floodplain Access:	Full	0	
LB: Floodplain Access:	Full	0	
Severity Scale:		3.0	
Notes: 303d: Impaired - Public Water Supply (DO & TDS)			
Restoration Option 1

Additional Site Features
Stream Channel Woody Material: Moderate
Impoundments: None
Substrate Composition: Medium Sand
Bank Material: Sand
Near Bank Stress: High
RB Landuse: Natural Forest
LB Landuse: Natural Forest

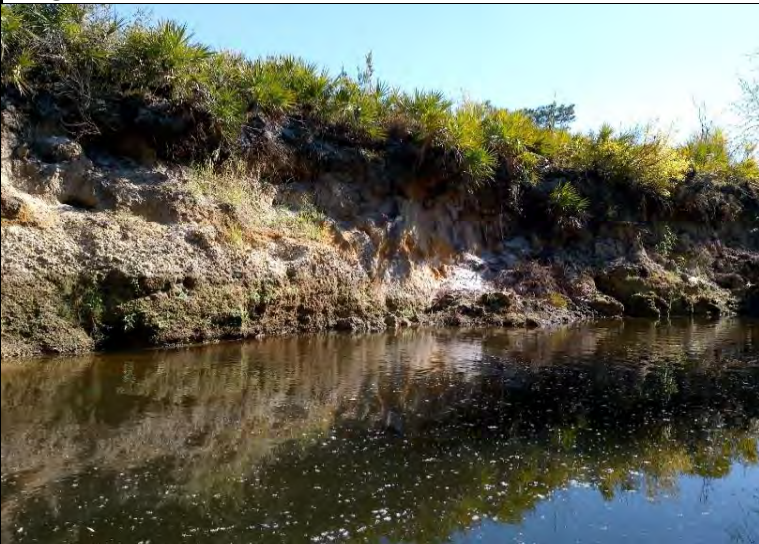
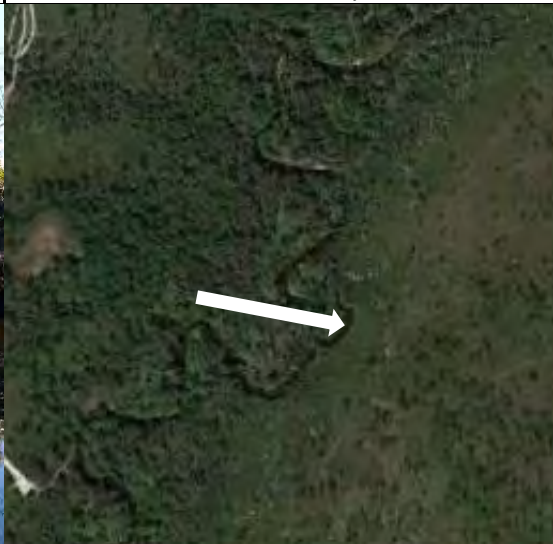
Prairie Creek			Severity Scale: 3.75-Low	
Watershed: Peace River Subwatershed: Lower Prairie Creek Latitude: 27.01929 Longitude: -81.88097			County: Charlotte Site Number: PI252 Reach Length: 165 ft. Landowner: Charlotte County

Pfankuch-Channel Stability:	Fair	1		
Channel Alteration:	None	0		
Bank Erosion:	Mass-wasting	1.5		
BEHI:	High (35.10)	1		
Local NPSP:	No Evidence	0		
Shoring Structures:	None	0		
Pipe Discharge:	None	0		
Water Odor:	Normal	0		
Fish Passage Barrier:	None	0		
RB: Riparian Buffer:	100 ft.	0		
LB: Riparian Buffer:	100 ft.	0		
RB: Floodplain Access:	Full	0		
LB: Floodplain Access:	Partial	0.25		
Severity Scale:		3.75	Additional Site Features	
			Stream Channel Woody Material: Moderate	
			Impoundments: None	
			Substrate Composition: Medium Sand	
			Bank Material: Sandstone, Shell Aggregate	
			Near Bank Stress: Low	
			RB Landuse: Natural Forest

LB Landuse: Natural Forest	
Notes: 303d: Impaired - Public Water Supply (DO & TDS)				
Restoration Option 1

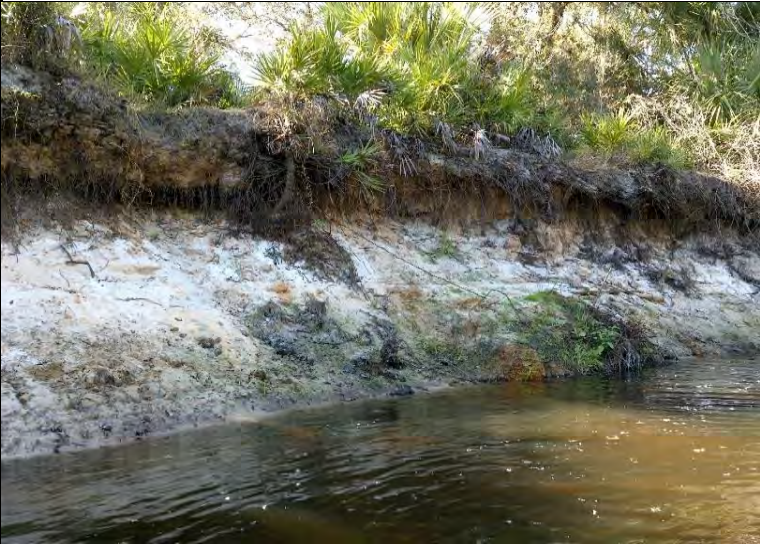
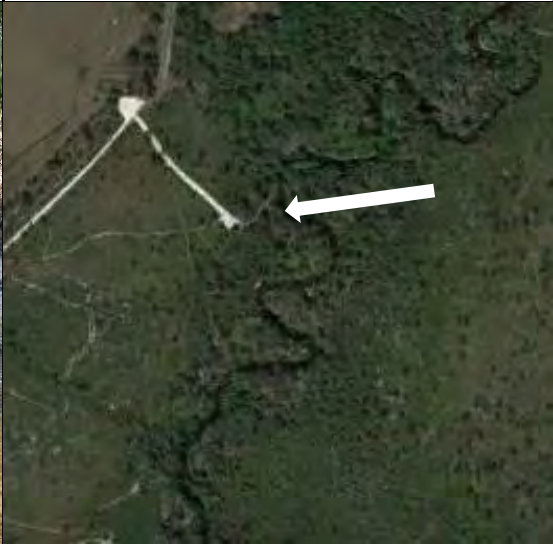
Prairie Creek			Severity Scale: 3.5-Low
Watershed: Peace River Subwatershed: Lower Prairie Creek Latitude: 27.01786 Longitude: -81.8841			County: Charlotte Site Number: PI253 Reach Length: 41 ft. Landowner: Charlotte County

Pfankuch-Channel Stability:	Fair	1	
Channel Alteration:	None	0	
Bank Erosion:	Active	1	
BEHI:	Very High (41.84)	1.5	
Local NPSP:	No Evidence	0	
Shoring Structures:	None	0	
Pipe Discharge:	None	0	
Water Odor:	Normal	0	
Fish Passage Barrier:	None	0	
RB: Riparian Buffer:	100 ft.	0	
LB: Riparian Buffer:	100 ft.	0	
RB: Floodplain Access:	Full	0	
LB: Floodplain Access:	Full	0	
Severity Scale:		3.5	Additional Site Features
Notes: 303d: Impaired - Public Water Supply (DO & TDS)  Restoration Option 1			Stream Channel Woody Material: Infrequent
			Impoundments: None
			Substrate Composition: Medium Sand
			Bank Material: Sand
			Near Bank Stress: Moderate

RB Landuse: Natural Forest
			LB Landuse: Natural Forest, Pasture

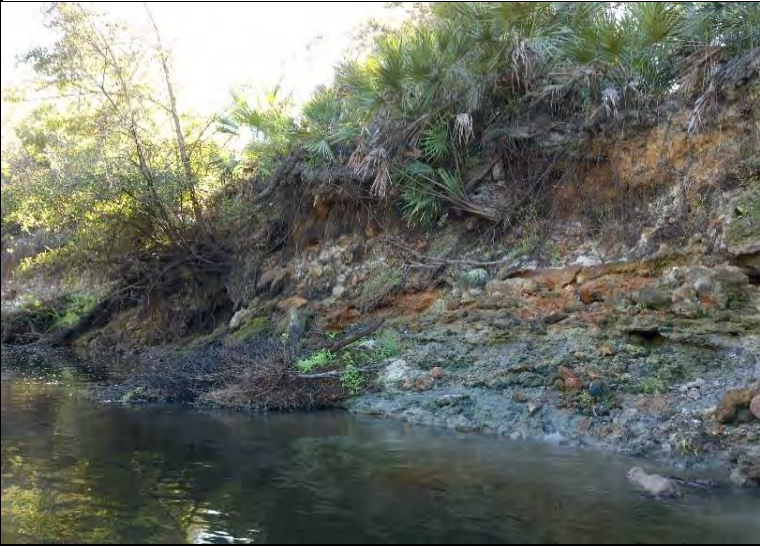
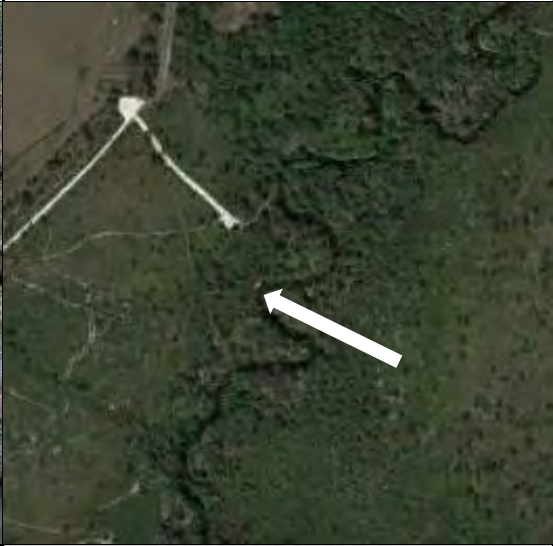
Prairie Creek			Severity Scale: 4.0-Low
Watershed: Peace River Subwatershed: Lower Prairie Creek Latitude: -81.88432 Longitude: 27.0167			County: Charlotte Site Number: PI254 Reach Length: 105 ft. Landowner: Charlotte County

Pfankuch-Channel Stability:	Fair	1	
Channel Alteration:	None	0	
Bank Erosion:	Mass-wasting	1.5	
BEHI:	Very High (41.65)	1.5	
Local NPSP:	No Evidence	0	
Shoring Structures:	None	0	
Pipe Discharge:	None	0	
Water Odor:	Normal	0	
Fish Passage Barrier:	None	0	
RB: Riparian Buffer:	100 ft.	0	
LB: Riparian Buffer:	100 ft.	0	
RB: Floodplain Access:	Full	0	
LB: Floodplain Access:	Full	0	
<b>Severity Scale:</b>		<b>4.0</b>	<b>Additional Site Features</b>
			Stream Channel Woody Material: Moderate
			Impoundments: None
			Substrate Composition: Medium Sand
			Bank Material: Sand
			Near Bank Stress: Moderate
			RB Landuse: Natural Forest
			LB Landuse: Natural Forest

Notes: 303d: Impaired - Public Water Supply (DO & TDS)			
Restoration Option 1

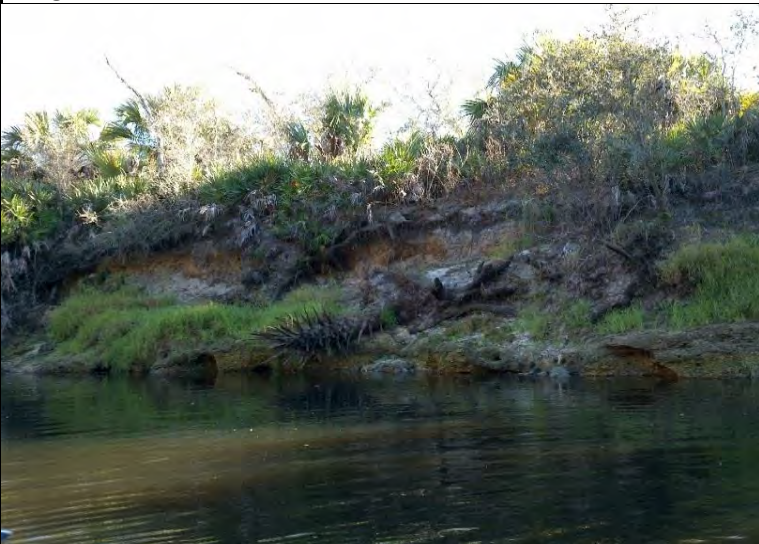
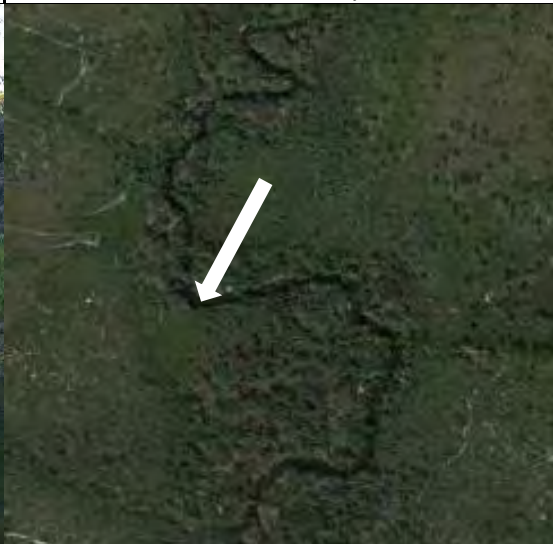
Prairie Creek			Severity Scale: 4.25-Moderate	
Watershed: Peace River Subwatershed: Lower Prarie Creek Latitude: 27.01337 Longitude: -81.8848			County: Charlotte Site Number: PI255 Reach Length: 156 ft. Landowner: Charlotte County

Pfankuch-Channel Stability:	Fair	1		
Channel Alteration:	None	0		
Bank Erosion:	Active	1		
BEHI:	Moderate (29.41)	0.5		
Local NPSP:	No Evidence	0		
Shoring Structures:	Present	1.5		
Pipe Discharge:	None	0		
Water Odor:	Normal	0		
Fish Passage Barrier:	None	0		
RB: Riparian Buffer:	100 ft.	0	<b>Additional Site Features</b>	
LB: Riparian Buffer:	100 ft.	0	Stream Channel Woody Material: Moderate	
RB: Floodplain Access:	Partial	0.25	Impoundments: None	
LB: Floodplain Access:	Full	0	Substrate Composition: Medium Sand	
<b>Severity Scale: 4.25</b>			Bank Material: Sand	
			Near Bank Stress: Moderate	
			RB Landuse: Natural Forest	
			LB Landuse: Natural Forest

Notes: 303d: Impaired - Public Water Supply (DO & TDS)				
Restoration Option 1

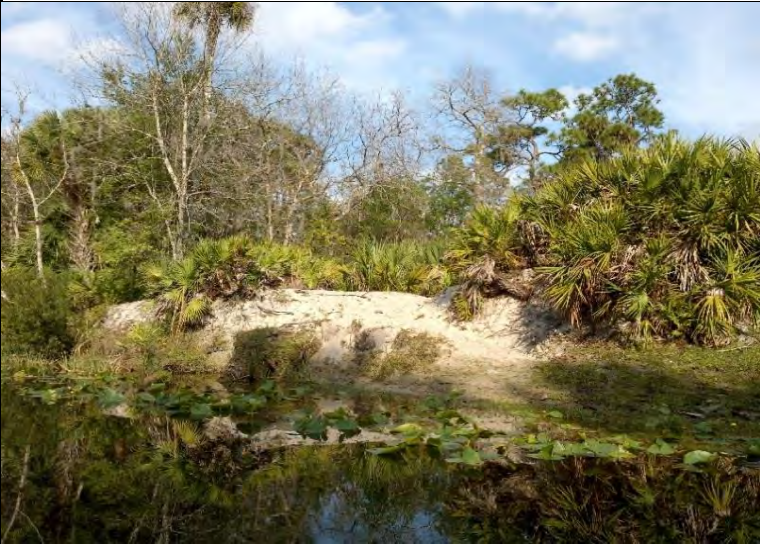
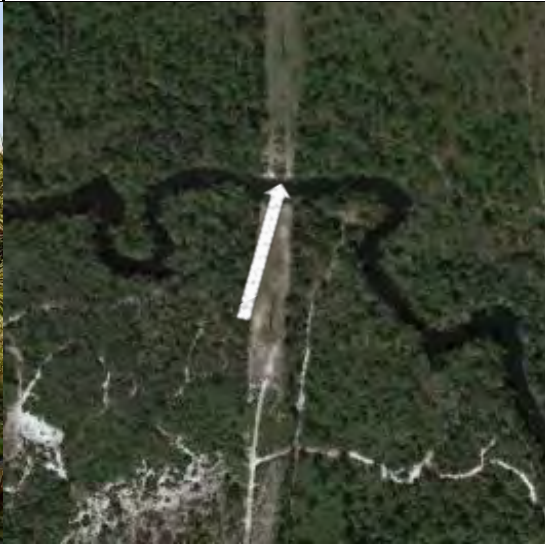
Shell Creek			Severity Scale: 4.0-Low
Watershed: Peace River Subwatershed: Middle Shell Creek Latitude: 26.96852 Longitude: -81.87551			County: Charlotte Site Number: PI256 Reach Length: 104 ft. Landowner: Maria Tibol & MAZ TRS & MT

Pfankuch-Channel Stability:	Good	0	
Channel Alteration:	None	0	
Bank Erosion:	Active	1	
BEHI:	Moderate (27.28)	0.5	
Local NPSP:	Obvious Sources	1.5	
Shoring Structures:	None	0	
Pipe Discharge:	None	0	
Water Odor:	Normal	0	
Fish Passage Barrier:	None	0	
RB: Riparian Buffer:	40 ft.	0.5	
LB: Riparian Buffer:	40 ft.	0.5	
RB: Floodplain Access:	Full	0	
LB: Floodplain Access:	Full	0	
<b>Severity Scale:</b>		<b>4.0</b>	Additional Site Features
			Stream Channel Woody Material: Moderate
			Impoundments: None
			Substrate Composition: Medium Sand
			Bank Material: Sand
			Near Bank Stress: Moderate
			RB Landuse: Natural Forest, Pasture
			LB Landuse: Power Lines

Notes: 303d: Impaired – Chloride, DO, Specific Conductivity and TDS			
Restoration Option 2 or 3

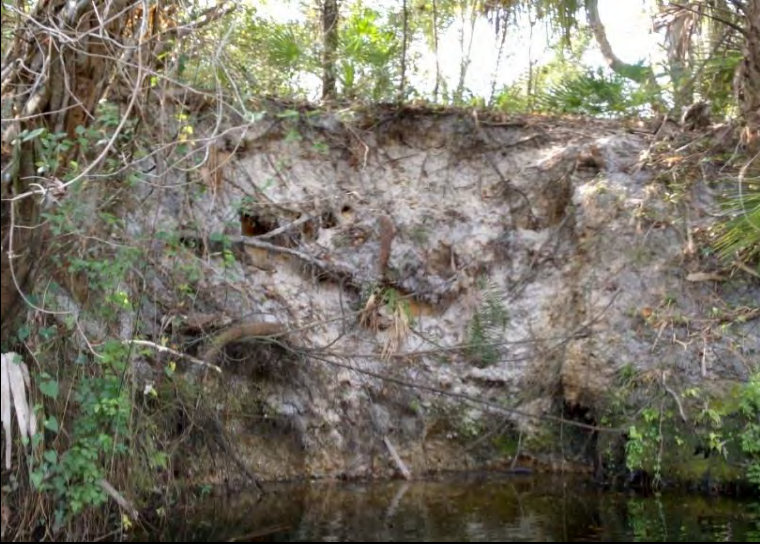
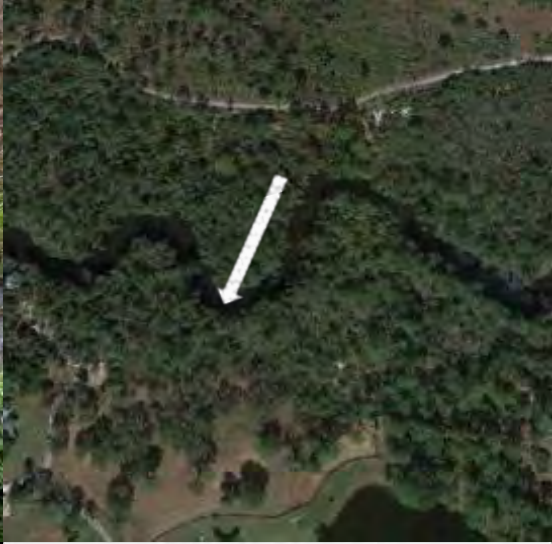
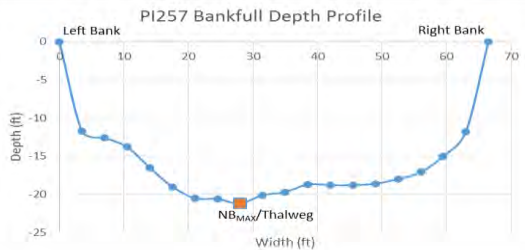
Shell Creek			Severity Scale: 2.5-Low
Watershed: Peace River Subwatershed: Middle Shell Creek Latitude: 26.96332 Longitude: -81.86494			County: Charlotte Site Number: PI257 Reach Length: 9 ft. Landowner: Brian & Mary M Presley

Risk Factor	Ranking	Score	
Pfankuch-Channel Stability:	Good	0	
Channel Alteration:	None	0	
Bank Erosion:	Mass-wasting	1.5	
BEHI:	High (32.93)	1	
Local NPSP:	No Evidence	0	
Shoring Structures:	None	0	
Pipe Discharge:	None	0	
Water Odor:	Normal	0	
Fish Passage Barrier:	None	0	
RB: Riparian Buffer:	100 ft.	0	
LB: Riparian Buffer:	100 ft.	0	
RB: Floodplain Access:	Full	0	
LB: Floodplain Access:	Full	0	
<b>Severity Scale:</b>		<b>2.5</b>	
Notes: 303d: Impaired – Chloride, DO, Specific Conductivity and TDS			
Restoration Option 1

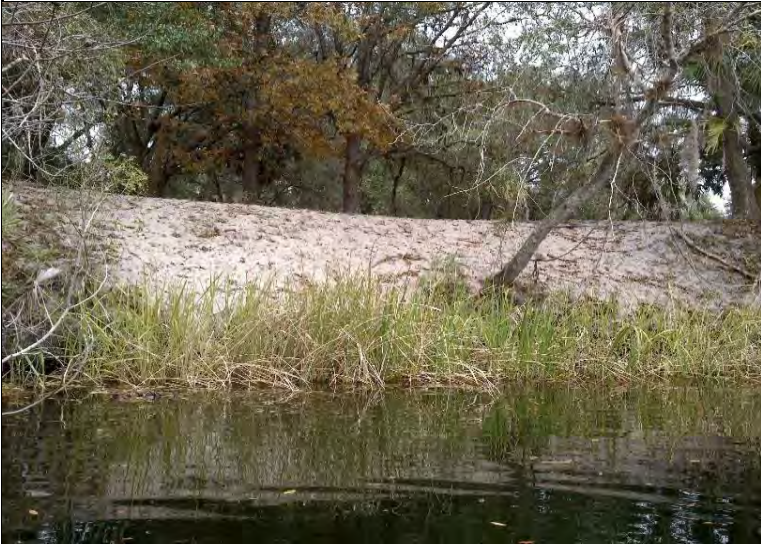
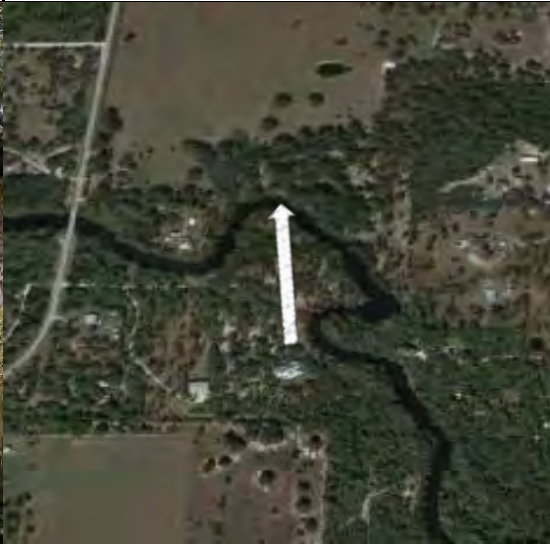
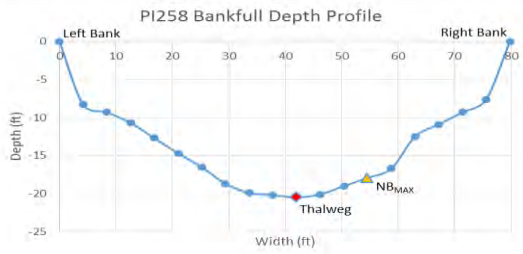
Shell Creek			Severity Scale: 4.25-Moderate
Watershed: Peace River Subwatershed: Middle Shell Creek Latitude: 26.97573 Longitude: -81.88478			County: Charlotte Site Number: PI258 Reach Length: 60 ft. Landowner: Robert W Hall Sr

Pfankuch-Channel Stability:	Good	0	
Channel Alteration:	None	0	
Bank Erosion:	Active	1	
BEHI:	Moderate (23.08)	0.5	
Local NPSP:	Obvious Sources	1.5	
Shoring Structures:	None	0	
Pipe Discharge:	None	0	
Water Odor:	Normal	0	
Fish Passage Barrier:	None	0	
RB: Riparian Buffer:	0 ft.	0.75	
LB: Riparian Buffer:	40 ft.	0.5	
RB: Floodplain Access:	Full	0	
LB: Floodplain Access:	Full	0	
<b>Severity Scale:</b>		<b>4.25</b>	
Notes: 303d: Impaired – Chloride, DO, Specific Conductivity and TDS			
Restoration Option 1

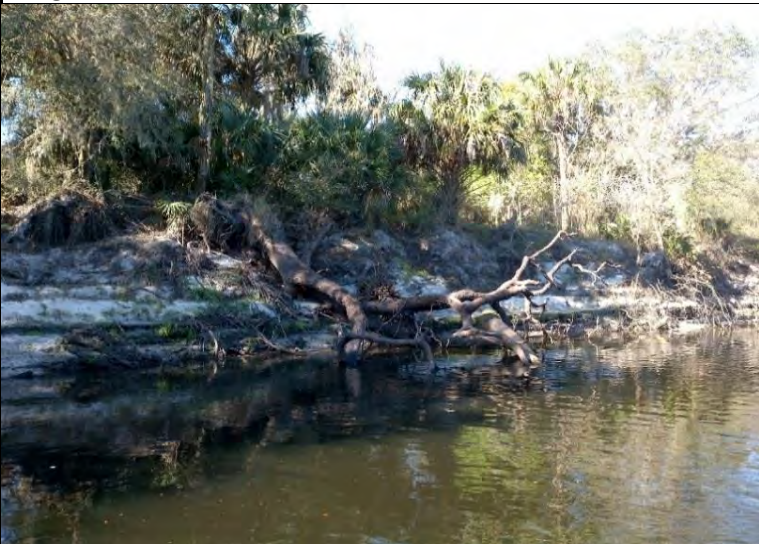
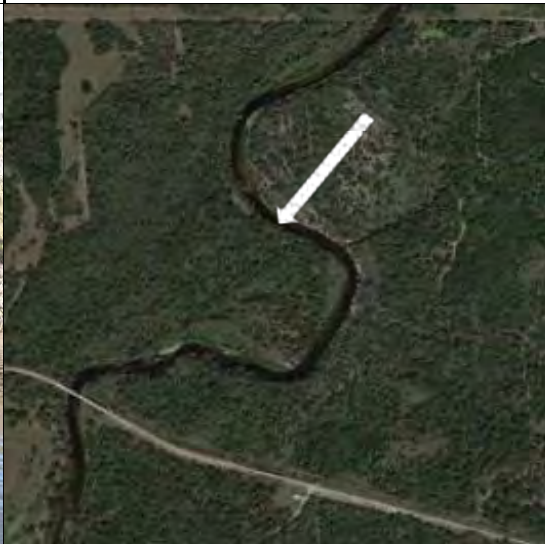
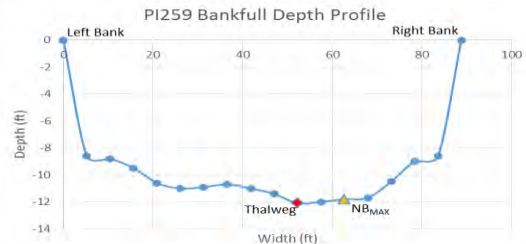
Peace River			Severity Scale: 4.0-Low	
Watershed: Peace River Subwatershed: McBride Branch Latitude: 27.30646 Longitude: -81.84203			County: DeSoto Site Number: PI259 Reach Length: Landowner: E & D Ranch LLP

Pfankuch-Channel Stability:	Good	0		
Channel Alteration:	None	0		
Bank Erosion:	Active	1		
BEHI:	Moderate (28.20)	0.5		
Local NPSP:	Obvious Sources	1.5		
Shoring Structures:	None	0		
Pipe Discharge:	None	0		
Water Odor:	Normal	0		
Fish Passage Barrier:	None	0		
RB: Riparian Buffer:	40 ft.	0.5	<b>Additional Site Features</b> Stream Channel Woody Material: Numerous Impoundments: None Substrate Composition: Medium Sand Bank Material: Sand Near Bank Stress: Moderate RB Landuse: Natural Forest, Pasture LB Landuse: Natural Forest, Pasture	
LB: Riparian Buffer:	60 ft.	0.25		
RB: Floodplain Access:	Partial	0.25		
LB: Floodplain Access:	Full	0		
<b>Severity Scale:</b>		<b>4.0</b>

Notes: 303d: Impaired - Aquatic Life Harvesting (fecal coliform, mercury in fish tissue)				
Restoration Option 1

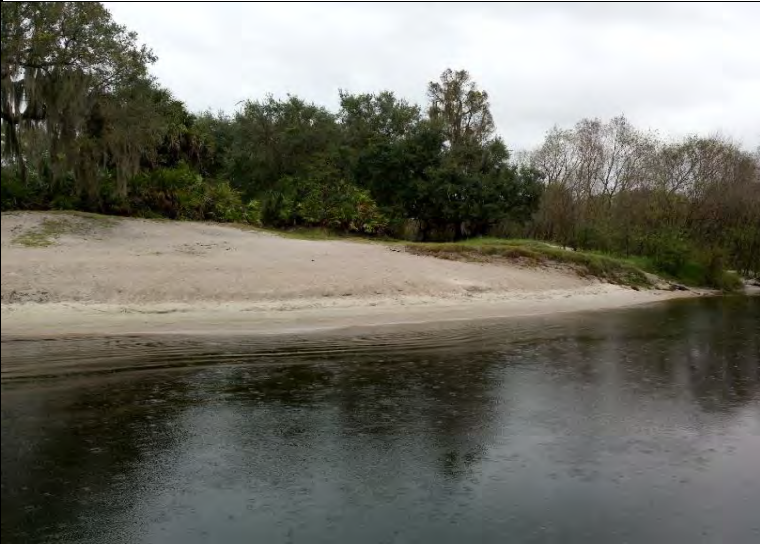
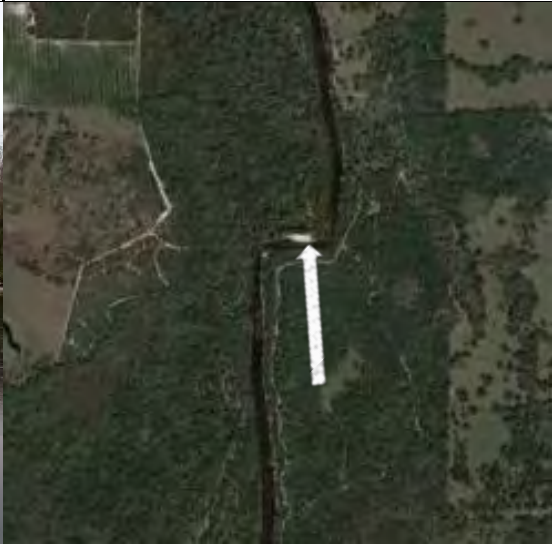
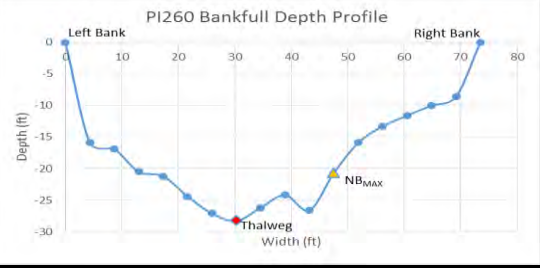
Peace River			Severity Scale: 4.25-Moderate
Watershed: Peace River Subwatershed: Peace River Branch Latitude: 27.3222 Longitude: -81.83658			County: DeSoto Site Number: PI260 Reach Length: 270 ft. Landowner: E & D Ranch LLP

Pfankuch-Channel Stability:	Good	0	
Channel Alteration:	None	0	
Bank Erosion:	Active	1	
BEHI:	Very High (43.01)	1.5	
Local NPSP:	Obvious Sources	1.5	
Shoring Structures:	None	0	
Pipe Discharge:	None	0	
Water Odor:	Normal	0	
Fish Passage Barrier:	None	0	
RB: Riparian Buffer:	100 ft.	0	
LB: Riparian Buffer:	100 ft.	0	
RB: Floodplain Access:	Partial	0.25	
LB: Floodplain Access:	Full	0	
<b>Severity Scale:</b>		<b>4.25</b>	<b>Additional Site Features</b>
			Stream Channel Woody Material: None
			Impoundments: None
			Substrate Composition: Medium Sand
			Bank Material: Sand
			Near Bank Stress: Low
			RB Landuse: Natural Forest, Pasture
			LB Landuse: Natural Forest

Notes: 303d: Impaired - Aquatic Life Harvesting (fecal coliform, mercury in fish tissue)			
Restoration Option 2 or 3

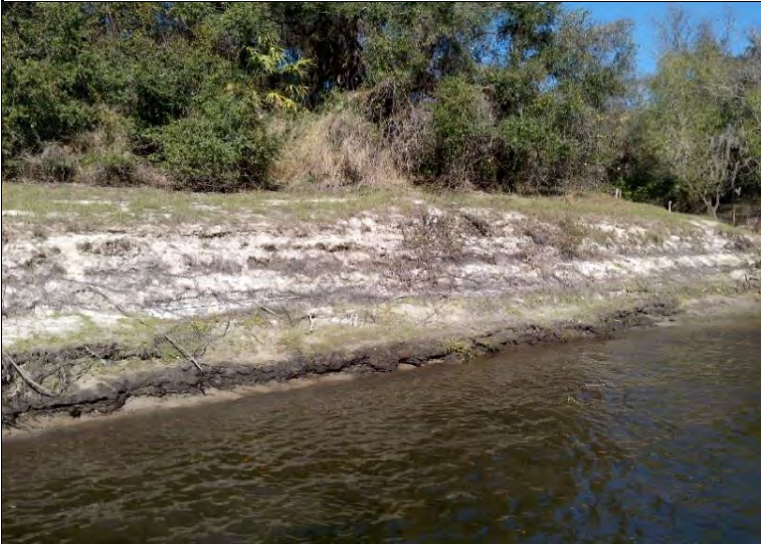
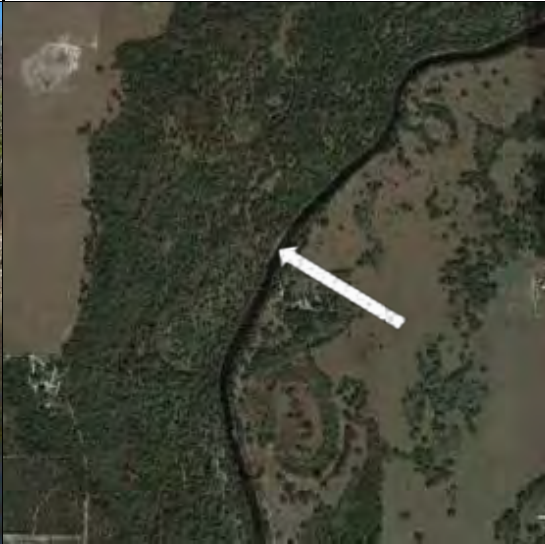
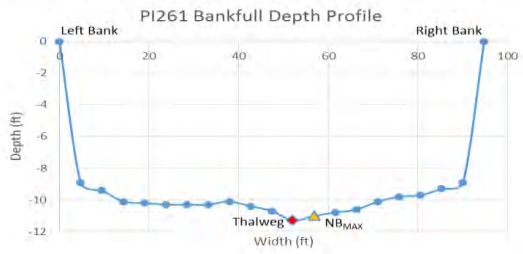
Peace River			Severity Scale: 3.5-Low
Watershed: Peace River Subwatershed: Peace River Branch Latitude: 27.33465 Longitude: -81.83554			County: DeSoto Site Number: PI261 Reach Length: 100 ft. Landowner: E & D Ranch LLP

Pfankuch-Channel Stability:	Good	0	
Channel Alteration:	None	0	
Bank Erosion:	Active	1	
BEHI:	Moderate (23.52)	0.5	
Local NPSP:	Obvious Sources	1.5	
Shoring Structures:	None	0	
Pipe Discharge:	None	0	
Water Odor:	Normal	0	
Fish Passage Barrier:	None	0	
RB: Riparian Buffer:	60 ft.	0.25	
LB: Riparian Buffer:	60 ft.	0.25	
RB: Floodplain Access:	Full	0	
LB: Floodplain Access:	Full	0	
<b>Severity Scale:</b>		<b>3.5</b>	<b>Additional Site Features</b> Stream Channel Woody Material: Infrequent Impoundments: None Substrate Composition: Medium Sand Bank Material: Sand Near Bank Stress: Moderate RB Landuse: Natural Forest, Pasture LB Landuse: Natural Forest

Notes: 303d: Impaired - Aquatic Life Harvesting (fecal coliform, mercury in fish tissue)			
Restoration Option 2 or 3

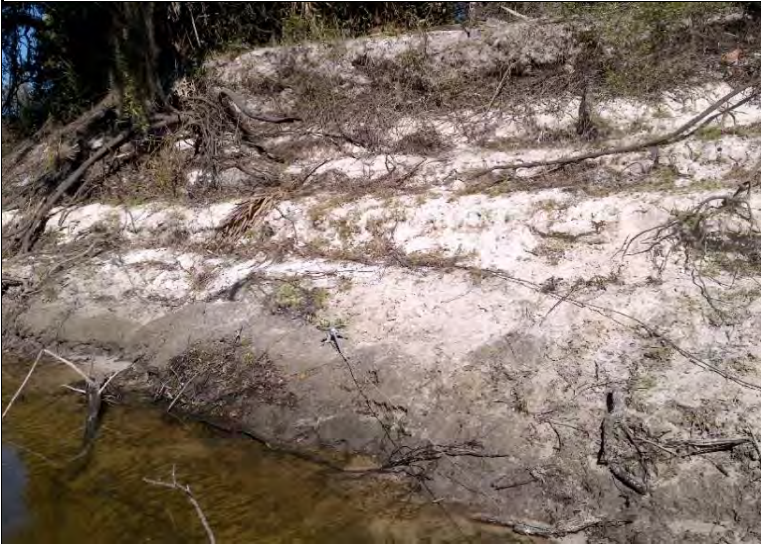
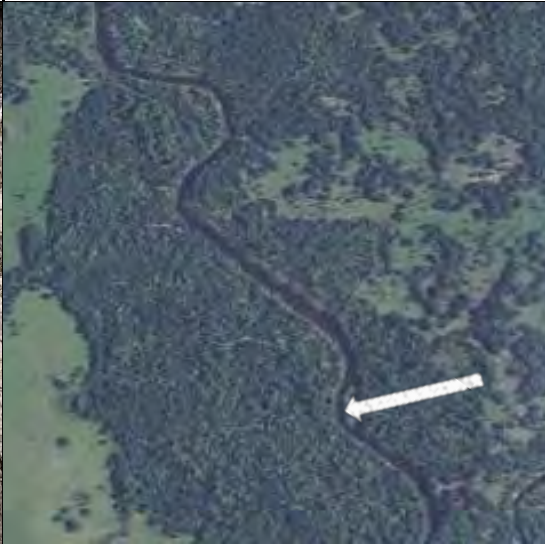
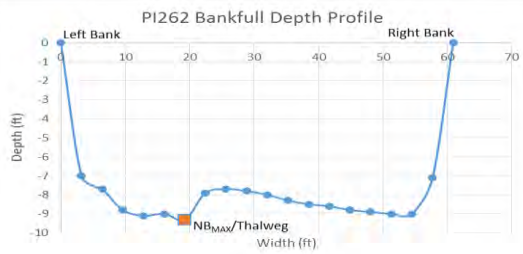
Peace River			Severity Scale: 4.0-Low
Watershed: Peace River Subwatershed: Peace River Branch Latitude: 27.35728 Longitude: -81.82603			County: Hardee Site Number: PI262 Reach Length: 285 ft. Landowner: Ben Hill Griffin Inc.

Pfankuch-Channel Stability:	Good	0	
Channel Alteration:	None	0	
Bank Erosion:	Active	1	
BEHI:	High (32.66)	1	
Local NPSP:	Obvious Sources	1.5	
Shoring Structures:	None	0	
Pipe Discharge:	None	0	
Water Odor:	Normal	0	
Fish Passage Barrier:	None	0	
RB: Riparian Buffer:	100 ft.	0	Additional Site Features
LB: Riparian Buffer:	40 ft.	0.5	
RB: Floodplain Access:	Full	0	
LB: Floodplain Access:	Full	0	
Severity Scale:		4.0	
Notes: 303d: Impaired - Aquatic Life Harvesting (mercury in fish tissue)			Stream Channel Woody Material: Moderate
Restoration Option 1			Impoundments: None
			Substrate Composition: Medium Sand
			Bank Material: Sand
			Near Bank Stress: High

RB Landuse: Natural Forest
			LB Landuse: Pasture, Natural Forest

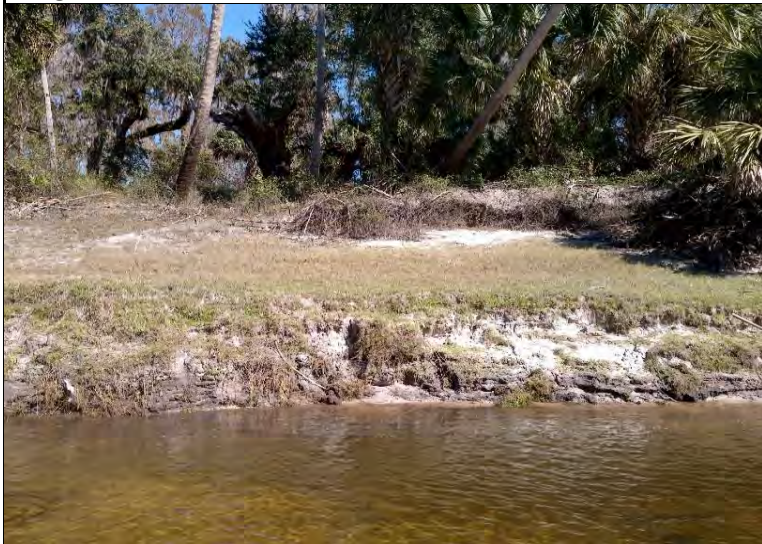
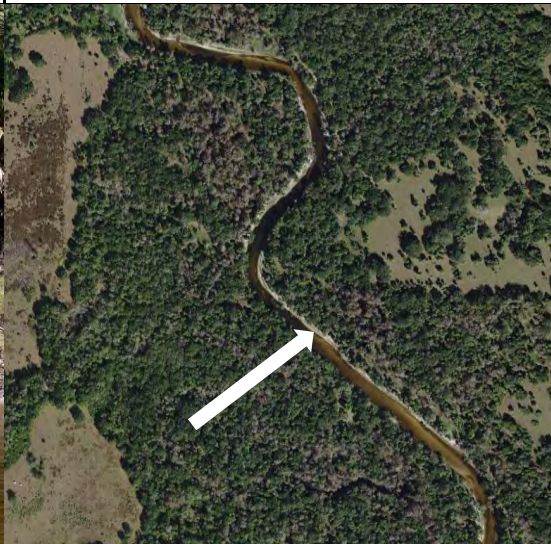
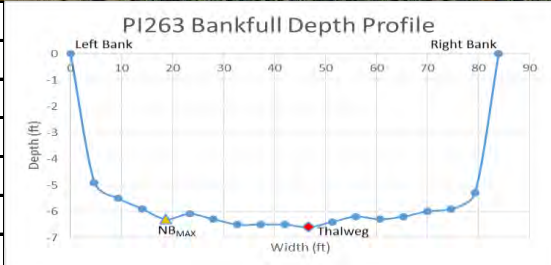
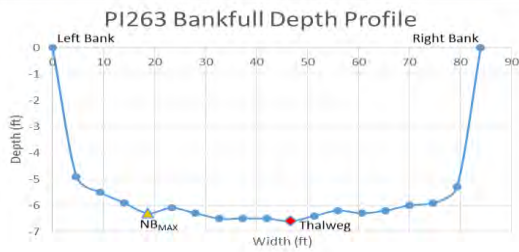
Peace River			Severity Scale: 5.0-Moderate																						
Watershed: Peace River Subwatershed: Peace River Branch Latitude: 27.36113 Longitude: -81.82877			County: Hardee Site Number: PI263 Reach Length: 150 ft. Landowner: Ben Hill Griffin Inc.

Width (ft)	Depth (ft)	0	0	10	-1.5	20	-2.5	30	-3.5	40	-4.5	50	-5.5	60	-6.5	70	-6.5	80	-5.5	90	0
Width (ft)	Depth (ft)																								
0	0																								
10	-1.5																								
20	-2.5																								
30	-3.5																								
40	-4.5																								
50	-5.5																								
60	-6.5																								
70	-6.5																								
80	-5.5																								
90	0																								
Pfankuch-Channel Stability:	Good	0																							
Channel Alteration:	None	0																							
Bank Erosion:	Active	1																							
BEHI:	Moderate (22.16)	0.5																							
Local NPSP:	Obvious Sources	1.5																							
Shoring Structures:	Present	1.5																							
Pipe Discharge:	None	0																							
Water Odor:	Normal	0																							
Fish Passage Barrier:	None	0																							
RB: Riparian Buffer:	100 ft.	0																							
LB: Riparian Buffer:	40 ft.	0.5																							
RB: Floodplain Access:	Full	0																							
LB: Floodplain Access:	Full	0																							
Severity Scale:		5.0	Additional Site Features																						
Notes: 303d: Impaired - Aquatic Life Harvesting (mercury in fish tissue)			Stream Channel Woody Material: Infrequent																						
Restoration Option 2 or 3			Impoundments: None																						
			Substrate Composition: Medium Sand																						
			Bank Material: Sand																						
			Near Bank Stress: Low																						
			RB Landuse: Natural Forest																						
			LB Landuse: Pasture, Natural Forest

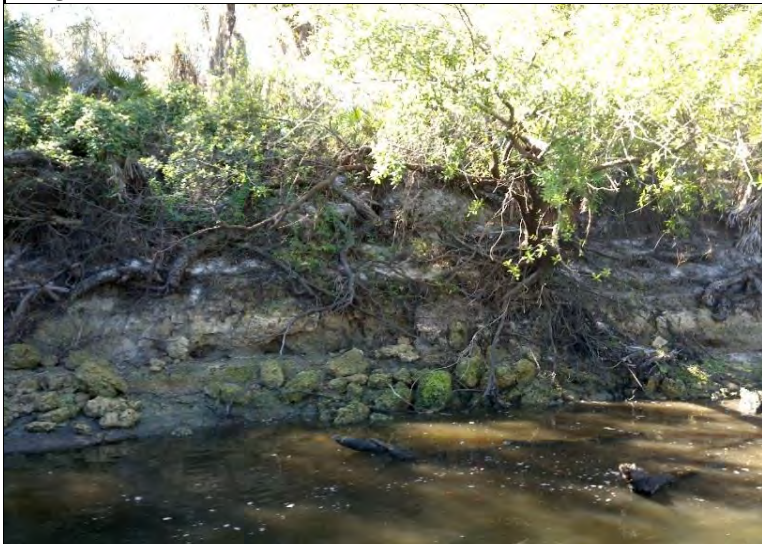
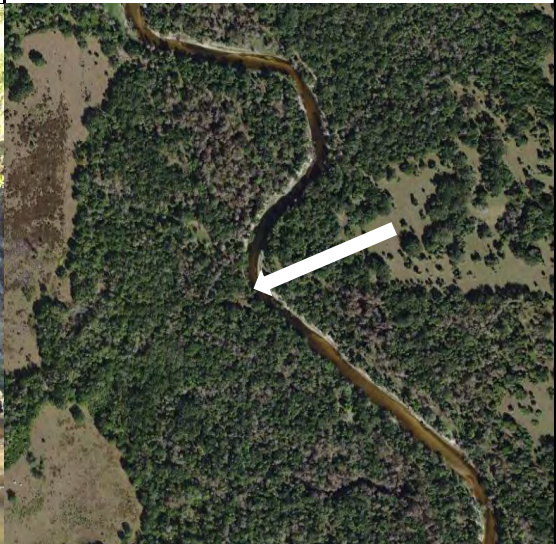
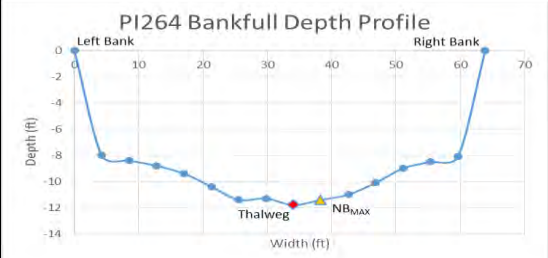
Peace River			Severity Scale: 4.5-Moderate	
Watershed: Peace River Subwatershed: Peace River Branch Latitude: 27.36189 Longitude: -81.8299			County: Hardee Site Number: PI264 Reach Length: 132 ft. Landowner: Ben Hill Griffin Inc.

Pfankuch-Channel Stability:	Good	0		
Channel Alteration:	None	0		
Bank Erosion:	Active	1		
BEHI:	High (36.07)	1		
Local NPSP:	Obvious Sources	1.5		
Shoring Structures:	None	0		
Pipe Discharge:	None	0		
Water Odor:	Normal	0		
Fish Passage Barrier:	None	0		
RB: Riparian Buffer:	60 ft.	0.25	<b>Additional Site Features</b> Stream Channel Woody Material: Numerous Impoundments: None Substrate Composition: Medium Sand Bank Material: Sand Near Bank Stress: Moderate RB Landuse: Pasture, Natural Forest LB Landuse: Pasture, Natural Forest	
LB: Riparian Buffer:	40 ft.	0.5		
RB: Floodplain Access:	Partial	0.25		
LB: Floodplain Access:	Full	0

<b>Severity Scale:</b>		<b>4.5</b>		
Notes: Impaired - Aquatic Life Harvesting (mercury in fish tissue)				
Restoration Option 1

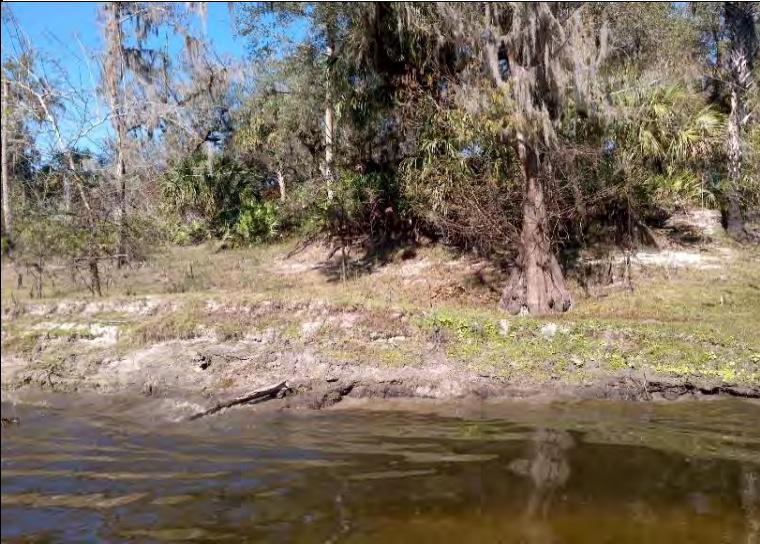
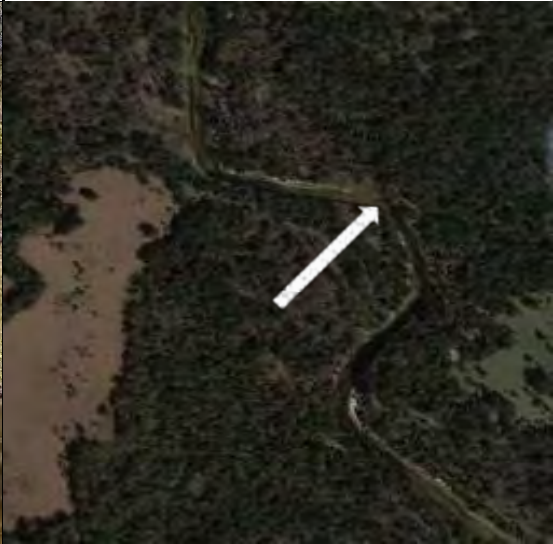
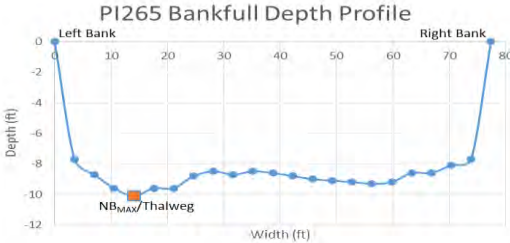
Peace River			Severity Scale: 3.5-Low
Watershed: Peace River Subwatershed: Peace River Branch Latitude: 27.36525 Longitude: -81.82954			County: Hardee Site Number: PI265 Reach Length: 84 ft. Landowner: Ben Hill Griffin Inc.

</div>
Pfankuch-Channel Stability:	Good	0	
Channel Alteration:	None	0	
Bank Erosion:	Active	1	
BEHI:	Moderate (27.41)	0.5	
Local NPSP:	Obvious Sources	1.5	
Shoring Structures:	None	0	
Pipe Discharge:	None	0	
Water Odor:	Normal	0	
Fish Passage Barrier:	None	0	
RB: Riparian Buffer:	100 ft.	0	
LB: Riparian Buffer:	40 ft.	0.5	
RB: Floodplain Access:	Full	0	
LB: Floodplain Access:	Full	0	
Severity Scale:		3.5	<b>Additional Site Features</b> Stream Channel Woody Material: Moderate Impoundments: None Substrate Composition: Medium Sand Bank Material: Sand Near Bank Stress: High RB Landuse: Natural Forest LB Landuse: Pasture, Natural Forest

Notes: Impaired - Aquatic Life Harvesting (mercury in fish tissue)			
Restoration Option 1

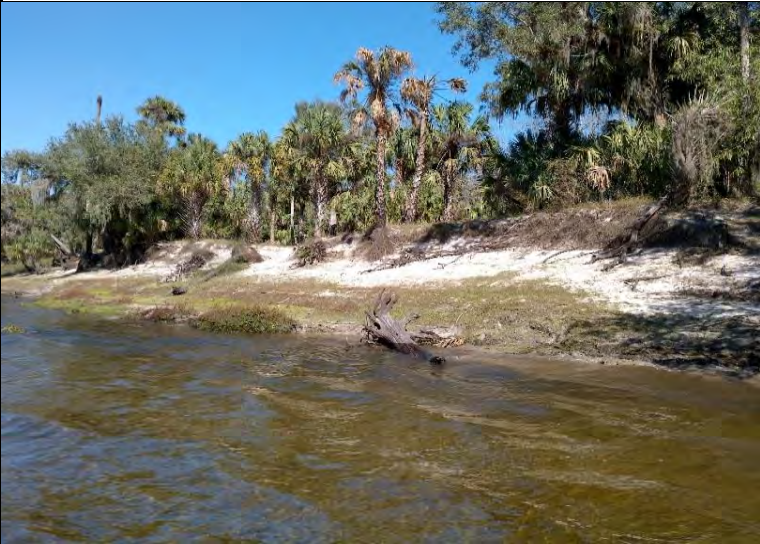
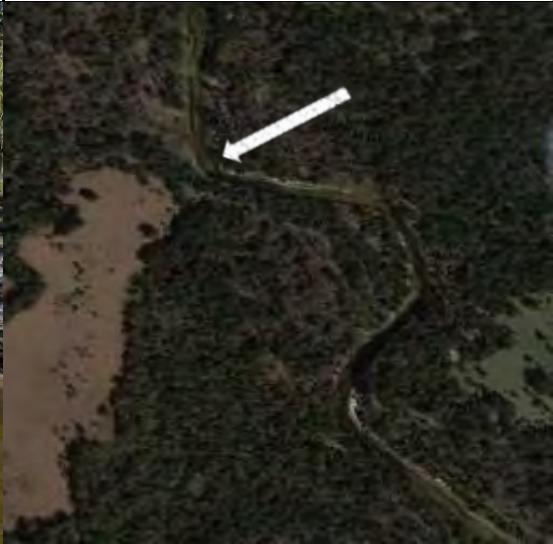
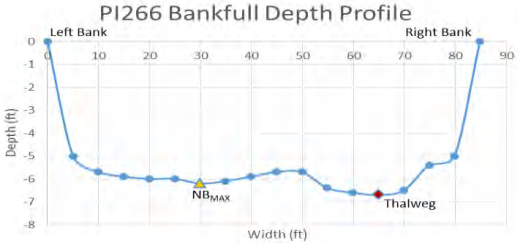
Peace River			Severity Scale: 5.0-Moderate
Watershed: Peace River Subwatershed: Peace River Branch Latitude: 27.3664 Longitude: -81.8320			County: Hardee Site Number: PI266 Reach Length: 223 ft. Landowner: Ben Hill Griffin Inc.

</div>
Pfankuch-Channel Stability:	Good	0	
Channel Alteration:	None	0	
Bank Erosion:	Active	1	
BEHI:	High (31.56)	1	
Local NPSP:	Obvious Sources	1.5	
Shoring Structures:	None	0	
Pipe Discharge:	None	0	
Water Odor:	Normal	0	
Fish Passage Barrier:	None	0	
RB: Riparian Buffer:	0 ft.	0.75	
LB: Riparian Buffer:	40 ft.	0.5	
RB: Floodplain Access:	Full	0	
LB: Floodplain Access:	Partial	0.25	
<b>Severity Scale:</b>		<b>5.0</b>	
Notes: Impaired - Aquatic Life Harvesting (mercury in fish tissue)			<b>Additional Site Features</b>
			Stream Channel Woody Material: Infrequent
			Impoundments: None
			Substrate Composition: Medium Sand

Bank Material: Sand
			Near Bank Stress: Low
			RB Landuse: Pasture, Natural Forest
			LB Landuse: Pasture, Natural Forest
Restoration Option 2 or 3

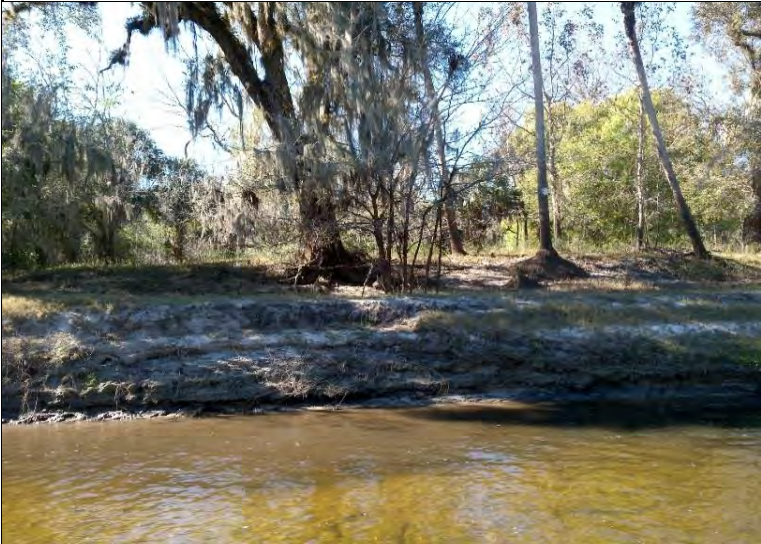
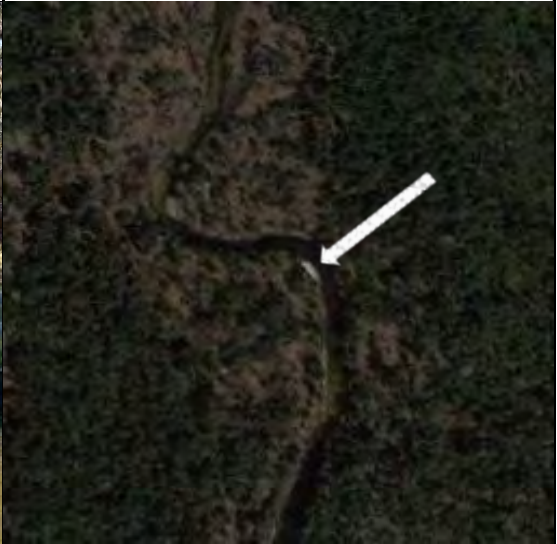
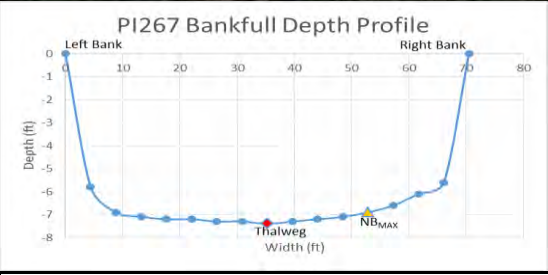
Peace River			Severity Scale: 4.0-Low
Watershed: Peace River Subwatershed: Peace River Branch Latitude: 27.38165 Longitude: -81.84265			County: Hardee Site Number: PI267 Reach Length: 133 ft. Landowner: Ben Hill Griffin Inc.

Pfankuch-Channel Stability:	Good	0	
Channel Alteration:	None	0	
Bank Erosion:	Active	1	
BEHI:	Moderate (26.98)	0.5	
Local NPSP:	Obvious Sources	1.5	
Shoring Structures:	None	0	
Pipe Discharge:	None	0	
Water Odor:	Normal	0	
Fish Passage Barrier:	None	0	
RB: Riparian Buffer:	40 ft.	0.5	
LB: Riparian Buffer:	40 ft.	0.5	
RB: Floodplain Access:	Full	0	
LB: Floodplain Access:	Full	0	
<b>Severity Scale:</b>		<b>4.0</b>	<b>Additional Site Features</b> Stream Channel Woody Material: Infrequent Impoundments: None Substrate Composition: Medium Sand Bank Material: Sand Near Bank Stress: Moderate RB Landuse: Pasture, Natural Forest LB Landuse: Pasture, Natural Forest

Notes: Impaired - Aquatic Life Harvesting (mercury in fish tissue)			
Restoration Option 2 or 3

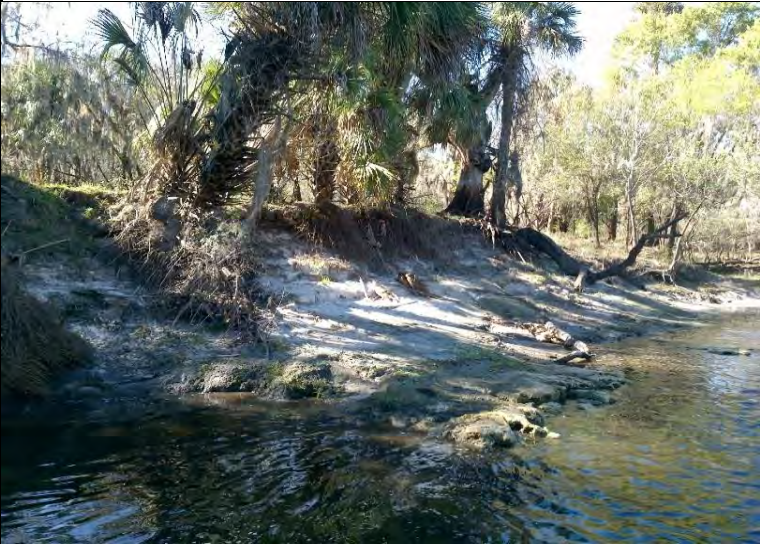
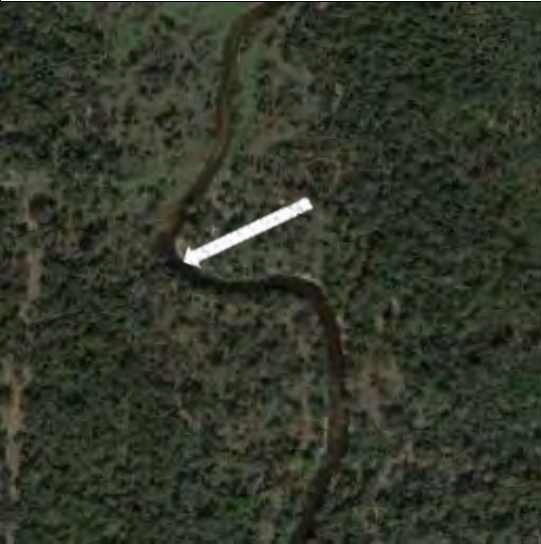
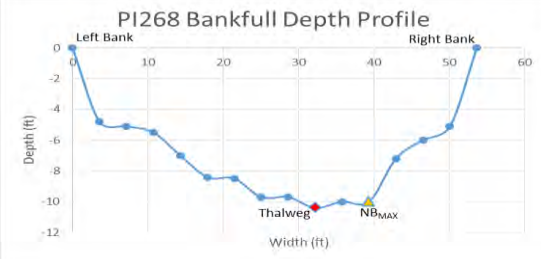
Peace River			Severity Scale: 4.75-Moderate
Watershed: Peace River Subwatershed: Peace River Branch Latitude: 27.38308 Longitude: -81.84419			County: Hardee Site Number: PI268 Reach Length: 41 ft. Landowner: Ben Hill Griffin Inc.

Pfankuch-Channel Stability:	Good	0	
Channel Alteration:	None	0	
Bank Erosion:	Active	1	
BEHI:	High (39.22)	1	
Local NPSP:	Obvious Sources	1.5	
Shoring Structures:	None	0	
Pipe Discharge:	None	0	
Water Odor:	Normal	0	
Fish Passage Barrier:	None	0	
			Additional Site Features
RB: Riparian Buffer:	40 ft.	0.5	Stream Channel Woody Material: Infrequent
LB: Riparian Buffer:	40 ft.	0.5	Impoundments: None
RB: Floodplain Access:	Partial	0.25	Substrate Composition: Medium Sand
LB: Floodplain Access:	Full	0	Bank Material: Sand
<b>Severity Scale:</b>			Near Bank Stress: Moderate
			RB Landuse: Pasture, Natural Forest
			LB Landuse: Pasture, Natural Forest

Notes: Impaired - Aquatic Life Harvesting (mercury in fish tissue)			
Restoration Option 1

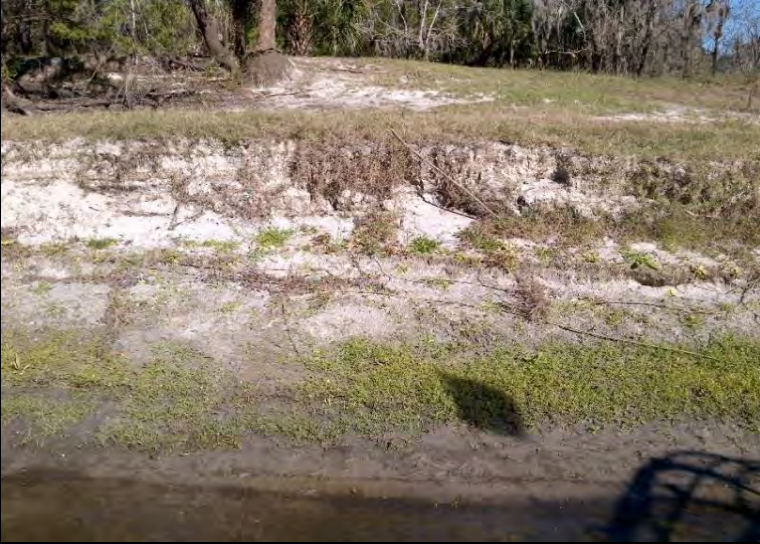
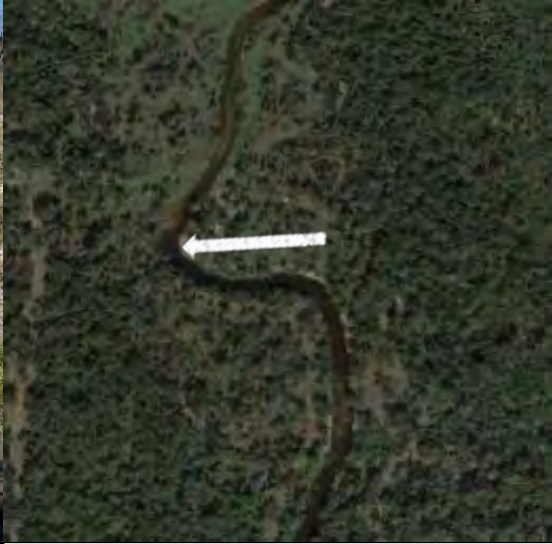
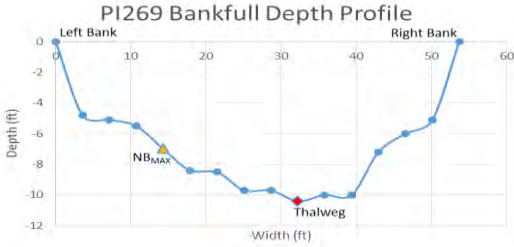
Peace River			Severity Scale: 4.75-Moderate
Watershed: Peace River Subwatershed: Peace River Branch Latitude: 27.38308 Longitude: -81.84419			County: Hardee Site Number: PI269 Reach Length: 15 ft. Landowner: Ben Hill Griffin Inc.

Pfankuch-Channel Stability:	Good	0	
Channel Alteration:	None	0	
Bank Erosion:	Active	1	
BEHI:	High (31.48)	1	
Local NPSP:	Obvious Sources	1.5	
Shoring Structures:	None	0	
Pipe Discharge:	None	0	
Water Odor:	Normal	0	
Fish Passage Barrier:	None	0	
RB: Riparian Buffer:	40 ft.	0.5	Additional Site Features
LB: Riparian Buffer:	40 ft.	0.5	
RB: Floodplain Access:	Partial	0.25	
LB: Floodplain Access:	Full	0	
Severity Scale:		4.75	
Notes: Impaired - Aquatic Life Harvesting (mercury in fish tissue)			Stream Channel Woody Material: Infrequent
Restoration Option 2 or 3			Impoundments: None
			Substrate Composition: Medium Sand
			Bank Material: Sand

Near Bank Stress: Low
			RB Landuse: Pasture, Natural Forest
			LB Landuse: Pasture, Natural Forest

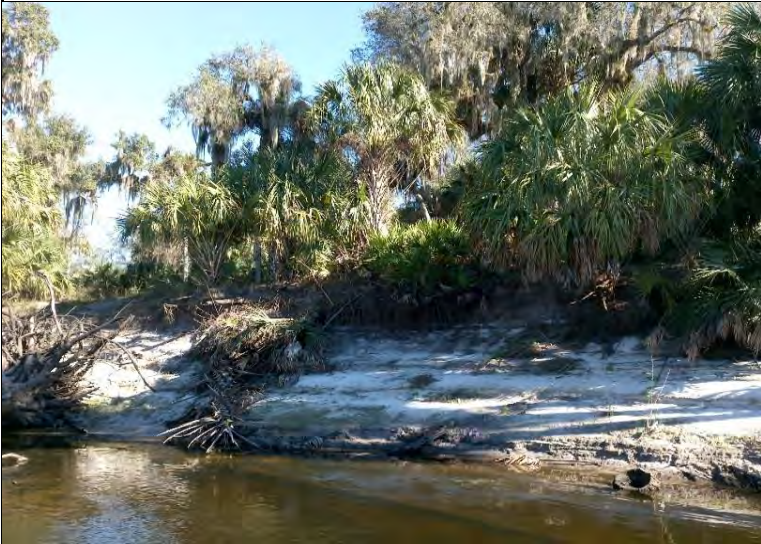
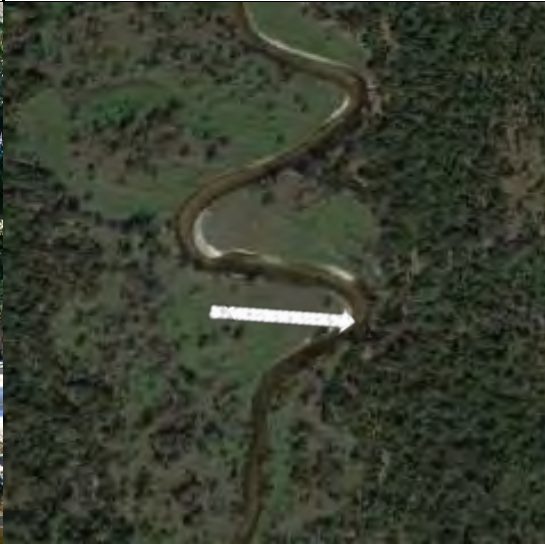
Peace River			Severity Scale: 6.5-Moderate
Watershed: Peace River Subwatershed: Peace River Branch Latitude: 27.38608 Longitude: -81.84283			County: Hardee Site Number: PI270 Reach Length: 62 ft. Landowner: Ben Hill Griffin Inc.

Pfankuch-Channel Stability:	Poor	1.5	
Channel Alteration:	None	0	
Bank Erosion:	Active	1	
BEHI:	High (39.45)	1	
Local NPSP:	Obvious Sources	1.5	
Shoring Structures:	None	0	
Pipe Discharge:	None	0	
Water Odor:	Normal	0	
Fish Passage Barrier:	None	0	
RB: Riparian Buffer:	0 ft.	0.75	
LB: Riparian Buffer:	40 ft.	0.5	
RB: Floodplain Access:	Full	0	
LB: Floodplain Access:	Partial	0.25	
<b>Severity Scale:</b>		<b>6.5</b>	
Notes: Impaired - Aquatic Life Harvesting (mercury in fish tissue)			<b>Additional Site Features</b>
			Stream Channel Woody Material: Numerous
			Impoundments: None
			Substrate Composition: Medium Sand
			Bank Material: Sand
			Near Bank Stress: Moderate

RB Landuse: Pasture
			LB Landuse: Pasture, Natural Forest
Restoration Option 1
